MINERALS PROGRAM INSPECTION REPORT
PHONE: (303) 866-3567

MINE NAME: Pikeview Quarry	MINE/PROSPECTING ID#: M-1977-211	MINERAL: Limestone (general), granite gneiss and do	COUNTY: El Paso
INSPECTION TYPE: Monitoring	WEATHER: Clear	INSP. DATE: September 30, 2024	INSP. TIME: 10:00
OPERATOR: Riverbend Industries Inc.	OPERATOR REPRESENTATIVE: Jerry Schnabel	TYPE OF OPERATION: 112c - Construction Regular Operation	
REASON FOR INSPECTION: Normal I&E Program	BOND CALCULATION TYPE: None	BOND AMOUNT: \$6,805,607.00	
DATE OF COMPLAINT: NA	POST INSP. CONTACTS: None	JOINT INSP. AGENCY: None	
INSPECTOR(S): Hunter Ridley	INSPECTOR'S SIGNATURE:

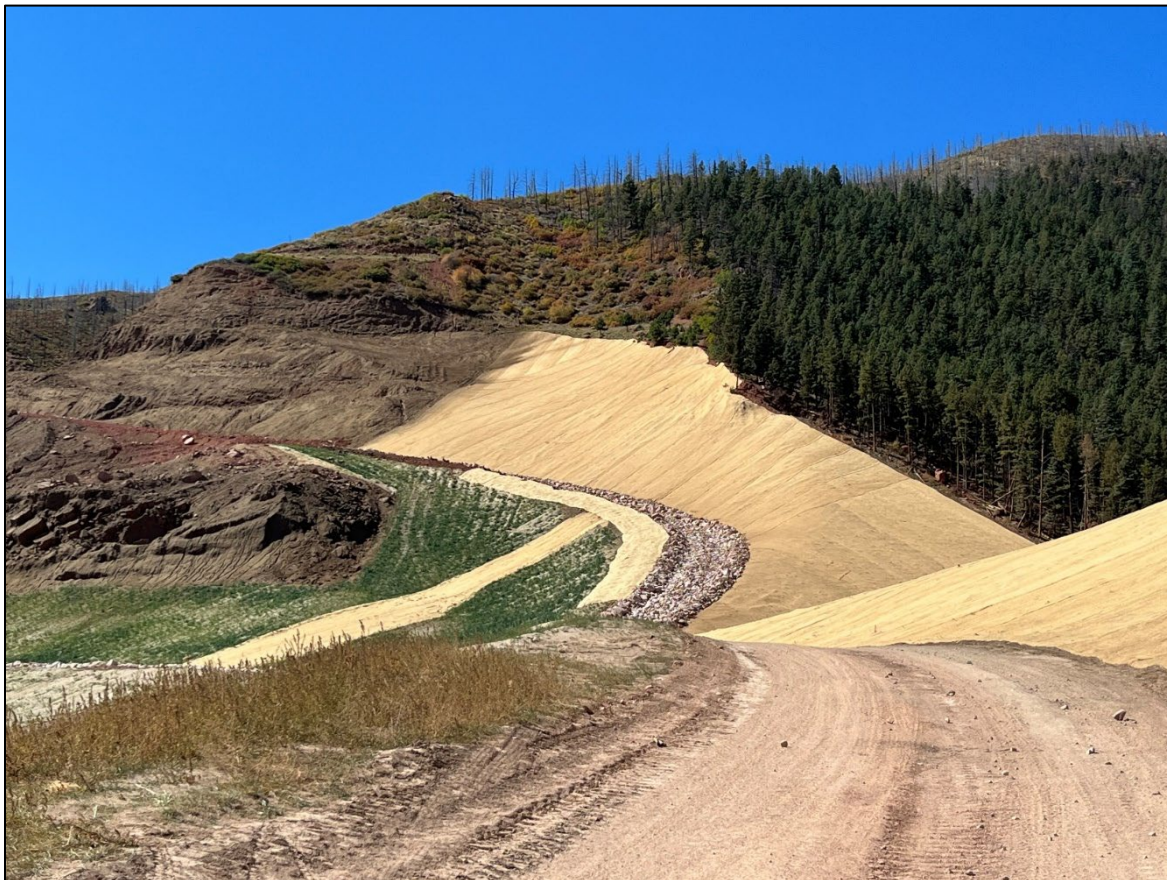
Hydroseeding of the upper peaks is complete and matting has been completed on benches just below this area (Photo 1). All matted areas continue to show signs of stability in supporting grasses and shrubs. Areas which were first matted are supporting thickening vegetation, with a diverse level of species coming through, ranging from grasses to shrubs to forbs. Newly mated areas, such as in the north borrow area and top slopes (Photo 1, 2, and 7), show small sprouts of growth within the first few weeks of mat placement. The north borrow area has been re drill seeded, mulched, and matted on Forest Service property. Tree plantings were preserved in this area by cutting holes in the new mat to accommodate the seedlings before final mat placement. Trees planted across the site are experiencing some dieback, but shrubs seem to be less impacted by Bighorn activity as previously.

Final configurations of the surface water drainage channels continue to be constructed onsite as per the approved design. All minor channels have received rip rap (Photos 1, 3, and 4). As final reclamation progresses, rip rap of various sizes will be used to stabilize major channels, depending on slope or the presence of bedrock. All rip rap needed for construction is already stored on site in the lower rip rap quarry area.

Photo 1: View west of the northern section of the upper bench, 'bare' areas have been hydro mulched, and the channel has been rip rapped.

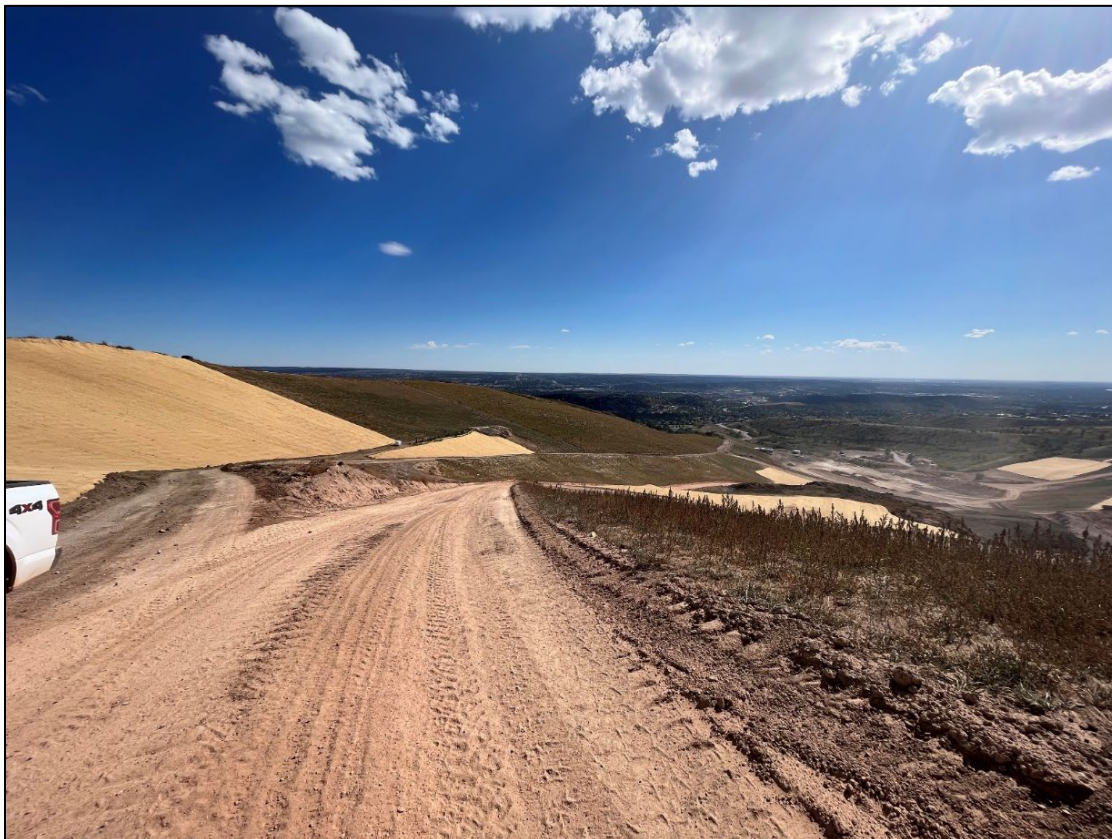
Photo 2: View east of the recently matted, mulched, and seeded north borrow area.

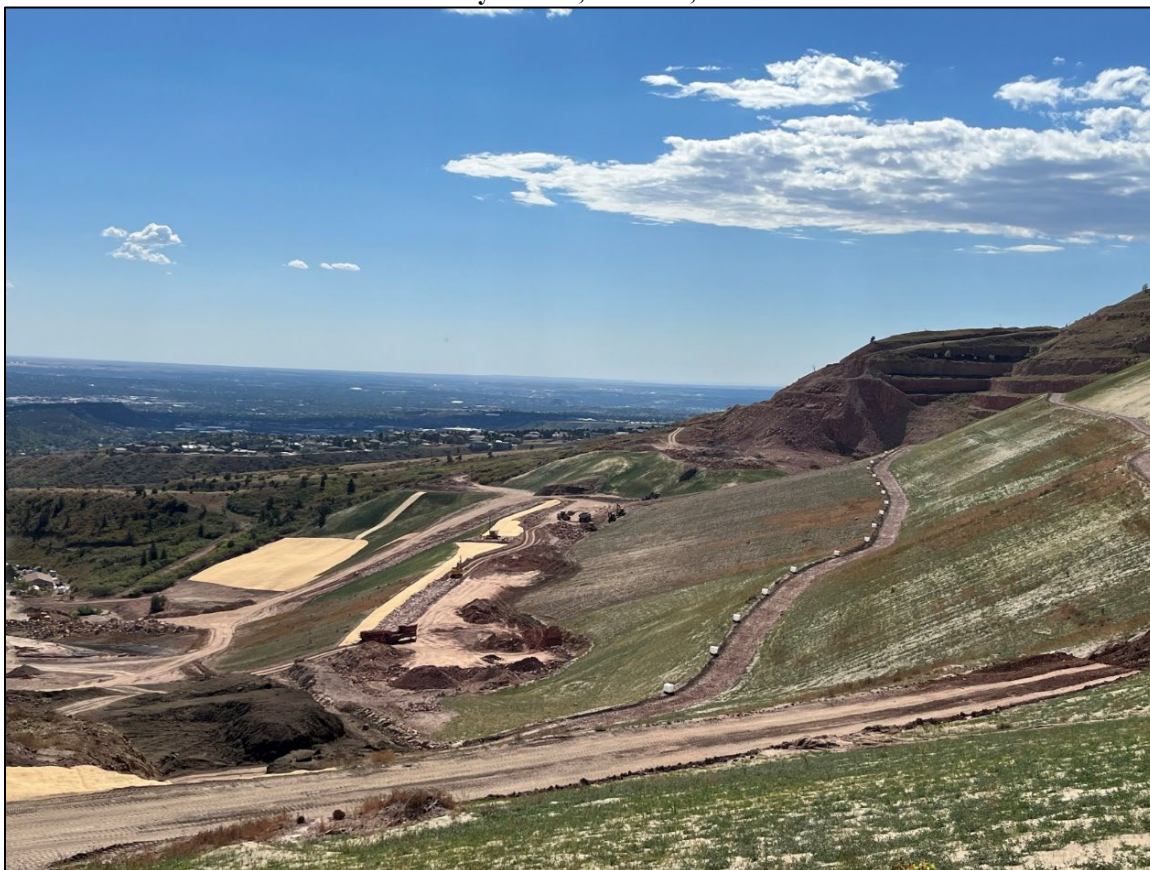
Recent vegetation growth was observed across the main buttress portion of the site (Photos 3 and 4). Irrigation tanks are located on the lower buttress bench (Photo 3), but site representatives stated that these are likely to be removed soon. No additional irrigation tanks are planned to be added anywhere onsite. Instead, the site will opt for more sporadic watering via a water truck. As previously discussed, irrigation may weaken the long-term stability of slope vegetation. Instead, more infrequent watering of the slopes may set vegetation up for more success in final reclamation and create vegetated conditions that are in compliance with Rule 3.1.10(1).

Photo 3: View south of the partially revegetated buttress and water tanks along the first bench.

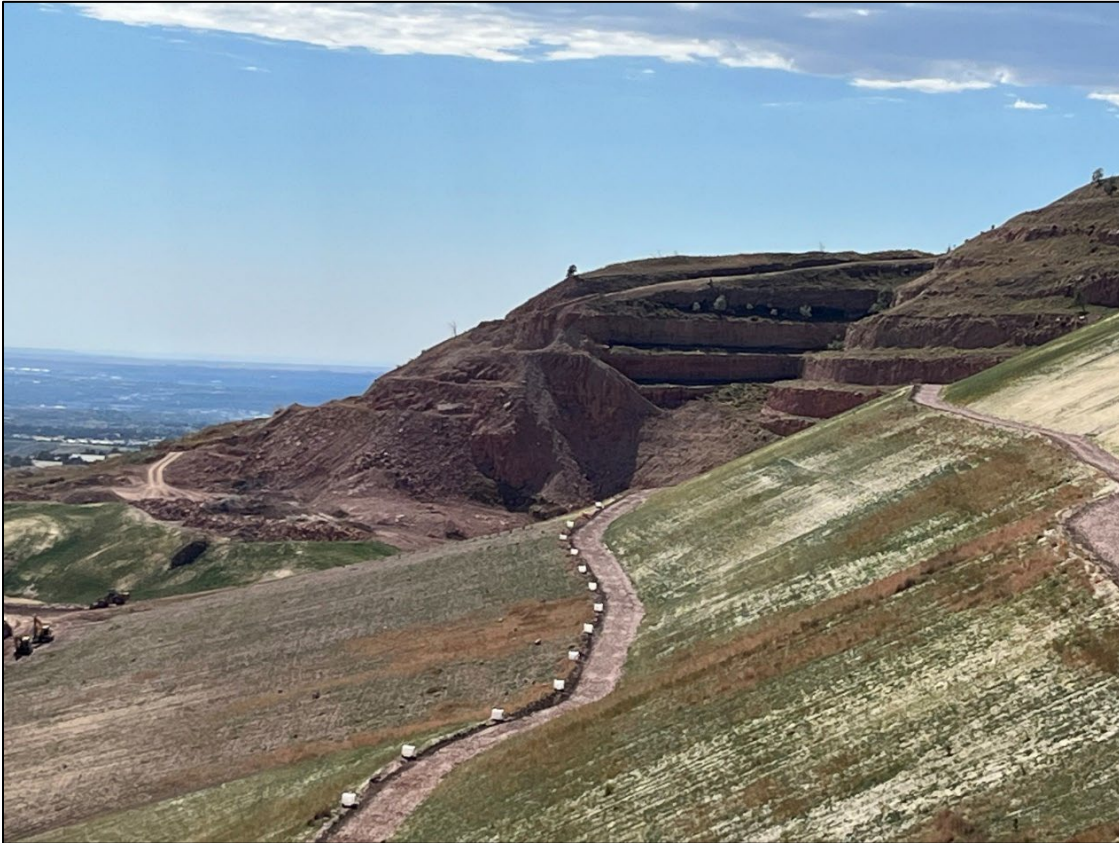
Photo 4: View south of the north facing slope of the south borrow area, to be partially backfilled and seeded.

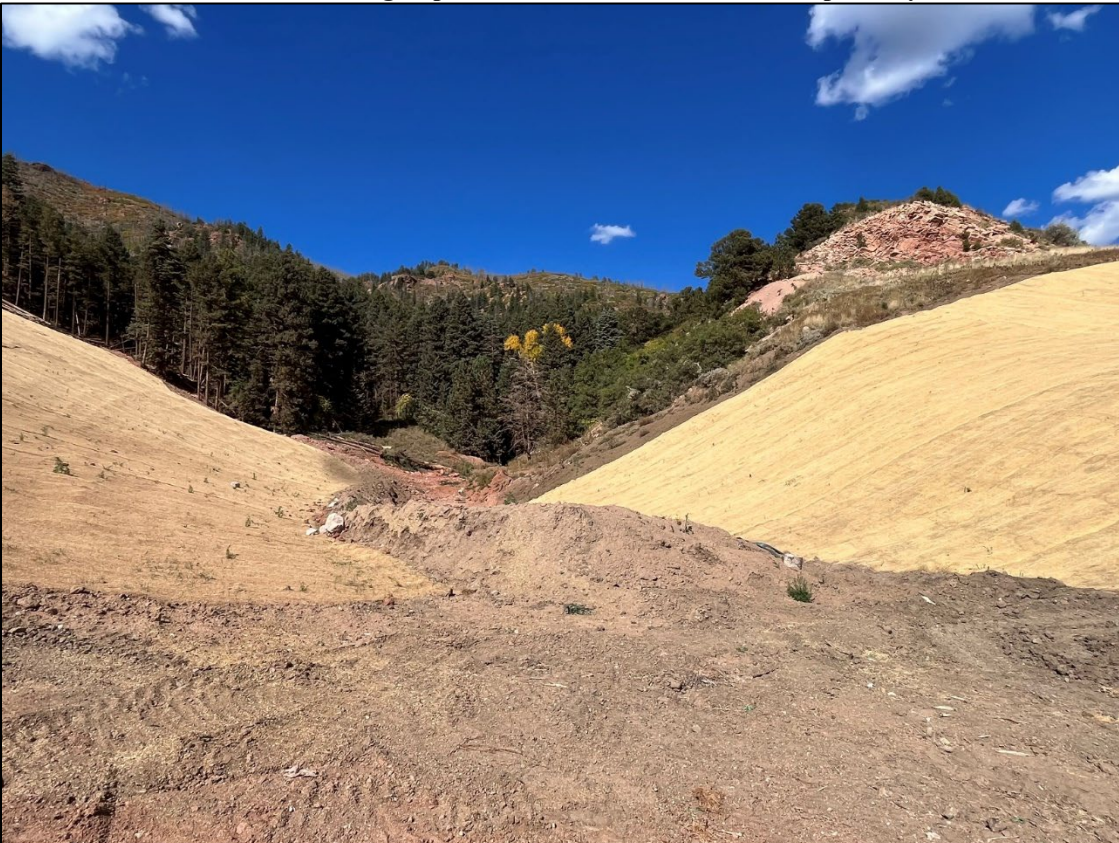
Hydrologic Balance: The area where a large culvert was previously is the highest accessible area via vehicle (Photo 5). The Division and site representatives hiked up to upper levels to inspect.

Photo 5: View northwest of the area where a large culvert was previously removed, this area will be cut to form the start of the main northern channel.

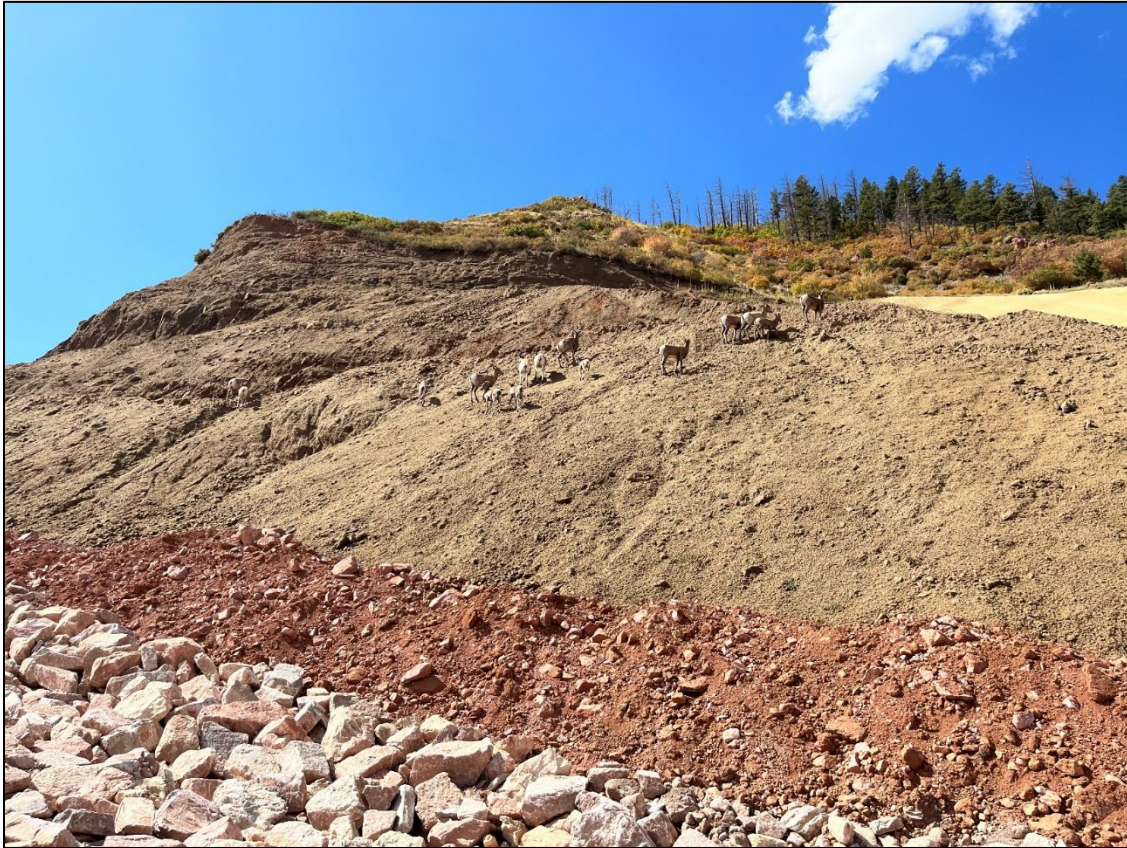
Fish and Wildlife: No negative impact on wildlife was observed. A small herd of ~12 Bighorn sheep and lambs were observed laying atop the upper most site benches (Photo 6).

Photo 6: A small group of Bighorn sheep were observed on the slopes upper benches.

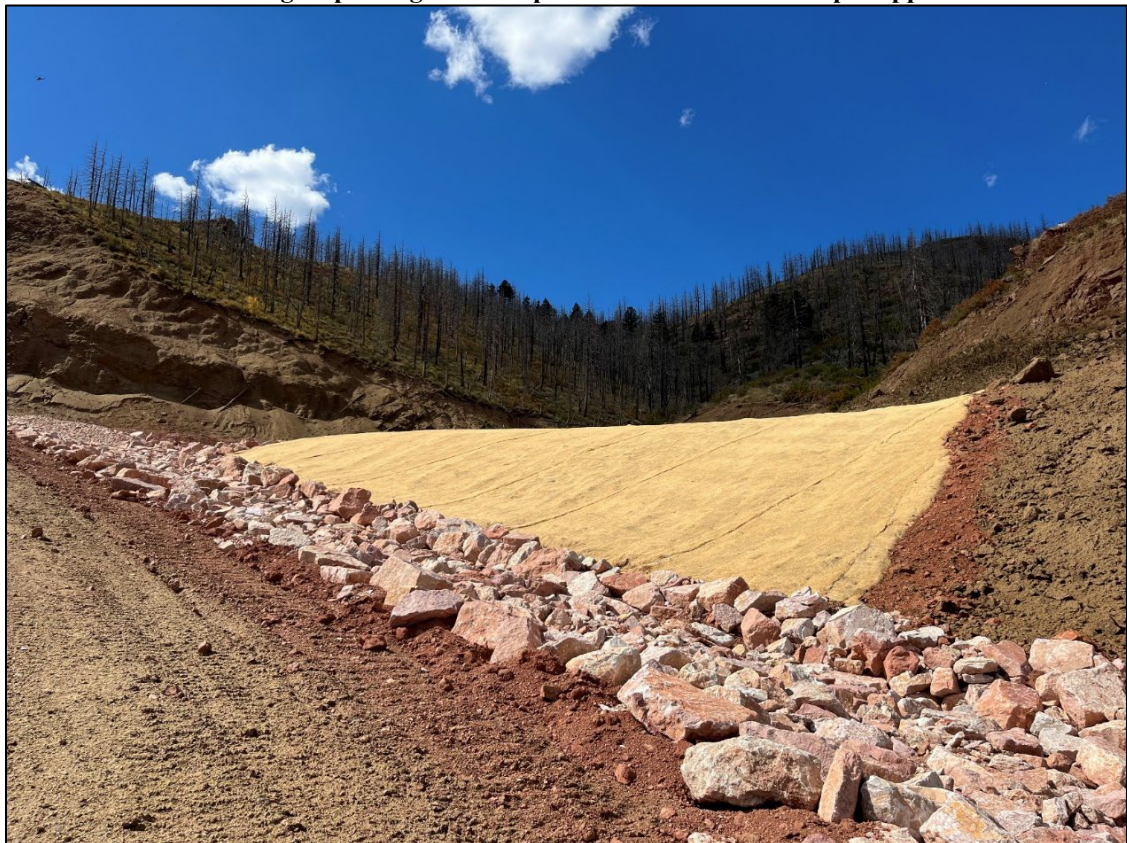
Pikeview has also addressed the future of the small water impoundment located near the top slopes, below the north peak area. This feature, also known as the 'sheep pond' onsite will be completely removed via final grading work. To address the seep in this area which creates the feature, a vertical standpipe will be added to direct the seep water into a 'guzzler system' (Photo 7). This system was recommended by CPW as a way to maintain the seep as a water source and continue to support the local population of Bighorn sheep. Since the system is mostly enclosed, this also relieves the need for an augmentation plan to cover evaporative losses. An excess water will be directed downslope into the approved main channel area.

Photo 7: View west of the slope where the CPW recommended 'guzzler' system will be installed to direct seep water out of the hillside, through the guzzler system, and down into the main channel.

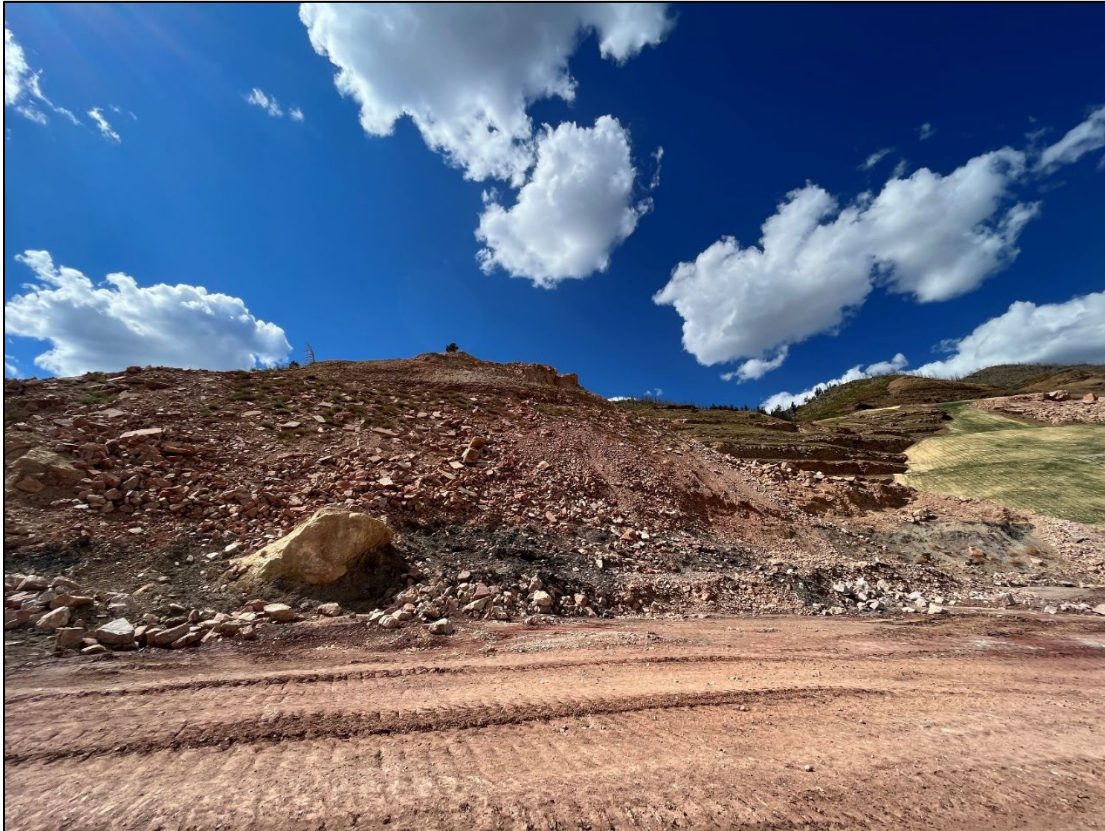
Photo 8: View south of the north face of the south borrow area.
