QUARTERLY SEDIMENTATION POND INSPECTION REPORT

CDMR Rule 4.05.9(17)

Mine: New Elk WP Containment #1

Inspection Period: Third Quarter 2024

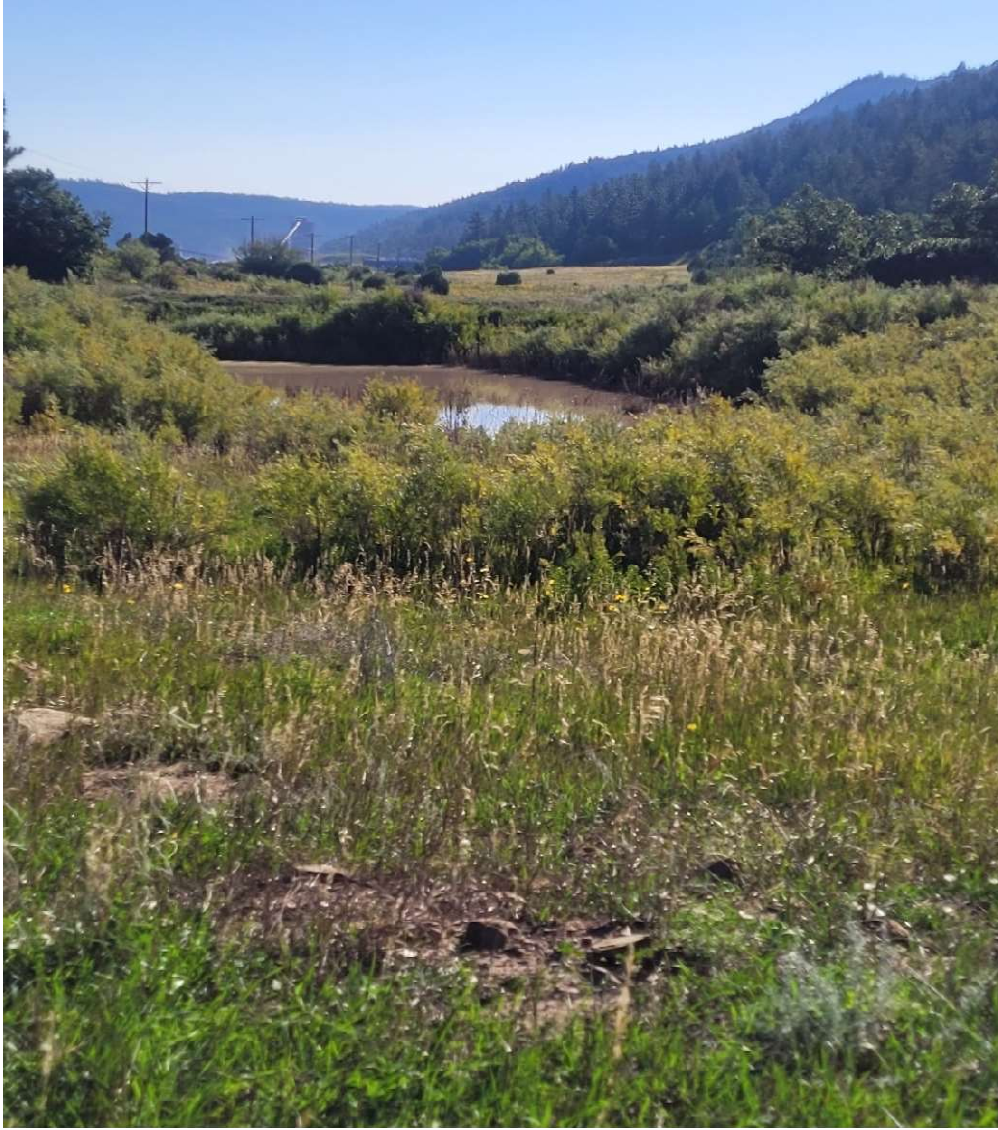
Containment was holding water at the time of inspection.

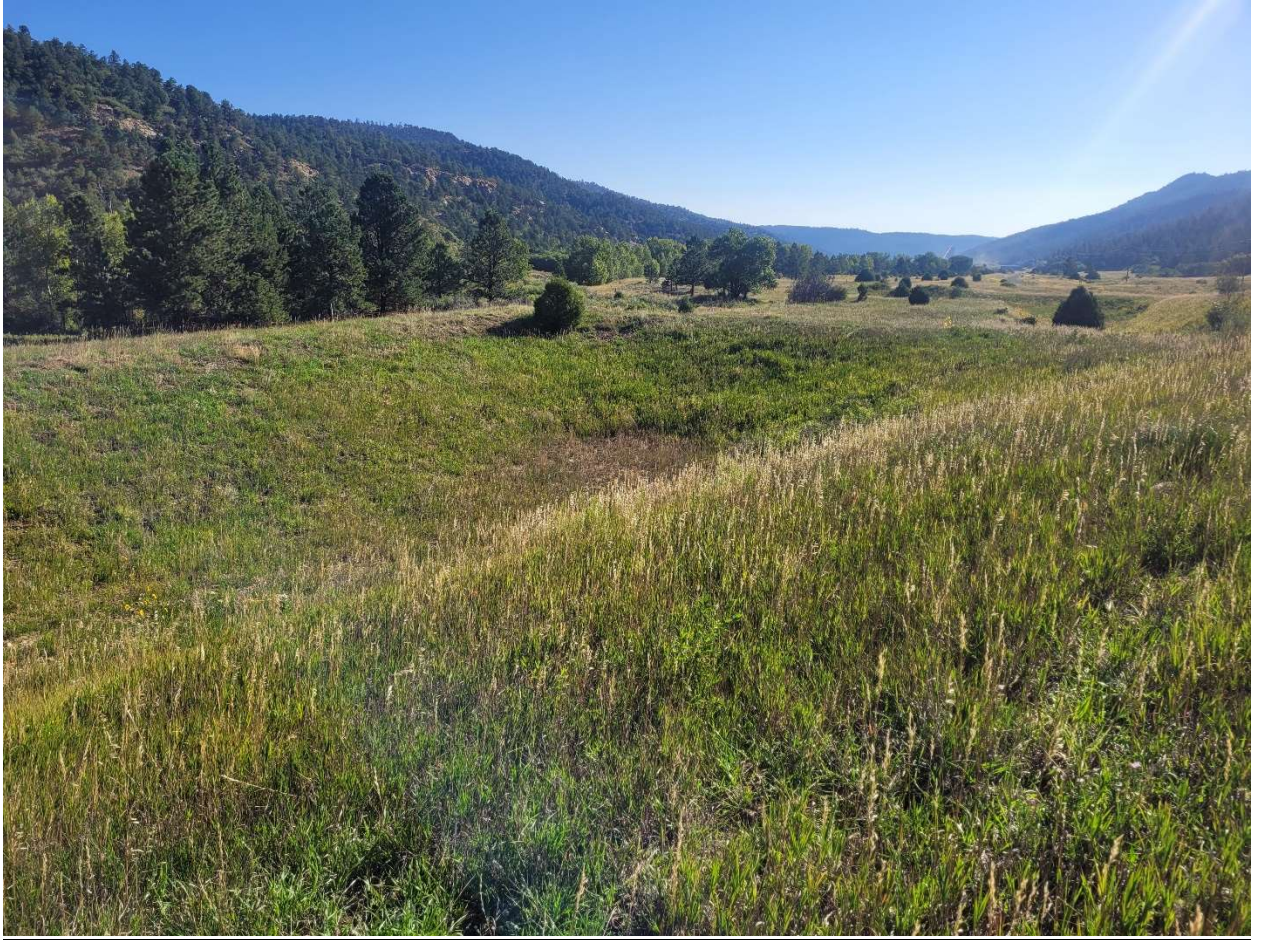
Mine: New Elk WP Containment #2

Containment was empty at time of inspection.

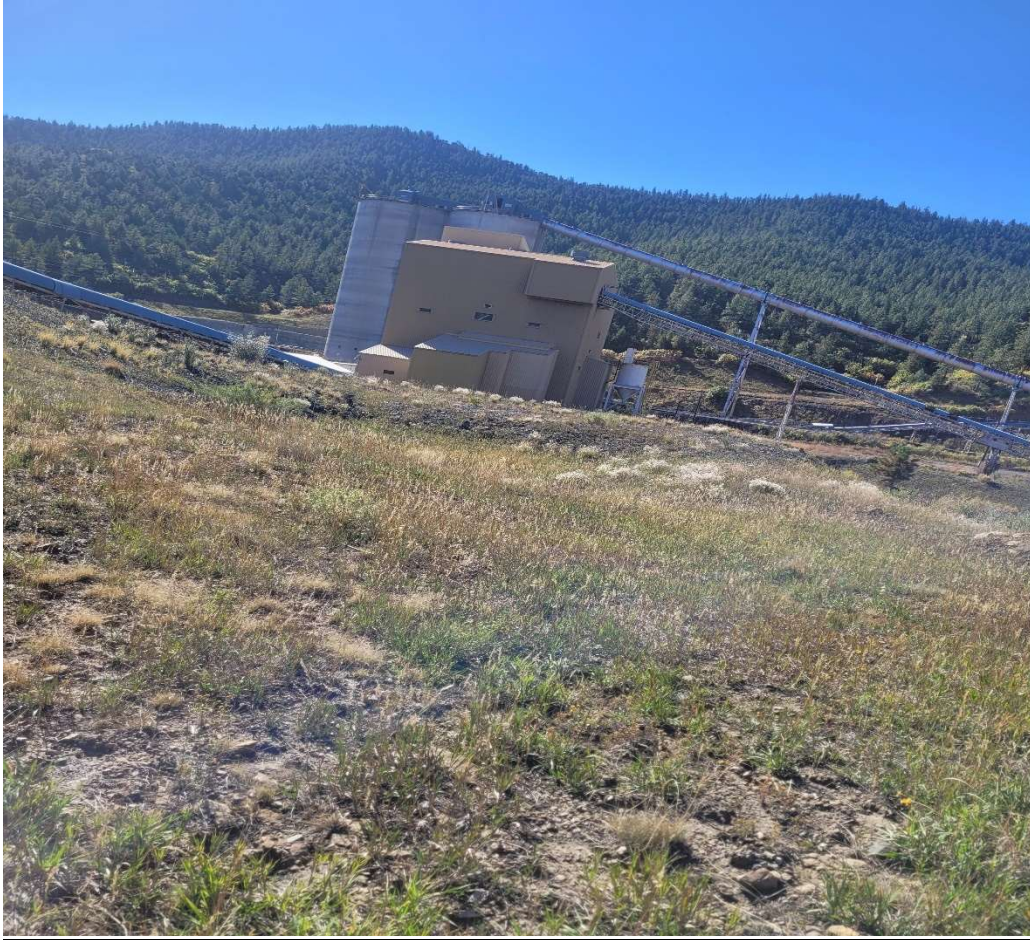
Mine: New Elk Containment #3

Containment Area was dry and in good condition at time of inspection.

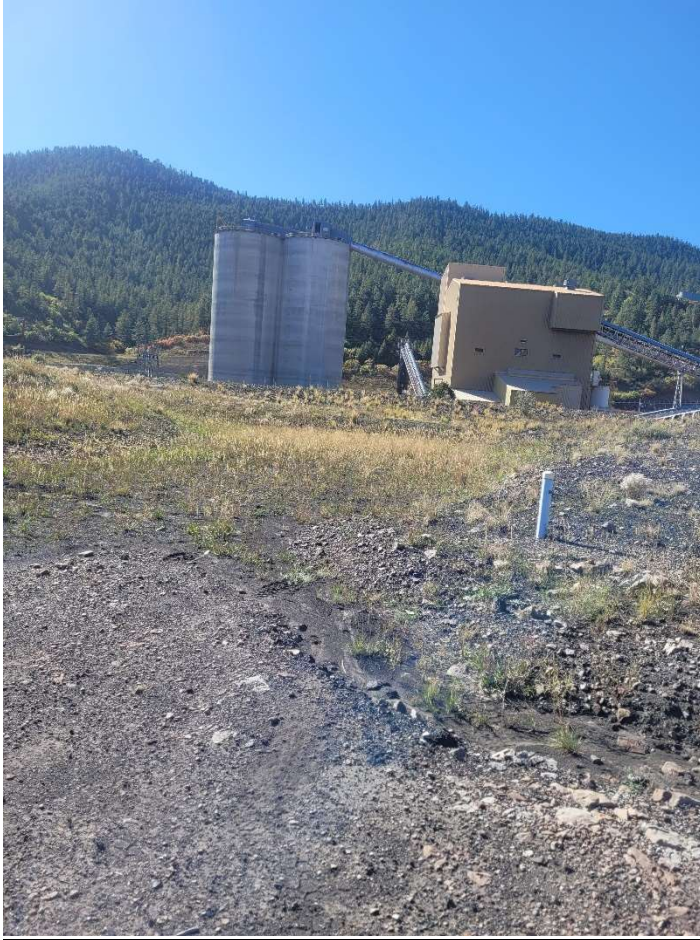
Mine: New Elk Containment #4

Containment Area was in good condition and not holding any water at time of inspection.

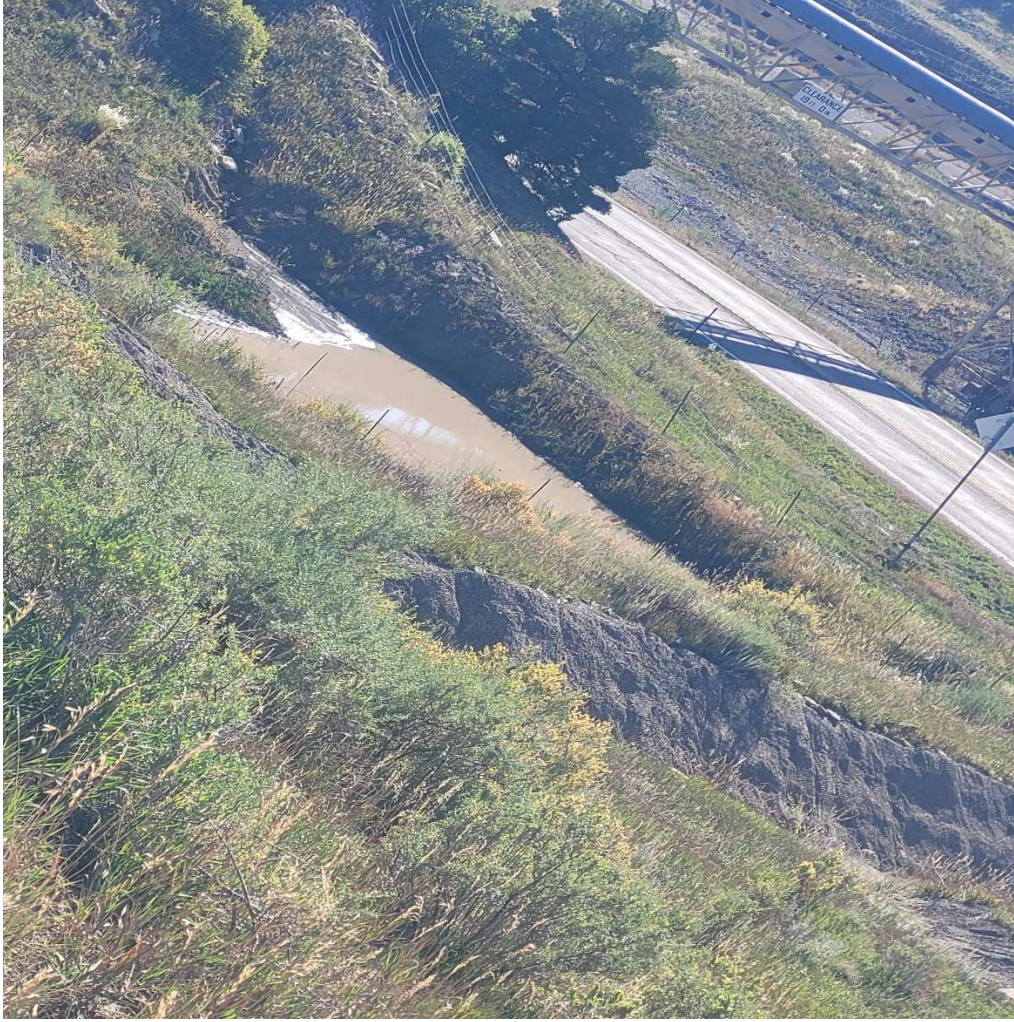
Mine: New Elk Containment #5

Containment Area was holding water and in good working order at time of inspection. It was cleaned in May of 2024.

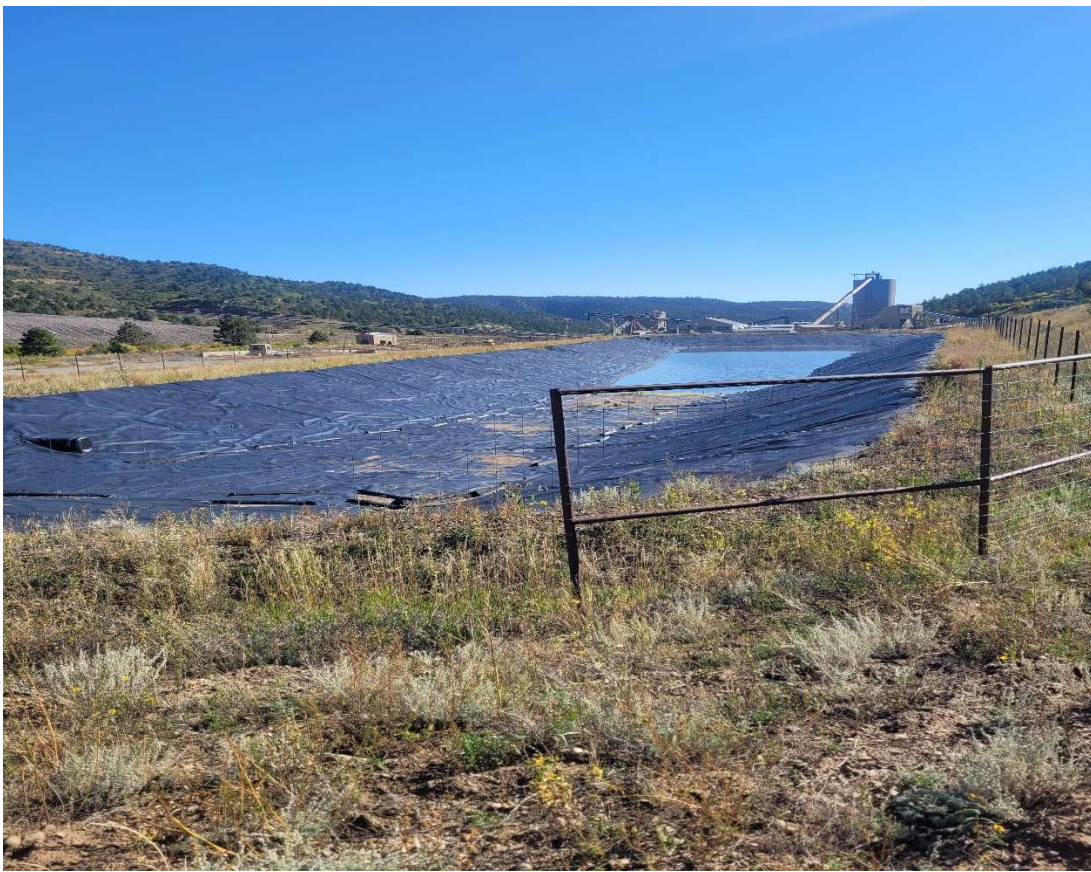
NPDES ID. No.: Pond #1

Pond liner is in good working condition at time of inspection. Pond was holding a small amount of water at time of Inspection. No issues observed.

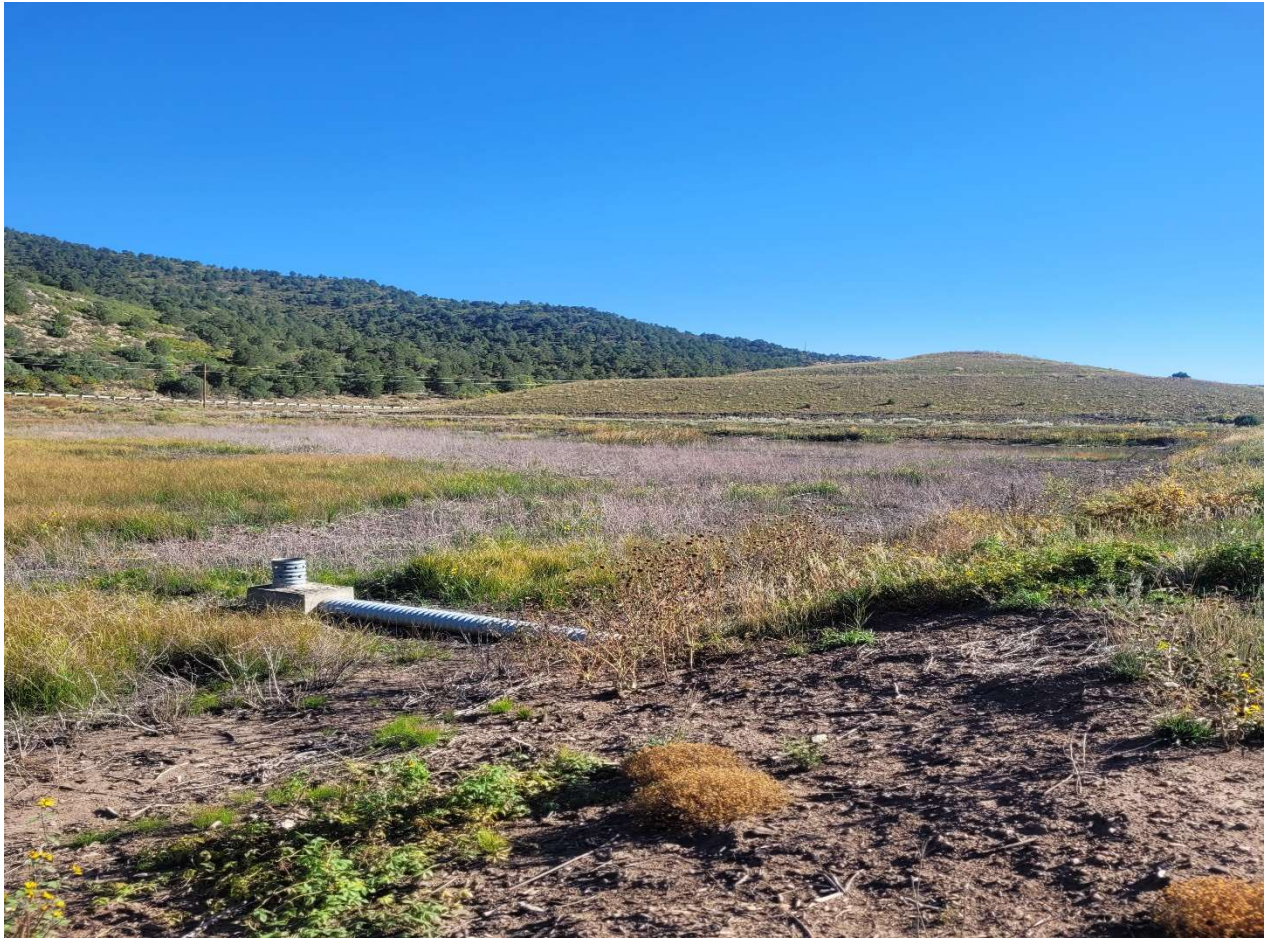
NPDES ID. No.: Pond #4

Pond was holding a small amount of water at the time of inspection, not near the discharge level. No Issues observed.

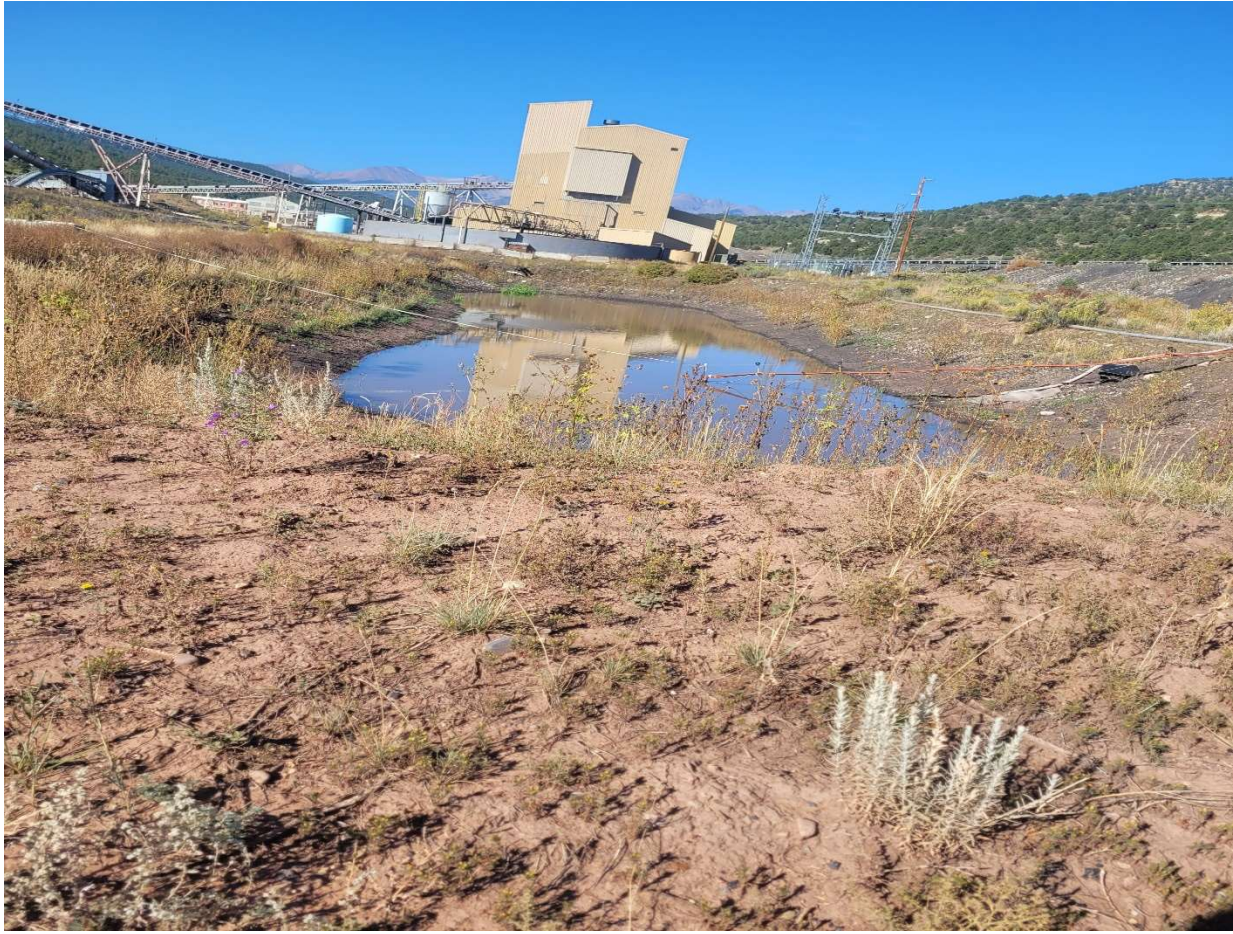
Mine: New Elk Pond 6

Pond is holding water at time of inspection; No issue observed.

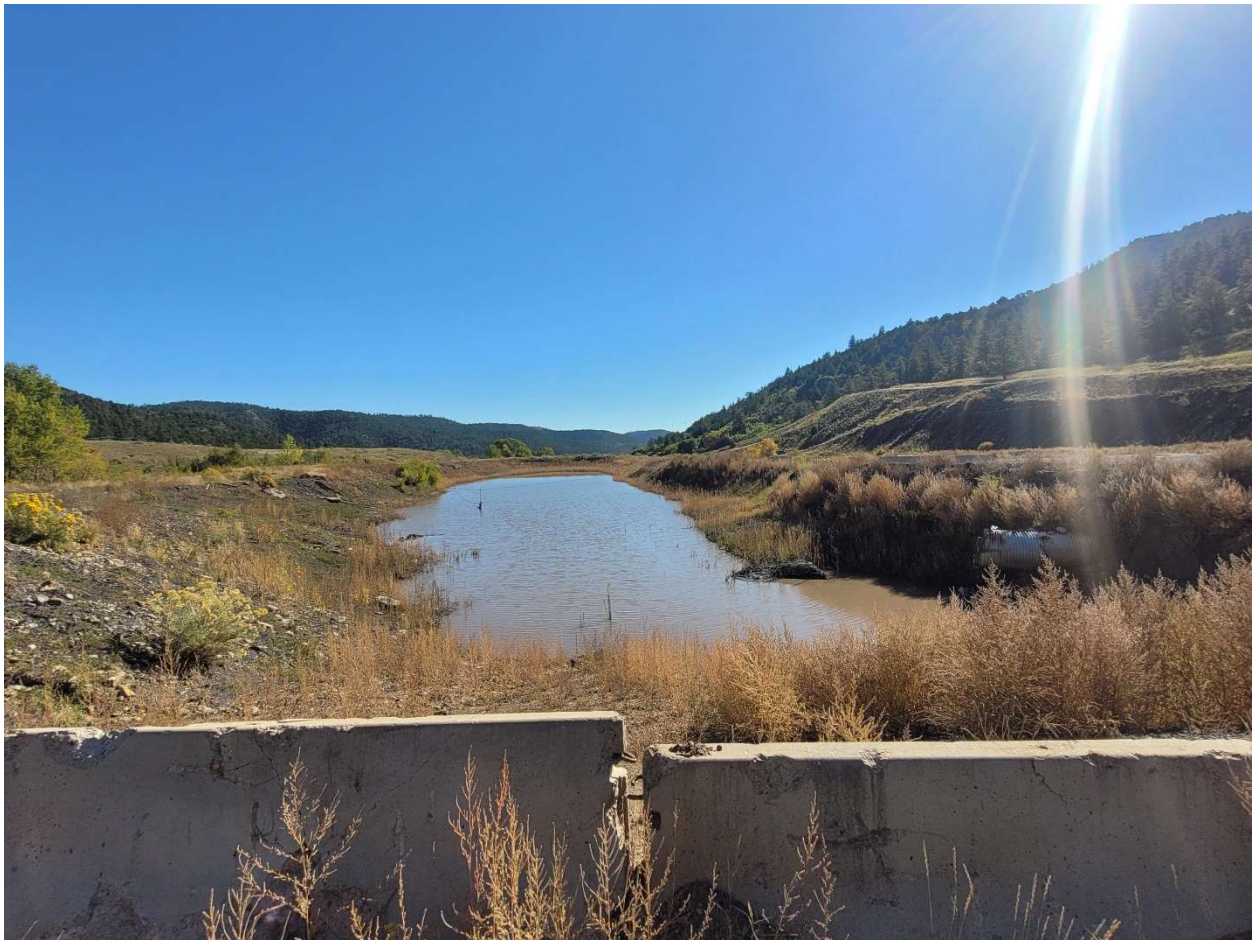
NPDES ID. No.: Pond #7

Pond is holding water at time of inspection. No issues observed.

No discharges have occurred, water level was still below the needed compacity level need for compliance

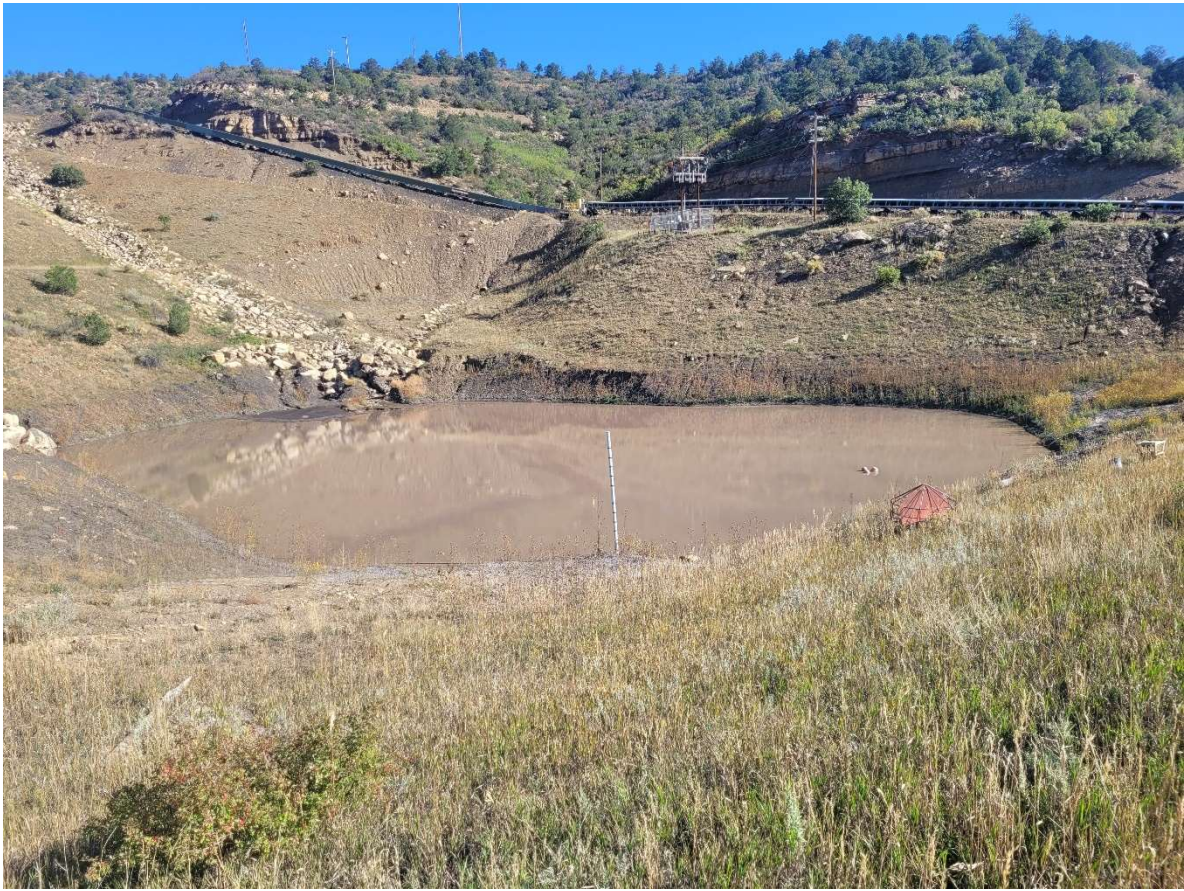
NPDES ID. No.: Pond #8

Pond is holding water at time of Inspection. The water level is now about 1 foot above the measuring device and has more than the design compacity. No discharges have occurred and No issues were found during the inspection.
