**MINERALS PROGRAM INSPECTION REPORT**  
**PHONE: (303) 866-3567**

<b>MINE NAME:</b> Ralston Quarry	<b>MINE/PROSPECTING ID#:</b> M-1974-086	<b>MINERAL:</b> Aggregate	<b>COUNTY:</b> Jefferson
<b>INSPECTION TYPE:</b> Monitoring	<b>WEATHER:</b> Cloudy	<b>INSP. DATE:</b> October 8, 2024	<b>INSP. TIME:</b> 11:30
<b>OPERATOR:</b> Oldcastle SW Group, Inc. DBA Asphalt Paving	<b>OPERATOR REPRESENTATIVE:</b> Sara Weimer	<b>TYPE OF OPERATION:</b> 112c - Construction Regular Operation	
<b>REASON FOR INSPECTION:</b> Normal I&E Program	<b>BOND CALCULATION TYPE:</b>	<b>BOND AMOUNT:</b> \$3,680,700.00	
<b>DATE OF COMPLAINT:</b> NA	<b>POST INSP. CONTACTS:</b> None	<b>JOINT INSP. AGENCY:</b> None	
<b>INSPECTOR(S):</b> Ben Hammar Zach Trujillo	<b>INSPECTOR'S SIGNATURE:</b>

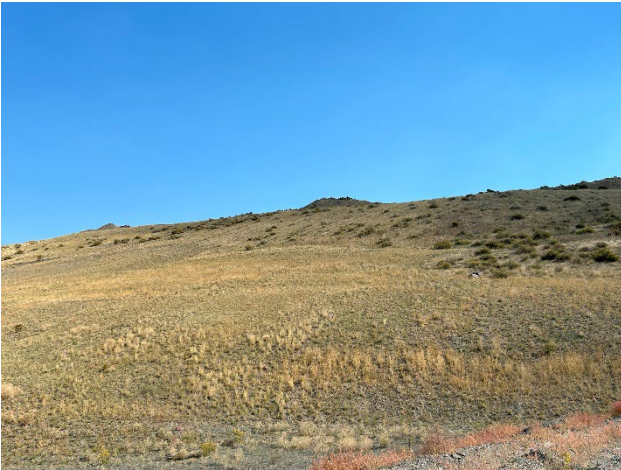
The permit boundary and site entrance were clearly marked by a fence line and posted DRMS permit sign respectively. APC representative Sara Weimer met DRMS at the mining office, and the inspection commenced with the remediated area previous impacted by slope failures. At the time of this inspection the slope appears to be well monitored and revegetated with no signs of continued slippage.

Photo 1: Revegetated and regraded site of past slope failure.

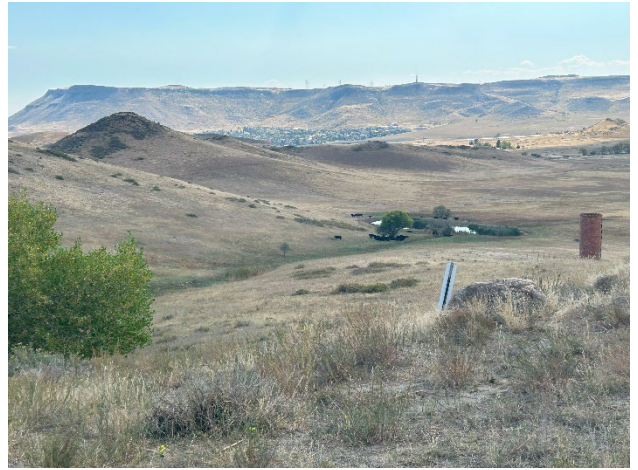
Photo 2: Pond located outside permit boundary, which flows into Van Bibber Creek.

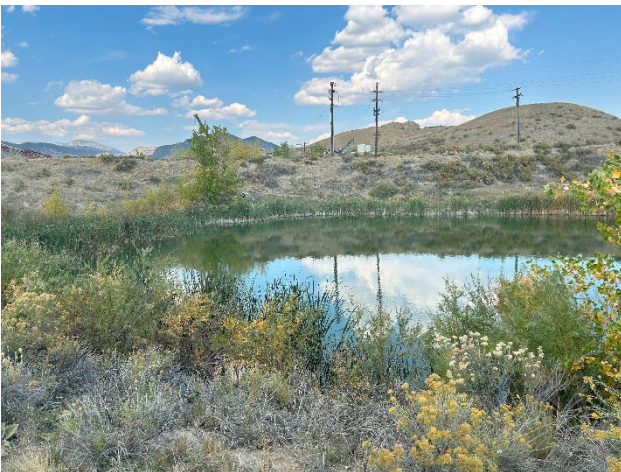
Photo 3: Detention basin #3.

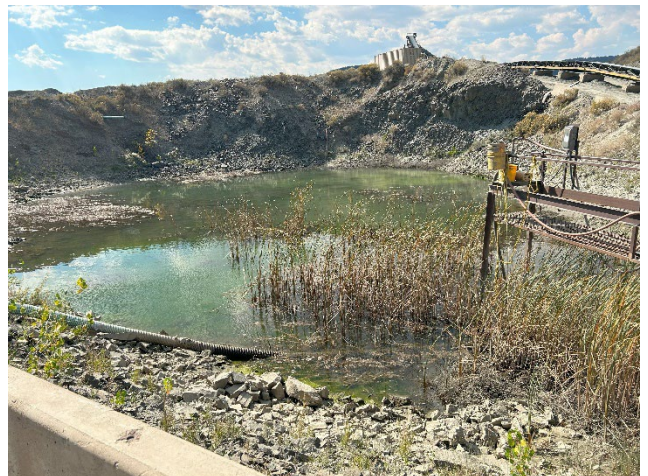
Photo 4: Detention basin #4.

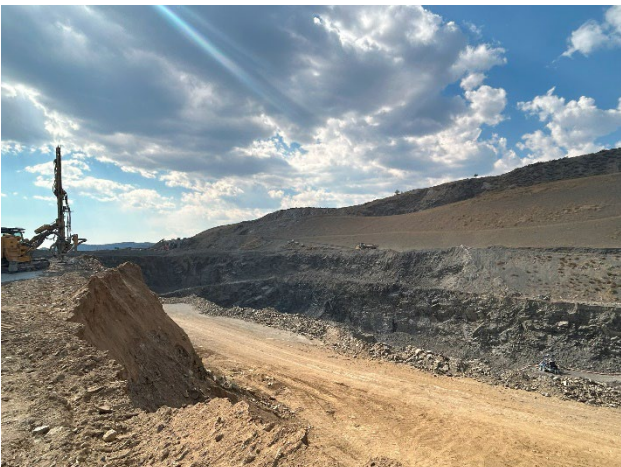
Photo 5: Representative photo of current mining activity.

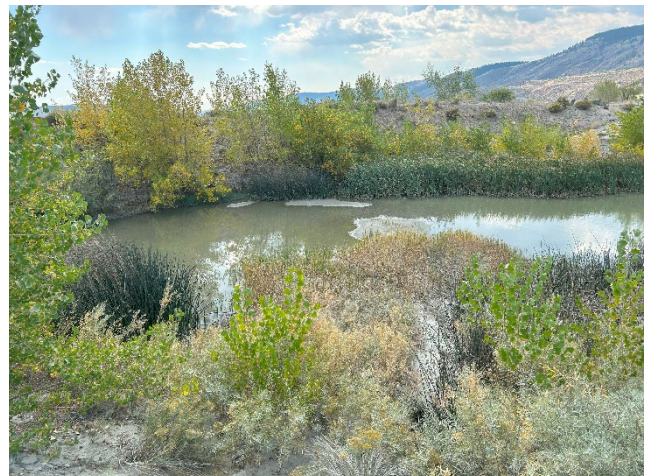
Photo 6: Detention basin #2.

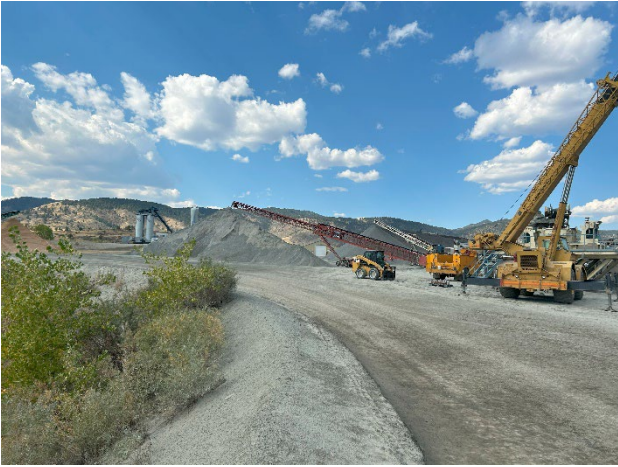
Photo 7: Current processing activity and stockpiles.

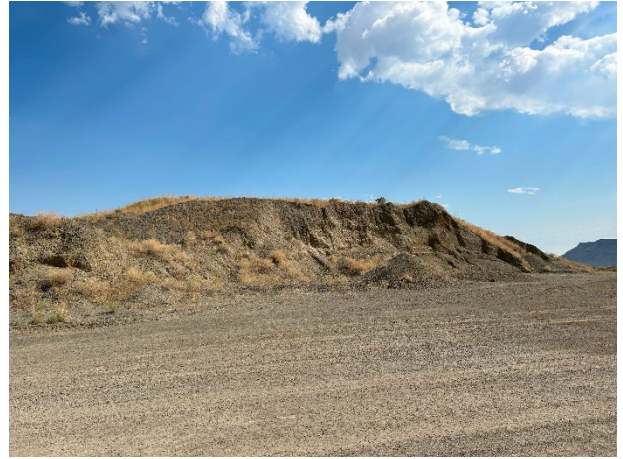
Photo : Seeded and stable topsoil pile.
