MINERALS PROGRAM INSPECTION REPORT
PHONE: (303) 866-3567

MINE NAME: Loesch Pit	MINE/PROSPECTING ID#: M-1981-068	MINERAL: Sand and gravel	COUNTY: Garfield
INSPECTION TYPE: Surety-Related Inspection	WEATHER: Clear	INSP. DATE: September 23, 2024	INSP. TIME: 14:00
OPERATOR: Western Slope Materials, LLC	OPERATOR REPRESENTATIVE: Sean Mello	TYPE OF OPERATION: 112c - Construction Regular Operation	
REASON FOR INSPECTION: Surety Related	BOND CALCULATION TYPE: Complete Bond	BOND AMOUNT: \$0.00	
DATE OF COMPLAINT: NA	POST INSP. CONTACTS: None	JOINT INSP. AGENCY: None	
INSPECTOR(S): Todd Jesse	INSPECTOR'S SIGNATURE:

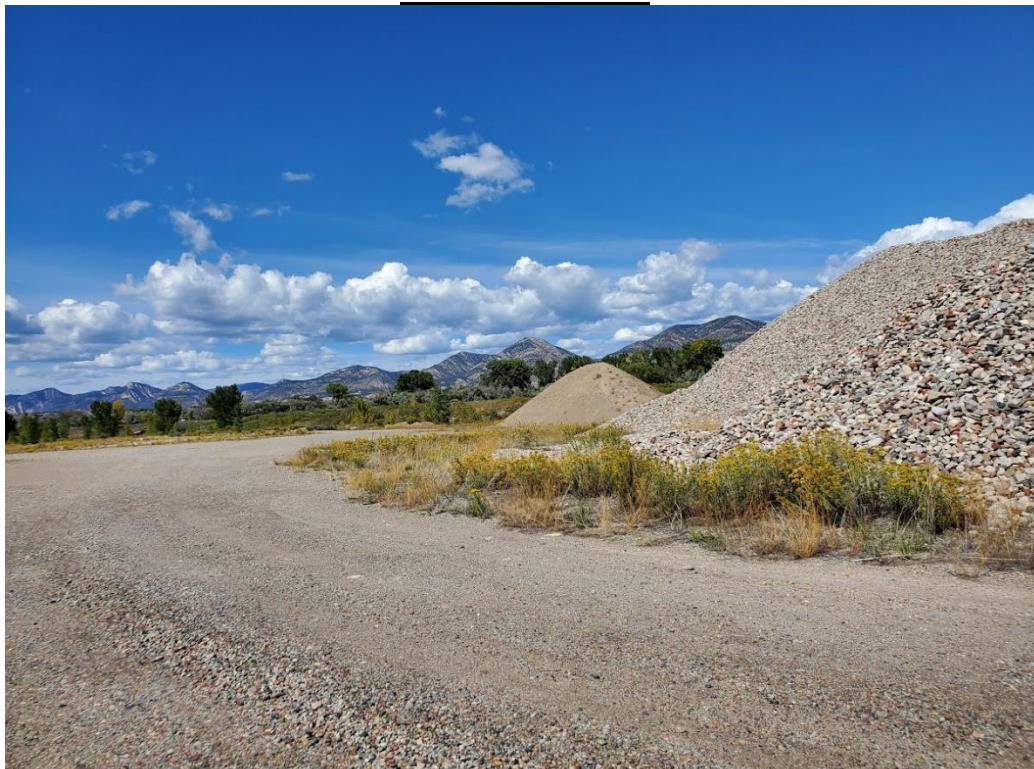
Mining is being conducted in accordance with the approved mining plan. At the time of the inspection, approximately 75 acres of the approved 167 acres were disturbed. Mining is occurring from east to west. There is a highwall approximately 700'-800' in length in the southwest corner of the pit. Product stockpiles are located within the pit. The western portion of the permit boundary is undisturbed.

Photo 1: View to the northwest of product stockpiles on pit floor

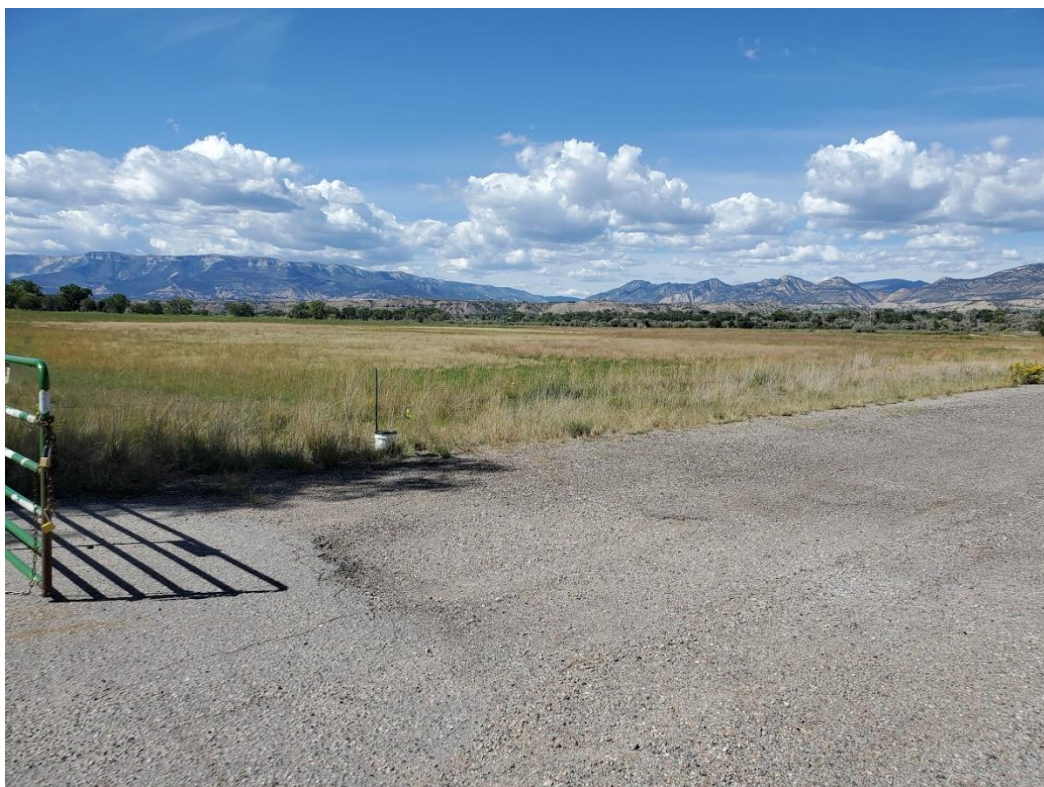
Photo 2: View to the northwest of undisturbed portions of the permit.

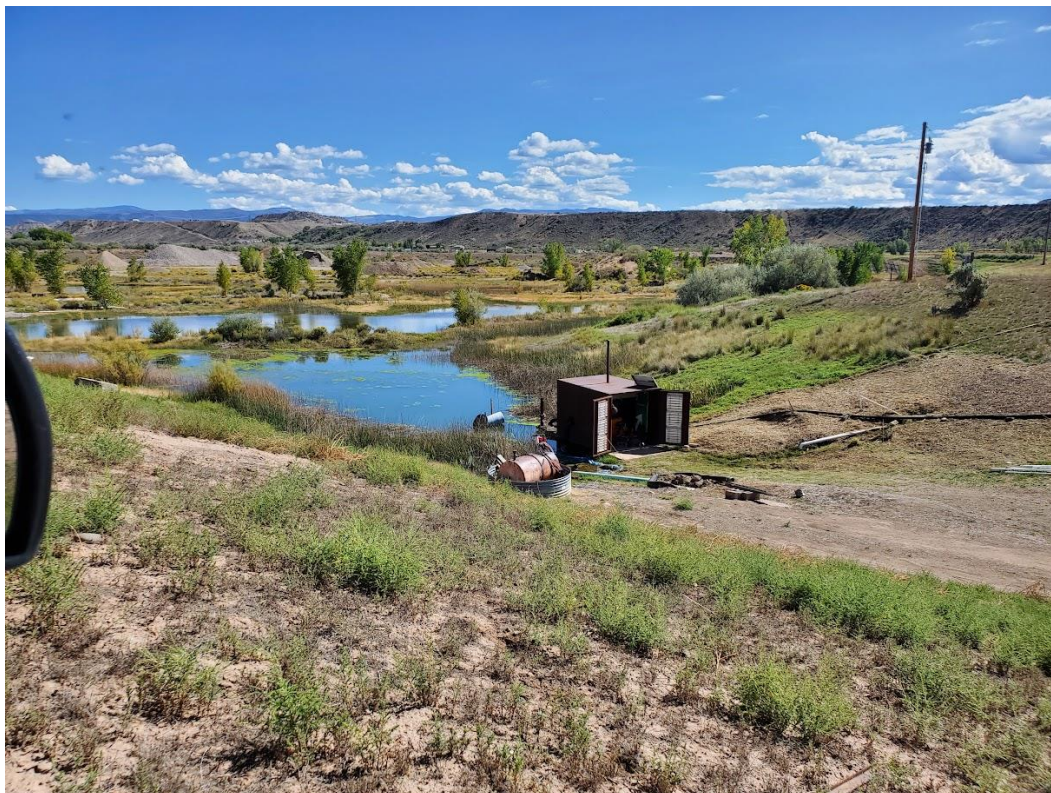
Groundwater has been exposed in the pit. The pit is being dewatered and the operator has a CPDPHE permit to discharge. A small ditch runs across the pit floor to direct seeping groundwater to the northwest corner of the pit. The water collects in a small pool with a pump house and is then discharged to the Colorado River.

Photo 3: View to the southeast of dewatering system.

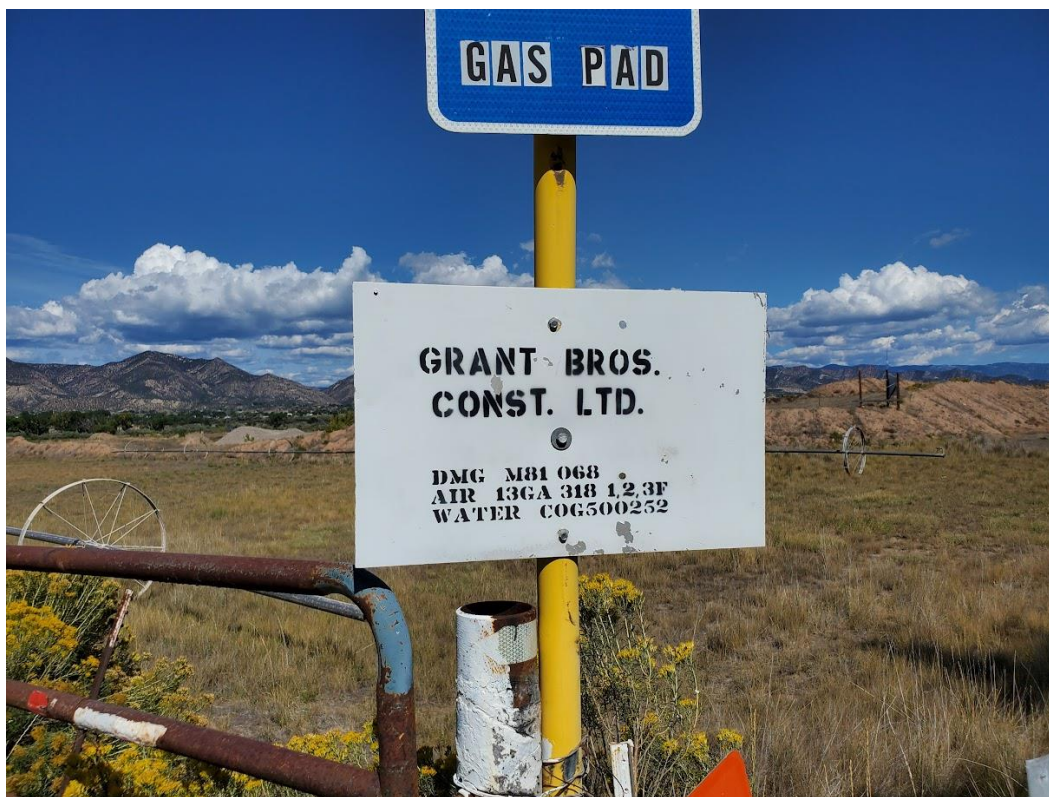
The mine identification sign and the affected area boundary markers are in place and in compliance with Rule 3.1.12. The boundary is marked by fence line that is easily identifiable. The mine identification sign was located on the permit boundary at the main entrance to the site off CO Hwy 346.

Photo 4: View to the north proper Mine ID at the entrance to the site.

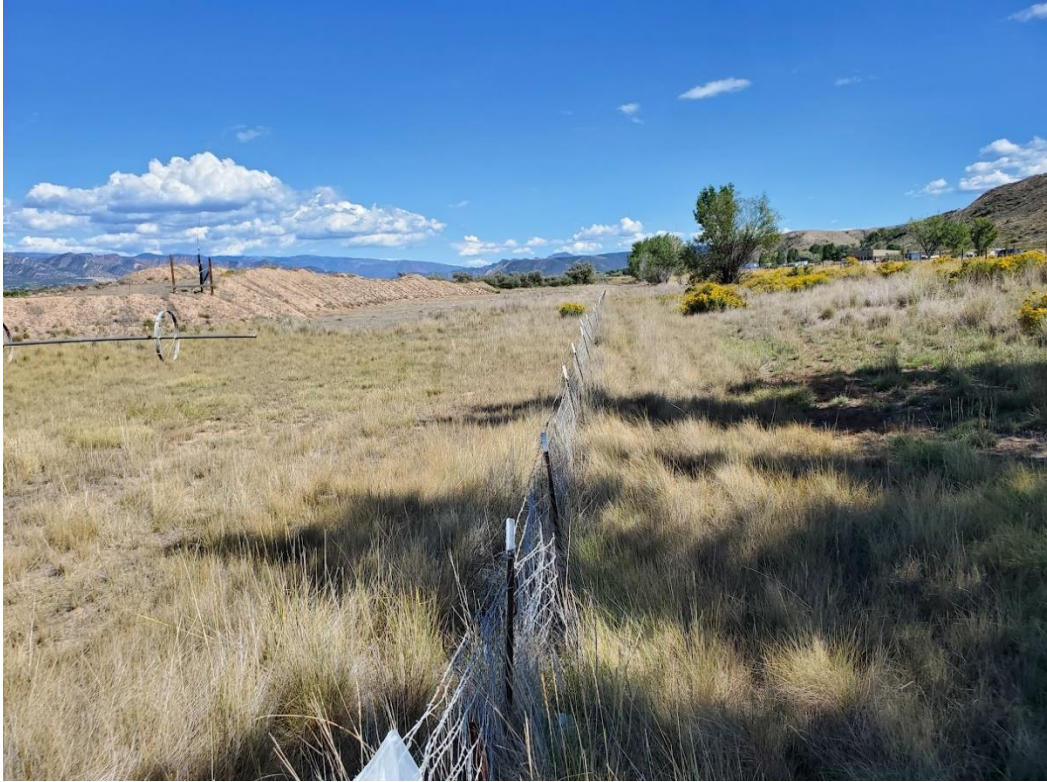
Photo 5: View to the east of fence marking the permit boundary.
