MINERALS PROGRAM INSPECTION REPORT
PHONE: (303) 866-3567

MINE NAME: Climax Mine	MINE/PROSPECTING ID#: M-1977-493	MINERAL: Molybdenum	COUNTY: Lake, Summit
INSPECTION TYPE: Monitoring	WEATHER: Clear	INSP. DATE: September 26, 2024	INSP. TIME: 11:00
OPERATOR: Climax Molybdenum Company, Climax Mine	OPERATOR REPRESENTATIVE: Alex Ungers	TYPE OF OPERATION: 112d-3 - Designated Mining Operation	
REASON FOR INSPECTION: Normal I&E Program	BOND CALCULATION TYPE: None	BOND AMOUNT: \$91,011,850.00	
DATE OF COMPLAINT: NA	POST INSP. CONTACTS: None	JOINT INSP. AGENCY: None	
INSPECTOR(S): Todd Jesse	INSPECTOR'S SIGNATURE:

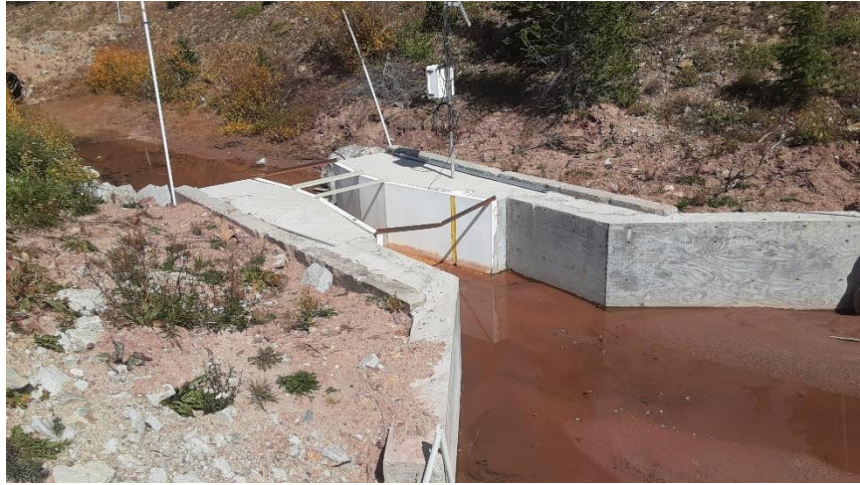
The East Interceptor conveys non-contact water to Clinton Reservoir. The interceptor consists of open channel, culverts and pipeline. Portions of the open channel were observed to be well maintained and able to conduct water (Photo 1). Culverts and openings to the underground pipeline are free of obstructions (Photo 2). No problems were noted with the East Interceptor.

Photo 1: View to the northeast of Parshall Flume on the East Interceptor.

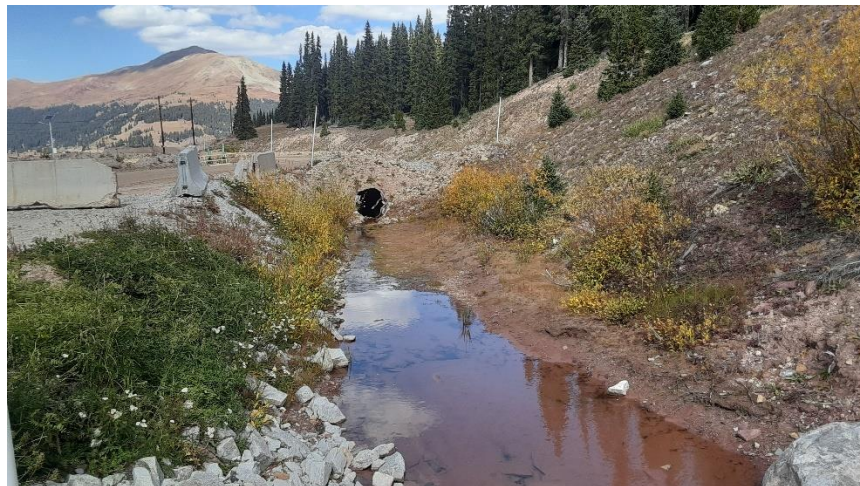
Photo 2: View to the north of East Interceptor as it enters the underground pipeline.

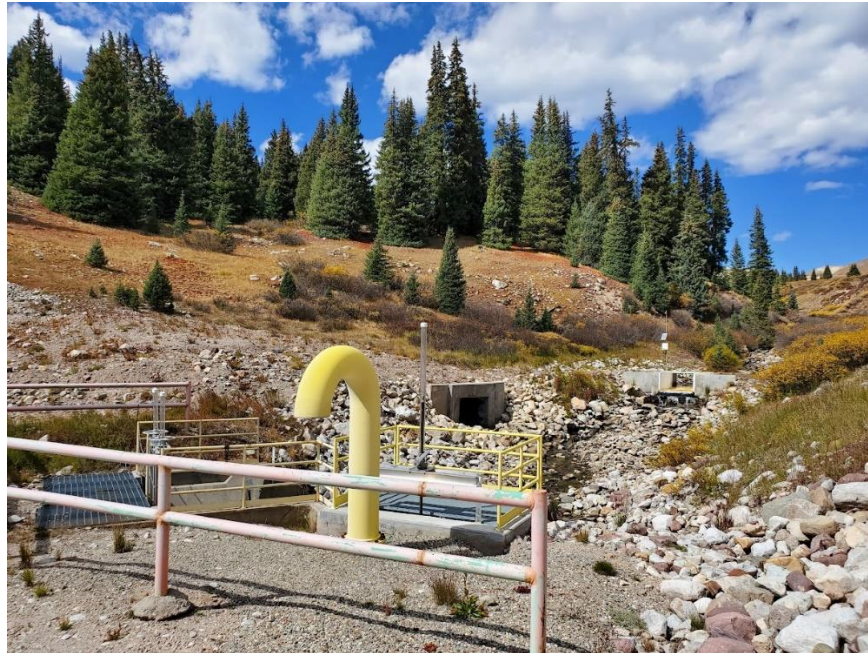
The West Interceptor captures non-contact water from the north side of the tailings ponds and conveys the freshwater east, around the mine area and into Tenmile Creek, just upstream of the PWDTP. For the most part, much of the West Interceptor flows along the road on the north side of the tailings area. The West Interceptor consists of open channel, pipeline, vaults, and culverts. Open channel sections of the interceptor that were observed were free of obstruction and showed no signs of significant erosion. Vaults that intercept clean water at Kokomo and Searle are in good working order and show no signs of instability (Photo 3). No problems with the West Interceptor were noted.

Photo 3: View to the west of vault on West Interceptor at Searle Gulch.

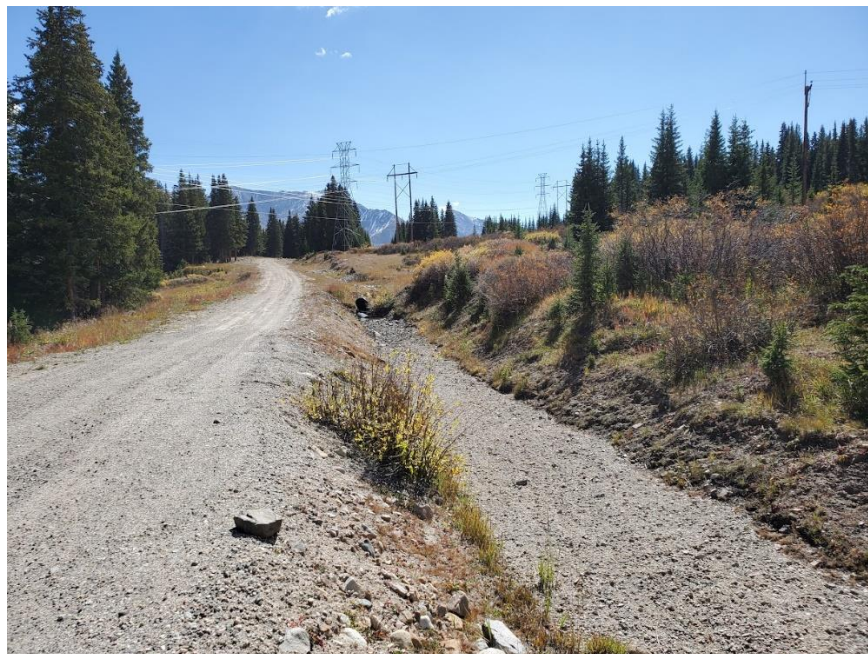
The Chalk Mountain Interceptor captures non-contact water from the Chalk Mountain drainages and conveys the freshwater to Eagle Park Reservoir. The Chalk Mountain Interceptor consists of open channel and culverts. The interceptor channel was observed along most of its reach, from the access road. Culverts are clear of obstruction and open channels appear to be able to convey water properly. The 4 Dam Seep Water Pump System directly below Eagle Park Reservoir was also inspected. Embankments of the collection pond show no signs of erosion and the water levels were below discharge levels. No problems were noted with the Chalk Mountain Interceptor.

Photo 4: View to the southeast of dry Chalk Mountain Interceptor.

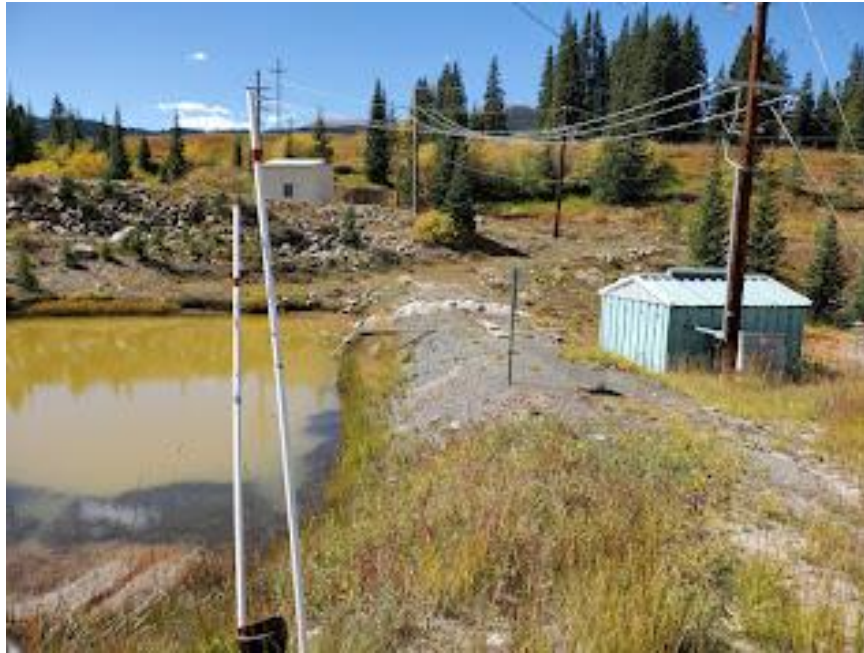
Photo 5: View to the south of 4 Dan Seep Water Pump System.

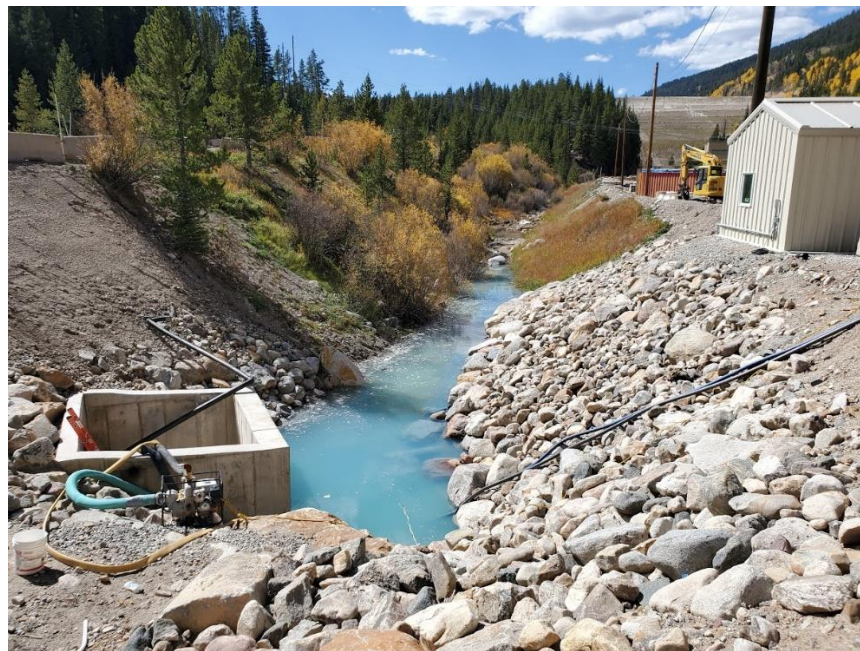
The system was functioning and construction was nearly completed on the 5 Dam Seepwater Collection System, approved under TR-36. However, the pipe from the ditch to the pumphouse was crushed after it was buried and needs to be replaced. The Operator has a temporary work around solution in place and is working with their contractor to replace the crushed pipe. The completed work appears to be consistent with the approved designs and no issues were noted within the construction area.

Photo 6: View to the south of TR-36 progress. The temporary pump can be seen in the foreground.

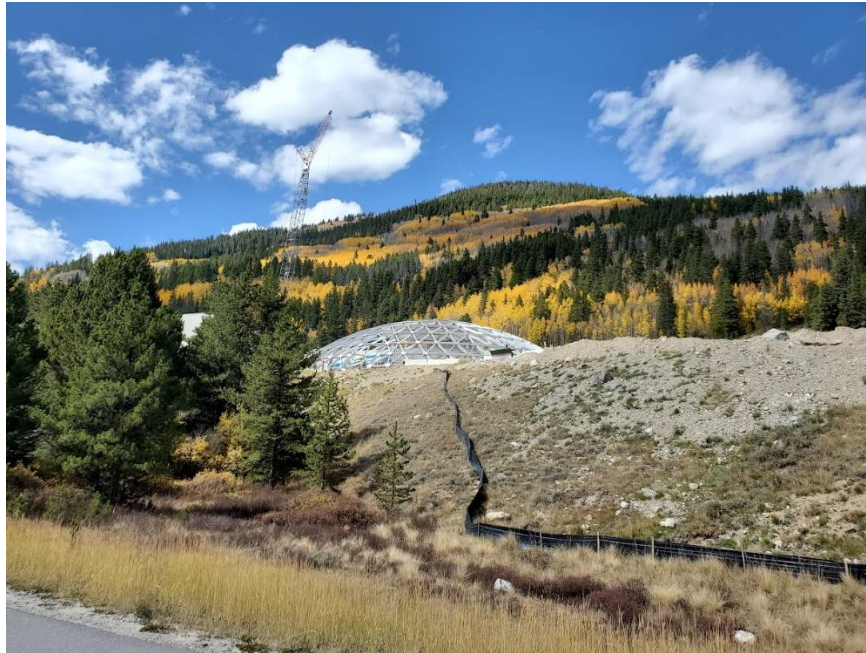
Construction continues on the new MRWTP building approved under TR-34. This is a supplementary process to Climax's PDWTP. Once online the raw water will first go into the Moly building, then water will go to the existing PDWTP building. A crane and several crews were observed working on the domes of the thickener tanks. The building still on schedule to be online in the first quarter of 2025.

Photo 7: View to the southwest of construction on thickener dome of MRWTP
