Inspections: 2024 September Partial

COLORADO
Division of Reclamation,
Mining and Safety
Department of Natural Resources

Permit Number: C-1994-082 Mine Name: Yeast Mine Operator Address: Seneca Property LLC Ms. Michael Howard 29515 Routt County Road No. 27 Oak Creek, CO 80467	County: Routt Operation Type: Surface Permit Status: Permanent Cessation Ownership: Private Operator Representative Present: Michael Howard
Operator Representative Signature: (Field Issuance Only) This report was issued electronically from the Divisions' Denver Office.

Inspection Start Date: 23 Sept. 2024 Inspection Start Time: 3:40 p.m. Inspection End Date: 23 Sept.2024 Inspection End Time: 5:00 p.m.	Inspection Type: Coal Partial Inspection Inspection Reason: Normal I&E Program Weather: Partly Cloudy
Joint Inspection Agency: None	Joint Inspection Contacts:
Post Inspection Agency: None	Post Inspection Contacts:
Inspector(s): Robin Reilley, M.S. GISP	Inspector's Signature:

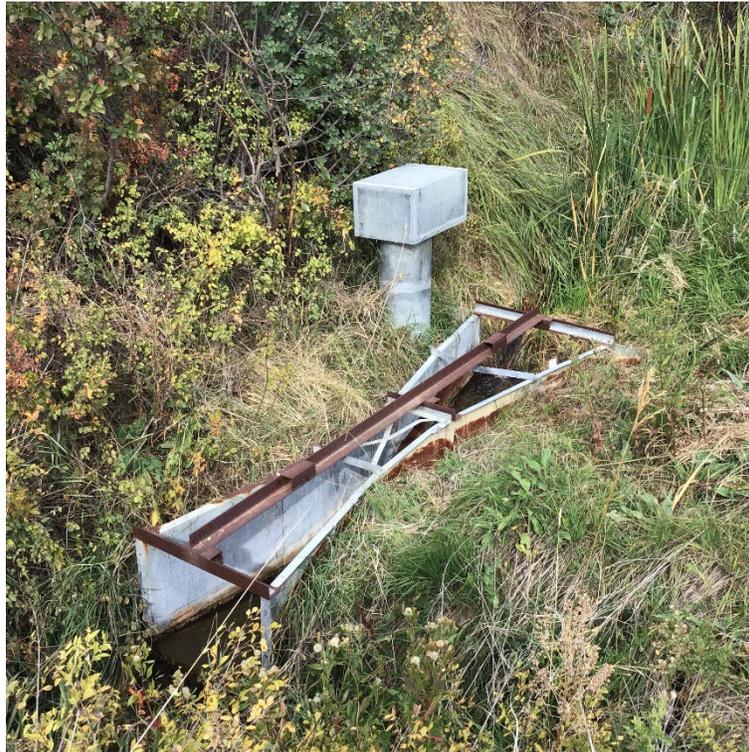
- 1. Cattails at Ponds 10 and 12 flume entrances and along upstream portion of flow have been removed.*

Photo 1: Pond 12 flume, cleared of vegetation.

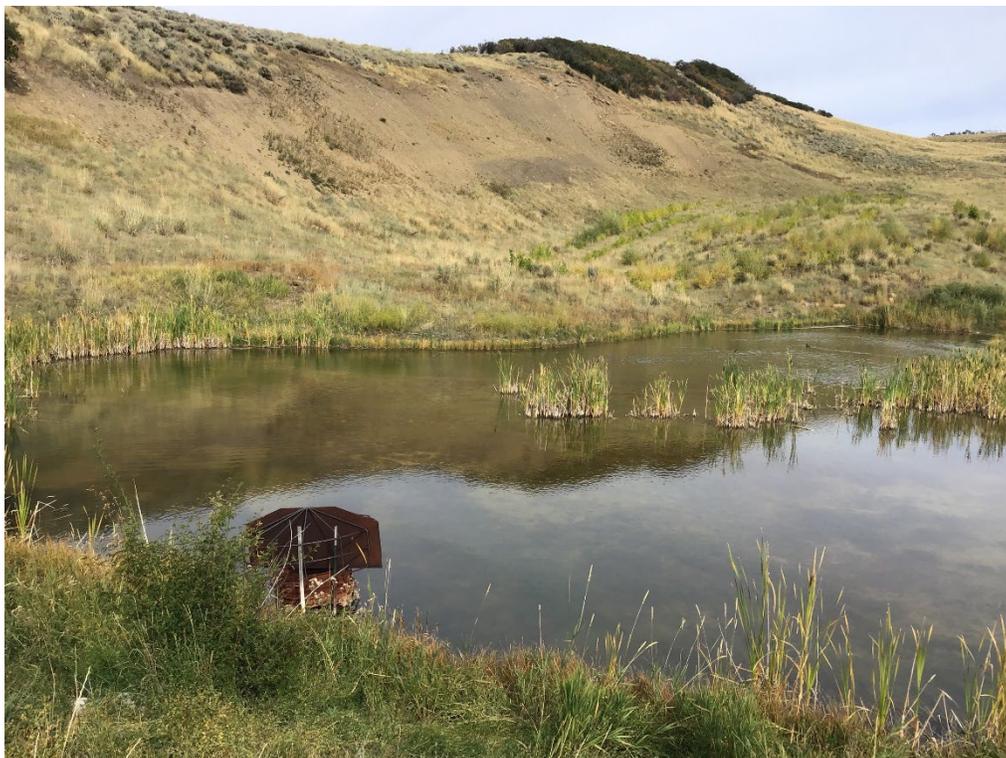
Photo 2: Pond 12 looking toward the highwall.

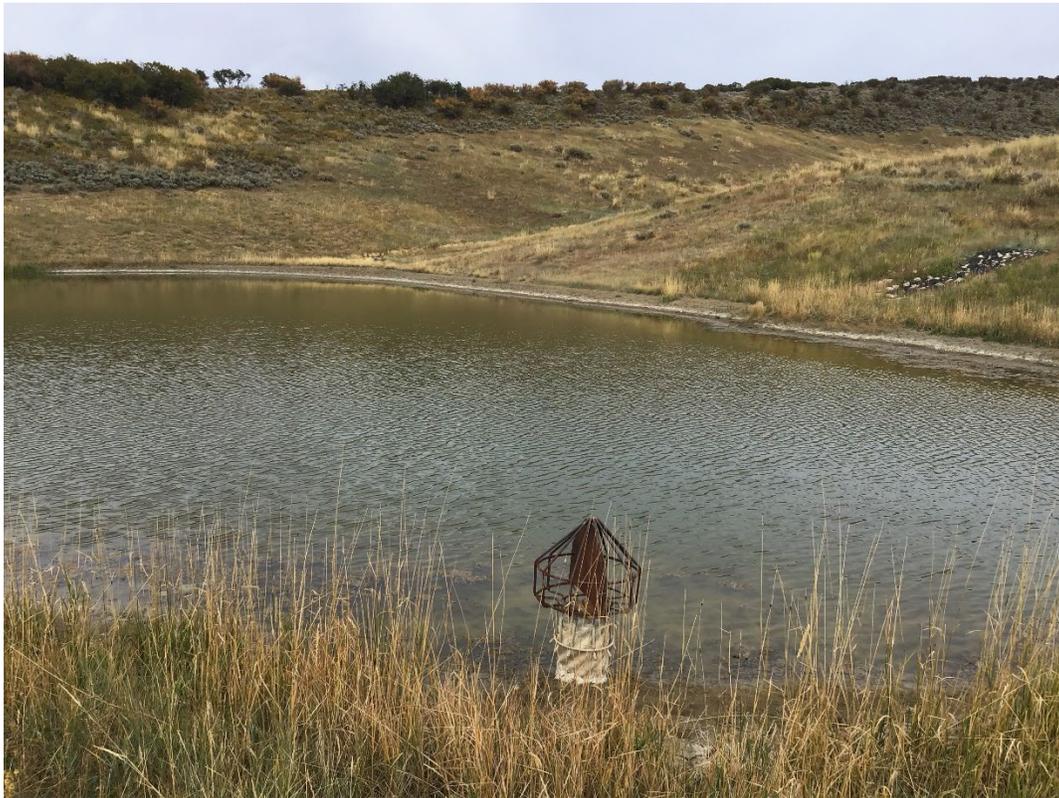
Photo 3: Pond 13 not discharging at the time of inspection.

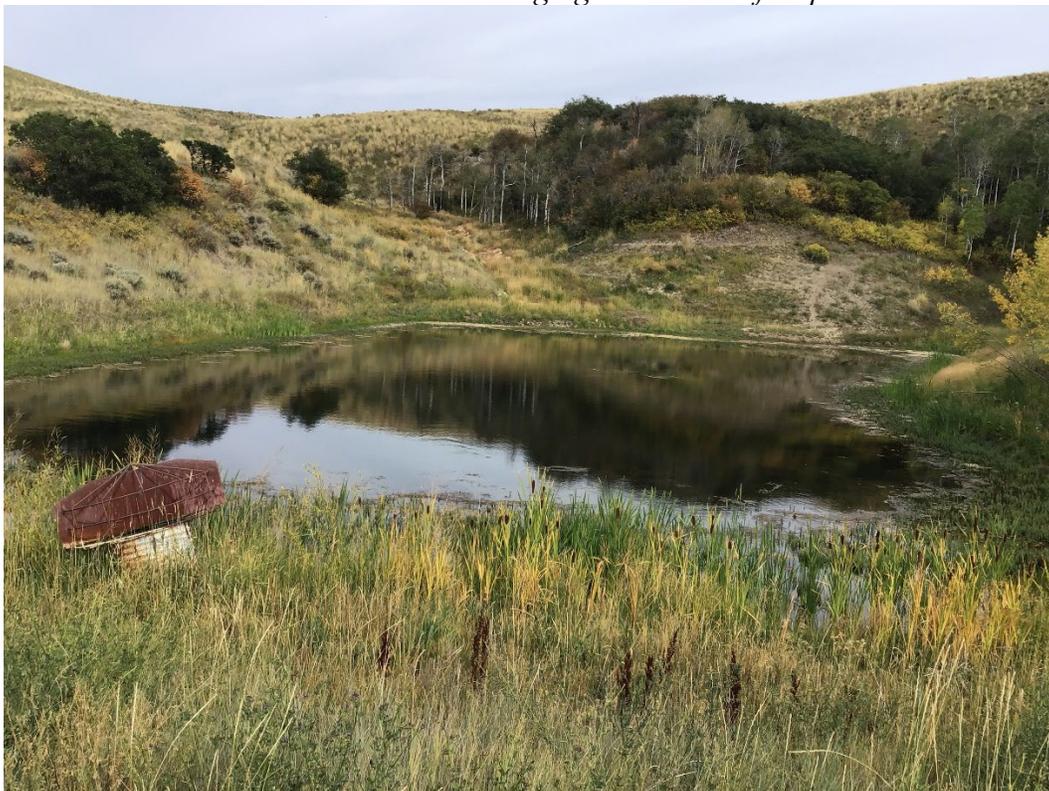
Photo 4: Pond 14 with its flume practically grounded due to low water.

- 1. Decant structures at ponds 10 and 14 require repairs. Repairs are slated for the second week of October.*

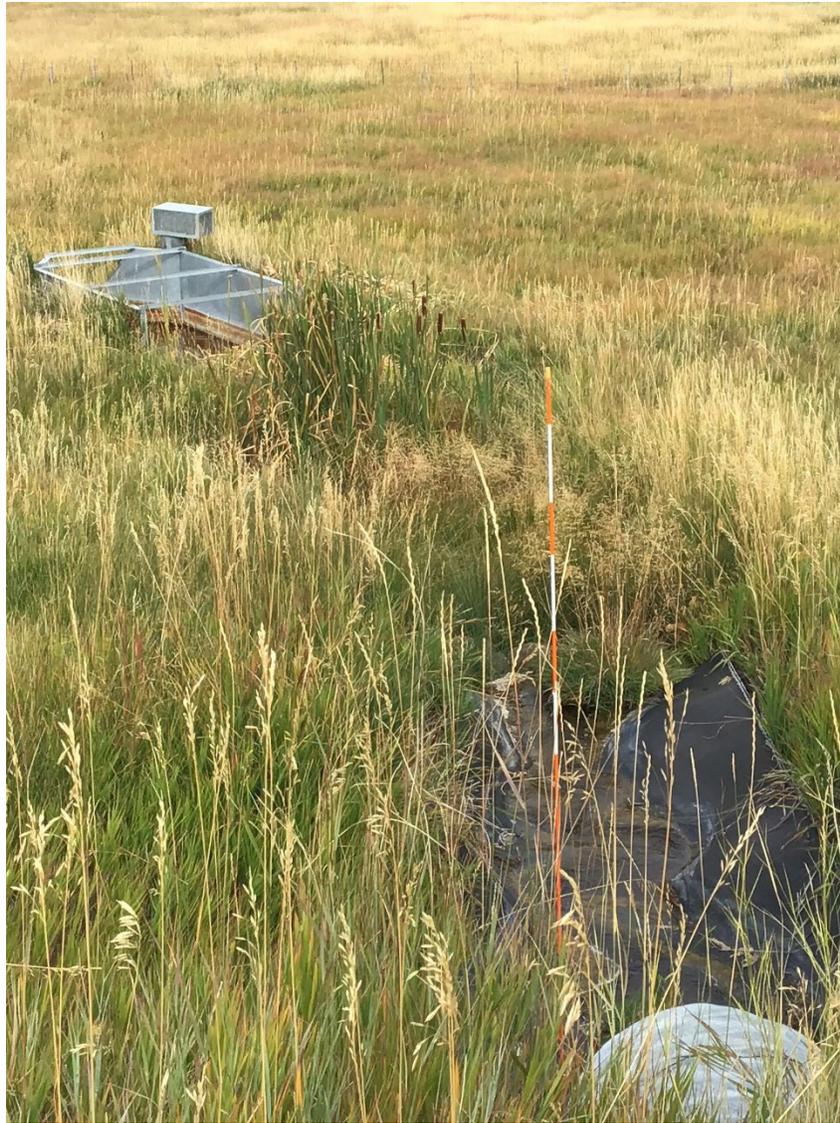
Photo 5: Pond 10 discharge culvert and flume cleared of vegetation.

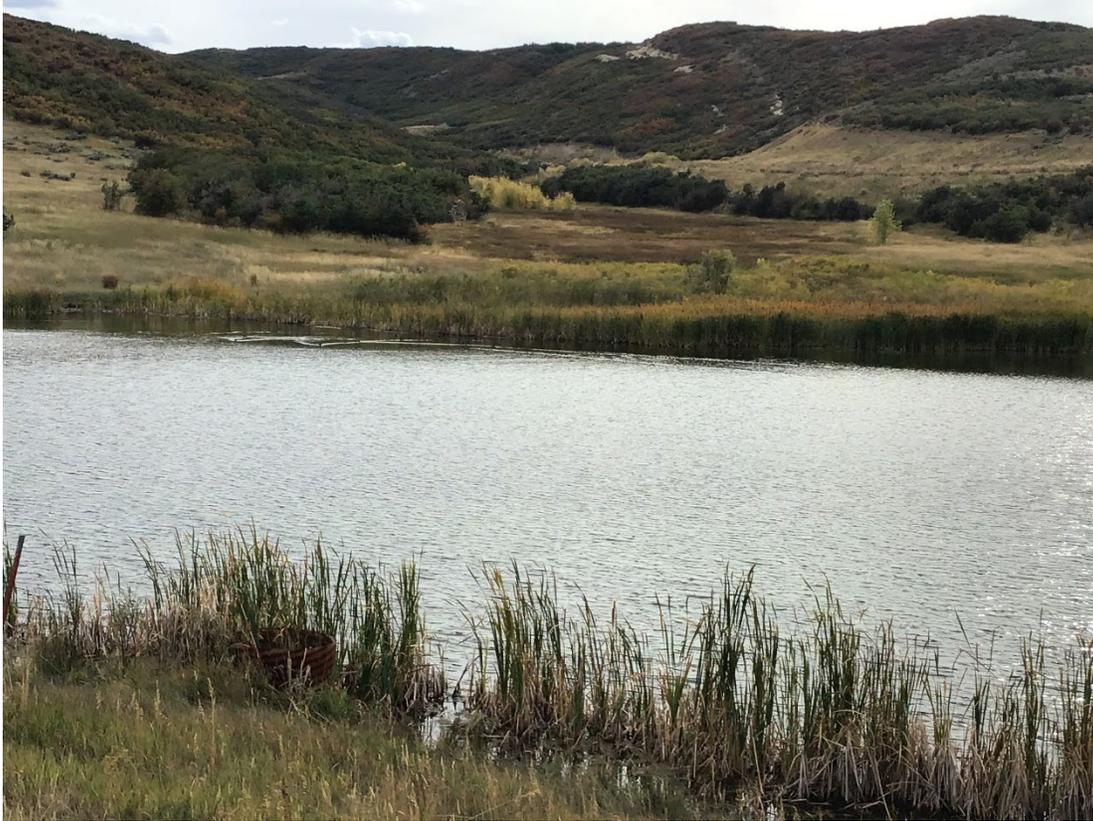
Photo 6: Pond 10 looking south.
