### MINERALS PROGRAM INSPECTION REPORT

<b>MINE NAME:</b> Colorado Moss Rock	<b>MINE/PROSPECTING ID#:</b> M-2011-039	<b>MINERAL:</b> Sandstone (silica, st quartzite)	<b>COUNTY:</b> Pueblo
<b>INSPECTION TYPE:</b> Monitoring	<b>WEATHER:</b> Clear	<b>INSP. DATE:</b> October 1, 2024	<b>INSP. TIME:</b> 10:20
<b>OPERATOR:</b> Premier Moss Rock, LLC	<b>OPERATOR REPRESENTATIVE:</b> Nick Simpson	<b>TYPE OF OPERATION:</b> 110c - Construction Limited Impact

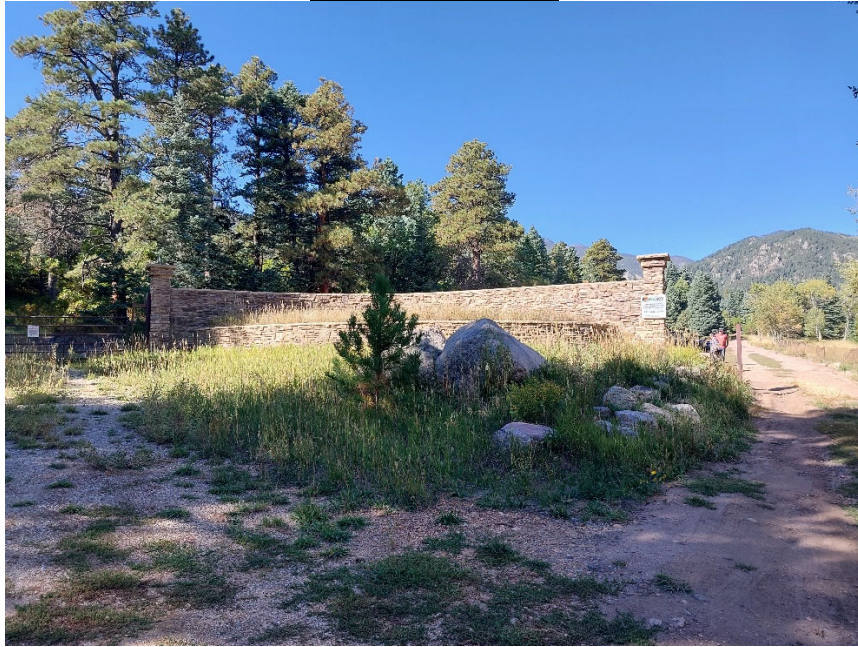
The mine sign is posted as required by Rule 3.1.12.(1) (see Photo #1), permit boundary markers were also verified for the staging area and the east boundary of the rock picking area (see Photos #2 - #10).

Photo #1: Mine sign posted at the entrance gate of the site, seen on the right side of the stonewall in the photo.

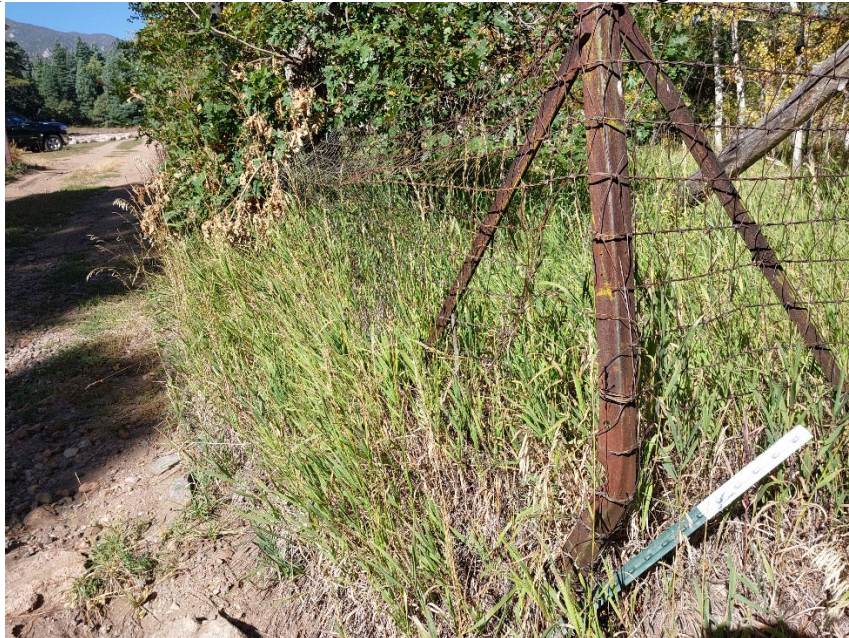
Photo #2: Permit boundary marker located in the northeast corner of the staging area, point St 2 on map below.

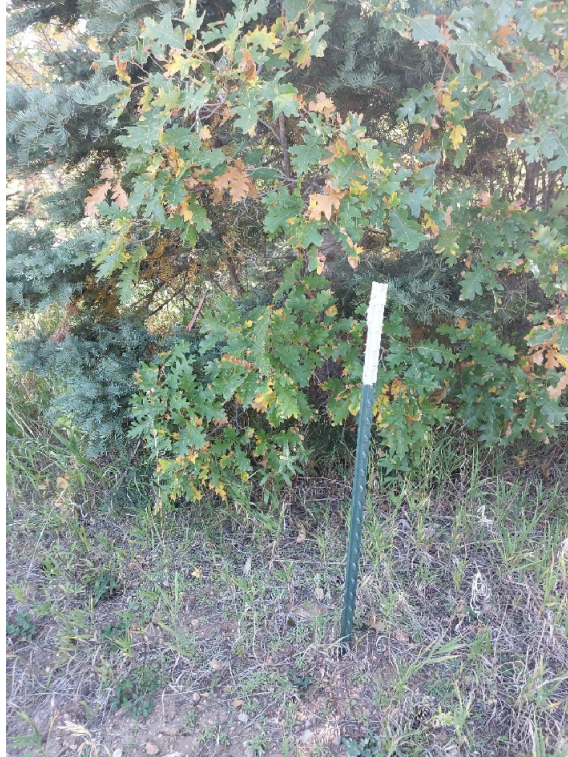
Photo #3: Permit boundary marker located at the southeast corner of the staging area, point St 3 on map below.

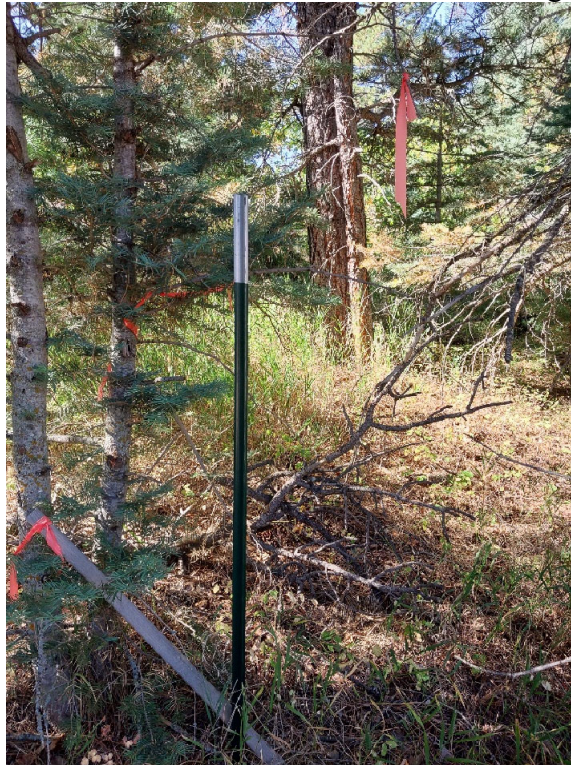
Photo #4: Permit boundary marker located at the south, point St 4 on map below.

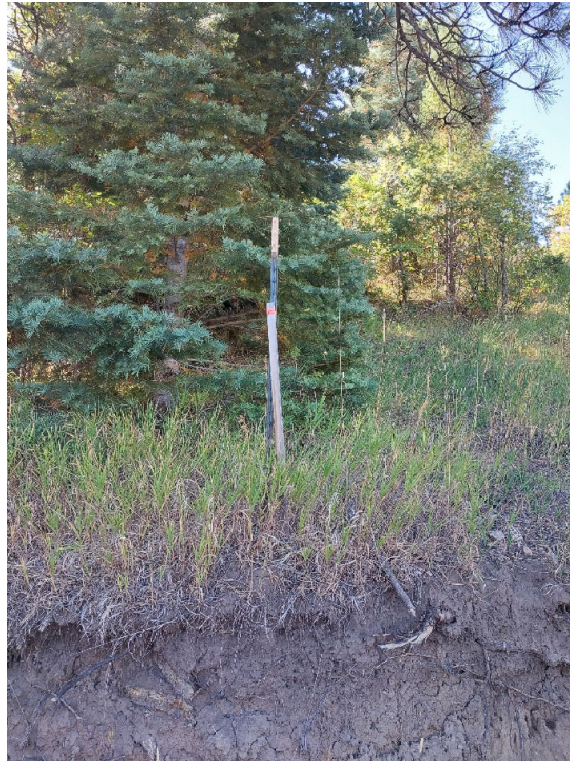
Photo #5: Permit boundary marker located along south perimeter of the staging area, point St 5 on map below.

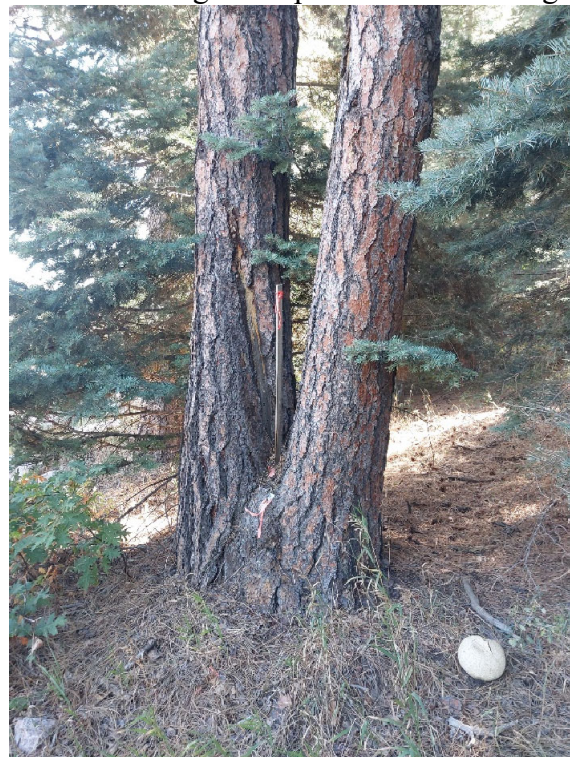
Photo #6: Permit boundary marker on the south perimeter of the staging area, point St 6 on map below.

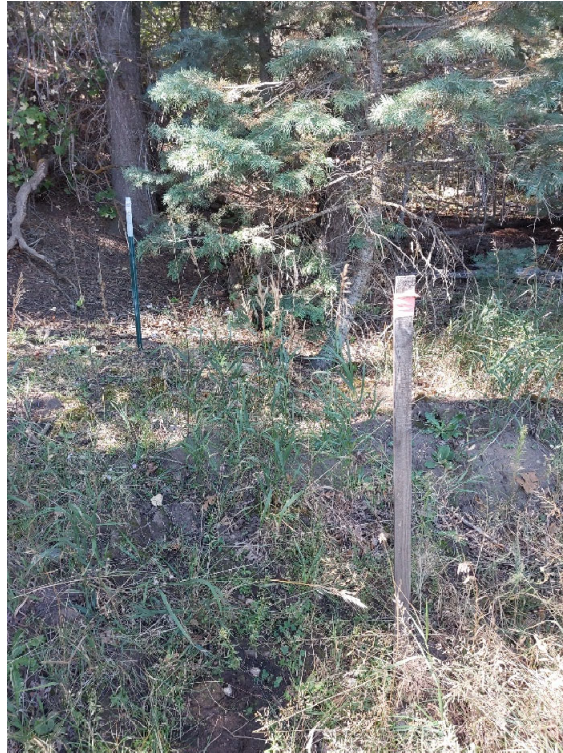
Photo #7: Permit boundary marker located in the southwest corner of the staging area, point St 7 on map below.

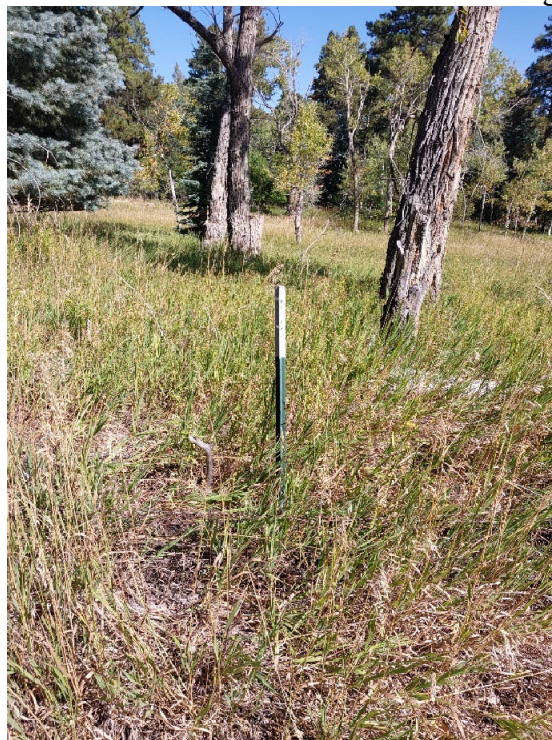
Photo #8: Permit boundary marker located at the northwest corner of the staging area, point St 1 on the map below

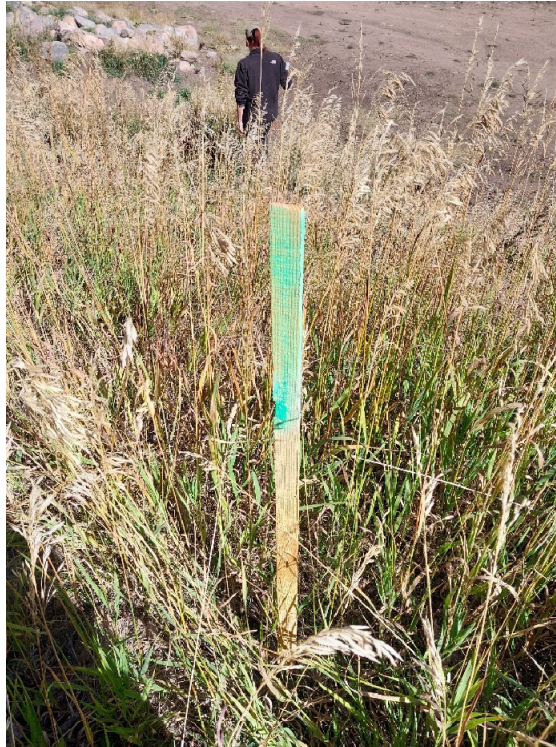
Photo #9: Permit boundary marker located in the southeast corner of the rock picking area, point SE on the map below.

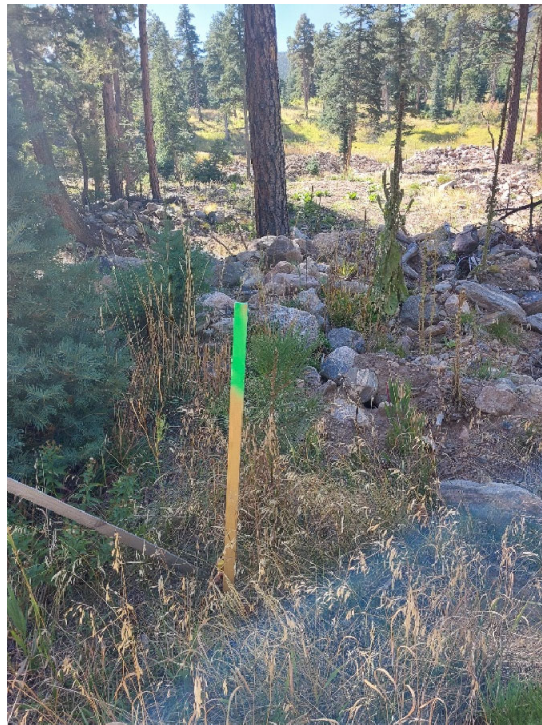
Photo #10: Permit boundary marker located in the northeast corner of the rock picking area, point NE on the map below

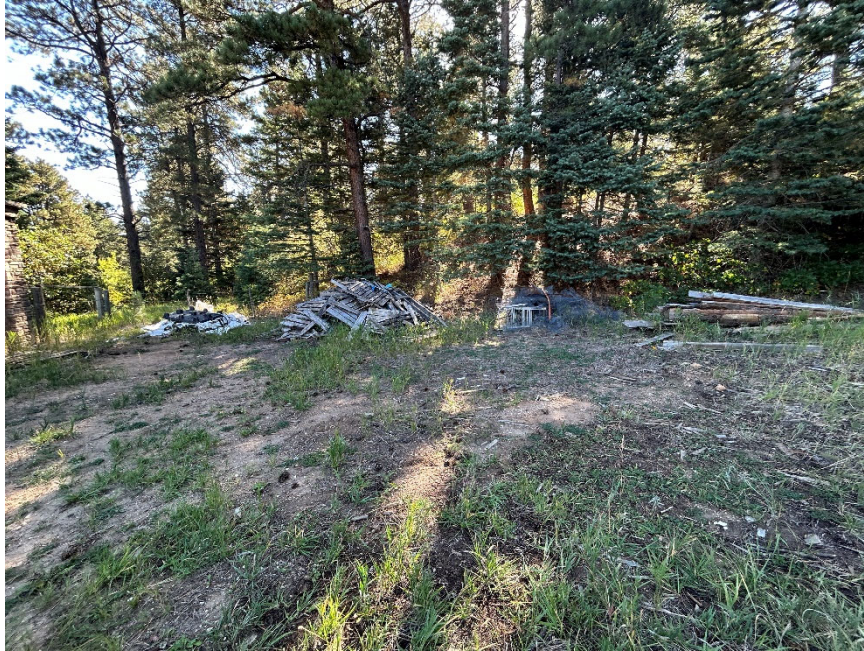
The area southeast of the staging area had some construction timber, stacked pallets, deconstructed pallets, and scrape wire mesh piled, just behind the rock entrance fence (see Photos #11 and #12). The landowner stated that they have been using the materials for his personal use on the property.

Photo #11: Off-site disturbance to the southeast of the staging area.

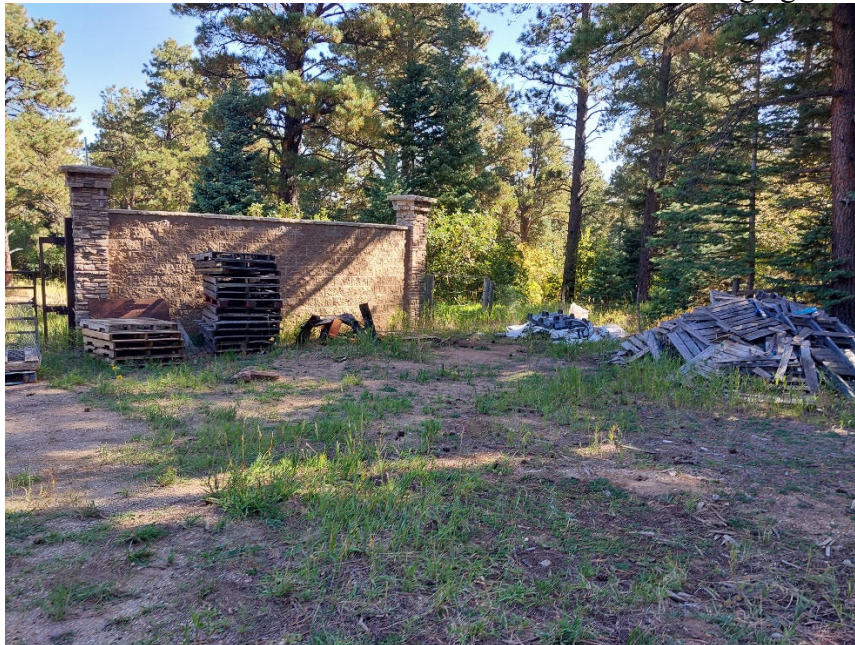
Photo #12: Off-site disturbance to the southeast of the staging area, labeled "Shipping Materials" on map below.

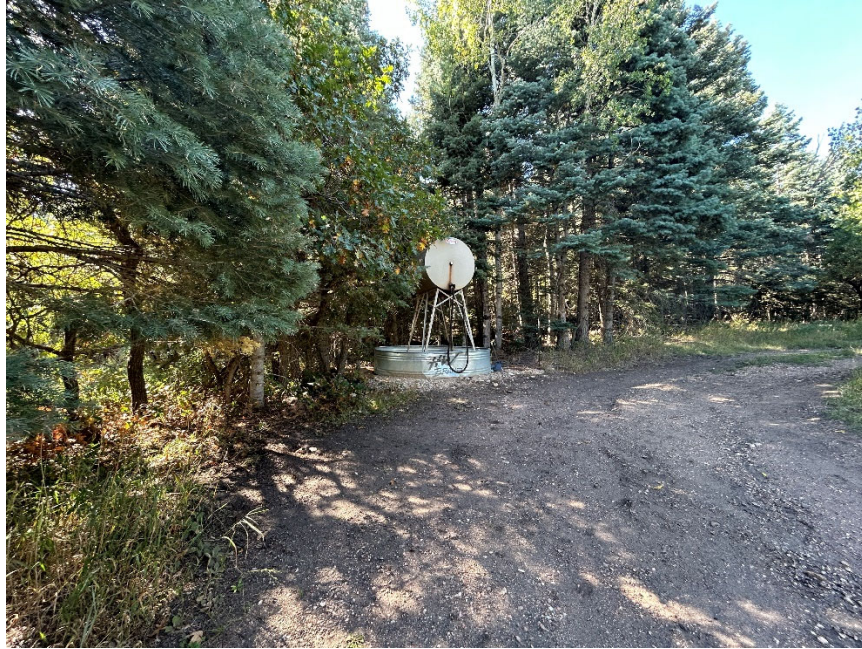
There is a fuel storage tank with a secondary containment on the west side of the staging area that was used for equipment during mining operations (see Photo #13). This is considered affected lands according to the definition given in Rule 1.1(3) and is also considered off-site damage. The landowners stated that they plan to

use the fuel tank and the secondary storage catchment for development projects on the property.

Photo #13: Off-site disturbance to the west of the staging area, labeled “Fuel Tank” on map below.

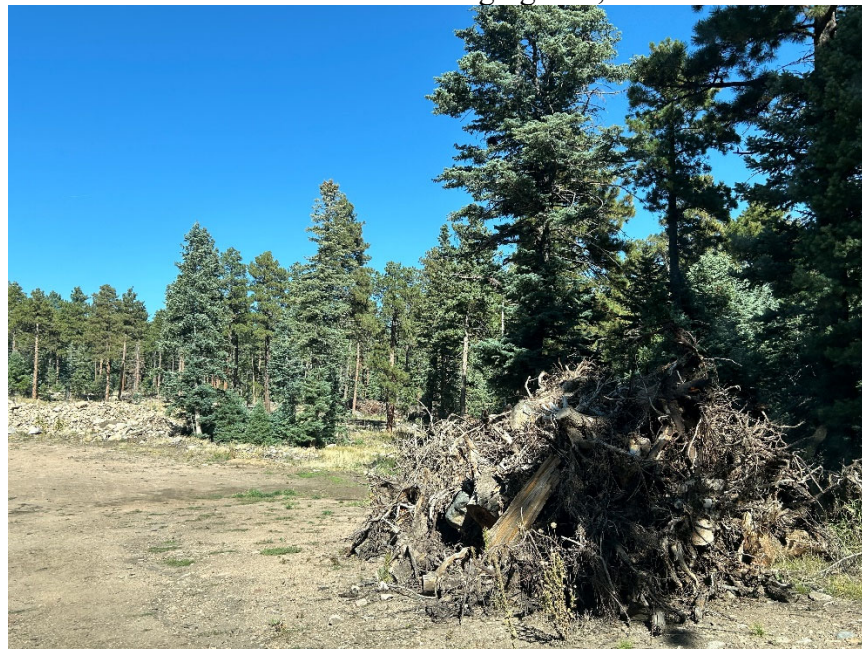
There is a pile of tree stumps that is located to the east of the southeast permit boundary of the rock picking area (see Photo #14). It appears that this pile of tree stumps was cleared from the permit area where rock picking occurred. Again, per Rule 1.1.(3), this is considered affected area and therefore off-site damage. When asked about this area, the landowners were not sure about the future plans for this area.

Photo #14: Off-site disturbance to the east of the rock picking area, labeled “Tree Stumps” on map below.

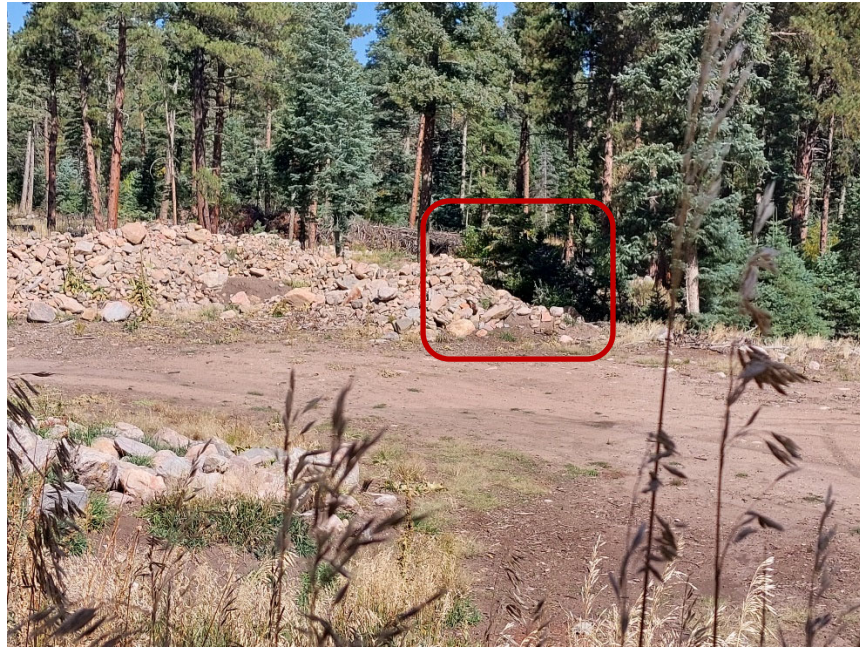
The east end of the material stockpile located in the rock picking area, outlined in red on the map below, spills over the permit boundary (see Photo #15). The portion of the stockpile that lies outside the permit boundary needs to be moved back into the permitted area.

Photo #15: Off-site disturbance to the east of the rock picking area, labeled “Material Stockpile” on the map below. The toe of the east end of the stockpile spills beyond the permit boundary, shown by the red box in the photo.

**CORRECTIVE ACTIONS:** Provide a signed statement from the landowners clearly identifying the disturbances caused by or attributed to mining operations that they would like to remain as is for their purposes as residential land use. Regarding the material stockpile located in the southeast region of the rock picking area, push the east end of the material that has spilled over the permit boundary back onto the permitted area to prevent further off-site damage. Provide photos of this correction to the Division by the given corrective action due date.

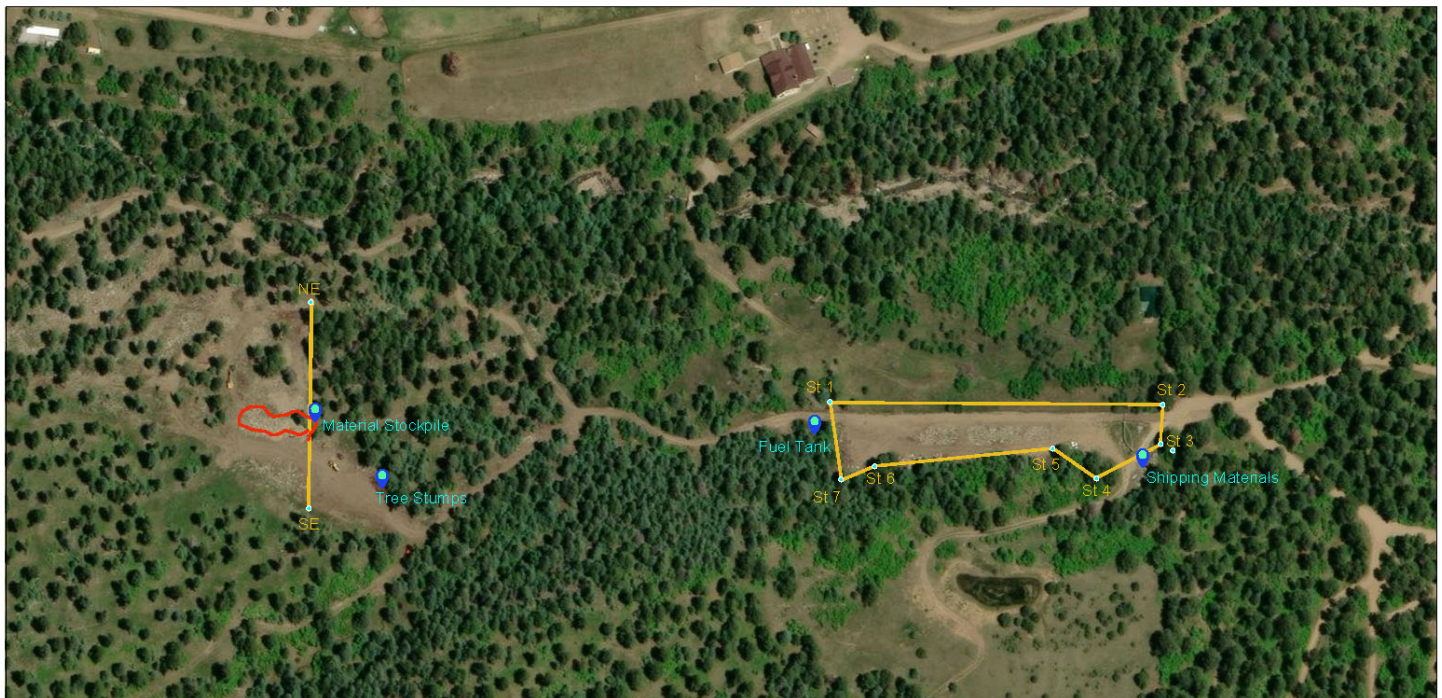
Map of inspection observation from October 1, 2024, inspection. The orange lines/polygons mark the permit

boundary according to the boundary markers viewed on site and the GPS points provided by the Operator. The red polygon marks a material stockpile located on the rock picking area. Off-site disturbances are marked by the blue and turquoise place markers.
