## M2009076 Hukill Gulch Millsite

### MINERALS PROGRAM INSPECTION REPORT

| <b>MINE NAME:</b><br>Hukill Gulch Millsite | <b>MINE/PROSPECTING ID#:</b><br>M-2009-076 | <b>MINERAL:</b><br>Silver and gold | <b>COUNTY:</b><br>Clear Creek |

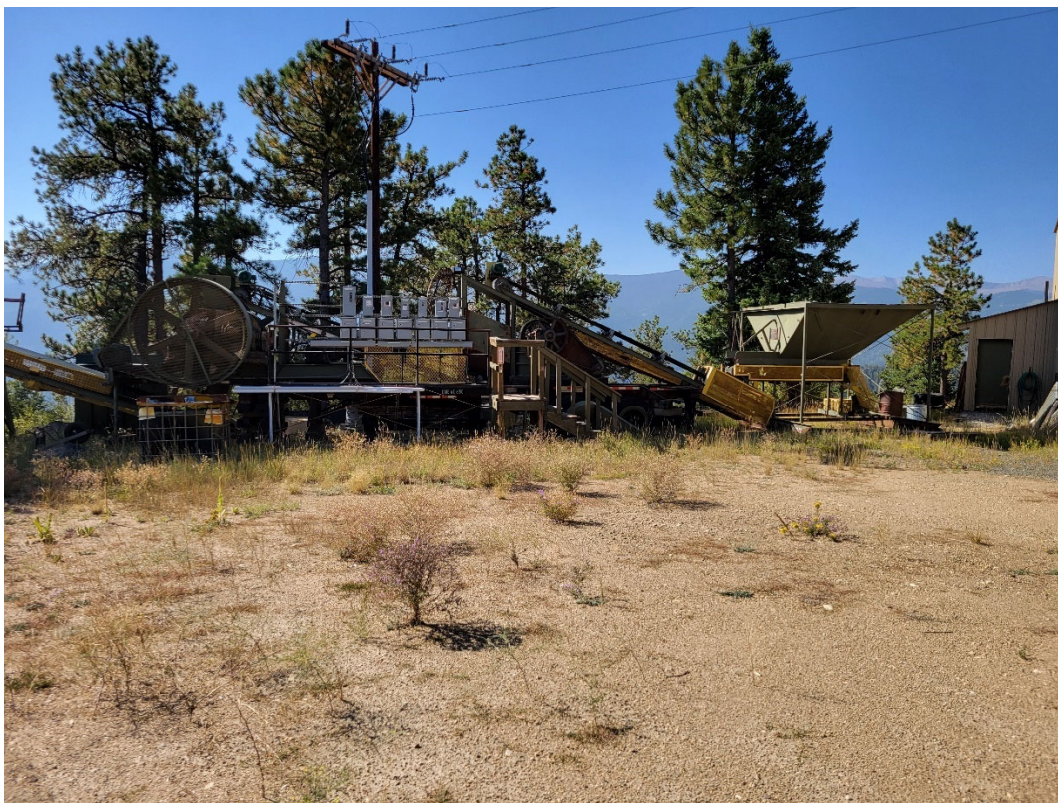
Photo 1: Standing in the Mill parking area looking south at the Crusher feed bin, crushing plant and conveyor.

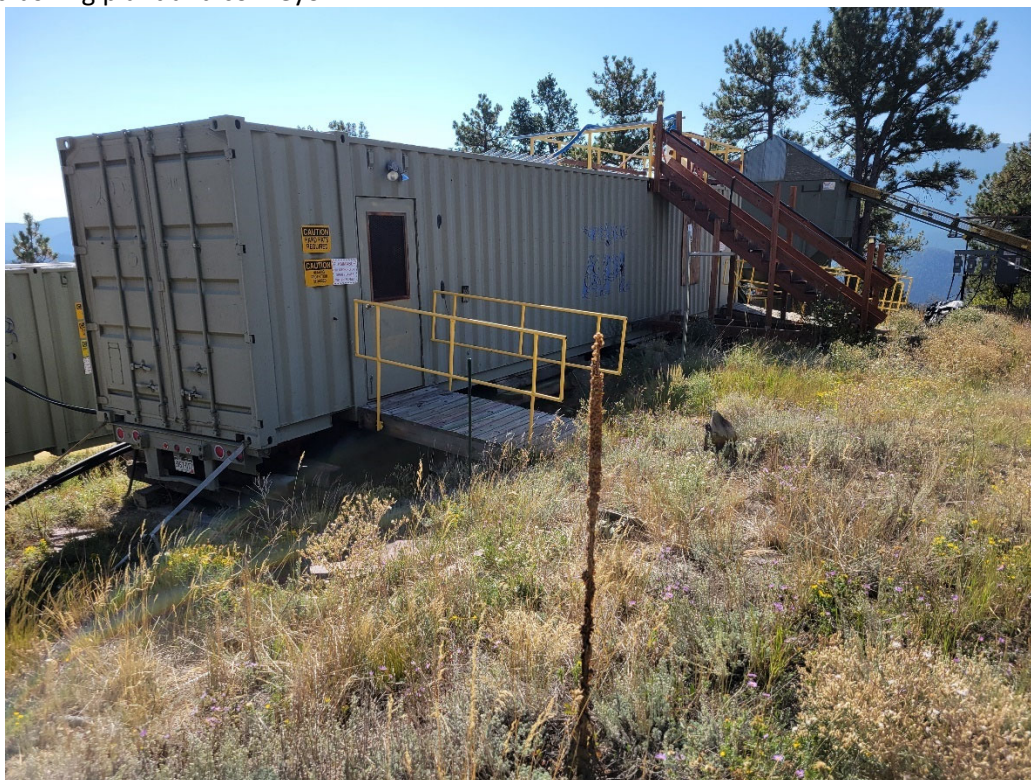
Photo 2: Looking southeast at the Ball Mill Trailer adjacent to the Mill parking area.

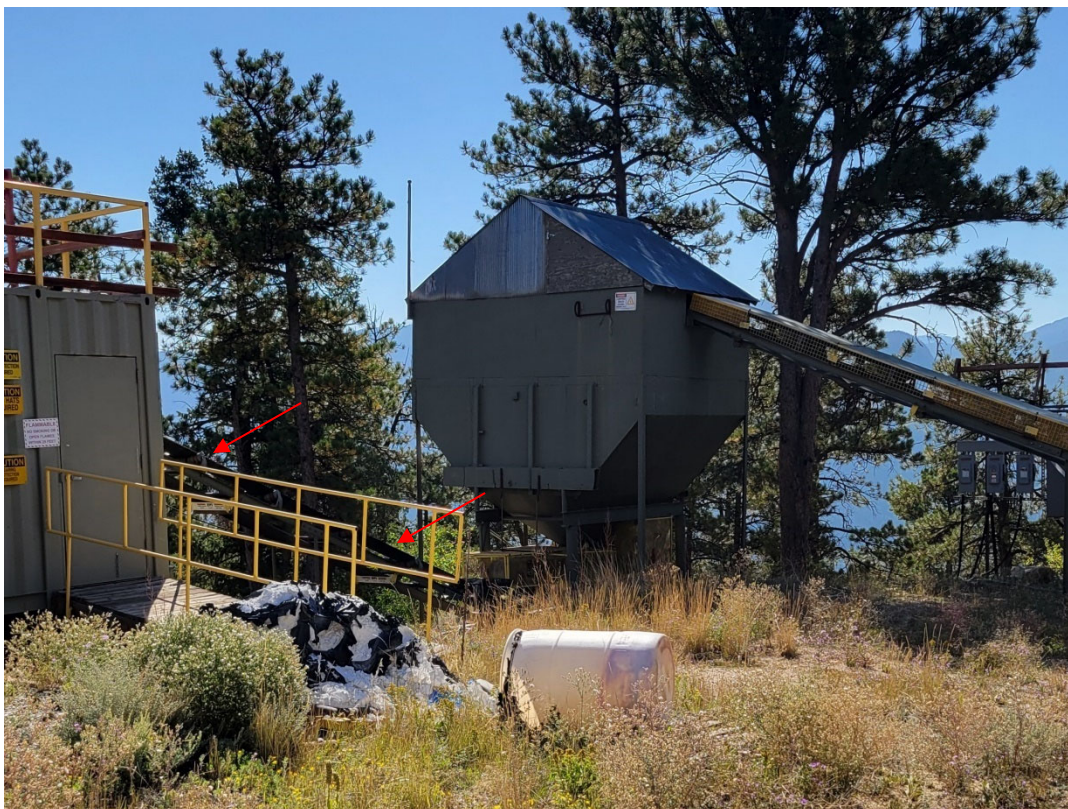
Photo 3: Looking at the Crushed Rock Bin. Conveyor between Ball Mill and Crushed Rock Bin is indicated by red arrow.

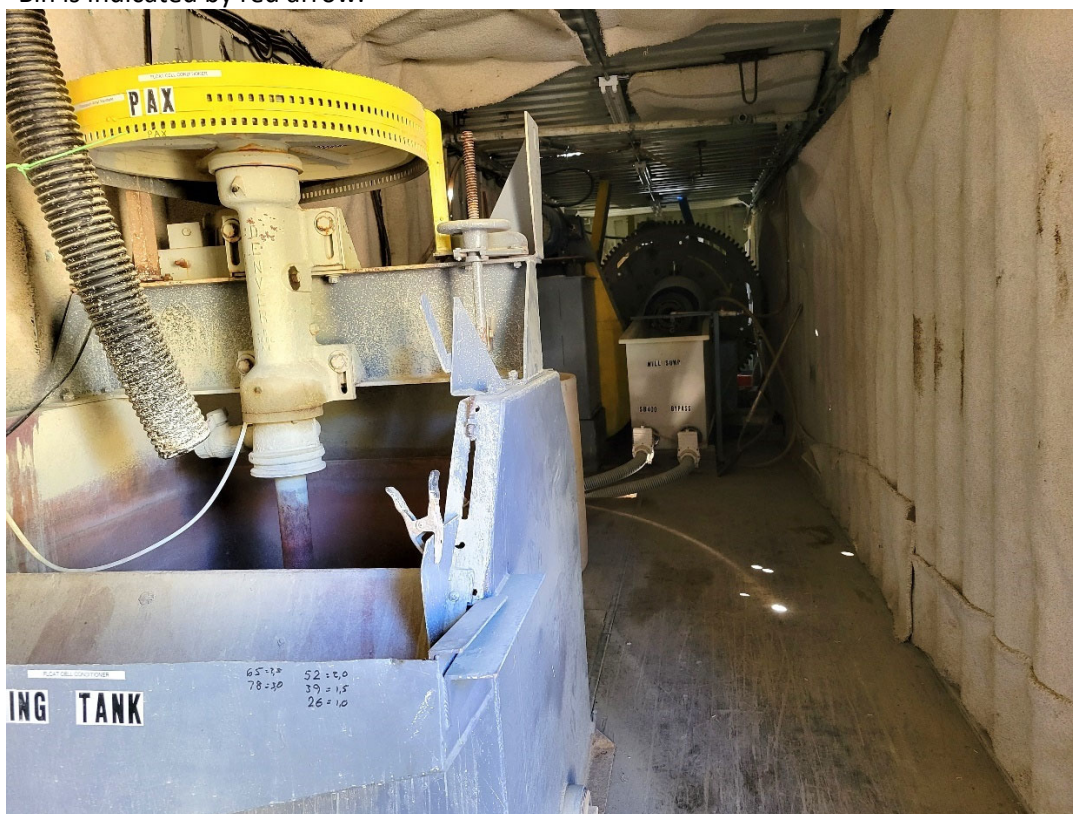
Photo 4: Inside view of the Ball Mill Trailer.

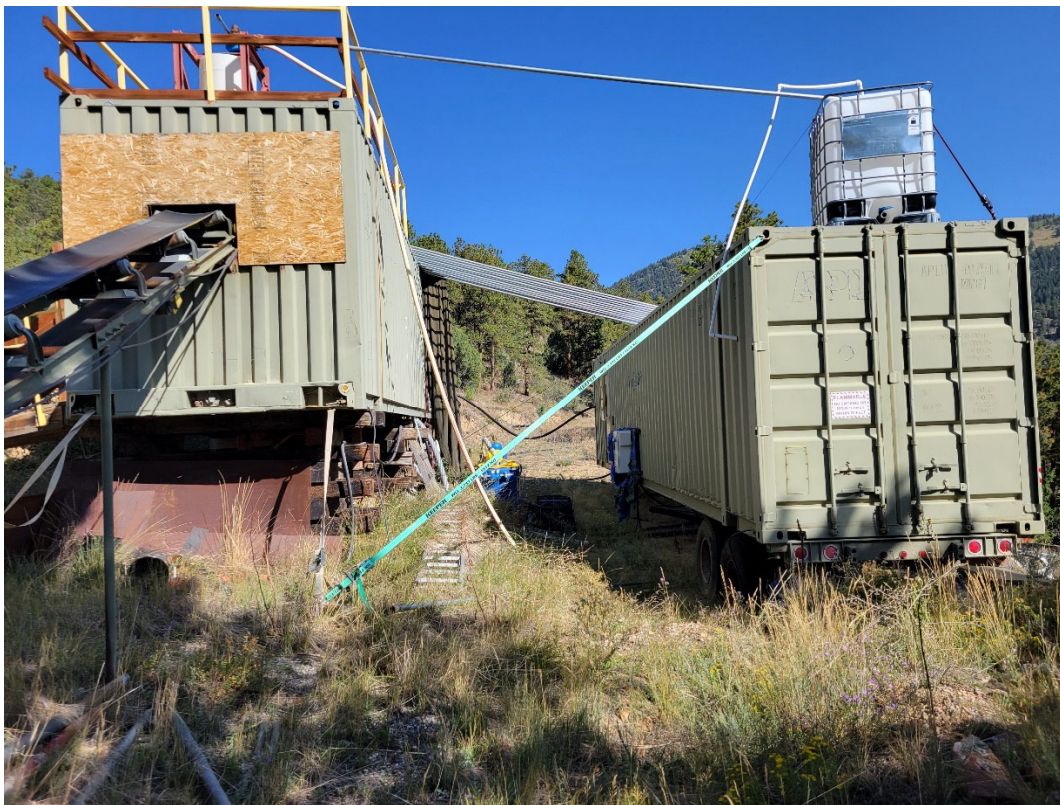
Photo 5: Looking north at the mobile Ball Mill Trailer on the left and Flotation Trailer on the right.

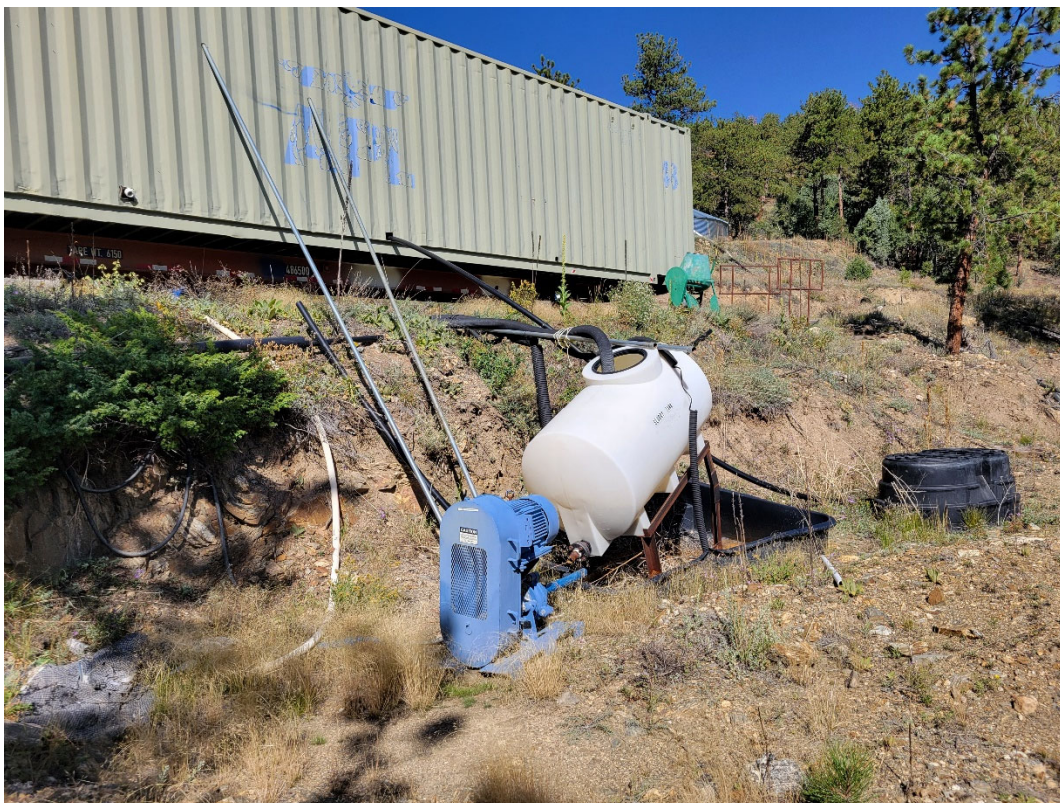
**PROBLEM 1:** The Division observed abandoned equipment, piping and trash around both permit areas. Additionally, a supply of lime is improperly stored in the mill area. This is a problem for failure to dispose of refuse in a manner that controls unsightliness or deleterious effects of such refuse pursuant to C.R.S. 34-32-116(7)(d).

Photo 6: View of poorly stored equipment in the area below the Flotation Trailer.

**CORRECTIVE ACTIONS:** The operator shall submit a written notice to the Division with photo documentation that the abandoned equipment, supplies, and piping has been properly stored or removed from the site. The

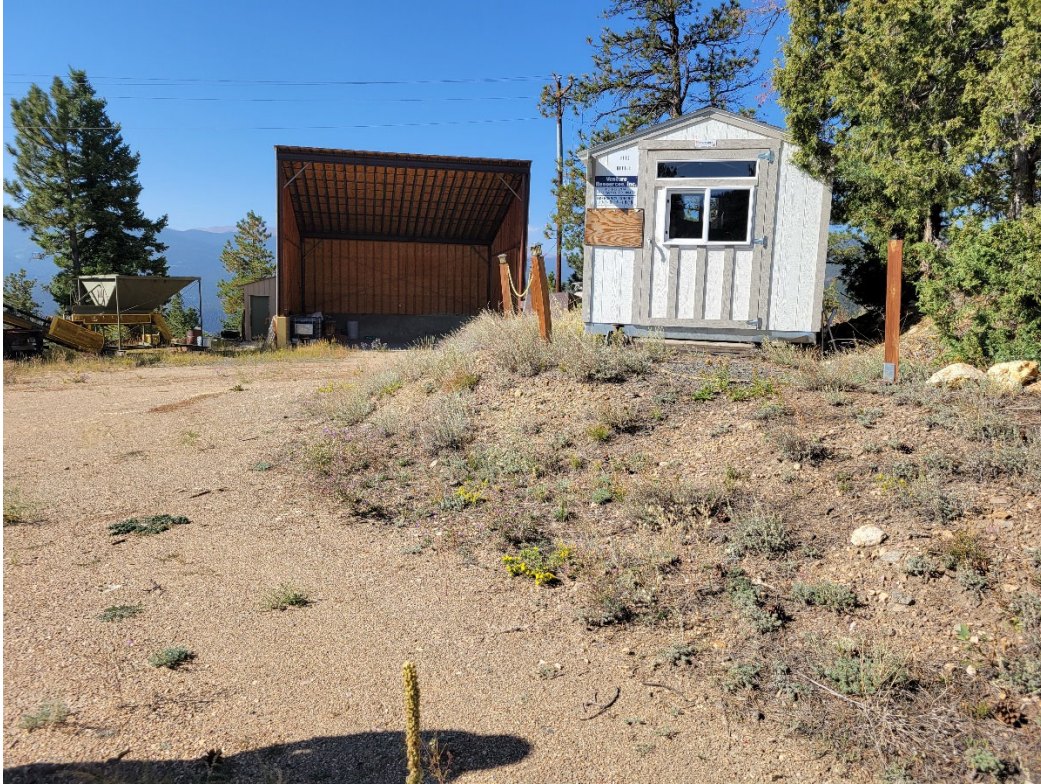
Photo 7: View of the Crusher Feed Pile Shelter and Mill Office from the entrance/access road.

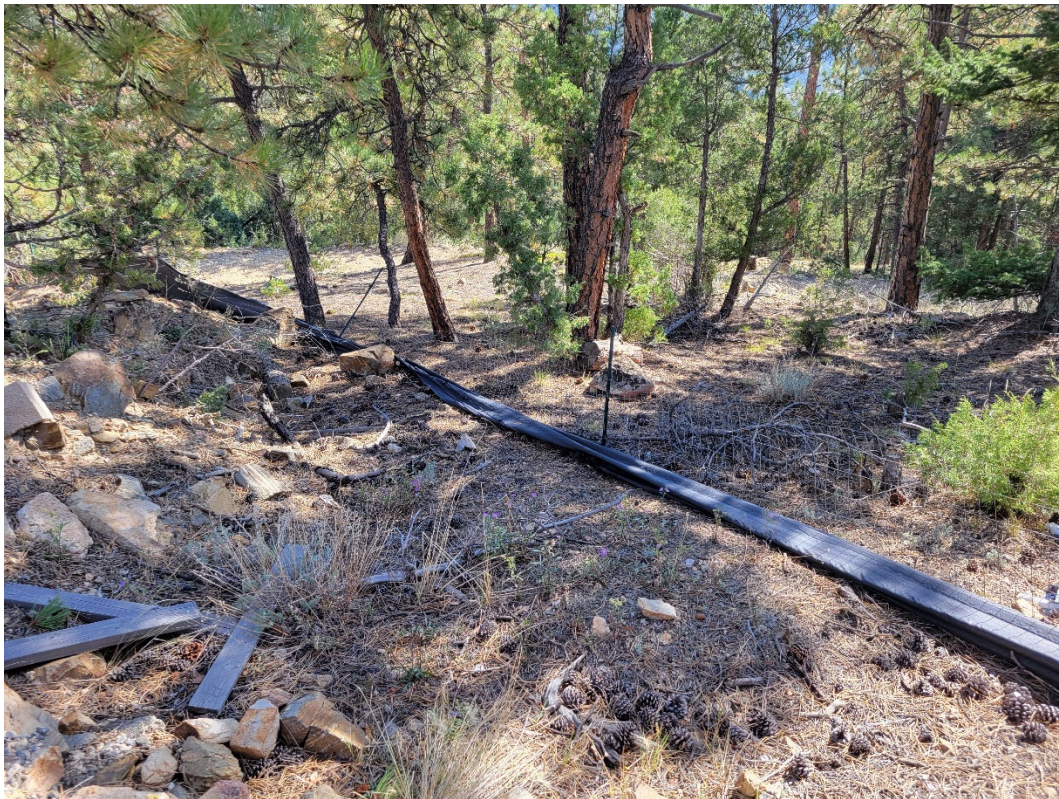
**PROBLEM 2:** The silt fence surrounding the mill site is damaged and not in good working order.

Photo 8: View of non functioning silt fence on the east side of the permit area.

**CORRECTIVE ACTIONS:** Per C.R.S. 34-32-116(7)(i) the Operator shall reinstall a silt fence and send evidence to the Division that this has been completed.

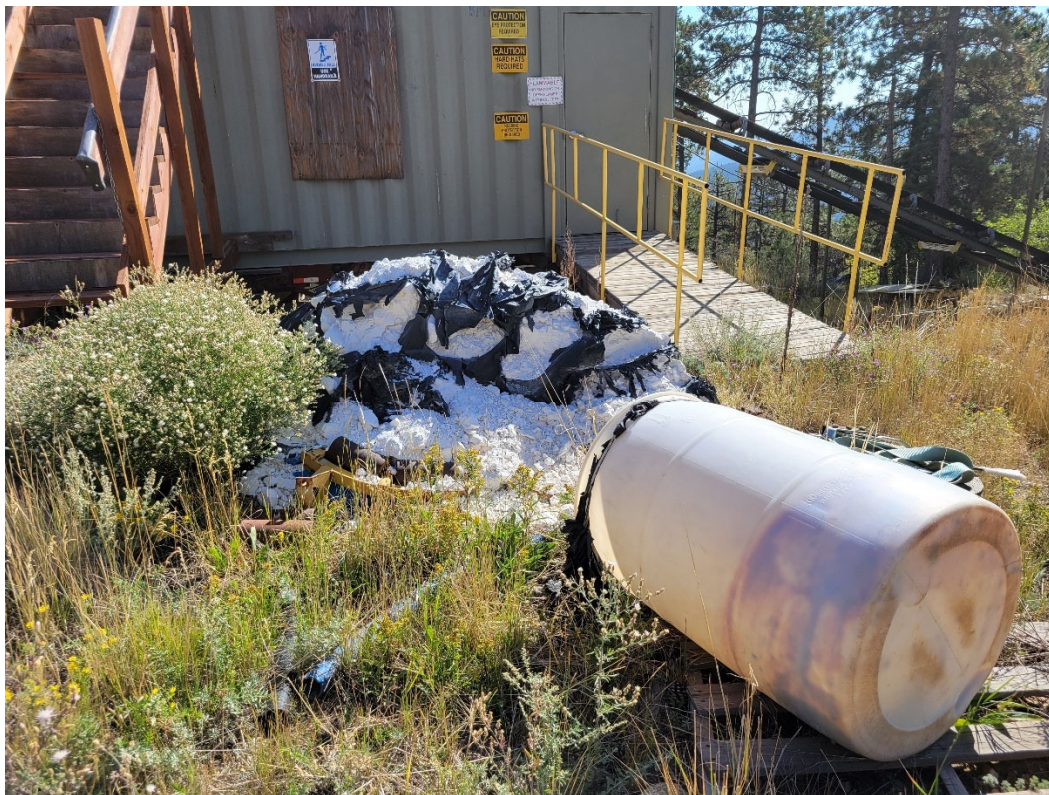
The Division observed abandoned equipment, supplies, and piping around the Mill Area. Additionally, the Division observed a weathered stockpile of lime next to the Ball Mill that appeared to be covered with a plastic tarp at one time. Only remnants of the tarp remain, and the lime is spilling out of the original bags. The

Photo 9: View of poorly maintained lime storage area jacent to the Ball Mill Trailer.

approved mine plan states that 50 pound bags of lime will be stored outside on a pallet and tarped to keep moisture out. As cited in Problem 2 above, the operator shall submit a written notice to the Division with photo documentation that the abandoned equipment, supplies, and piping around the mill area are properly stored or removed from the site and the lime is properly contained and covered.

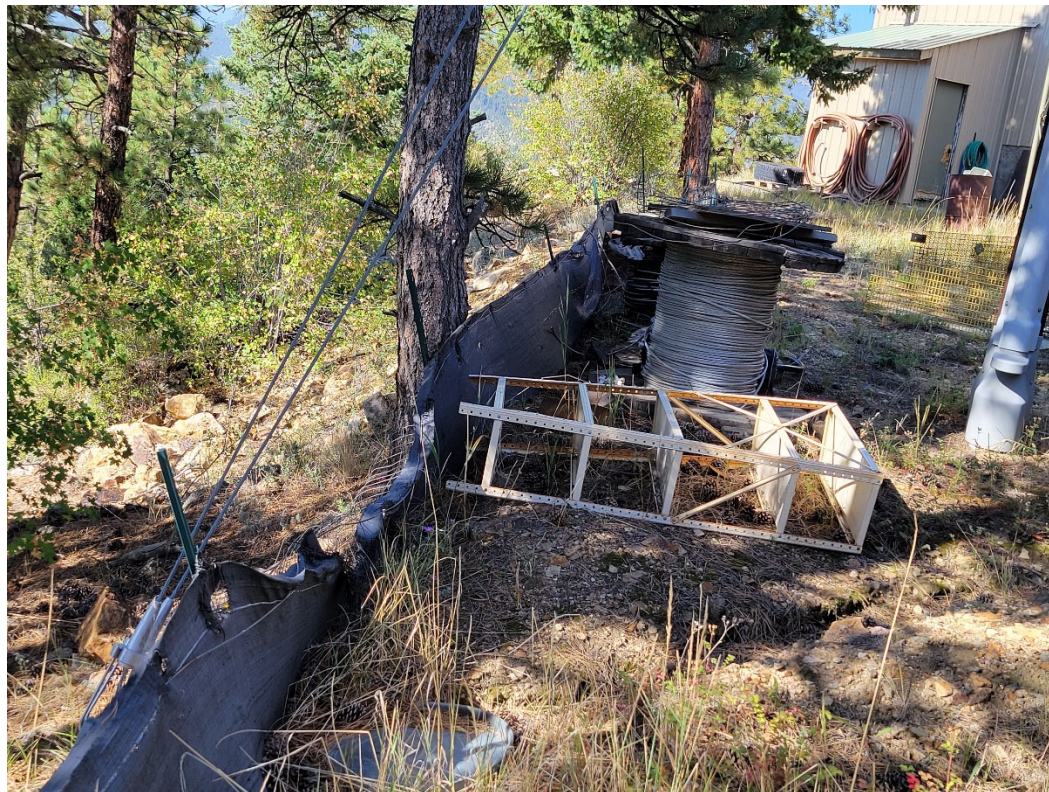
Photo 10: Looking at poorly maintained area behind the crusher plant. Trash, equipment, and a damaged silt fence were observed here.

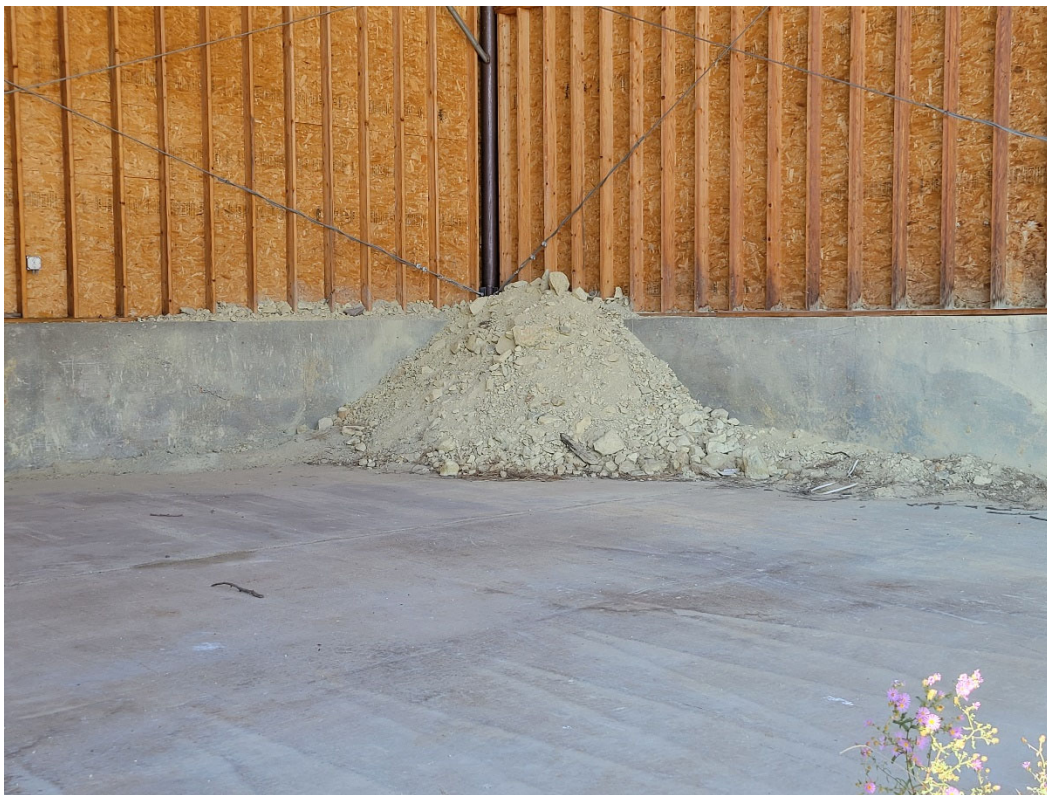
Photo 11: Small stockpile of waste rock in the storage shed area.

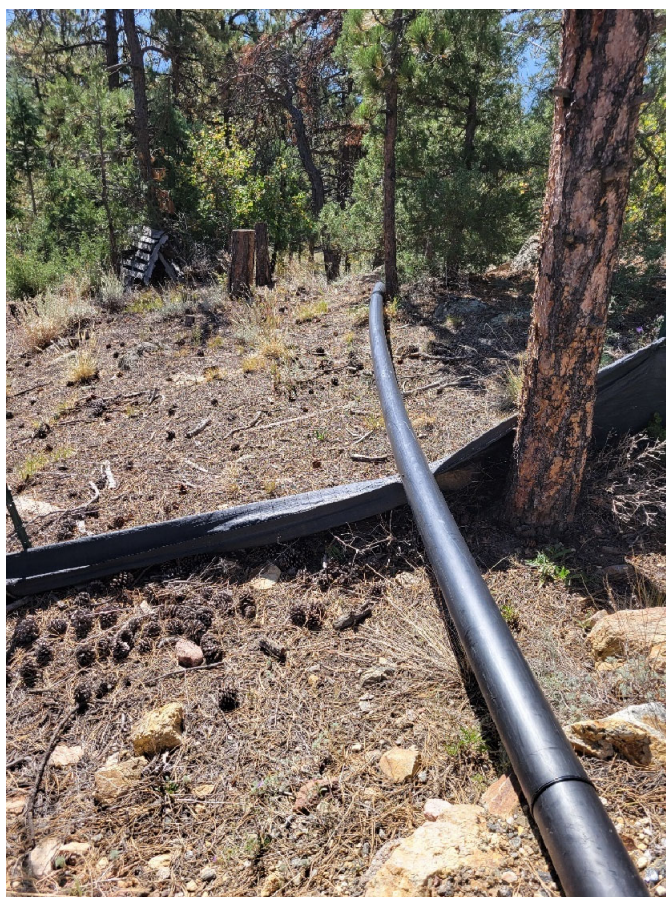
Photo 12: Looking at pipeline to the Tailings Impoundment Area.

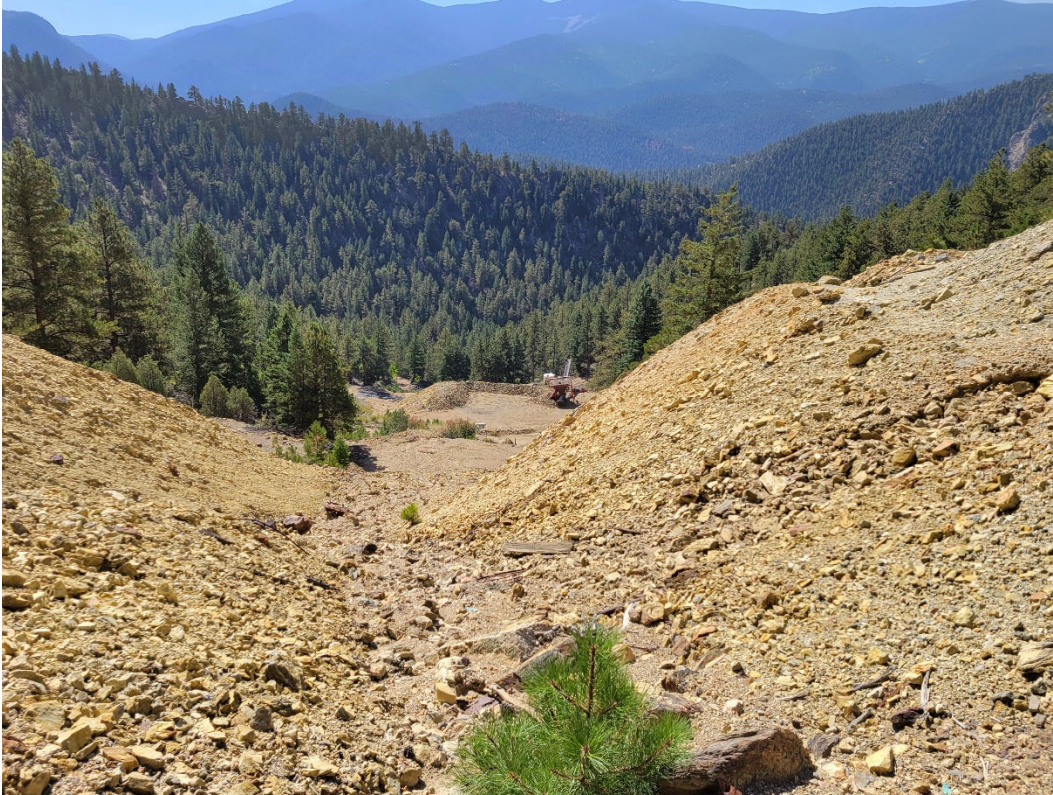
Photo 13: Historic mine waste piles above the Tailings Storage Impoundment.

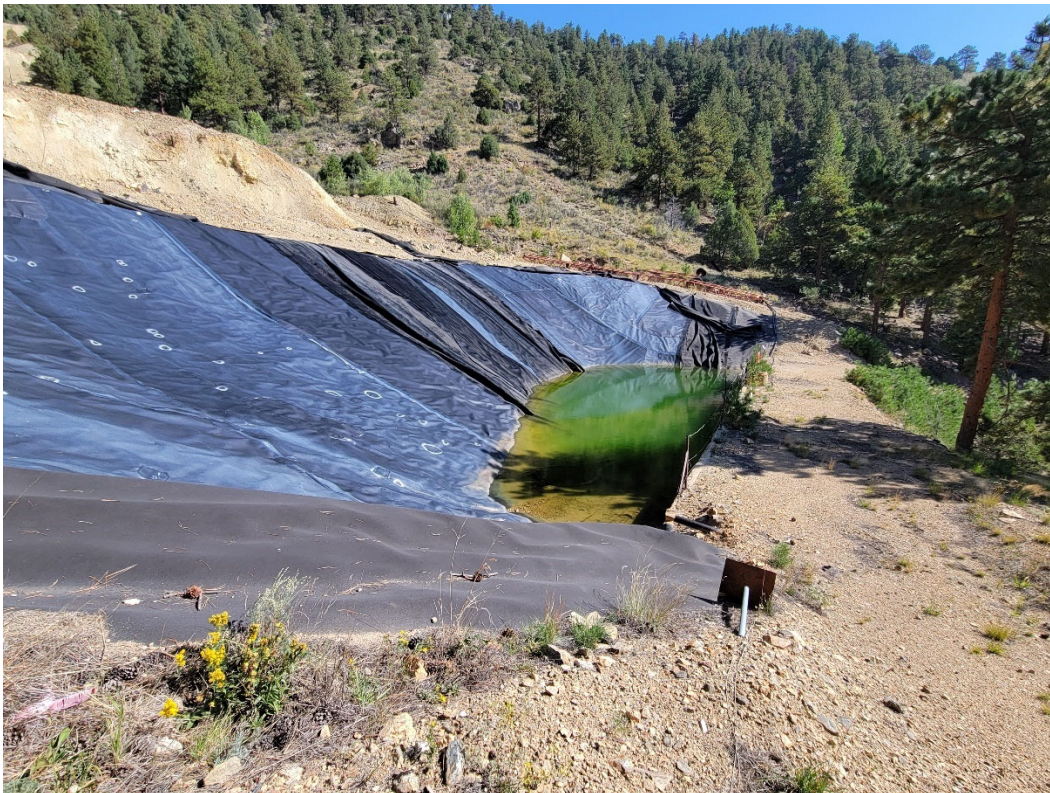
**PROBLEM 4:** The site is improperly impounding surface drainage/runoff in the tailings impoundment area.

During the inspection, the Division observed stormwater in the tailings impoundment. The water is a few feet below the top of the concrete dam. The Operator has a stormwater discharge permit, which does not allow for the discharge of process water. No discharge was observed during this inspection. As cited in Problem 4 above, the operation is improperly impounding surface drainage/runoff in the tailings impoundment area. Per Rule 3.1.6(1)(a) the Operator shall submit documentation from the State Engineer's Office demonstrating that the impoundment of water in the tailings impoundment is authorized by that office.

Photo 14: Looking at composite liner system in Tailings Storage Impoundment.  
Stormwater observed in the impoundment.

**CORRECTIVE ACTIONS:** Per Rule 3.1.6(1)(a) submit documentation from the State Engineer's Office demonstrating that the impoundment of water in the tailings impoundment is authorized by that office.

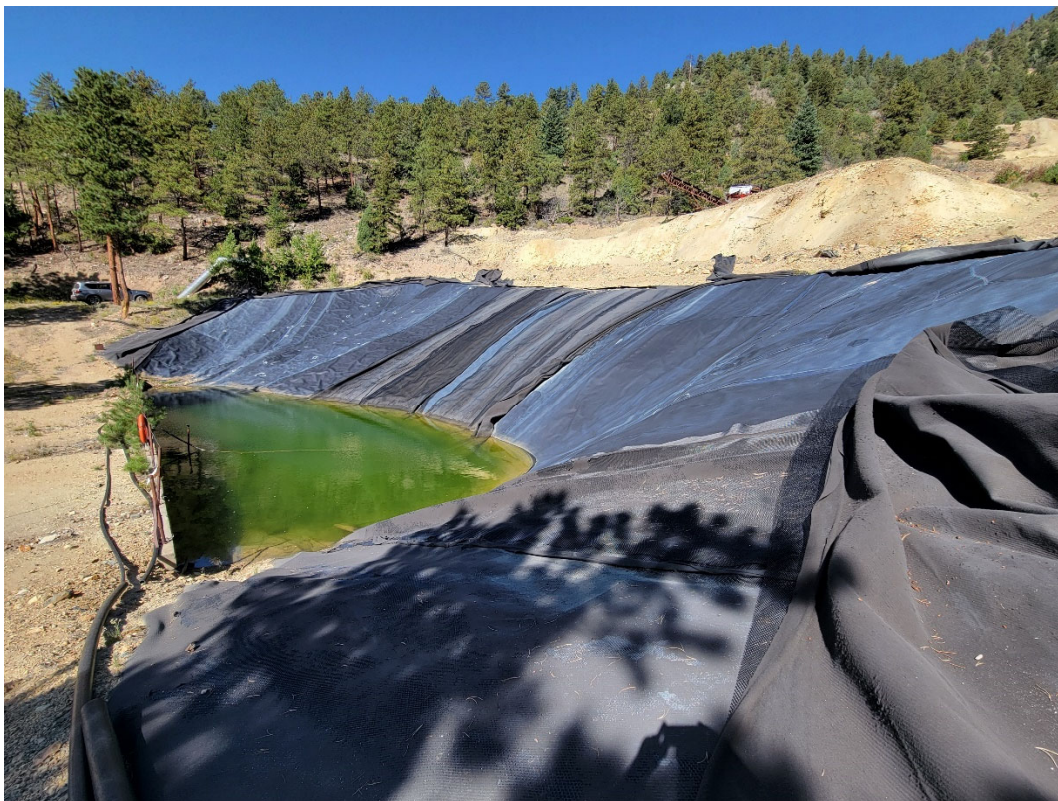
**Problem 3:** The tailings impoundment is an Environmental Protection Facility, designed and certified to permanently contain mill tailings and be protective of surface and groundwater resources. The geo composite liner system is weathered and poorly maintained and may no longer be effective as designed in accordance with Rule 6.4.21(7). The Division considers the certification of this facility void.

Photo 15: View of poorly maintained liner system within the Tailings Storage Impoundment.

**CORRECTIVE ACTIONS:** Prior to placing tailings within the impoundment, the facility will need to be recertified in accordance with Rule 7.3.2. If the facility cannot be recertified, the Operator will need to file a Technical Revision to update the Environmental Protection Plan to repair and/or modify the Environmental Protection Facility in accordance with Rule 6.4.21(7) and 7.3.

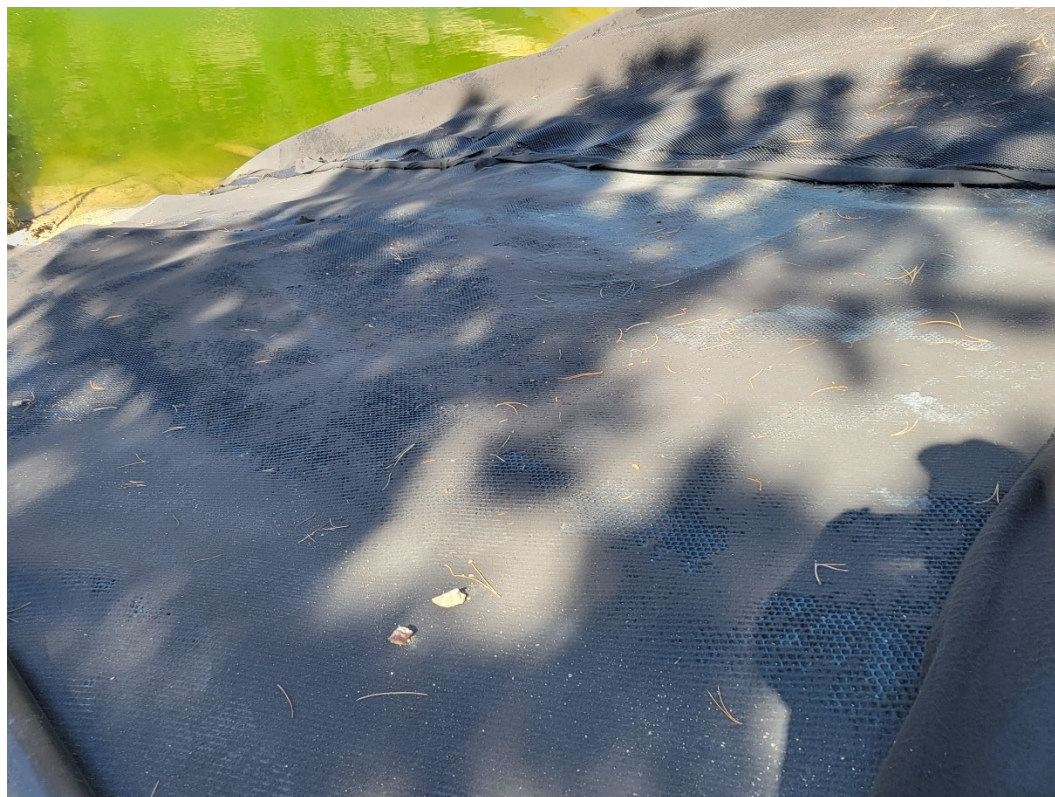
Photo 16: Closeup view of the weathered liner in the Tailings Storage Impoundment.

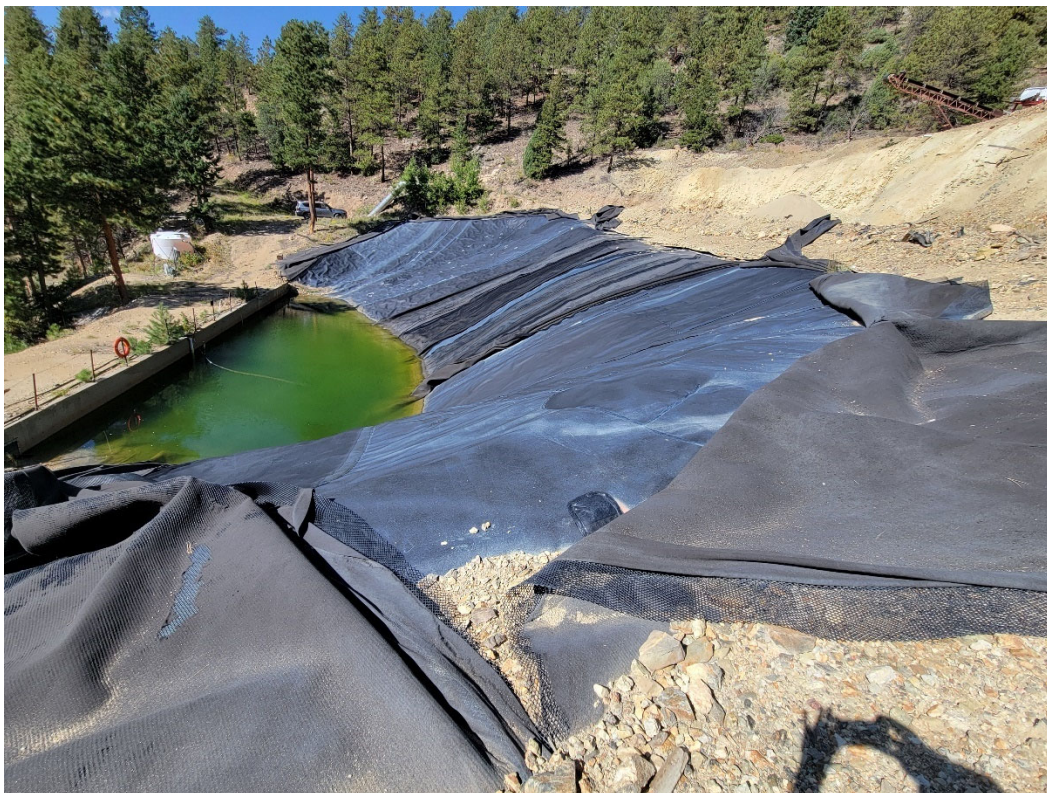
Photo 17: Looking at weathered composite liner. Top layer is blow off and laying above the Tailings Storage Impoundment.

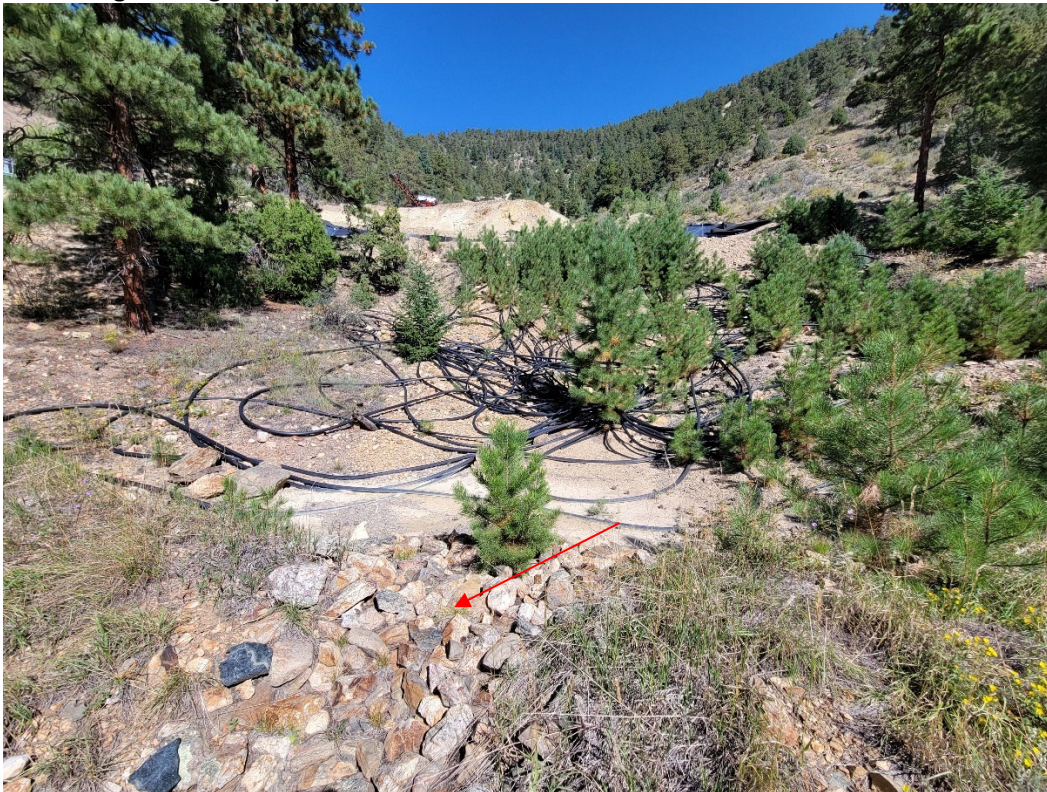
A small storm water catchment/sedimentation pond is located below the concrete barrier. The sediment pond was dry during this inspection. The Division observed numerous sections of HDPE pipe tossed into the sedimentation pond. Pursuant to C.R.S. 34-32-116(7)(d), all refuse shall be disposed in a manner that will control unsightliness or deleterious effects from such refuse, therefore the Operator has a responsibility to maintain the site from debris/refuse. The pipes shall be properly stored, reinstalled, or disposed of and evidence of compliance shall be submitted to the Division.

Photo 18: Sedimentation collection pond for surface runoff below the Tailings Storage Impoundment. Rip-rapped discharge weir indicated by red arrow. HDPE pipes from the slurry pipeline to the Mill are tossed into the sedimentation collection pond.

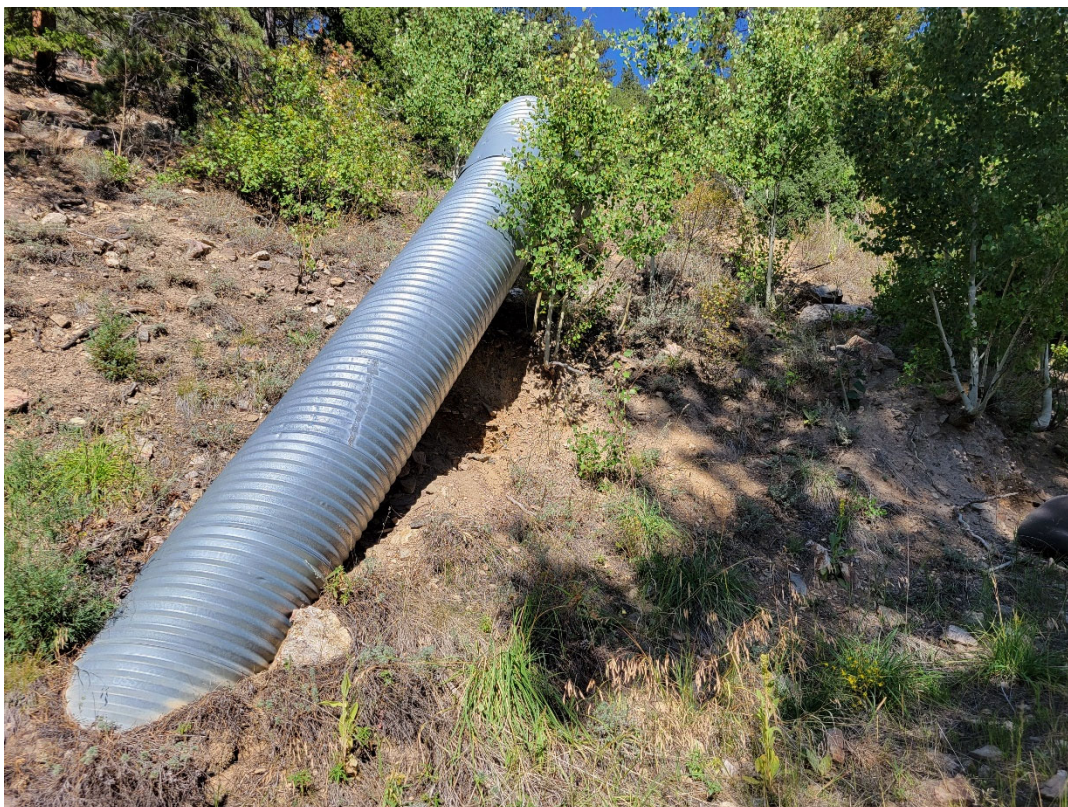
Photo 19: Stormwater diversion pipeline on the west side of the Tailings Impoundment Area.

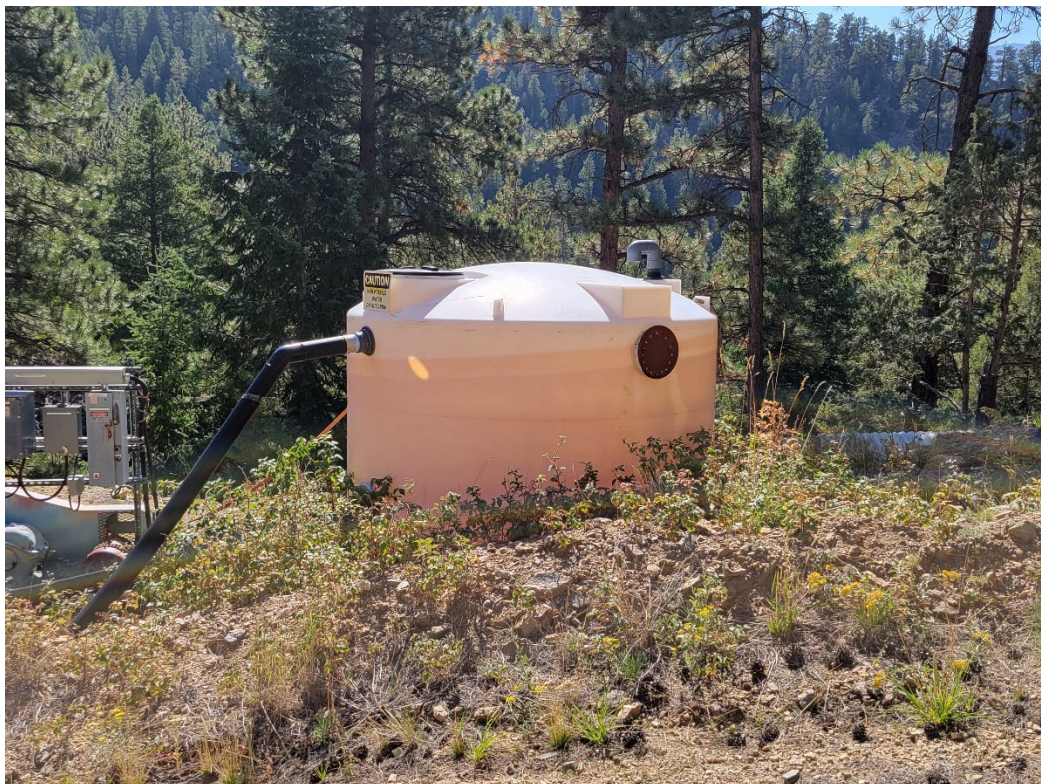
Photo 20: Process water storage tank adjacent to the Tailings Impoundment.

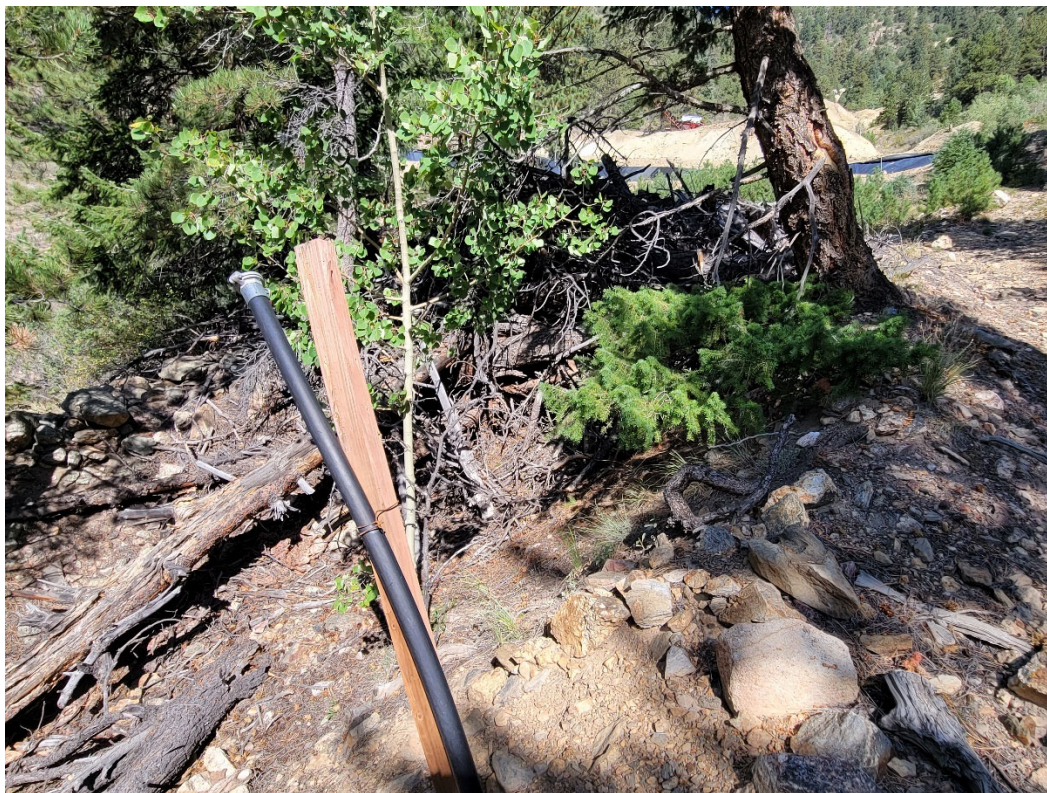
Photo 21: View of the groundwater monitoring well downgradient from the sedimentation pond in the Tailings Impoundment Area.

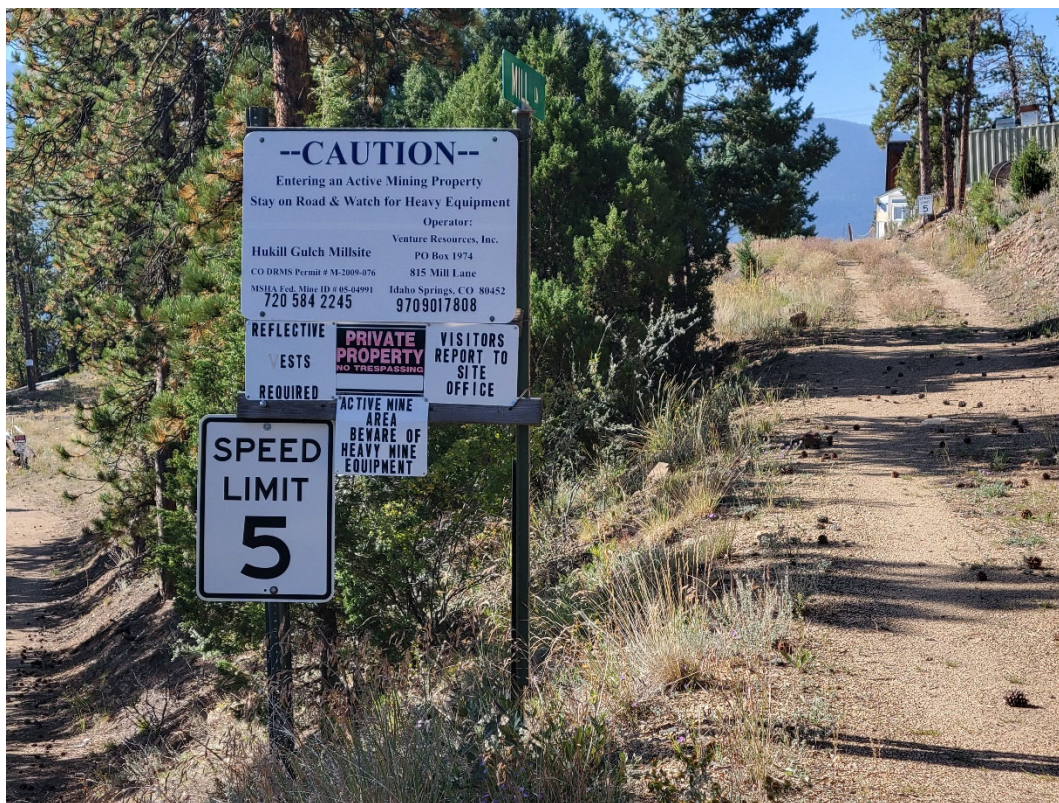
Photo 22: Mine sign posted at the entrance to the Mill.

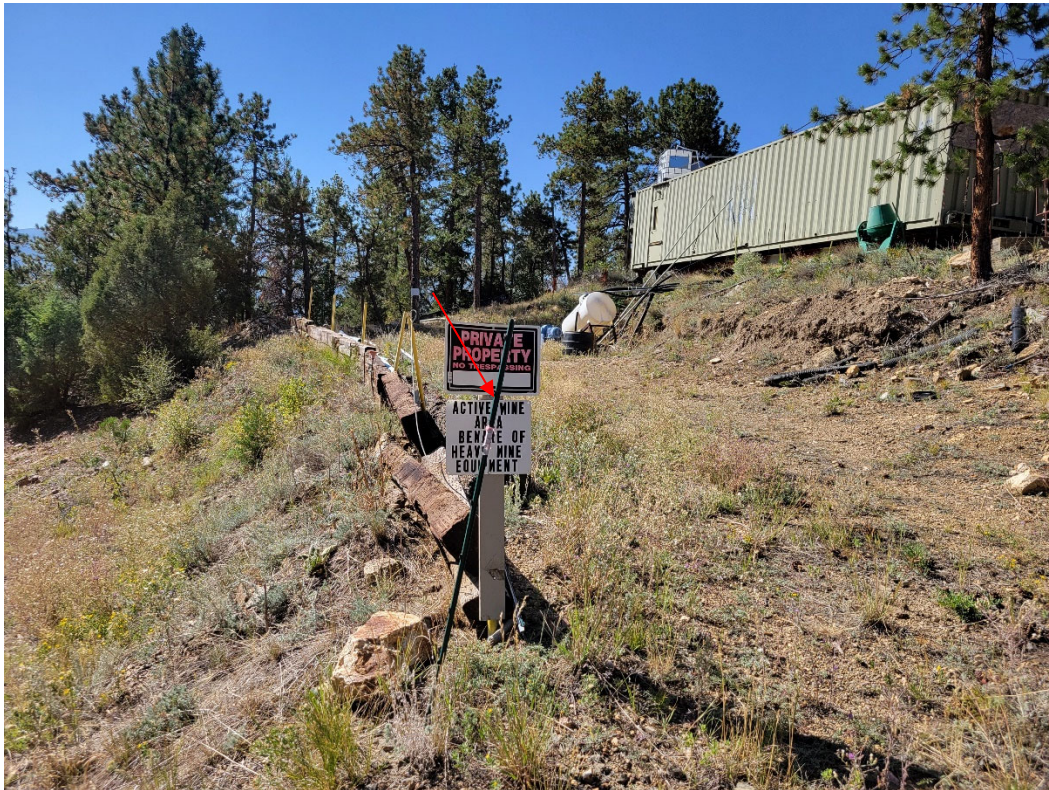
Photo 23: Boundary marker observed on the east side of the Mill.
