MINERALS PROGRAM INSPECTION REPORT
PHONE: (303) 866-3567

MINE NAME: Dewitt Excavating	MINE/PROSPECTING ID#: M-1983-132	MINERAL: Sand	COUNTY: Prowers
INSPECTION TYPE: Monitoring	WEATHER: Clear	INSP. DATE: September 24, 2024	INSP. TIME: 14:53
OPERATOR: DeWitt Excavating, Inc.	OPERATOR REPRESENTATIVE: Staci Dewitt	TYPE OF OPERATION: 110c - Construction Limited Impact

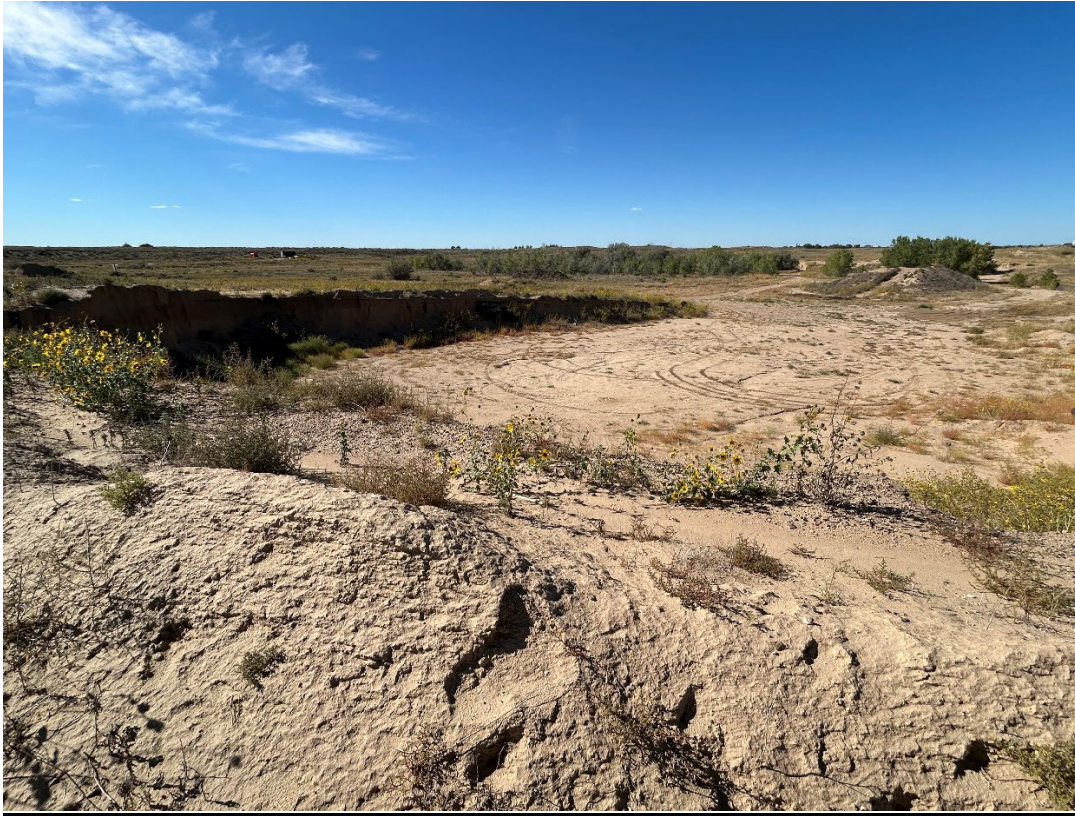
Photo 1. View looking northwest across pit area from its southern edge. Note large material stockpile stored on pit floor.

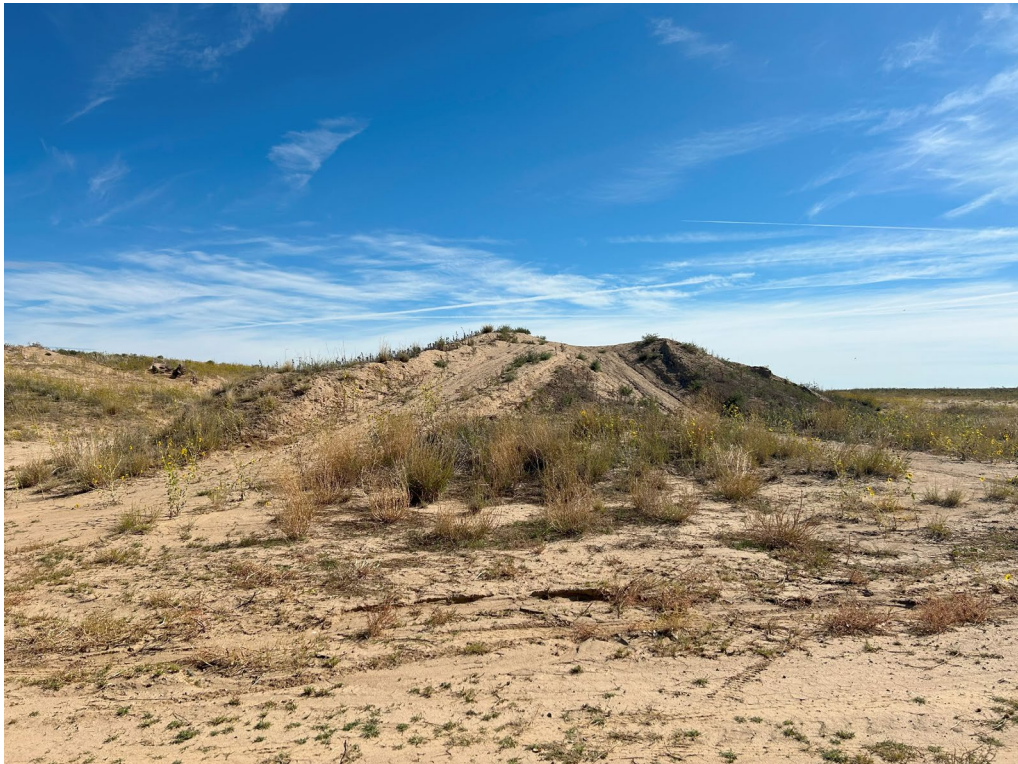
Several dirt bike trails were present throughout the permit area, including over portions of the pit wall and over the larger material stockpile on the pit floor. According to the Division's inspection report from April 18, 2012, the county owns a motorcycle track on the adjacent property, from which, the bikers will frequently ride across the operator's property, including the pit area. Once reclamation of the pit has been initiated, the operator will need to somehow restrict access to the pit to protect it from being re-disturbed by these activities. It appears the pit has almost been mined out given its proximity to the northern, southern, and eastern permit boundaries.

Photo 2. View looking south across pit area, showing large material stockpile with dirt bike trail across its middle stored on pit floor.

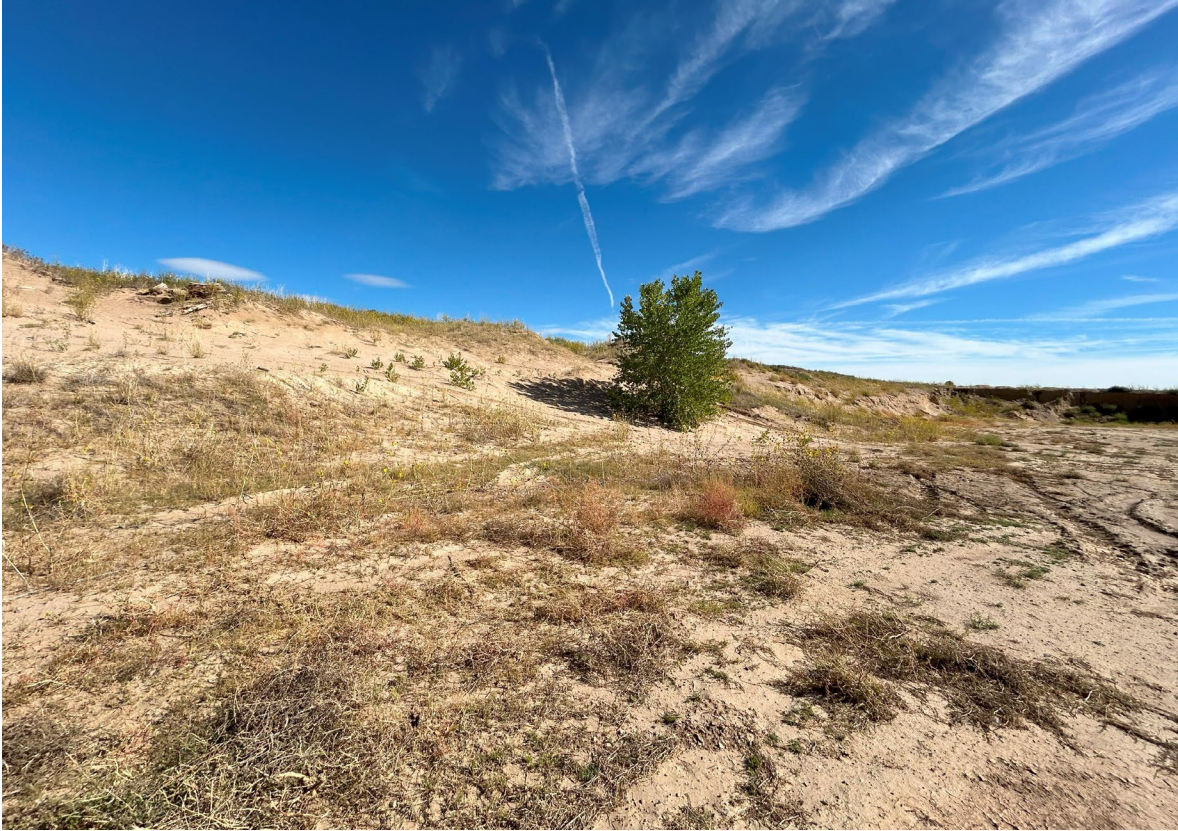
Photo 3. View looking southeast across pit area.

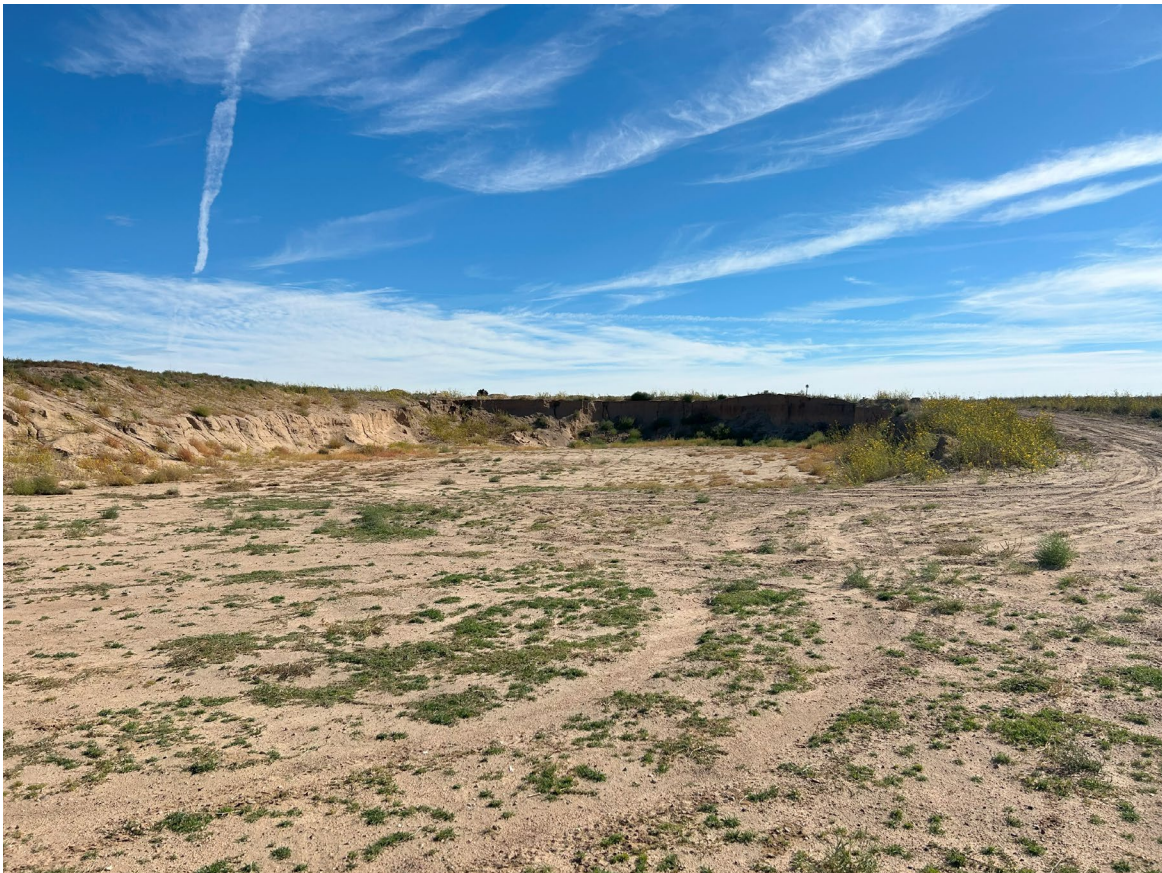
Photo 4. View looking south across pit area at southern pit wall.

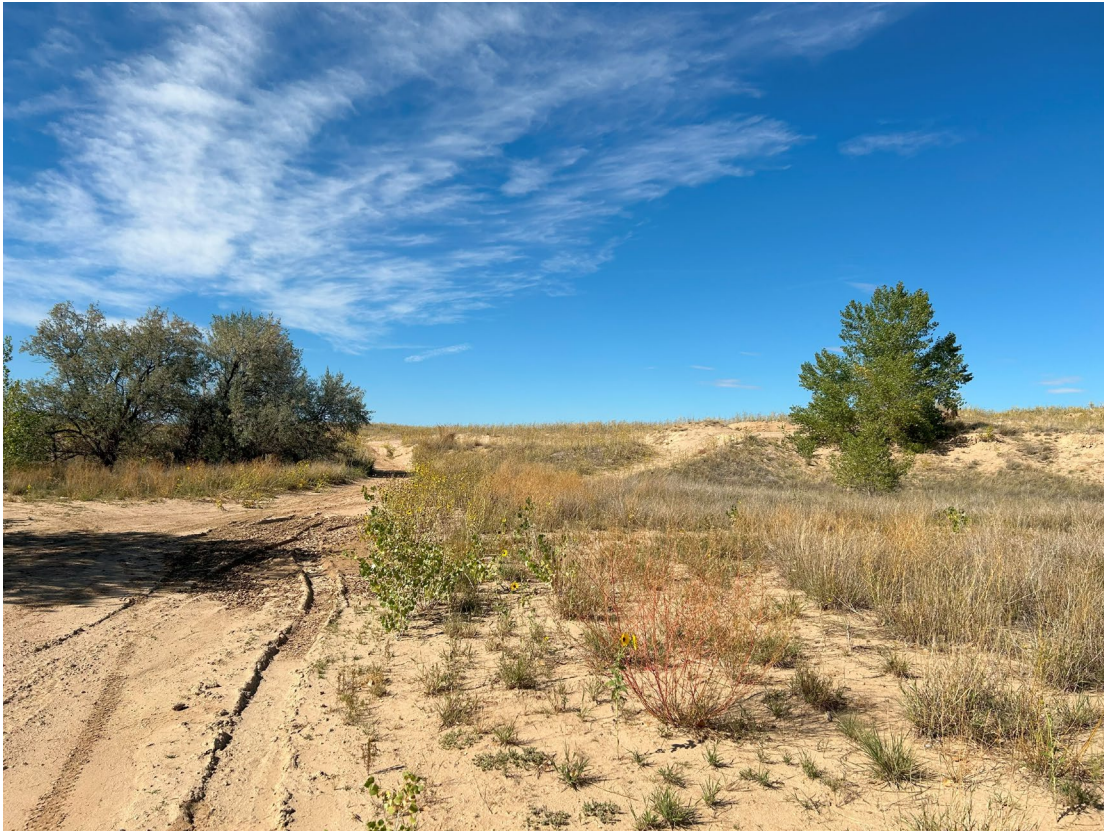
Photo 5. View looking north across the center of the permit area.

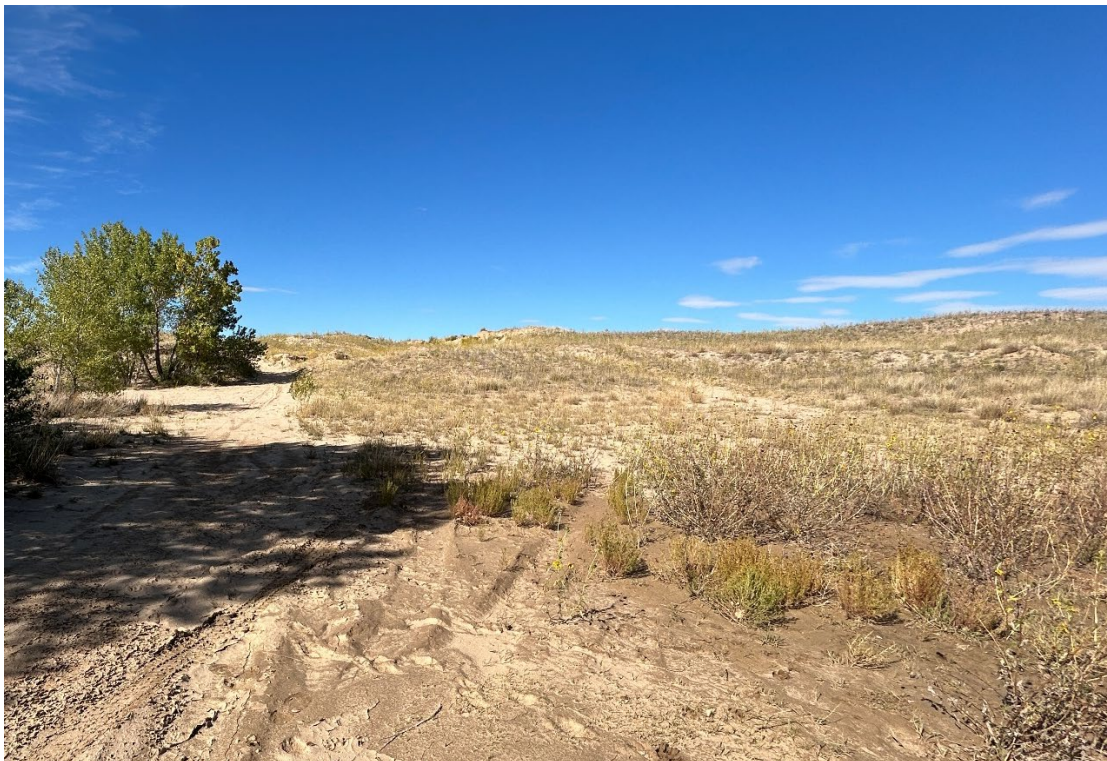
Photo 6. View looking north at northeastern pit wall, which has more vegetative cover consisting primarily of annual weeds.

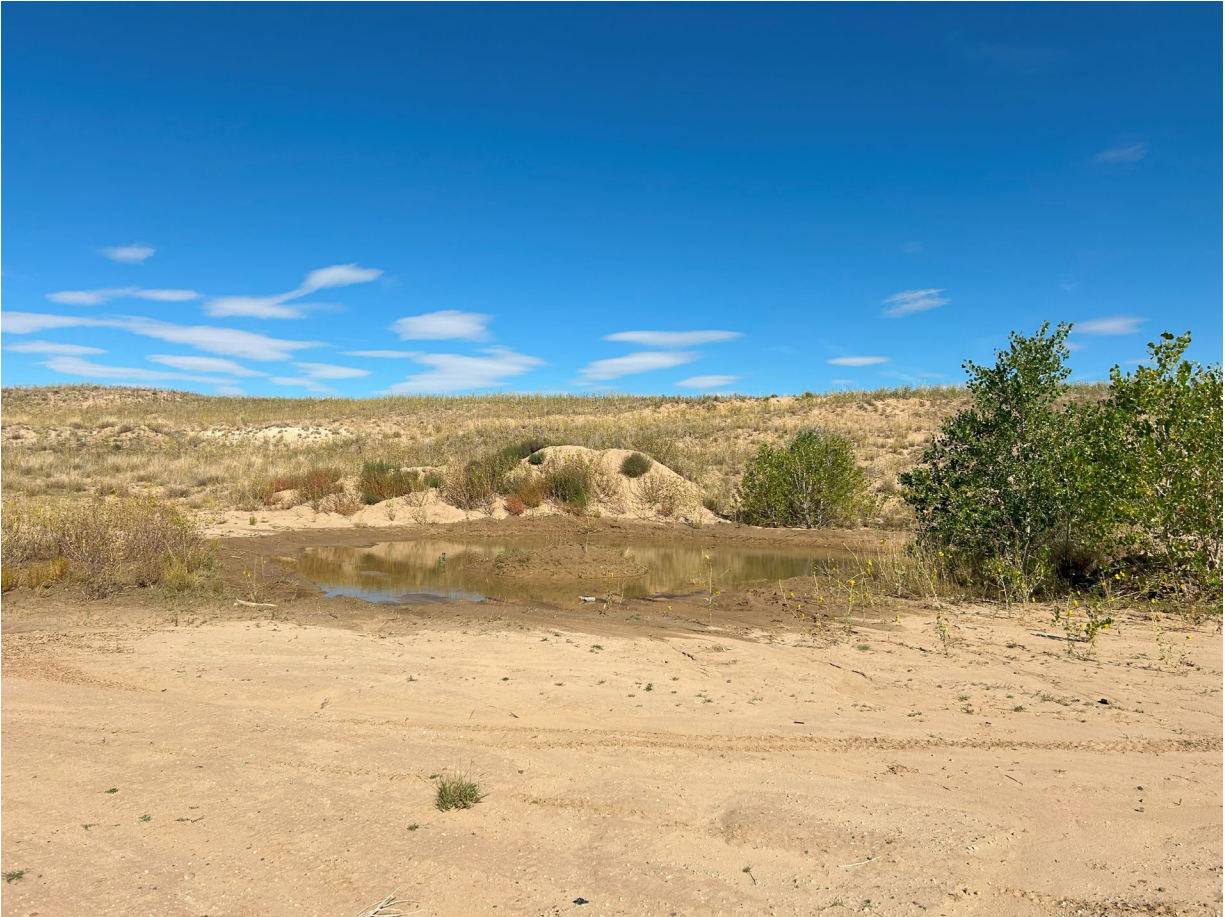
The sand pit is oriented in a north-south direction. The pit wall daylights primarily to the west, and is approximately 15 feet in height with slope gradients ranging from near vertical to 2H:1V. The Division estimates the pit wall to be approximately 1,100 feet in total length. A few material stockpiles were stored on the pit floor, and adjacent to the access road where it enters the pit. The previously mined western portion of the permit area was fairly flat and well-vegetated with grasses, some shrubs, and mature trees (primarily cottonwoods). Vegetative cover of the pit area consisted primarily of annual weeds (e.g., kochia, wild sunflowers) and a few volunteer cottonwood trees. There was some standing water on the pit floor, but given the recent storms in the area, the water is not considered an issue by the Division.

Photo 7. View looking east at standing water on pit floor from recent storms.

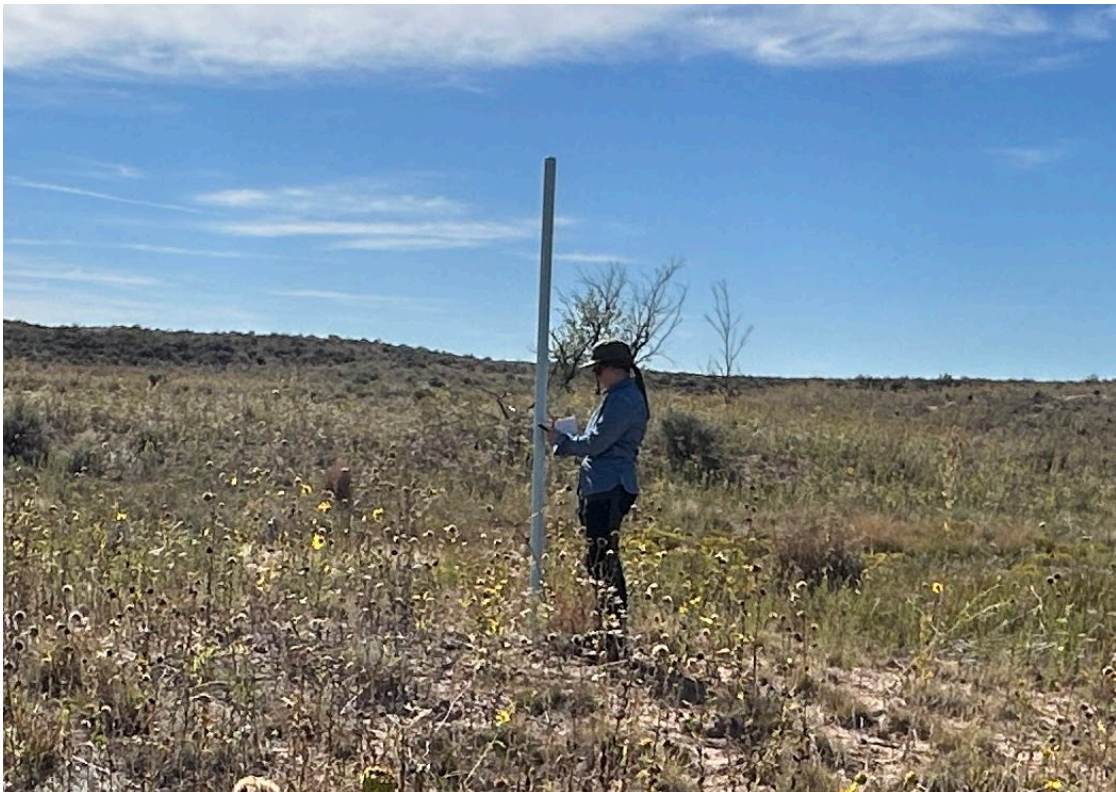
Photo 8. Northwest permit boundary marker, directly next to DRMS employee (looking west).

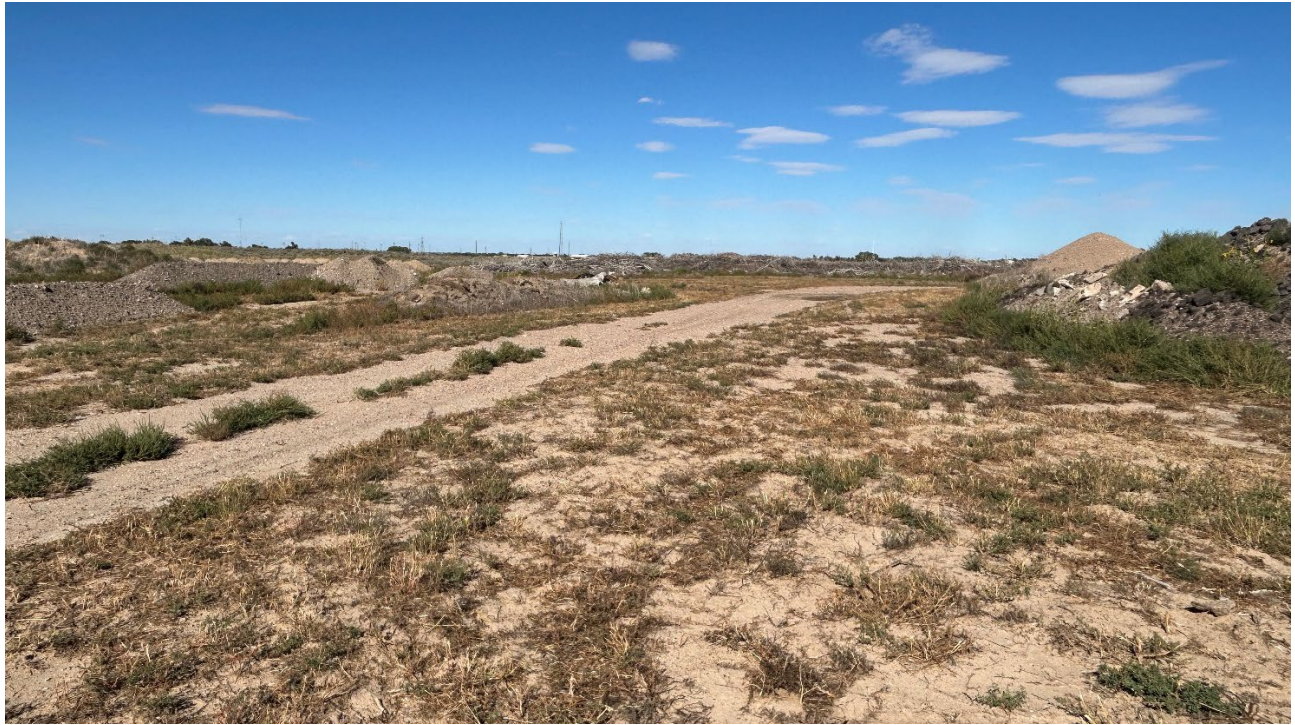
The Division observed an area located directly southeast of the permit area in which the operator is storing concrete rubble, asphalt rubble, slash piles, dirt piles, and old (empty) storage tanks. The Division estimates this storage area to cover approximately 5.75 acres. The Division found documentation in the permit file (November 30, 1993 inspection report) indicating these materials had been initially stored within the permit area, and the Division required the operator to either remove them from the permit area, or to revise the approved mining and reclamation plans to account for the temporary or permanent storage of these materials within the permit area. According to the October 10, 2019 inspection report, these materials were brought to the property from various construction jobs that were completed off site, and they are not associated with the mine site in any way. The Division did not find any mining related material in this area, and none of the stored construction material piles crossed into the mine permit boundary. The operator was reminded to be careful not to utilize this offsite storage area in any way for the mining operation, including storing material mined from the pit, storing material to be used for reclamation of the pit, using the area for mine operation parking, equipment storage, or any other use associated with the mining operation.

Photo 9. View looking north at off-site storage area located directly southeast of permit area, showing various stockpiles of imported construction materials stored in this area.

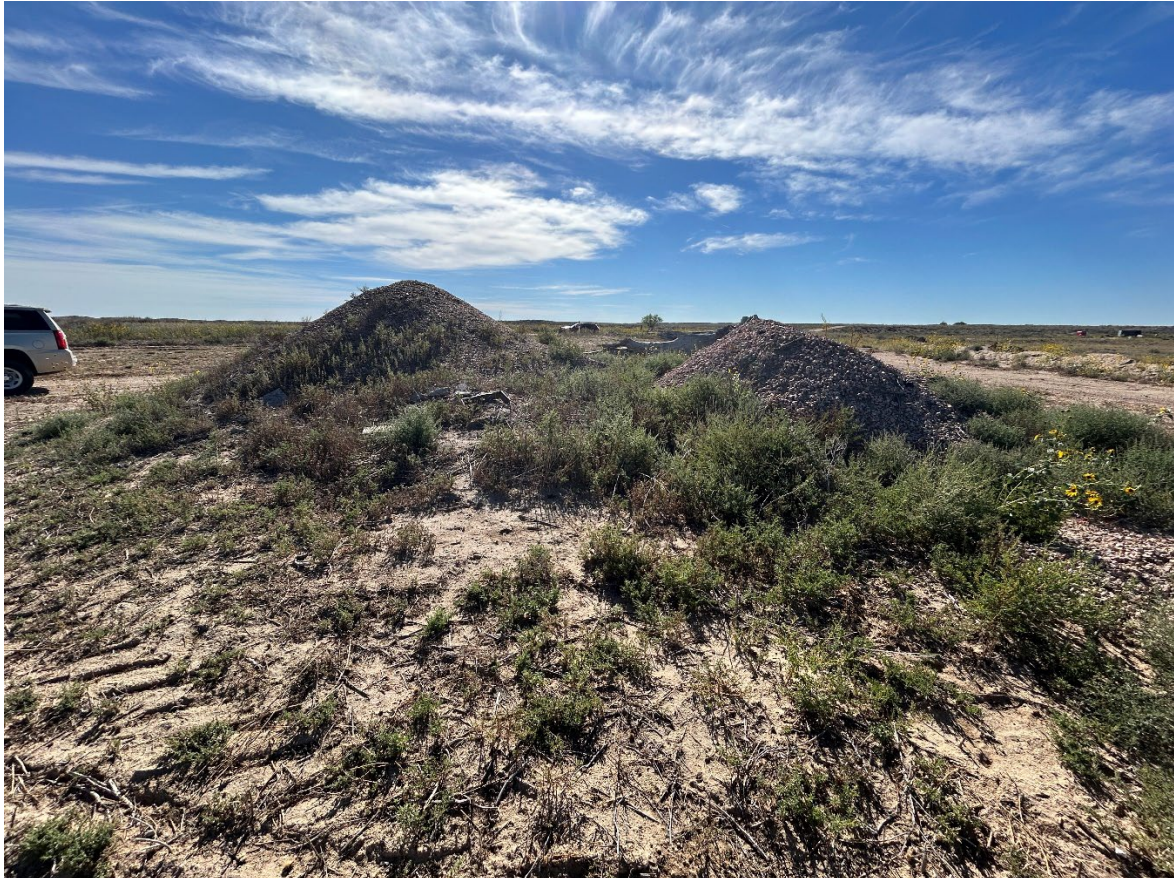
Photo 10. View looking southwest at off-site storage area located directly southeast of permit area, showing dirt and stone stockpiles stored in this area.

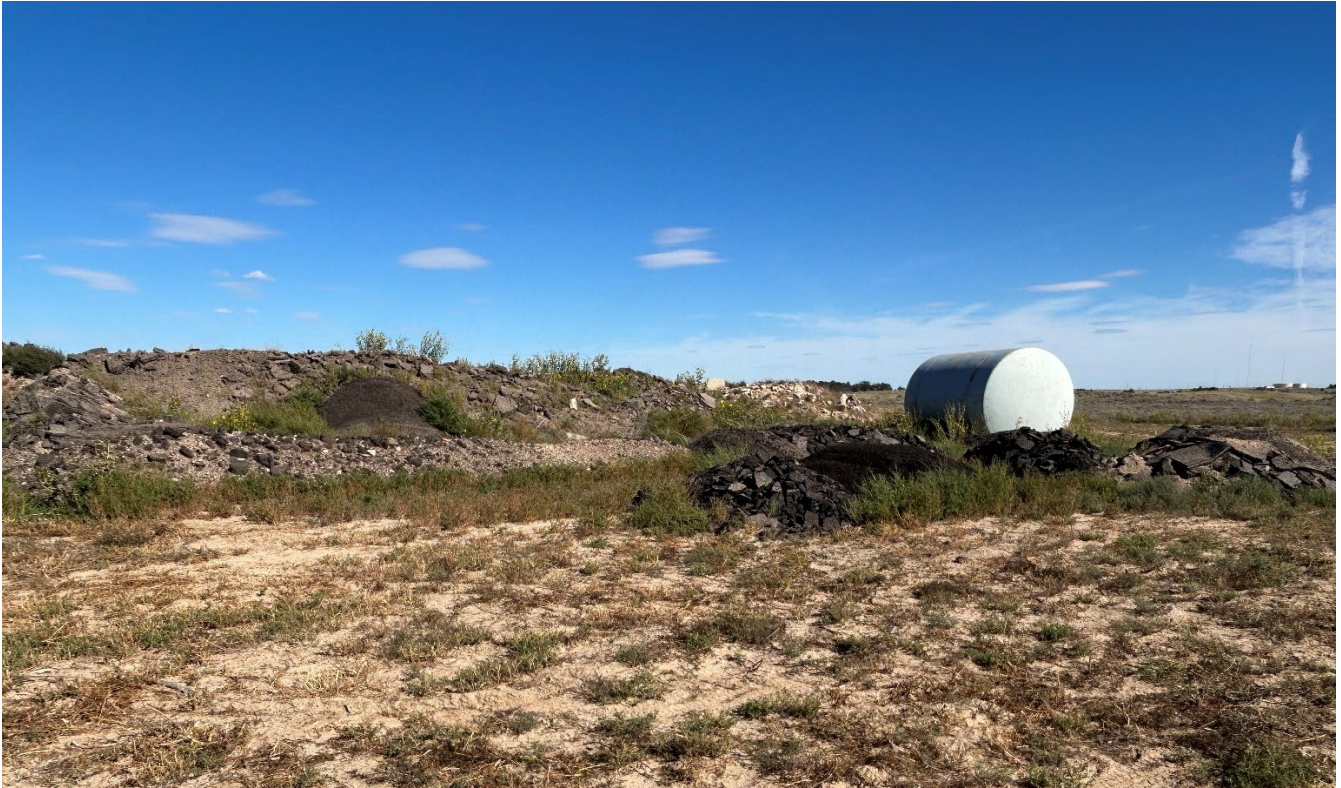
Photo 11. View looking east at off-site storage area located directly southeast of permit area, showing concrete rubble, asphalt rubble, and an old storage tank stored in this area.

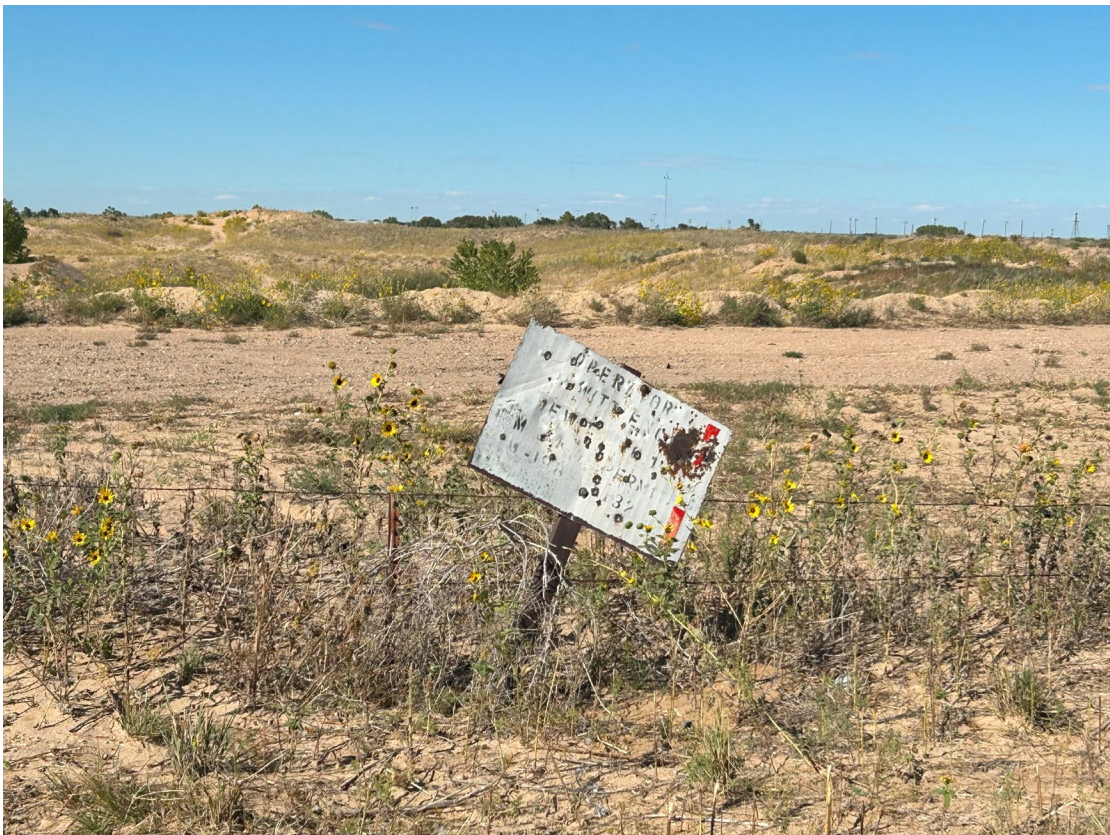
PROBLEM #1: A proper mine identification sign was not posted at the entrance of the mine site. This is a problem for failure to post a mine identification sign in accordance with Rule 3.1.12(1).

At the time of the inspection, the weather was clear, warm, and dry. A permit sign was posted at the main site entrance off Co Rd Ff. However, the sign was damaged due to several bullet holes, making it difficult to read. The operator will need to replace the mine identification sign and ensure it meets all requirements of Rule 3.1.12(1). A problem is cited for this issue; see Problem #1 in this report for the required corrective actions. The corners of the permit boundary were marked with PVC pipes. The site was not active during the inspection. However, according to the operator, the site is active every year in accordance with its intermittent status. The operator representative told the Division mined material was recently hauled off the site and used for local construction in Lamar, and that they keep blow sand stored at their office location. For the operator to retain the permit, they need to be active every year (e.g. material extraction, hauling off-site, or processing stockpiled material), unless the operator wants to apply for Temporary Cessation or initiate final reclamation.

Photo 12: Mine identification sign with damage from bullet holes.

CORRECTIVE ACTIONS: The Operator shall, at the entrance of the mine site post a sign, which shall be clearly visible from the access road, with a minimum size equaling one hundred and eighty-seven (187) square inches, such as eleven (11) inches in height and seventeen (17) inches in width, with appropriate font size, with the following: the name of the Operator, the operation name, a statement that a reclamation permit for the operation has been issued by the Colorado Mined Land Reclamation Board, and the permit number. The operator shall submit photo documentation that a proper sign has been posted by the corrective action date.
