MINERALS PROGRAM INSPECTION REPORT
PHONE: (303) 866-3567

MINE NAME: Klondike Basin Exploratory Drilling Project	MINE/PROSPECTING ID#: P-2022-005	MINERAL: Copper	COUNTY: San Miguel
INSPECTION TYPE: Multi Person Inspection	WEATHER: Clear	INSP. DATE: October 2, 2024	INSP. TIME: 10:15
OPERATOR: Tarsis Resources US Inc.	OPERATOR REPRESENTATIVE: None	TYPE OF OPERATION: MP - Mineral Prospecting

REASON FOR INSPECTION: Surety Release Requested	BOND CALCULATION TYPE:	BOND AMOUNT: \$23,828.00
DATE OF COMPLAINT: NA	POST INSP. CONTACTS: None	JOINT INSP. AGENCY: None
INSPECTOR(S): Lucas West	INSPECTOR'S SIGNATURE:

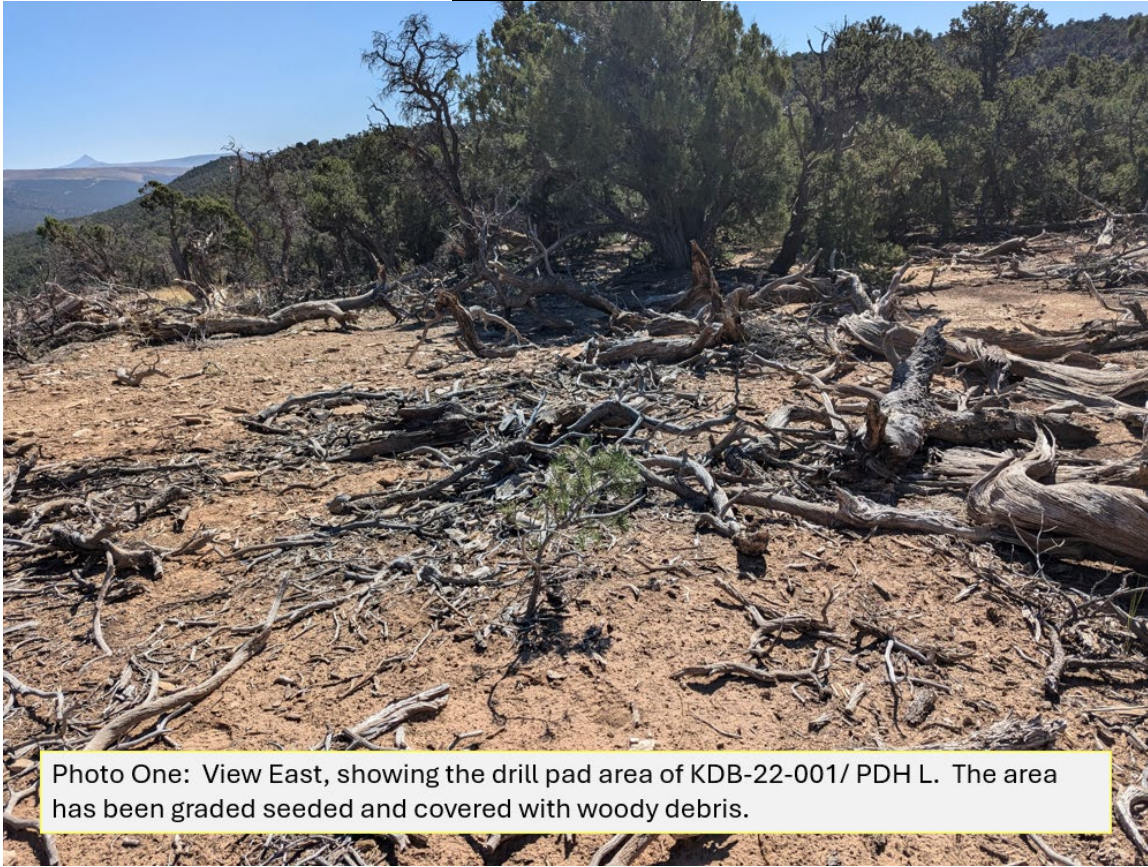
The KDB-22-001 pad and associated access road is located North of an area referred to as Buck Knob. The access road has been graded, and made to blend with the surrounding area by spreading woody debris across the footprint of the road. The area was seeded, however given the aspect of the road, and soil conditions very few reclamation species were identified. This is not considered a problem however, given the condition of adjacent undisturbed lands. An example of the access road can be seen in Photo One. Photo Two shows the pad area. The pad has been graded to blend the surrounding landscape, seeded and covered with large rocks as well as woody debris. Similar to the access road, the vegetative cover is minimal, however is as good or better than the surrounding area. The drill hole was successfully reclaimed to the point where it was unable to be located. The drill hole abandoned report confirms the details of the reclamation.

Photo One: View East, showing the drill pad area of KDB-22-001/ PDH L. The area has been graded seeded and covered with woody debris.

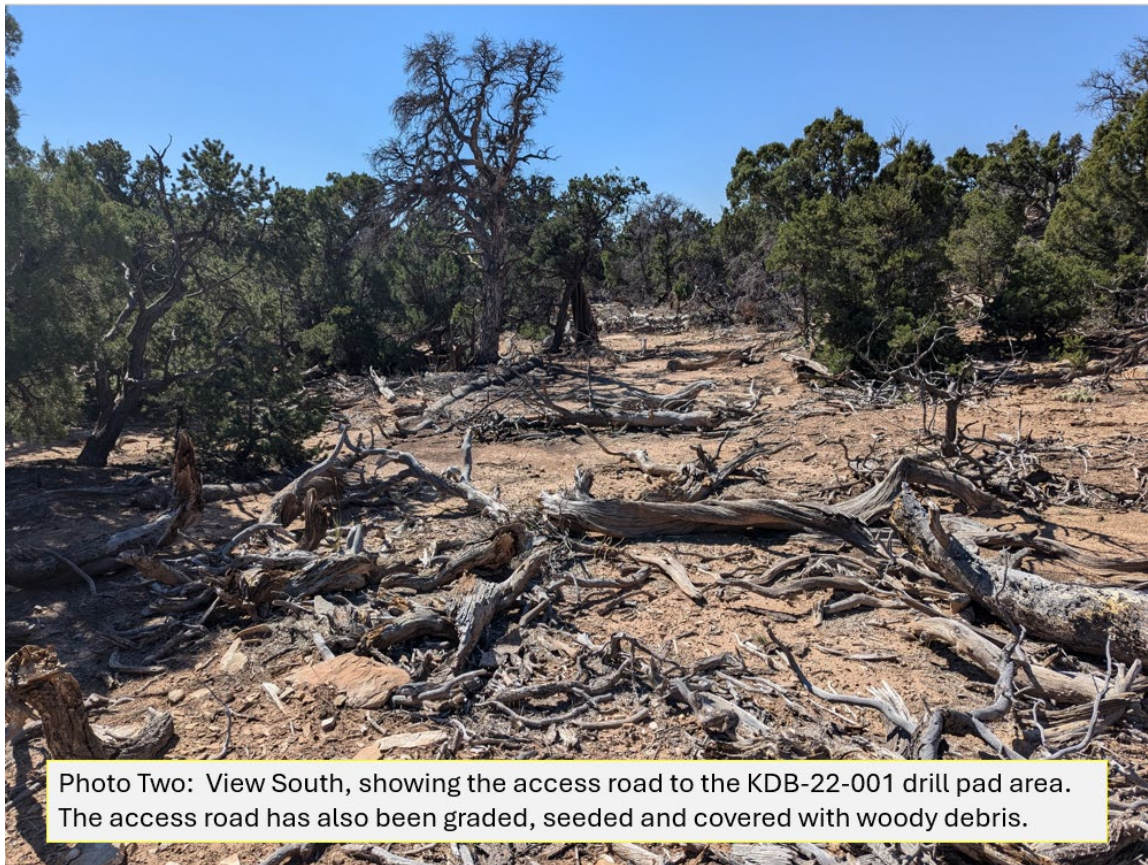
Photo Two: View South, showing the access road to the KDB-22-001 drill pad area. The access road has also been graded, seeded and covered with woody debris.

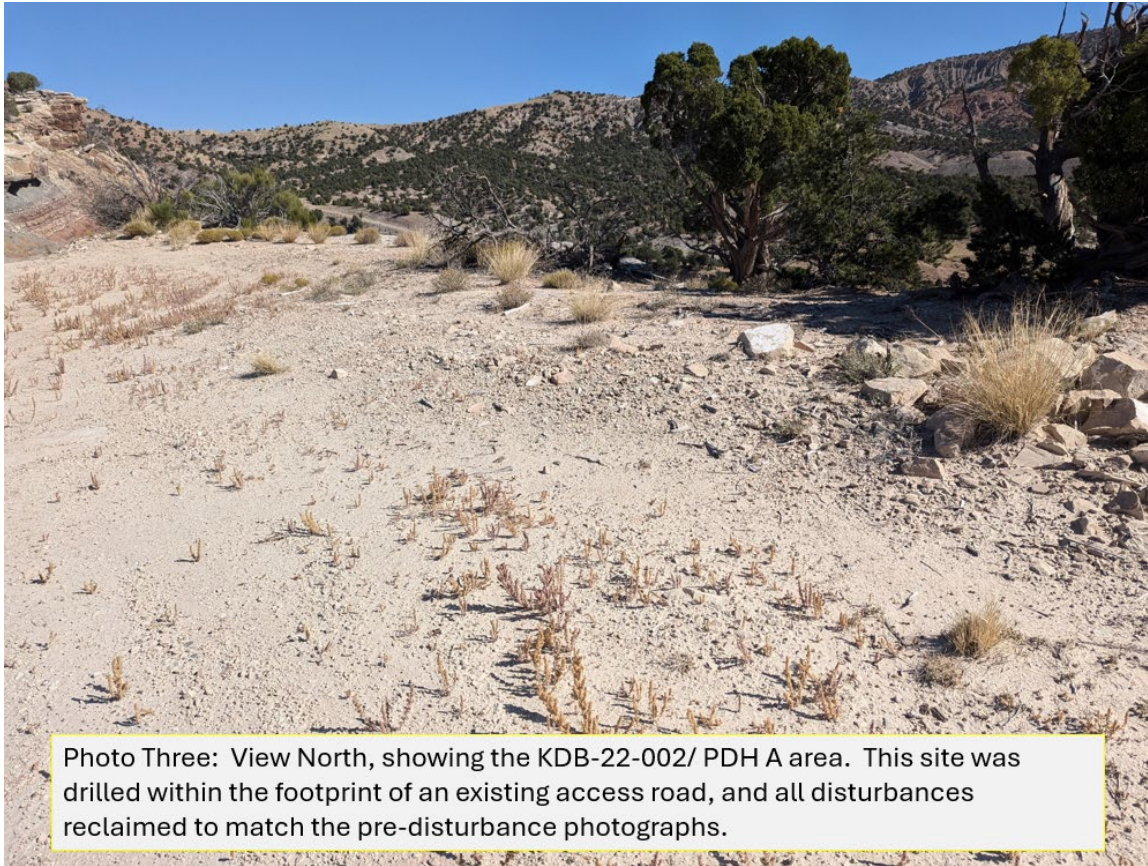
The KDB-22-002/ PDH A was completed on a wide spot of an existing access road. Very minimal surface work was needed to complete the pad and was largely indiscernible from the site photos of pre-existing conditions. Photos Three and Four show the area. Based on the received Drill Hole Abandonment Report and the pre-disturbance photographs the reclamation of the area is considered successful.

Photo Three: View North, showing the KDB-22-002/ PDH A area. This site was drilled within the footprint of an existing access road, and all disturbances reclaimed to match the pre-disturbance photographs.

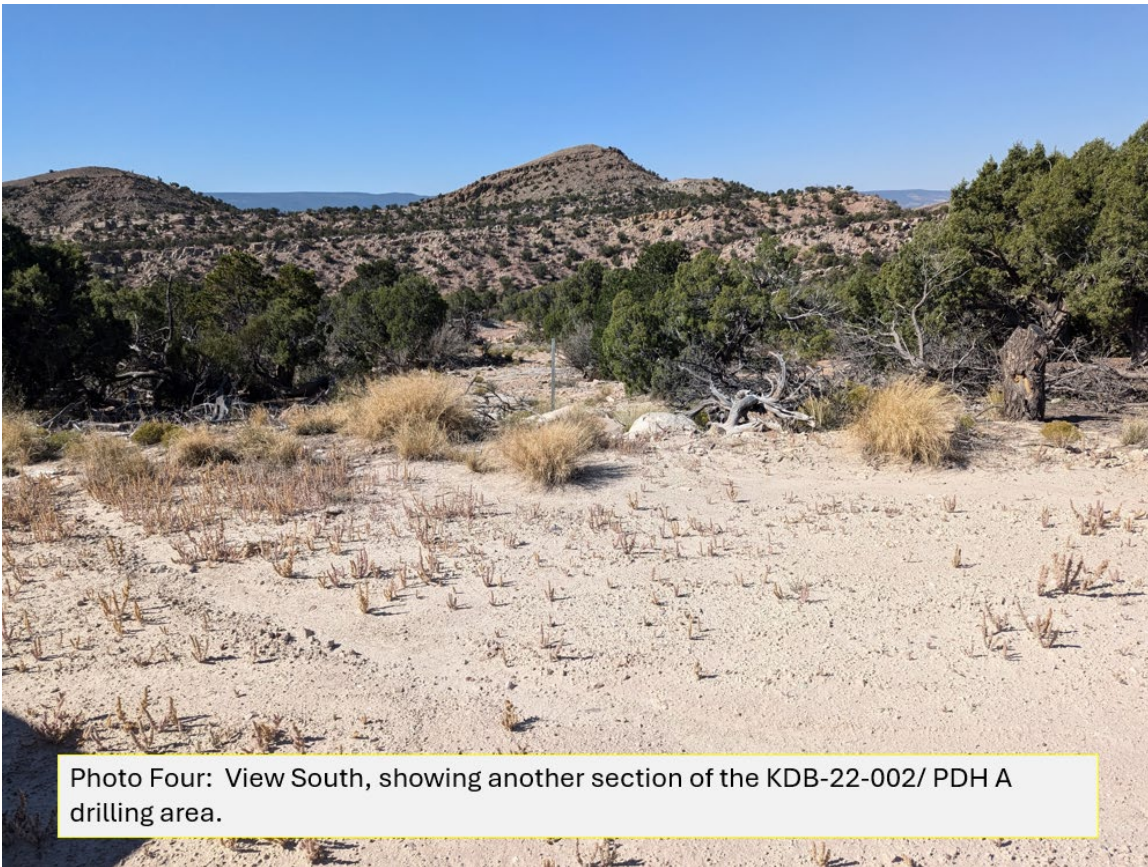
Photo Four: View South, showing another section of the KDB-22-002/ PDH A drilling area.

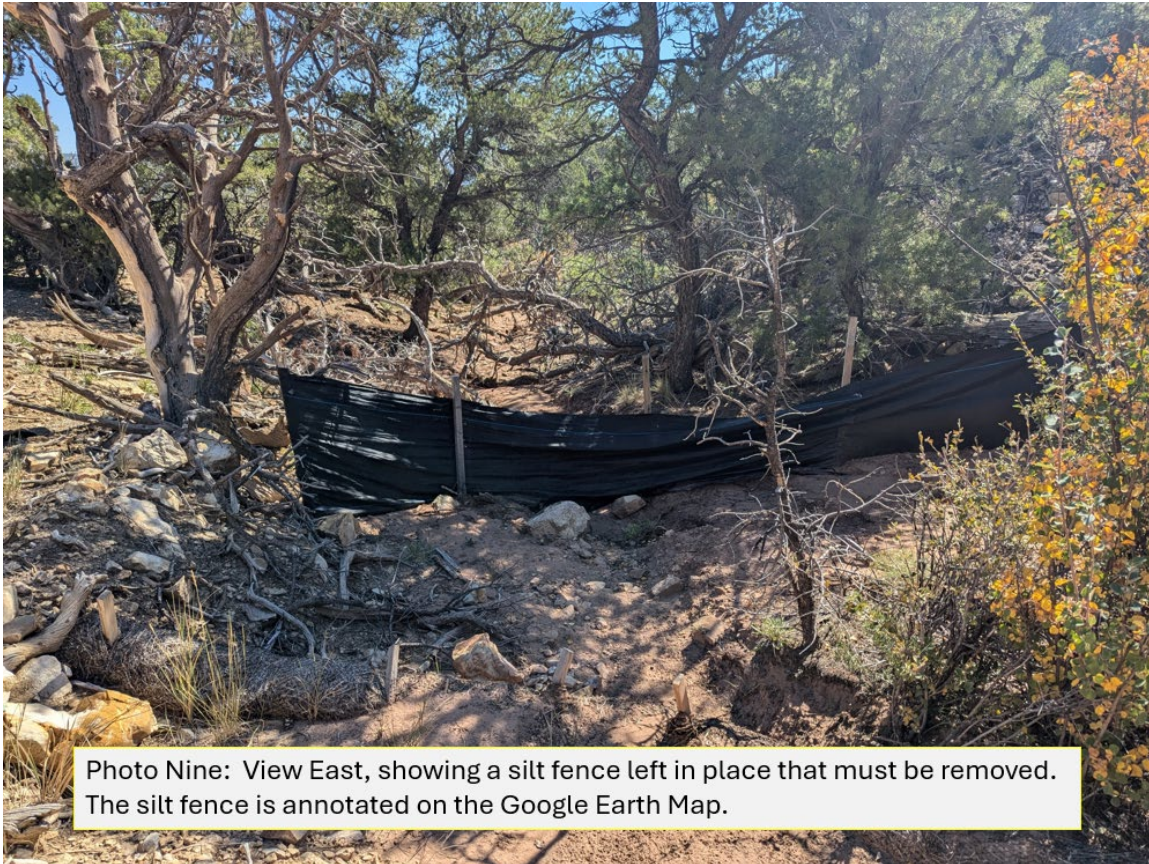
The KDB-22-004/ PDH N site also lies at the end of a long stretch of access road near the area known as Buck Knob. The access road has been graded, reseeded and covered by woody debris such that it was difficult to locate in the juniper trees. The access road appeared to be stable and in good condition along the entire length. No evidence of erosion or sedimentation was noted and an example of the area can be seen in Photo Eight. Along the access road several erosion control devices were noted to be left in place. While straw wattles are allowed to be left in place, a traditional black mesh silt fence with staking was observed to be in place that needs to be removed. Photo Nine shows the silt fence and it is annotated on the enclosed map. This is a problem at this time for failure to dispose of refuse in a manner that controls unsightliness or deleterious effects of such refuse pursuant to C.R.S. 34-32.5-116(4)(e). The operator shall submit photo documentation to the Division that the items have been removed from the site no later than Monday December 2, 2024.

Photo Nine: View East, showing a silt fence left in place that must be removed. The silt fence is annotated on the Google Earth Map.

refuse in a manner that controls unsightliness or deleterious effects of such refuse pursuant to C.R.S. 34-32.5-116(4)(e). The operator shall submit photo documentation to the Division that the items have been removed from the site no later than Monday December 2, 2024.

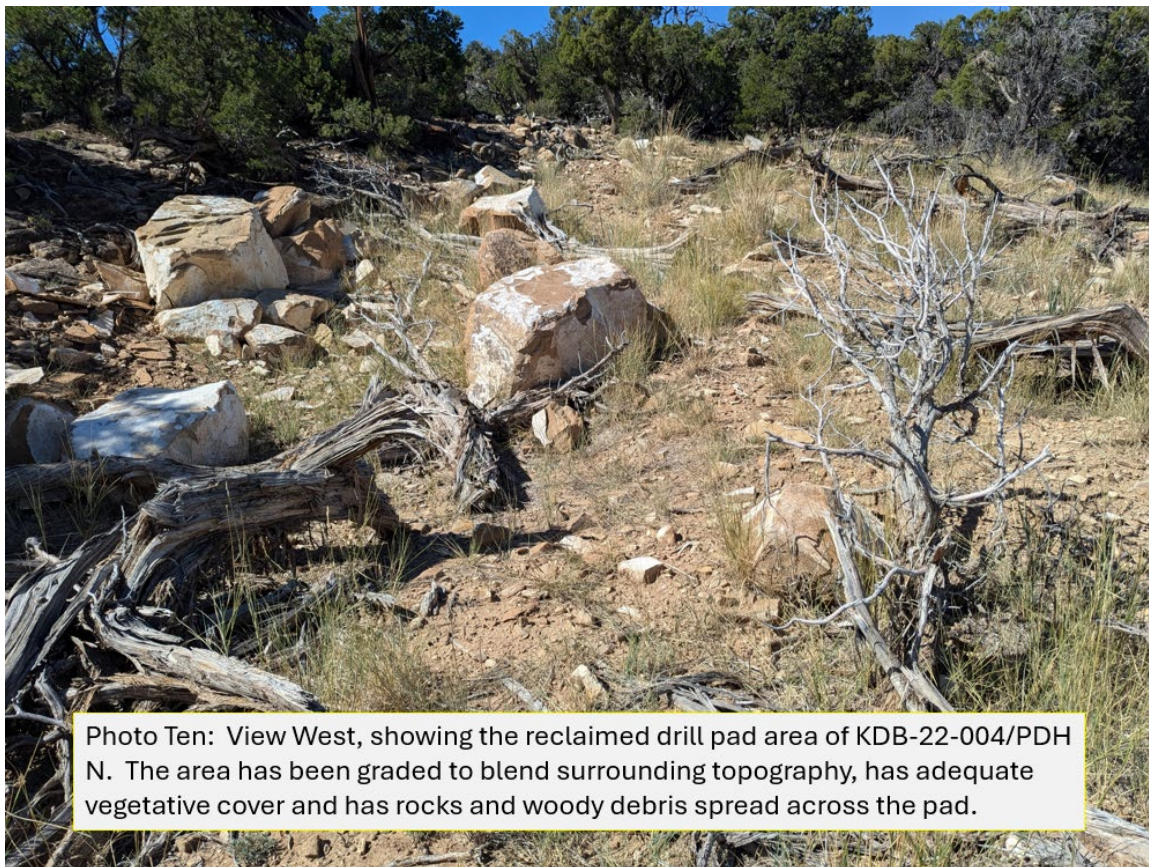
The pad and drill location was observed and found to be stable at the time of the inspection. The pad has been graded, seeded and had large boulders and woody debris spread across it to blend it with the surrounding area. No evidence of erosion or sedimentation was observed and the vegetative cover is dense, diverse and in good condition. The pad area can be seen in Photo Ten.

Photo Ten: View West, showing the reclaimed drill pad area of KDB-22-004/PDH N. The area has been graded to blend surrounding topography, has adequate vegetative cover and has rocks and woody debris spread across the pad.

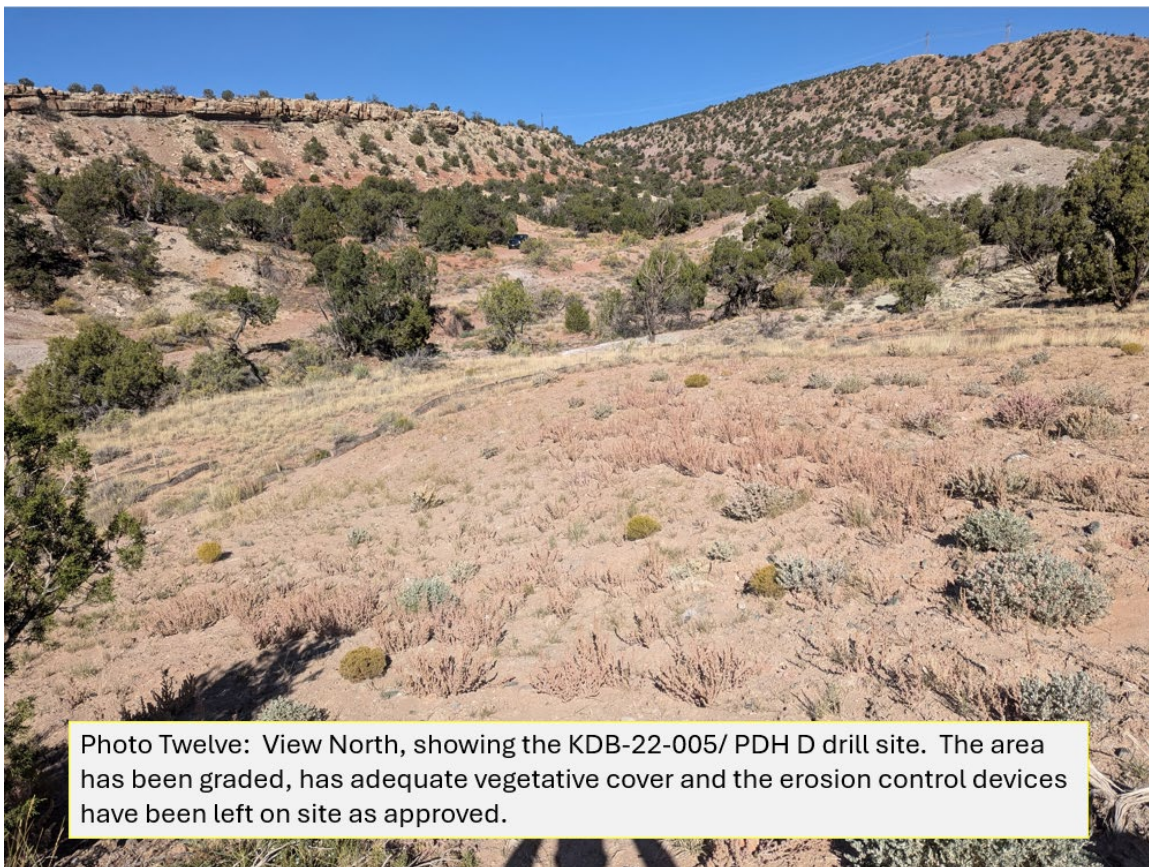
The drill pad at the site was also observed and can be seen in Photo Twelve. The pad has been graded and seeded. No evidence of significant erosion or sediment transport was noted, and the vegetative cover is dense and diverse. Some annual weeds were noted in the footprint of the pad, however this is not considered a problem at this time as reclamation species were noted and the annual weeds are sparse.

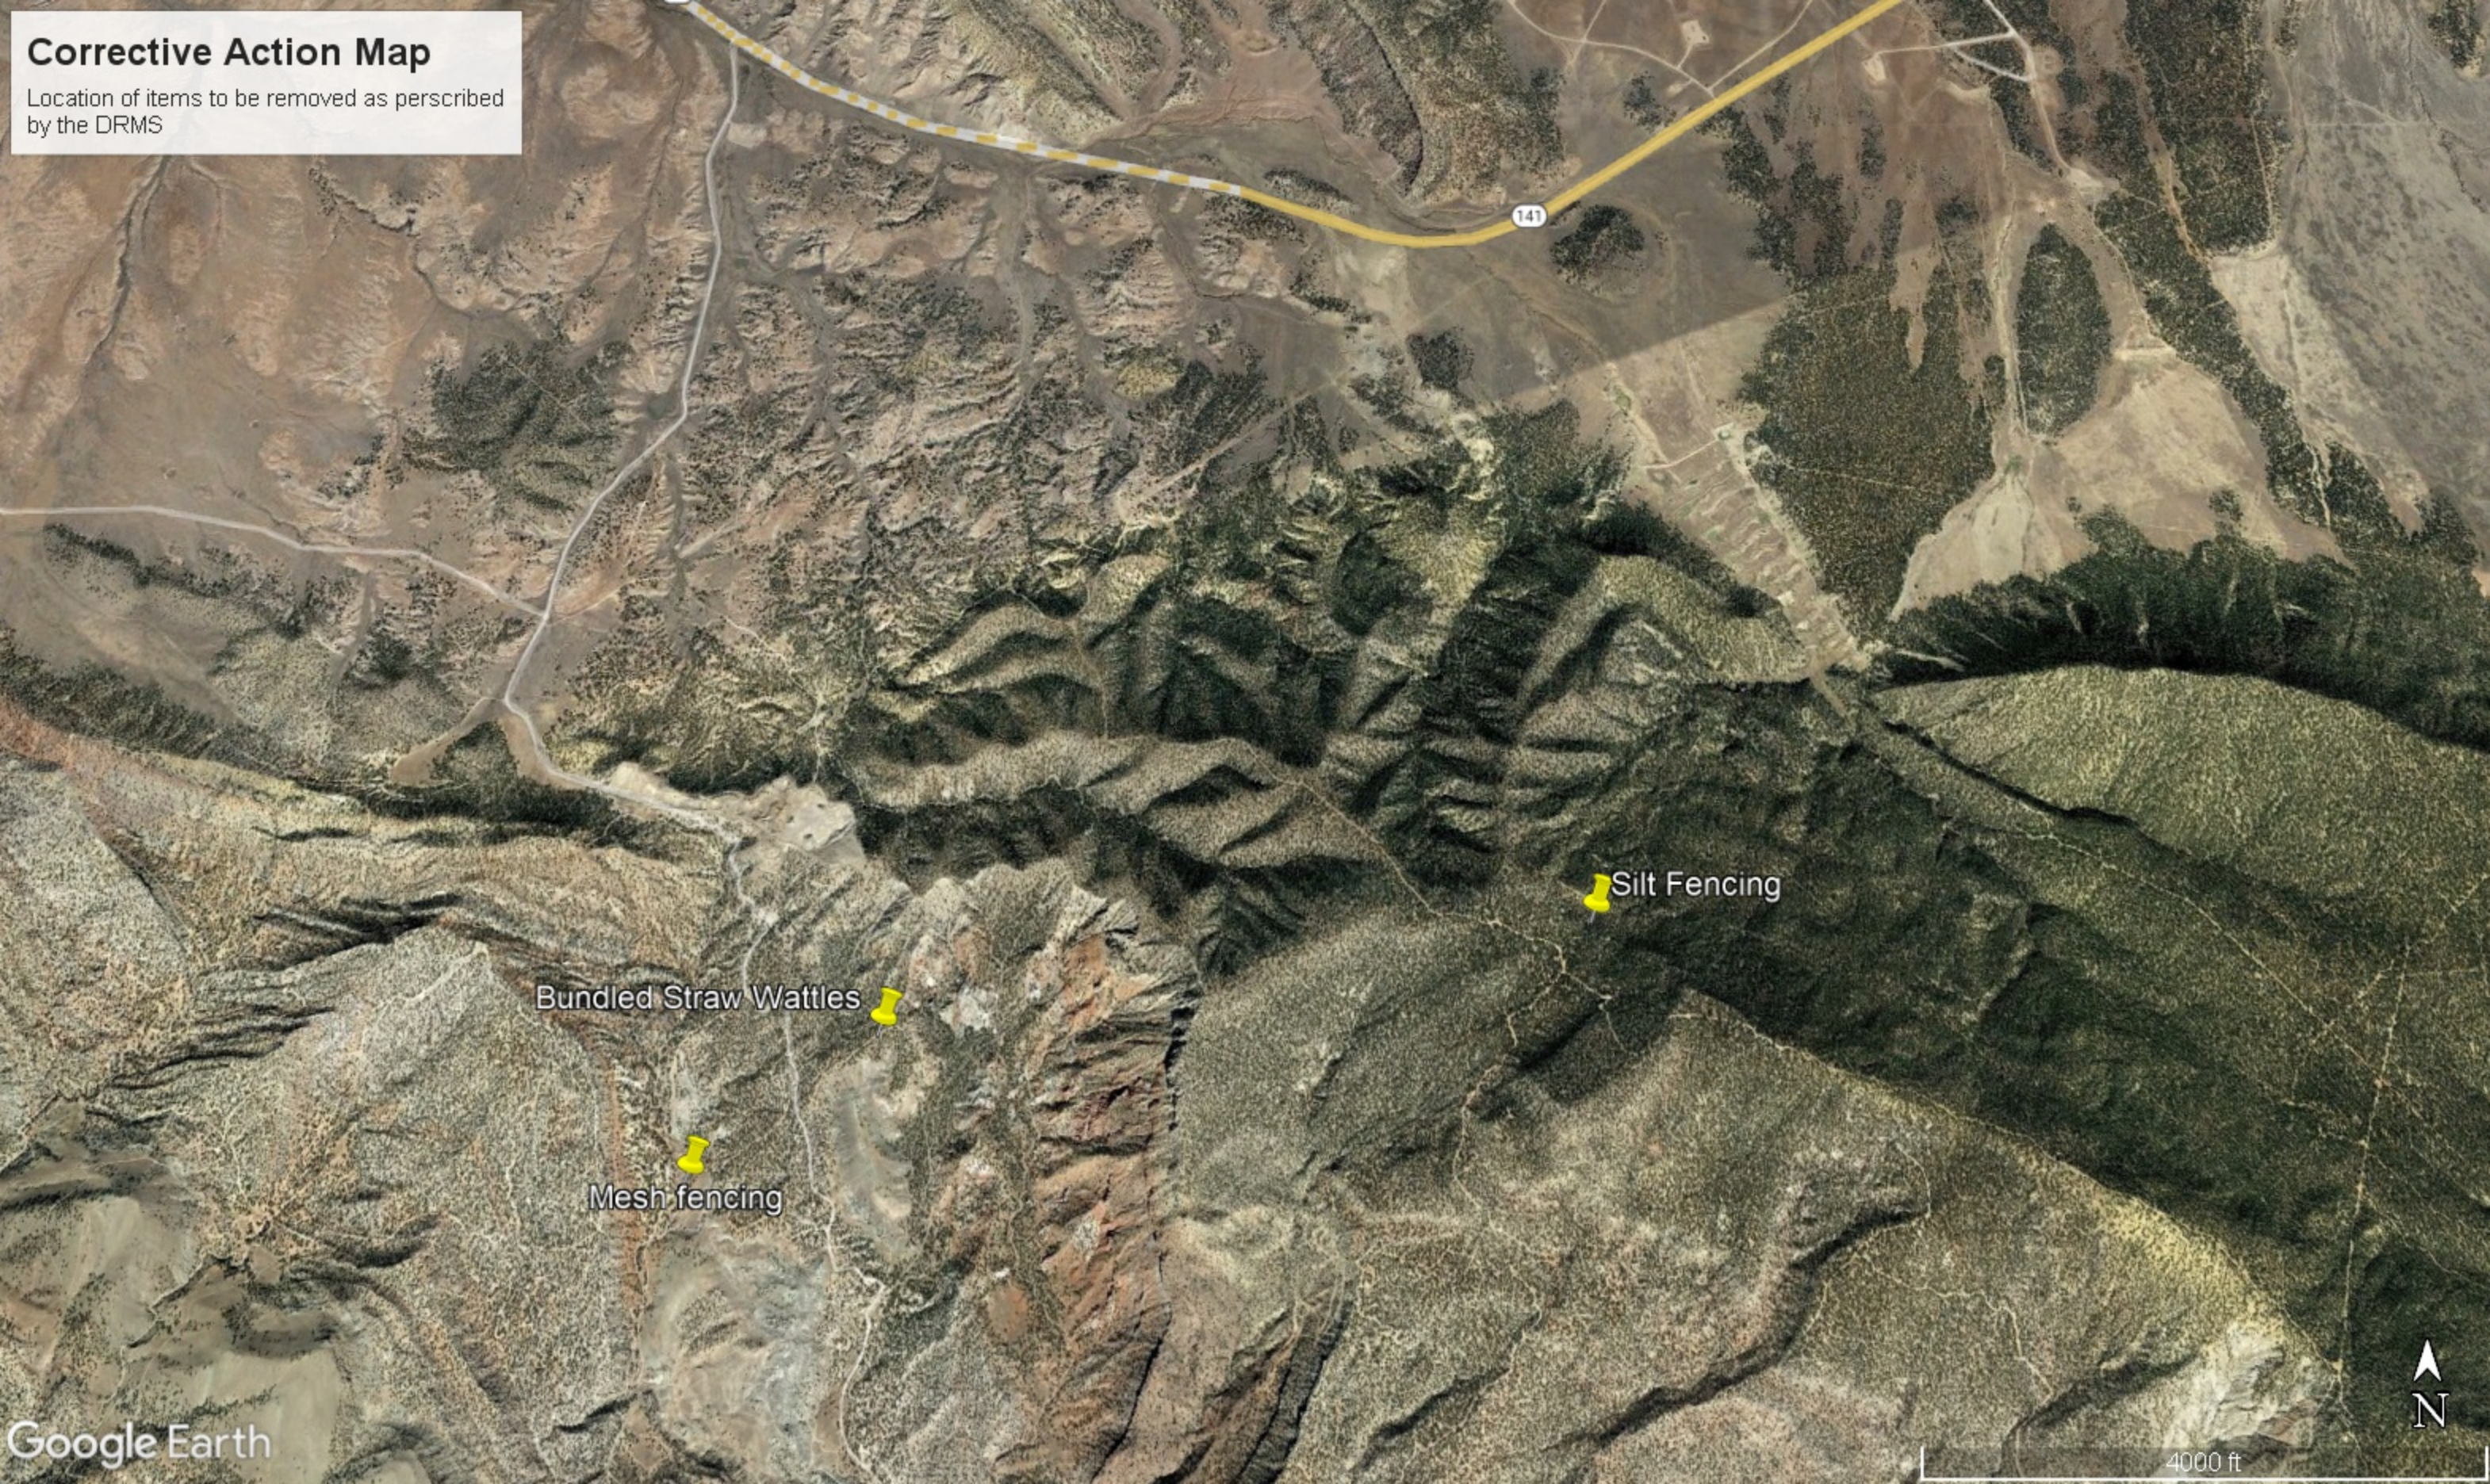
Corrective Action Map

Location of items to be removed as perscribed by the DRMS

Bundled Straw Wattles

Mesh fencing

Silt Fencing

<p>INSPECTION TOPIC: Other</p> <p>PROBLEM/POSSIBLE VIOLATION: Problem: Trash and refuse was noticed on the site. This is a problem at this time for failure to dispose of refuse in a manner that controls unsightliness or deleterious effects of such refuse pursuant to C.R.S. 34-32.5-116(4)(e). Specifically excess erosion control devices were left in three separate locations that must be removed.</p> <p>CORRECTIVE ACTIONS: The operator shall submit photo documentation to the Division that the items have been removed from the site by the corrective action date.</p> <p>CORRECTIVE ACTION DUE DATE: 12/02/24</p>
