DRMS Inspection Reports 2024 October for Williams Fork, Seneca IIW and Yoast.

10 October 2024

Permit Number: C-1981-044
Mine Name: Williams Fork Mines
Operator: Moffat County Mining, LLC
Operator Address:
Ms. Miranda Kawcak
29515 Routt County Road #27
Oak Creek, CO 80467

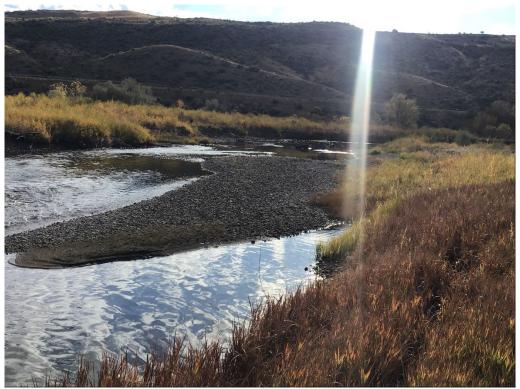
Photo 1: South end of the site looking across the Williams Fork River to the east.

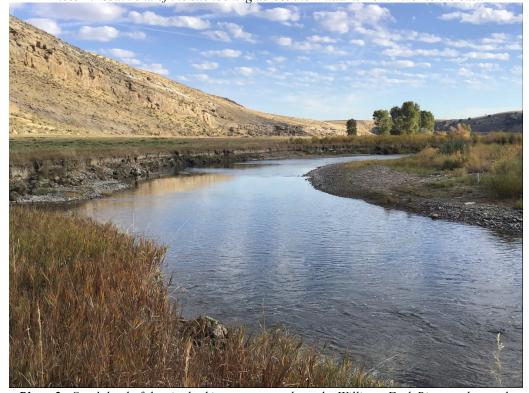
Photo 2: South lend of the site looking upstream along the Williams Fork River to the north.

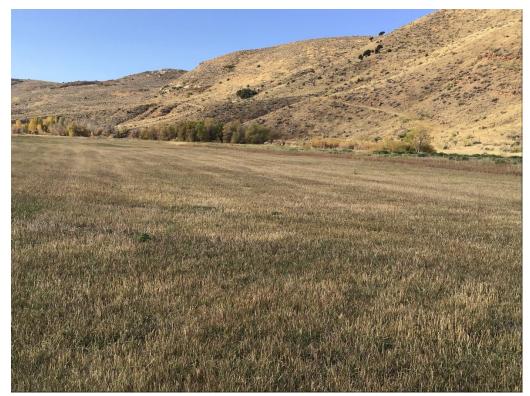
Photo 3: South end of the bottomlands looking south

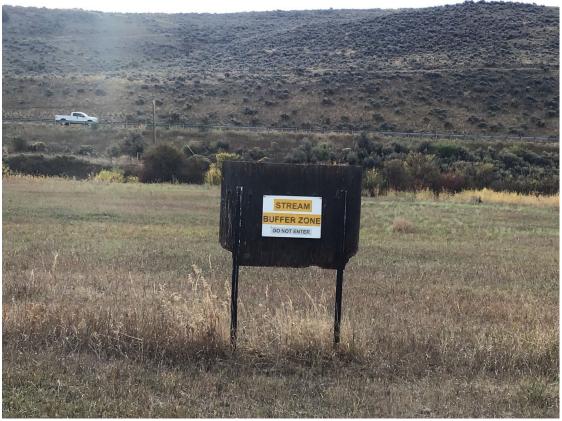
- o Pond identification t stakes were prominently displayed in the vicinity of the ponds.
- o Topsoil stockpiles observed were clearly marked with identifying stake.
- o Stream buffer zone along the Williams Fork River in the cropland area is marked.

Photo4: Signage along the Williams Fork River in the bottomlands looking east.

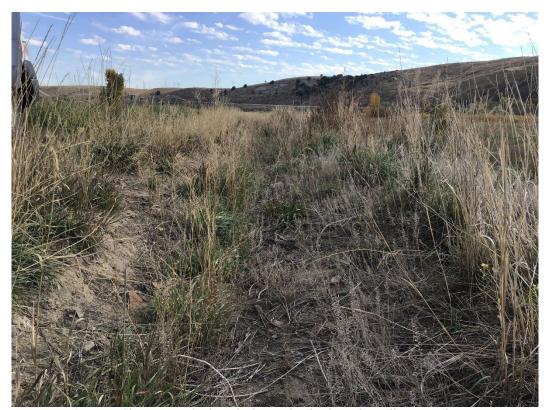
- o Slopes to Pond 5A-P1 were covered with dormant yellow sweet clover.
- o Ditches throughout the site, along haul roads and in the cropland area appeared to be functioning adequately.
- o All ponds were dry at the time of inspection.

Photo 5: Clean water ditch in the bottomlands along the Williams Fork River.

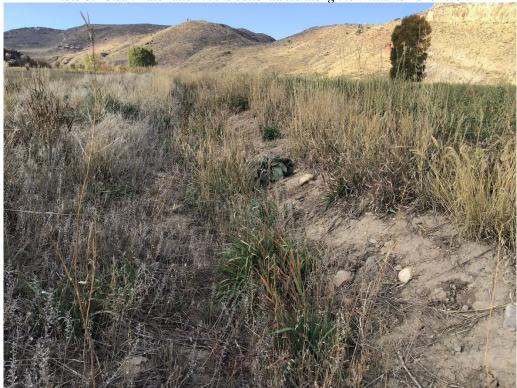
Photo 6: Clean water ditch in the bottomlands along the Williams Fork River, looking north.

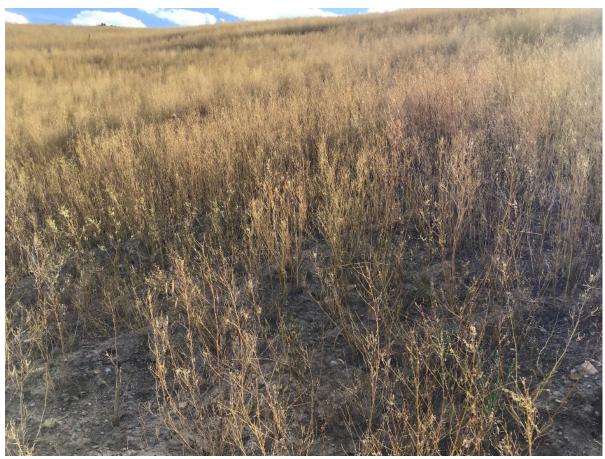
- o Revegetated areas of reclamation appeared stable at the time of inspection.
- o 5A Portal area exhibits grasses, and a dense stand of now dormant yellow sweet clover
- o Small sage and chamisa shrubs are present on the 5A portal slopes as are some grasses.
- Vegetation throughout the site appeared dormant at the time of inspection.
- Croplands exhibited dormant vegetation with the exception of some alfalfa with dry hay stubble throughout having been harvested in early August.
- o No significant weeds were noted at the time of inspection.

Photo 7: Vegetation on portal slopes exhibiting some shrubs, grasses and a plethora of dormant sweet yellow clover.
