## HIGHWALL INSPECTION REPORT

<b>To:</b>	Mr. Kurt Thurman	<b>From:</b>	Nathaniel White, EIT
<b>Company:</b>	Holcim - WCR, Inc.	<b>CC:</b>	Ryan O'Connel, PE
<b>Project:</b>	8-Mile / Byzantine Quarry	<b>Date:</b>	9.17.2024
<b>Location:</b>	Fremont County, CO	<b>RE:</b>	Geotechnical Field Report
<input type="checkbox"/> Reviewed <input checked="" type="checkbox"/> For Review <input checked="" type="checkbox"/> For Approval <input type="checkbox"/> Information Only <input type="checkbox"/> Revise & Resubmit

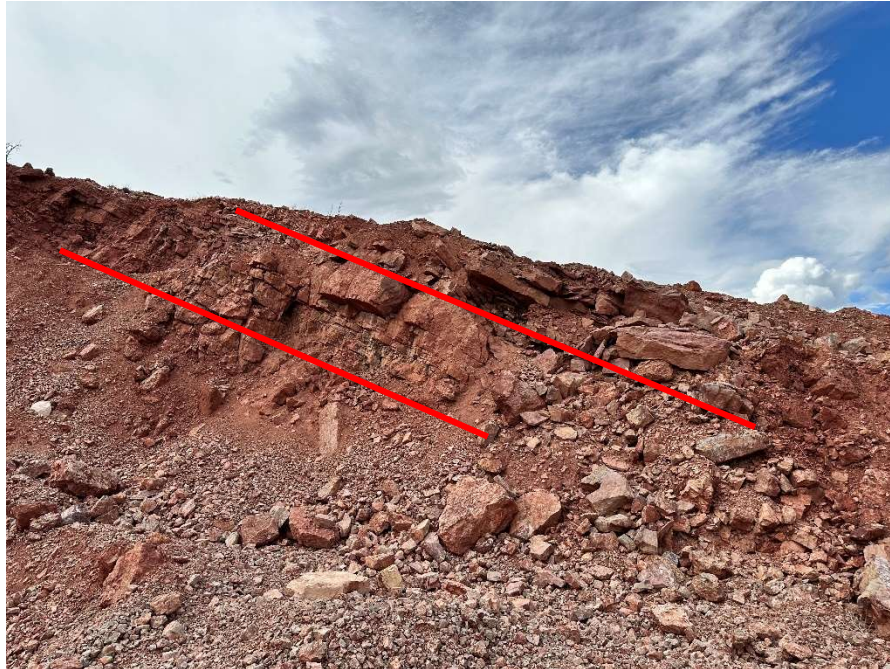
The quarry is very small and contains only three relatively short benches (~20-30 feet tall) along the north-south strike of the bedrock and are approximately east facing. The mine is relatively low production, with only 40,000 tons mined a year used primarily for landscape rock. The encountered rockmass consisted of red carbonaceous sandstone and cherty dolomite, with a dip direction of approximately 52 degrees (NE) and a dip of about 26 degrees. An example of the rockmass orientation is shown in Figure 2.

The primary joint set was observed to be joints with a dip direction of approximately 235 degrees and a dip of 59 degrees that exhibits 0.1-3 inch aperture, 1 inch to 10 feet spacing, 1 to 3 feet of persistence, and some silty/clayey infilling. The primary joint set tended to control stability of the benches and relative geometry of the benches, as is shown in Figure 2.

Figure 2: North facing exposure of rockmass dip and dip direction (highlighted in red).

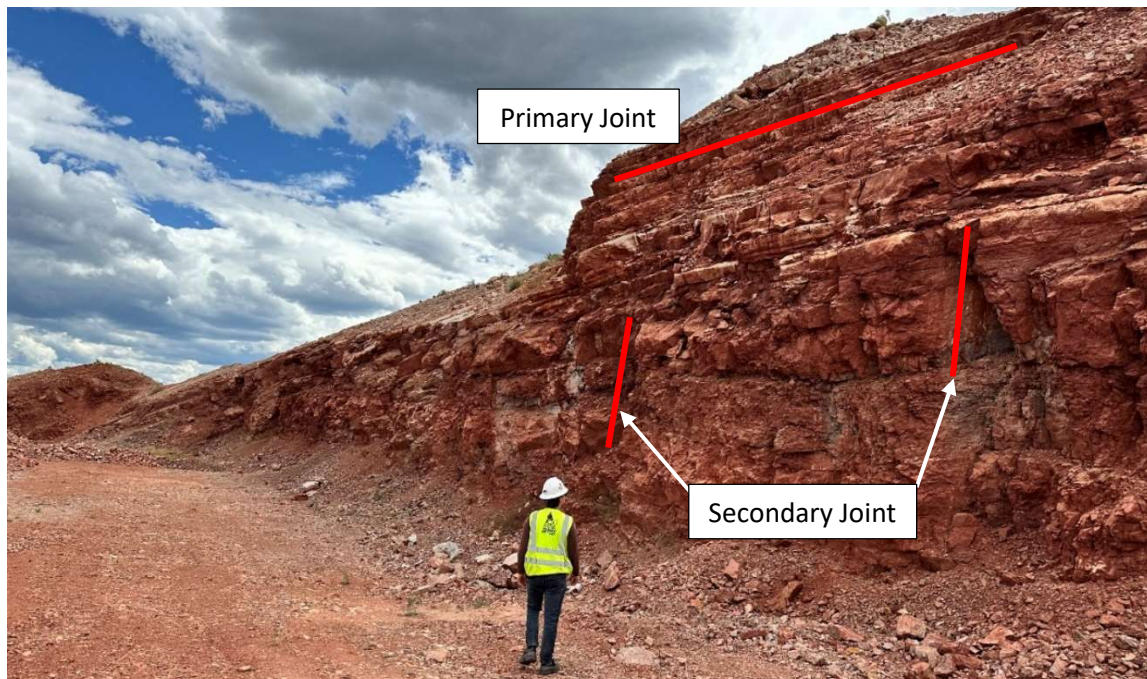
The exposed east-facing benches contain various discontinuity joint sets as shown in Figure 3, characterized by very weak to medium strong rock, slightly to highly weathered, extremely close to very wide spacing, clean to moderately infilled, seamy to wavy joints with a tight to very wide aperture.

Figure 3: Primary joint sets along exposed east-facing benches.

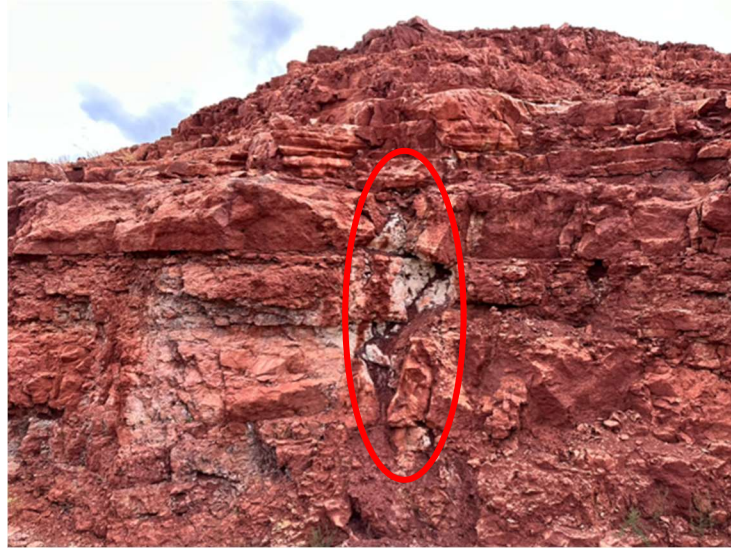
The secondary joint set was observed to be joints with a dip direction of approximately 135-200 degrees and a dip of 85 degrees that exhibits 0.5-3 inch aperture, 2 to 10 feet spacing, 5 to 20 feet of persistence, and some silty/clayey and calcite infilling. Figure 4 presents the observed infilling of the sub-vertical secondary joint set. The secondary joint set tended to control localized block failure along the benches and observed blockiness of the exposed rockmass, as is shown in Figure 3.

Figure 4: Silty/Clayey joint infilling along the secondary sub-vertical joint set outlined in red.
