MINERALS PROGRAM INSPECTION REPORT
PHONE: (303) 866-3567

MINE NAME: Klondike Pit	MINE/PROSPECTING ID#: M-1981-220	MINERAL: Sand and gravel	COUNTY: San Miguel
INSPECTION TYPE: Monitoring	WEATHER: Clear	INSP. DATE: October 2, 2024	INSP. TIME: 12:40
OPERATOR: San Miguel County	OPERATOR REPRESENTATIVE:	TYPE OF OPERATION: 112c - Construction Regular Operation	
REASON FOR INSPECTION: Normal I&E Program	BOND CALCULATION TYPE:	BOND AMOUNT: \$0.00	
DATE OF COMPLAINT: NA	POST INSP. CONTACTS: None	JOINT INSP. AGENCY: None	
INSPECTOR(S): Lucas West	INSPECTOR'S SIGNATURE:

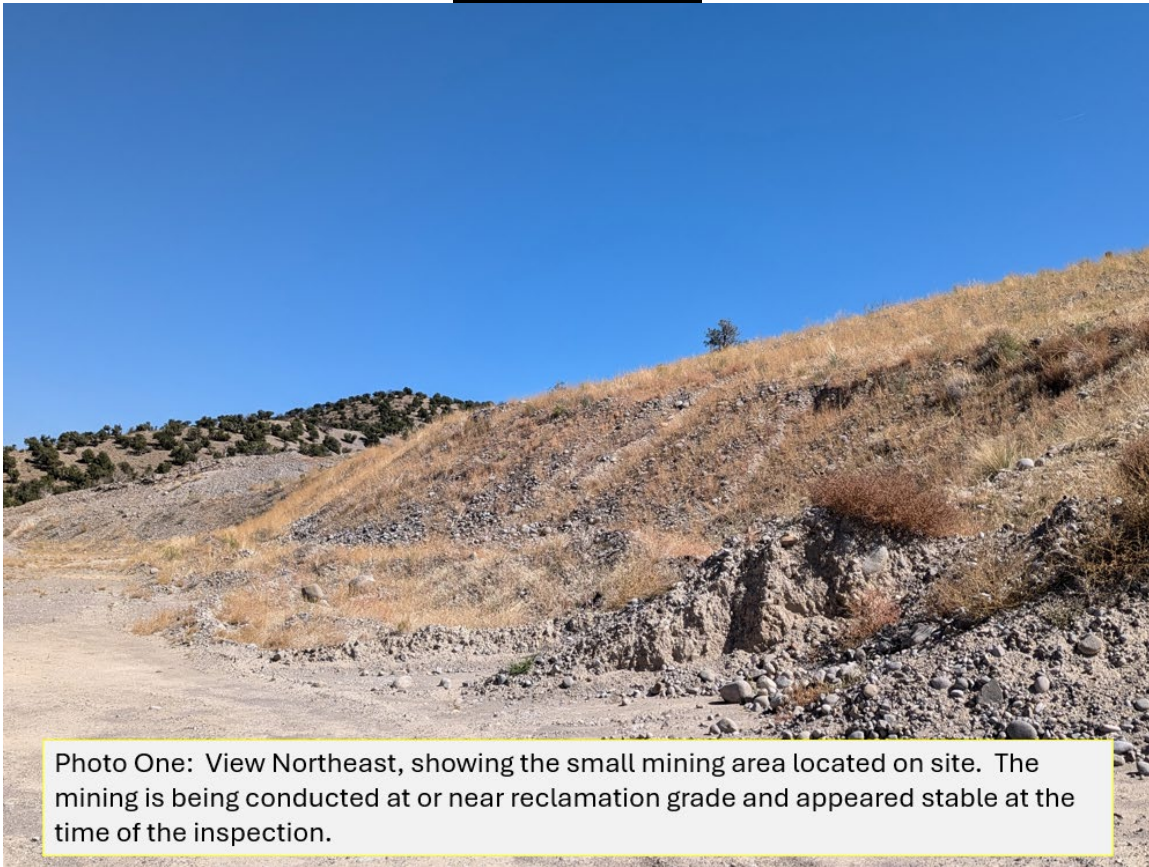
Photo One: View Northeast, showing the small mining area located on site. The mining is being conducted at or near reclamation grade and appeared stable at the time of the inspection.

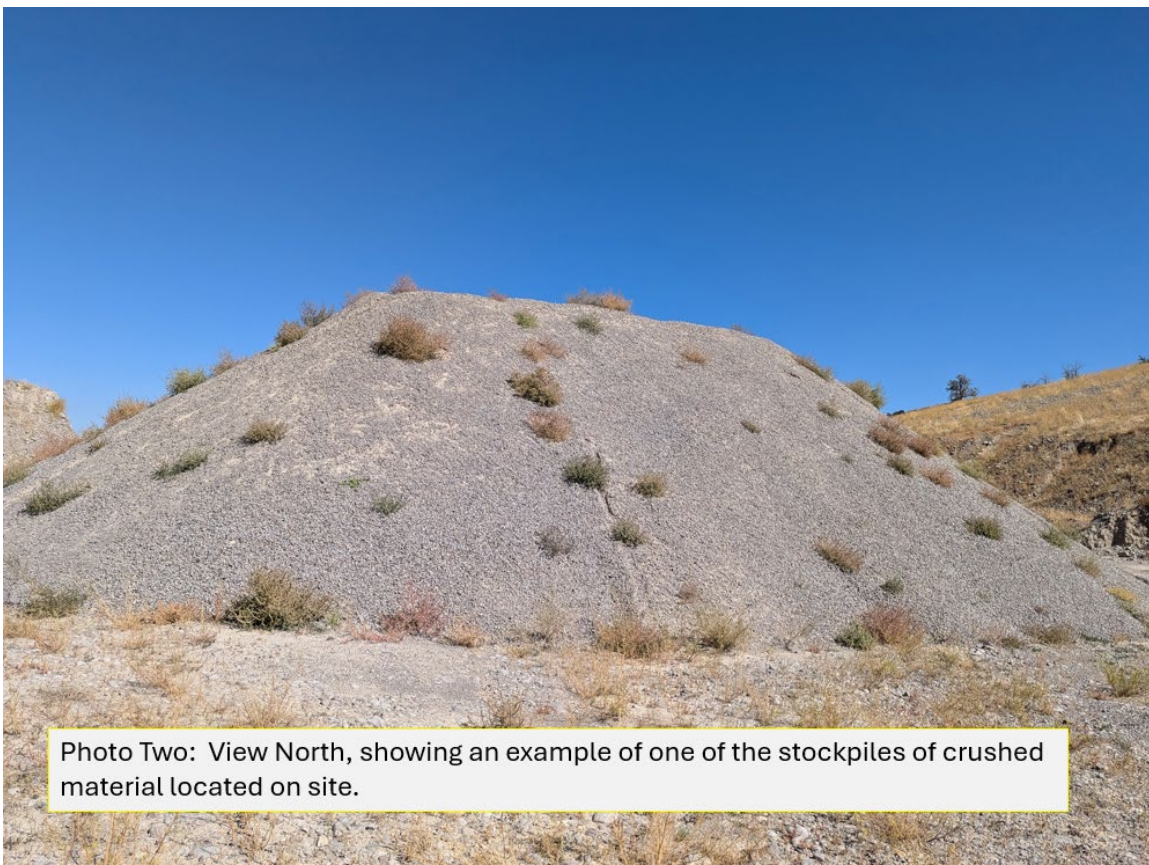
Photo Two: View North, showing an example of one of the stockpiles of crushed material located on site.

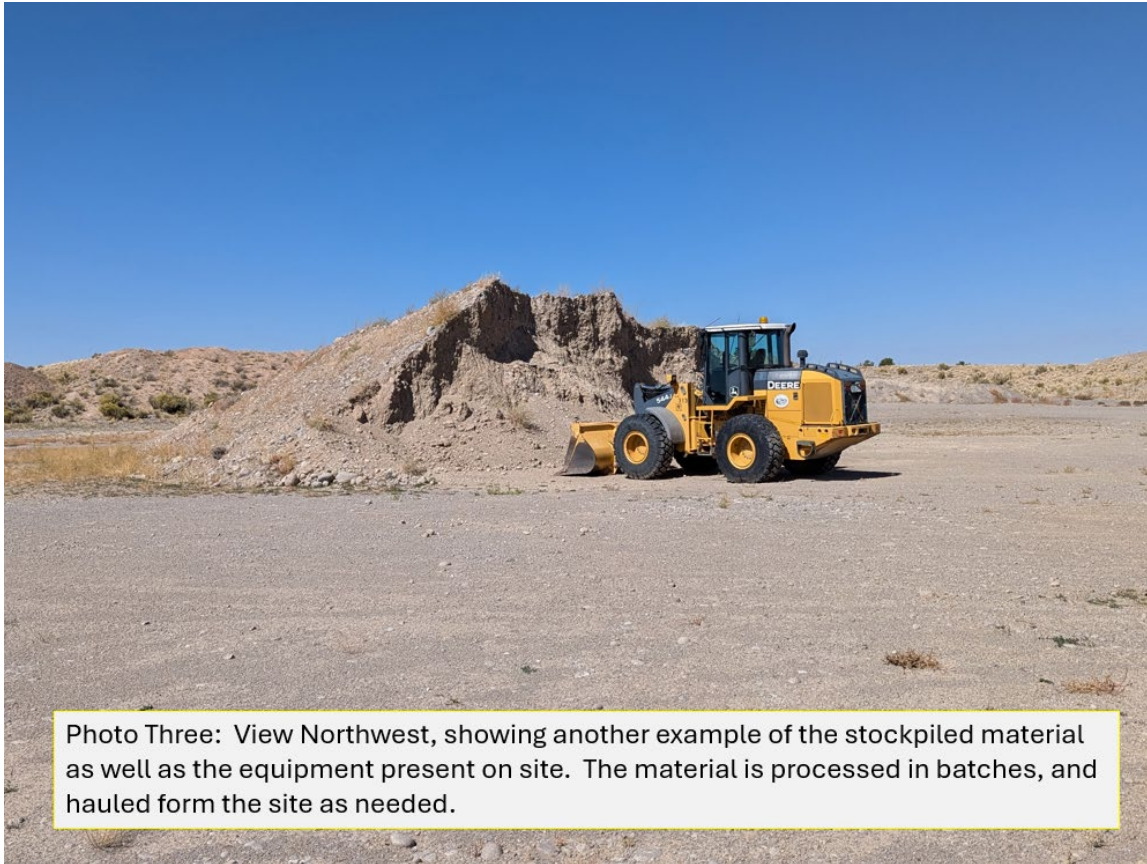
Photo Three: View Northwest, showing another example of the stockpiled material as well as the equipment present on site. The material is processed in batches, and hauled form the site as needed.

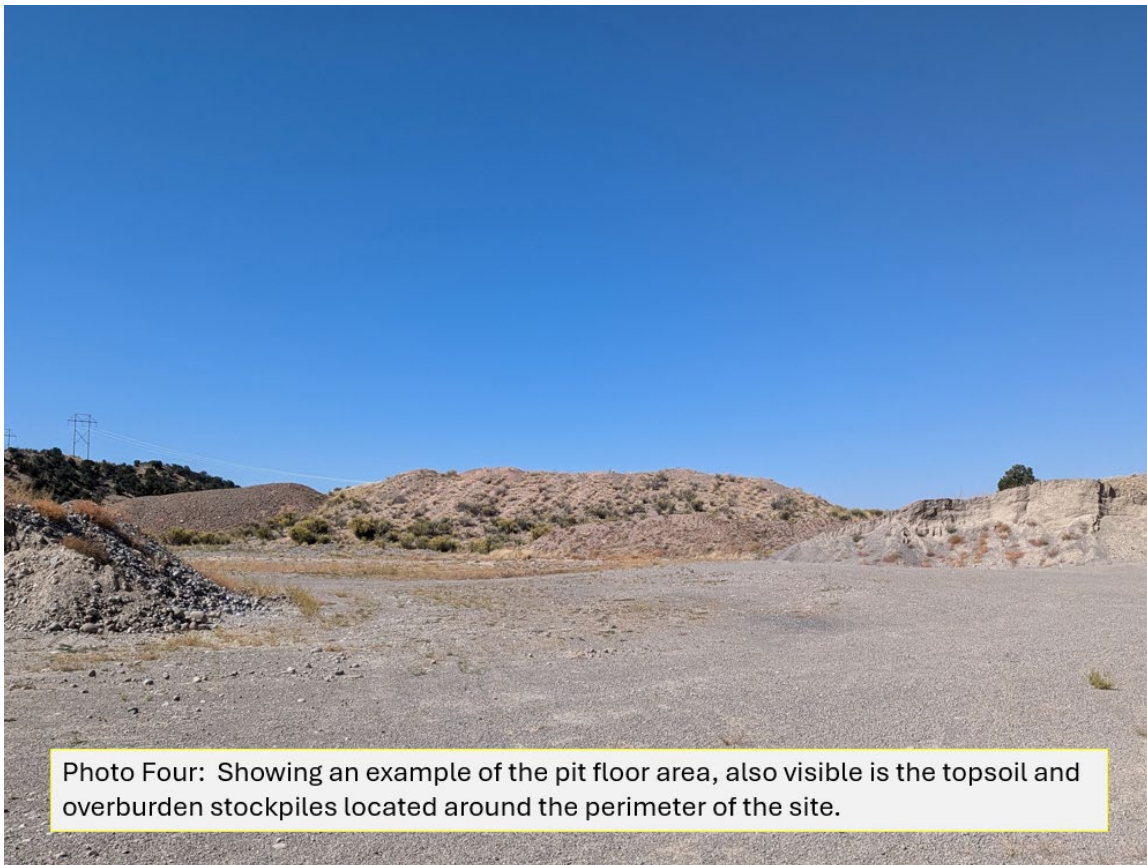
The proper mine identification signage was posted at the entrance to the site and the permit boundaries were also clearly delineated. The active mining area consists of a small area that is mined at approximately reclamation grade and measures about 12 feet tall by 20 linear feet in length. The mining area appeared to be stable at the time of the inspection, in good condition and can be seen in Photo One. The equipment staged on site is limited to a Front End Loader to load trucks from stockpiled material as needed. The loader appeared to be in good working order and showed no signs of damage or vandalism. Also located on the pit floor were various stockpiles of materials that all appear to be in good condition and stable. Evidence of recent hauling activities were noted in the area. An example of the stockpiles can be seen in Photos Two and Three. Evidence of recent hauling from the stockpiles was noted. The remainder of the pit floor and stockpile area is in good condition and can be seen in Photo Four.

Photo Four: Showing an example of the pit floor area, also visible is the topsoil and overburden stockpiles located around the perimeter of the site.
