MINERALS PROGRAM INSPECTION REPORT
PHONE: (303) 866-3567

MINE NAME: Patton Clay Mine	MINE/PROSPECTING ID#: M-1998-067	MINERAL: Clay (general)	COUNTY: Fremont
INSPECTION TYPE: Monitoring	WEATHER: Clear	INSP. DATE: October 9, 2024	INSP. TIME: 10:30
OPERATOR: Summit Brick & Tile Co.	OPERATOR REPRESENTATIVE: Julie Welte	TYPE OF OPERATION: 112c - Construction Regular Operation	
REASON FOR INSPECTION: Normal I&E Program	BOND CALCULATION TYPE: None	BOND AMOUNT: \$29,500.00	
DATE OF COMPLAINT: NA	POST INSP. CONTACTS: None	JOINT INSP. AGENCY: None	
INSPECTOR(S): Jocelyn Carter	INSPECTOR'S SIGNATURE:

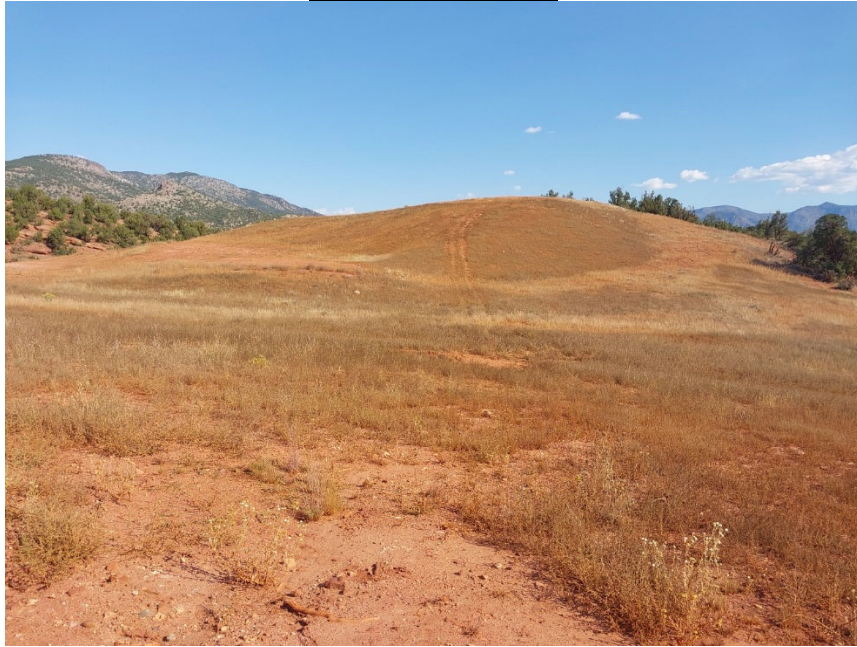
The area to the southeast of the pit boundary is approximately where the landowner plans to build. At the time of the inspection, there were two small piles of earth material, and a small area had been scrapped in preparation for the building project, see Photos #1, #5, and #8.

Photo #1: Looking northeast from the southwest portion of the reclaimed area. The small area in the immediate foreground is part of the portion that has been disturbed by the new landowners. The hill in the center of the photo is where the mining operation occurred.

The Division feels that the reclamation success of Area F meets the post mine land use of rangeland and encourages the Operator to submit an acreage release request to the Division within 30 days of this inspection, and prior to any further disturbances to the land as a result of the landowner's building project(s).

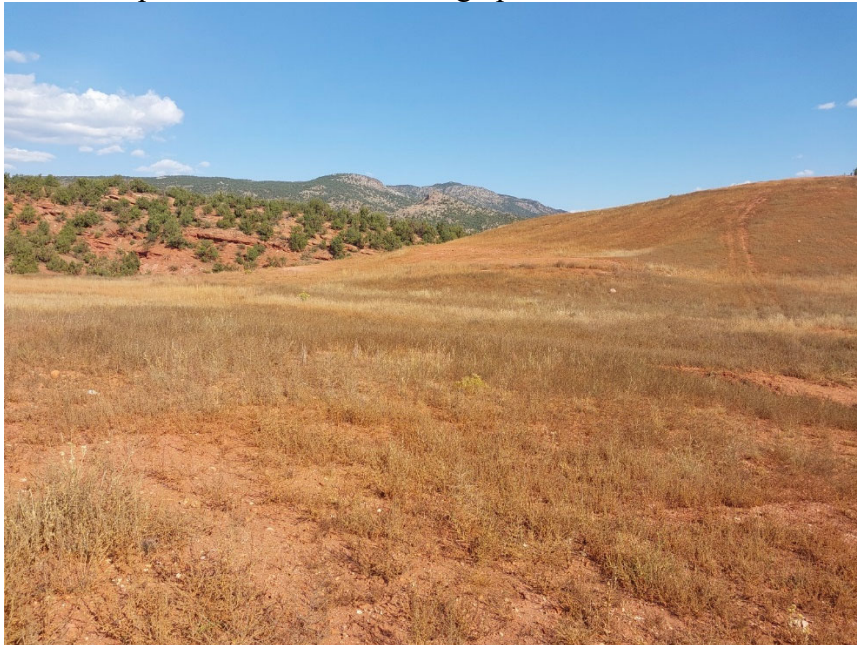
Photo #2: Looking north from the southwest portion of the reclaimed area.

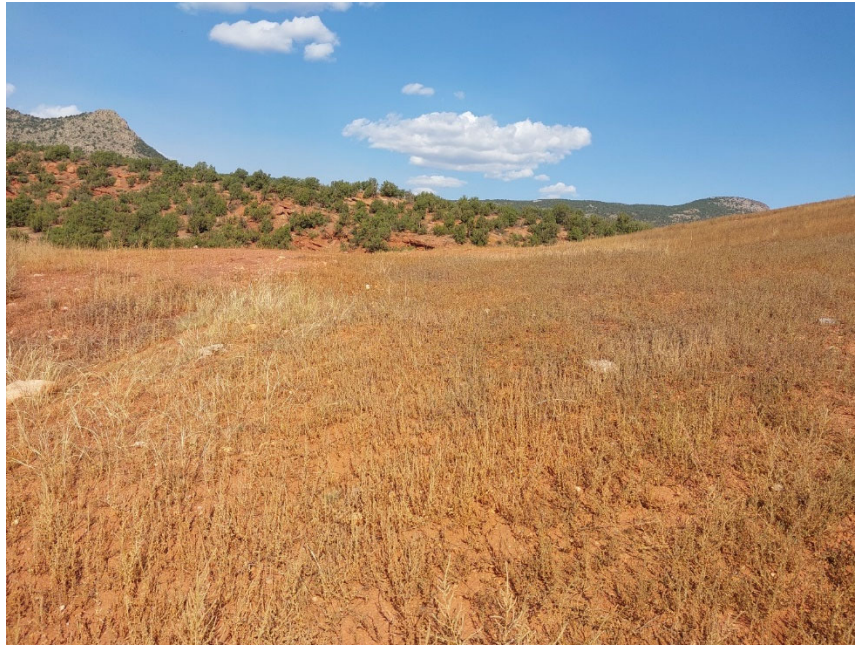
The reclamation plan appeared to have been followed, backfilled slopes appeared to be 3H:1V or less and vegetation is re-established on the majority of the affected lands. According to Ms. Welte, the area was seeded in May 2022. The weed management plan approved by DRMS in TR-1 appears to have been effective given the lack of noxious weeds.

Photo #3: Looking northwest from the southeast portion of where the highwall used to be, the reclaimed slope of 3H:1V and established vegetation can be seen.

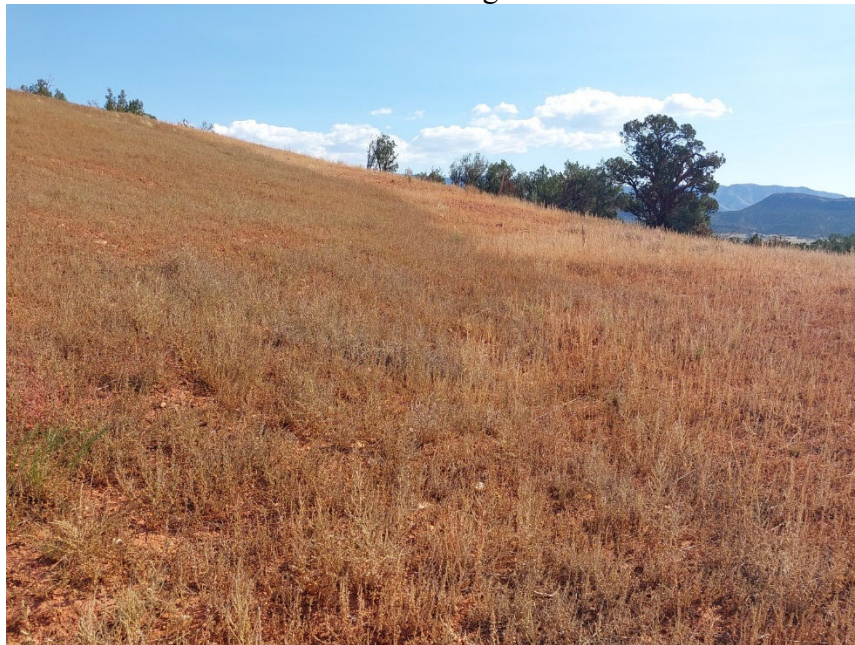
Photo #4: Looking southeast from the northwest portion of the base of where the highwall used to be; the reclaimed 3H:1V slope and established vegetation can be seen.

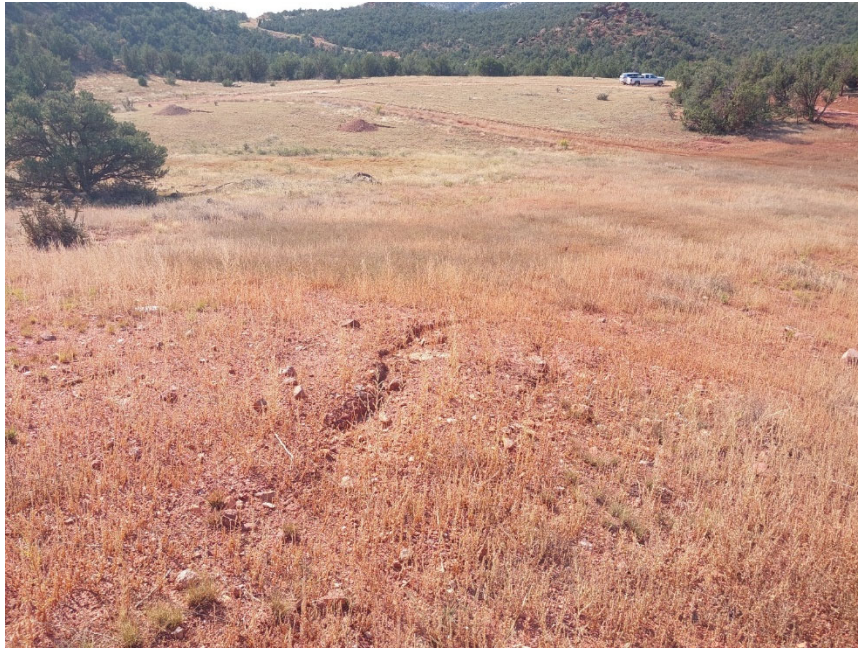
There did not appear to be any noxious weeds present during the inspection. There were areas of sparse vegetation, totaling approximately 0.5 acres; less than 5% of the total affected area. The state of the vegetation is good throughout the remaining affected area with a ground cover that is similar to that of the adjacent lands.

Photo #5: Looking southwest from the east side of the reclaimed area. In the foreground, a small area of relatively sparse vegetation can be seen. In the background, the two earth material piles and the small scrapping disturbance done by the landowner in preparation of a building project can be seen. The area of where the proposed building location is circled in the photo.

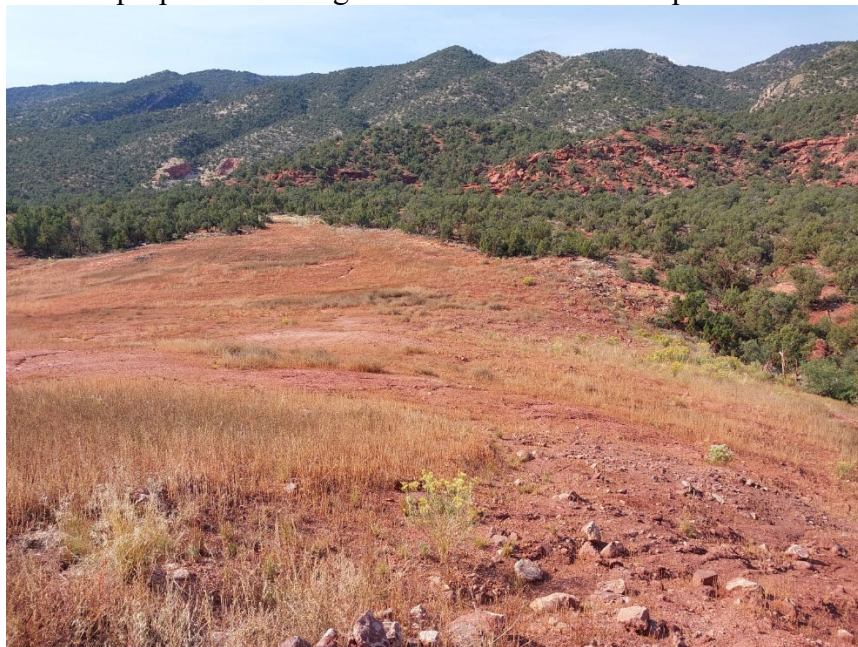
Photo #6: Looking west from the northeast portion of the reclaimed area, a small area of sparse vegetation can be seen, outlined by yellow lines in the photo.

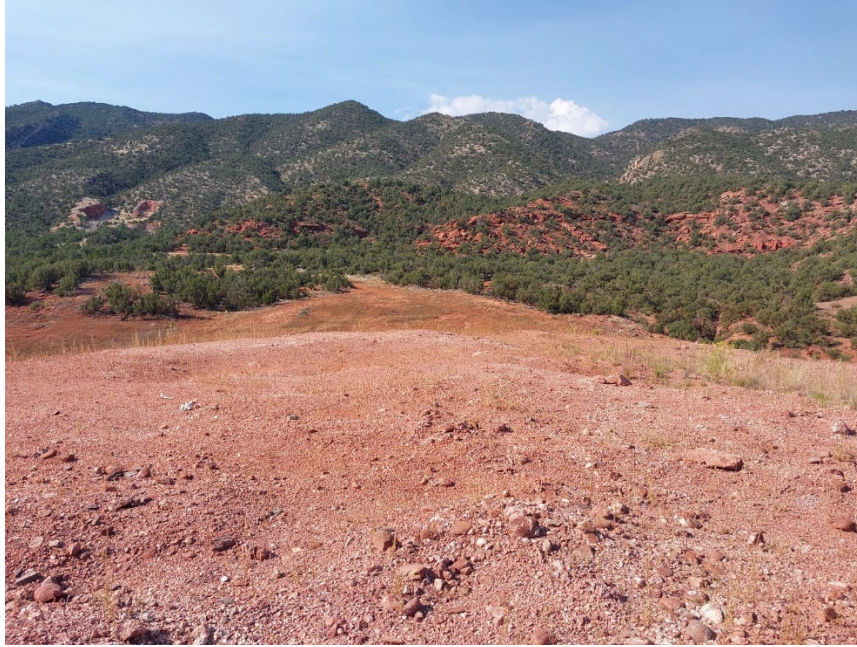
Photo #7: Looking northwest from the top of the hill, there is sparse vegetation on the top of the hill. The area of sparse vegetation in the reclaimed area is relatively small.

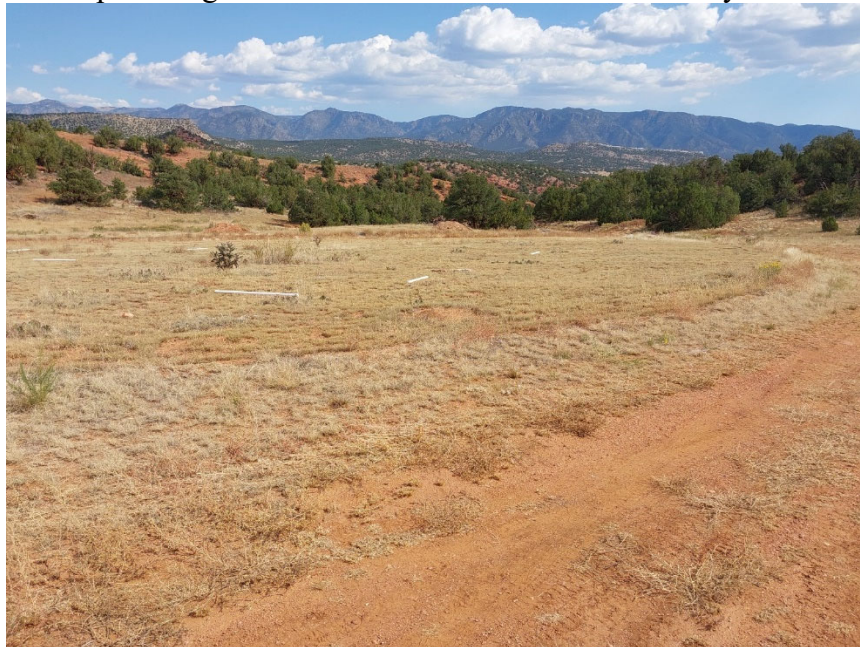
Photo #8: Looking east from the southwest portion of the affected area at the area of where the proposed building will be constructed.
