## Bromley Lakes Inspection Report

**MINERALS PROGRAM INSPECTION REPORT**  
**PHONE: (303) 866-3567**

<b>MINE NAME:</b> Bromley Lakes	<b>MINE/PROSPECTING ID#:</b> M-1987-049	<b>MINERAL:</b> Sand and gravel	<b>COUNTY:</b> Adams
<b>INSPECTION TYPE:</b> Monitoring	<b>WEATHER:</b> Clear	<b>INSP. DATE:</b> September 24, 2024	<b>INSP. TIME:</b> 13:00
<b>OPERATOR:</b> City of Brighton	<b>OPERATOR REPRESENTATIVE:</b> Scott Olsen	<b>TYPE OF OPERATION:</b> 112c - Construction Regular Operation

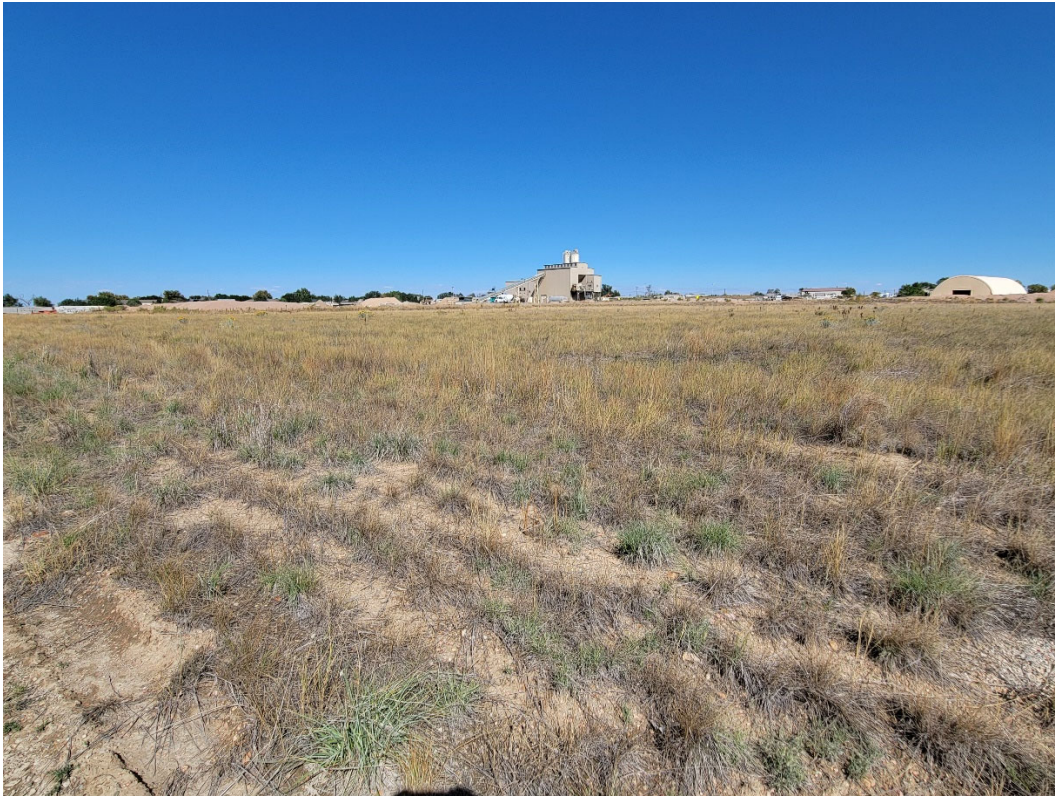
Photo 1: Looking northeast across Phase 18 area near the entrance.

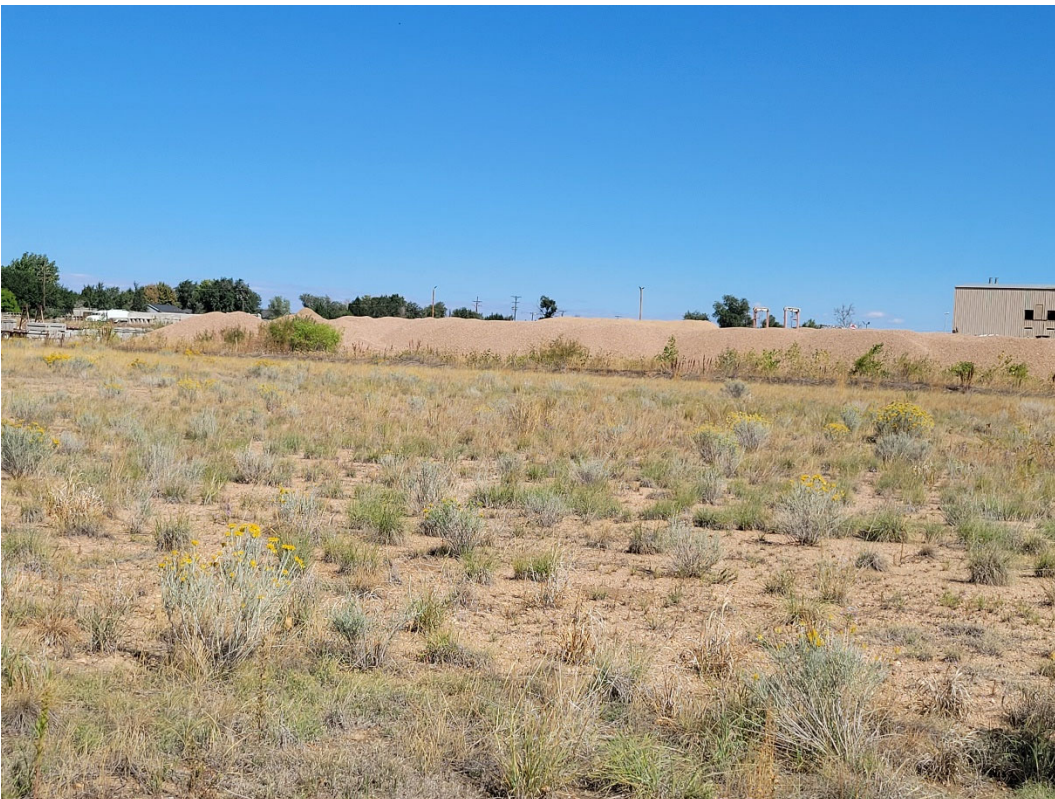
The Phase 18 area near the entrance was the location of the former processing facilities. Per the approval of Technical Revision No. 8 (TR08) this area is to be reclaimed as upland wildlife habitat. During this inspection, the Division observed stockpiles of material stored in the Phase 18 area. Following the inspection, Mr. Olsen sent a memo to the Division which stated that the City has an agreement with Ready Mixed Concrete to use the stockpile area. The lease of that property expires in May 2027 and Ready Mixed is required to remove all structures and re-seed the entirety of the area.

Photo 2: Looking northeast at stockpiles in the Phase 18 area.

Lastly, it appears that we have agreements allowing Ready Mixed Concrete to use the area that you noted the stockpile in near the entrance. The lease of that property expires in May 2027 and Ready Mixed is required to remove all structures and re-seed the entirety of the area.

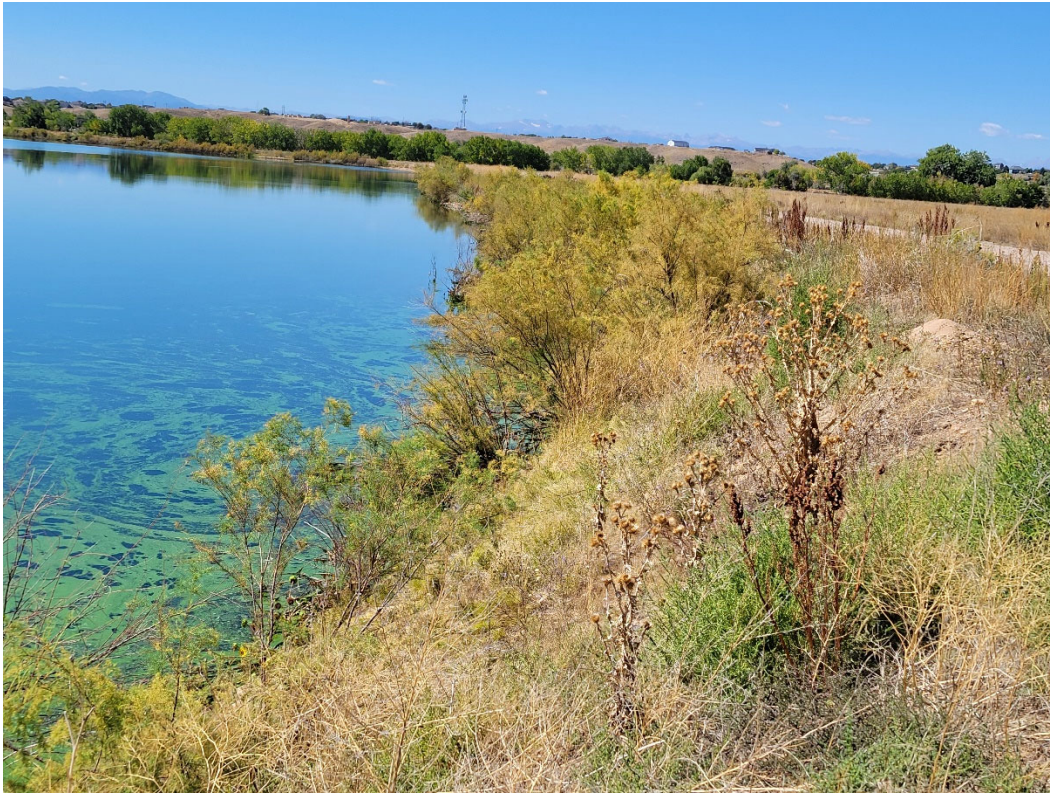
The western side of the permit area along the bike path that runs along the South Platte River was observed to be adequately vegetated with native grasses. Tamarisk trees were observed along the western and southern shorelines of the Cell No. 3 area. Additionally, the Division observed noxious weeds (primarily cheatgrass and thistle) in all areas of the permit area. This issue was discussed with the Operator. These trees and weeds need to be treated with an appropriate weed control method. The Division reviewed the permit file and did not find an approved weed control plan. Per Problem #1 cited above, the City shall develop a weed control and management plan in accordance with Section 3.1.10 (6) of the Rules. This plan should be developed in consultation with the county extension agency or weed control district office and should include specific control measures to be applied, a schedule for when control measures will be applied and a post-treatment monitoring plan. **This weed control plan shall be submitted to the Division as a Technical Revision to the approved plan with the appropriate Technical Revision fee of \$216.00 by the corrective action date.**

Photo 3. Looking west from the northeast corner of Cell No. 2. Tamarisk trees, Canada thistle and cheatgrass plants observed along the shoreline.

**CORRECTIVE ACTIONS:** Implement approved weed control plan and provide proof to the Division that this has been done. If a weed control plan is not already in place, the operator shall develop a weed control and management plan in accordance with Section 3.1.10 (6) of the Rule. This plan should be developed in consultation with the county extension agency, or weed control district office and should include specific control measures to be applied, a schedule for when control measures will be applied and a post-treatment monitoring plan. This weed control plan shall be submitted to the Division as a Technical Revision to the approved plan with the appropriate Technical Revision fee of \$216.00 by the corrective action date.

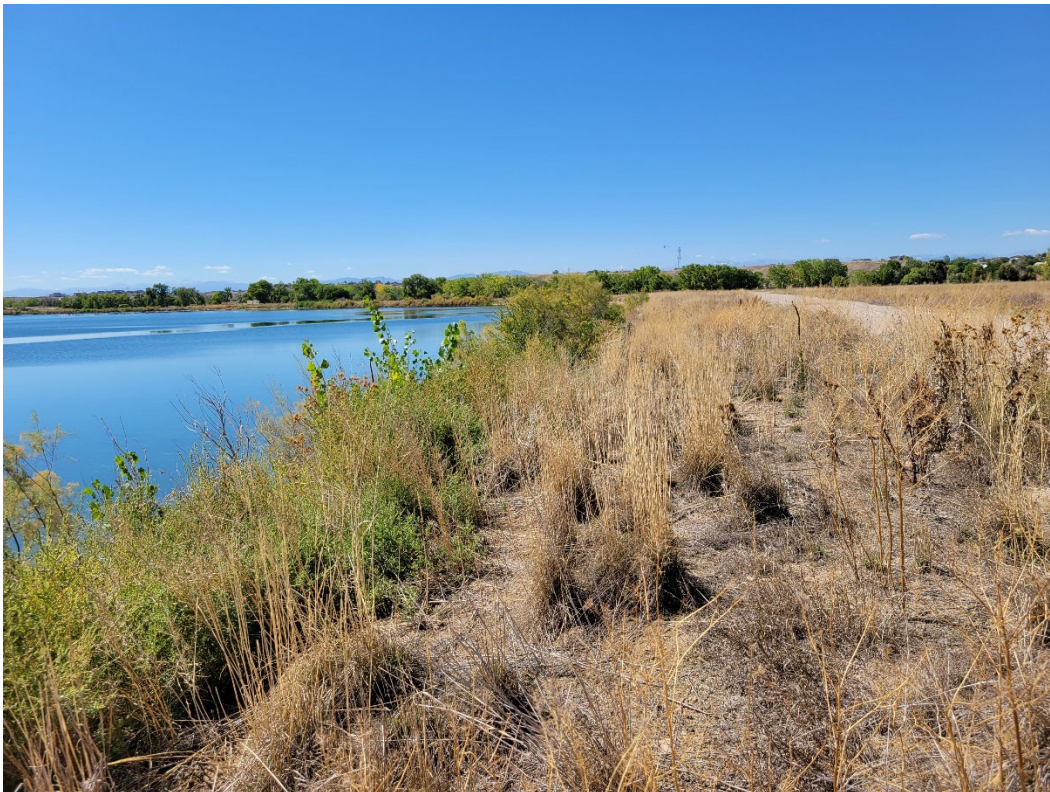
Photo 4: Looking west at revegetation along the northern shoreline of Cell No. 3.

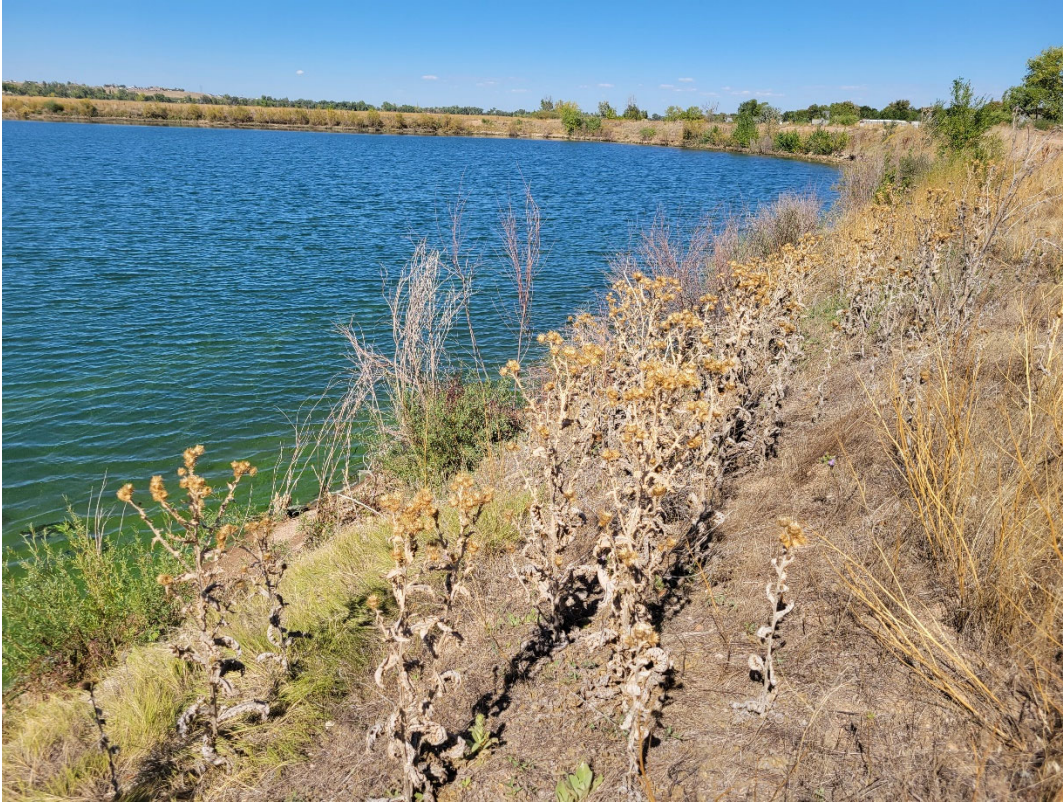
Photo 5: Looking at revegetation along the eastern shoreline of Cell No. 3.

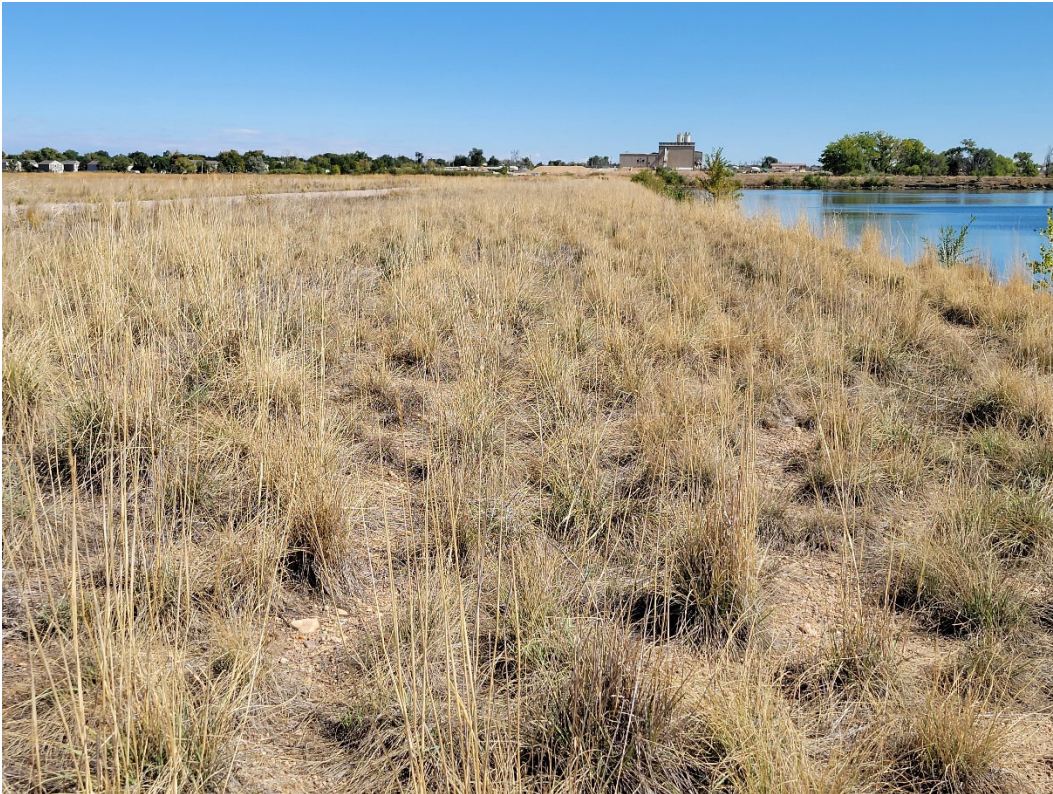
Photo 6: Looking east at revegetation in the northwest corner of Cell No. 3.

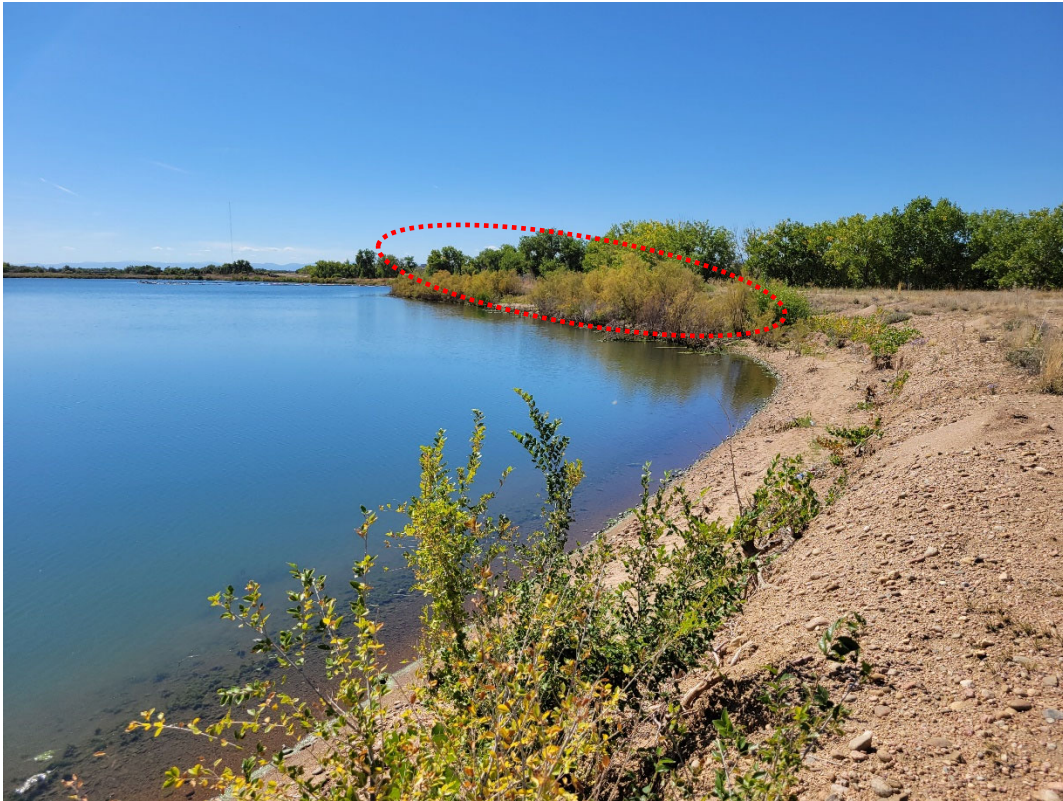
Photo 7: Looking south from the northwest corner of Cell No. 3. Red dashed circle indicates Tamarisk trees observed.

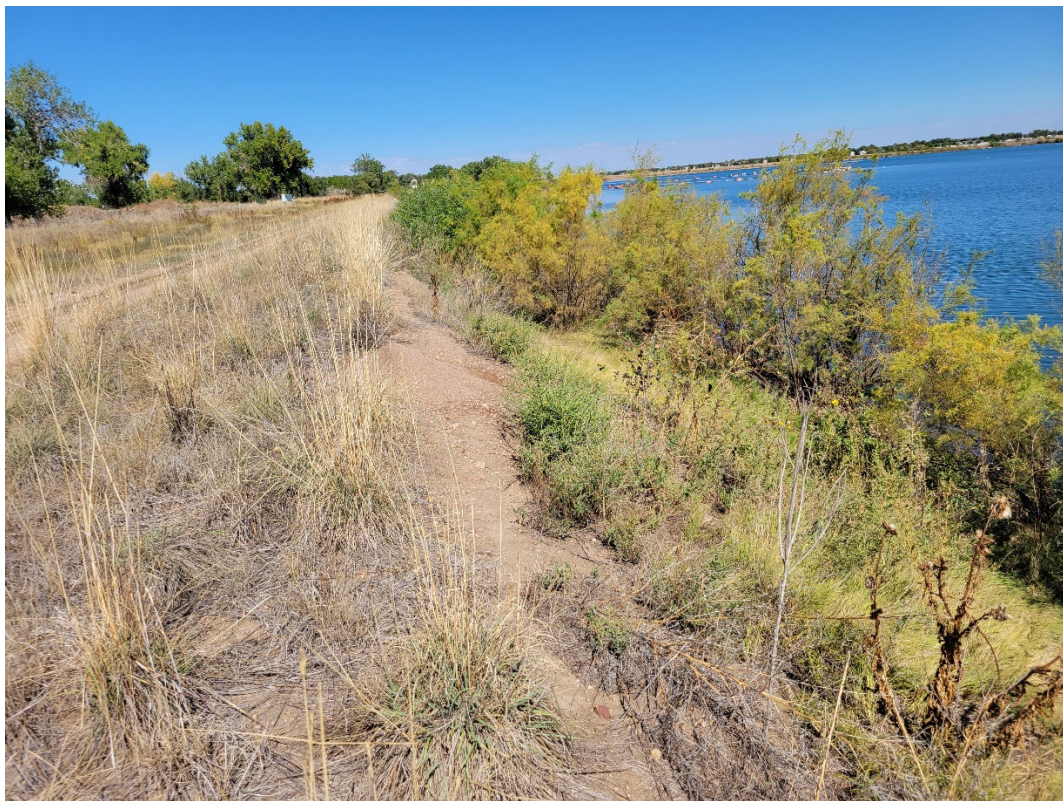
Photo 8: Looking north along the western shoreline of Cell No. 3. Tamarisk trees and thistles observed here.

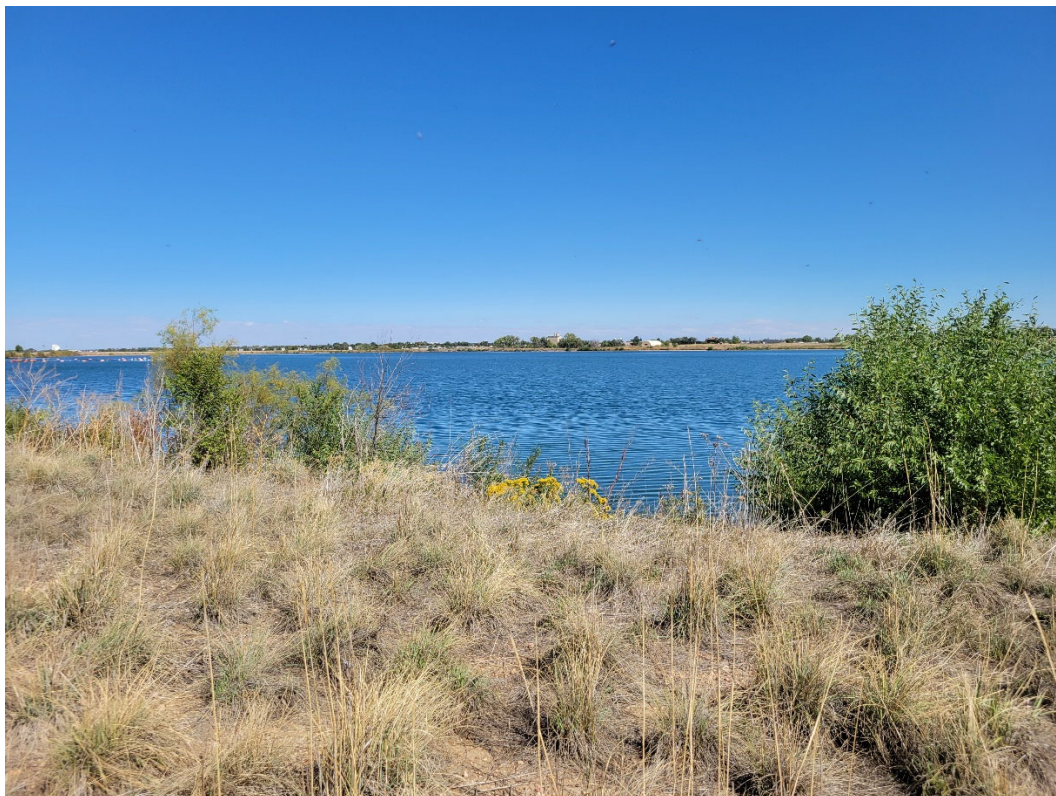
Photo 9: Looking northeast from the southwest corner of Cell No. 3.

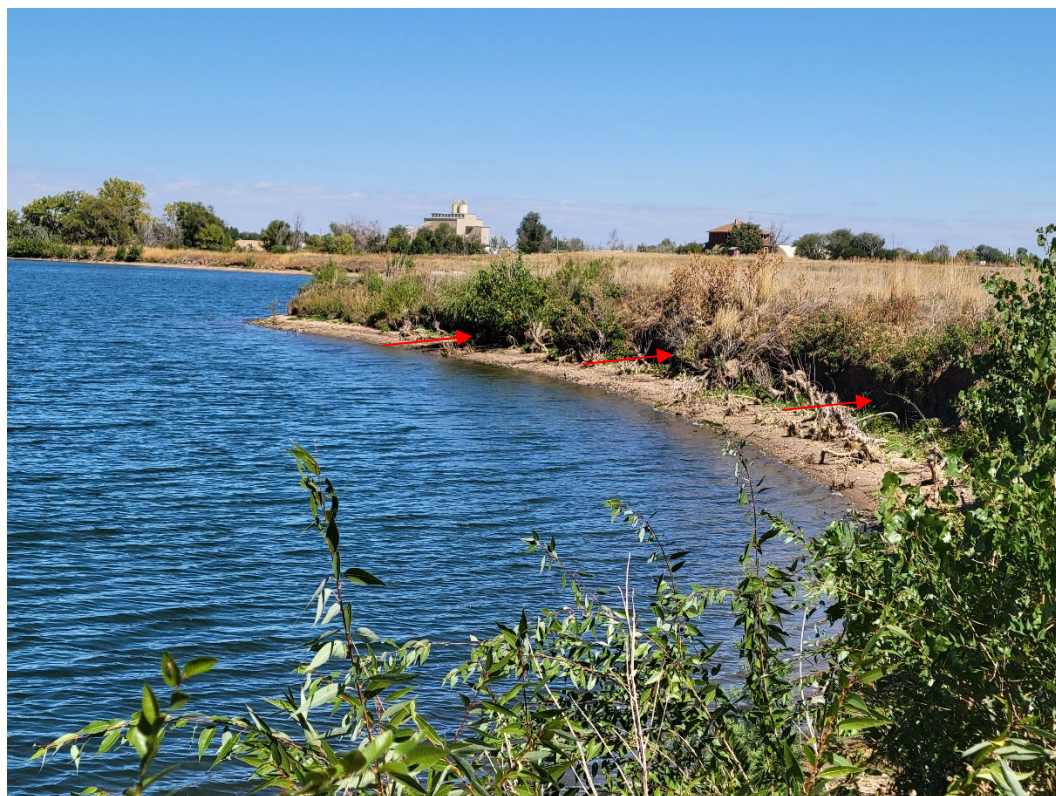
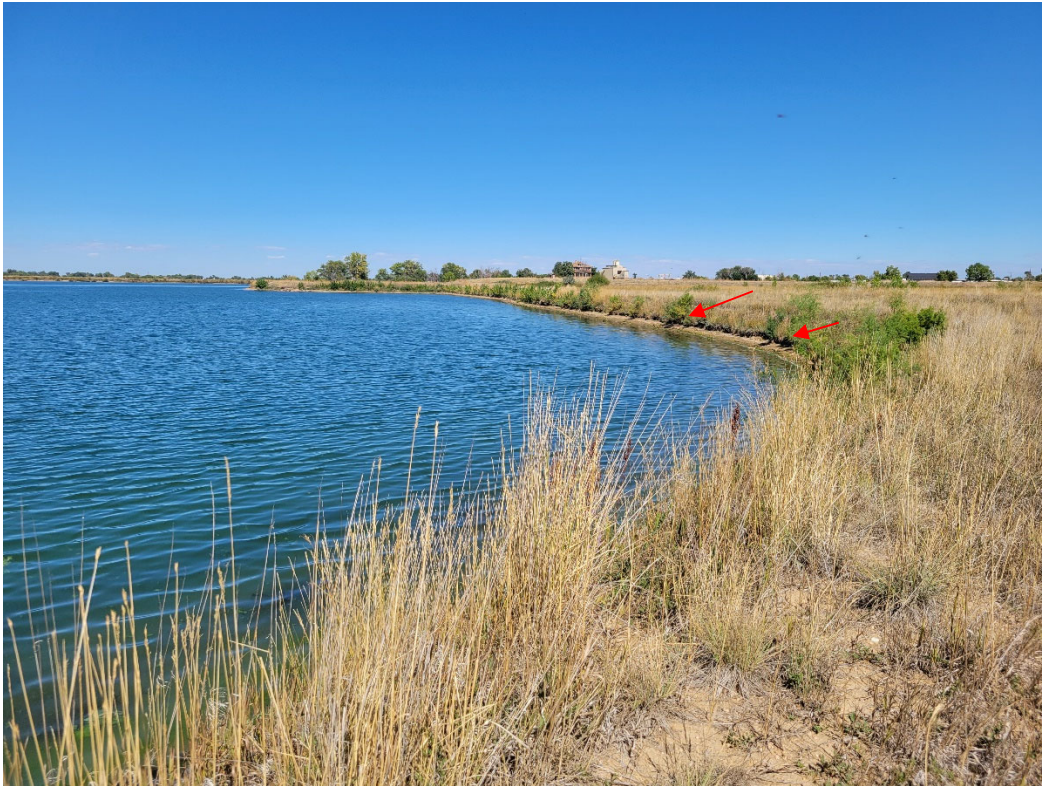
The Bromley Lakes Cell No. 3 is a former pit excavation that has been reclaimed as a slurry wall lined water storage reservoir. A review of the permit file shows the operator submitted a slurry wall liner certification from DWR in 2013. The Division observed vertical slopes in some areas around the reservoir caused by water erosion. As mentioned in the previous inspection report the side slopes surrounding Cell No. 3 need weed control and repair and treatment of tamarisk trees. Repairs will consist of grading slopes to 3H:1V and installation of rip-rap to prevent future erosion. Following the inspection, Mr. Olsen sent an email to the Division which indicated they will either repair and seed the banks or work on moving the timeframe up for the bank stabilization project which includes rip rap. **Please note, the City will need to submit a technical revision to update the reclamation plan and map to show any bank stabilization measures installed around the reservoir.**

Photo 10: Looking northeast at shoreline on the east side of Cell No. 3. Arrow indicates wave cutting along the shoreline.

Photo 11: Looking northeast at shoreline on the east side of Cell No. 3. Arrow indicates wave cutting along the shoreline.

Looking at our capital improvement plan, it appears the bank stabilization at Cell #3 is farther out than I thought. I think we are going to have to add a project to repair the banks above the high-water line and re-seed, or move the bank stabilization project forward. This will have to be discussed with our budget team. We just finished our budget cycle, so the soonest we could add this in would be 2026.

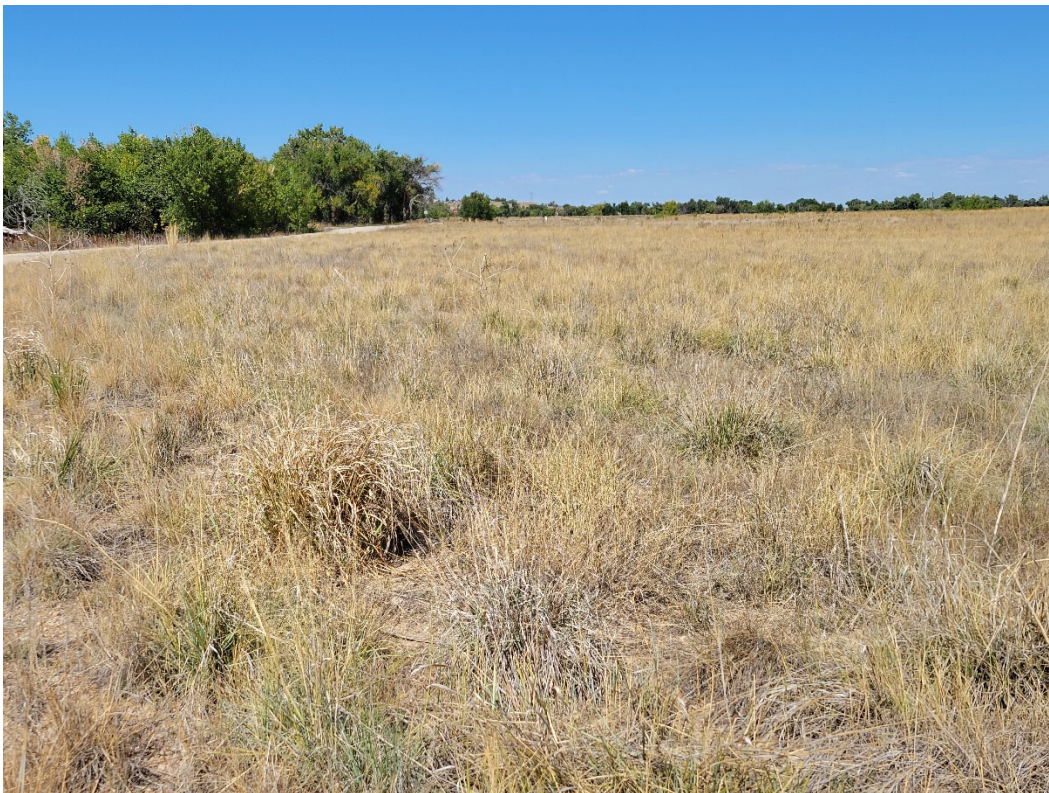
Bromley Lakes Cell No. 2 was mined and backfilled completely and is approved to be reclaimed as upland wildlife habitat. The Division observed the revegetation in this area. Mature grasses are established across the backfilled area. A few dense patches of annual weeds were noted on the east site. A unvegetated gravel pad (approximately 300x80 ft.) was observed along the access road in the Cell 2 area. The gravel pad needs to be prepped and reseeded according to the approved reclamation plan.

Photo 12: Looking north across backfilled and revegetated Cell No. 2.

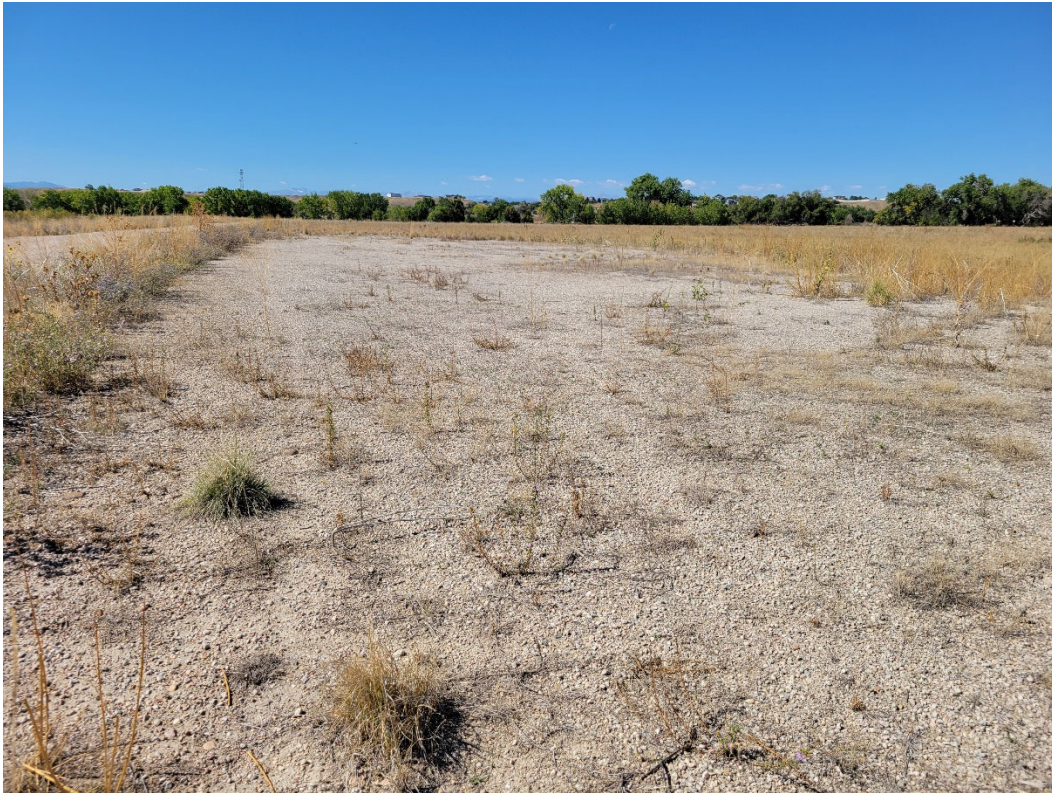
Photo 13: Gravel pad observed adjacent to the access road in the Cell No. 2 area.

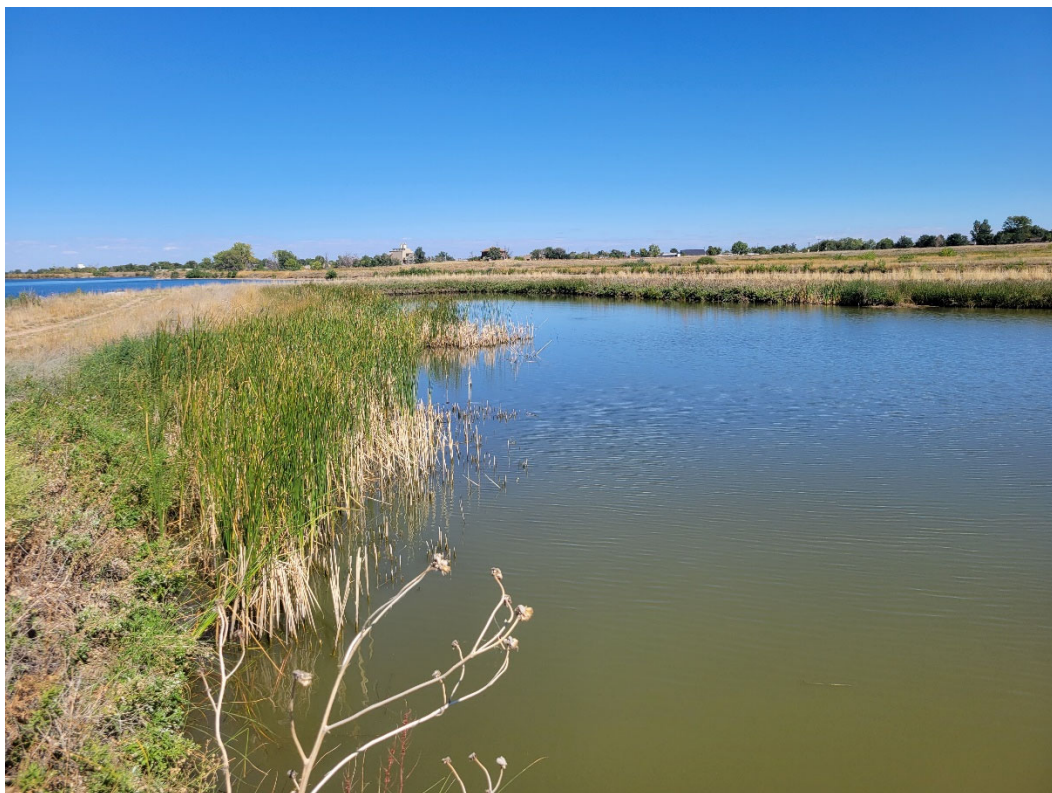
The French Drain installed adjacent to the Spier Property appears to be functioning. Water was discharging from the drain into the McCanne Ditch. The Division observed a pond in the southeast corner of the Cell 3 area. The approved reclamation plan map does not show a pond in this area. The operator indicated it the pond is fed from a groundwater seep and the water flows into the realigned McCanne Ditch. **The City will need to submit a Technical Revision to update the reclamation plan map to show the pond and slurry wall alignment in the southeast corner of Cell 3.**

Photo 14: Pond observed in the southeast corner of the Cell No. 3.

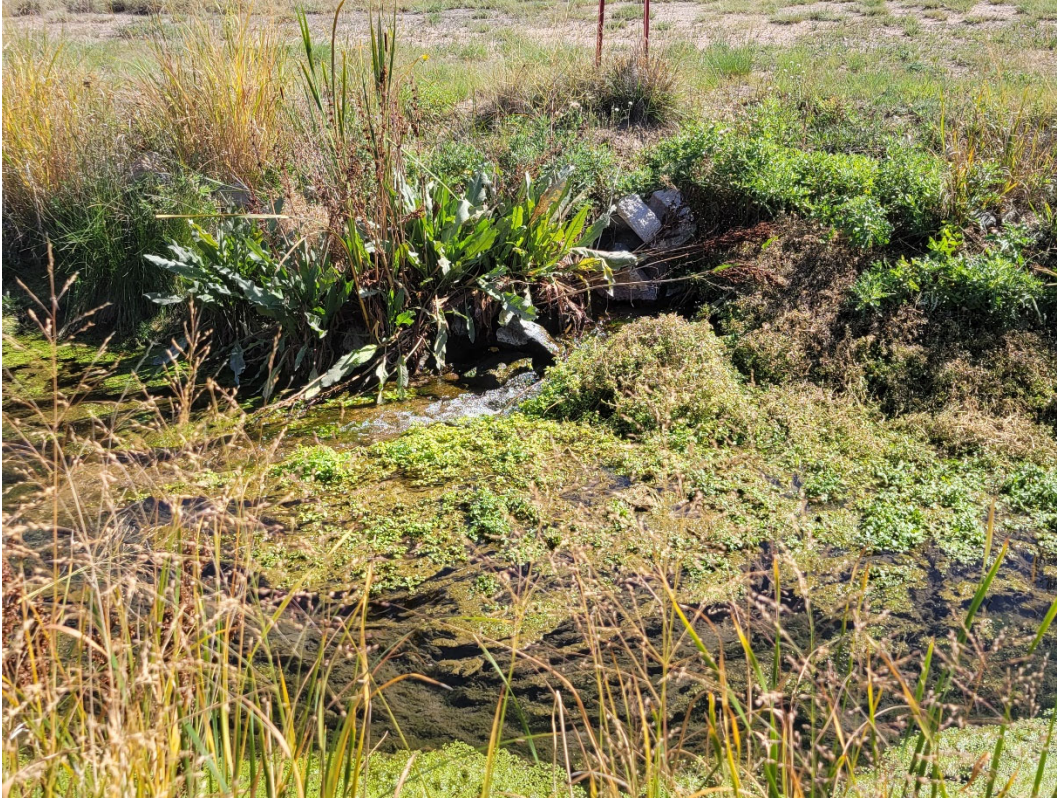
Photo 15: French drain outlet. Water observed discharging from the drain into the McCanne Ditch.

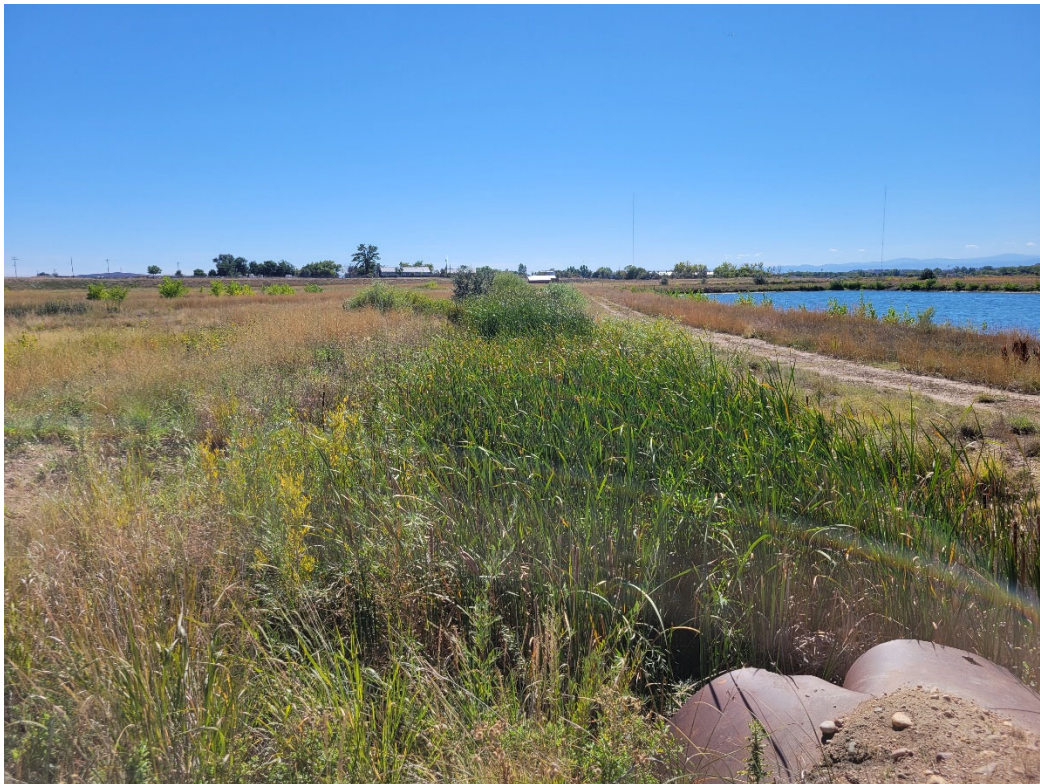
Photo 16: Looking south at McCanne Ditch in the ARA Addition area on the east side of Cell No. 3.

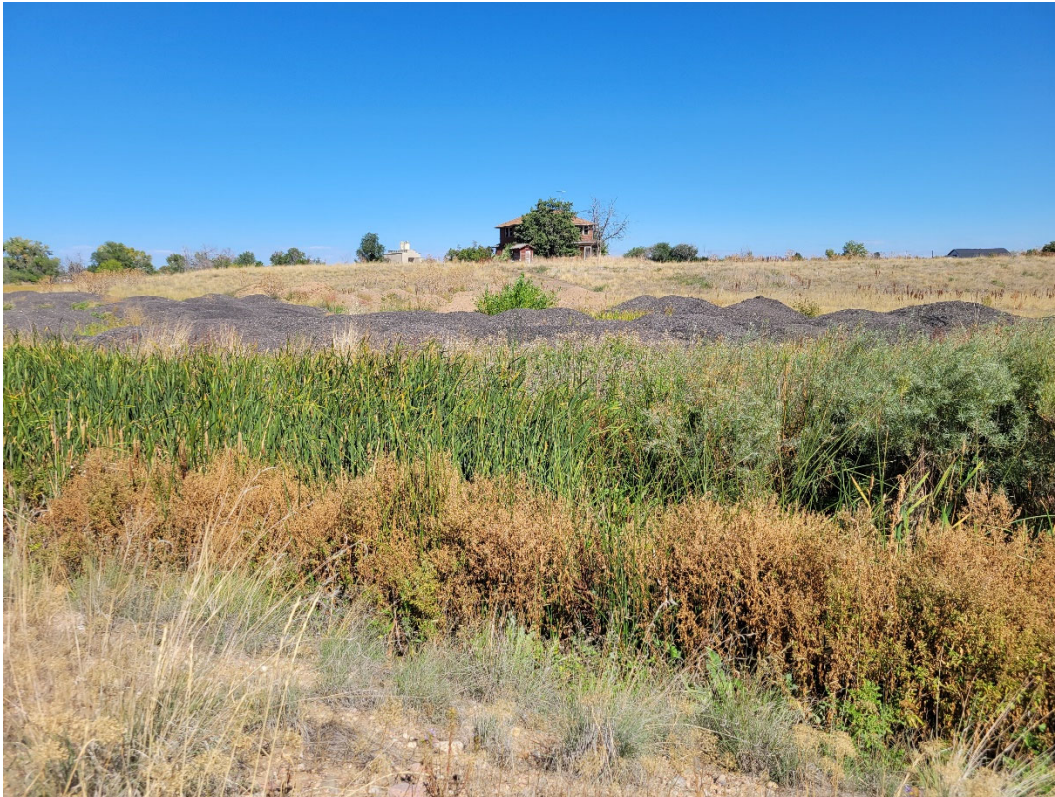
The area known as the ARA Addition area on the east side of the permit area was mined and reclaimed as upland wildlife habitat. The realigned McCanne Ditch flows through this area. The Division observed several piles of road base stored in this area. The stockpiles will need to be removed, and the area should be prepped and reseeded according to the approved reclamation plan. Additionally, the Division observed an abandoned house in this area at the top of a small hill. Mr. Olsen indicated they plan to keep the house and incorporate it into the future open space park. **Please note, the City will need to submit a Technical Revision to update the reclamation plan map to show the house remaining in the ARA Addition area.**

Photo 17: Looking at road base stockpiled in the ARA Addition area on the east side.

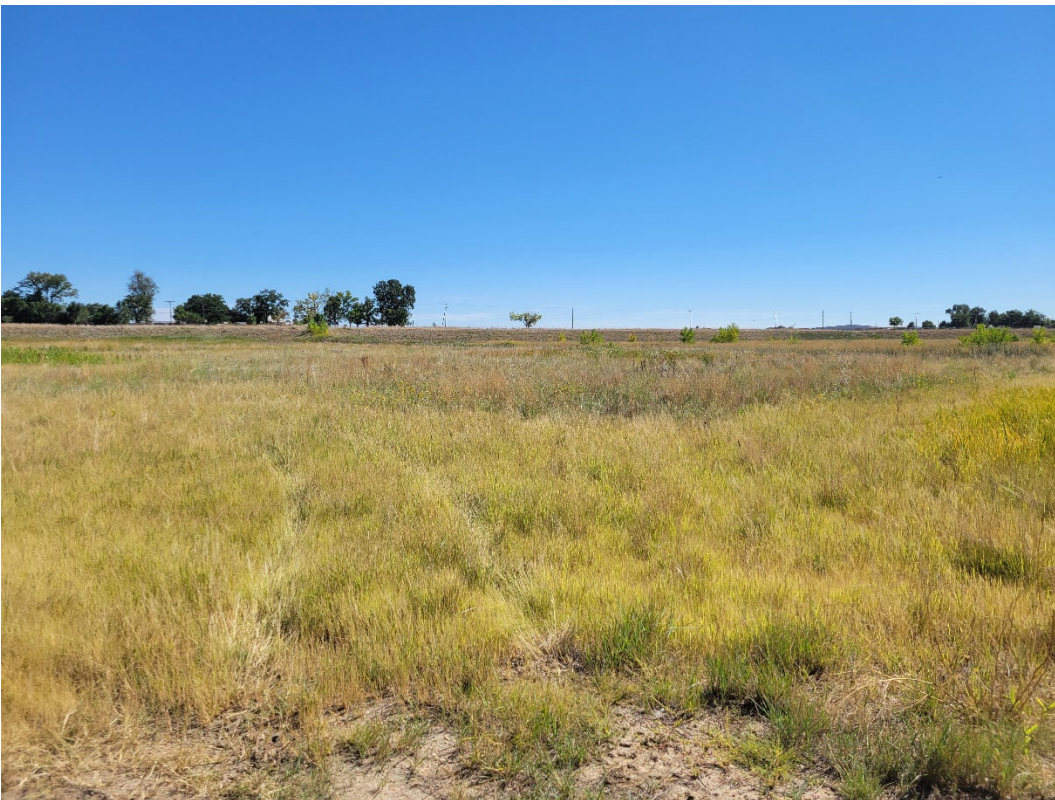
Photo 18: Looking southeast at the revegetated upland in the ARA Addition area.

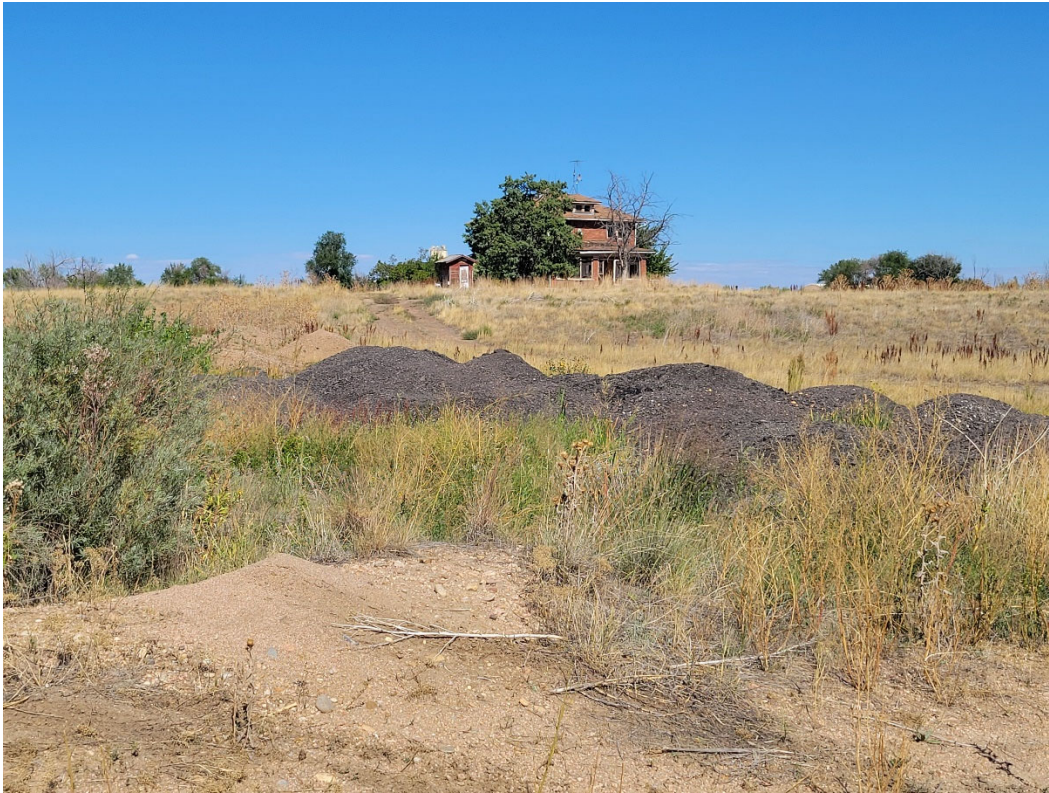
Photo 19: Abandoned house on a hill in the ARA Addition area.
