**MINERALS PROGRAM INSPECTION REPORT**  
**PHONE: (720) 688-0626**

<b>MINE NAME:</b> Bulldog Mine Operation	<b>MINE/PROSPECTING ID#:</b> M-1977-215	<b>MINERAL:</b> Lead and silver	<b>COUNTY:</b> Mineral
<b>INSPECTION TYPE:</b> Monitoring	<b>WEATHER:</b> Clear	<b>INSP. DATE:</b> September 25, 2024	<b>INSP. TIME:</b> 07:30
<b>OPERATOR:</b> Rio Grande Silver, Inc.	<b>OPERATOR REPRESENTATIVE:</b> Randy McClure	<b>TYPE OF OPERATION:</b> 112d-2 - Designated Mining Operation	
<b>REASON FOR INSPECTION:</b> Normal I&E Program	<b>BOND CALCULATION TYPE:</b> None	<b>BOND AMOUNT:</b> \$163,228.13	
<b>DATE OF COMPLAINT:</b> NA	<b>POST INSP. CONTACTS:</b> None	<b>JOINT INSP. AGENCY:</b> None	
<b>INSPECTOR(S):</b> Todd Jesse	<b>INSPECTOR'S SIGNATURE:</b>

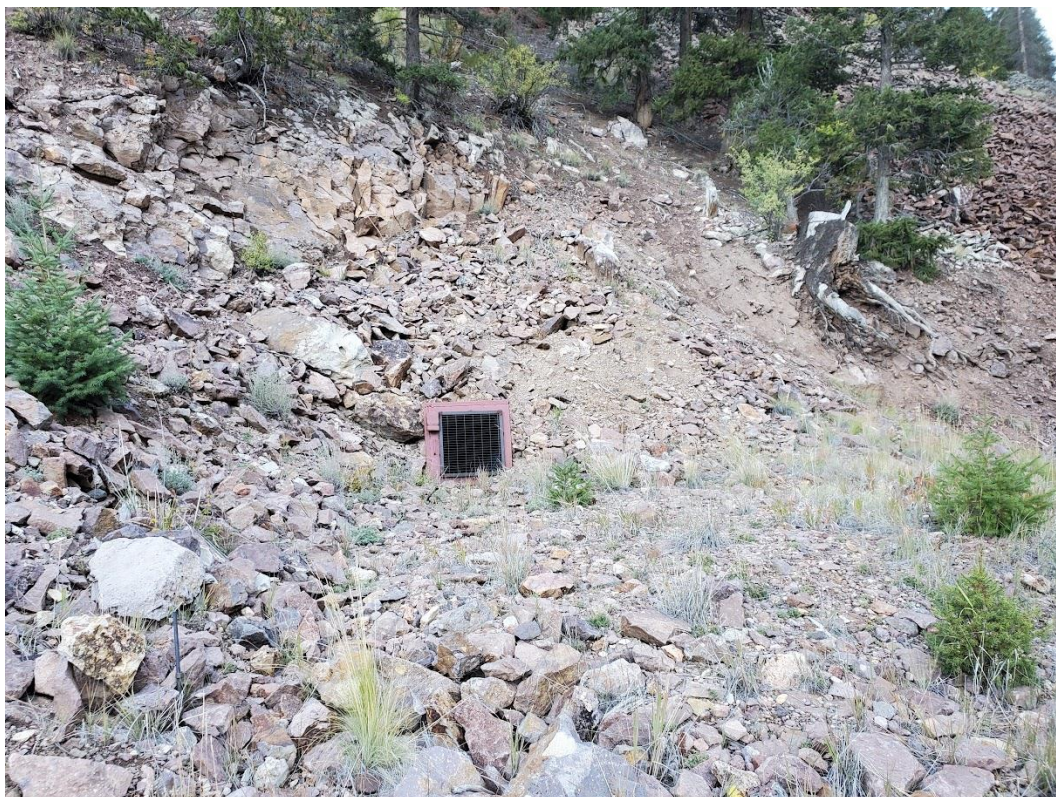
The 9700 Level Portal has been reclaimed and is not used in operations (Photo 1). The bat gate at the portal was secured at the time of the inspection. The portal closure is stable. There are no signs of displacement around the gate. The slopes above and adjacent to the closure are stable and show no signs of slumping or erosion.

Photo 1: View to the northwest of 9700 Portal.

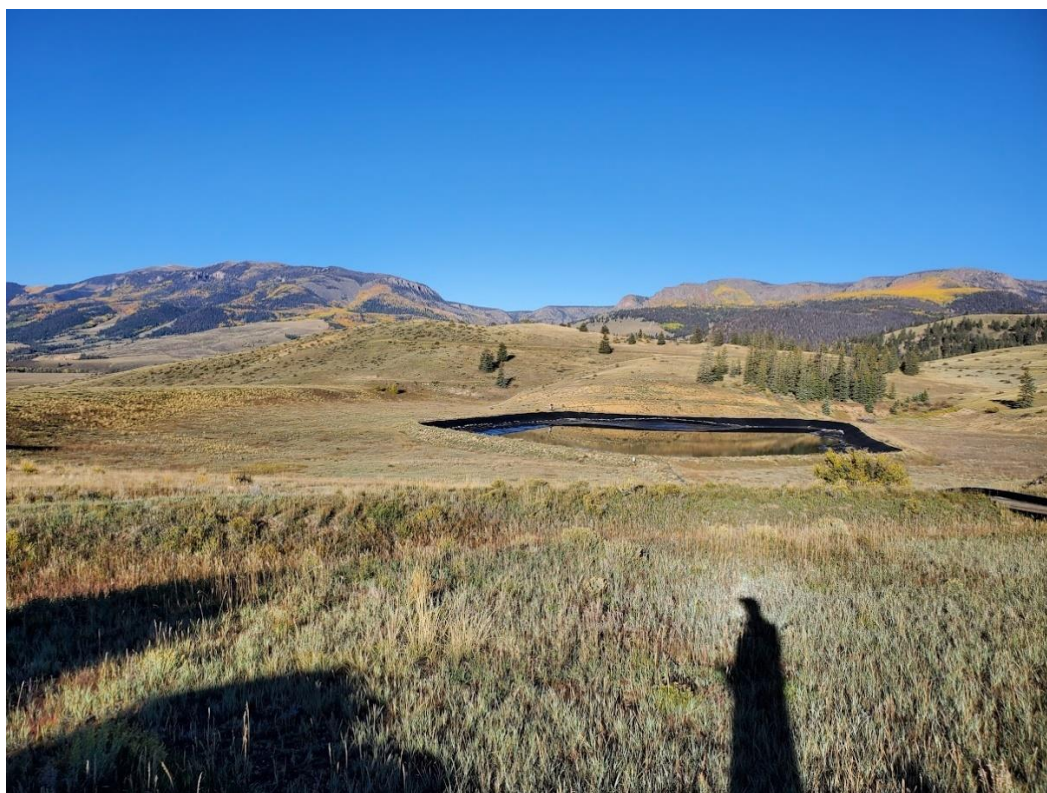
The mine is not being dewatered at this time and no water is being trucked to the lined contact water pond on TP-2. There is a small amount of meteoric water that has collected in the lined contact water pond (Photo 2). The operator does not anticipate the need to dewater and truck water in the future. The operator submitted a technical revision in the fall of 2023 to install infrastructure to discharge to Windy Gulch. The TR was approved, but infrastructure has yet to be constructed. The operator is awaiting issuance of a discharge permit from CDPHE before constructing infrastructure.

Photo 2: View to the west of TP-2. Small amount of meteoric water in lined contact water pond.

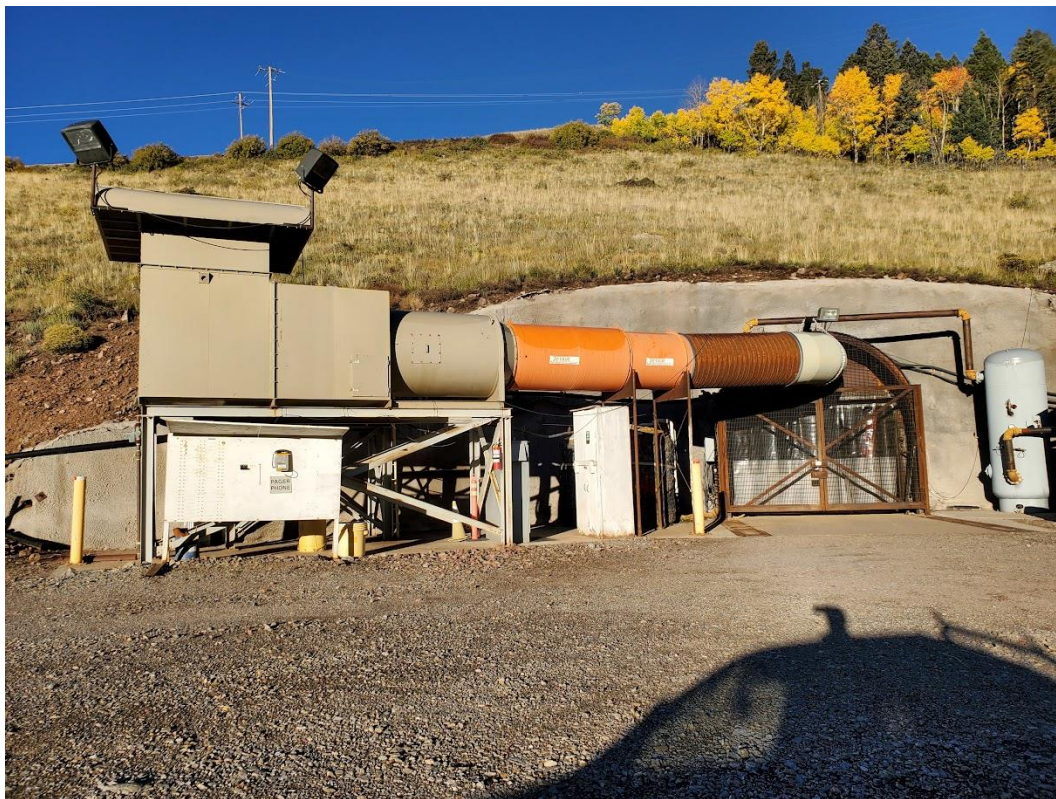
The site was not active at the time of the inspection. The 9400 Level portal is the main access and ore removal for underground workings (Photo 3). The main portal was closed at the time of the inspection. The portal door is in excellent condition and shows no signs of damage or vandalism. The vent fan and electrical equipment (Photo 4) is in good condition and appears well maintained. There are no signs of settling, slumping, or erosion above or around the portal.

Photo 3: View to the west of 9400 Level Portal. Portal closed at time of inspection.

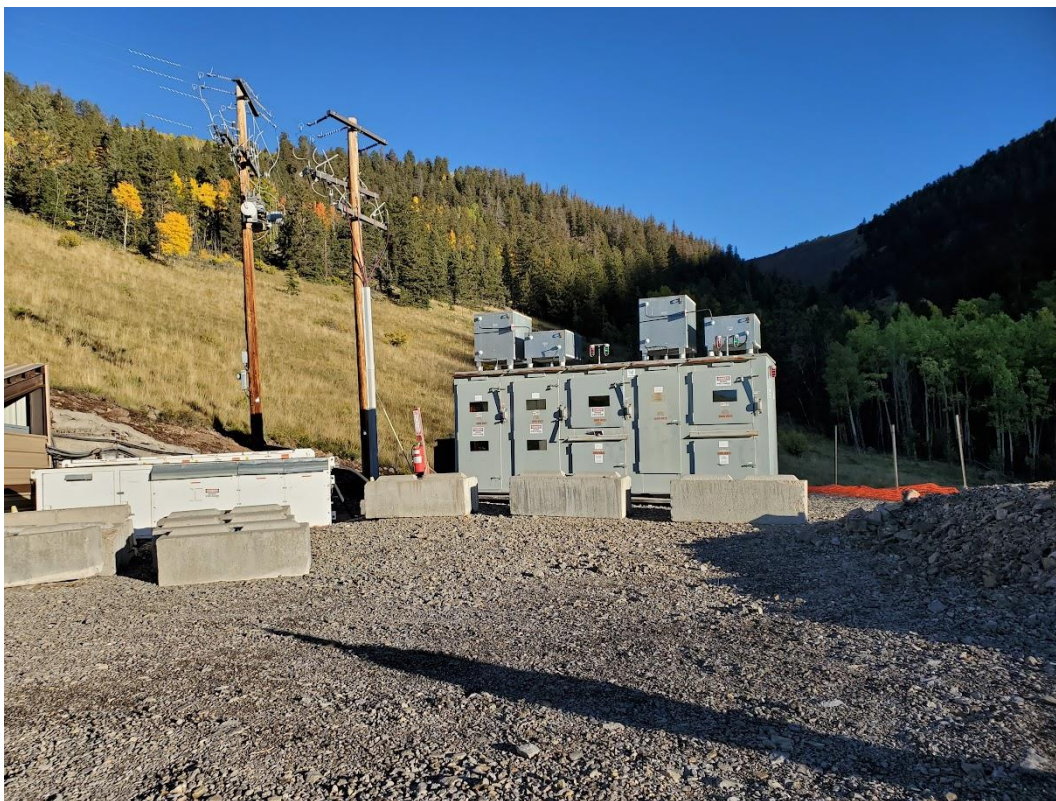
Photo 4: View to the north of electric equipment at the 9400 Level Portal.

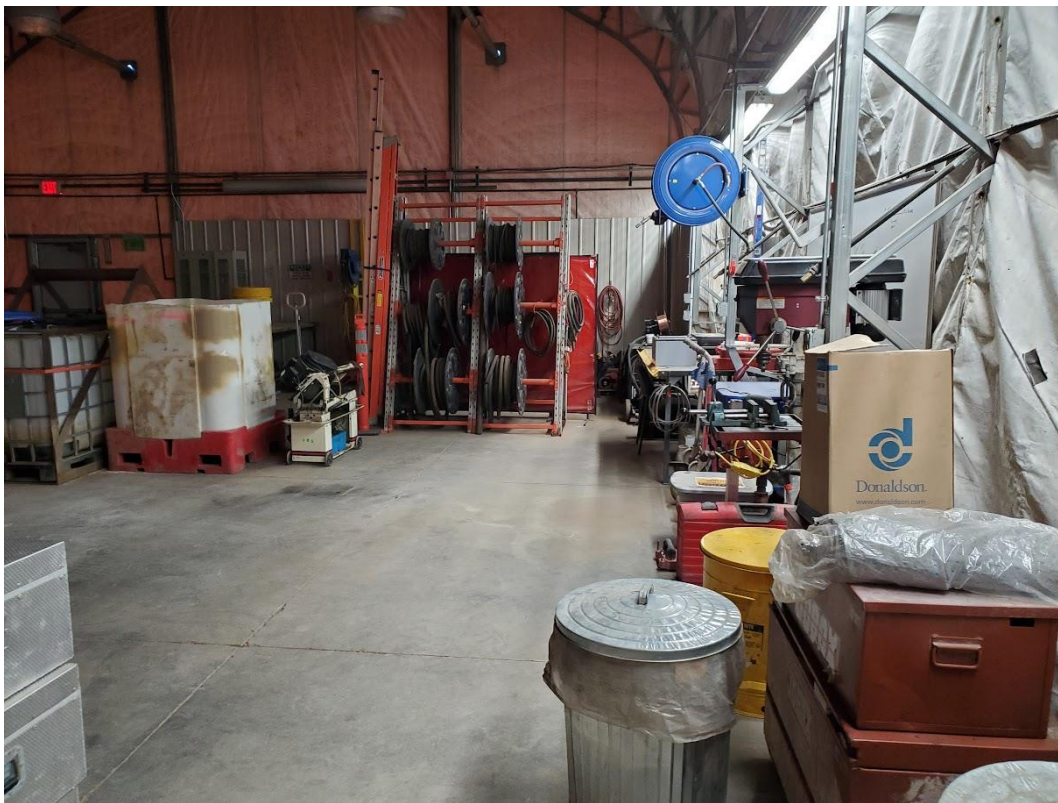
Facilities observed include the maintenance shop, fuel storage building, laydown yard and Windy Gulch Vent Shaft. The maintenance shop was in immaculate condition and very well kept (Photo 5). Spill kits and rag bins

Photo 5: View to the north of interior of maintenance shop in the main facilities area.

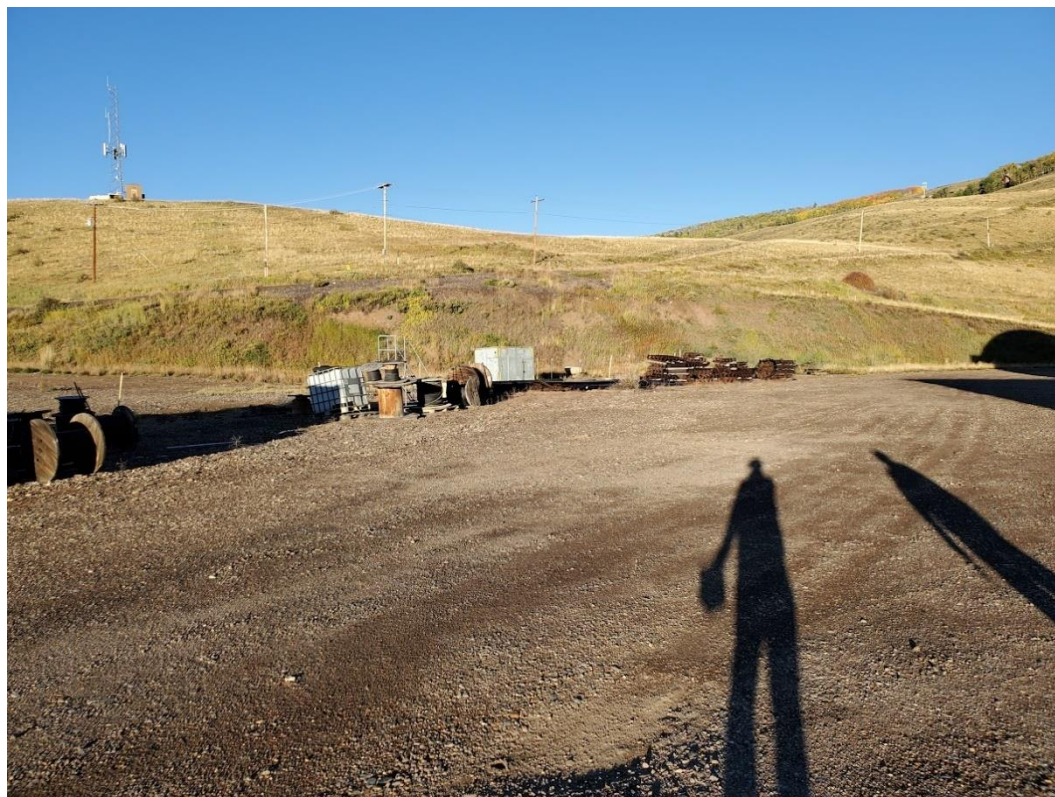
were observed in good condition. The shotcrete batch plant was removed from site and the building that housed it is now used for a maintenance and storage building. Like the maintenance shop, all other structures in the facilities area are in good condition and very well kept. The laydown yard in the main facilities area is also very well organized (Photo 6). The Windy Gulch Vent Shaft is surrounded by chain link fence with a locked gate to prevent unauthorized entry and vandalism (Photo 7). The shaft is in good condition. The collar and closure show no evidence of displacement, settling, slumping, or erosion.

Photo 6: View to the west of laydown yard in the main facilities area.

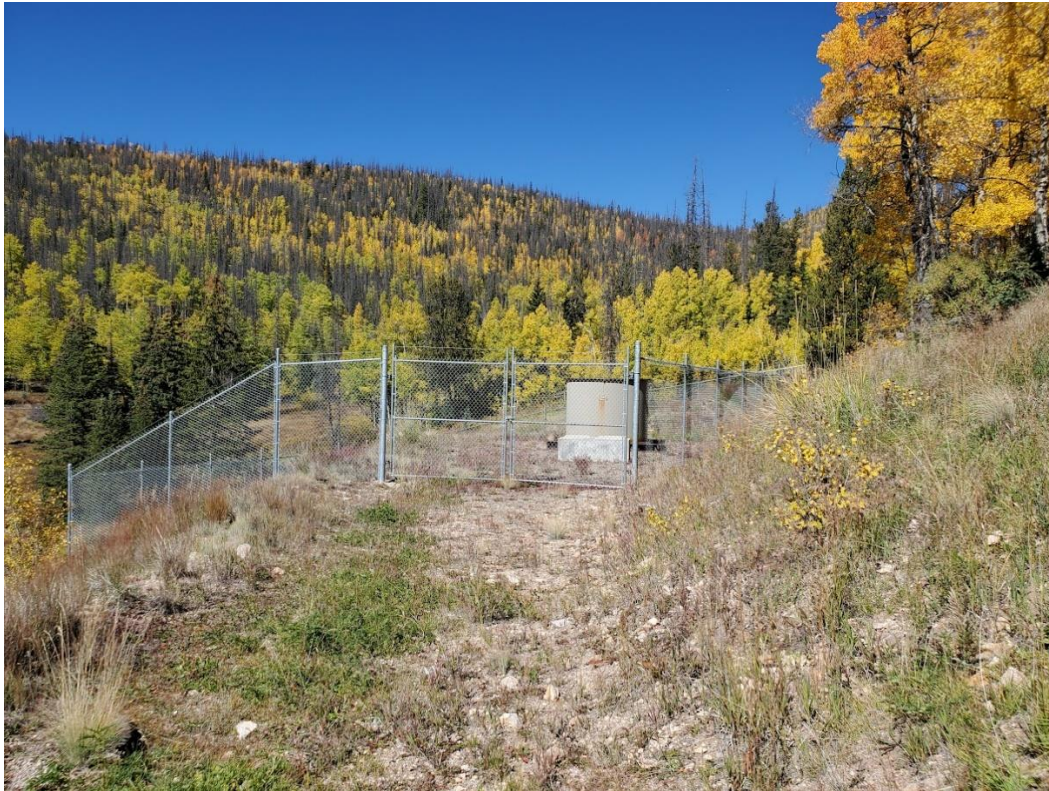
Photo 7: View to the northwest of Windy Gulch Vent Shaft.
