Henderson Mine M-1977342 Inspection Report

MINERALS PROGRAM INSPECTION REPORT
PHONE: (303) 866-3567

MINE NAME: Henderson Mine	MINE/PROSPECTING ID#: M-1977-342	MINERAL: Molybdenum	COUNTY: Clear Creek, Grand
INSPECTION TYPE: Monitoring	WEATHER: Clear	INSP. DATE: September 25, 2024	INSP. TIME: 09:00
OPERATOR: Climax Molybdenum Company	OPERATOR REPRESENTATIVE: Miguel Hamarat	TYPE OF OPERATION: 112d-3 - Designated Mining Operation	
REASON FOR INSPECTION: Normal I&E Program	BOND CALCULATION TYPE: None	BOND AMOUNT: \$143,264,468.00	
DATE OF COMPLAINT: NA	POST INSP. CONTACTS: None	JOINT INSP. AGENCY: None	
INSPECTOR(S): Nikie Gagnon Robert Zuber, P.E. Amber Gibson	INSPECTOR'S SIGNATURE:

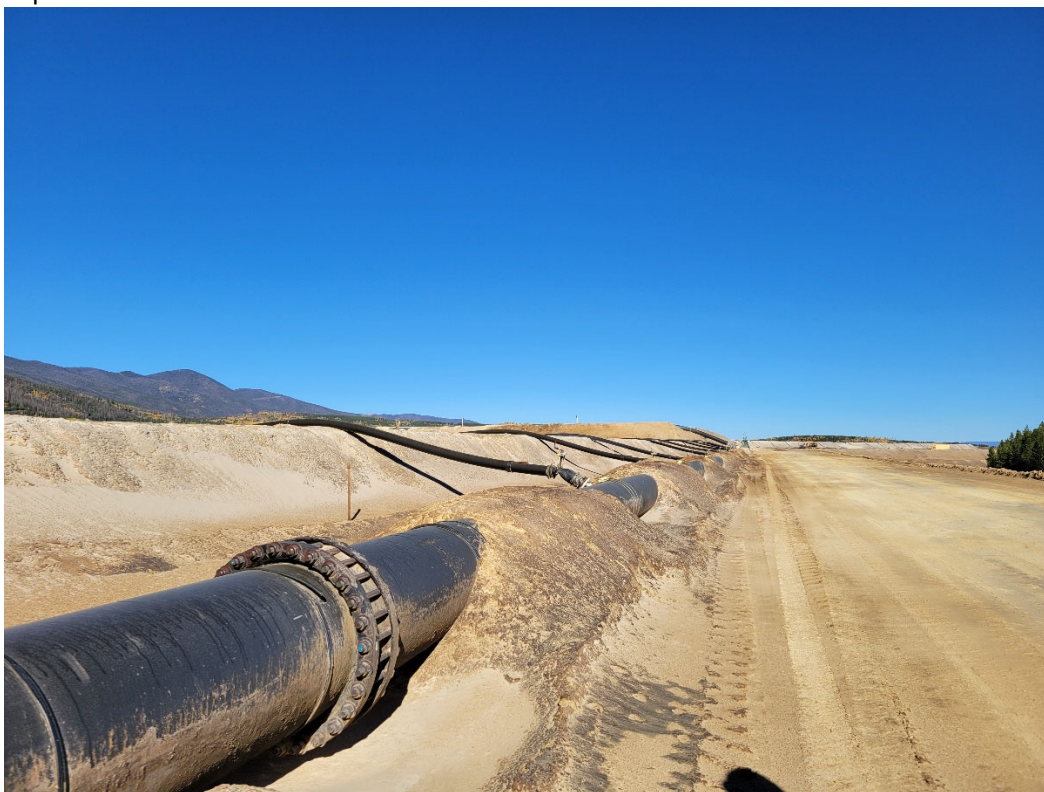
Photo 2: Looking north down the 30" tailings delivery pipeline on the east side of 3-Dam. The 8" spigot lines deliver the slurry over the raised dam to the deposition area.

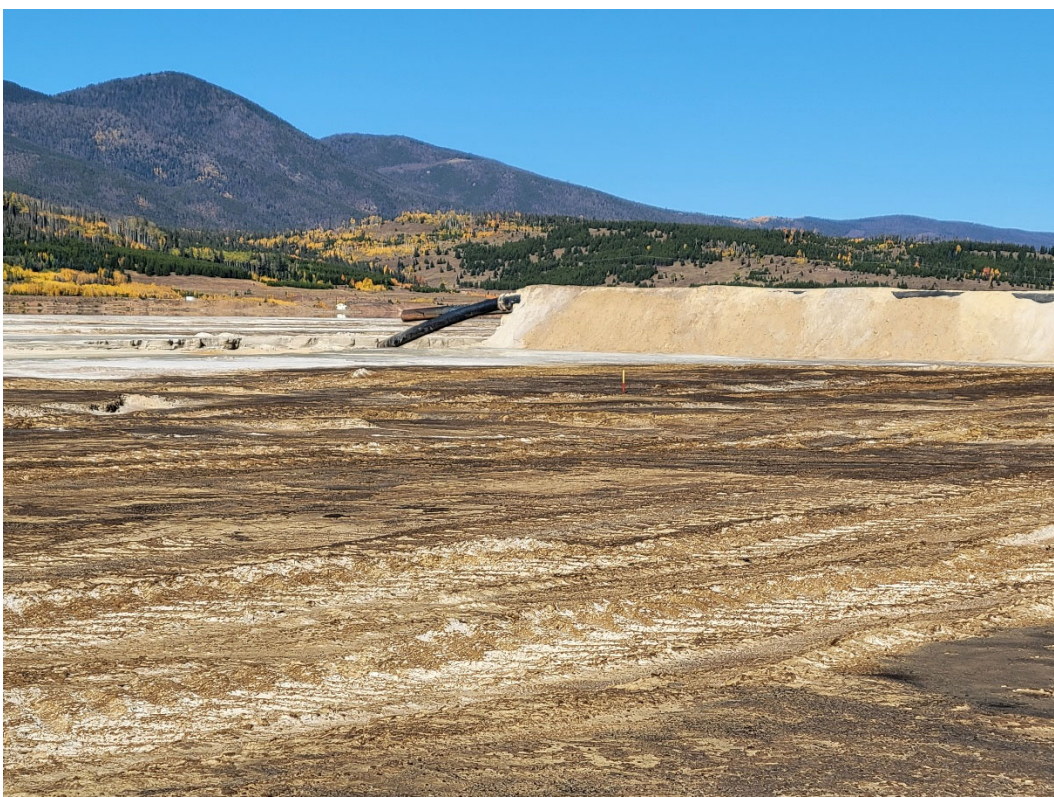
Photo 4: Looking northwest at 24" lead-off tailings delivery pipeline in the 3-Dam area. The lead-off pipes are used predominantly in the winter months.

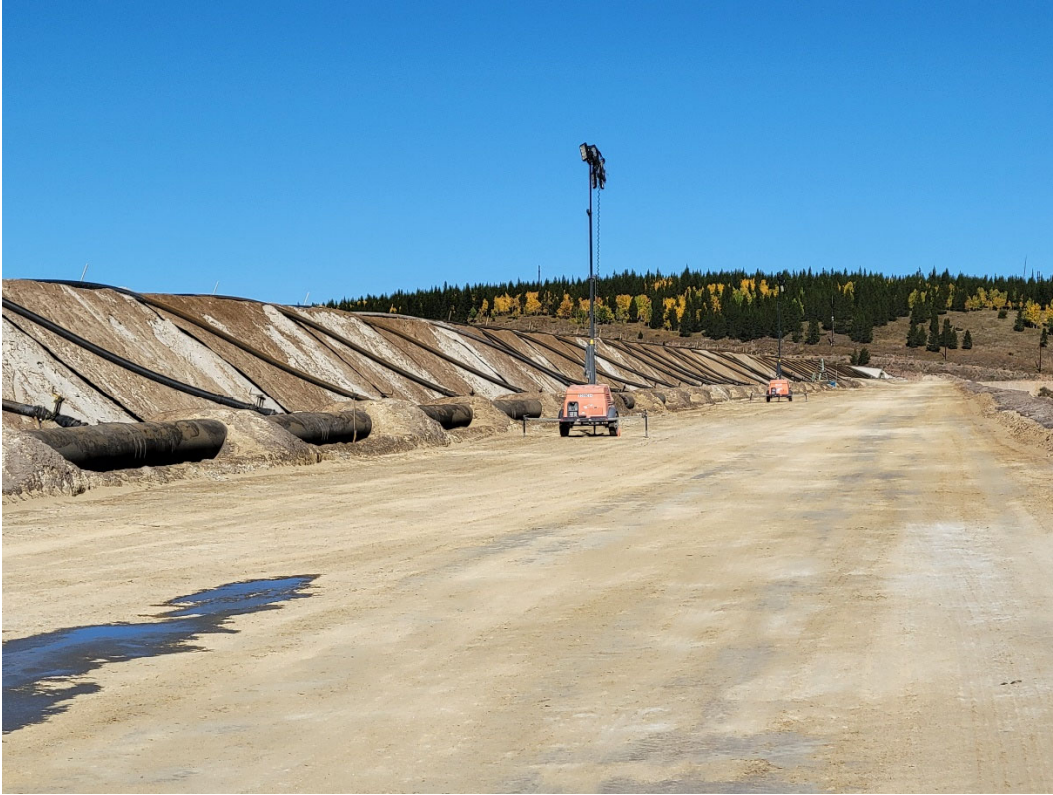
Photo 5: Looking north at the 30" tailings pipeline and 8" spigot lines on 1-Dam.

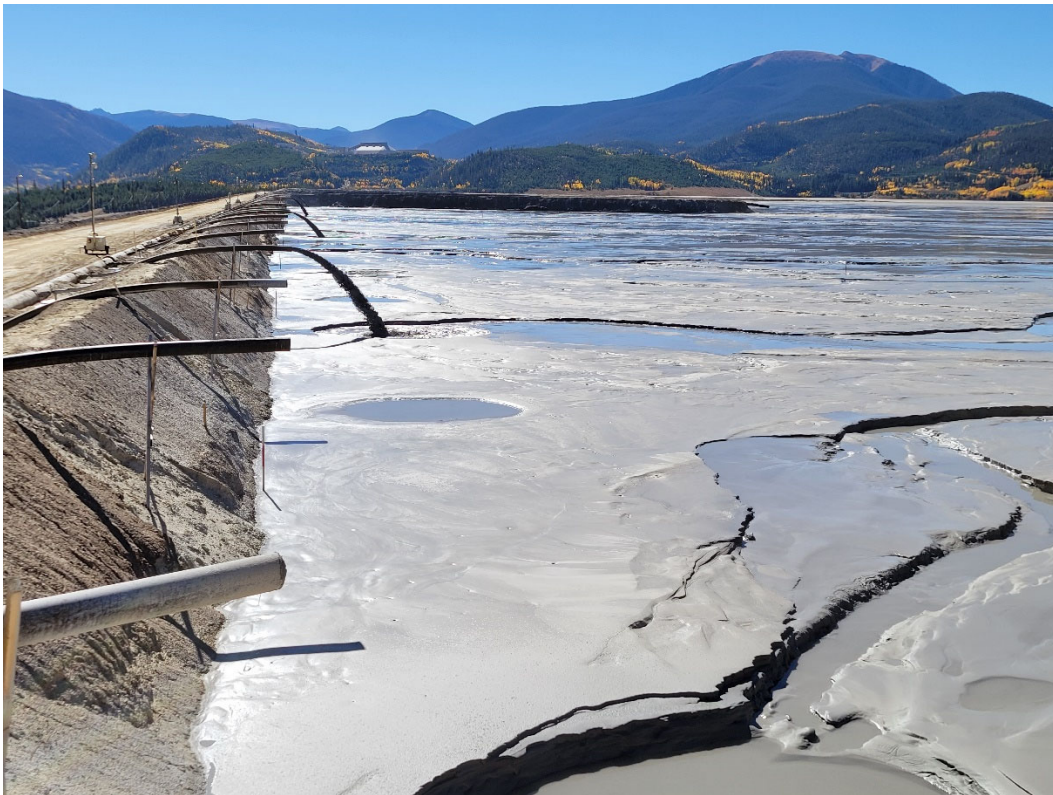
Active tailings deposition was occurring during the inspection with the use of spigots in Cells 6 and 7 (operations in Cell 7 had just been initiated). The beaches appeared to be constructed well, with consistent deposition between the cells. The 8" spigot lines are inspected daily.

Photo 6: Looking south at tailings deposition within Cell 6 of 1-Dam. Deposition is almost complete here.

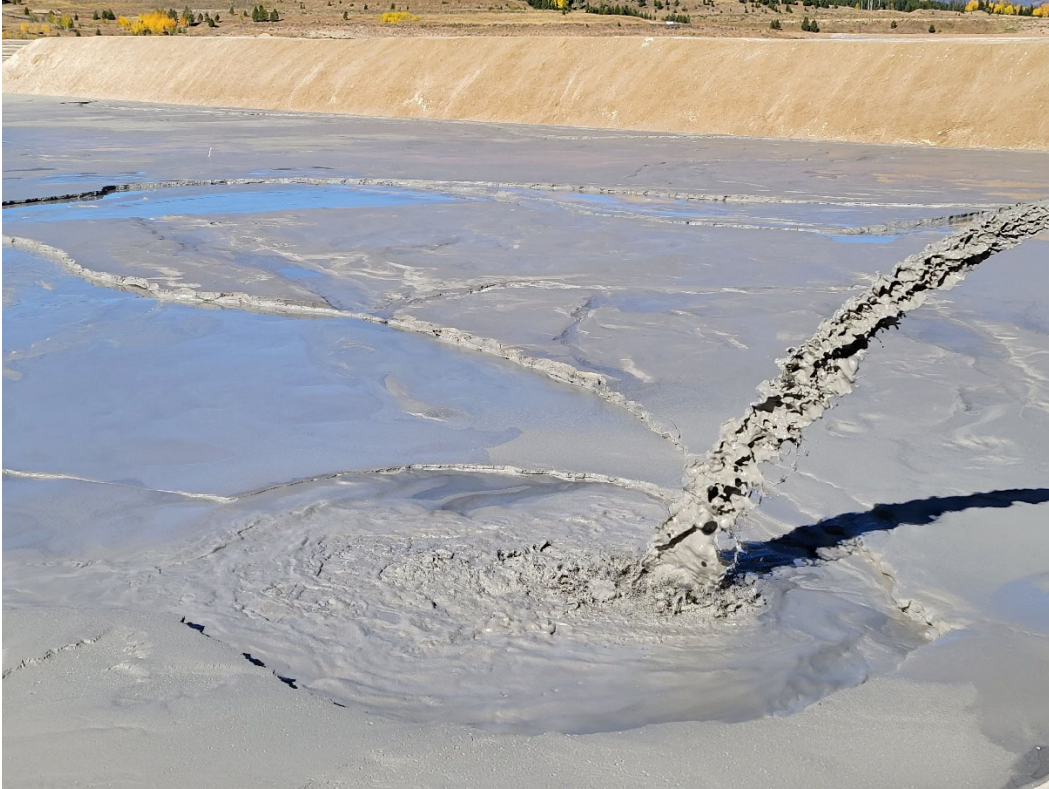
The beaches were observed for key performance indicators, as described by Ms. Yenne. The plunge pools were the desired depth, approximately 6 - 8 feet. The projection of the slurry exiting spigots was the desired size, approximately 3 – 5 feet. The channels of water and sediment leaving the spigot area were found to be

Photo 7: Closeup of plunge pool created by deposition within Cell 6 of 1-Dam.

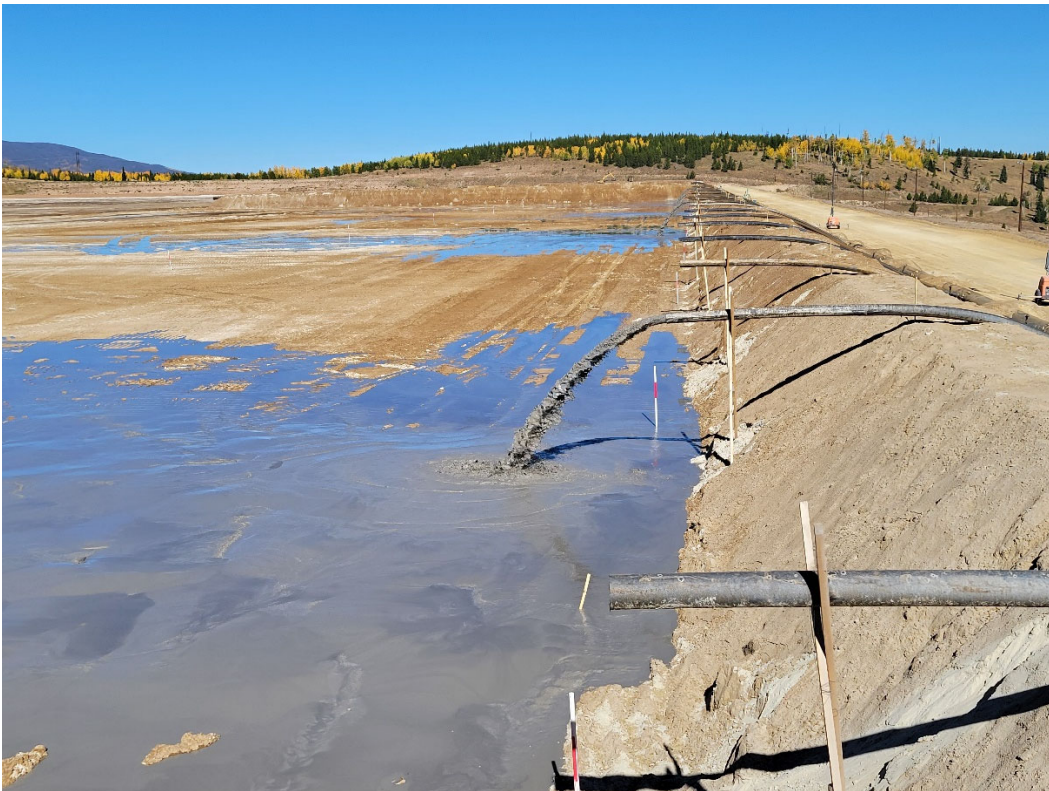
Photo 8: North end of 1-Dam. Looking north at tailings deposition starting within Cell 7.

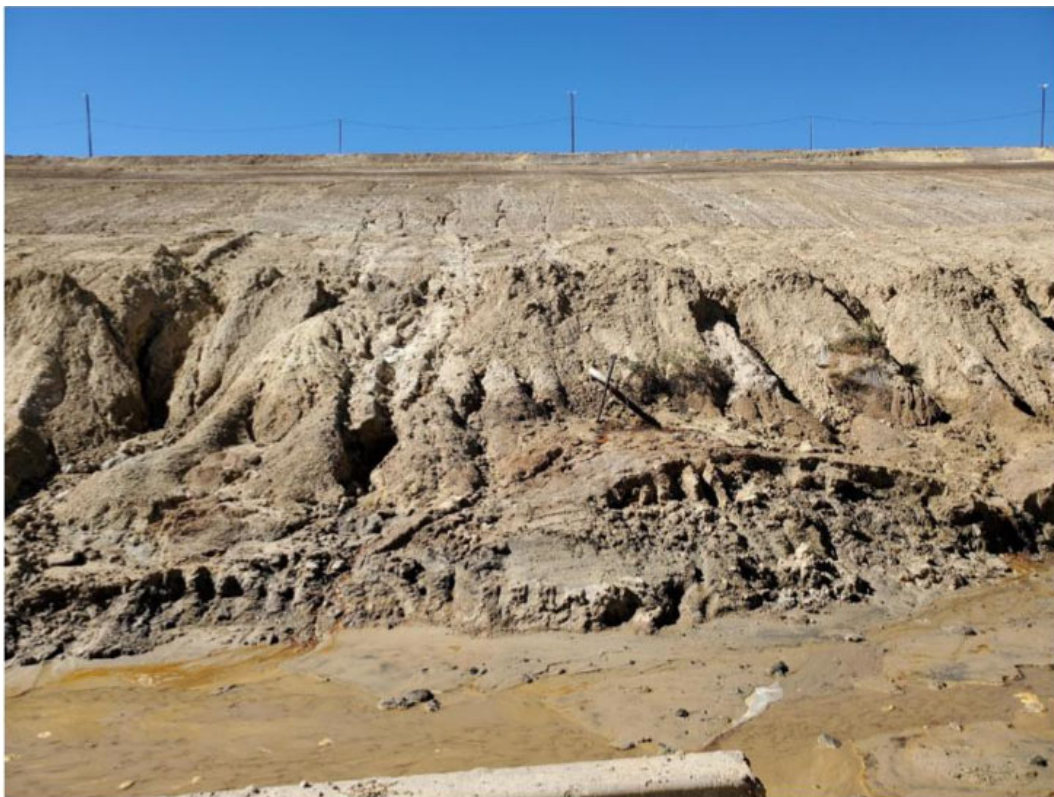
The following aspects of the dams were observed during the inspection: dam crests, downstream faces, toes, abutments, starter dams, and buttress. No settlement, cracking, or signs of movement were observed. No ponds were observed on the crest road. Some rills were observed on the faces of the dams. They did not appear to be more than maintenance issues but should be addressed in the fall of 2024. In particular, erosion on the buttress needs to be addressed soon. Some seepage was observed near the toe of 1-Dam but did not appear to be problematic as the horizontal drains were operating nearby. Also, this seepage has been noted during past inspections by Division inspectors. Mr. Hamarat indicated that they typically conduct erosion control repair work across both dams in the fall.

Photo 13: Looking at erosion rills along the eastern slope of 1-Dam. Attached map indicates location.

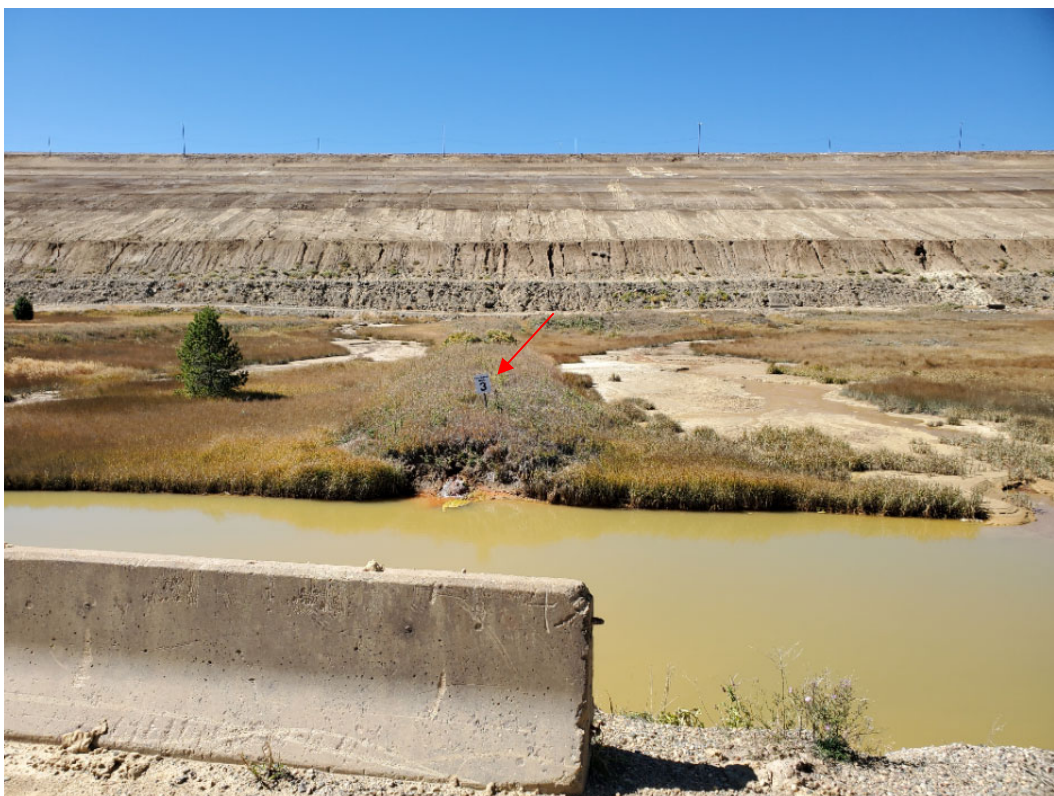
Some of the foundation drains were flowing (e.g., #3) and some were not (e.g., #2). Mr. Hamarat indicated that these drains are not cleaned because they are fragile and nearing the end of their life. A French drain system has been constructed at the south end of 1 Dam where it abuts the natural ground. This structure appeared to be functioning.

Photo 14: Looking at 1-Dam from the Ute Park collection area. Seepage channel in the foreground. Erosion rills observed along the base of the dam. Berm indicated by red arrow is the location of the foundation drain #3 as indicated by sign.

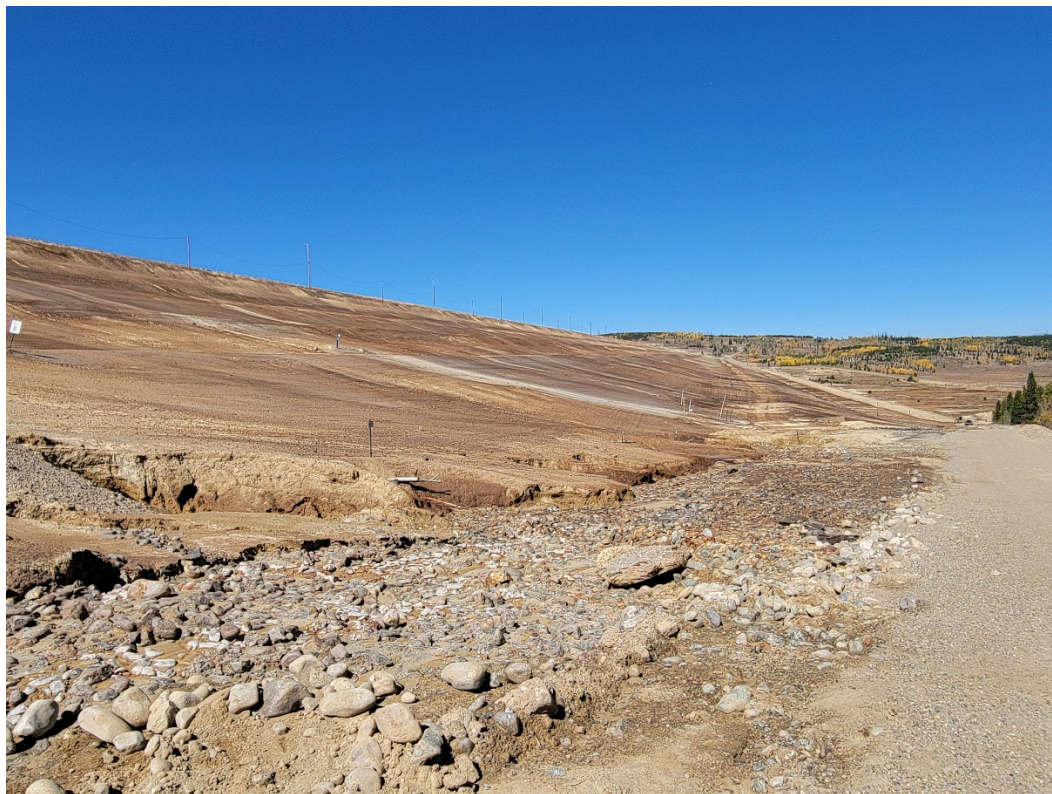
Photo 16: Looking north from the south end of 1-Dam, erosion rills on the dam recently repaired in this area. Erosion at base is being addressed by the installation of the adjacent French drain.

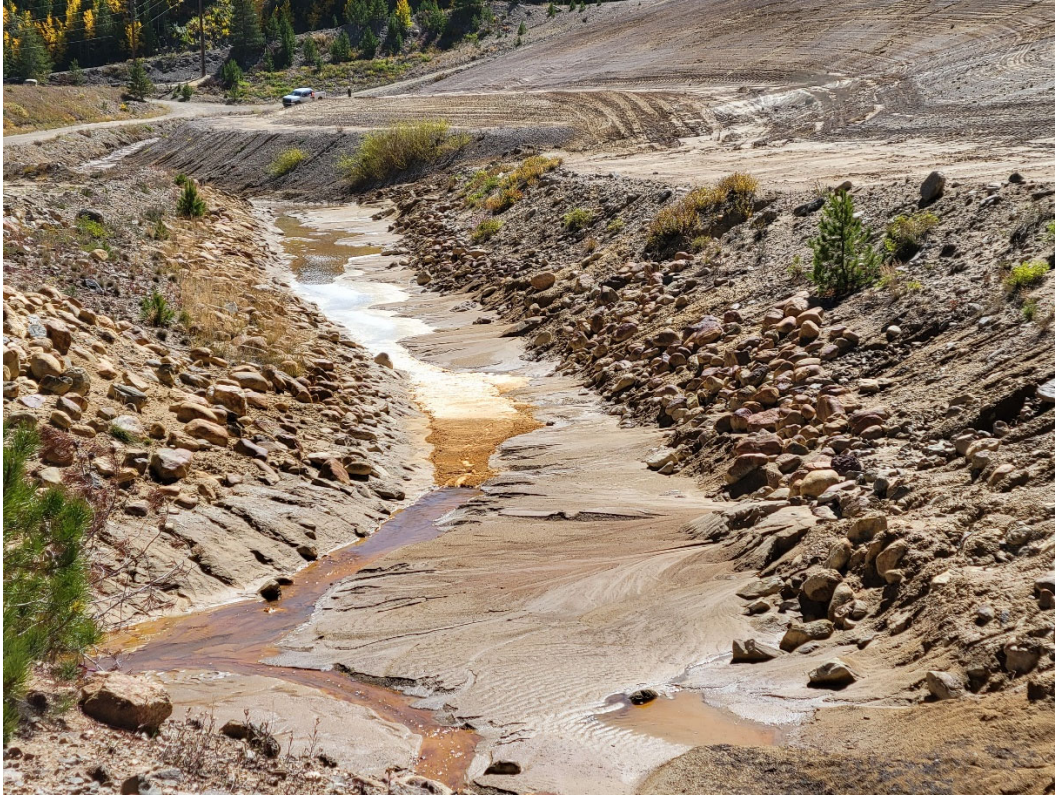
Photo 19: Seepage collection canal below 3-Dam. Attached map indicates location.

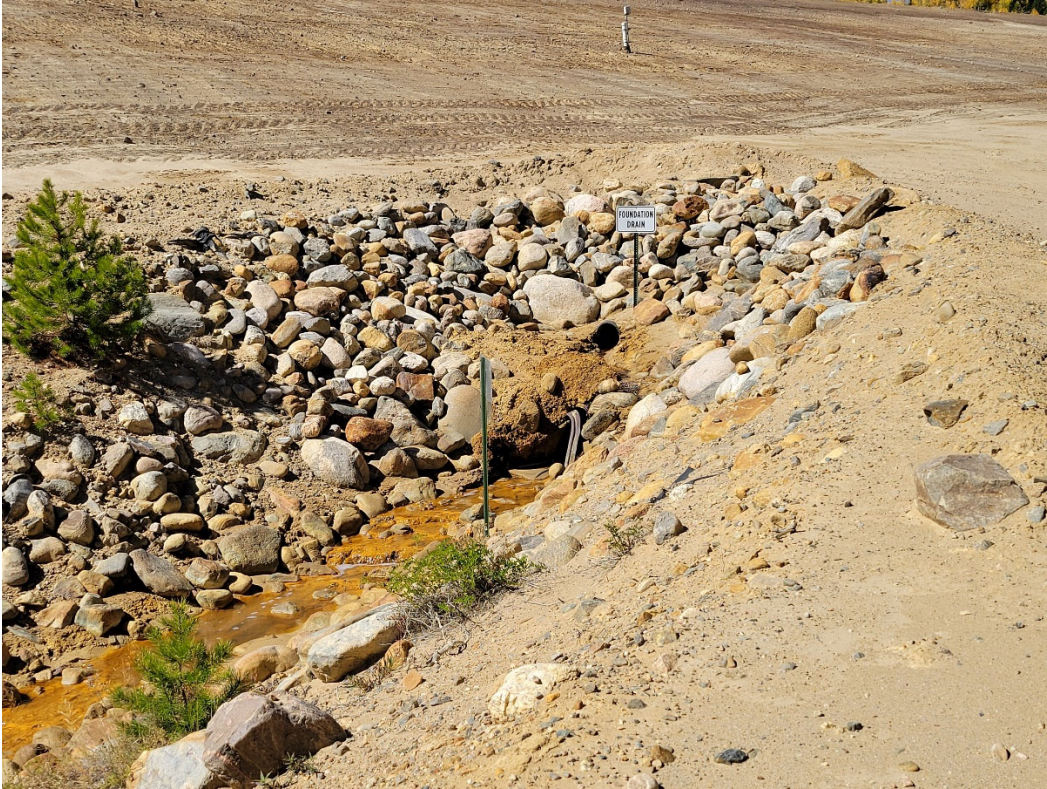
Photo 21: Foundation drain discharge below 3-Dam.

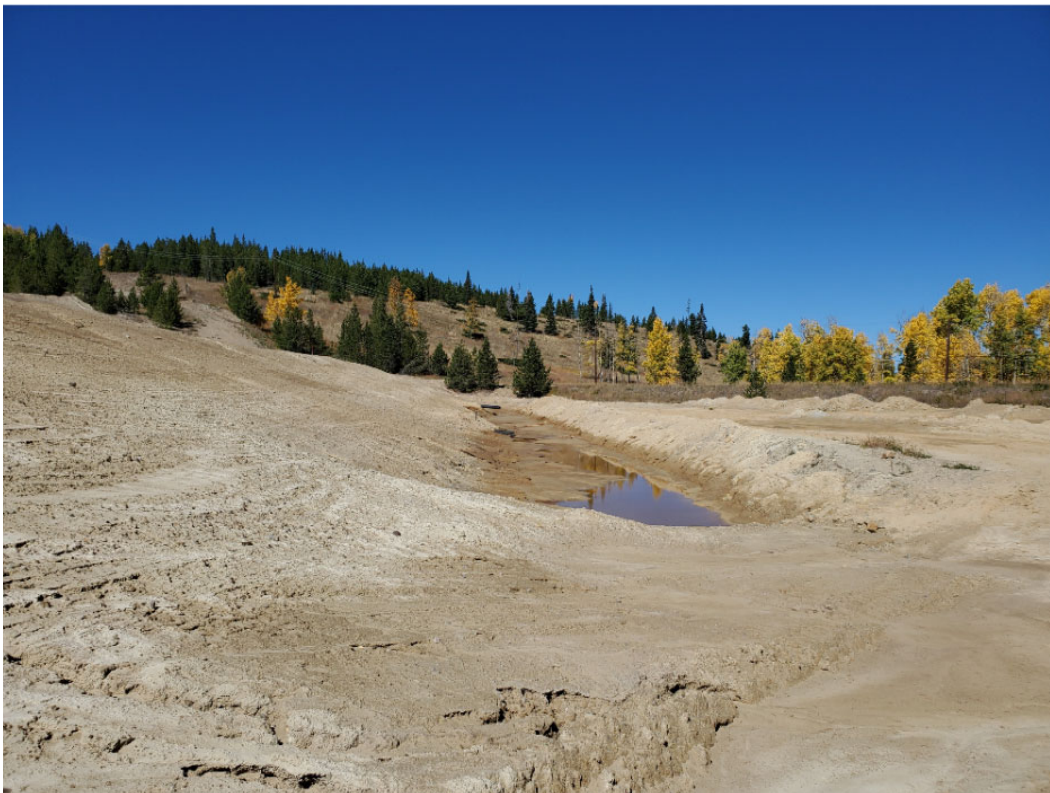
Photo 22: Seepage collection canal on the constructed south buttress below 3-Dam.
