Bowie #2 inspection report

Permit Number: C-1996-083 Mine Name: Bowie No. 2 Mine Operator: Bowie Resources, LLC Operator Address: Mr. Basil Bear P.O. Box 1488 Paonia, CO 81428	County: Delta Operation Type: Underground Permit Status: Active Ownership: Private
	Operator Representative Present: Basil Bear, Art Etter
Operator Representative Signature: (Field Issuance Only)

Inspection Start Date: October 22, 2024 Inspection Start Time: 09:00 Inspection End Date: October 22, 2024 Inspection End Time: 11:50		Inspection Type: Coal Partial Inspection Inspection Reason: Normal I&E Program Weather: Clear	
Joint Inspection Agency: None		Joint Inspection Contacts: 	
Post Inspection Agency: None		Post Inspection Contacts: 	
Inspector(s): Robert Zuber, P.E.	Inspector's Signature:

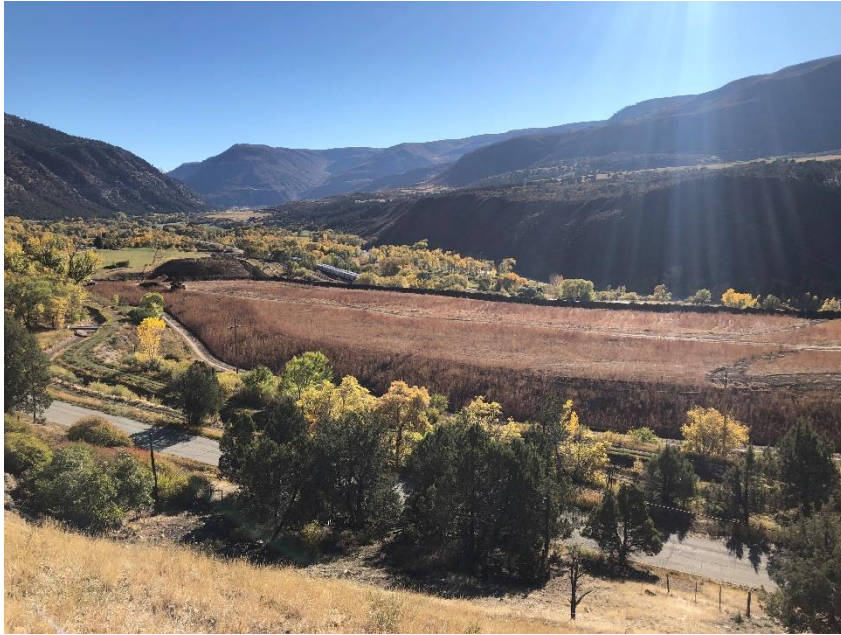
Tribble and Sons was hauling topsoil to the upper portion of Gob Pile #3. Seth Tribble indicated that this project

will require 26,300 cubic yards; this appears accurate per a DRMS calculation. Mr. Tribble also indicated that the pile east of Gob Pile #3 contains 55,000 cubic yards, which also appears reasonable per a DRMS calculation.

East side of Gob Pile #3 with topsoil piles staged around the perimeter of the top

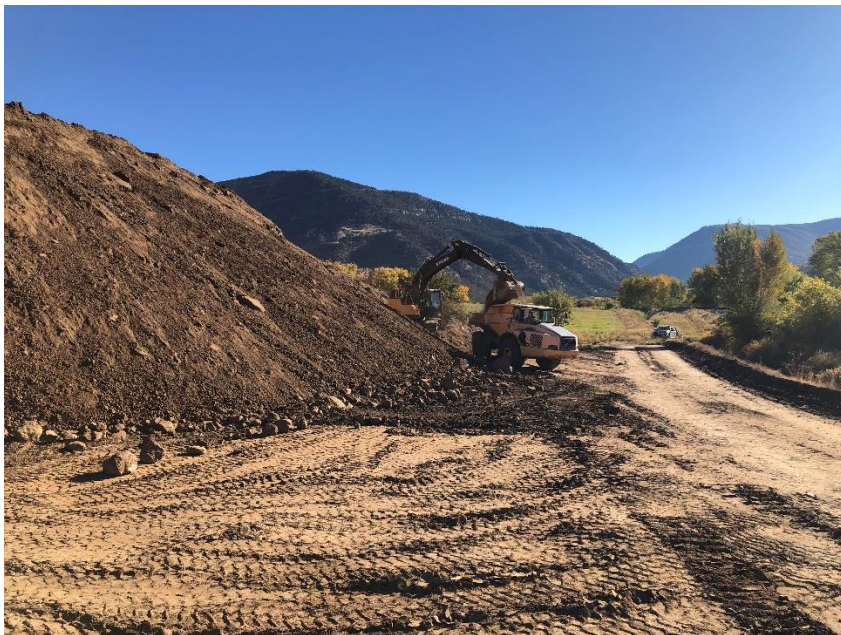
The contractor (Tribble and Sons) was hauling topsoil from the large pile east of Gob Pile #3. This pile has a very steep side where material is being accessed, and BRL should consider measures (e.g., a berm or temporary wattles) to prevent loss of this resource during large precipitation events.

Loading of topsoil for hauling to Gob Pile #3

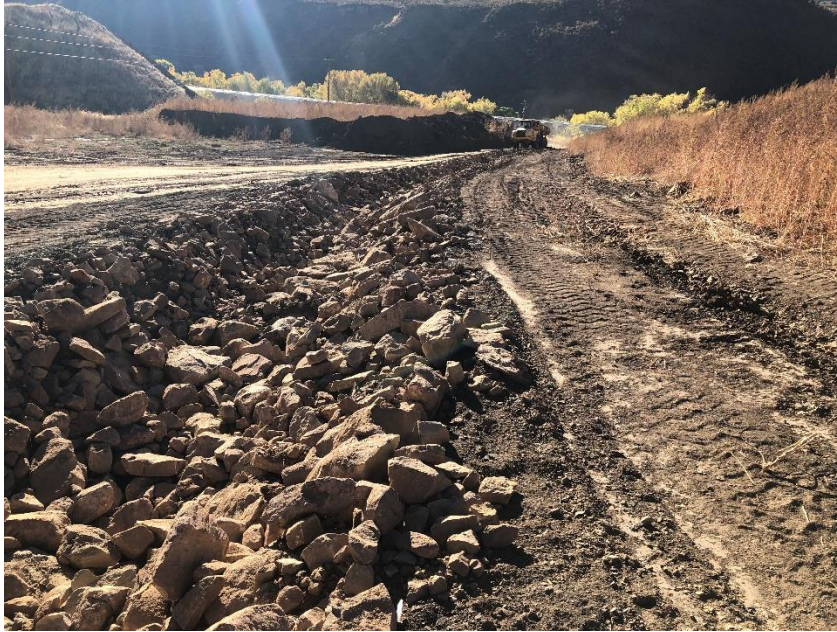
The following dimensions were estimated by DRMS for the newly constructed ditch east of Gob Pile #3 (Ditch D-J11 on PAP maps):

- Top width of 10 feet
- Bottom width of 3 feet
- Depth of 4 feet
- D50 (average diameter) riprap of 12 to 18 inches
- Side slopes of 2:1

Other observations regarding this structure included the following. The slope is relatively flat, likely in the range of 5 to 10 percent. There is a good gradation of rock, with many smaller rocks “chinked in” to the large rocks. The culvert below it (C-J4) is a 30-inch diameter CMP (corrugated metal), which carries flows from D-J11 to the large ditch below, D-J3.

These observations indicate that the ditch matches the specifications in Appendix B of Volume XI in the PAP (Permit Application Package).

Newly constructed ditch by Gob Pile #3 (D-J11)

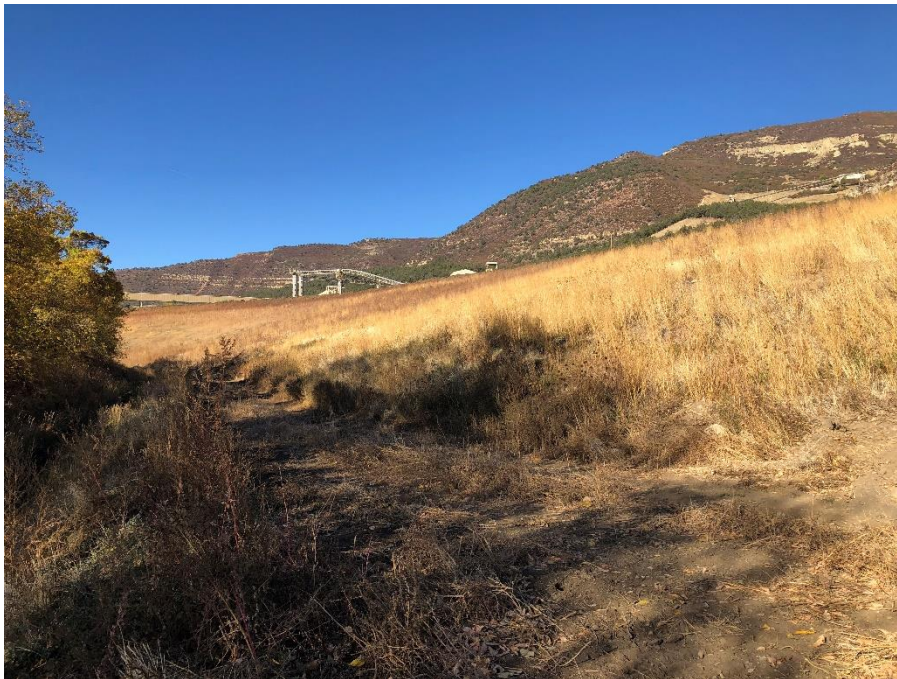
The slope at the southwest corner of Gob Pile #3 was checked with a laser rangefinder, and the slope is 14 degrees. The pile was checked about 50 to 100 feet east of the corner, and the slope is 15 degrees.

Water was not seen in the ditch below Gob Pile #3, but Basil Bear indicated that water was flowing through the underdrain. Apparently, the flow was small, and the water infiltrated before flowing to the east side of Gob Pile #3.

Lower portion of Gob Pile #3

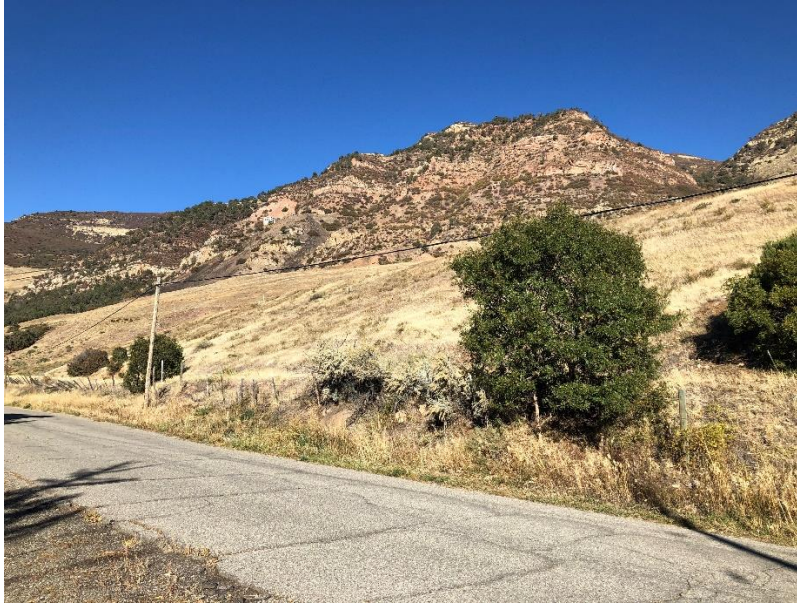
Gob Piles 1, 2, 3, and 4 appeared stable.

Lower portions of Gob Piles 1, 2, and 4

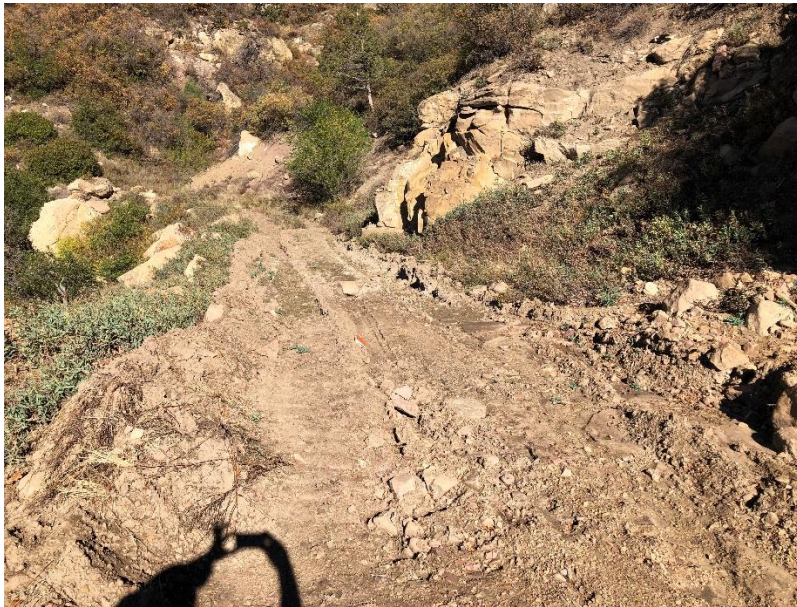
The eastern portion of the large diversion ditch above Gob Pile #2 was inspected. It appears that a portion of this ditch, just east of the large bend, requires some sediment removal. Below this, Ditch D-F4 is in good shape.

Diversion ditch above Gob Pile #2, in need of cleaning

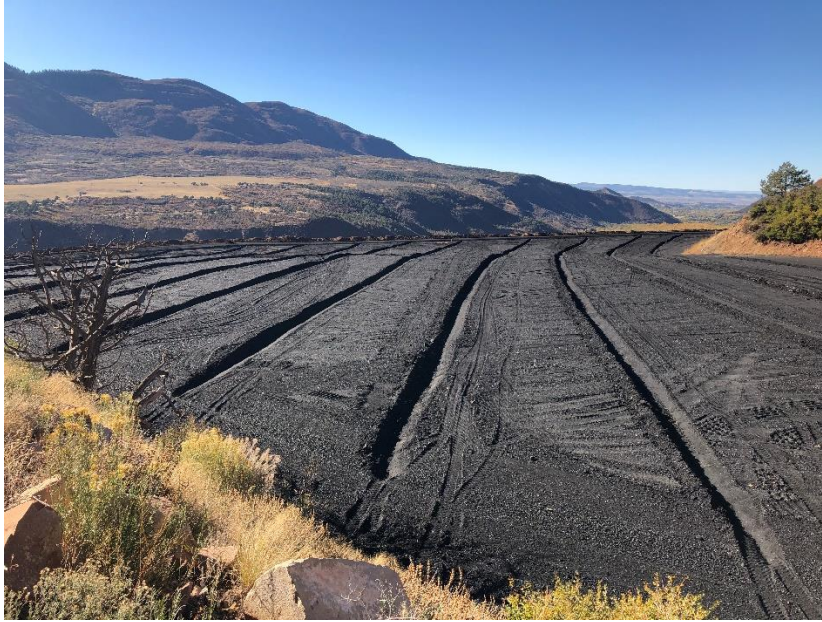
Grading of coverfill on Gob Pile #2 is still in progress on the upper slope. No erosion was identified. BRL staff was using a backhoe to check soil depths. No ponded water was seen on the upper (relatively flat) portion of Gob Pile #2. The sediment control structures where the upper portion of the pile drains to a riprap ditch have been removed. The Division recommends that new BMPs be constructed or installed in this area to reduce the sediment load to Pond F. BRL has dug small ditches on the upper portion of this pile, and these look well-constructed and will likely function for several months.

Ditches on upper level of Gob Pile #2

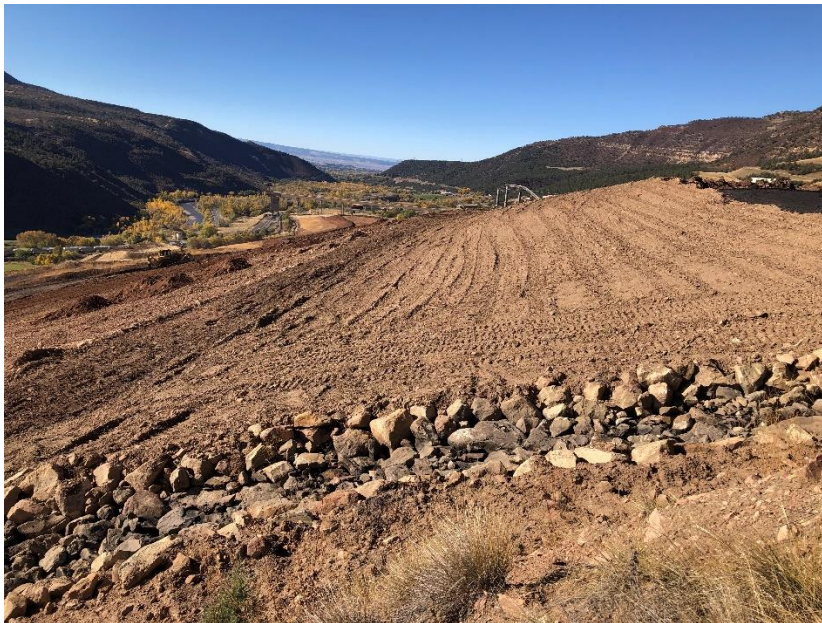
Spreading of coverfill material on slope of Gob Pile #2

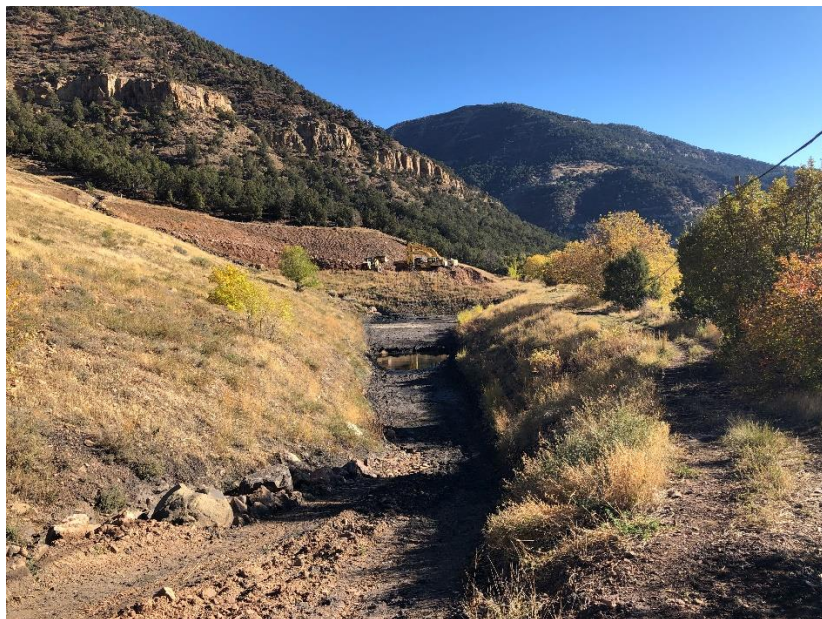
Pond F was inspected. It contained a very small amount of water and was not close to discharging. No problems were identified with the embankment, spillways, inlet channels, or other features of the pond.

Pond F and equipment on soil piles

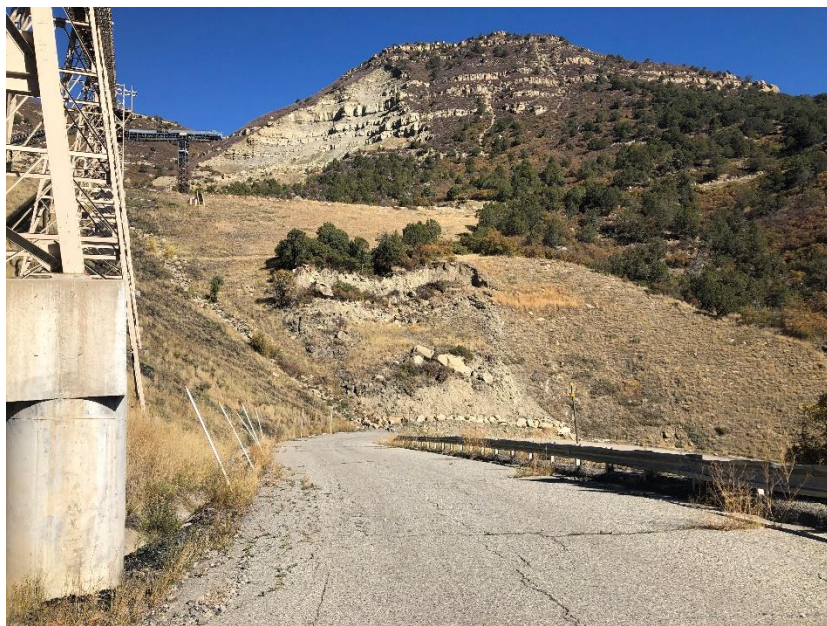
The road to the portals was in adequate condition. The slopes adjacent to this road are generally stable, except for the slide at Curve 10 (see Slides and Other Damage section).

No problems were seen on the slopes above and below the benches. The slides above the B Portal Bench and Curve 11 (noted in the past) look stable. The slide above Curve Number 10 appears to have not moved in recent months. This is an ongoing project for BRL.

Slide at Curve 10
