Bowie #1 inspection report

PERMIT INFORMATION

Permit Number: C-1981-038 Mine Name: Bowie No. 1 Mine Operator: Bowie Resources, LLC Operator Address: Mr. Basil R Bear P.O. Box 1488 Paonia, CO 81428	County: Delta Operation Type: Underground Permit Status: Active Ownership: Private
	Operator Representative Present: None
Operator Representative Signature: (Field Issuance Only)

Inspection Start Date: October 22, 2024 Inspection Start Time: 11:55 Inspection End Date: October 22, 2024 Inspection End Time: 13:40		Inspection Type: Coal Partial Inspection Inspection Reason: Normal I&E Program Weather: Clear	
Joint Inspection Agency: None		Joint Inspection Contacts:	
Post Inspection Agency: None		Post Inspection Contacts:	
Inspector(s): Robert Zuber, P.E.	Inspector's Signature:

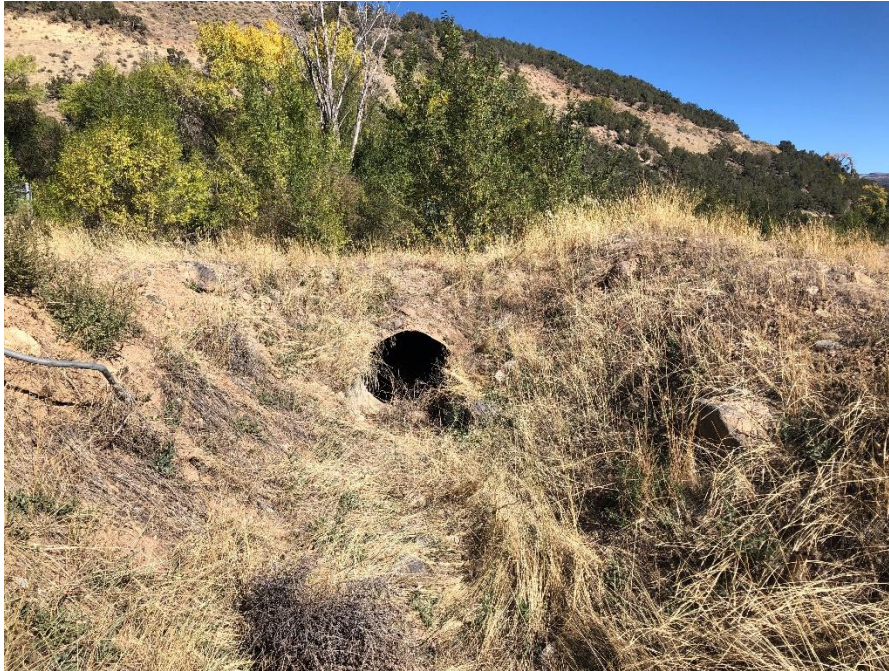
36" culvert at loadout (upstream side)

No problems were identified with culverts, including the large culvert under the loadout and the 36” culvert that is under the road at the loadout. The Farmers Ditch was flowing, and the culvert was approximately half full.

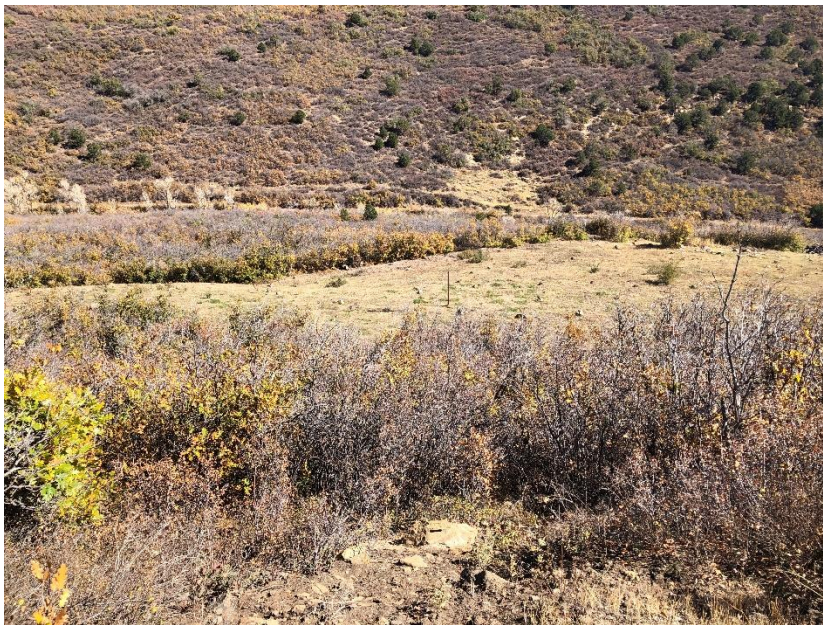
West Mine fan area

No erosion was seen at the West Mine, including the reclaimed road and the fan area. The vegetation cover was good.

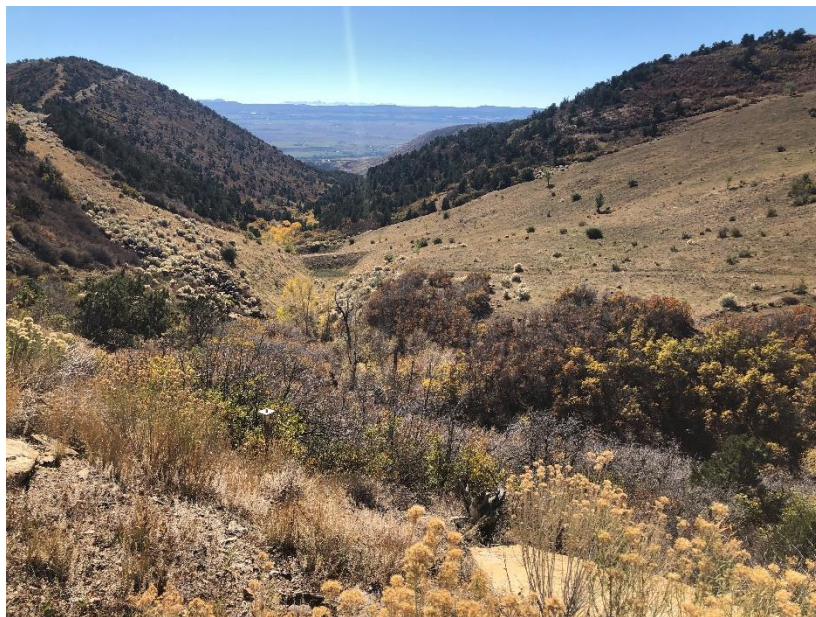
West Mine ponds

The ponds at the loadout, the Coal Storage Area (near Black Bridge Road), and the West Mine contained no water, and no problems were identified with these ponds.

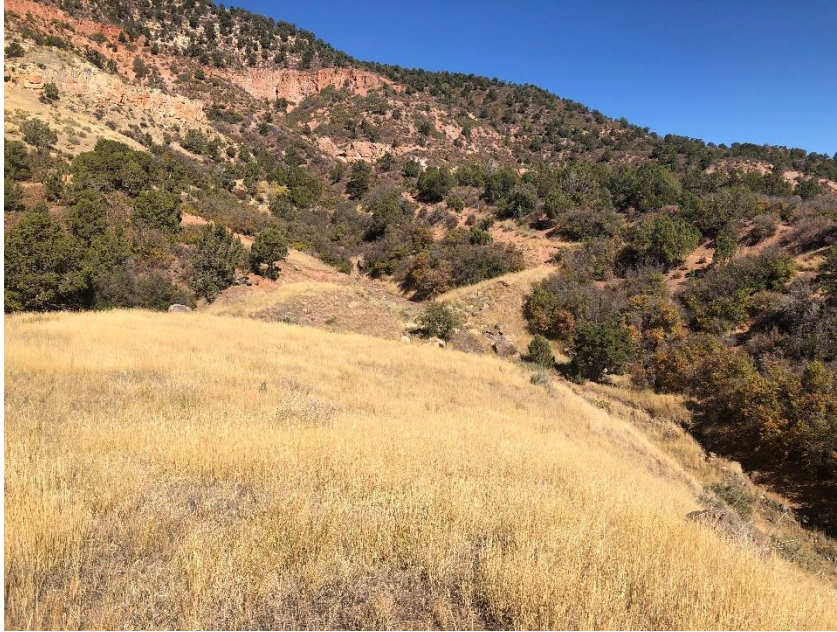
East Mine, looking up drainage at reclaimed Pond 1

No problems were identified with the reclamation in the area of Ponds 1, 2, 3, and 4 (East Mine).
