Keenesburg inspection report

PERMIT INFORMATION

Permit Number: C-1981-028 Mine Name: Keenesburg Strip Mine Operator: Coors Energy Company Operator Address: Mr. Ben Moline P.O. Box 4030 Golden, CO 80402	County: Weld Operation Type: Surface Permit Status: Permanent Cessation Ownership: Private
	Operator Representative Present: None
Operator Representative Signature: (Field Issuance Only)

INSPECTION INFORMATION

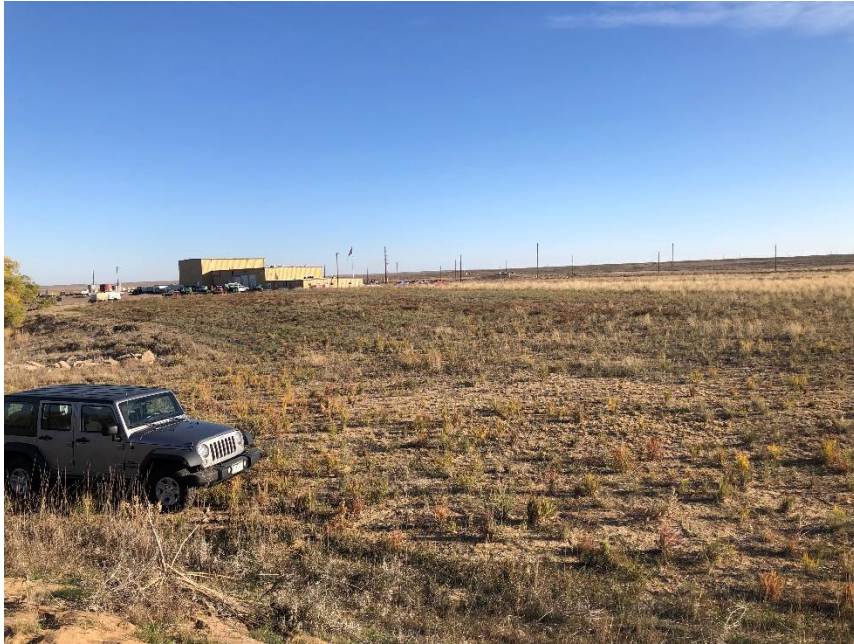
Sediment Pond 2 and the Dugout Pond contained no visible water. In both ponds the bottom is obscured by heavy vegetation. They were not discharging during the inspection. There were no signs that either pond had discharged recently. No problems were observed.

- Area 34 – Vegetation cover is mediocre.
- Area 35 (B Pit) – Vegetation cover is good on the east side.
- Area 36 (Long-Term Spoil Area) – Vegetation cover is mediocre on the east side and better on the west side with large stands of desirable grasses.
- Area 38 – Vegetation cover is mediocre.
- Area 42 – Along the reclaimed road south of Area 25, the vegetation cover is mediocre.
- Area 43 - Vegetation cover is good.

Area 38 and southeast corner of the Dugout Pond

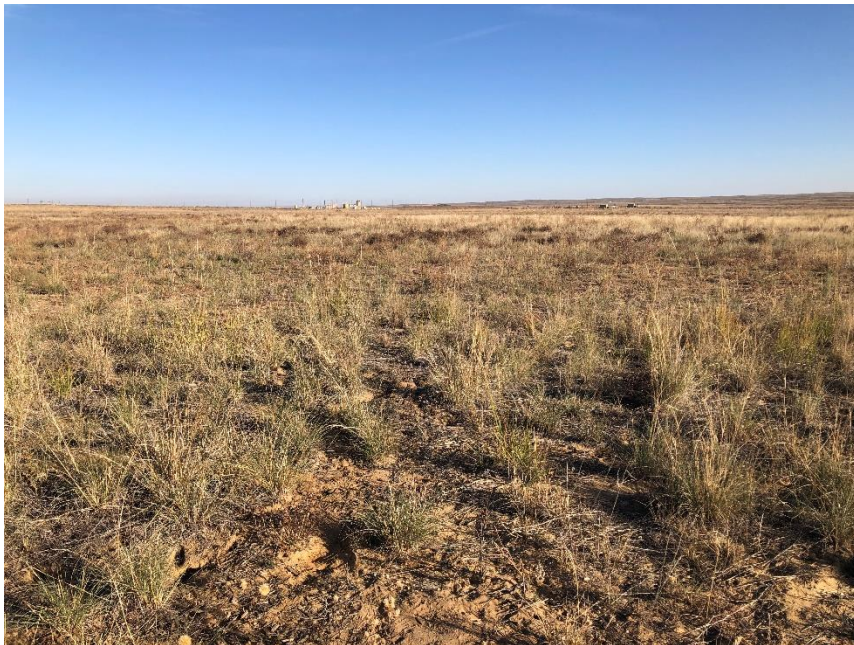
Area 36, west side

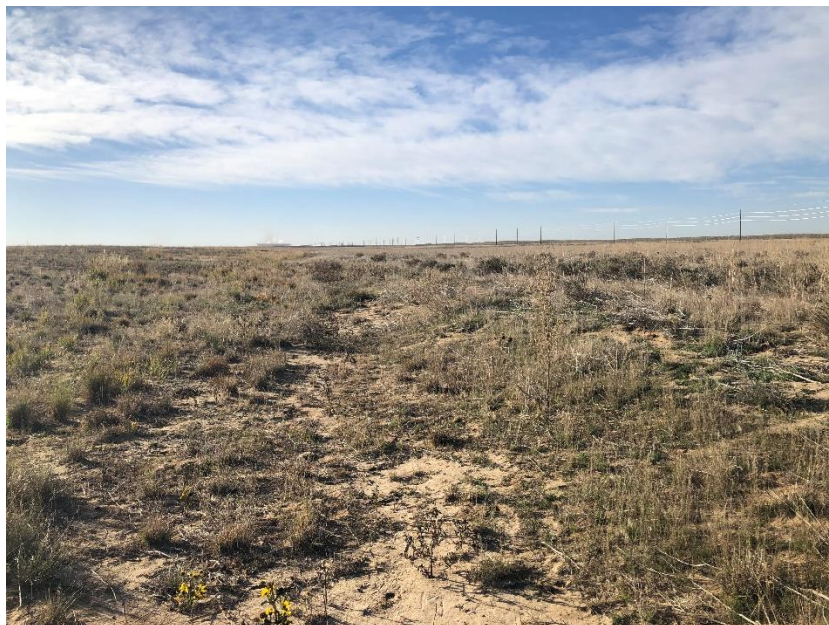
West side of site, looking south at Area 44

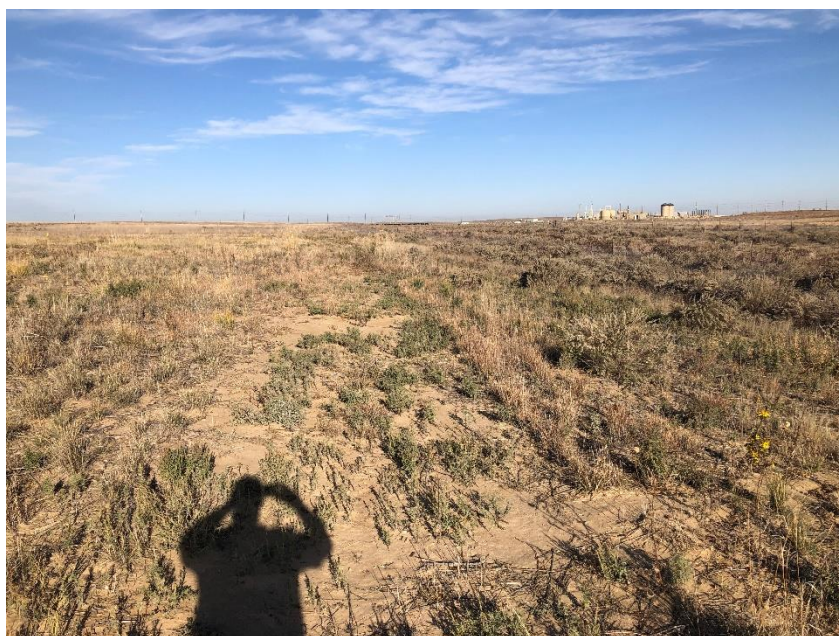
The northern boundary of the site (the down gradient side) was observed, and no signs of pollutant loading from the mine site, or any other problems, were seen. All other sides were also observed, and no problems were seen.

North side of site, looking northeast from Area 37
