TRAPPER MINING INC.  
CRAIG, COLORADO

HORSE GULCH FILL  
QUARTERLY FILL CERTIFICATION

# Horse Gulch Fill Quarterly Inspection Report

Fourth Quarter 2024

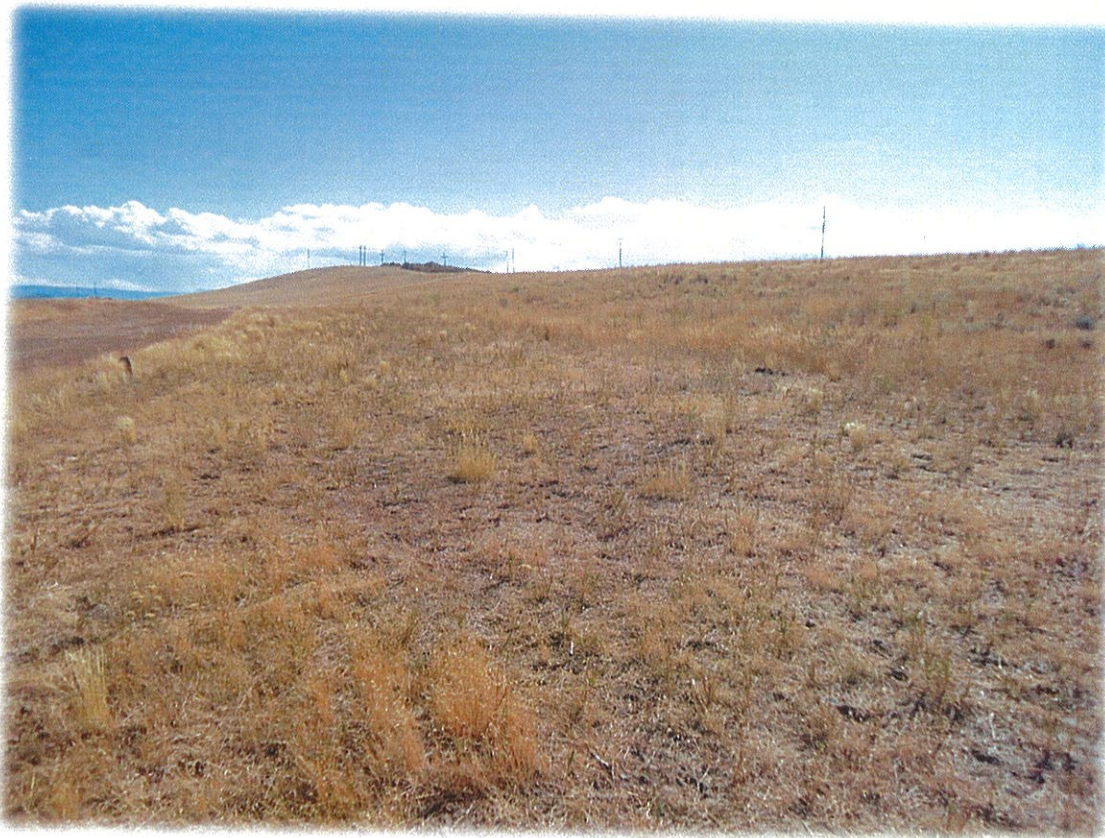
No appearances of instability, structural weakness, or other hazardous conditions were observed. Both the southeast side of the fill and the northeast side of the fill were inspected this quarter (Photographs 1 and 2). The area where cracks were detected on the top south portion of the dump during the first quarter of 2013 inspection was checked. There was no additional cracking found.

Photograph 1: North-east Side Looking South (10/15/2024)

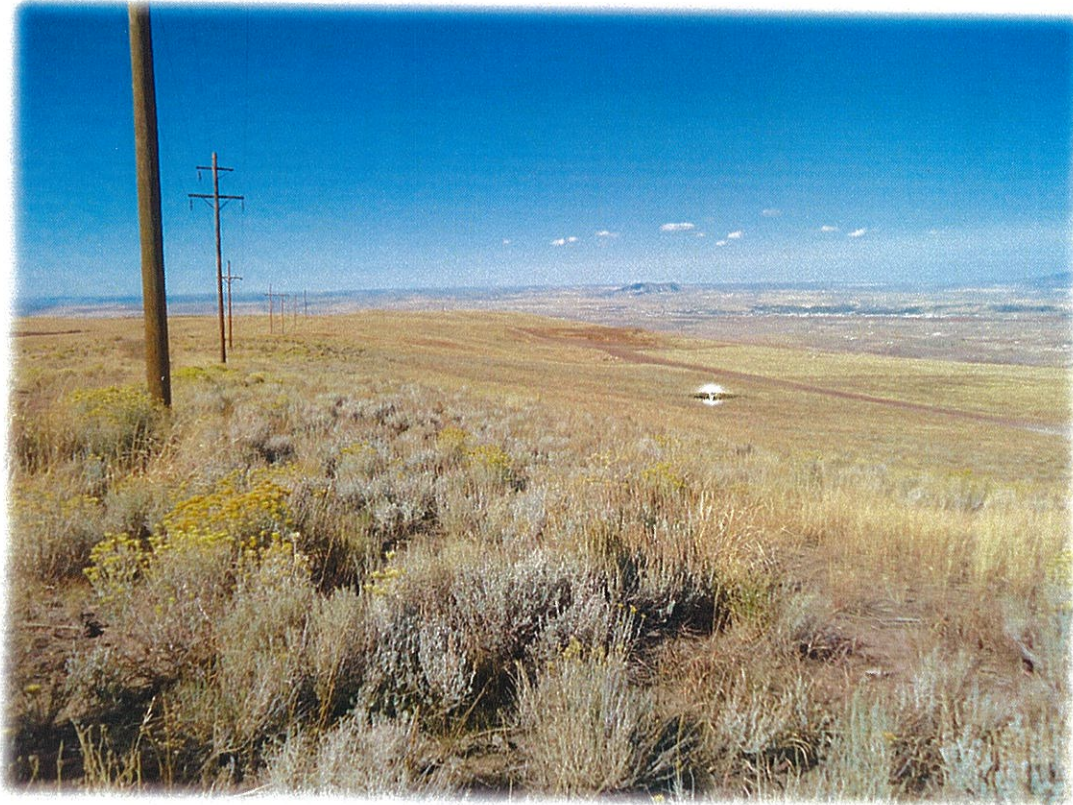
*Photograph 2: South Side Looking North (10/15/2024)*

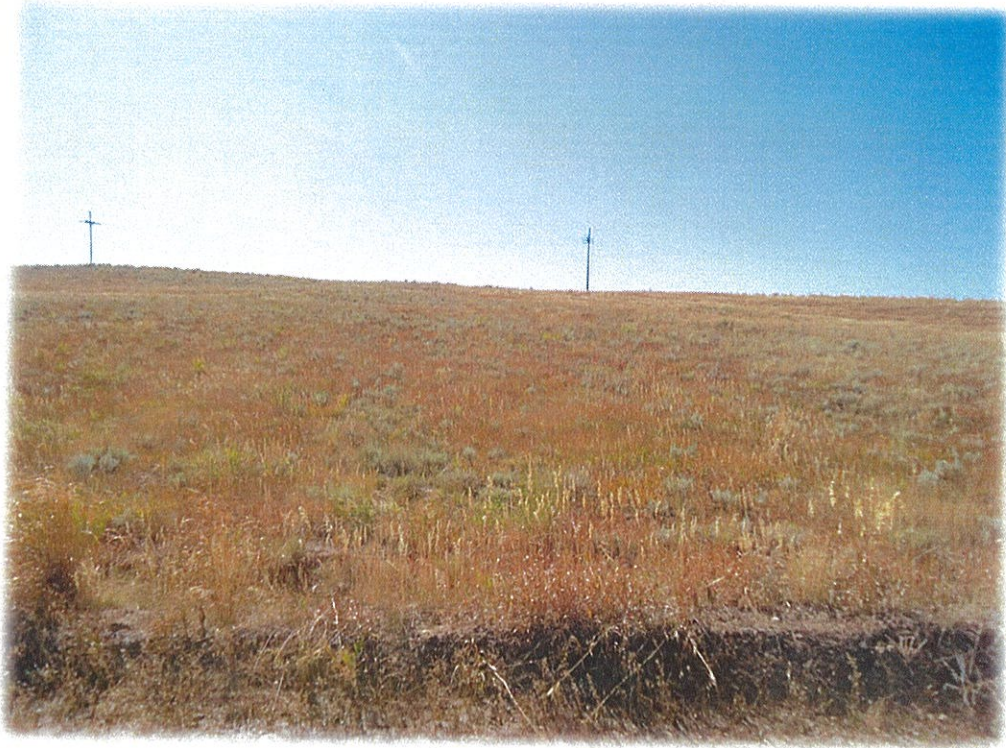
Photograph 3 depicts the east facing slope of the fill.

*Photograph 3: East Side of the Fill Looking West (10/15/2024)*
