MINERALS PROGRAM INSPECTION REPORT
PHONE: (303) 866-3567

MINE NAME: Bradford Mesa Quarry	MINE/PROSPECTING ID#: M-2019-046	MINERAL: Diabase/basalt	COUNTY: Huerfano
INSPECTION TYPE: Monitoring	WEATHER: Clear	INSP. DATE: October 22, 2024	INSP. TIME: 11:30
OPERATOR: Southway Construction Company, Inc.	OPERATOR REPRESENTATIVE: Paul Bottini	TYPE OF OPERATION: 112c - Construction Regular Operation	
REASON FOR INSPECTION: Normal I&E Program	BOND CALCULATION TYPE: Partial Bond	BOND AMOUNT: \$534,185.00	
DATE OF COMPLAINT: NA	POST INSP. CONTACTS: None	JOINT INSP. AGENCY: None	
INSPECTOR(S): Amber M. Gibson	INSPECTOR'S SIGNATURE:

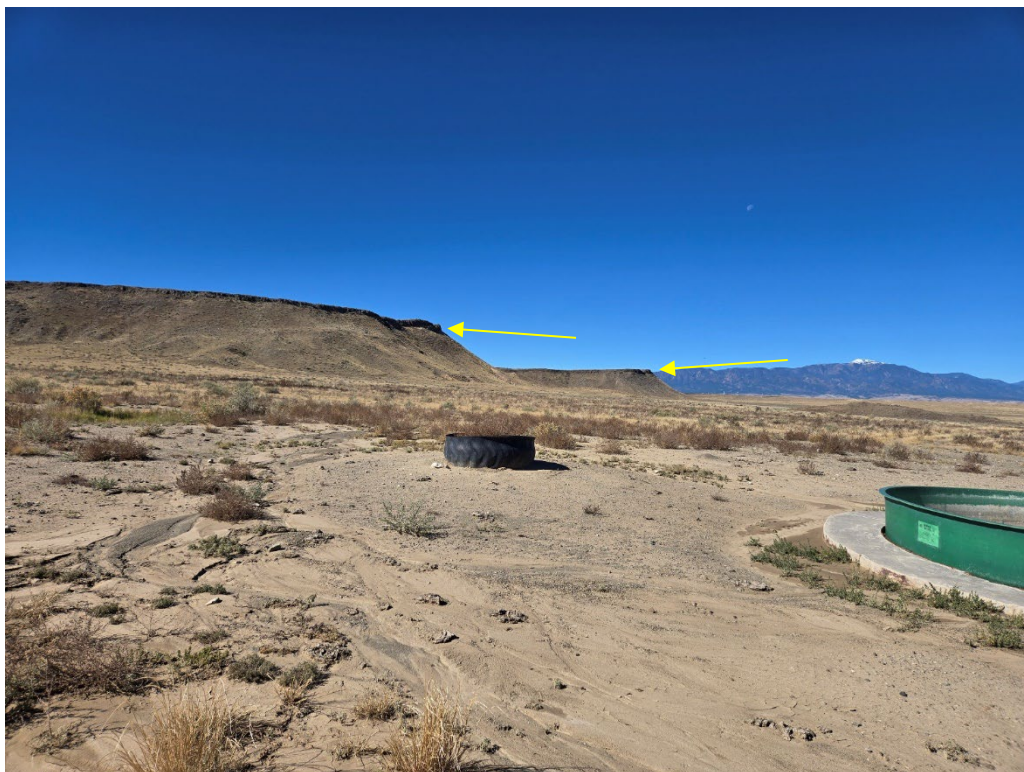
The Bradford Mesa Quarry is located in Huerfano County approximately 7 miles northwest of Walsenburg, Colorado. The entrance to the 1190.2 acre permit area is via County Road 120 approximately 6.9 miles from the intersection of County Road 120 and State Highway 10. The area where the proposed mining activity will occur is at the end of the 3.2 mile haul road leading to the mesa. The site is permitted as a 112c Construction Materials Reclamation Permit with a maximum allowed disturbance of 100 acres. The primary commodity to be mined at the site is a diabase sill, located throughout the Bradford Mesa (Photo 1). Both the pre-mining and post-mining land use is rangeland.

Photo 1: Looking west from the haul road at the north side of the mesas. The diabase sill can be seen outcropping along the top of the mesas in this image.

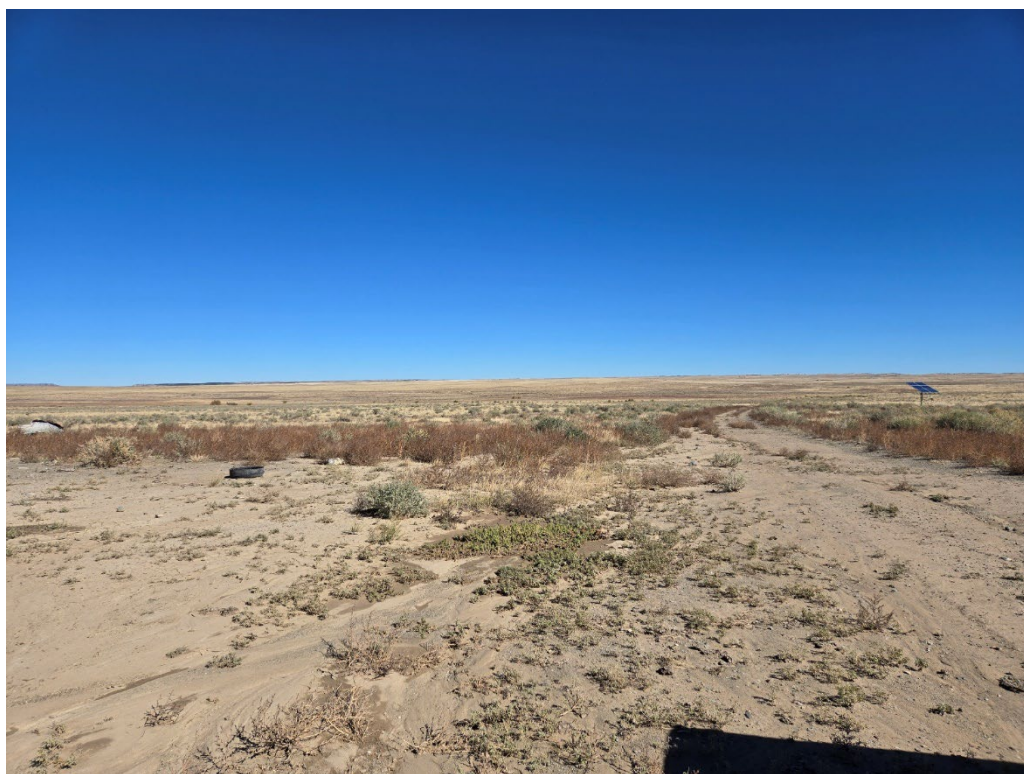
The Operator stated during the inspection that other than the haul road (Photo 2), no disturbance has occurred on site and will not within the near future. The Operator brought the inspector to where the processing area will be established (Photos 3-5), to the future dump location, and atop the mesa to see the Bradford Reservoir located to the northeast of the permit boundary (Photos 6 & 7). Photos were taken and are attached at the end of this report, providing documentation that no disturbance has occurred on the site as of the time of the inspection.

The haul road was bladed but has not yet been graveled. The permit area had received rain in the days leading up to the inspection, and areas of the haul road were somewhat difficult to navigate. However, prior to beginning operations, the Operator stated that the road will be graveled for bringing equipment into and out of the site. A rail spur will be utilized within the permit area as the primary method of hauling material off-site, but the haul road may be used to haul material off for smaller local projects.

Photo 2: Looking north along the access road located on the east side of the permit.

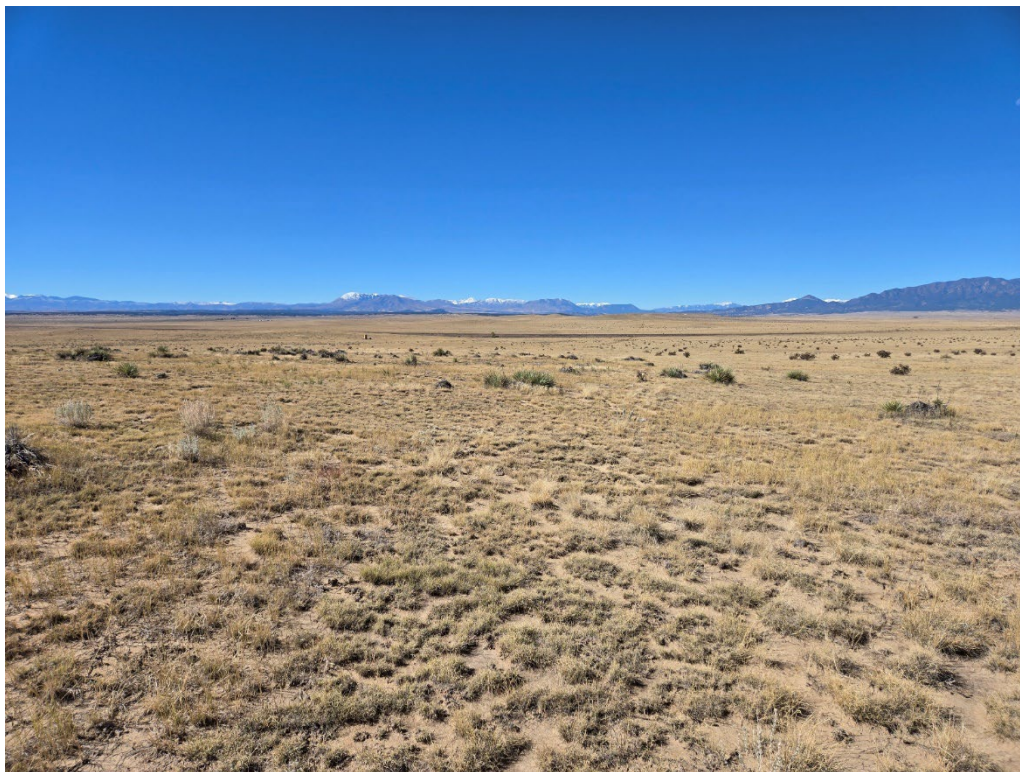
Photo 3: Looking southwest, standing approximately where the processing area will be located.

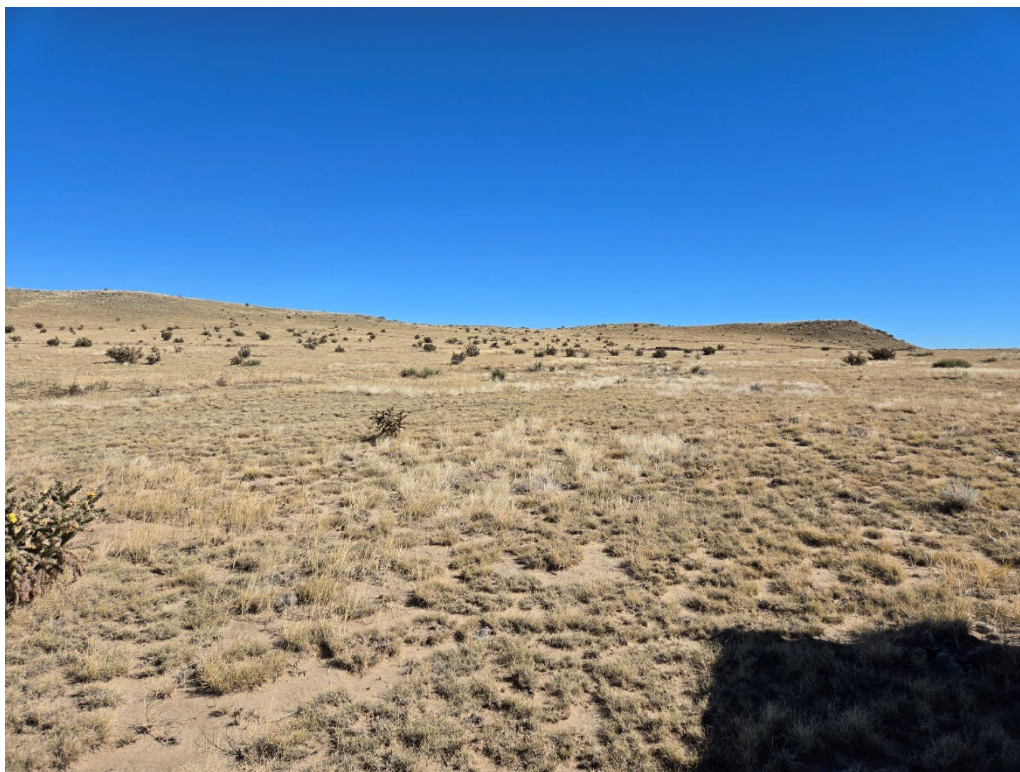
Photo 4: Looking northeast, standing approximately where the processing area will be located.

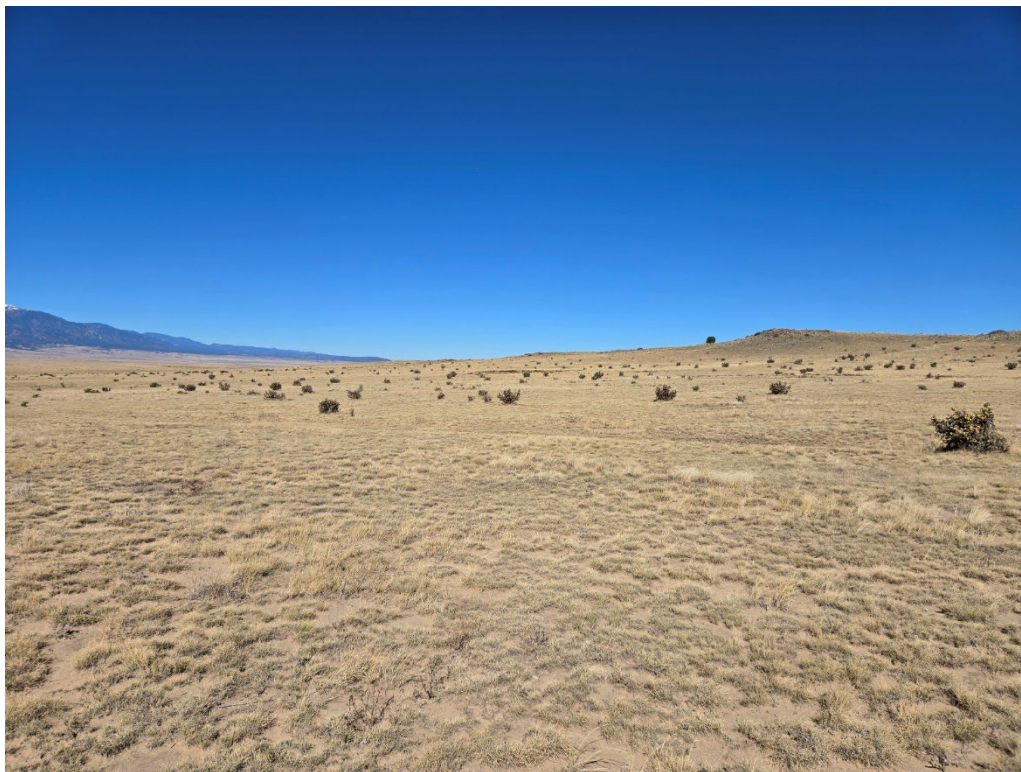
Photo 5: Looking northwest, standing approximately where the processing area will be located.

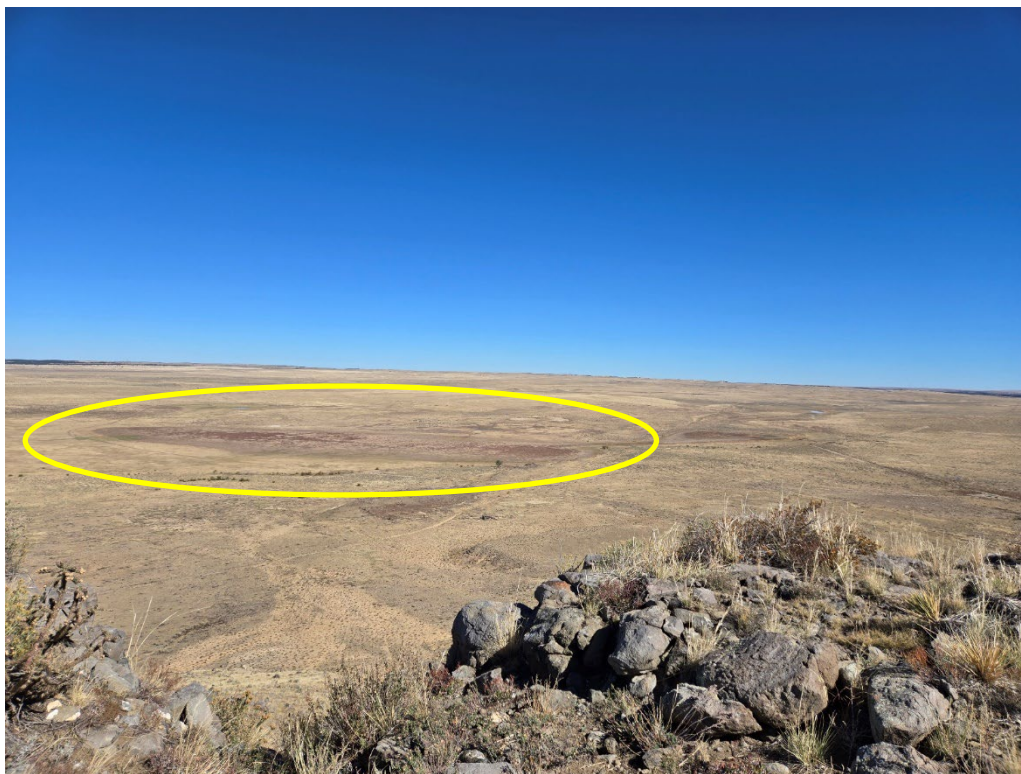
Photo 6: Standing on top of the eastern mesa, looking northeast at the Bradford Reservoir (circled).

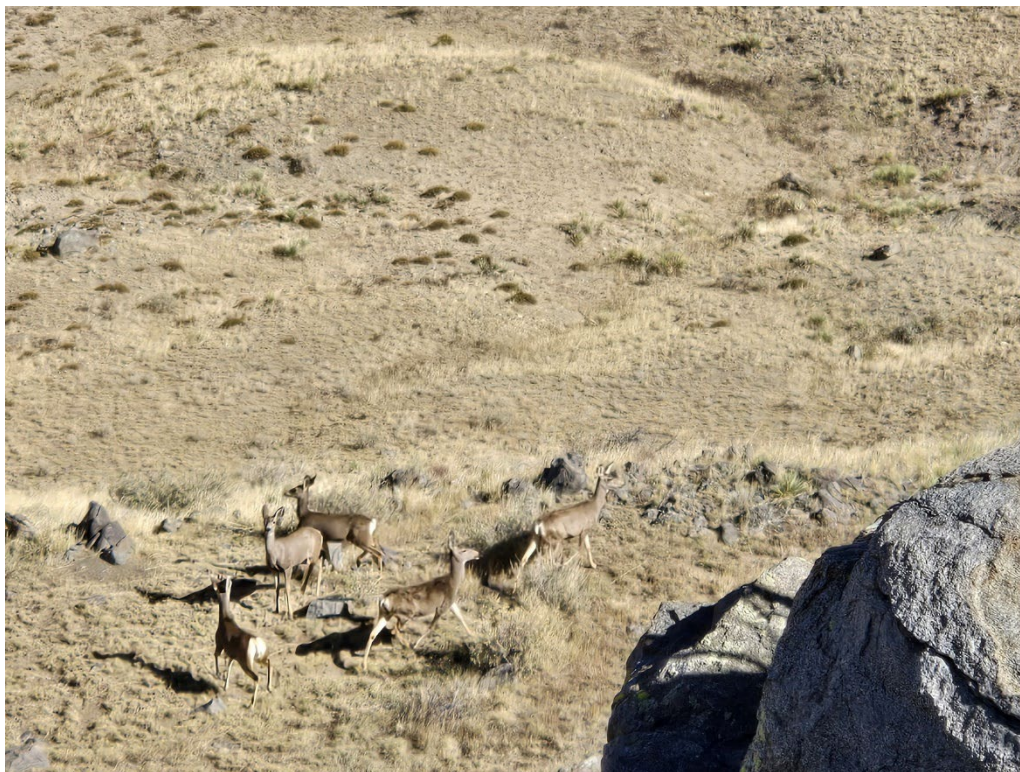
Photo 7: Looking down at some mule deer walking along the mesa during the inspection.

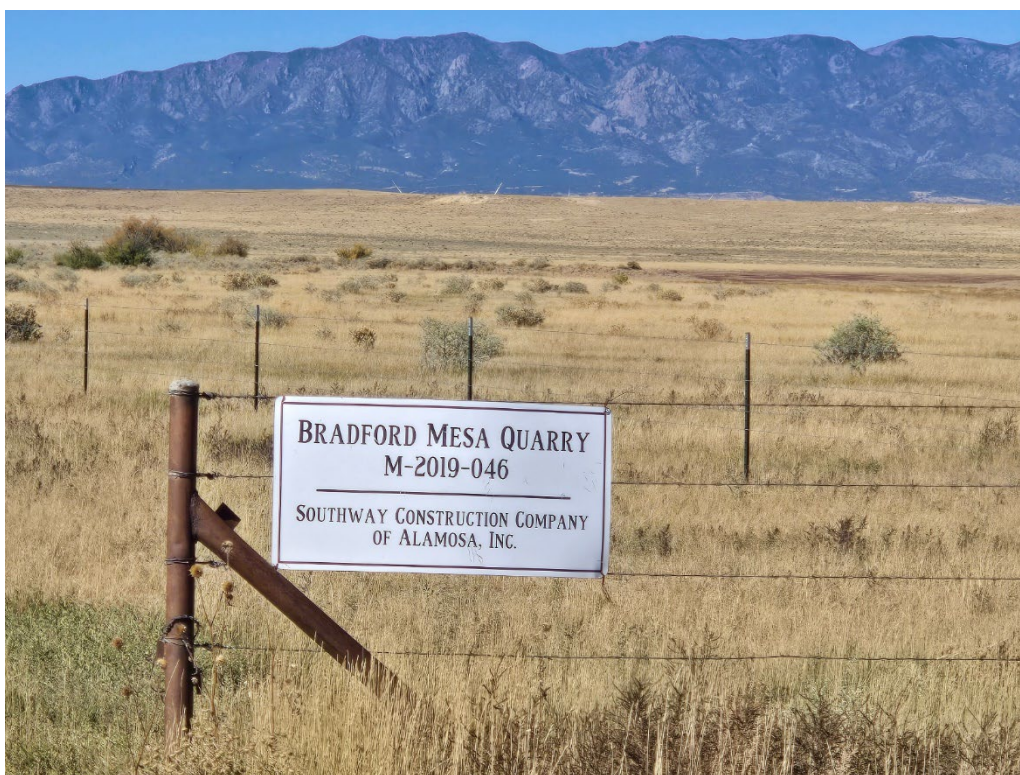
A mine sign was posted in compliance with Rule 3.1.12(1). The sign was located on the gate where the haul road connects to the main permit area (Photo 8). A fence runs along most of the east and south side of the permit boundary. The railroad to the west indicates the approximate location of the western boundary. The actual affected land boundary markers shall be installed prior to any disturbance at the site, per Rule 3.1.12(2).

Photo 8: Looking west at the mine sign located where the haul road enters the main permit area.

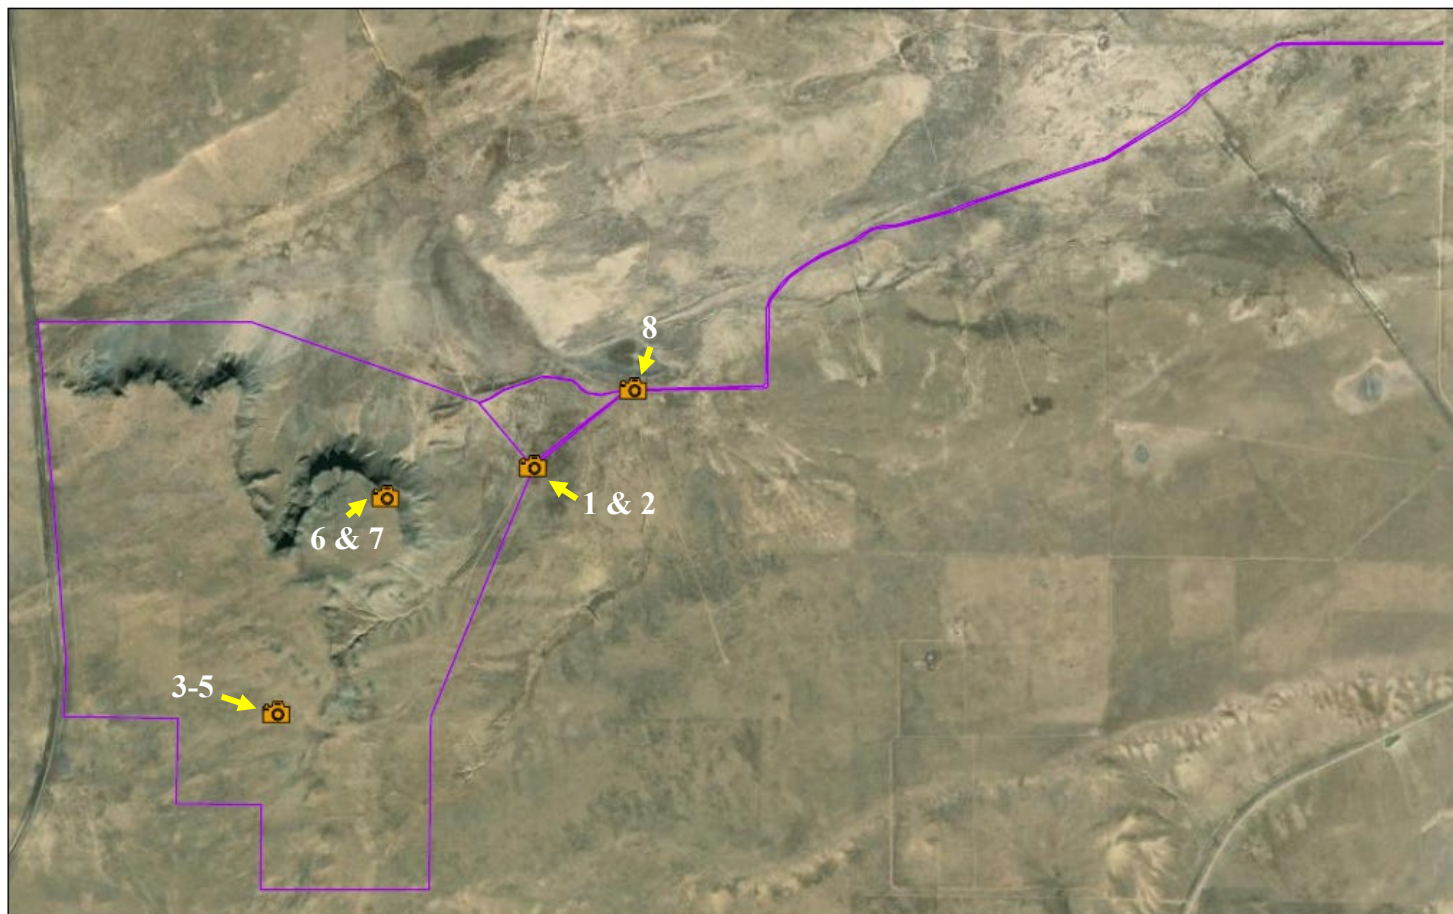
Bradford Mesa Quarry, File No. M-2019-046 2024 Inspection Map

Map 1: Inspection Map generated using ArcGIS Online for the Bradford Mesa Quarry, file no. M-2019-046. The camera icons indicate the locations where photos were taken during the inspection. The numbers correspond with the inspection photo caption numbers within this report.
