Inspection Report, New Elk Coal Mine, C-1981-012

Attached for your records is a copy of the Division's inspection report for the partial inspection conducted at the New Elk Coal Mine on October 23, 2024.

Permit Number: C-1981-012 Mine Name: New Elk Mine Operator: New Elk Coal Company, LLC Operator Address: Mr. John Terry 12250 Highway 12 Weston, CO 81091	County: Las Animas Operation Type: Underground Permit Status: Active Ownership: Private
	Operator Representative Present: None
Operator Representative Signature: (Field Issuance Only)

Inspection Start Date: October 23, 2024 Inspection Start Time: 09:28 Inspection End Date: October 23, 2024 Inspection End Time: 13:28	Inspection Type: Coal Partial Inspection Inspection Reason: Normal I&E Program Weather: Clear
Joint Inspection Agency: None	Joint Inspection Contacts:
Post Inspection Agency: None	Post Inspection Contacts:
Inspector(s): Amber M. Gibson	Inspector's Signature:

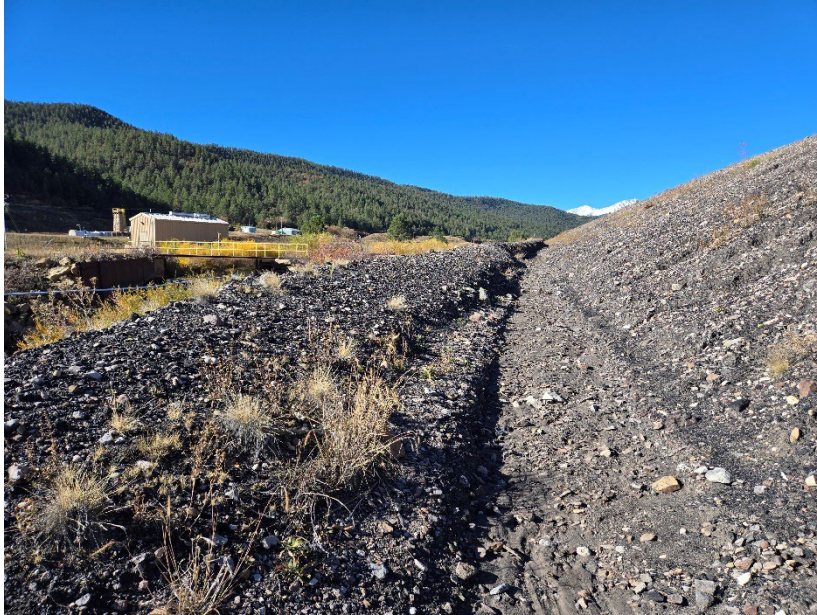
- The Division walked along the berm around the south side of DWDA #2 and along the entirety of Ditch D14 (Photo 1). The berm appeared to be stable and functional, and no apparent structural issues were observed. Also, the D14 was clear of sediment and obstructions.

Photo 1: Looking west along Ditch D14, on the south side of DWDA #2.

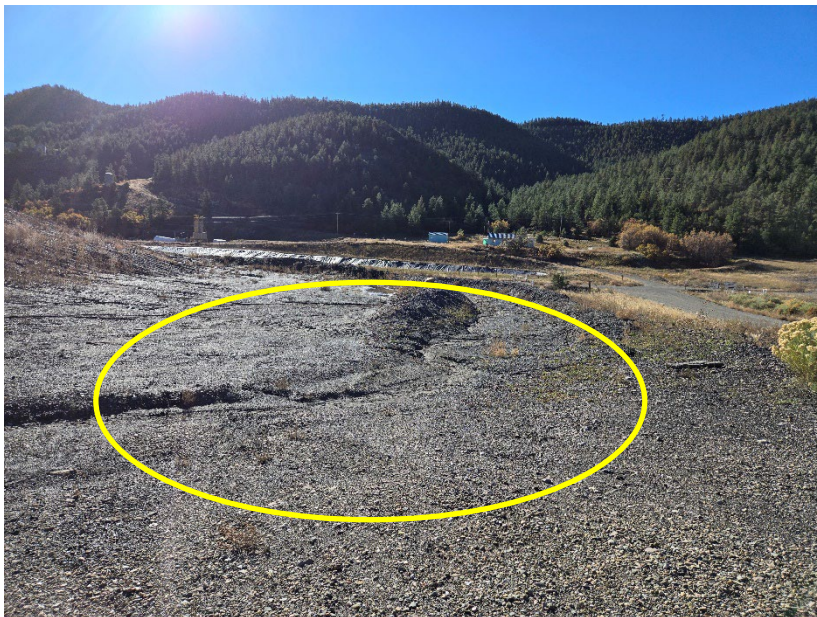
- Where ditches D12 and D14 meet on the west side of DWDA #2, an increased amount of sediment deposition was observed (Photo 2)– likely due to the recent rainfalls. Much of the increased sediment deposition appears to be coming from the pond cleanout-sediment drying area, located on the west side of DWDA #2 (Photo 3). This area where the ditches converge should be monitored and cleaned out within the next year.

Photo 2: Looking south at the northwest corner of DWDA #2, where ditches D12 and D14 join. Circled is where an increased amount of sediment has accumulated.

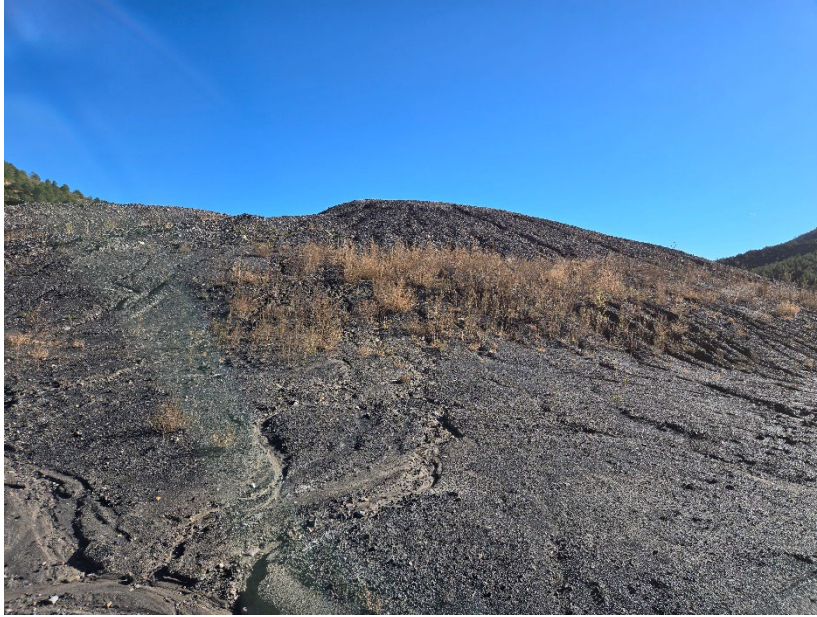
Photo 3: Looking west at the pond-cleanings-sediment-drying area, on the west side of DWDA #2.

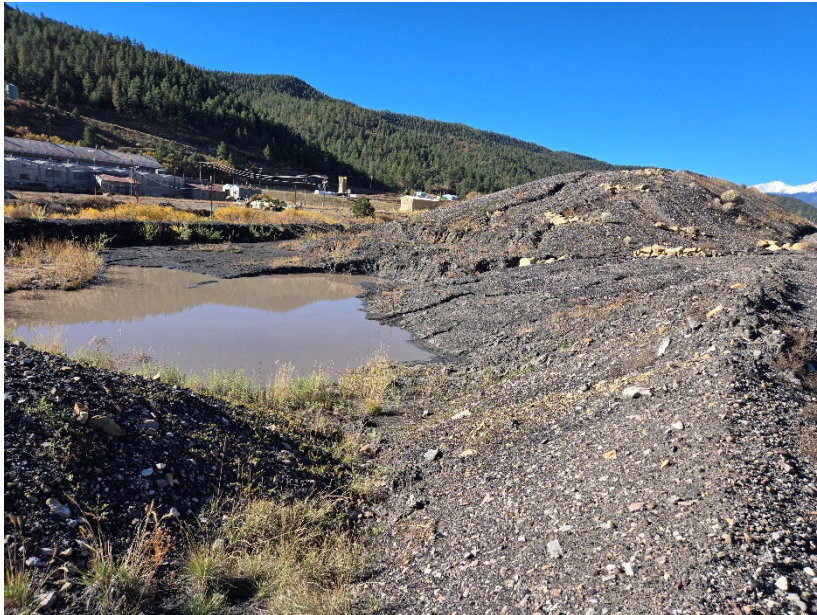
Photo 4: Looking west at the sediment basin on the east side of DWDA #2.

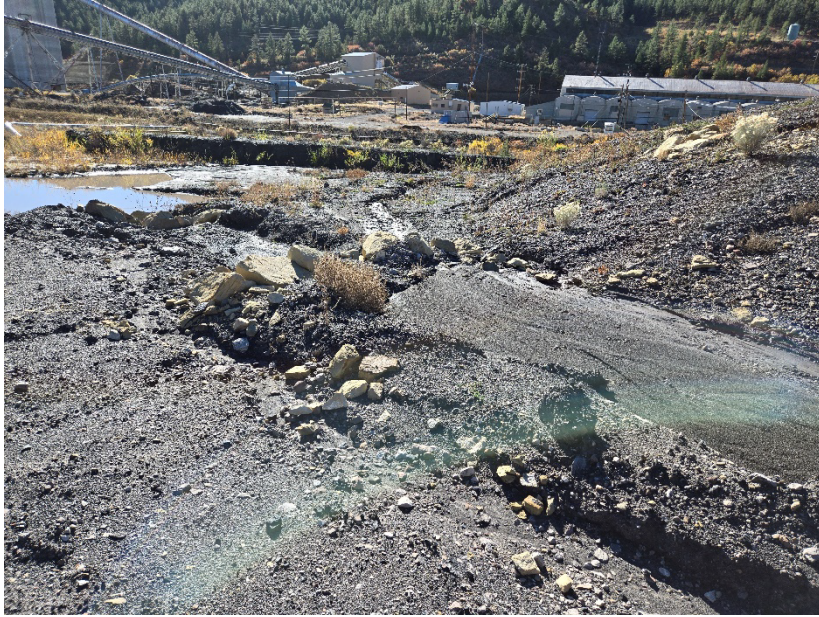
- The sediment basin at the east end of DWDA #2 held water at the time of the inspection (Photo 4). The berm around the basin appeared to be stable. The check dams along the north side of the sediment basin have filled with sediment (Photo 5). **The Operator shall clean the check dams of sediment and ensure that the sediment control structures are functioning appropriately.**

Photo 5: Check dam filled with sediment, north of DWDA #2's sediment basin.

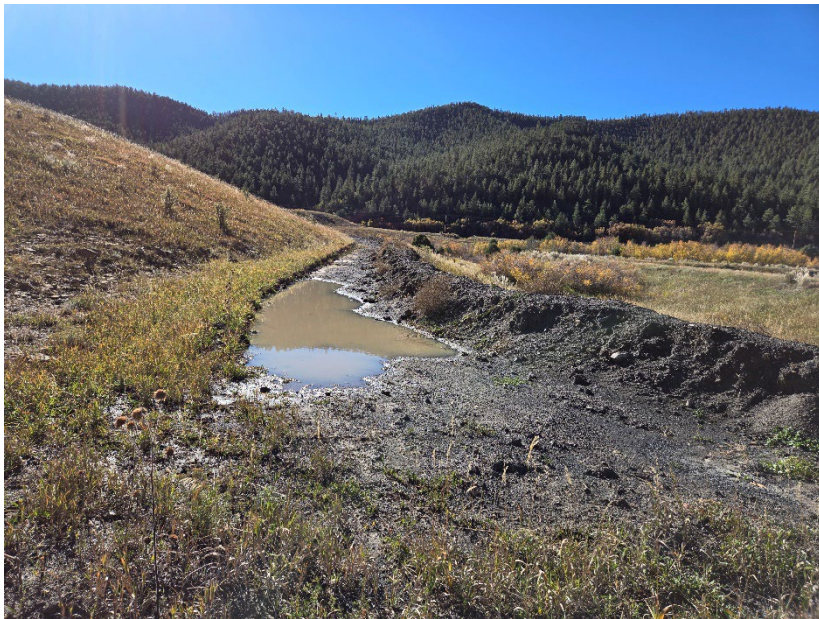
- Culvert C13 was free of obstructions. However, the vegetation in-front of C13 should be cleared before next spring.
- Ditch D3, along the west side of DWDA #1, contained some water at the time of the inspection (Photo 6).

Photo 6: Looking south along ditch D3, on the west side of DWDA #1.

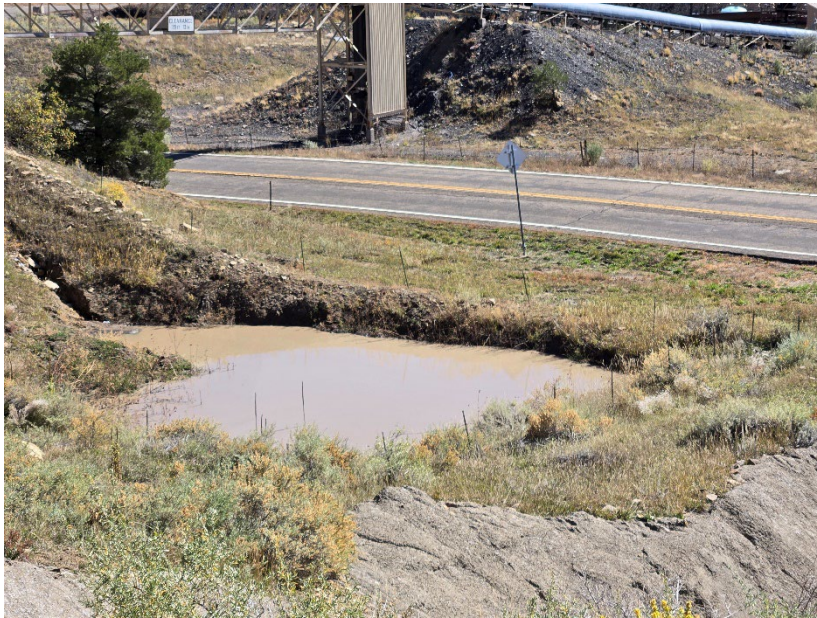
- Containment area #5 contained water at the time of the inspection. **This containment shall be monitored as the water may need to be pumped out if more accumulates before winter (Photo 7).**

Photo 7: Containment area 5 located north of Highway 12.

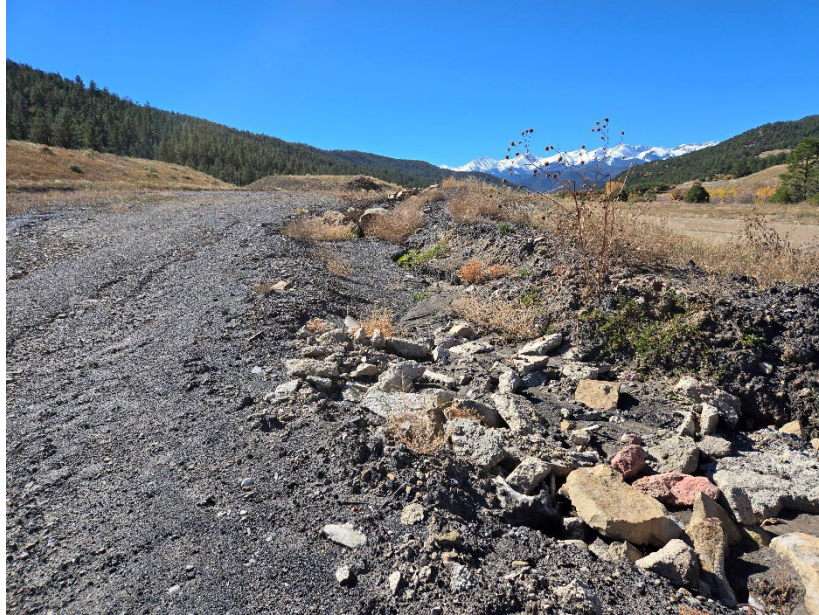
- The check dams located along the north side of the Soil Storage Area have filled with sediment in some areas, and the sides of the check dams have begun to erode (Photo 8). **The Operator shall clean the check dams and stabilize the erosion.**

Photo 8: Check dams filled with sediment along the north side of the Soil Storage Area.

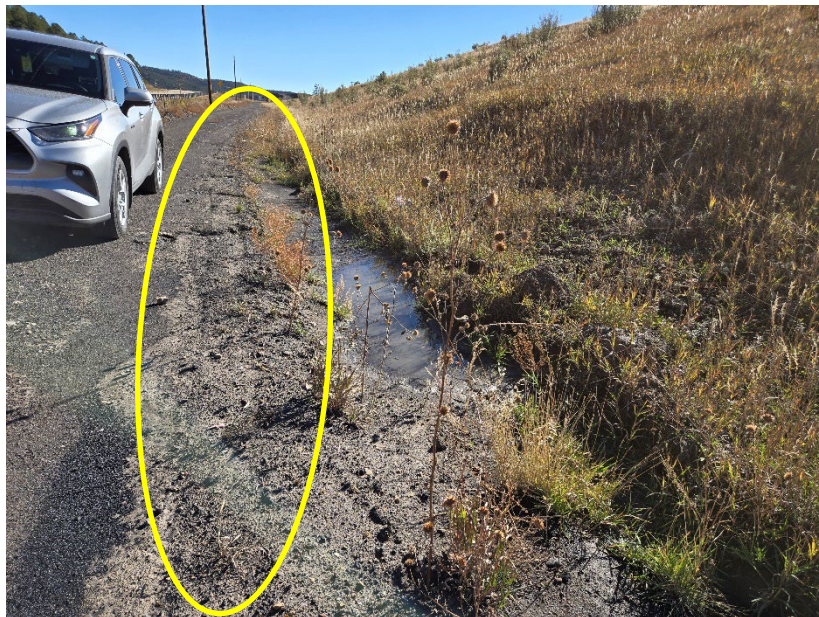
- Ditch D2, located to the north of DWDA #1, contained water at the time of the inspection. Areas along D2 have begun to fill with sediment. Some erosion along the road leading to Pond 004A was also observed (Photo 9). **The Operator shall clean this ditch and stabilize the road.**

Photo 9: Looking east along D2. Circled are some areas along the road where erosion ruts have formed.

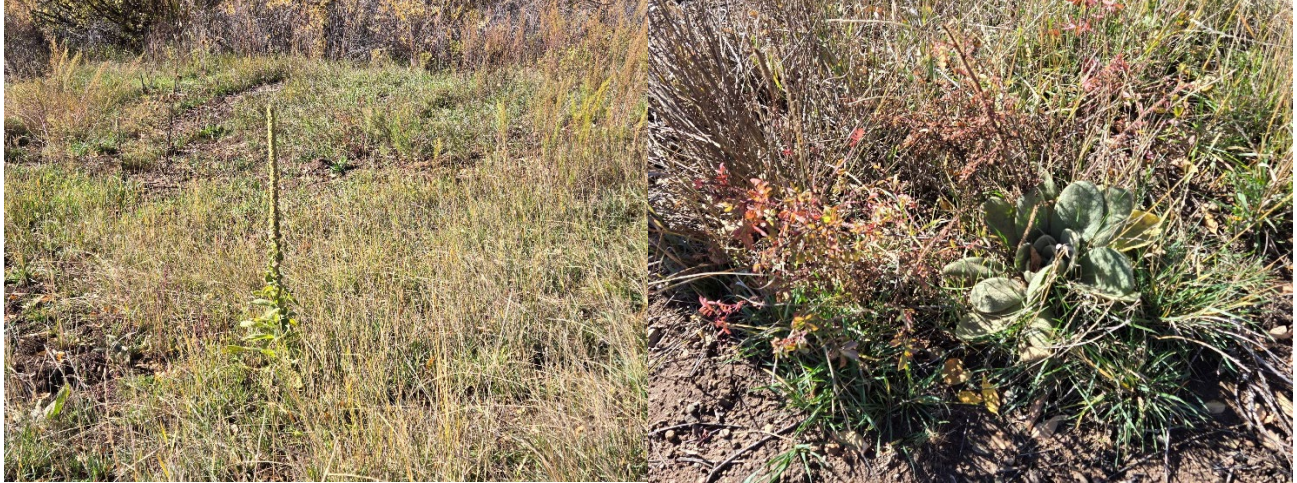
- Pond 004A contained a small amount of water. The bank appeared to be stable. Many treated Mullein weeds were observed along the bank, as well as a few new stalks and florets (Photo 10). **The Operator shall treat the new Mullein stalks and florets to help prevent spreading.**

Photo 10: New Mullein stalks (left) and florets (right) observed around Pond 004.

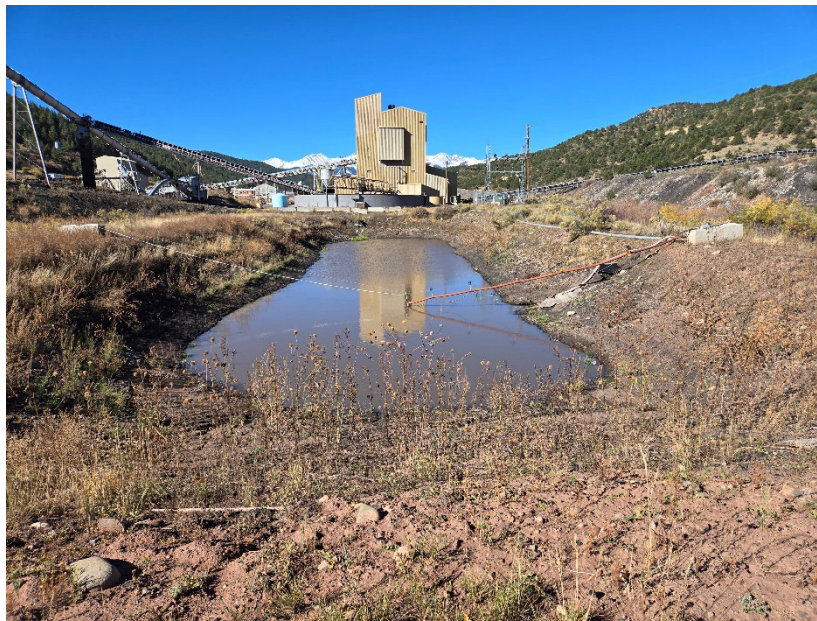
Photo 11: Pond 006a

- Pond 006A contained some water at the time of the inspection (Photo 11). The banks of the pond appeared to be stable at this time.

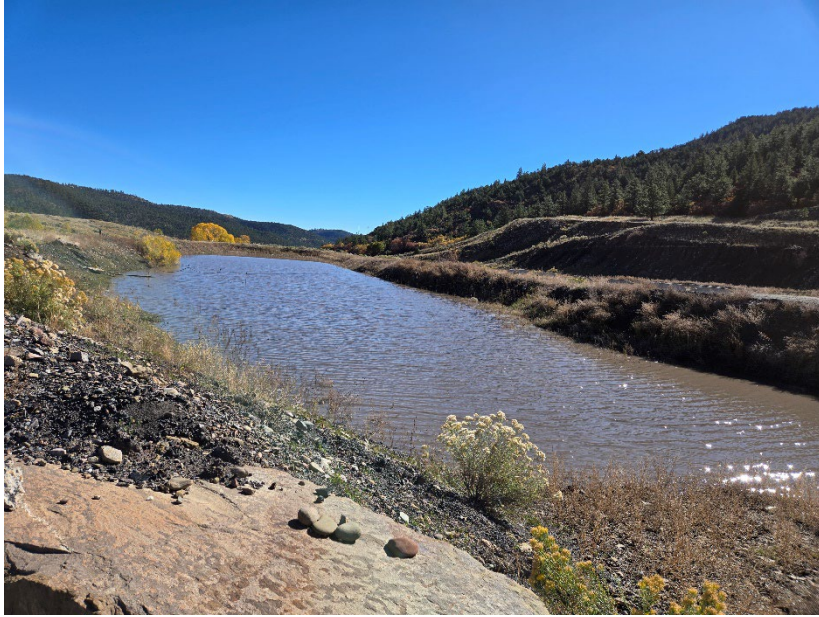
Photo 12: Pond 007A.

- Pond 007A contained water at the time of the inspection and was not discharging. The emergency spillway was free of obstructions and the embankment appeared to be stable. (Photo 12).

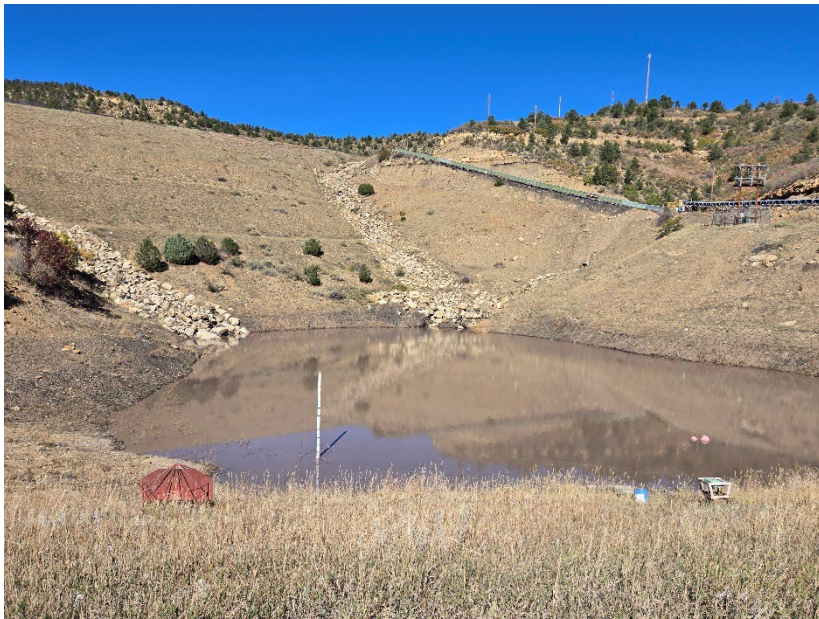
Photo 13: Pond 08

- Pond 08 contained water at the time of the inspection and was below its capacity (Photo 13). The spillways appeared clear, and the banks were stable. Pond 08 was not discharging.

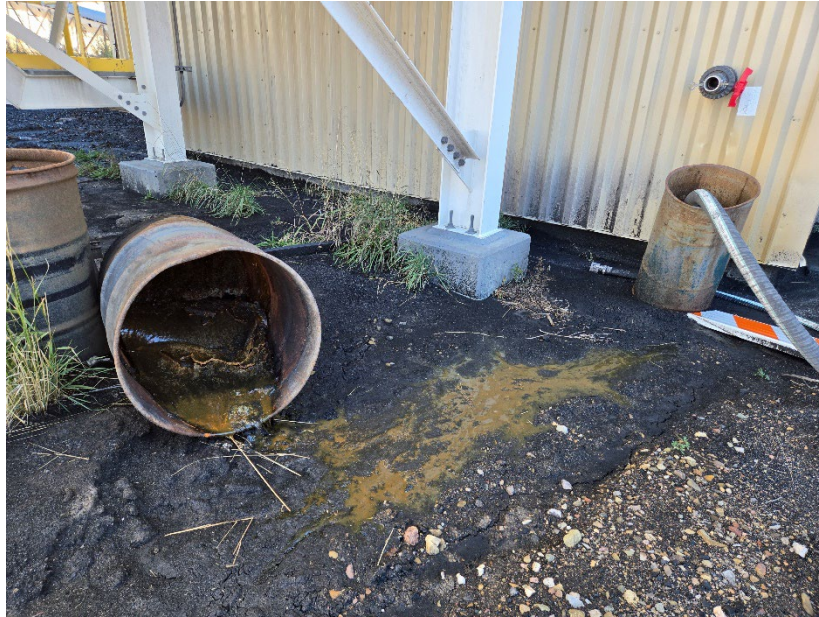
- During the Division's September 2024 inspection, a few barrels were observed along the west side of the wash plant building, within the raw coal storage area. One of the barrels had fallen over, and its liquid contents have spilled onto the ground next to the wash plant building. The Division believes the spilt material to be rusty stormwater. The Division observed the overturned barrel again during the October inspection and has not yet received confirmation that the spill has been cleaned (Photo 14). **The Operator shall provide evidence to the Division that the spill has been cleaned prior to the Division's next inspection.**

Photo 14: Overturned barrel near the wash plant within the raw coal storage area.

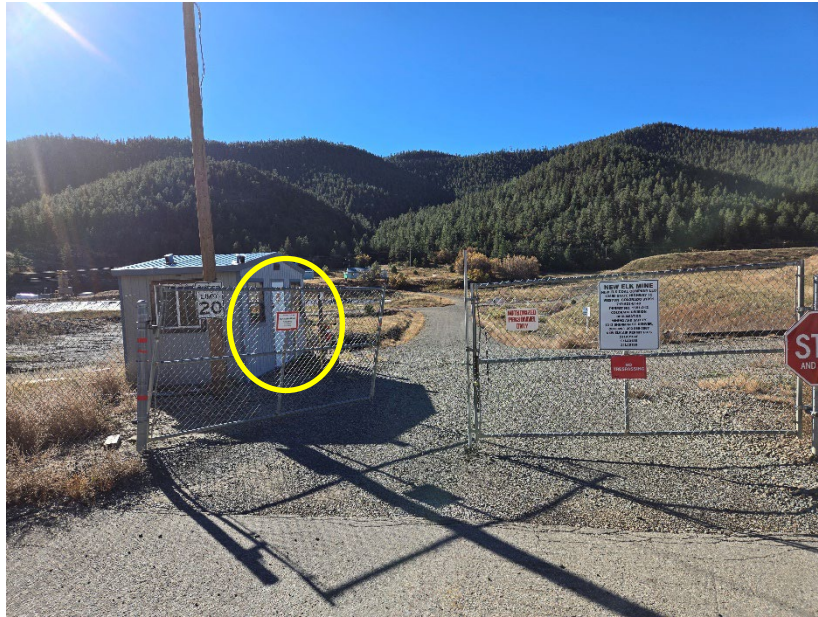
- A mine sign was posted at the main entrance to the New Elk mine site in compliance with Rule 4.02 (Photo 15). A new contact number has also been provided and posted on the entrance gate to comply with the public access requirements of Rule 5.02.4.

Photo 15: The Division was able to access the site with the gate code provided to the inspector. Circled is the new contact information sign for outside parties to request access to the site and access to the records.
