MINERALS PROGRAM INSPECTION REPORT
PHONE: (303) 866-3567

MINE NAME: Potter Ranch	MINE/PROSPECTING ID#: M-2024-044	MINERAL: Unknown	COUNTY: Ouray
INSPECTION TYPE: Illegal(Unpermitted Operation)	WEATHER: Clear	INSP. DATE: September 25, 2024	INSP. TIME: 15:40
OPERATOR: Weber Ranch	OPERATOR REPRESENTATIVE: Rich Weber	TYPE OF OPERATION: ILL - Illegal	
REASON FOR INSPECTION: Citizen Complaint	BOND CALCULATION TYPE:	BOND AMOUNT: None	
DATE OF COMPLAINT: NA	POST INSP. CONTACTS: None	JOINT INSP. AGENCY: None	
INSPECTOR(S): Lucas West	INSPECTOR'S SIGNATURE:

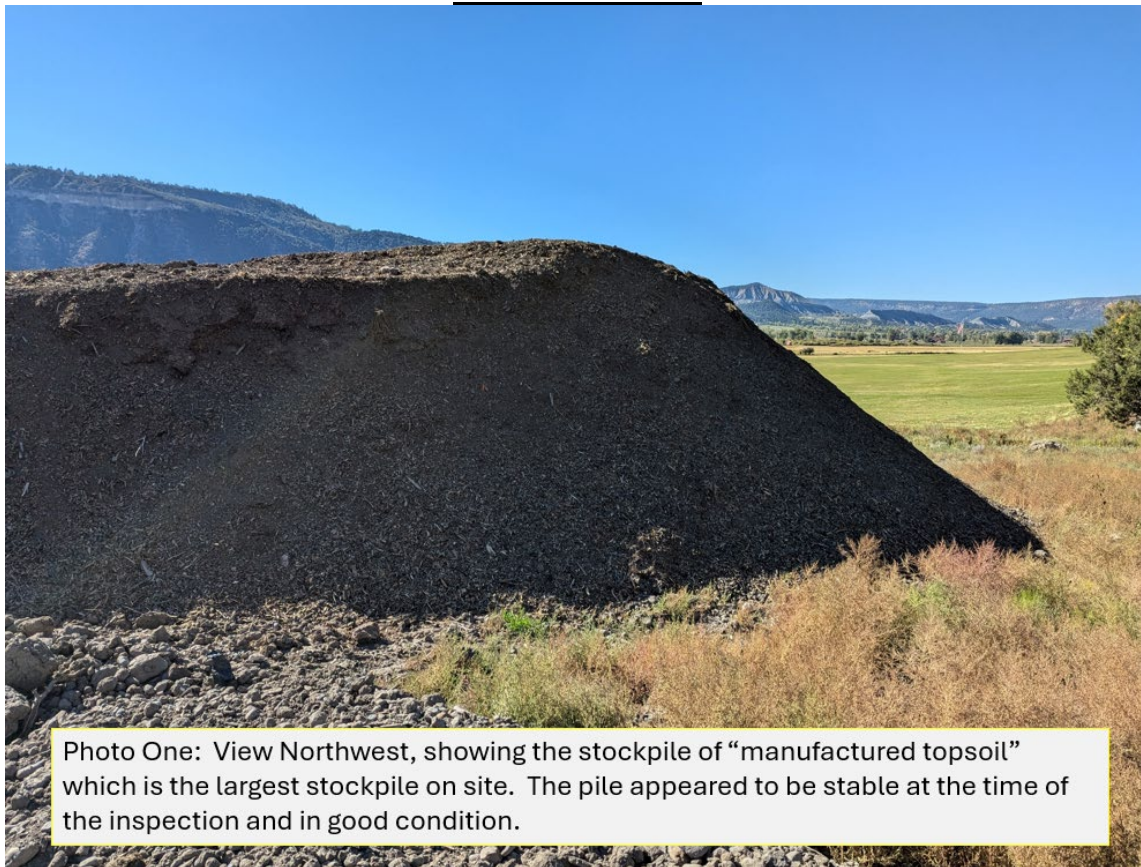
Photo One: View Northwest, showing the stockpile of “manufactured topsoil” which is the largest stockpile on site. The pile appeared to be stable at the time of the inspection and in good condition.

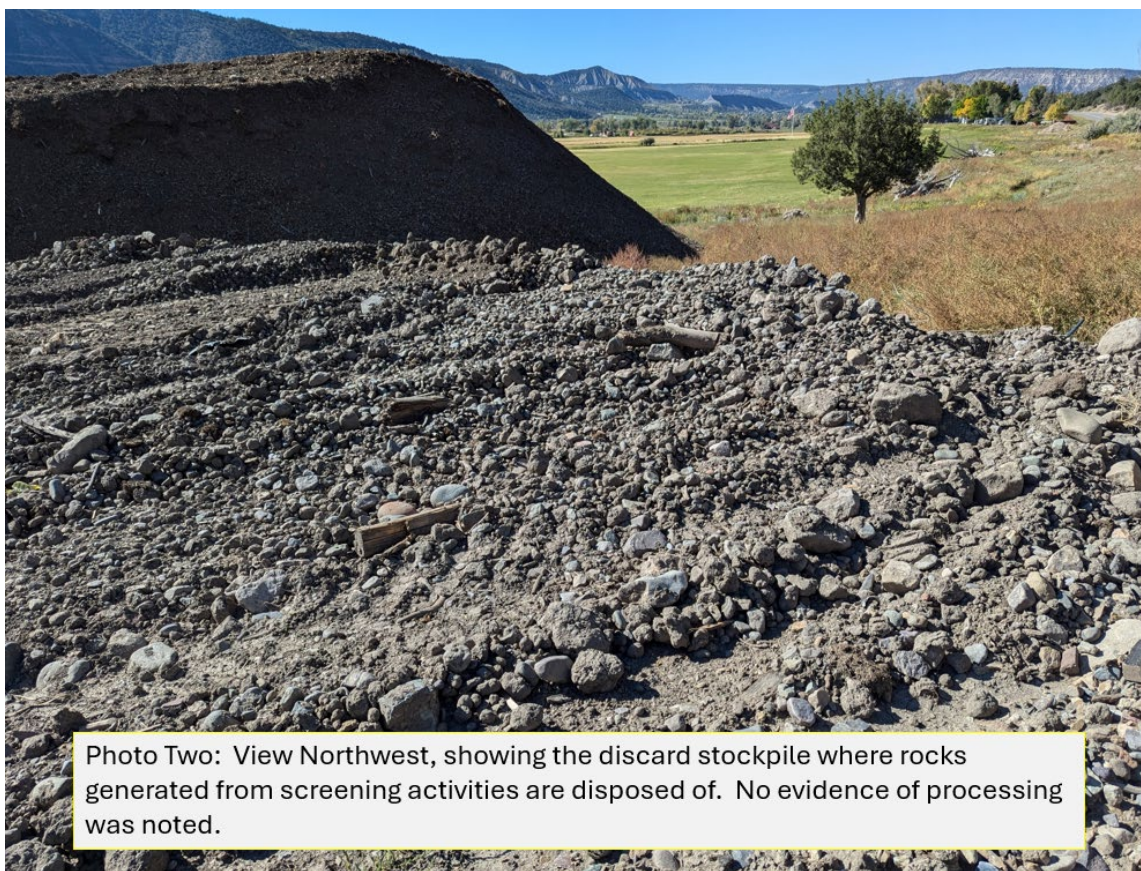
Photo Two: View Northwest, showing the discard stockpile where rocks generated from screening activities are disposed of. No evidence of processing was noted.

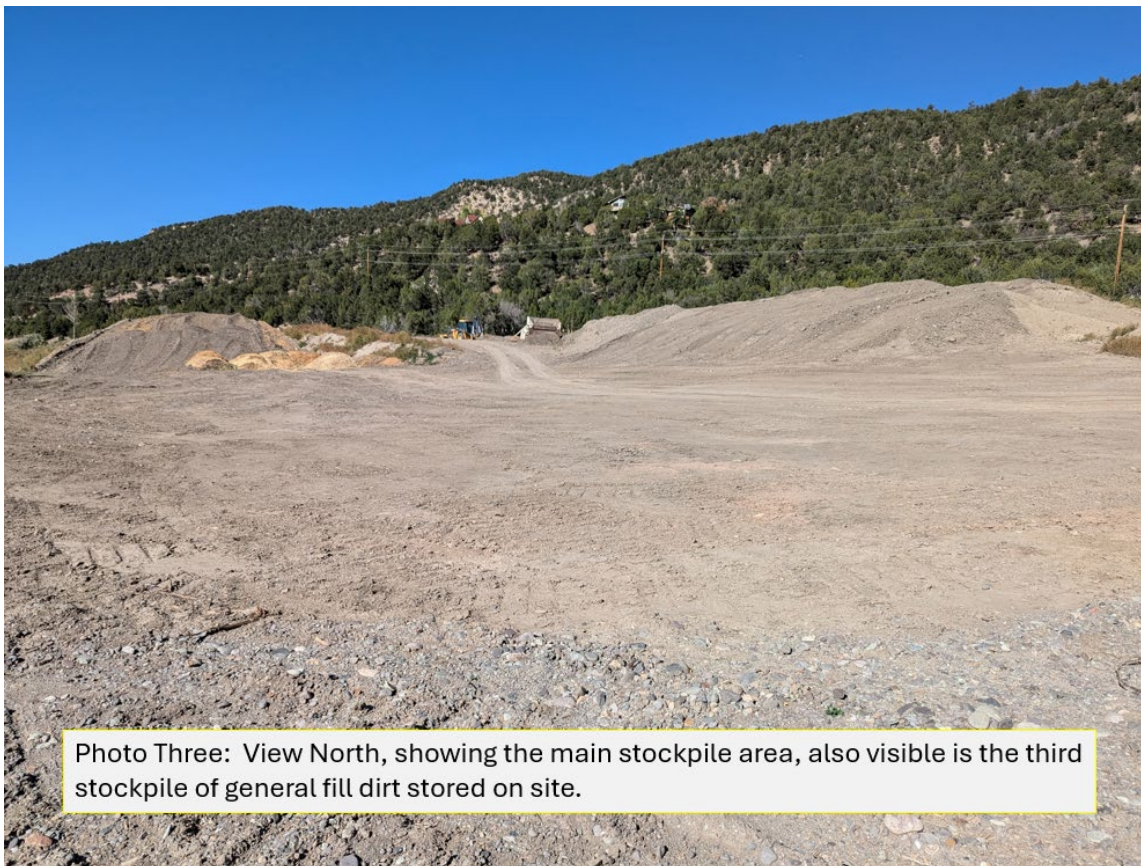
Photo Three: View North, showing the main stockpile area, also visible is the third stockpile of general fill dirt stored on site.

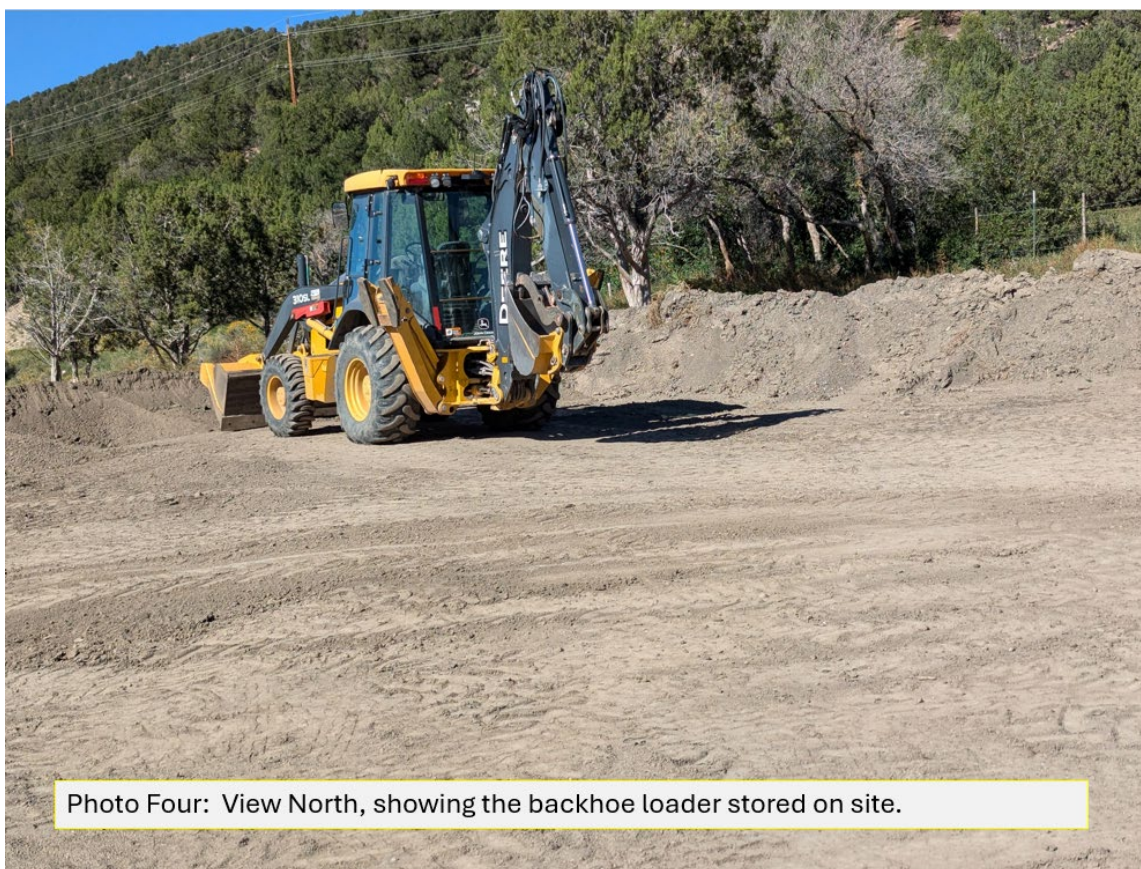
Photo Four: View North, showing the backhoe loader stored on site.

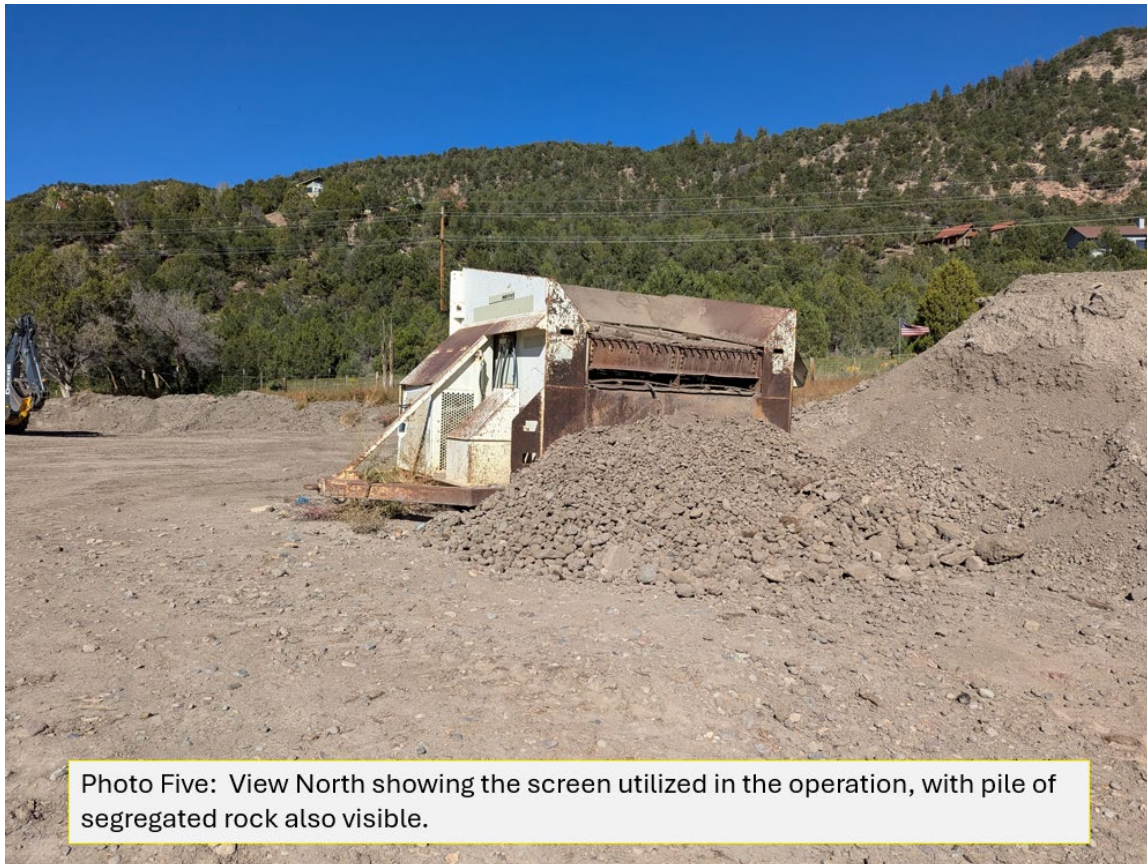
Photo Five: View North showing the screen utilized in the operation, with pile of segregated rock also visible.

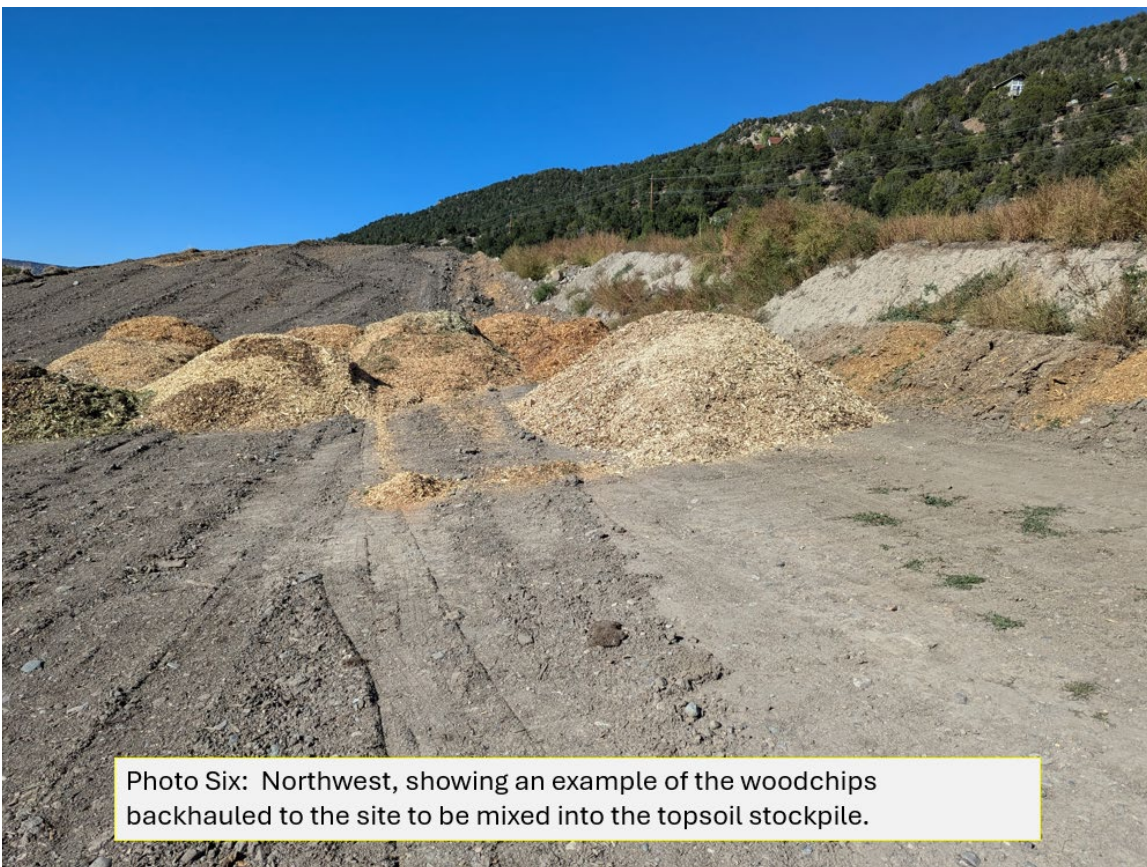
Photo Six: Northwest, showing an example of the woodchips backhauled to the site to be mixed into the topsoil stockpile.

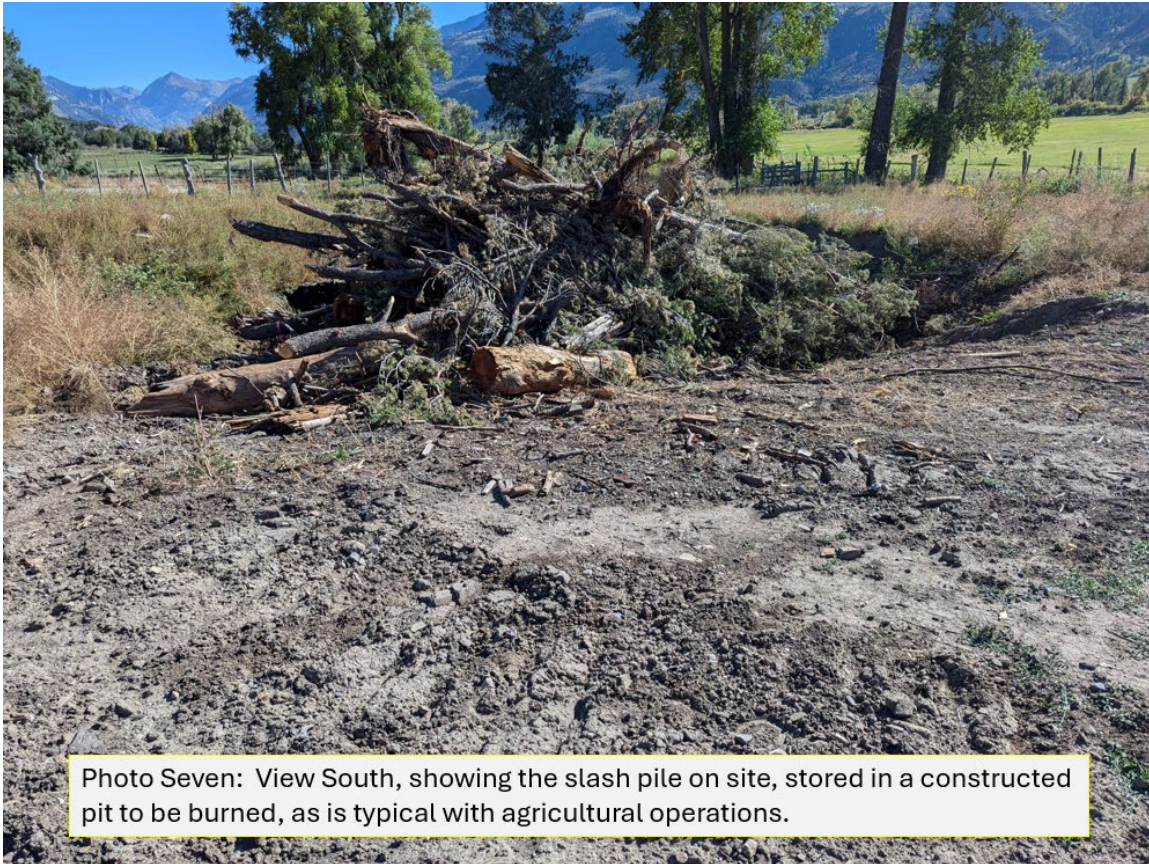
Photo Seven: View South, showing the slash pile on site, stored in a constructed pit to be burned, as is typical with agricultural operations.

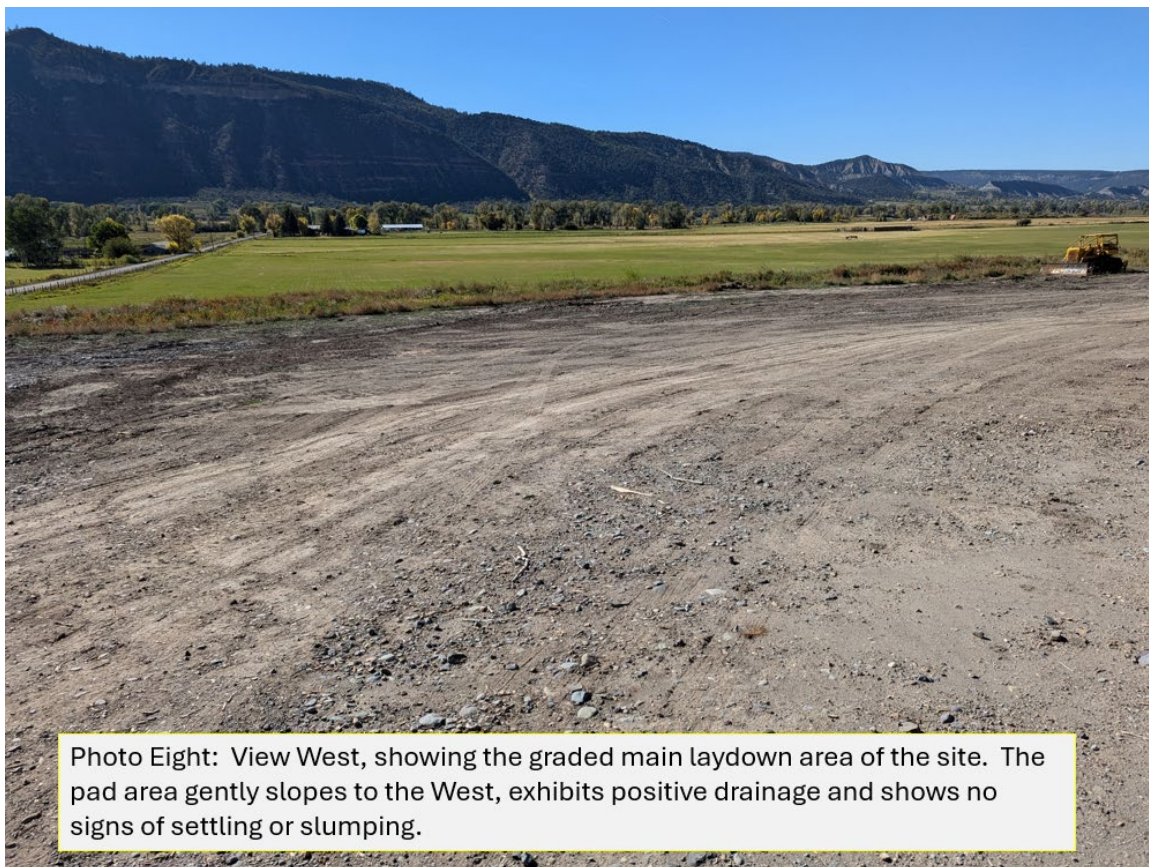
Photo Eight: View West, showing the graded main laydown area of the site. The pad area gently slopes to the West, exhibits positive drainage and shows no signs of settling or slumping.
