MINERALS PROGRAM INSPECTION REPORT PHONE: (303) 866-3567

MINE NAME:	MINE/PROSPECTING ID#:	MINERAL:	COUNTY:
Knox Pit	M-2017-036	Sand and gravel	Larimer
INSPECTION TYPE:	WEATHER:	INSP. DATE:	INSP. TIME:
Monitoring	Clear	September 24, 2024	09:15
OPERATOR:	OPERATOR REPRESENTATIVE:	TYPE OF OPERATION:	
Loveland Ready-Mix Concrete, Inc.	Corey Sheldon	112c - Construction Regular Operation	
REASON FOR INSPECTION:	BOND CALCULATION TYPE:	BOND AMOUNT:	
Normal I&E Program	Complete Bond	\$788,900.00	
DATE OF COMPLAINT:	POST INSP. CONTACTS:	JOINT INSP. AGE	NCY:
NA	None	None	
INSPECTOR(S):	INSPECTOR'S SIGNATURE:	SIGNATURE DAT	E:
Joel Renfro	$\bigcirc 10$	October 30, 2024	
	AUKINTE		
	Under and

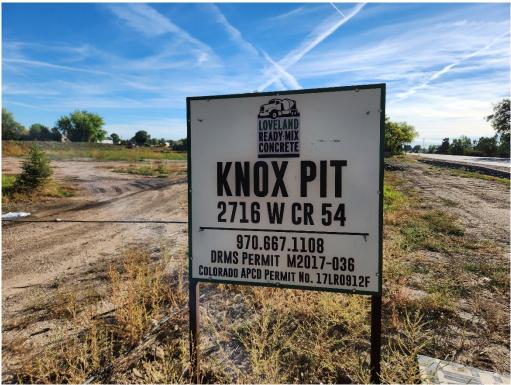
A mine entrance sign was observed and there is a fence on all sides of the permit boundary. All around, this operation appears to be in compliance with their mining plan and groundwater monitoring requirements.

Photo 1. Mine entrance sign, looking north.

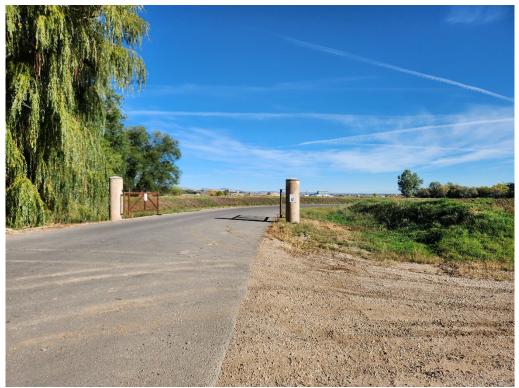
Photo 2. Mine entrance, looking north.

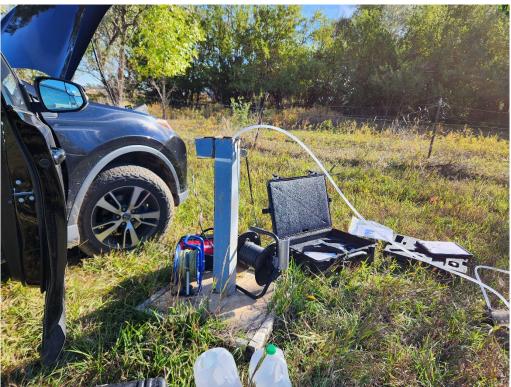
One objective of this inspection was to document the existence and location of each monitoring well on site. The 2024 Annual Report Map, which shows the location of each monitoring well, is attached. Every monitoring well was observed except for MW-02, which is no longer within the permit boundary but on a construction site that was carved out of the permit area as part of a 2.5-acre Acreage Reduction (AR-1) in May 2022. The monitor wells were actively being tested during the inspection, as seen in **Photo 3**.

Photo 3. Monitoring Well 13 (MW-13) being tested, looking east.

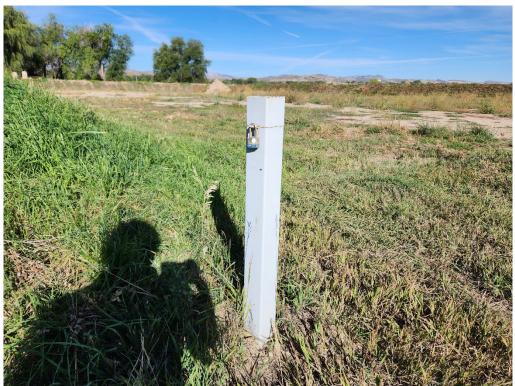
Photo 4. MW-12, looking northwest.

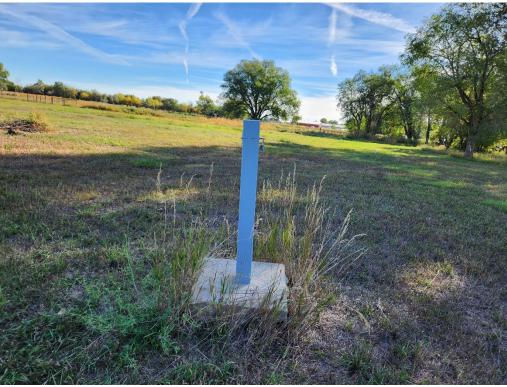
Photo 5. MW-13, looking east.

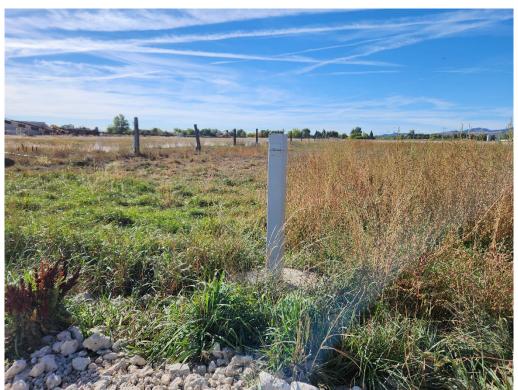
Photo 6. MW-9, looking southwest.

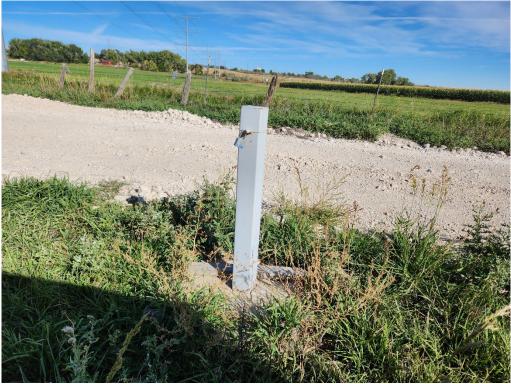
Photo 7. MW-6, looking south.

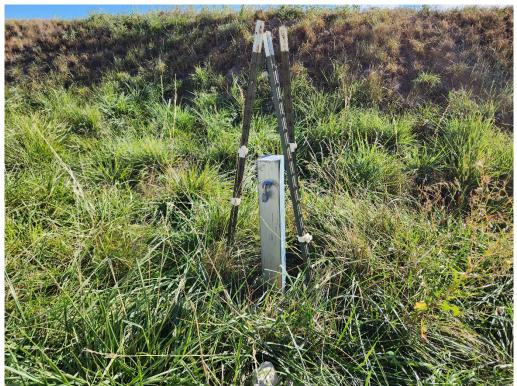
Photo 8. MW-8, looking east.

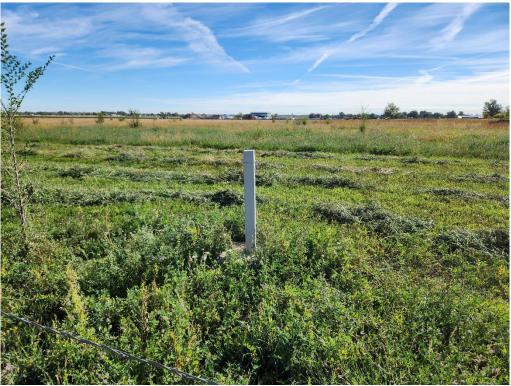
Photo 9. MW-5, looking east.

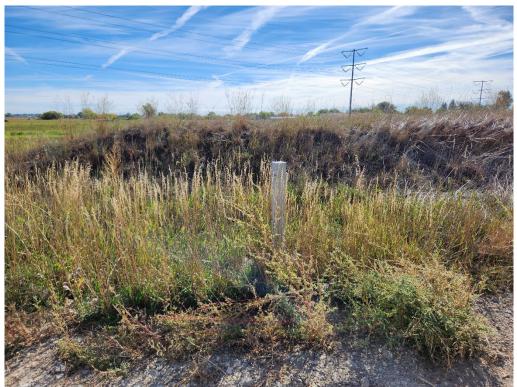
Photo 10. MW-3, looking east.

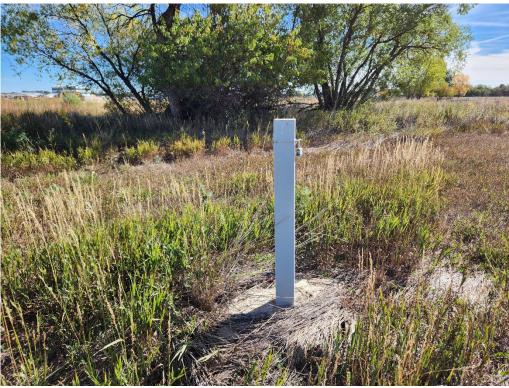
Photo 11. MW-4, looking north.

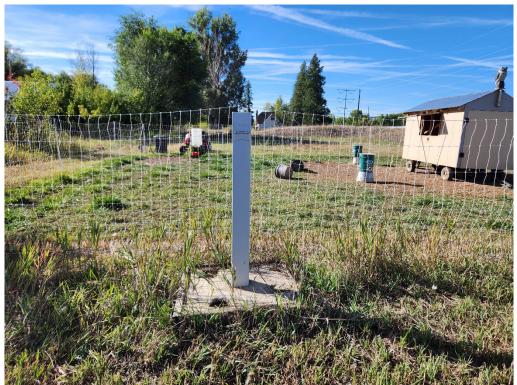
Photo 12. MW-12, looking south.

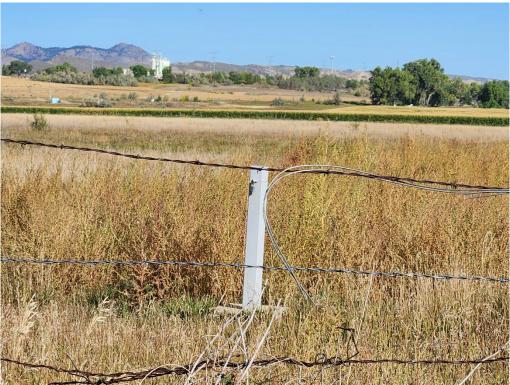
Photo 13. MW-7, looking south.

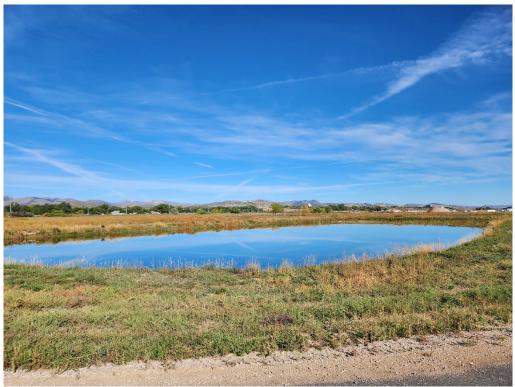
Photo 14. Southeast infiltration pond, looking north.

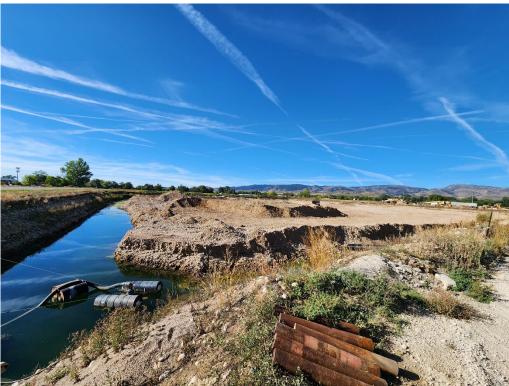
Photo 15. Current mining, looking south.
