Job Number: 99-3983

Subject: Quarterly Observation Report,  
Refuse Pile, Foidel Creek Mine, Routt  
County, Colorado.

## TCC Refuse Pile-Quarterly Inspection

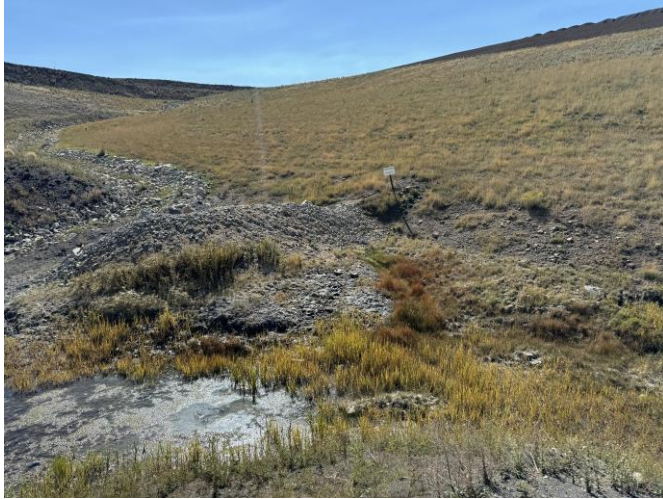
A seepage area at the toe of the northeast end of the refuse pile expansion area, approximately 30 feet northwest of the outlet of the underdrain, developed in fall 2014. At the time of our observations, the seepage was surfacing at the toe of the slope and flowing into the drainage from the undrain outlet then into the existing pond east of the Refuse Pile Expansion Area. The discharge was clear, with no evidence of sediment. No signs of washout, slumps or slope instability were observed at this time. The seepage area will be monitored during future inspections and noted in our inspection reports. Photographs of the seepage area taken at the time of our inspection on June 28, 2024 are attached.

September 30, 2024-Drain Outlet and Seepage Area

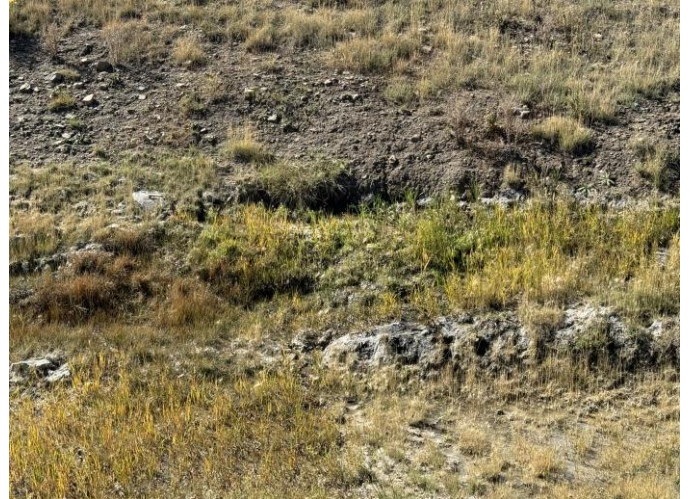
September 30, 2024-Seepage Area

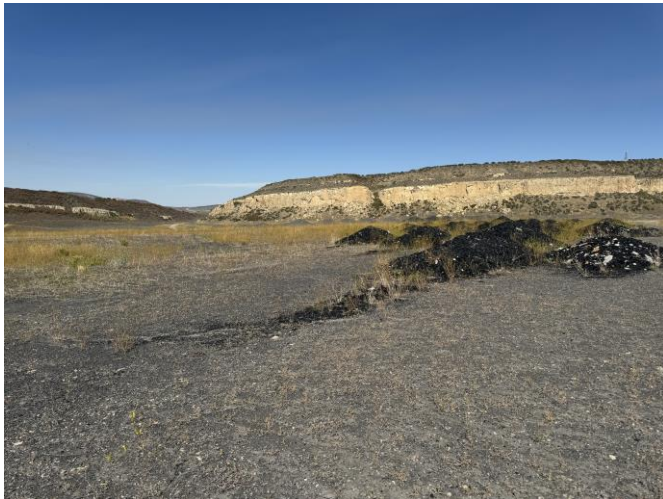
The internal roadways in the new expansion area of the pile are in good condition. The upper haul road to Areas 2, 3 and 4 of the refuse pile was accessible and in good condition.

September 30, 2024- Areas 2, 3 and 4

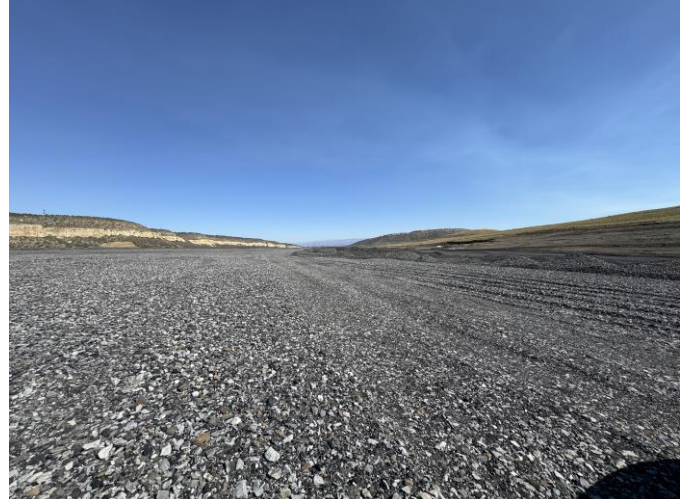
At the time of our site visit on September 30, 2024, NWCC completed a site inspection of the existing refuse pile. Based on our observations made during this visit, it appeared that the contractor was presently stockpiling, grading and compacting refuse coal in the new Expansion Area. At the time of our site visit, the refuse coal had been placed and compacted to an elevation above the third bench situated along the east side of the stockpile. Cover materials were being stockpiled on the third bench to be spread over the slope below the third bench

September 30, 2024- Expansion Area

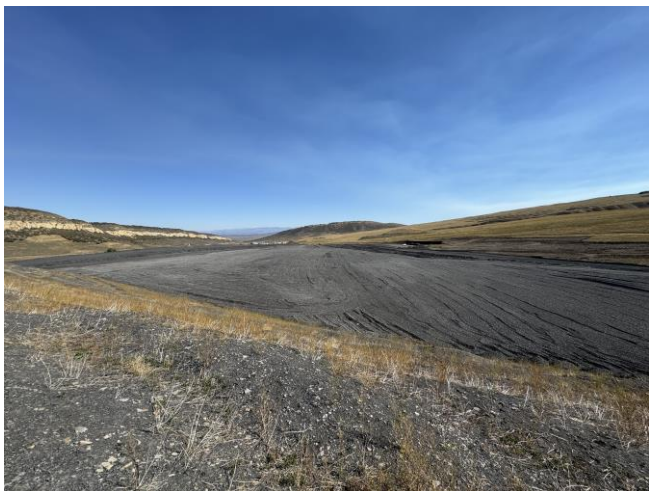
September 30, 2024- Expansion Area

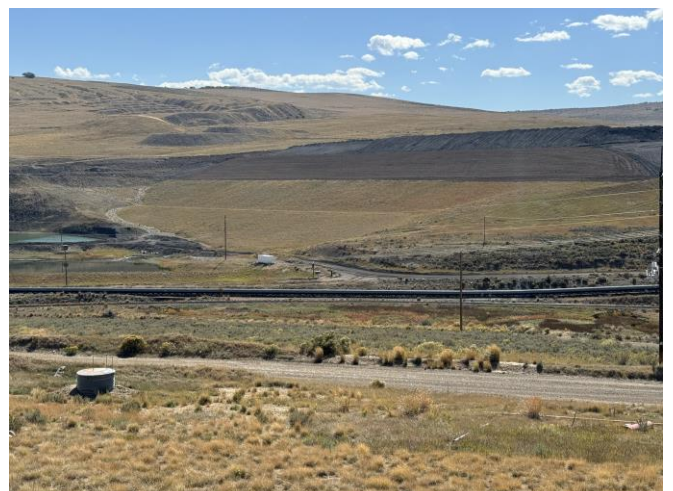
September 30, 2024- East End of Expansion Area
