Inspection Report, Lorencito Canyon Mine, C-1996-084

Permit Number: C-1996-084 Mine Name: Lorencito Canyon Mine Operator: New Elk Coal Company, LLC Operator Address: Mr. John Terry 12250 Highway 12 Weston, CO 81091	County: Las Animas Operation Type: Surface Permit Status: Permanent Cessation Ownership: Private
	Operator Representative Present: None
Operator Representative Signature: (Field Issuance Only)

Inspection Start Date: October 23, 2024 Inspection Start Time: 11:00 Inspection End Date: Inspection End Time:	Inspection Type: Coal Complete Inspection Inspection Reason: Normal I&E Program Weather: Clear
Joint Inspection Agency: None	Joint Inspection Contacts:
Post Inspection Agency: None	Post Inspection Contacts:
Inspector(s): Amber M. Gibson	Inspector's Signature:

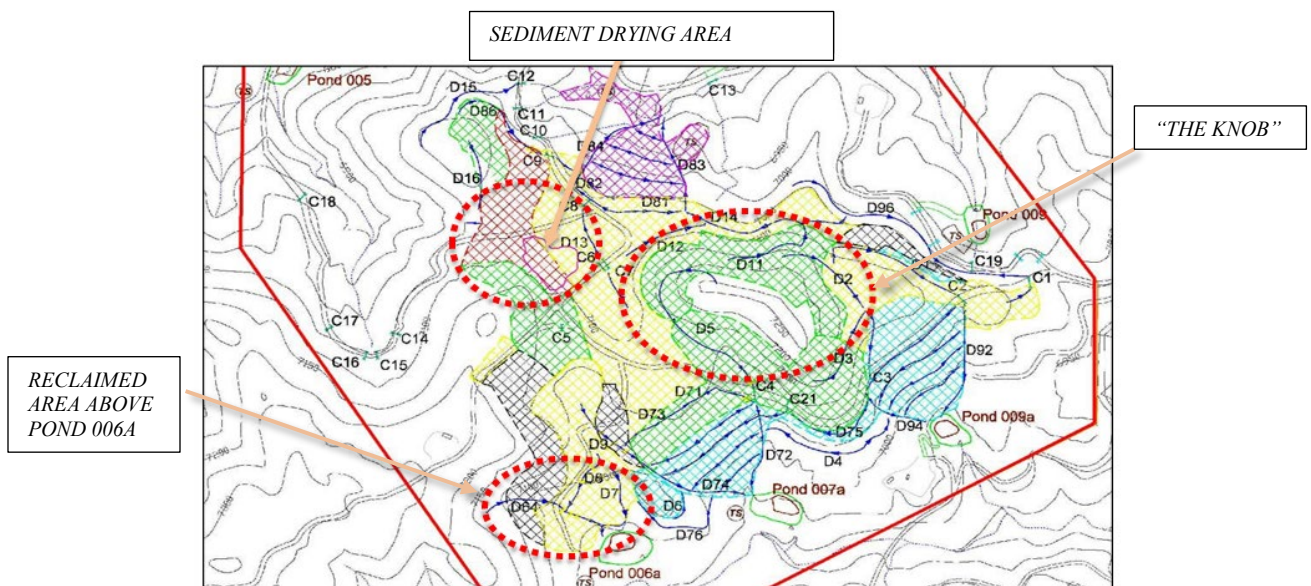
- (4) The following items pertain to ongoing erosional issues in the areas shown in Figure 1, that pursuant to Rule 4.14.6 need to be addressed. A Technical Revision will be required to expand on the current Rill and Gully plan in the PAP. **The Operator shall submit the technical revision, obtain approval, repair the erosion, and stabilize the slopes pursuant to the approved plan by December 31, 2024**

FIGURE 1. AREAS WHERE RILLS, GULLIES AND SPARSE VEGETATION HAS BEEN FOUND TO BE A PERSISTENT PROBLEM AT THE SITE ARE WITHIN THE DOTTED CIRCLE AREAS. BACKGROUND IMAGE IS THE 2020 ANNUAL REPORT MAP.

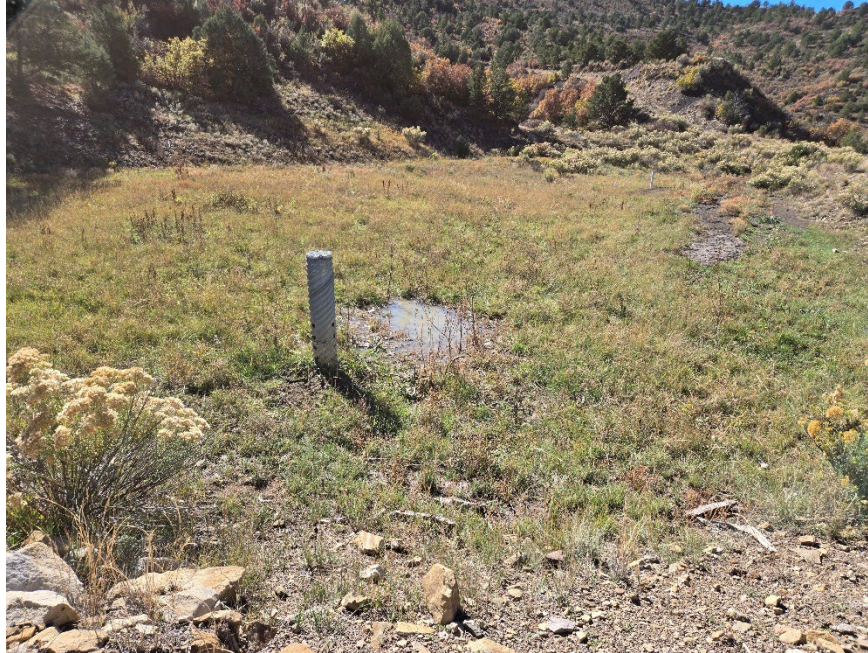
- Pond 005:
 - The pond contained some water at the time of the inspection (Photo 1) but was not discharging.
 - The pond embankment was stable and vegetated.
 - The primary and emergency spillways appeared clear and functional.
 - The state listed noxious weed, Mullein, was observed by the spillway. **The Operator shall treat and/or remove Mullein in this area.**

Photo 1: Pond 005

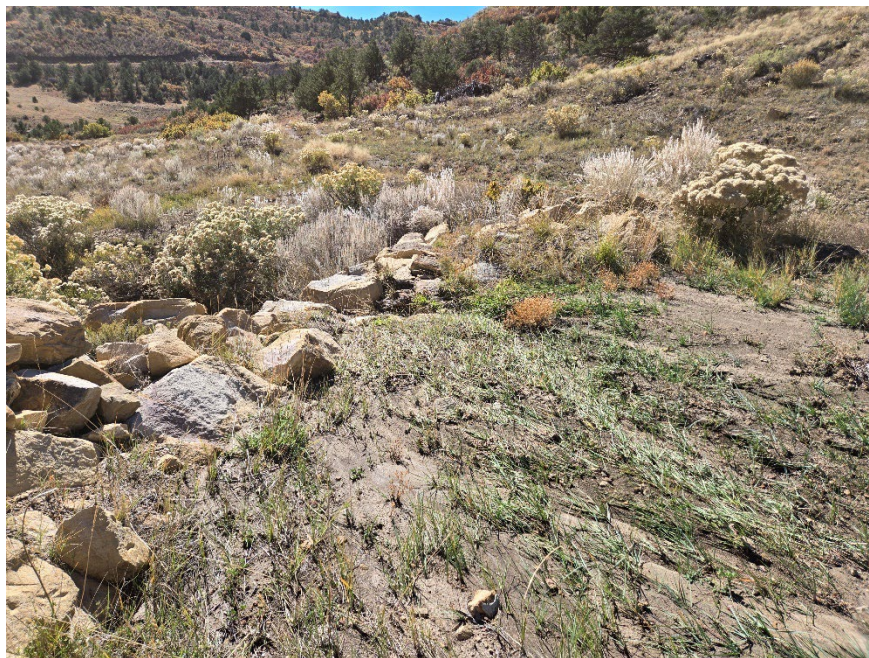
- Ditch D9:
 - The check dams within Ditch D9, leading down to Pond 006a, contain an excess amount of sediment (Photo 2). A gully was also observed cutting down from the road and adding sediment to the third check dam. **The Operator shall remove the excess sediment from the check dams within D9.**

Photo 2: Looking southwest down the check dams within D9.

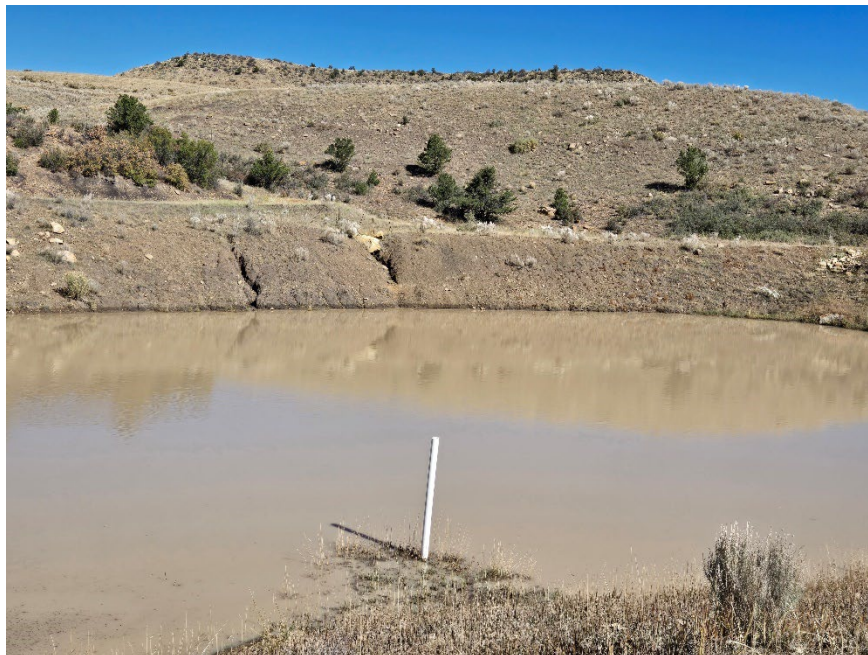
- (1) Erosion rills are forming on the north and west banks of Pond 006a. The erosion on the north bank appears to have been addressed at some point, because rebar is placed above the rills. However, it appears that the prior BMPs are no longer functioning adequately. **Pursuant to Rule 4.05.5(1)(c), the Operator shall address the erosion and repair the north bank.** The erosion on the west bank appears to have been caused by runoff from the road located east of Pond 006a. **Pursuant to Rule 4.05.5(1)(c), the Operator shall address the erosion and repair the west bank.**
- (2) The majority of Pond 008's embankment was stable and vegetated, however, the west bank contains some erosion rills and gullies. The erosion appears to have been caused by run-off from the roads above and down to the pond. **Pursuant to Rule 4.05.5(1)(c), the Operator shall repair**

Photo 3: Looking northeast at Pond 006a. The erosion seen on the bank is that which is referred to in Item #1 on the first page of this report.

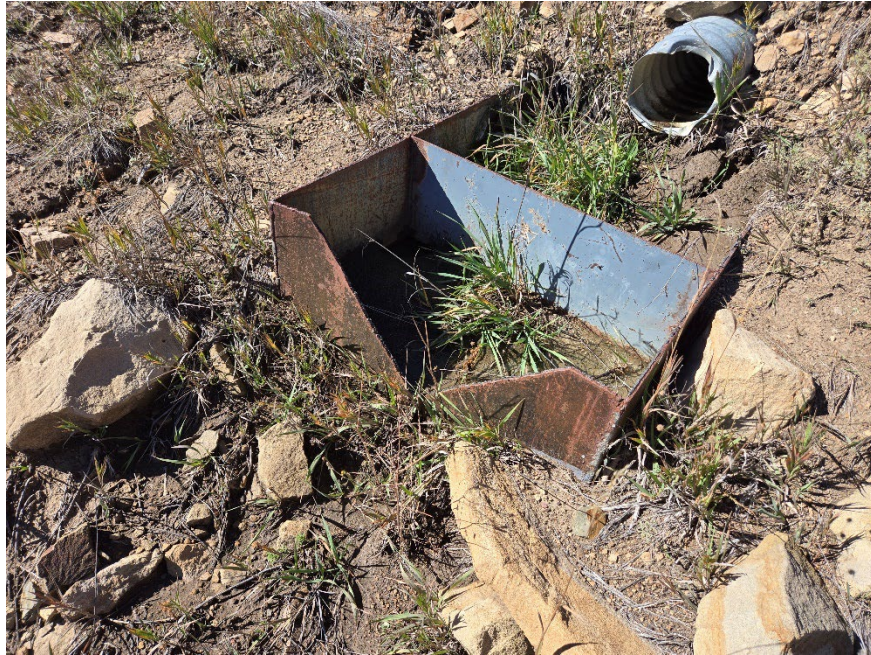
- Pond 006a contained water (Photo 3) and was not discharging at the time of the inspection, but appeared to have discharged recently (Photo 4). Sediment has built up within the upper portion of the flume. **The Operator shall clean the flume of sediment and vegetation to ensure it functions properly.**
- The pond embankment still requires maintenance (see Item # 1 in the outstanding maintenance items list on the first page of this report).
- The west bank referenced in Item #1 in the outstanding maintenance items list on the first page of this report, currently has a vegetative cover due to volunteer vegetation (circled area in Photo 5). This area will likely still need to be re-stabilized, but may need to be re-addressed at a later date once the vegetation has cleared for the season.
- The primary and emergency spillways appeared to be clear and functional.

Photo 4: Flume was not discharging during the inspection, but appears to have done so recently.

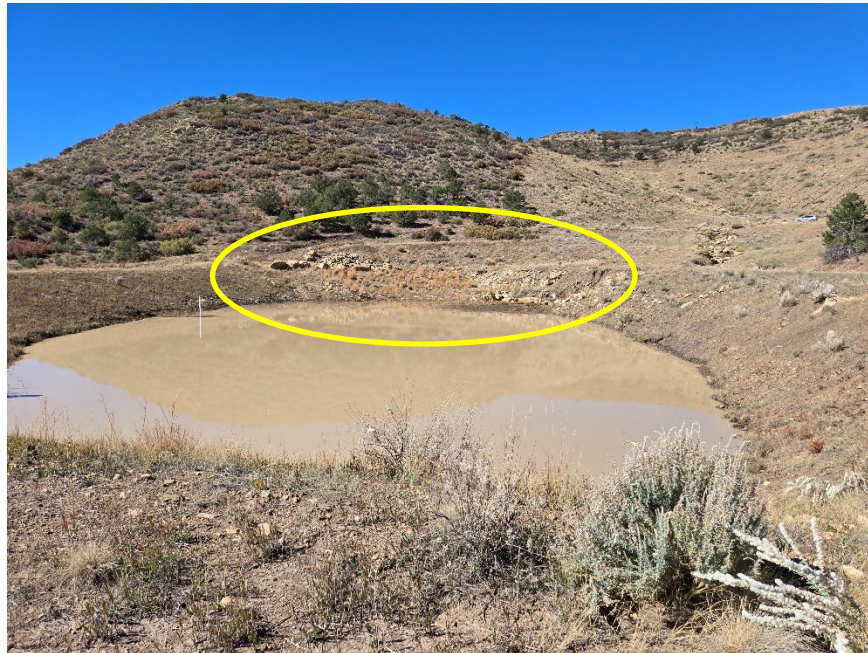
Photo 5: Circled is the area along the west bank of Pond 006a referenced in Item #1 in the ongoing maintenance section on the first page of this report.

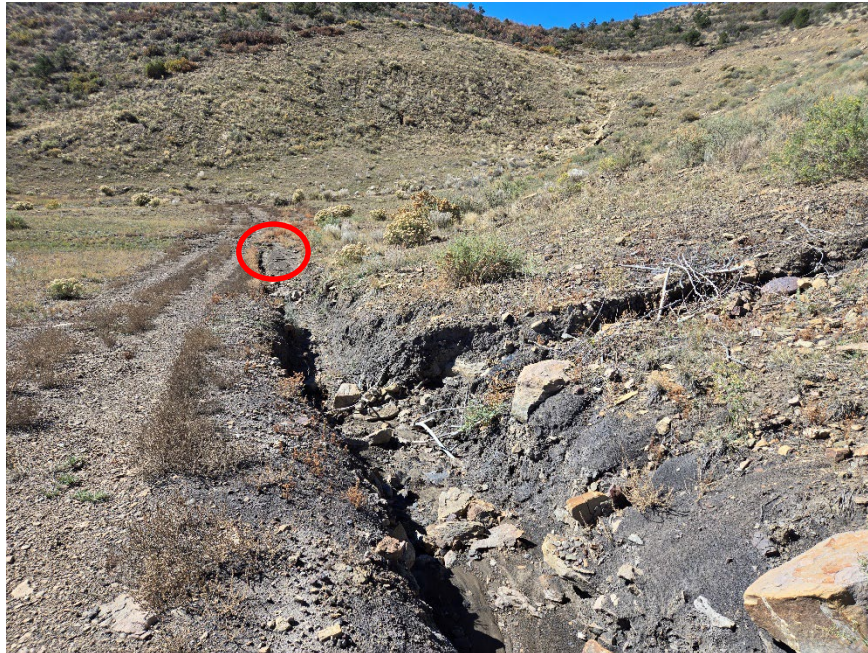
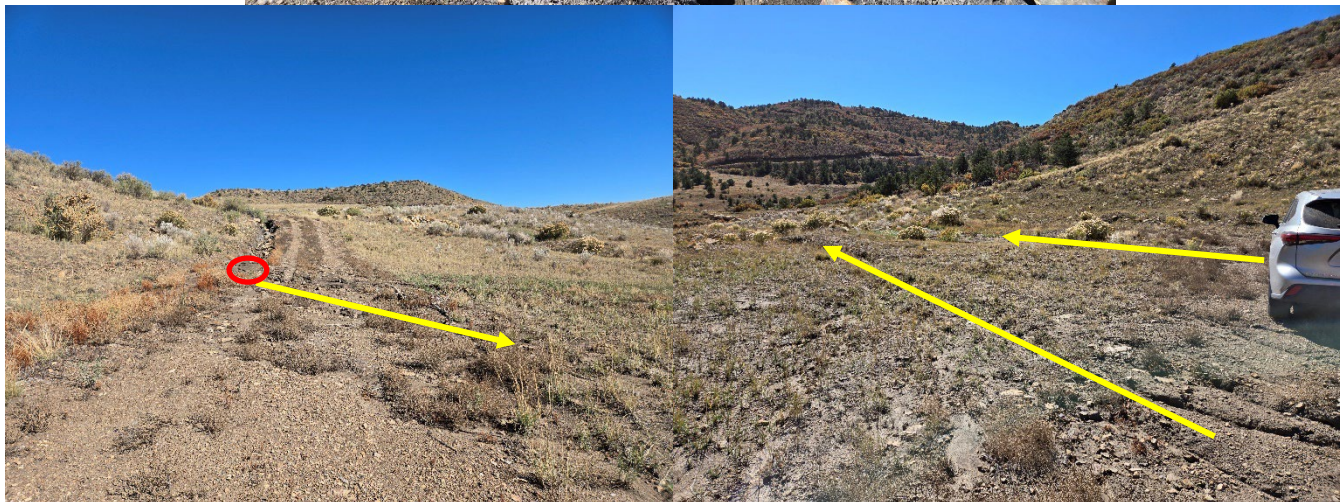
- a. The ditch along the road leading to Pond 006a is eroding and nearly full of sediment. The overloaded ditch is contributing to the build-up of sediment in the check dams of ditches D8 and D64. **Pursuant to Rule 4.03.2(4), the ditch along the west side of the road leading to Pond 006a needs to be cleaned out and repaired.**

- b. The check dams leading to Pond 006a, within ditches D8 and D64, are nearly full of sediment. **Pursuant to Rules 4.05.3(1)(c)-(e) and 4.05.5, the Operator shall clean out the sediment from the check dams to prevent excess sediment from entering the pond.**

Photo 6: See outstanding maintenance Item #3 in the first pages of this report. (Top) Looking south at the west side of the road leading down to Pond 006a. The red circle corresponds approximately with the red circle in the bottom left image. (Left) Looking north along the access road to Pond 006a. The arrow indicates where erosion has cut across the road and is leading to the check dams within ditch D8. (Right) The arrows indicate where erosion is leading from the reclaimed area above Pond 006a, into the check dams located in ditch D64 and into Pond 006a.

- See ongoing maintenance Item #2 and #3. The road along Pond 006A is washed out in the area between the reclaimed area and Pond 006A, and needs to be repaired (Photo 6 above). The road leading down into Pond 008 has some ruts that will require repairs. The ruts* and divots in the road to Pond 008 make vehicle access to the pond difficult and not advisable (Photo 20). **These are planned to be addressed at the time the west bank is stabilized.*

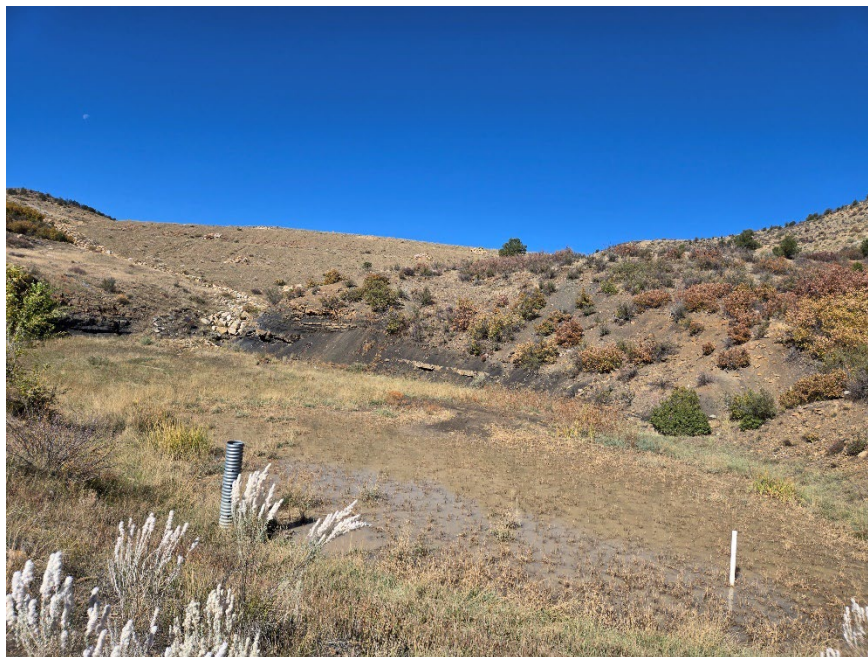
Photo 7: Looking northwest across Pond 007a.

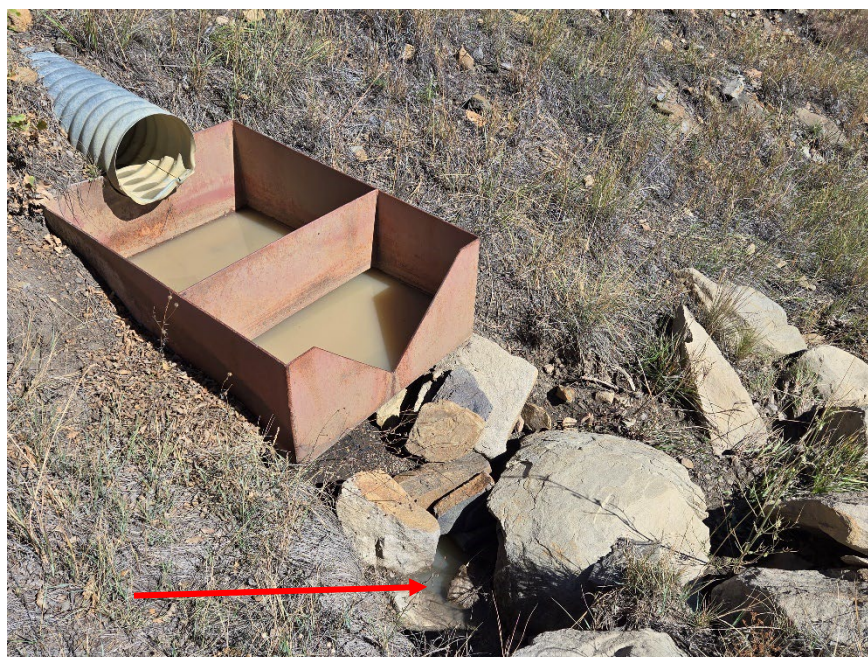
Photo 8: Flume at Pond 007a. Pooled water is seen below the flume, indicating it had recently discharged.

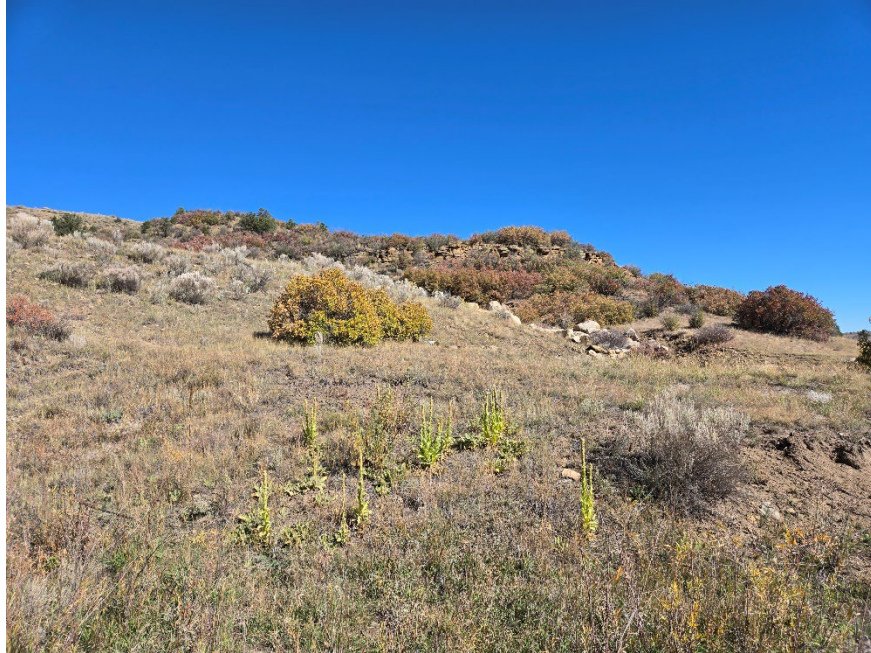
- Pond 007a:
 - The pond contained water at the time of the inspection (Photo 7) and had recently discharged but was not discharging at the time of the inspection (Photo 8).
 - The pond embankment appeared to be stable and vegetated.
 - The primary and emergency spillways appeared clear and functional.
 - Mullein was observed in the field to the south and west of Pond 007a, within the permit boundary (Photos 9-10). **The Operator shall treat/remove Mullein within this area.**

Photo 9: Mullein located west of the flume at Pond 007a.

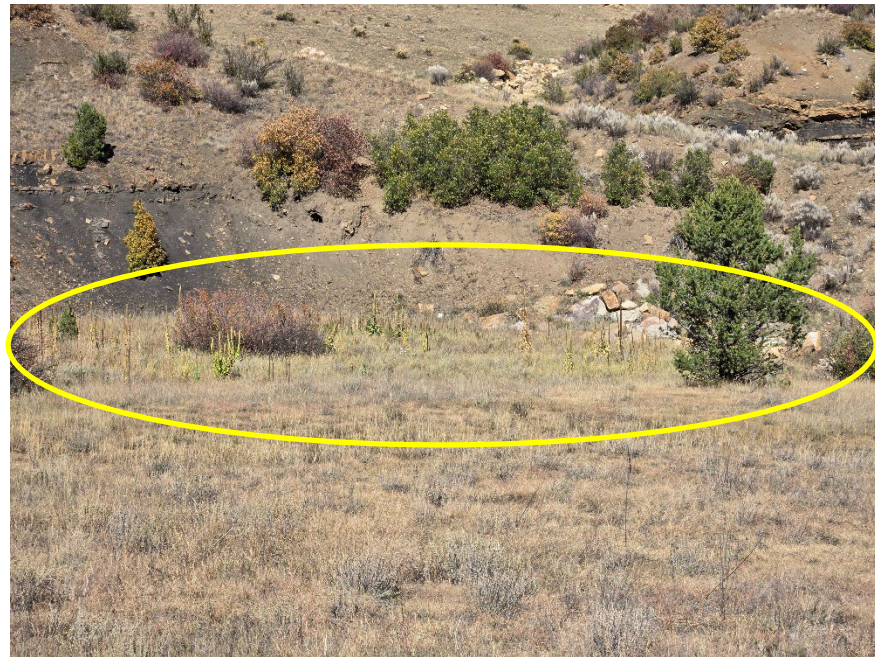
Photo 10: Area circled contains numerous stalks of Mullein. Fill 007 is seen in the background.

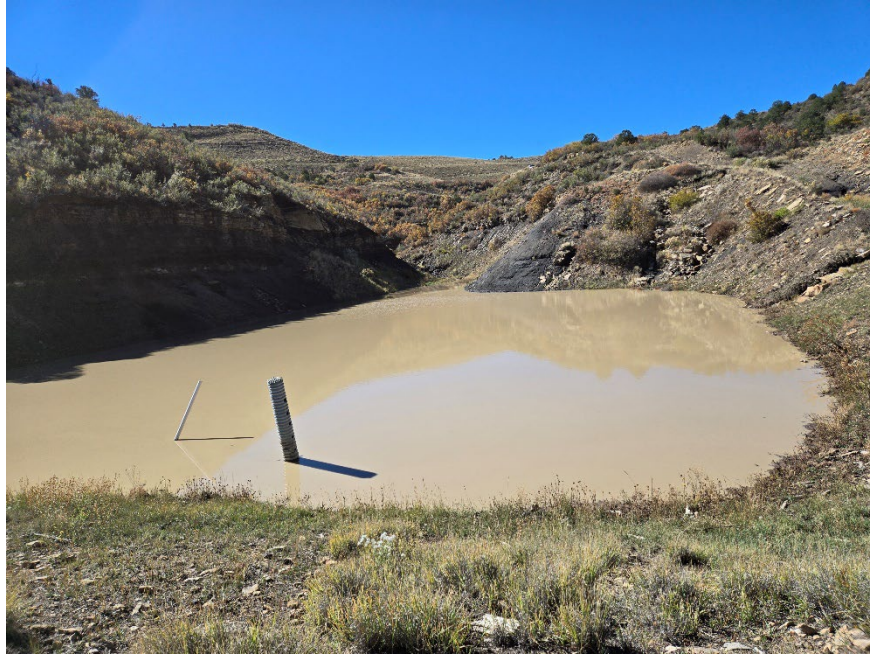
- **Pond 008:**
 - The pond contained water (Photo 11) and was discharging at the time of the inspection (Photo 12).
 - The pond embankment still requires maintenance (see Item #2 in the outstanding maintenance items list on the first page of this report).
 - The primary and emergency spillways appeared clear and functional.

Photo 11: Looking south at Pond 008.

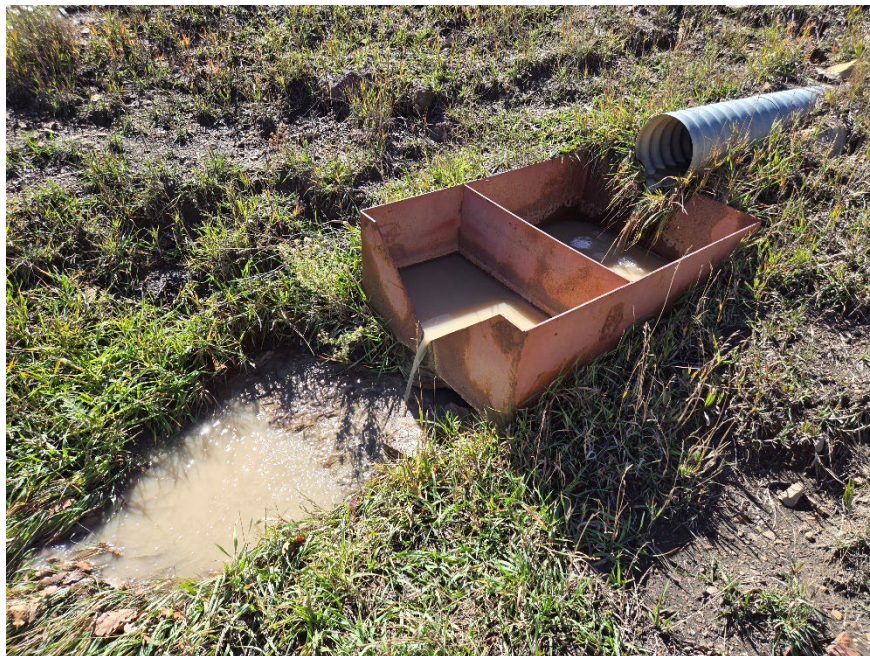
Photo 12: Discharging flume at Pond 008.

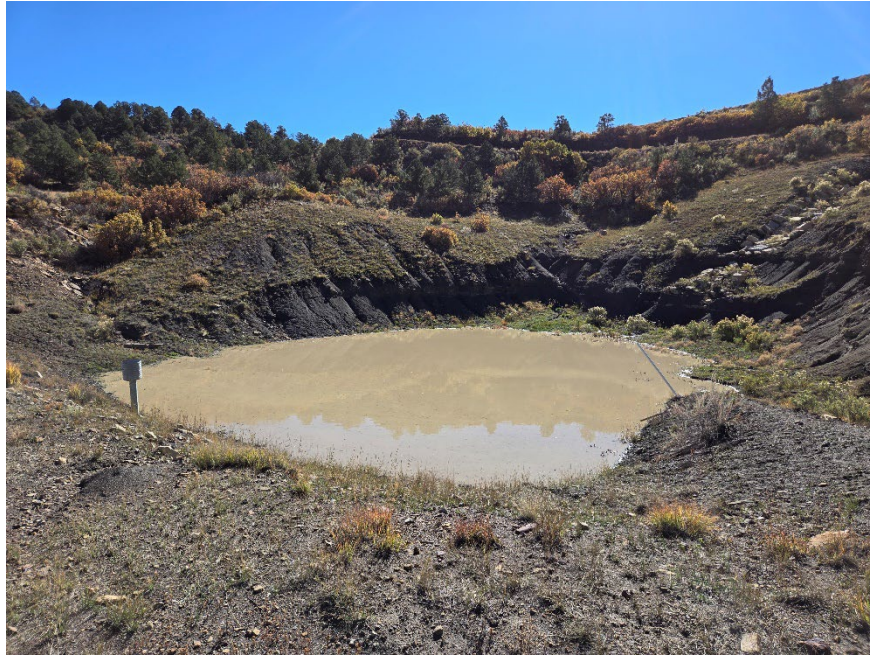
- Pond 009:
 - Pond 009 contained water (Photo 13), but was not discharging.

Photo 13: Looking southeast at Pond 009.

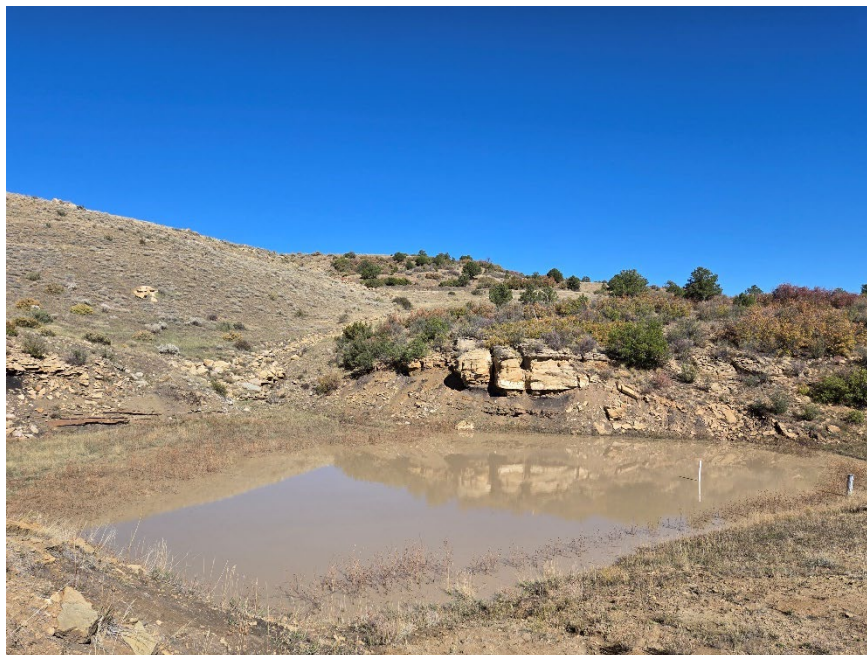
- Pond 009a:
 - The pond contained water (Photo 14) and was discharging (Photos 15-16).
 - The pond embankment appeared to be stable and vegetated.
 - The primary and emergency spillways appeared clear and functional.

Photo 14: Looking northeast at Pond 009a.

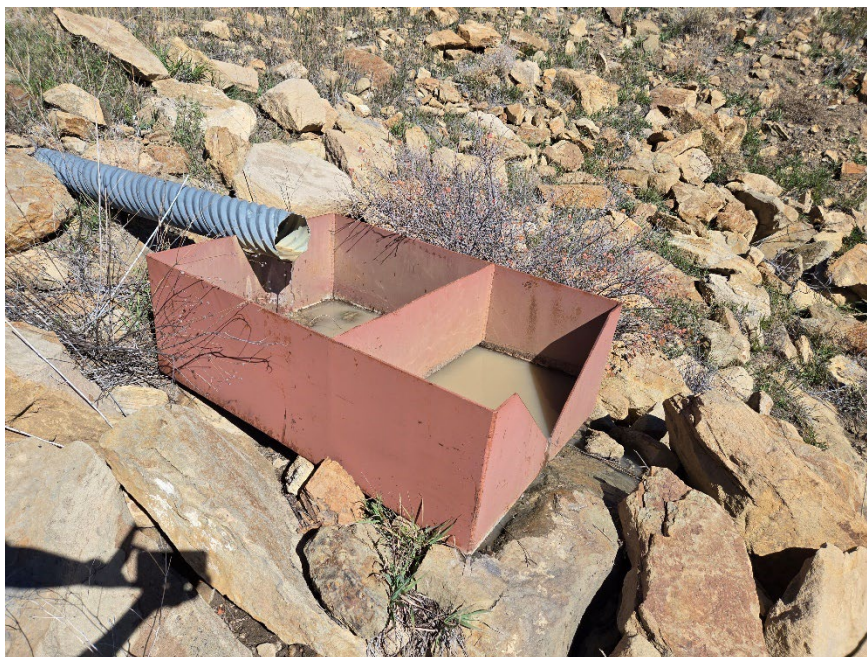
Photo 15: Looking north at the water discharging from the flume at Pond 009a.

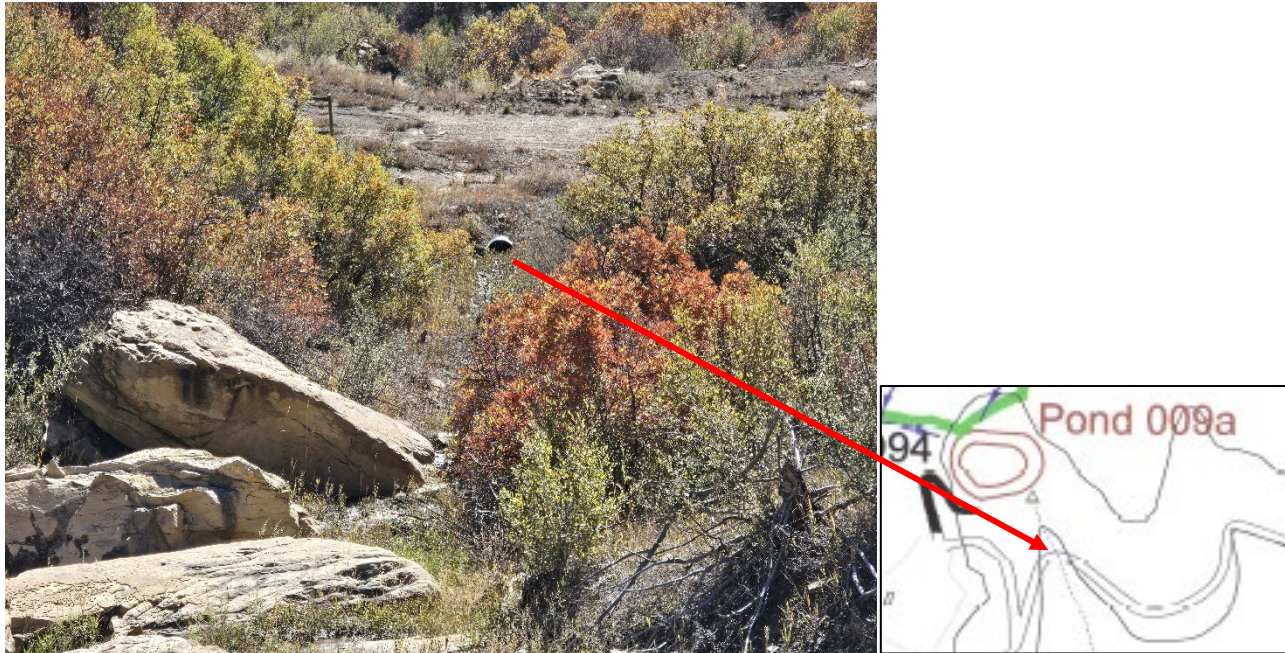
Photo 16: The discharge from the flume at Pond 009a was observed going downhill and into the culvert under the road, as depicted in the Permittee's Map 2.05.3-7 (see excerpt from the map above).

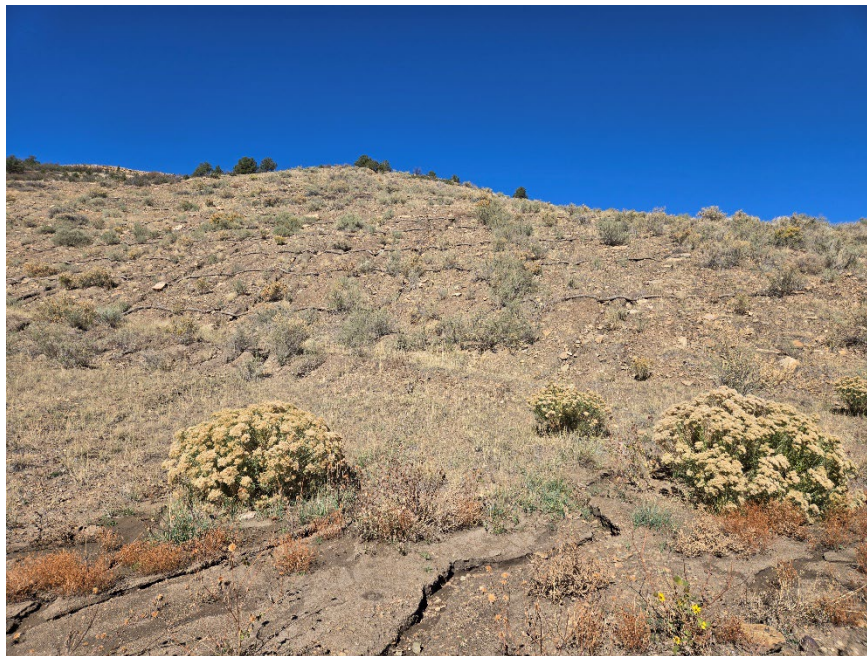
- The Reclaimed Area above and to the west of Pond 006a was observed (Photo 17). This area still requires maintenance (See Items 3 and 4 in the Ongoing Maintenance Items section on the first page of this report).

Photo 17: Reclaimed area to the west of Pond 006a. Run-off from reclaimed slopes is carrying sediment into and across the

road and depositing the sediment into the check dams.

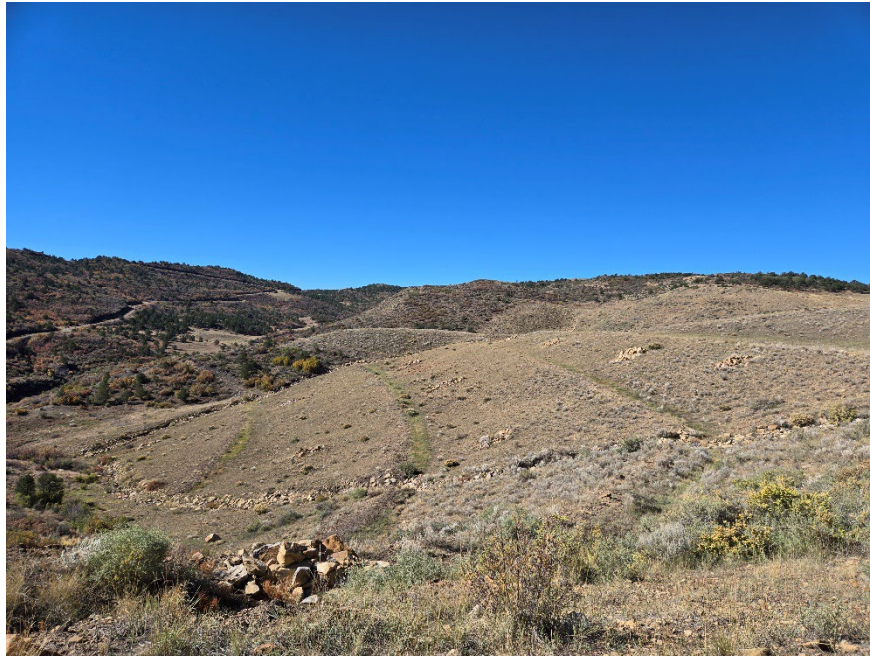
- Fill 7 was well vegetated and appeared stable (Photo 18).

Photo 18: Looking southwest at Fill 7.

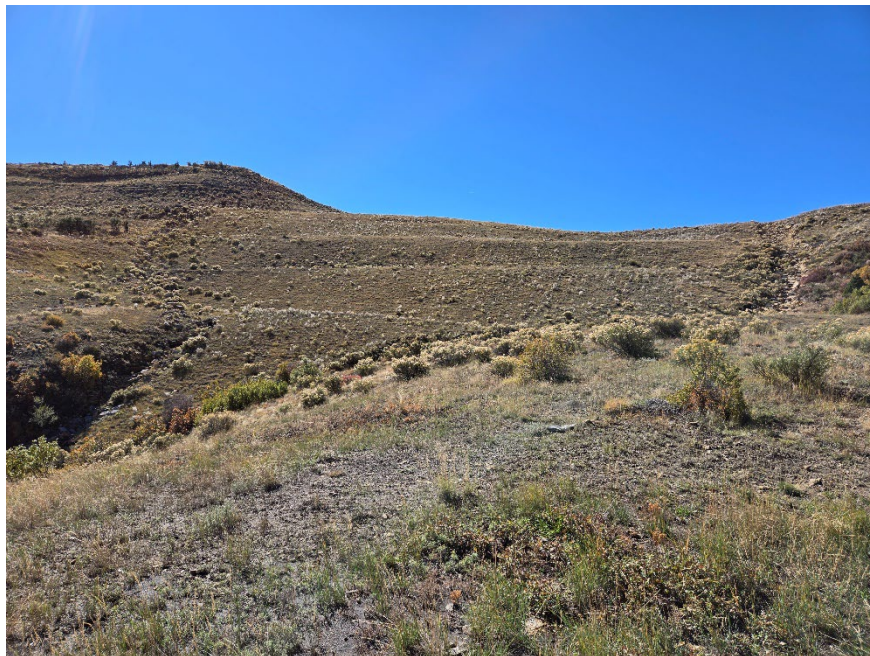
- Fill 8 was well vegetated and appeared stable (Photo 19).

Photo 19: Looking southeast at Fill 8.

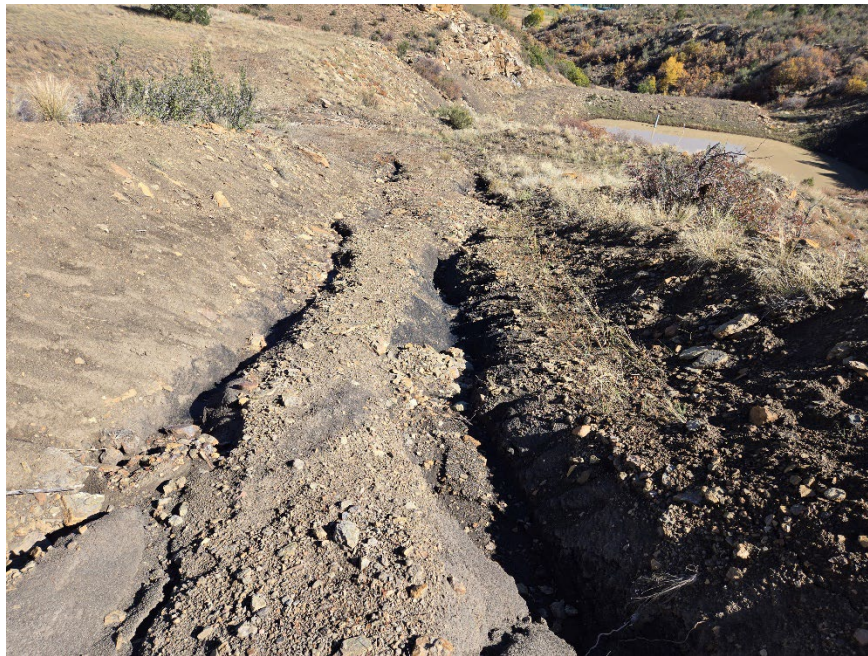
Photo 20: Looking north, down the access road to Pond 008.

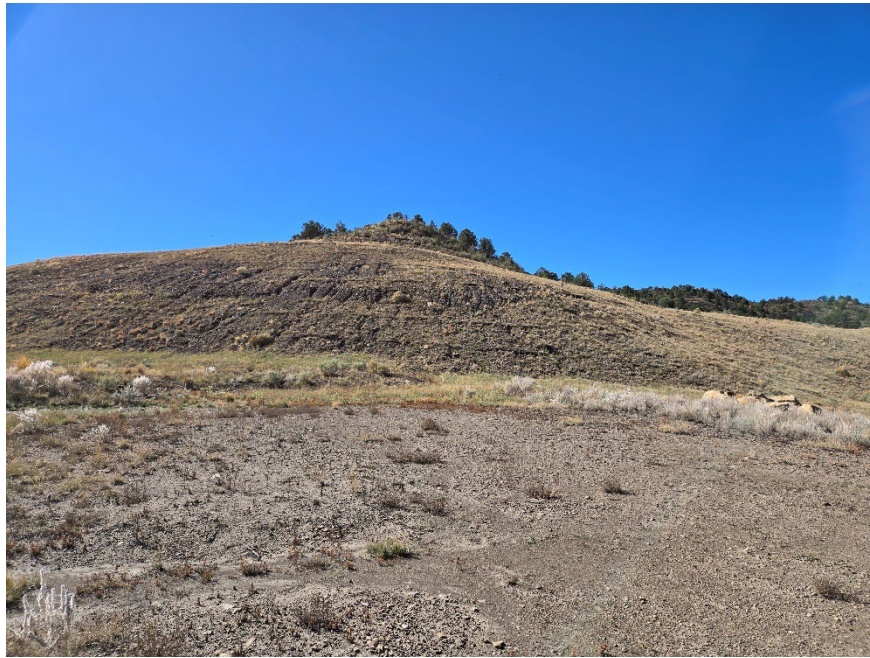
- The area above where NECC stores pond and ditch cleanings consists of a steep slope. This slope was observed during the inspection (Photo 21). Erosion rills and gullies were observed but the vegetation on this slope appears better established this year than in years previously observed by DRMS. NECC is encouraged to continue to monitor this area and conduct maintenance as needed.

Photo 21: Sediment drying area and seeded slope.

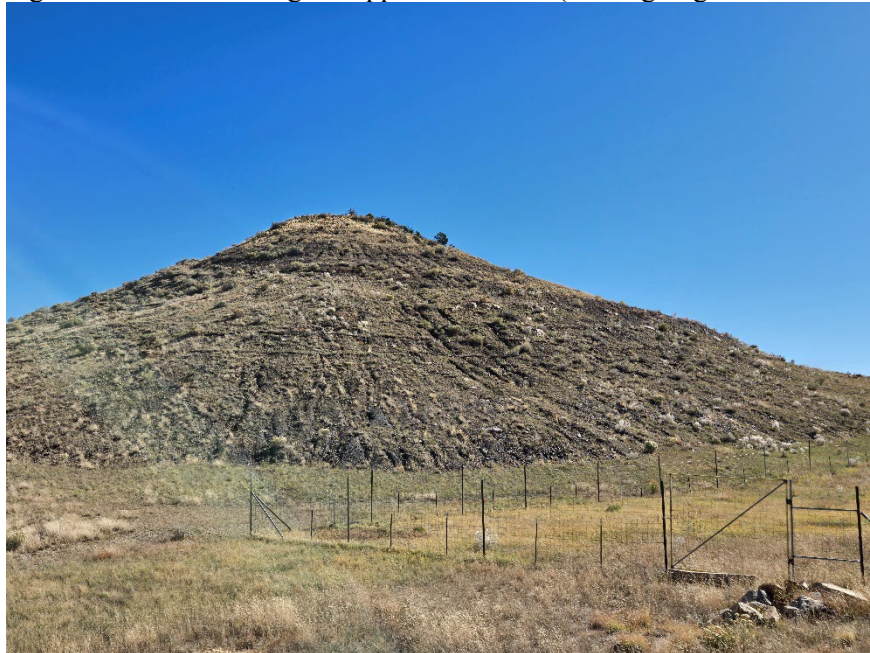
- A previously disturbed area north of Fill 7 and north of the road, referred to as “The Knob”, exhibits erosion on the south and west facing slopes (Photo 22). There is also a small catchment at the base of the slope that was holding water at the time of the inspection. NECC is required to provide a plan to stabilize this area through a revision following the approval of RN5 (see ongoing maintenance item number 4).

Photo 22: “The Knob” with rills that have formed on the less vegetated areas on the south and west facing slopes.

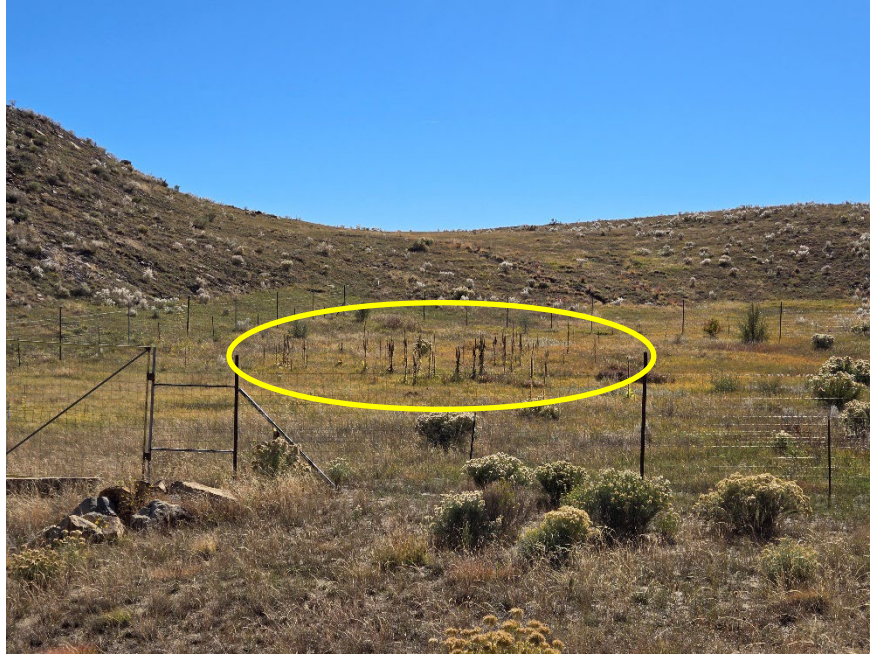
- An area designated as a vegetation test plot has been infested with Mullein (Photo 23). **The Operator shall treat and/or remove the Mullein within this area.**

Photo 23: Mullein growing in the test plot area southwest of “The Knob”.

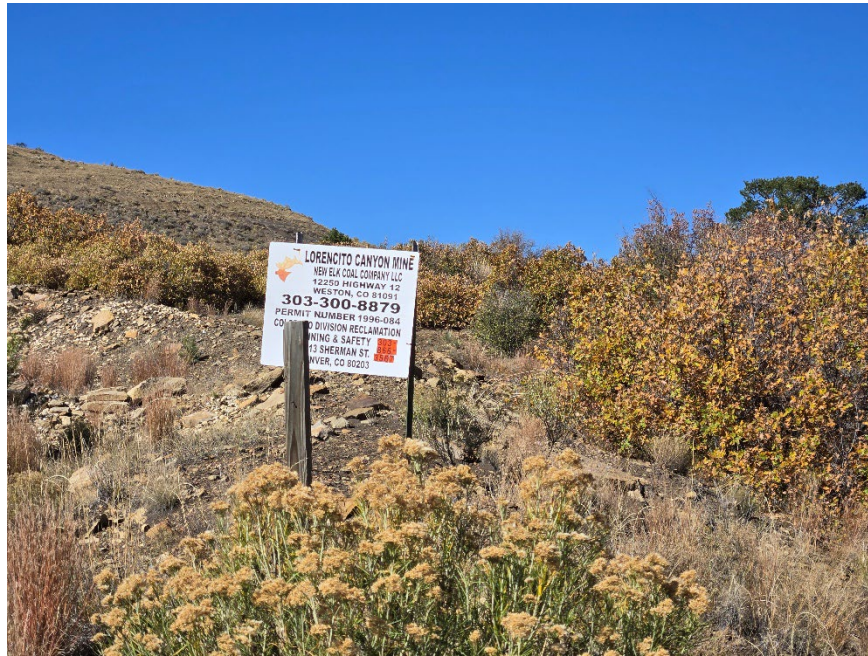
- Mine signs were posted at road entrances and at the entrance to permit boundary in compliance with Rule 4.02 (Photo 24).

Photo 24: Mine sign located at the permit boundary, south of Pond 009.
