To: Jerald Schnabel  
Castle Aggregate  
File: September 2024 Monitoring Summary

From: Paul Kos  
Denver, CO 80202  
Date: October 31, 2024

**Reference: September 2024 Geotechnical Monitoring Summary Pikeview Quarry**

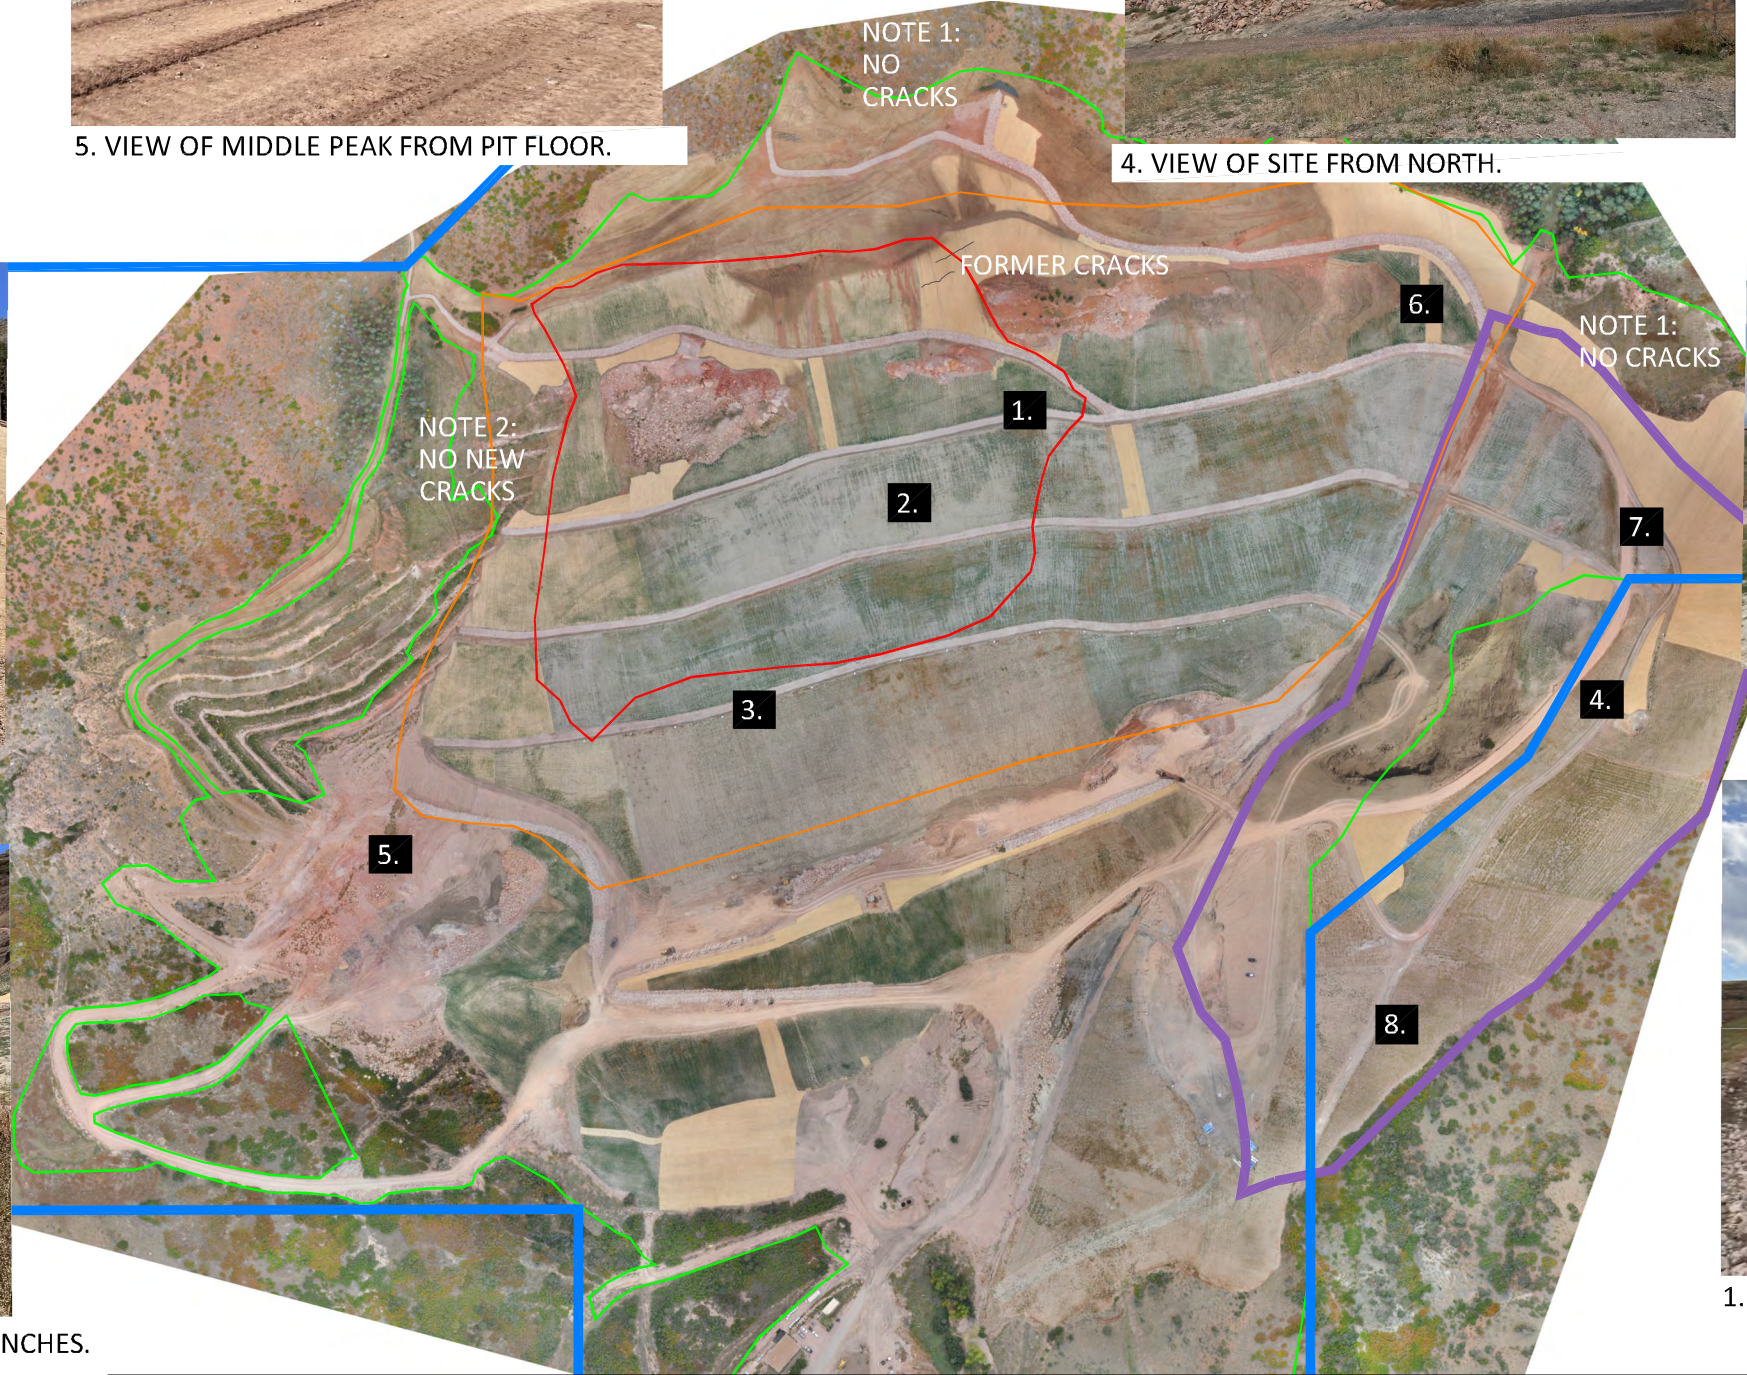
2. VEGETATION GROWING ON SLOPE.

1. NO CRACKS OBSERVED IN THIS AREA.
2. NO NEW CRACKS OBSERVED IN THIS AREA.
3. PHOTOS TAKEN SEPTEMBER 30, 2024.

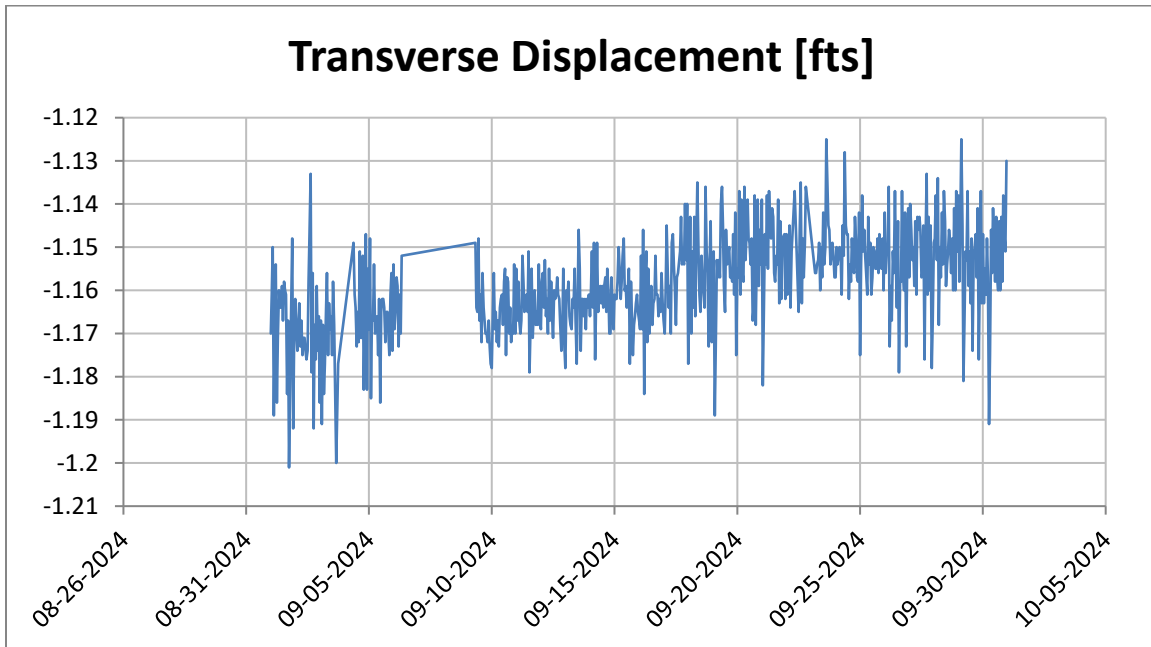
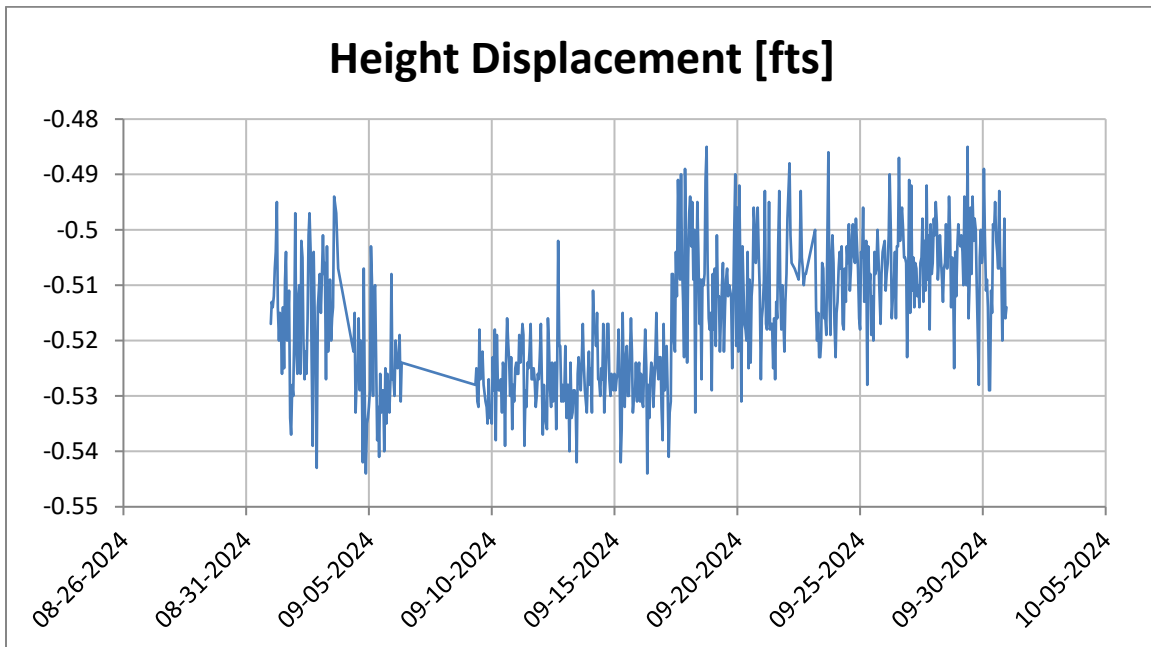
## Prism P70R

| Date(s) | Alert | Cause/Actions taken | Resolved |
|---|---|---|---|
| 17-Sep | P70R regression limits | Rain and fog. No work being performed at time of alerts. | 17-Sep |

| Prism ID | Cumulative Transverse Displacement (ft) | Cumulative Height Displacement (ft) | Monthly Delta (ft) | Cumulative Delta (ft) | Notes |
|---|---|---|---|---|---|
| P70R | -1.130 | -0.514 | -0.027 | 2.064 | |

1. Survey accuracy is  $\pm 0.016$  feet.
2. Alert threshold is  $\pm 0.35$  feet.
3. Transverse displacement is in the horizontal direction. Positive direction means closer to the robotic total station.
4. Height displacement is in the vertical direction. Positive direction means higher in elevation.
5. Regression limit alert received on September 17.

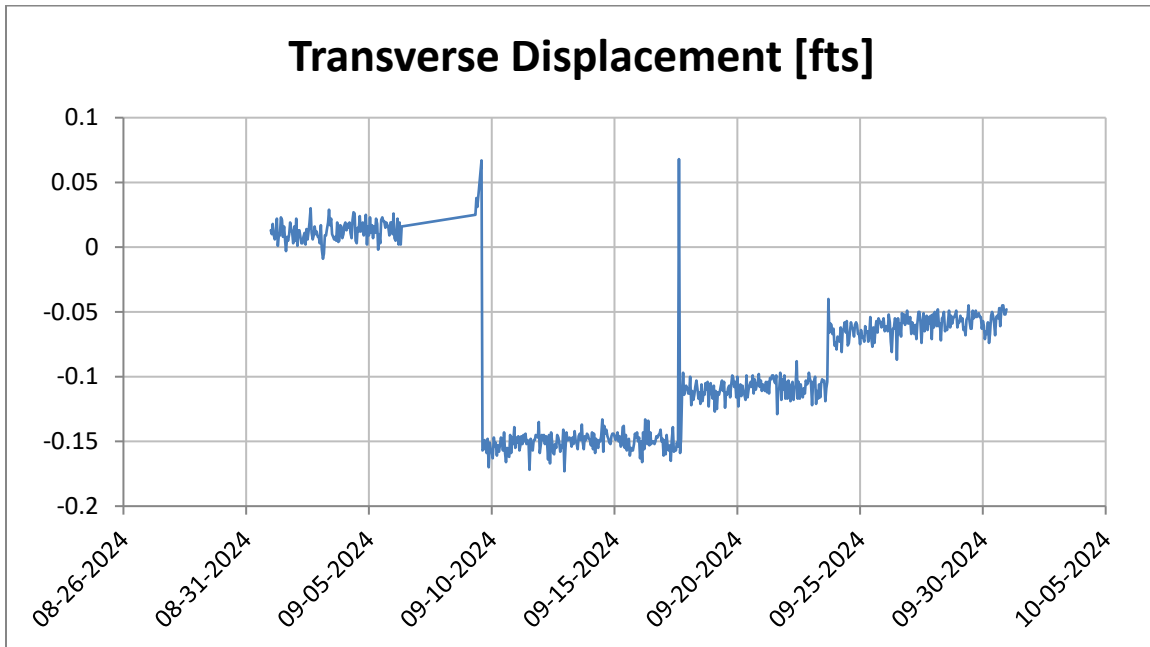
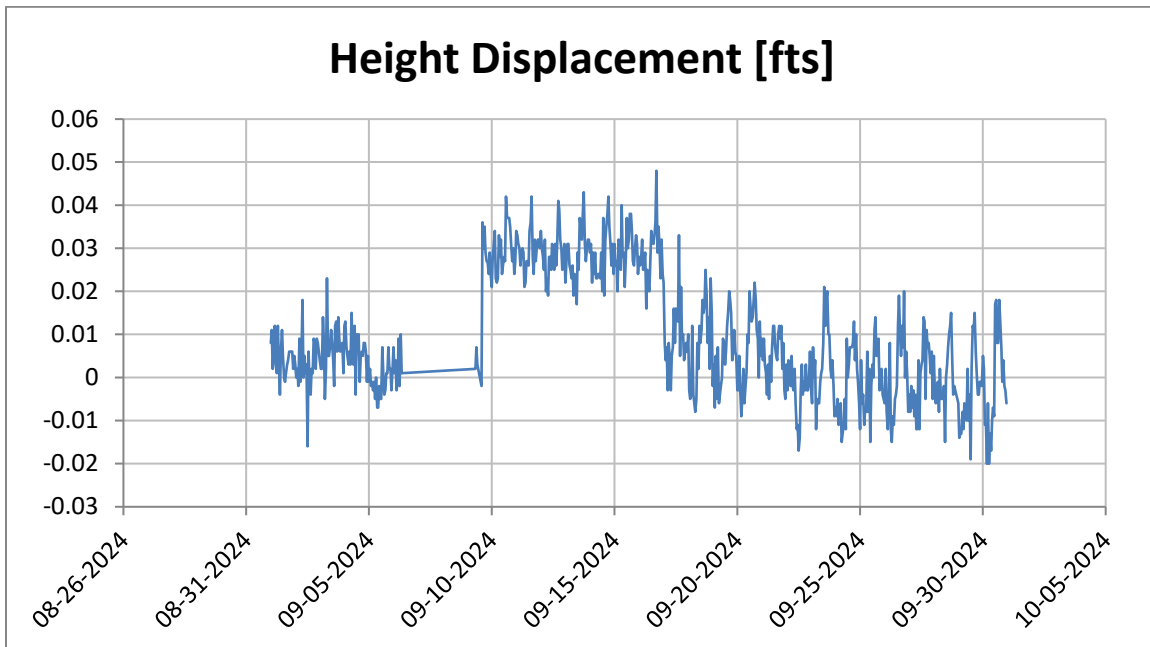
## Prism B7700-1

| Date(s) | Alert | Cause/Actions taken | Resolved |
|---|---|---|---|
| 9-Sep | B7700-1 not found | Equipment operations in area moved prism out of alignment. Operators watching out for each other. | 9-Sep |

| Prism ID | Cumulative Transverse Displacement (ft) | Cumulative Height Displacement (ft) | Monthly Delta (ft) | Cumulative Delta (ft) | Notes |
|---|---|---|---|---|---|
| B7700-1 | -0.048 | -0.006 | 0.038 | 0.054 | Prism impacted by workers. |

1. Survey accuracy is +/-0.016 feet.
2. Alert threshold is +/-0.35 feet.
3. Transverse displacement is in the horizontal direction. Positive direction means closer to the robotic total station.
4. Height displacement is in the vertical direction. Positive direction means higher in elevation.
5. Prism was impacted by construction workers on September 9 and then realigned.
6. Rain and fog caused erroneous data on September 17.

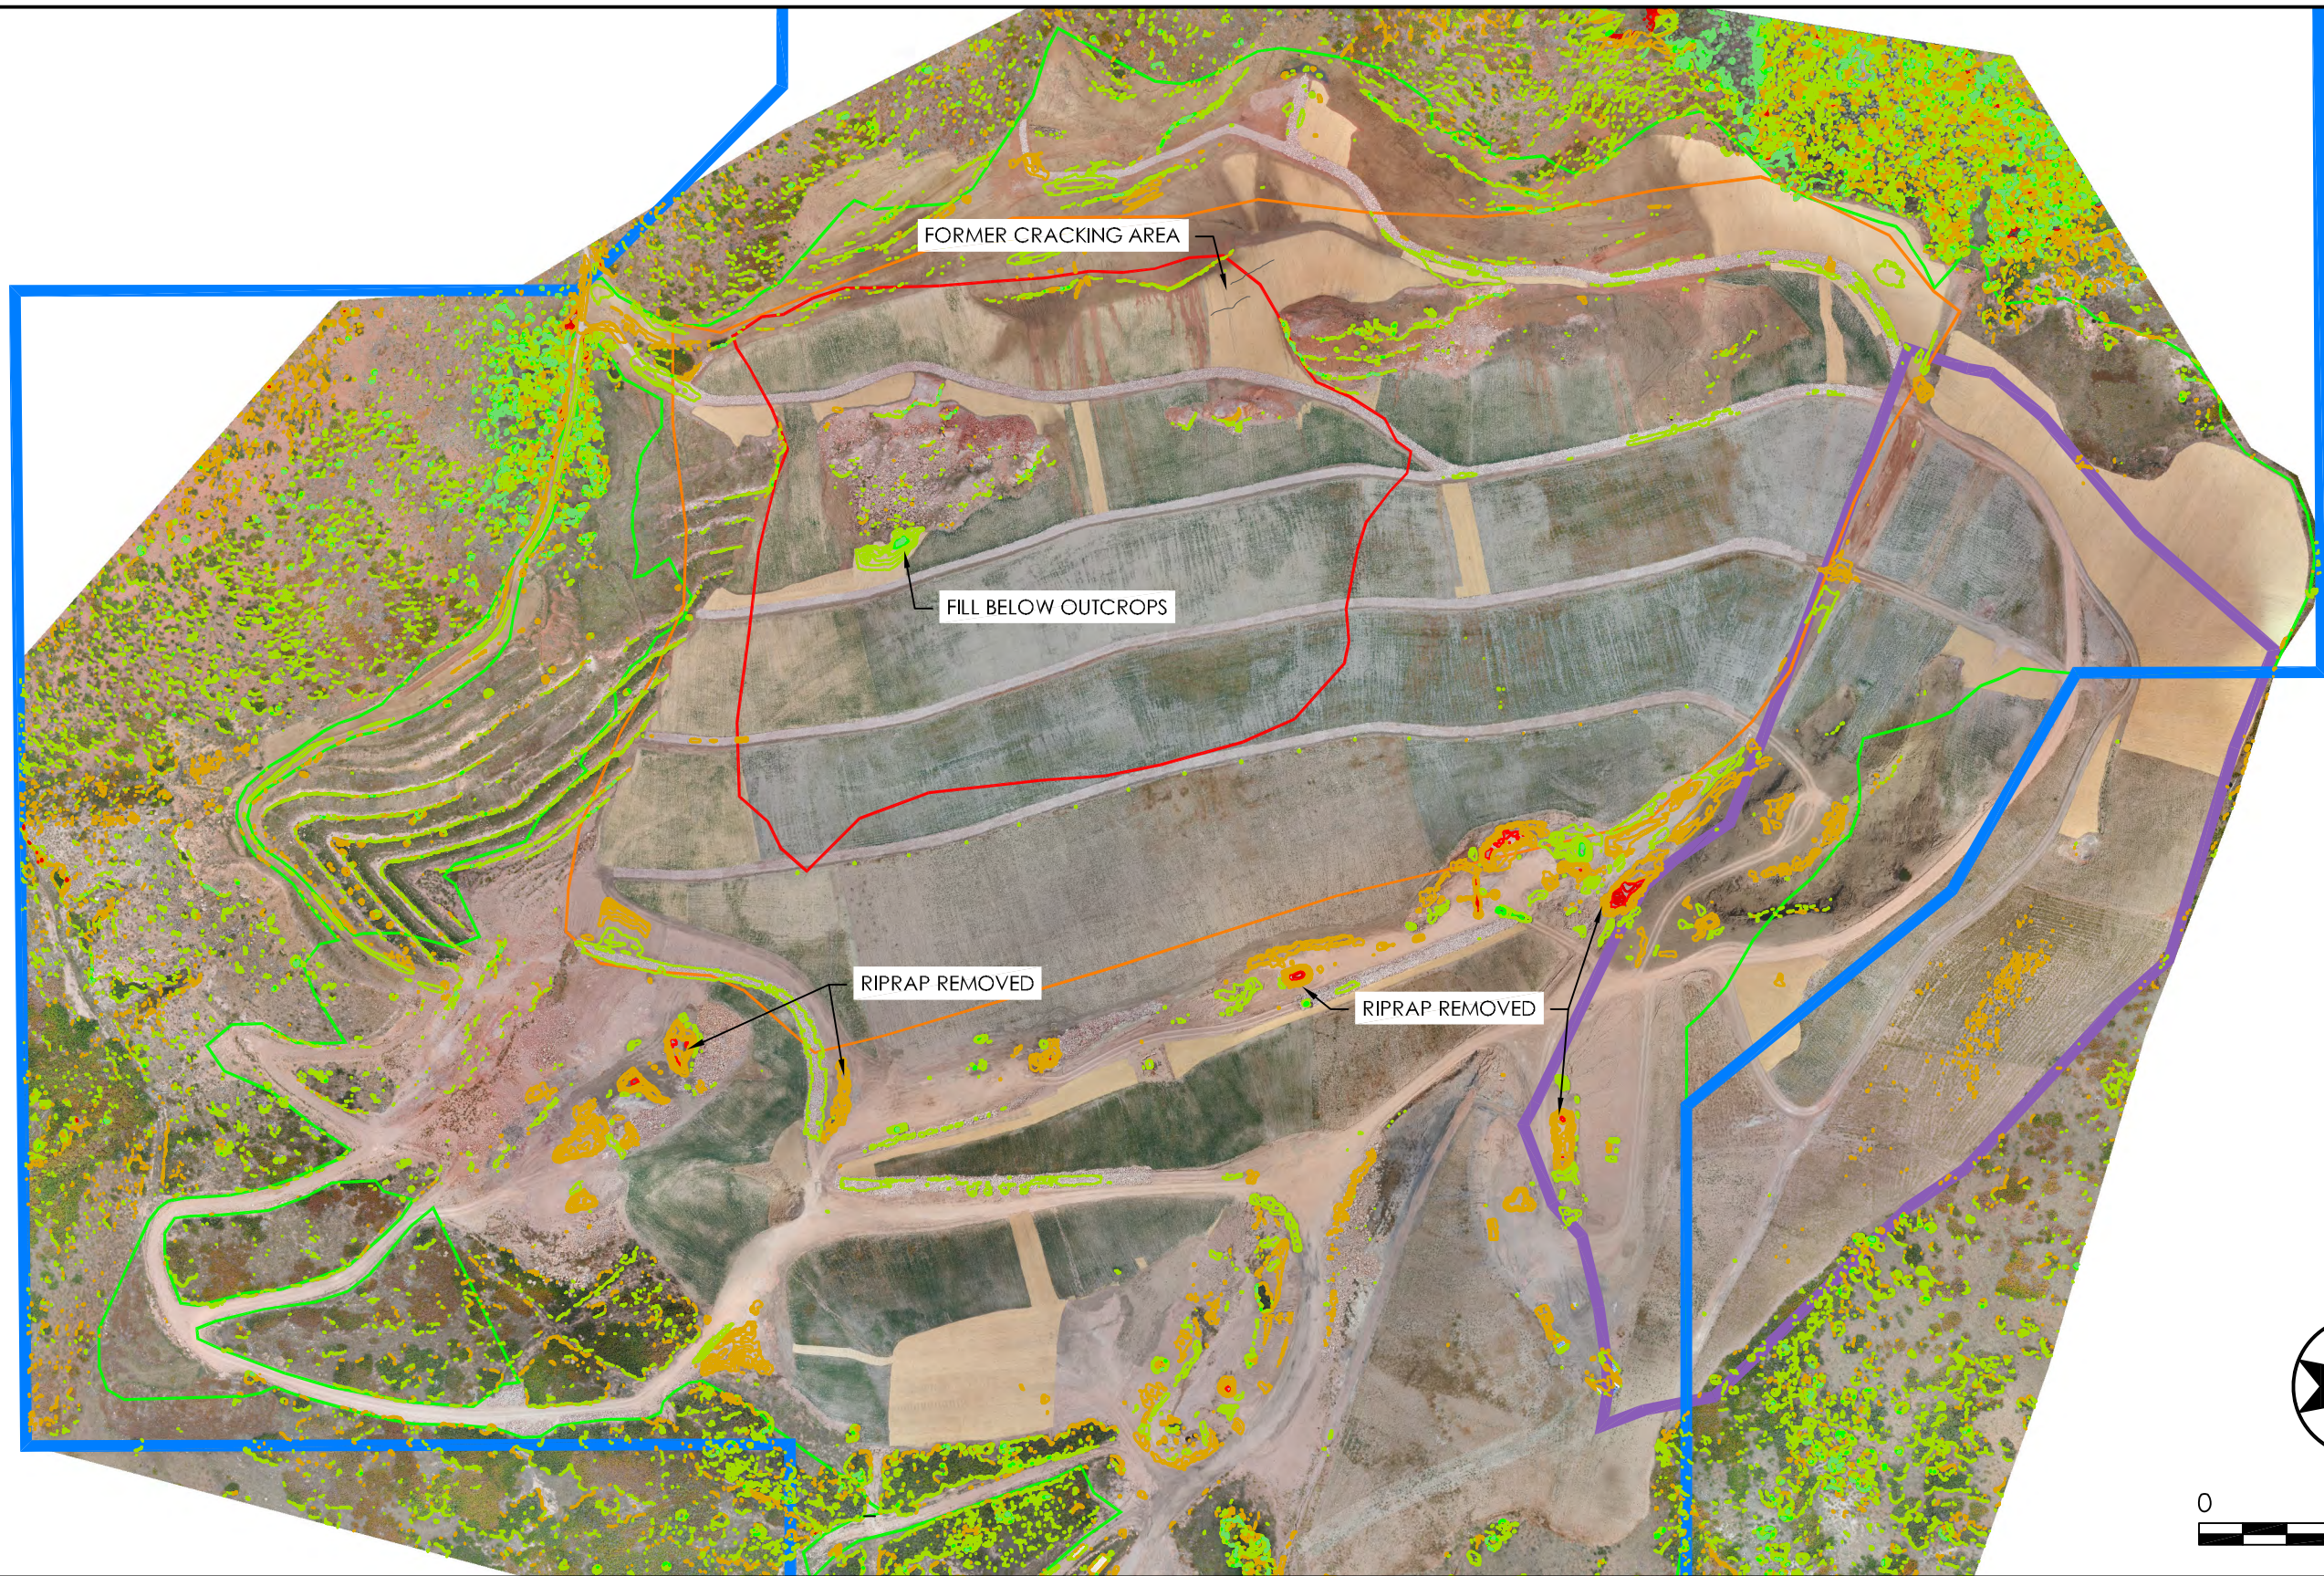
Drone Survey

The September topography was also compared to the August topography to identify changes in the site topography. Comparison of the two surveys showed no slope movements or other changes in topography other than related to recent earthworks and revegetation activities. No slope movements were recorded in the area where cracking was observed. The current imagery and topography are included in Figures 1 and 2, and the comparison surface is included as Figure 4 in Appendix C.

As previously reported in the September 2020 monitoring report, there are limitations with the method of comparing drone surveys from different months. The drone data indicate changes in the slopes along each of the reclamation benches, buildings, and areas with trees or shrubs. These areas are stable, and the changes are the result of survey limitations on or near vertical slopes.
