MINERALS PROGRAM INSPECTION REPORT
PHONE: (303) 866-3567

MINE NAME: Burns Ranch Property	MINE/PROSPECTING ID#: M2024-051	MINERAL: Unknown	COUNTY: Weld
INSPECTION TYPE: Possible Illegal, Unpermitted Operation	WEATHER: Clear	INSP. DATE: October 17, 2024	INSP. TIME: 10:30
OPERATOR: Van Cleave	OPERATOR REPRESENTATIVE: Colby Van Cleave	TYPE OF OPERATION: ILL – Illegal (Possible)	
REASON FOR INSPECTION: Citizen Complaint	BOND CALCULATION TYPE: None	BOND AMOUNT: NA	
DATE OF COMPLAINT: NA	POST INSP. CONTACTS: None	JOINT INSP. AGENCY: None	
INSPECTOR(S): Patrick Lennberg	INSPECTOR'S SIGNATURE:

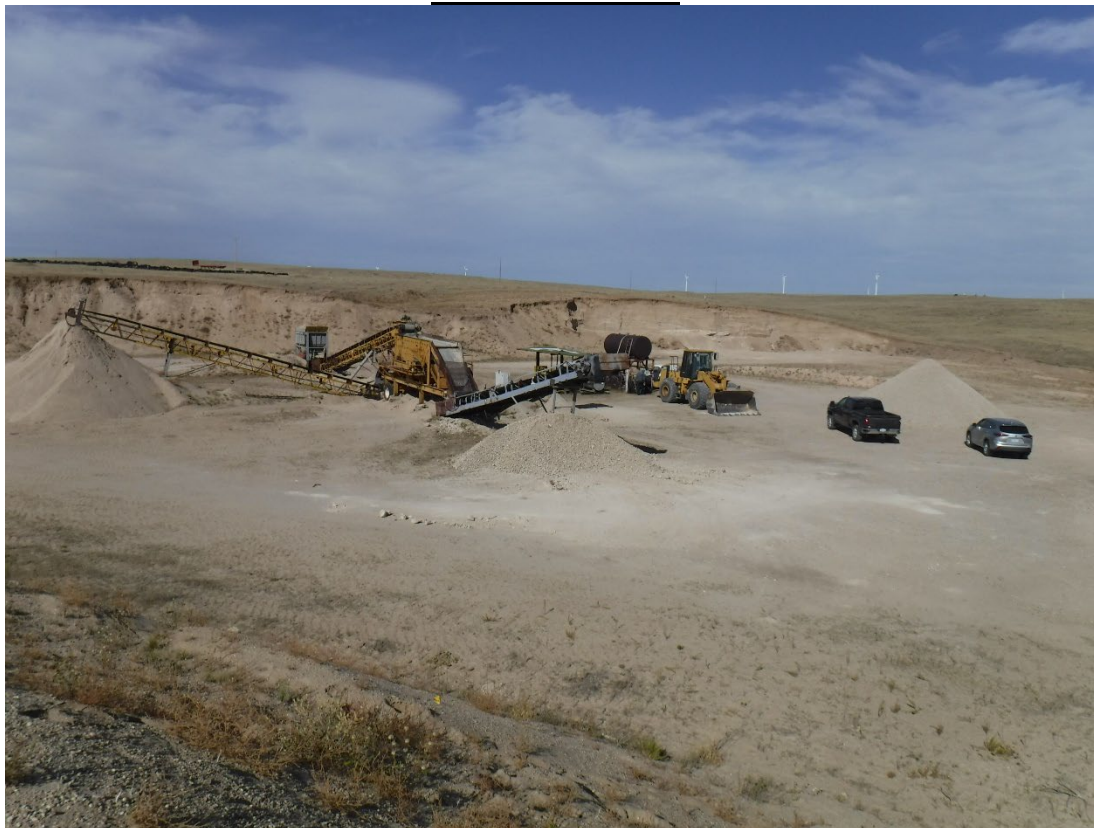
Photo 1: Processing area

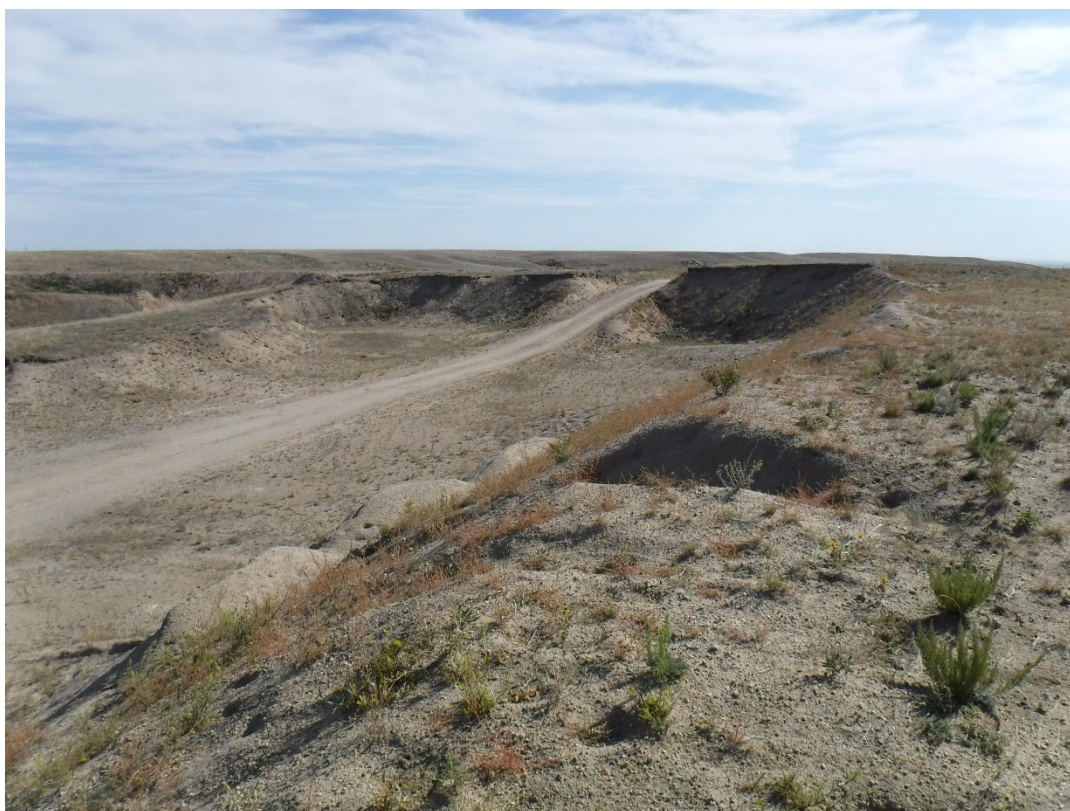
Photo 2: Haul road leading to extraction and processing area

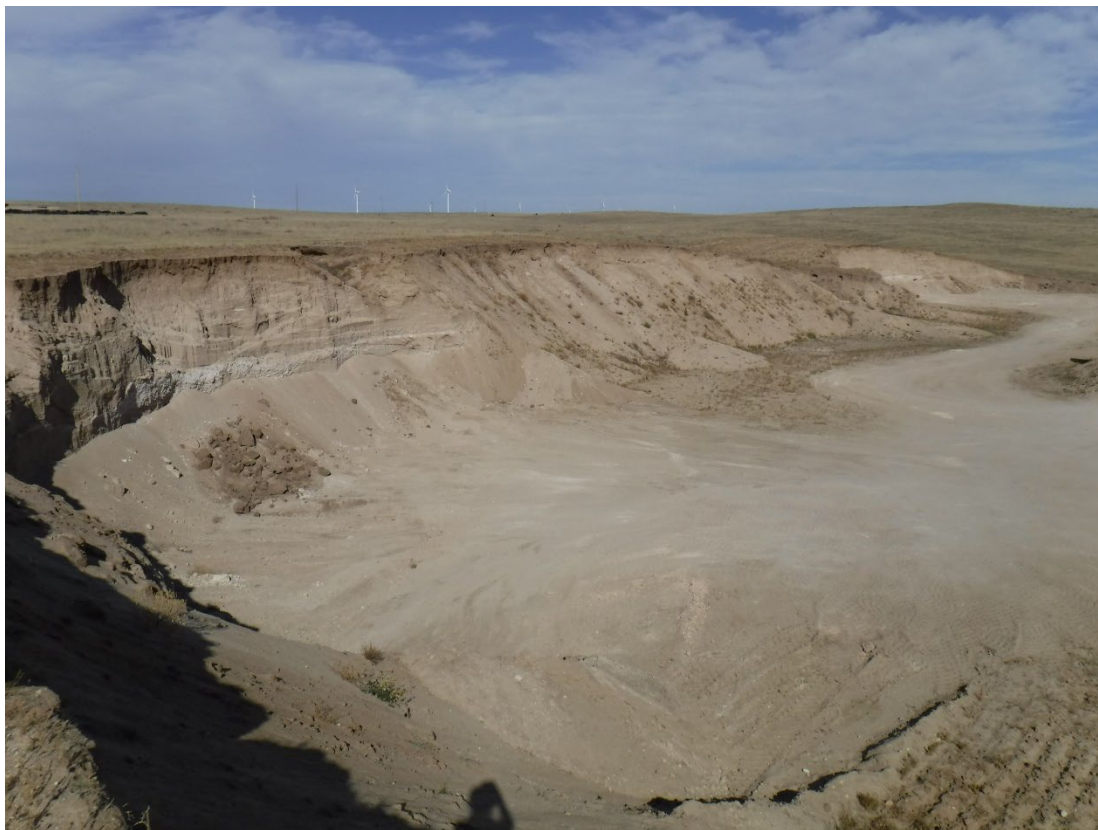
Photo 3: Typical extraction face looking north-northwest, approximately 15-feet in height

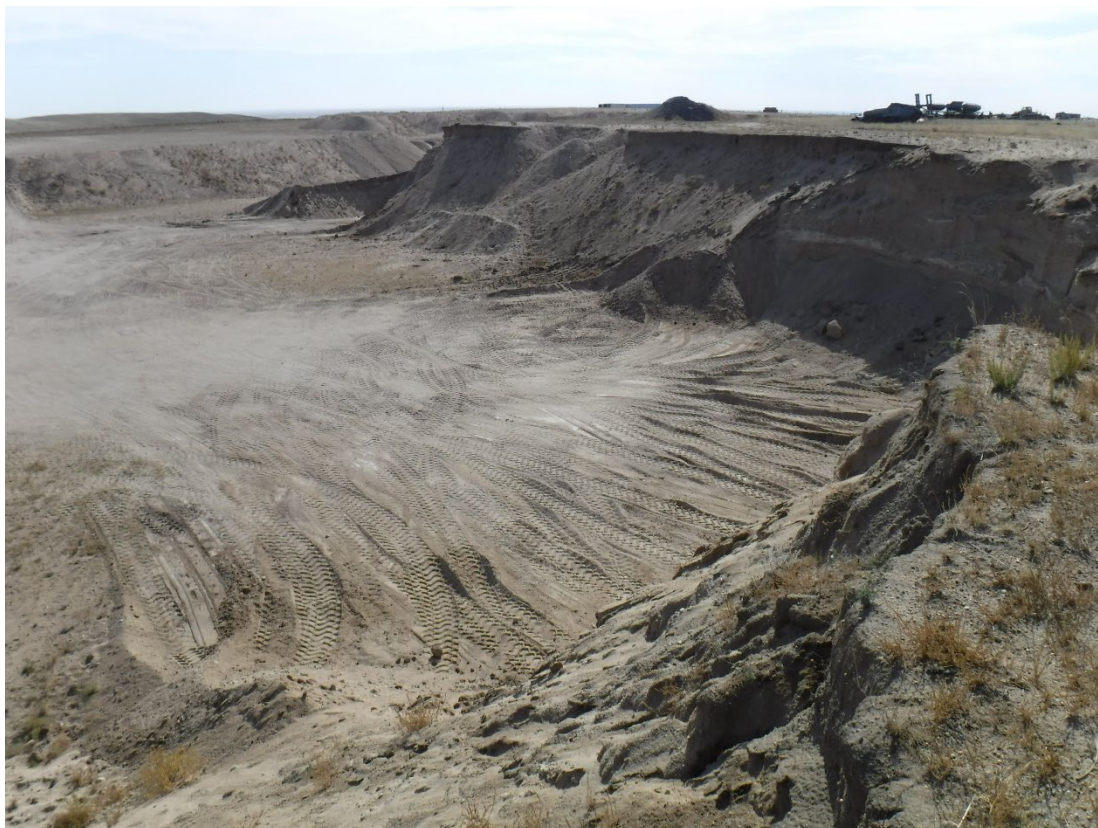
Photo 4: Typical extraction face looking south-southeast, approximately 15-feet in height

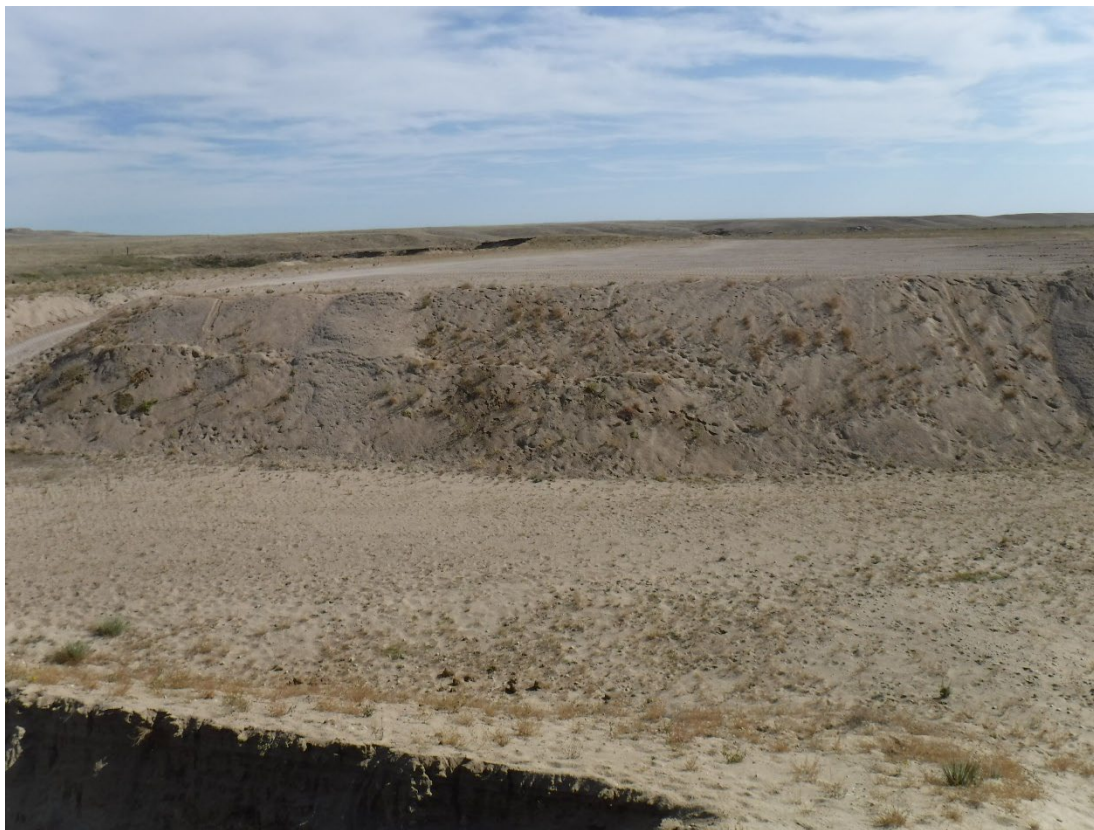
Photo 5: Fine-grained material currently being used to level surrounding area

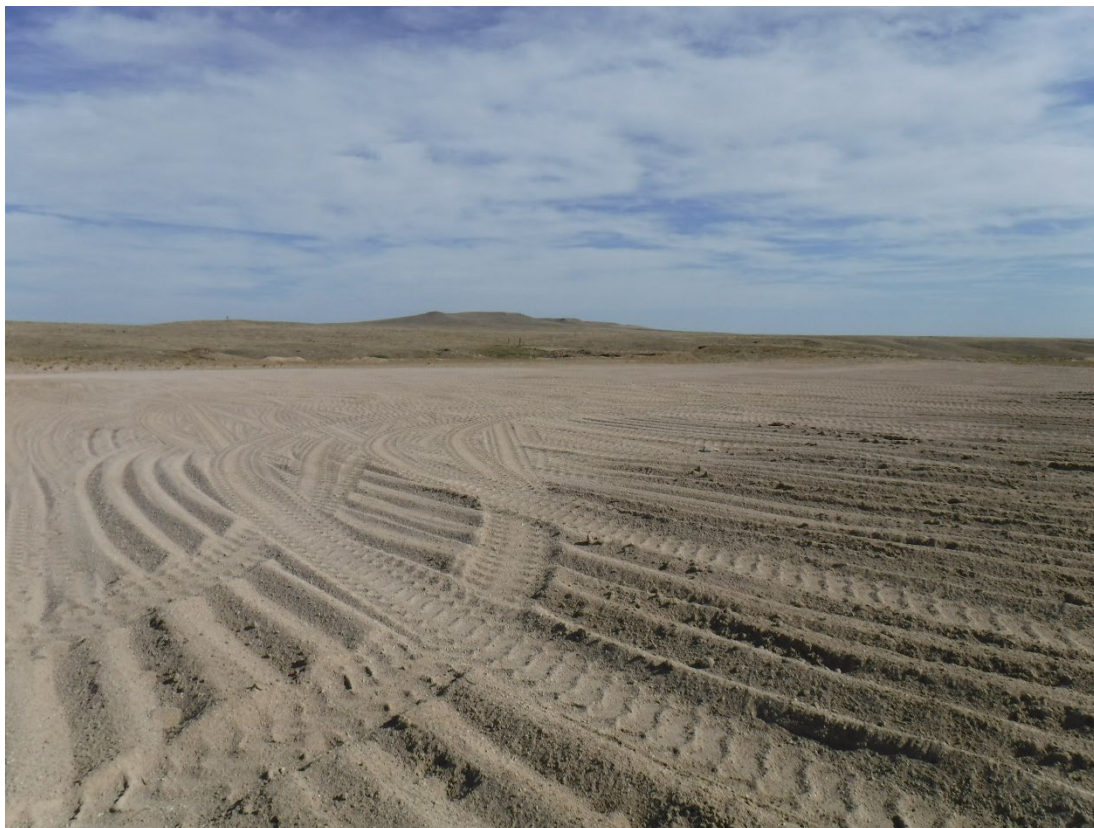
Photo 6: Graded top of fine-grained material placed by Van Cleave's

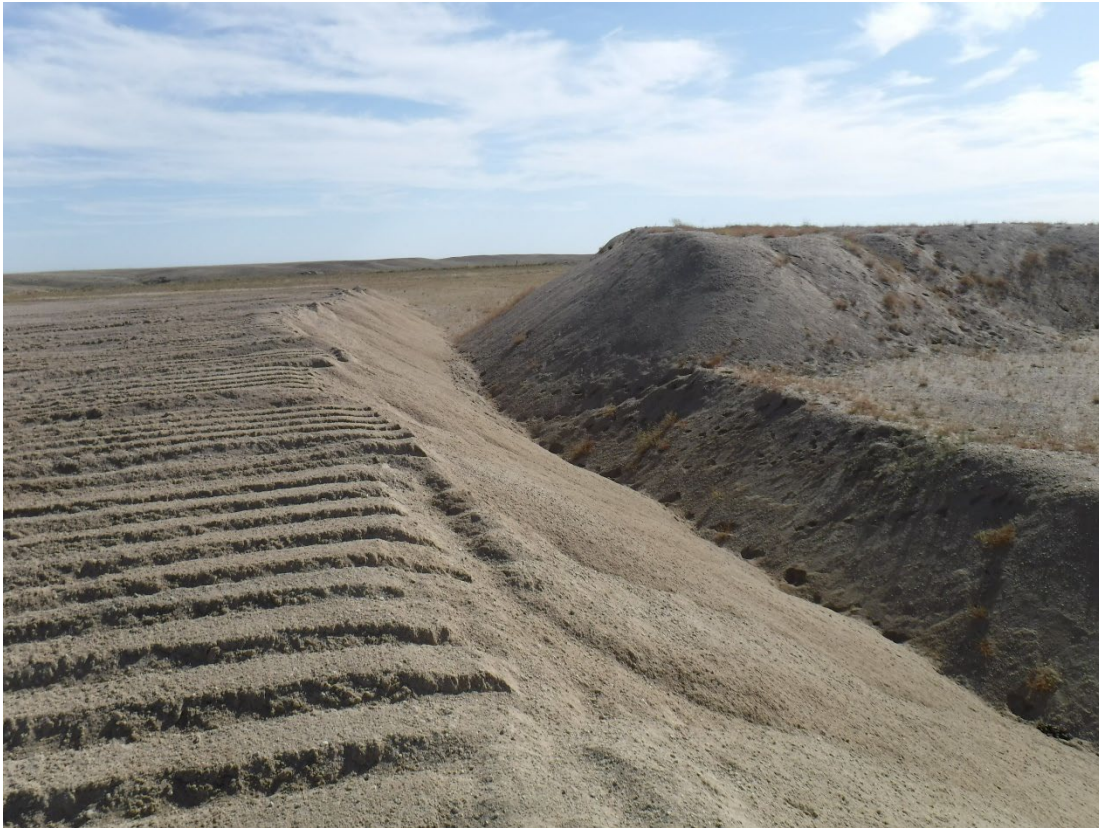
Photo 7: Photo of the fine-grained material placed by Van Cleaves (left) and landowner (right)

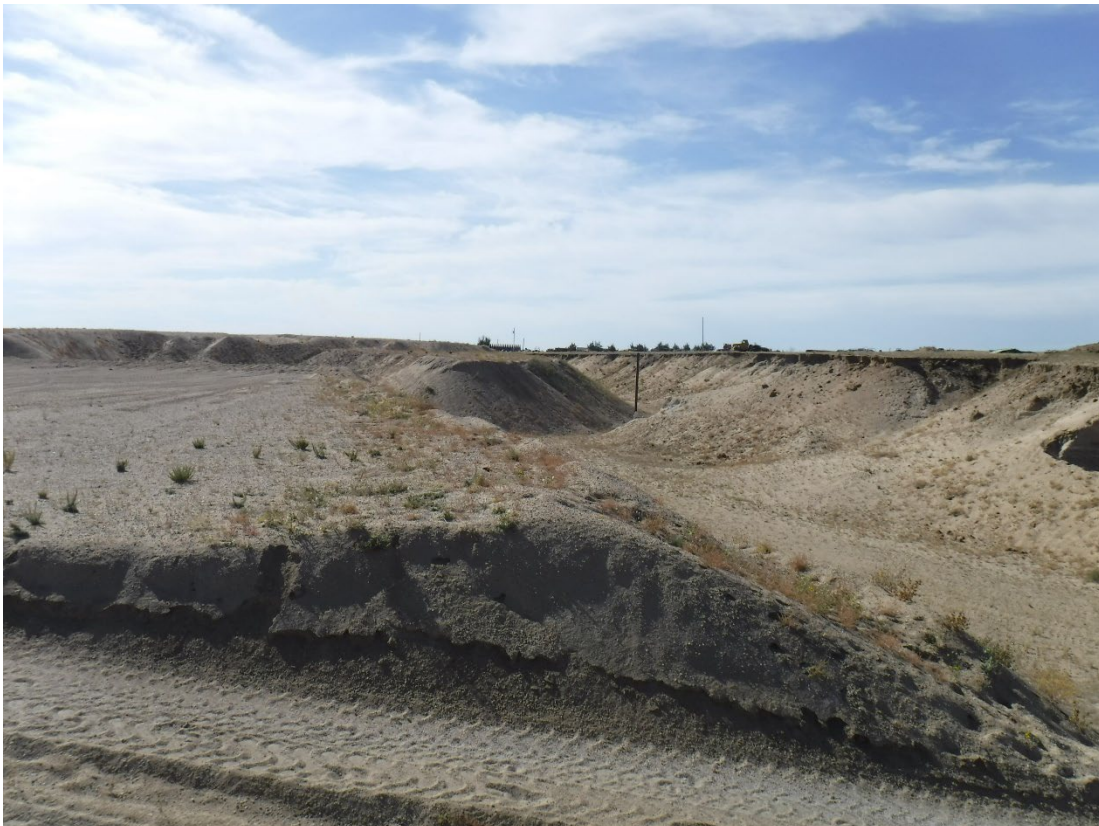
Photo 8: Looking south along the axis of extraction performed by the landowner

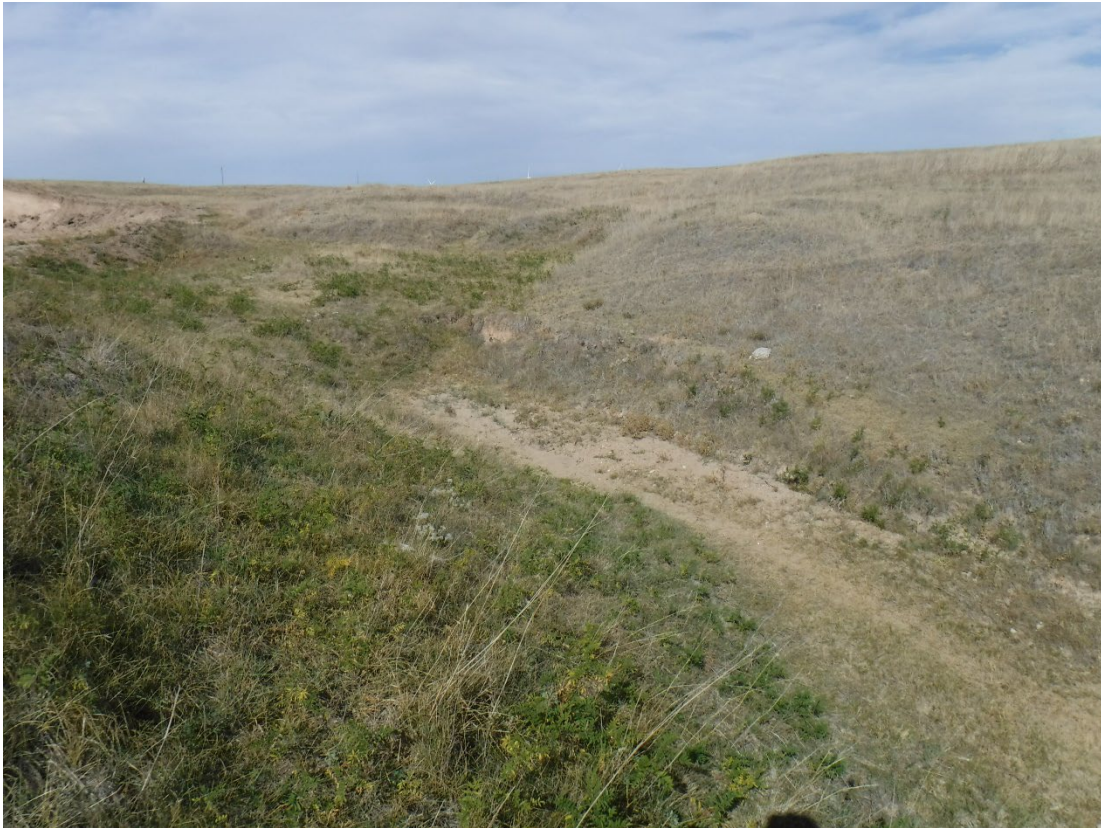
Photo 9: Looking upgradient along the ephemeral drainage

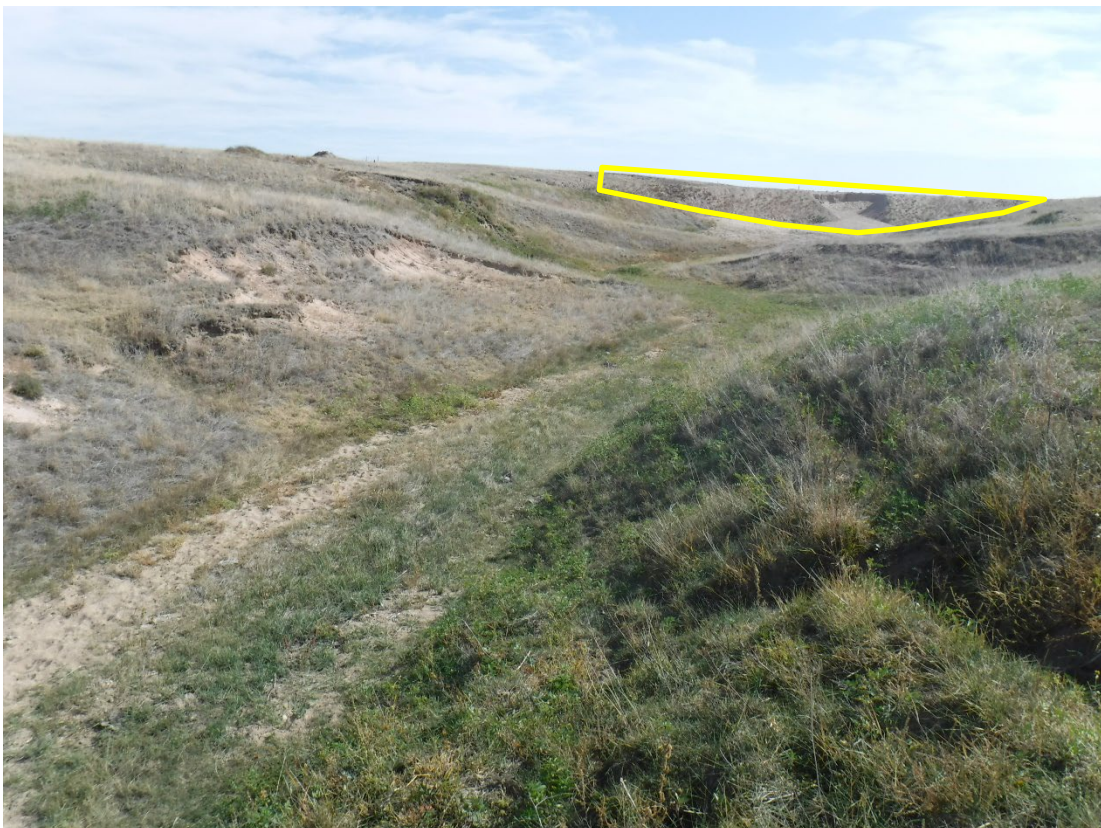
Photo 10: Looking downgradient along the ephemeral drainage, constructed dam outlined yellow

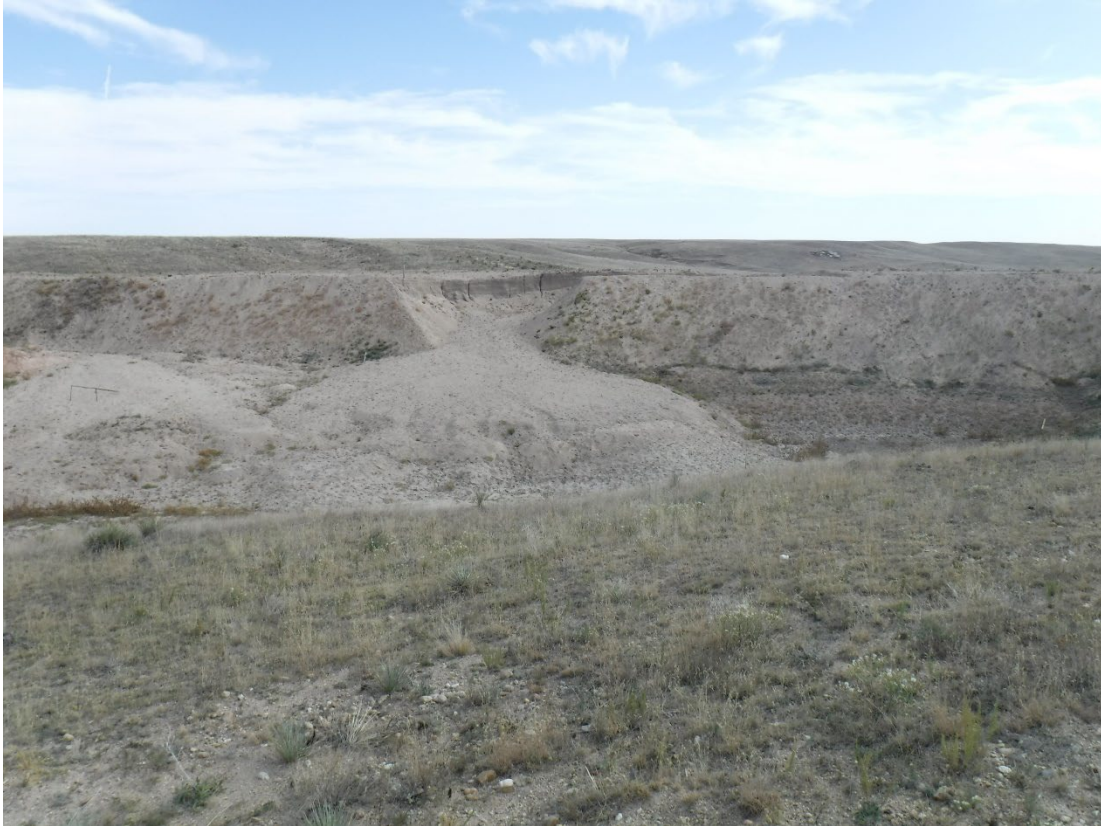
Photo 11: The dam approximately 20 feet in height, the dam has suffered from erosion depositing material at the upstream toe of slope

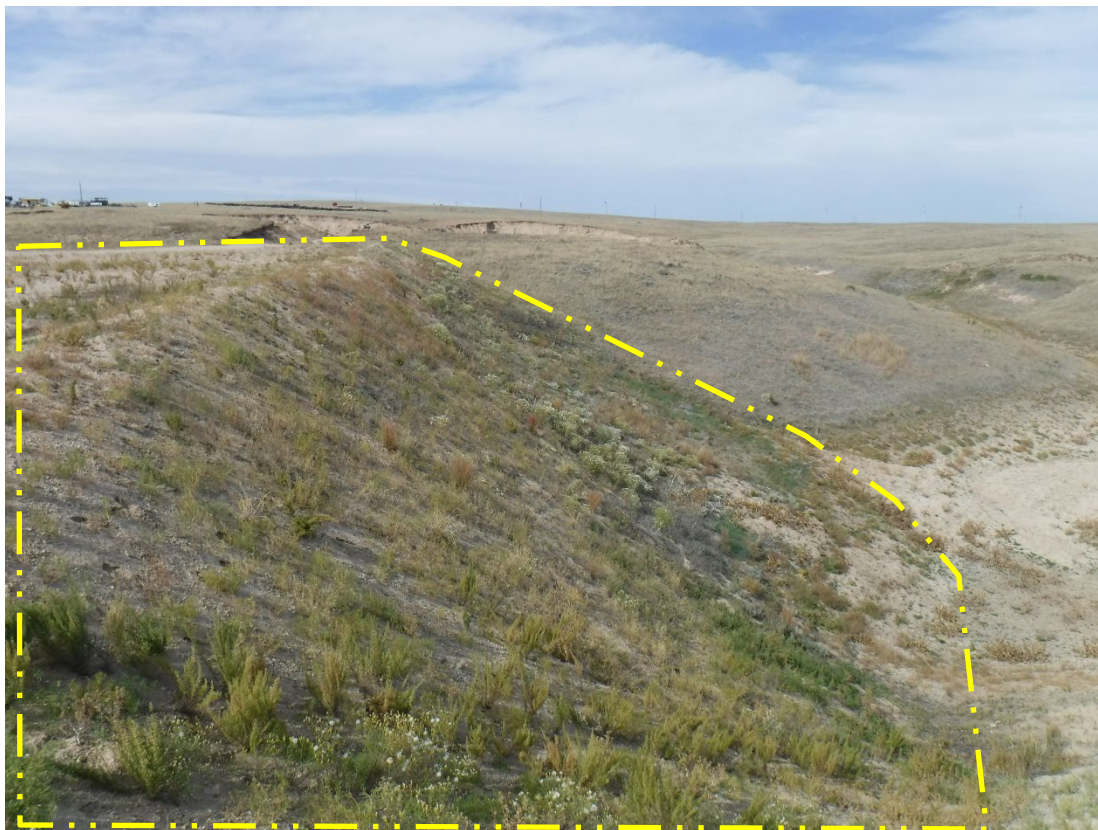
Photo 13: Looking west from south end of dam, material outlined in yellow has been placed by landowner during pervious land leveling activities

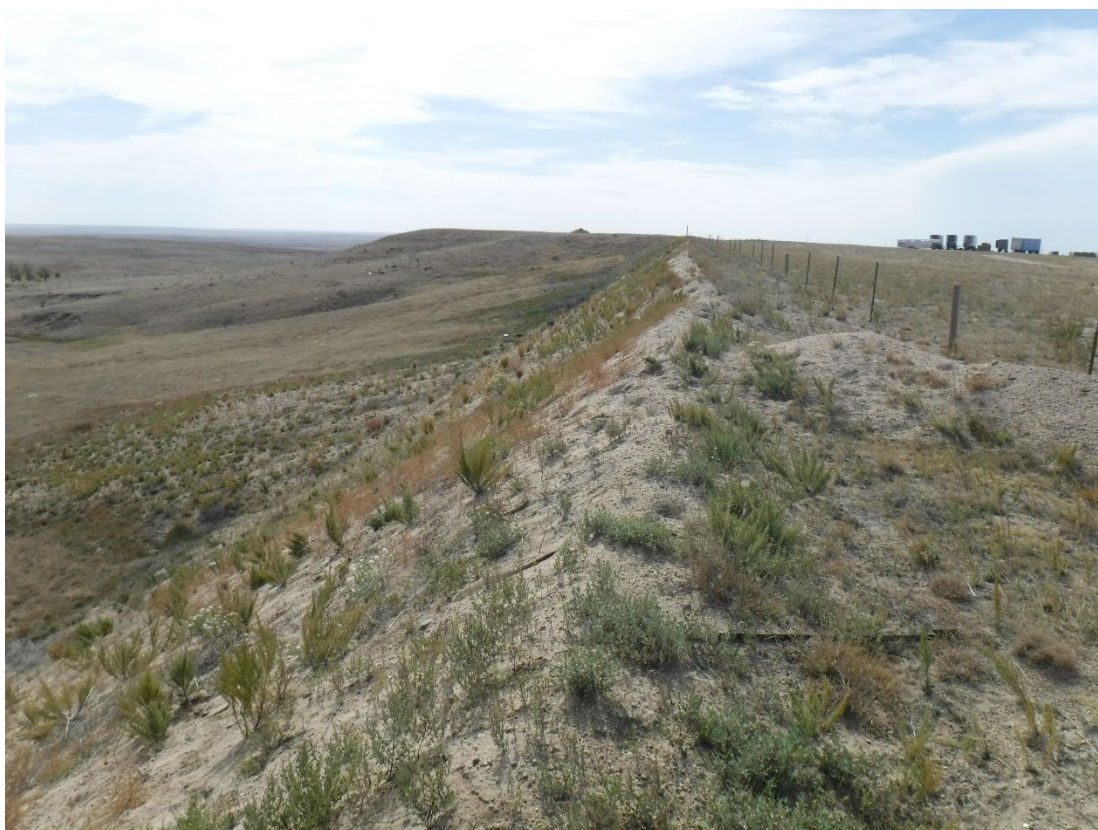
Photo 14: Looking south from south end of dam along downgradient slope of material placed for leveling

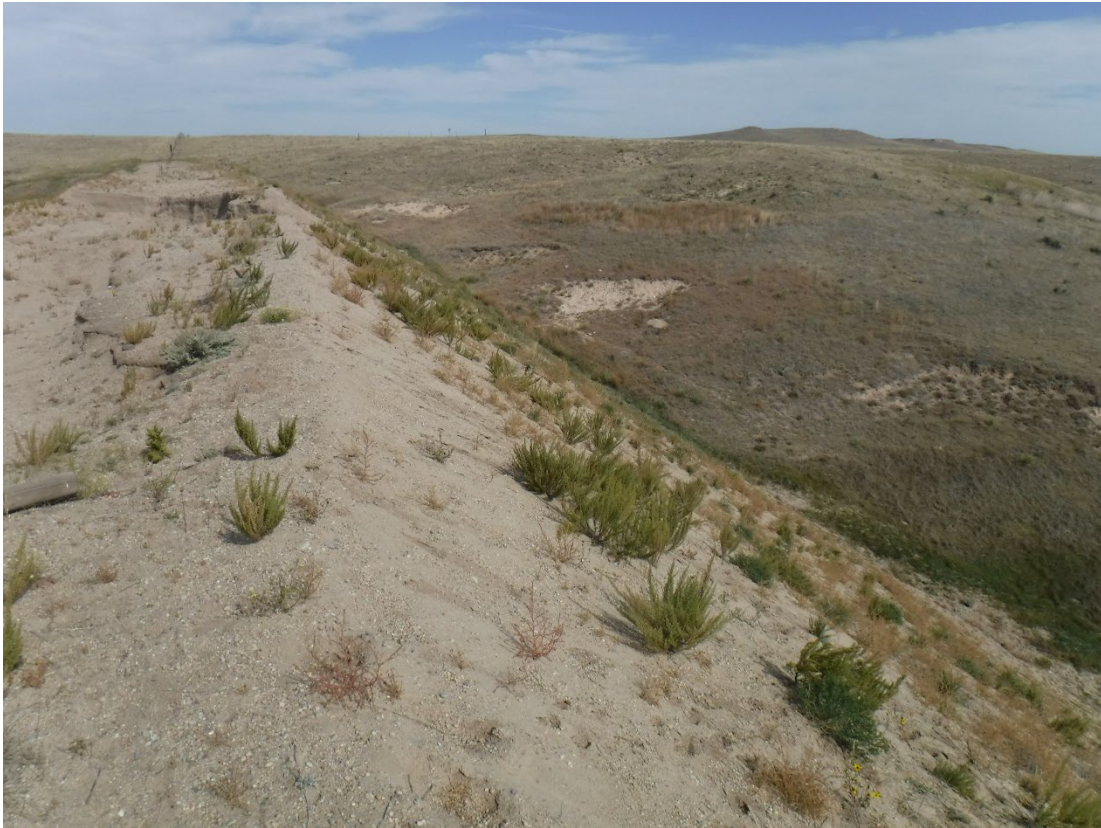
Photo 15: Looking north along downgradient slope dam

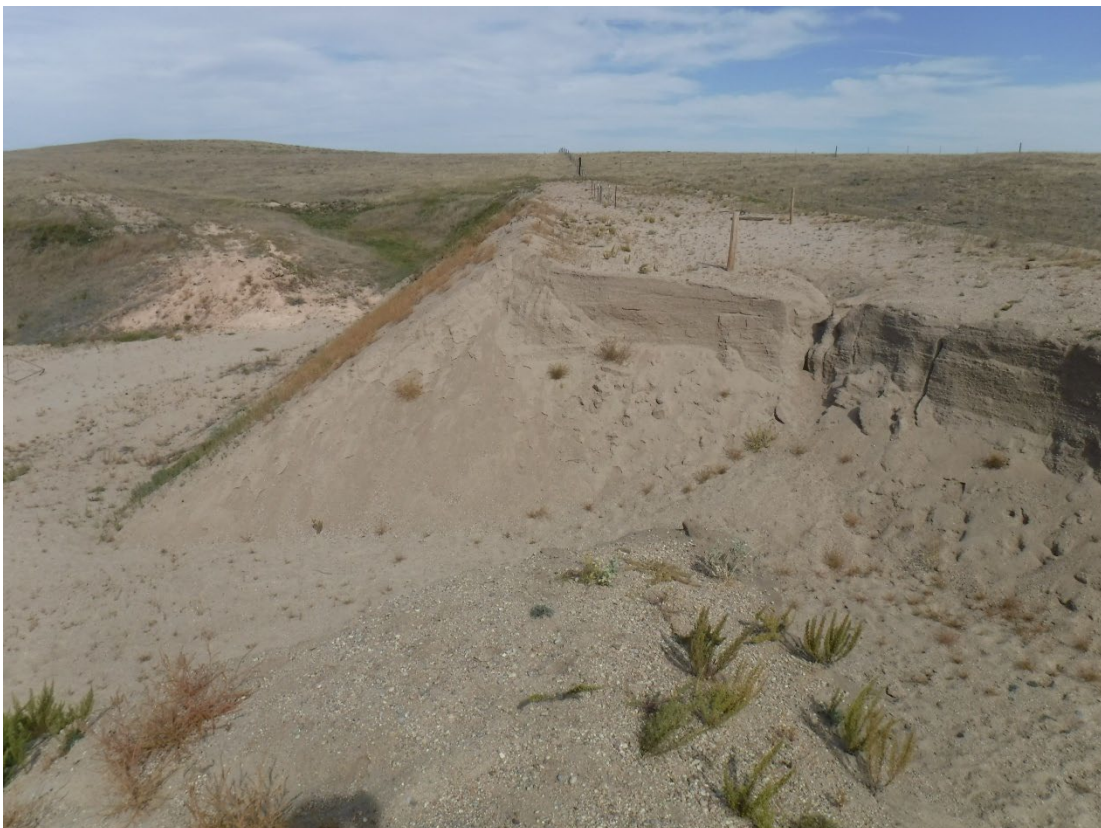
Photo 16: Erosion feature of the dam

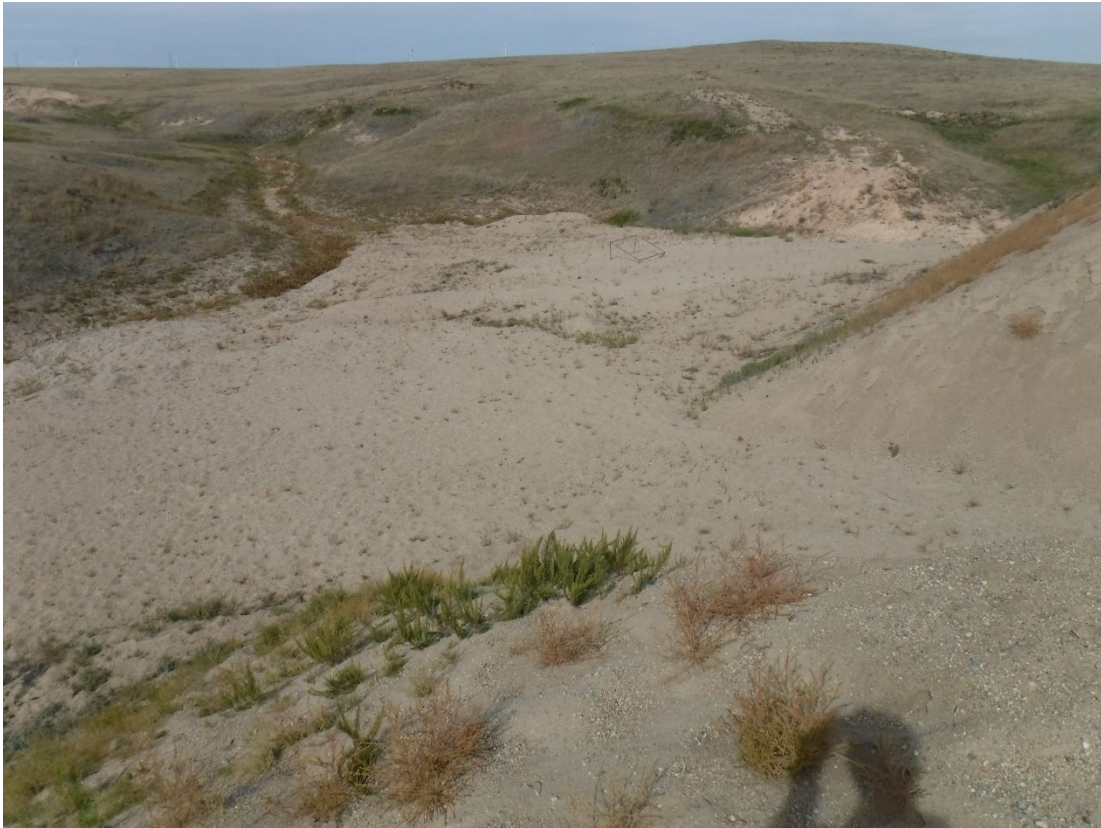
Photo 17: Erosion deposition in drainage

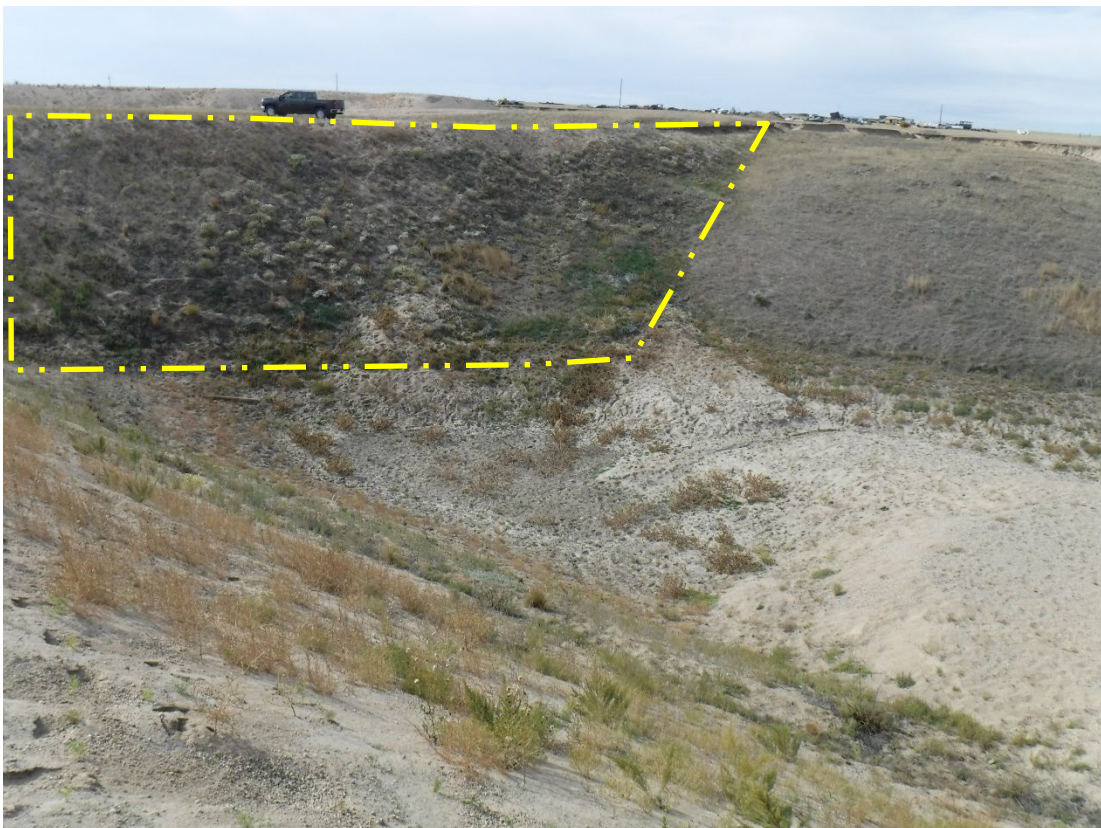
Photo 18: Material outlined in yellow has been placed by landowner during pervious land leveling activities
