MINERALS PROGRAM INSPECTION REPORT
PHONE: (303) 866-3567

MINE NAME: Climax Mine	MINE/PROSPECTING ID#: M-1977-493	MINERAL: Molybdenum	COUNTY: Lake, Summit
INSPECTION TYPE: Monitoring	WEATHER: Clear	INSP. DATE: October 30, 2024	INSP. TIME: 13:00
OPERATOR: Climax Molybdenum Company, Climax Mine	OPERATOR REPRESENTATIVE: Alex Ungers	TYPE OF OPERATION: 112d-3 - Designated Mining Operation	
REASON FOR INSPECTION: Normal I&E Program	BOND CALCULATION TYPE: None	BOND AMOUNT: \$91,011,850.00	
DATE OF COMPLAINT: NA	POST INSP. CONTACTS: None	JOINT INSP. AGENCY: None	
INSPECTOR(S): Dustin Czapla	INSPECTOR'S SIGNATURE:

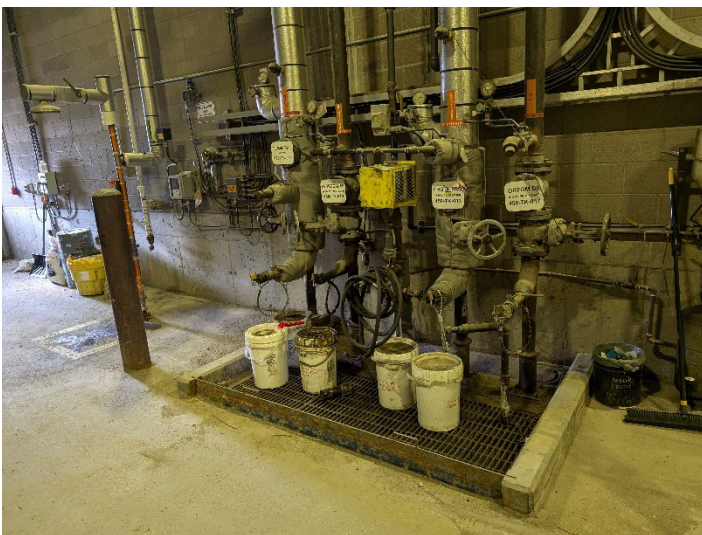
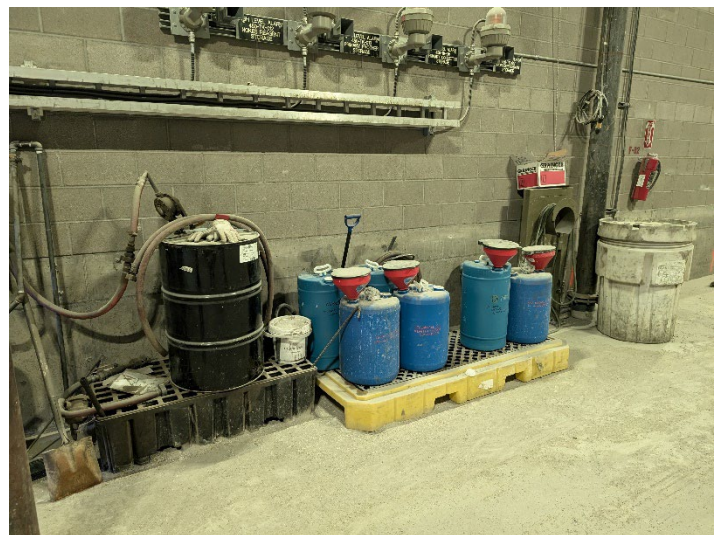
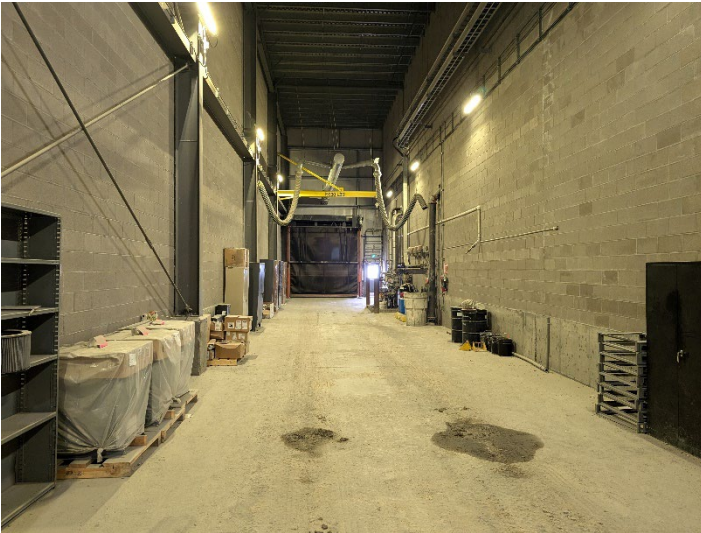
Mill Chemicals Reagent Transfer Area

The Reagent Storage Room and transfer bay were observed to be in excellent condition. The transfer bay was clean, neat and well kept. The pipes and delivery systems appeared to be in good working order and no evidence of spillage during transfer was noted. The sump associated with the transfer station was clean and free from obstruction. The transfer bay is sloped towards the interior of the mill facility providing for secondary containment should any spillage occur.

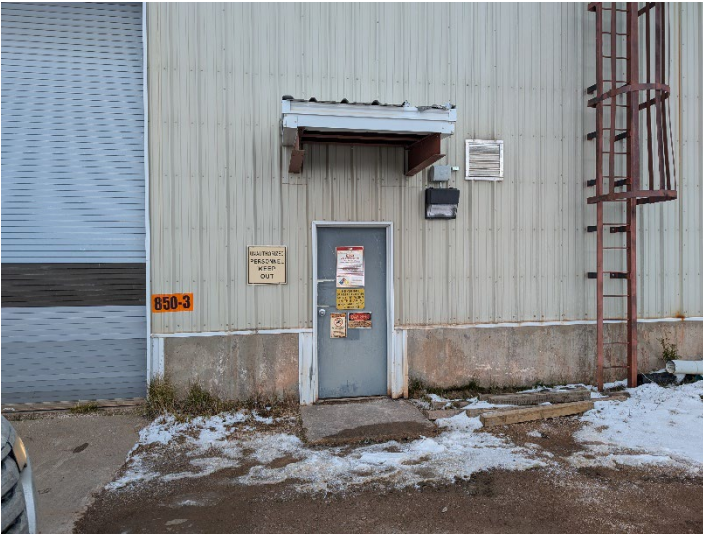
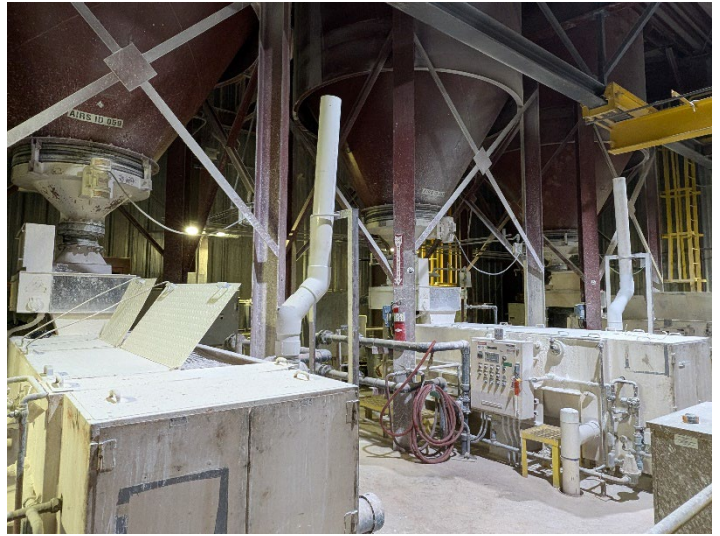
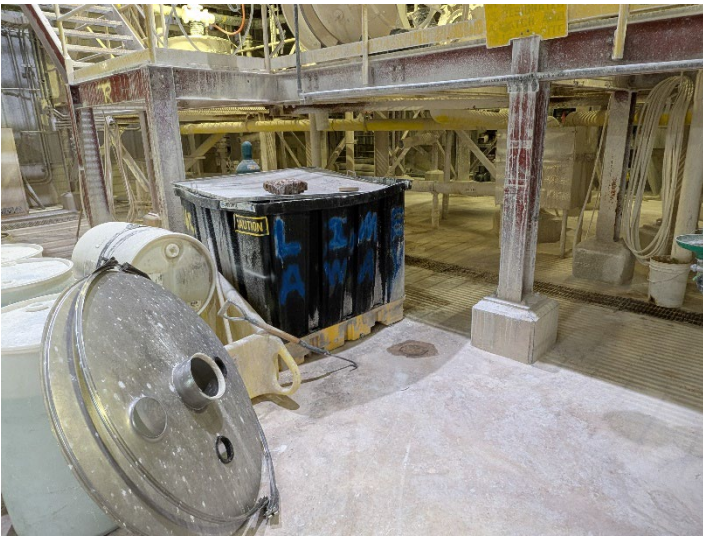
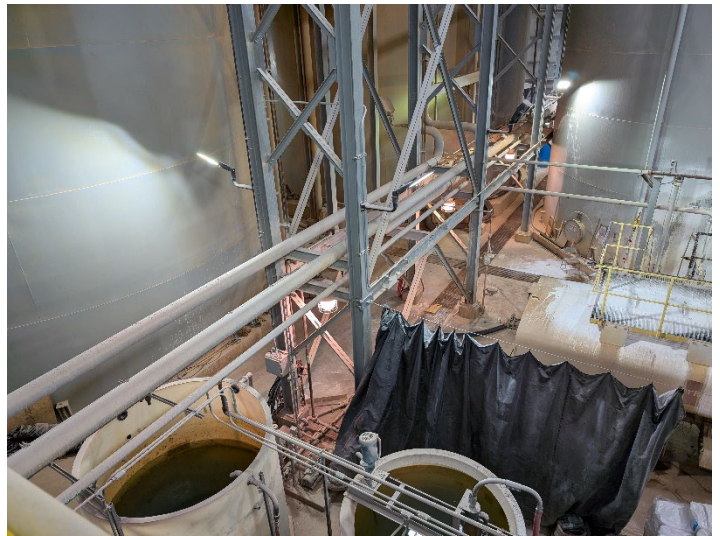
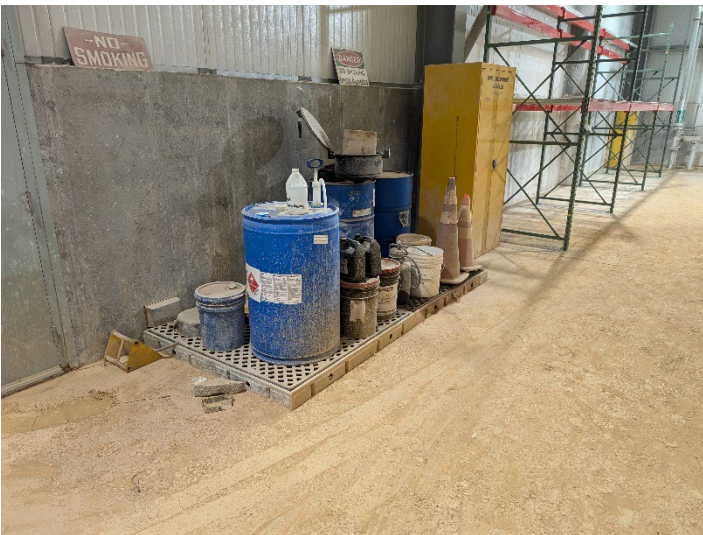
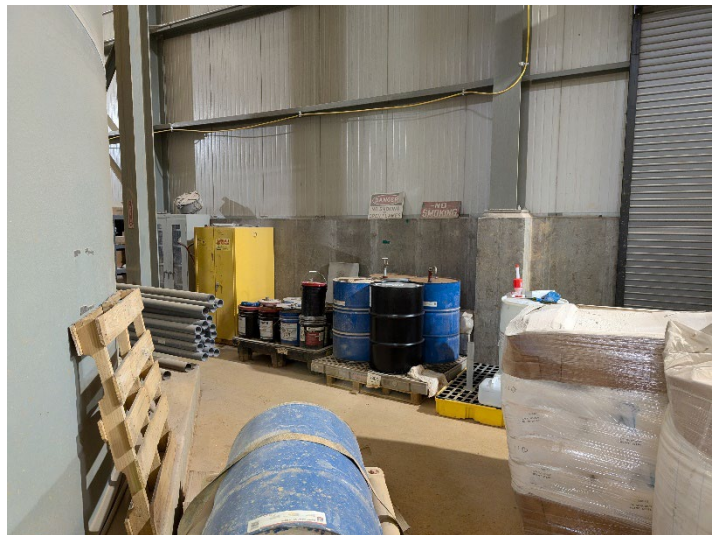
Sludge Density Plant (SDP) and Lime Station

The SDP is located on the east side of Tenmile Pond. The SDP provides first stage metals treatment for a significant portion of the mine's affected waters and creates sludge for deposition in tailings storage facilities. When possible, water is recycled through Robinson Lake for use in the mill facility. The plant has been constructed with adequate secondary containment, in the form of concrete sumps, to contain spills that could occur within the plant. Spills were not noted during this inspection. Operation of the SDP is automated, and emergency generators are in place in case of power outages. Reagents utilized in the SDP include lime and flocculant. All chemicals and reagents observed in the SDP area were properly stored with adequate secondary containment protections. Containers were clearly labeled.

The SDP Lime Station is located approximately 800 feet south of the SDP. The lime station includes conventional silos for storage of lime and lime slakers. Slaked lime is produced by mixing lime from the silos with fresh water. No problems were noted in the lime station.

The SDP facility appeared to be well maintained and functioning as designed. No problems were noted.

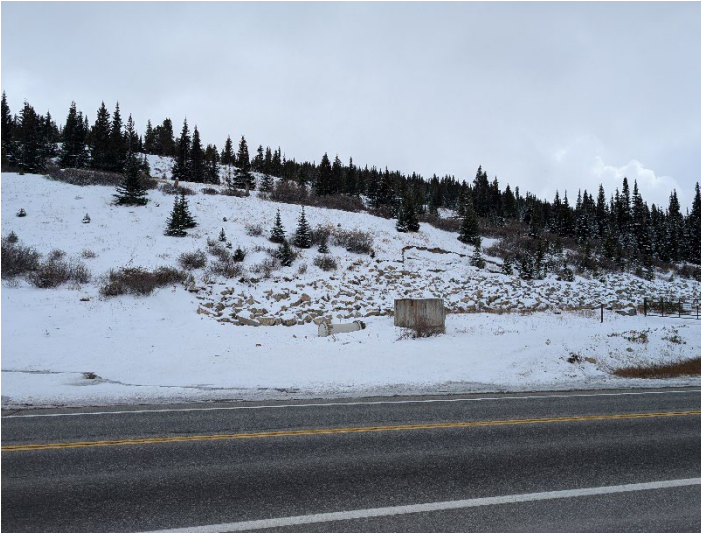
Sinkhole repair at TDL Drop Structure 2

On October 4, 2024, Climax notified the Division that a leak was discovered on a buried portion of the TDL HDPE pipe near Drop Structure 2. Climax made repairs by completing removal and replacement of a 10-foot section of the HDPE pipe. The pipe was leak tested prior to backfilling. The leak repair area was observed during this inspection. No problems were noted.

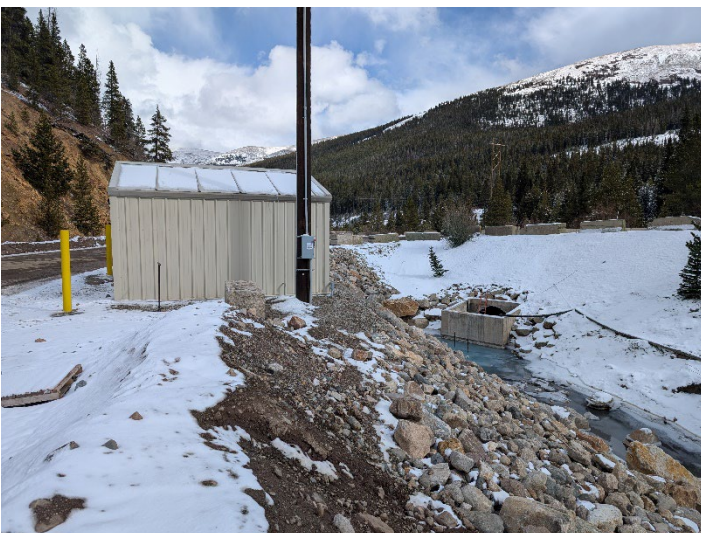
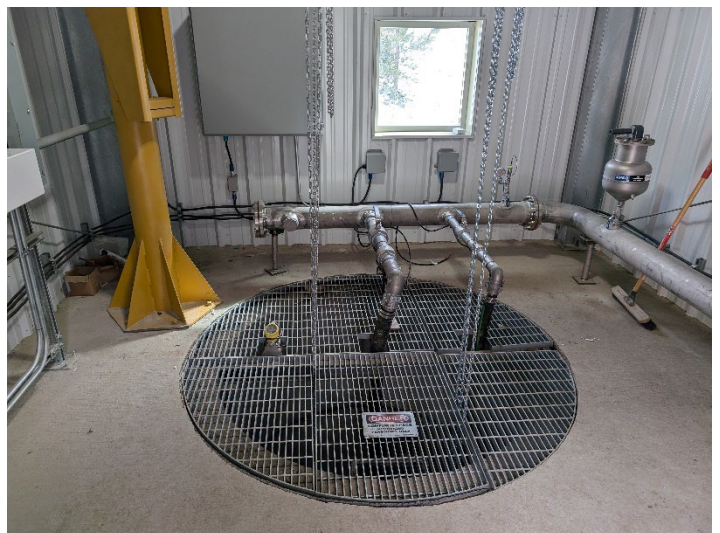
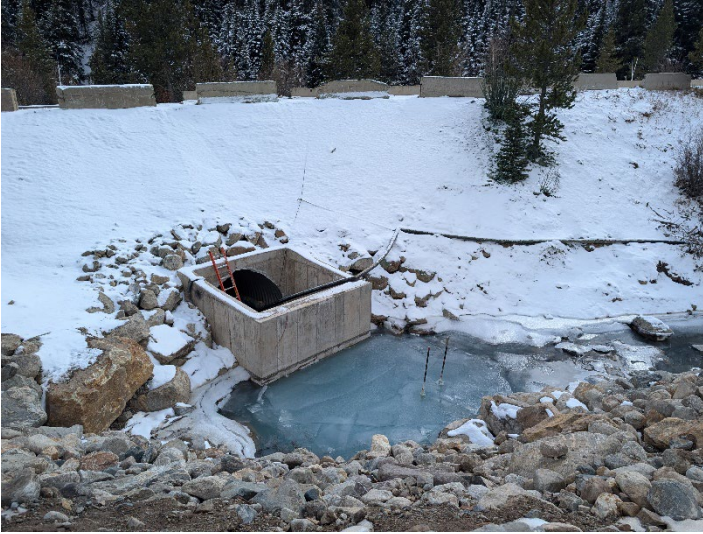
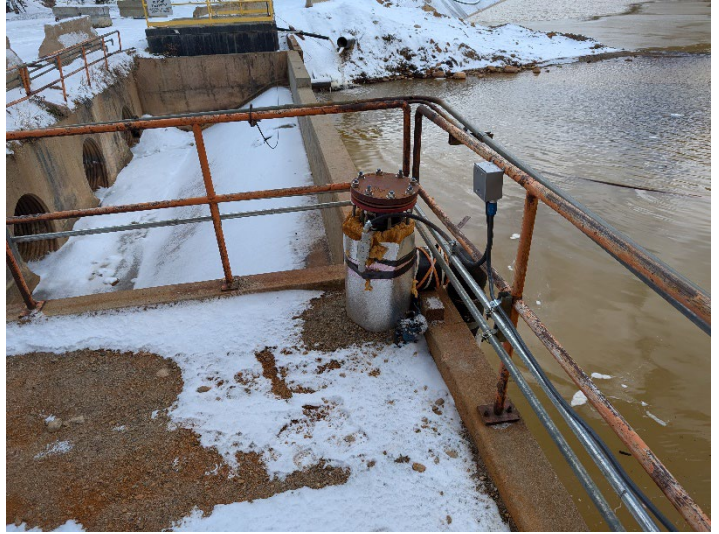
Mayflower Pump Station and 5 Dam Seepwater Collection Area (TR36)

The system was functioning, and construction was completed on the 5 Dam Seepwater Collection System approved under TR-36. The pipe from the ditch to the pumphouse that was crushed after it was buried has been replaced. The completed work appears to be consistent with the approved designs and no issues were noted within the construction area.
