# **PERMIT INFORMATION**

Permit Number: C1981033 Mine Name: Bear Mine Operator: N/A Operator Address: N/A	County: Gunnison Operation Type: Underground Permit Status: Revoked Ownership: Private Operator Representative Present:
Operator Representative Signature: (Field Issuance Only)

# **INSPECTION INFORMATION**

Inspection Start Date: October 2 Inspection Start Time: 15:30 Inspection End Date: Inspection End Time:	4, 2024		Inspection Type: Coal Complete Inspection Inspection Reason: Normal I&E Program Weather: Clear
Joint Inspection Agency:		Joint Inspection Contacts:	
None			
Post Inspection Agency:		Post Inspection Contacts:	
None			
Inspector(s):	Inspector's Signature: Signature Date:		
Leigh Simmons	Bli		November 1, 2024

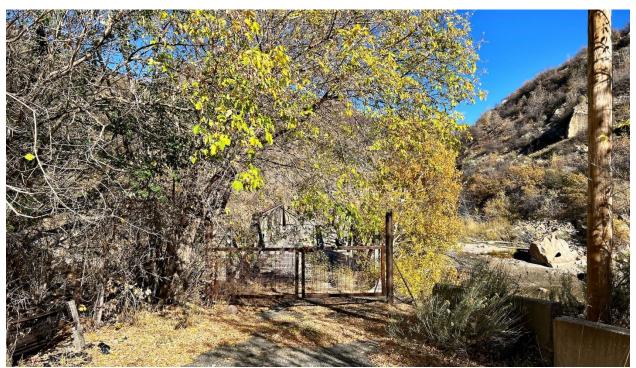
Figure 1: Access to the site

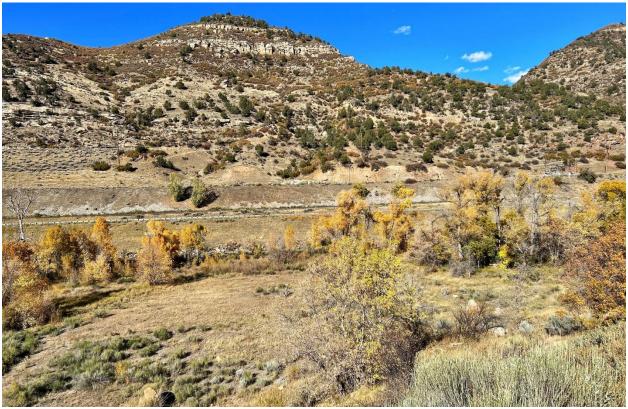
Figure 2: Eastern part of site

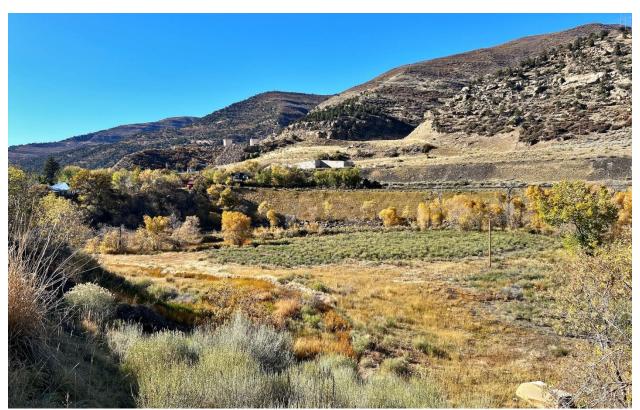
Figure 3: Western part of site

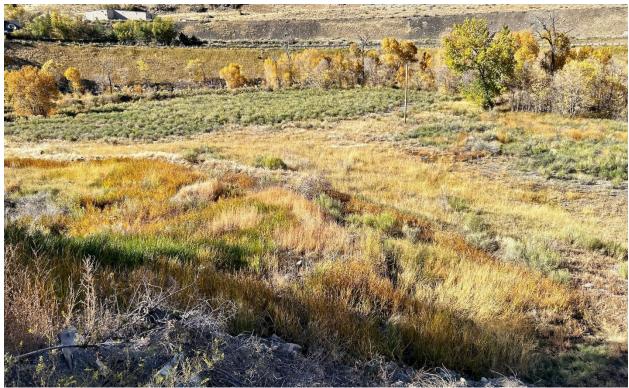
There was no evidence of recent fire or landslide activity. Groundwater continued to seep from a slump at the toe of the landslide. The slump obstructed the sinuous channel, so some of the water flowed across the pad to the north, saturating the ground.

Figure 4: Groundwater seep

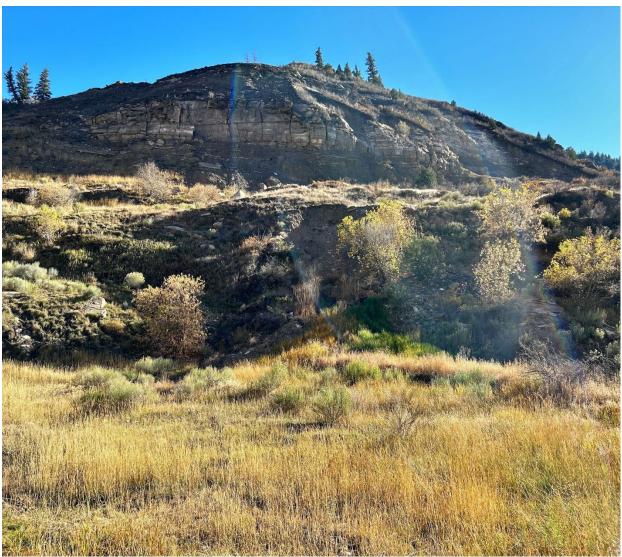
Figure 5: Slide area, with groundwater seep in foreground

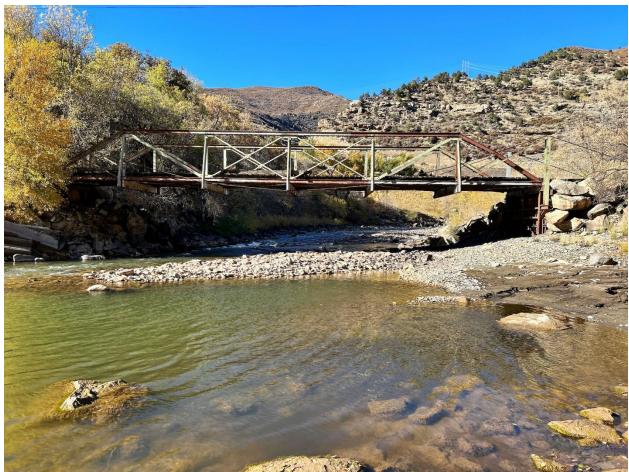
The gate to the bridge was secure. The bridge itself was passable on foot, but the timbers making the bridge deck had continued to deteriorate.

Figure 6: Bridge
