## C1980007, West Elk Mine, October Inspection Report

**PERMIT INFORMATION**

**INSPECTION INFORMATION**

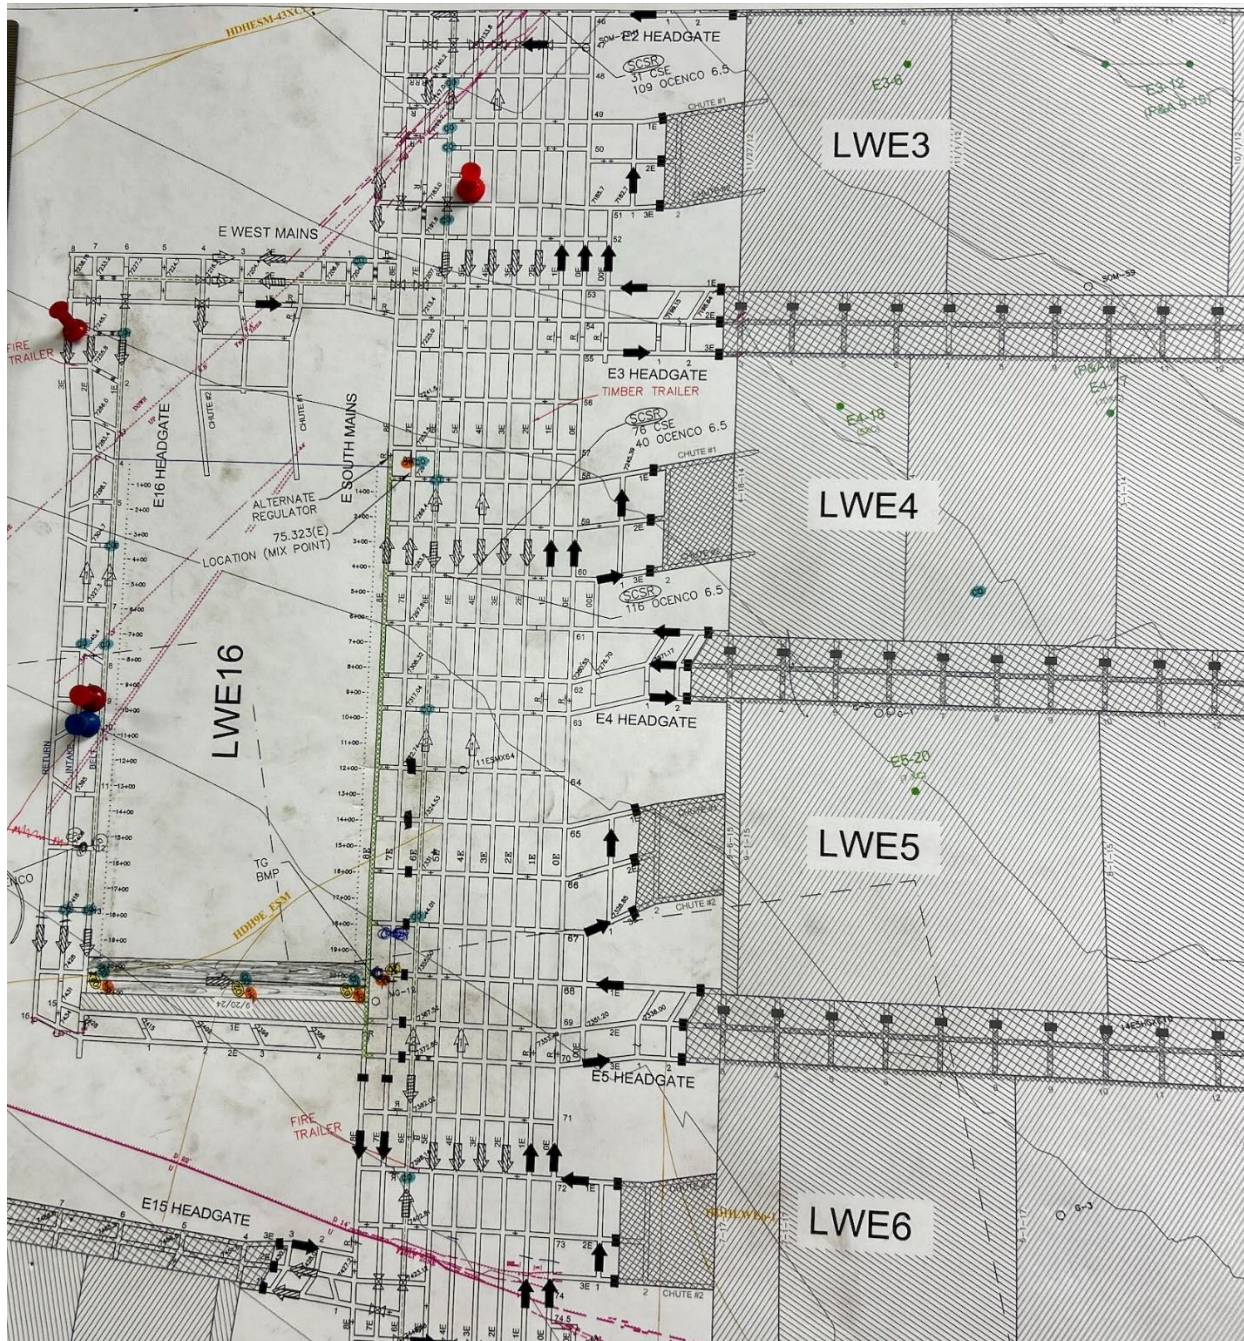
Longwall mining of the LWE16 panel was in progress, between cross-cuts 14 and 13 on the head gate.

Figure 1: Mine Map showing longwall progress

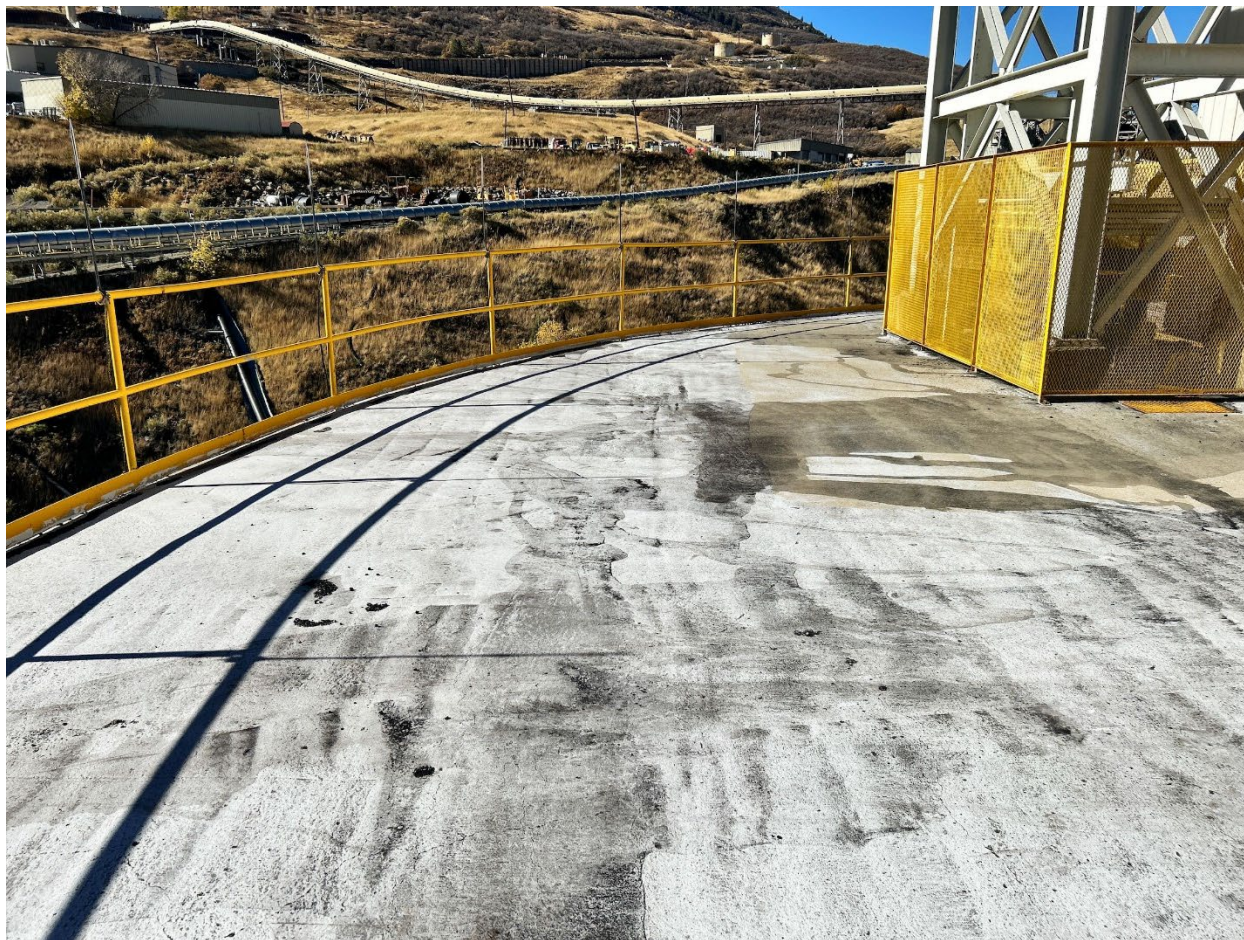
Work had begun on Silo 2. The top of the concrete silo had been sealed and protected. The inside of the silo had been whipped with air hoses to clean and prepare the surface. The next step will be to remove a cone and cut a hole above the false floor to allow access, then assemble slip-form scaffolding inside the silo. The aim was to begin pumping concrete in December.

*Figure 4: Top of Silo 2, sealed*

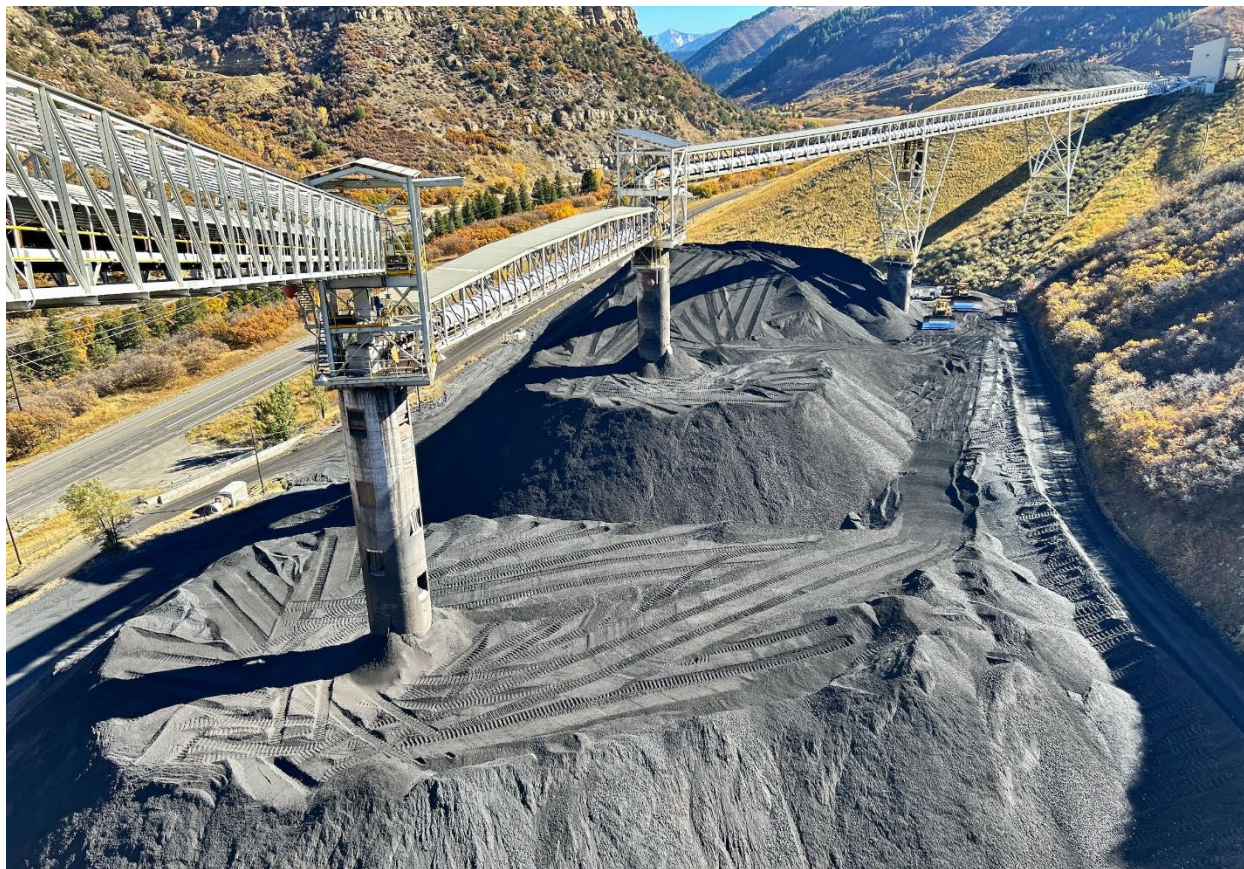
*Figure 5: Clean coal stockpile pad from top of silo*

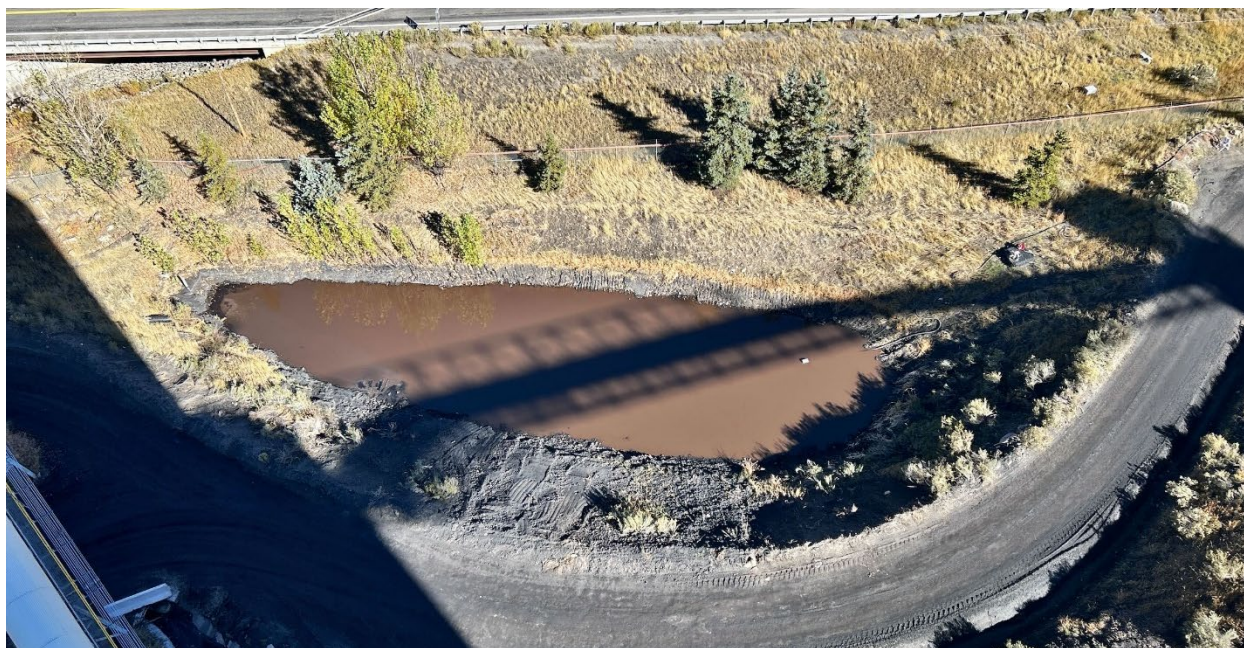
Work to clean the sediment ponds had been completed. Material removed from the ponds had been transported by haul truck to the RPEE and was drying out. A survey of the cleaned ponds had been completed; results were expected to be included with the next quarterly report.

*Figure 6: MB3 pond, cleaned, from top of silo*

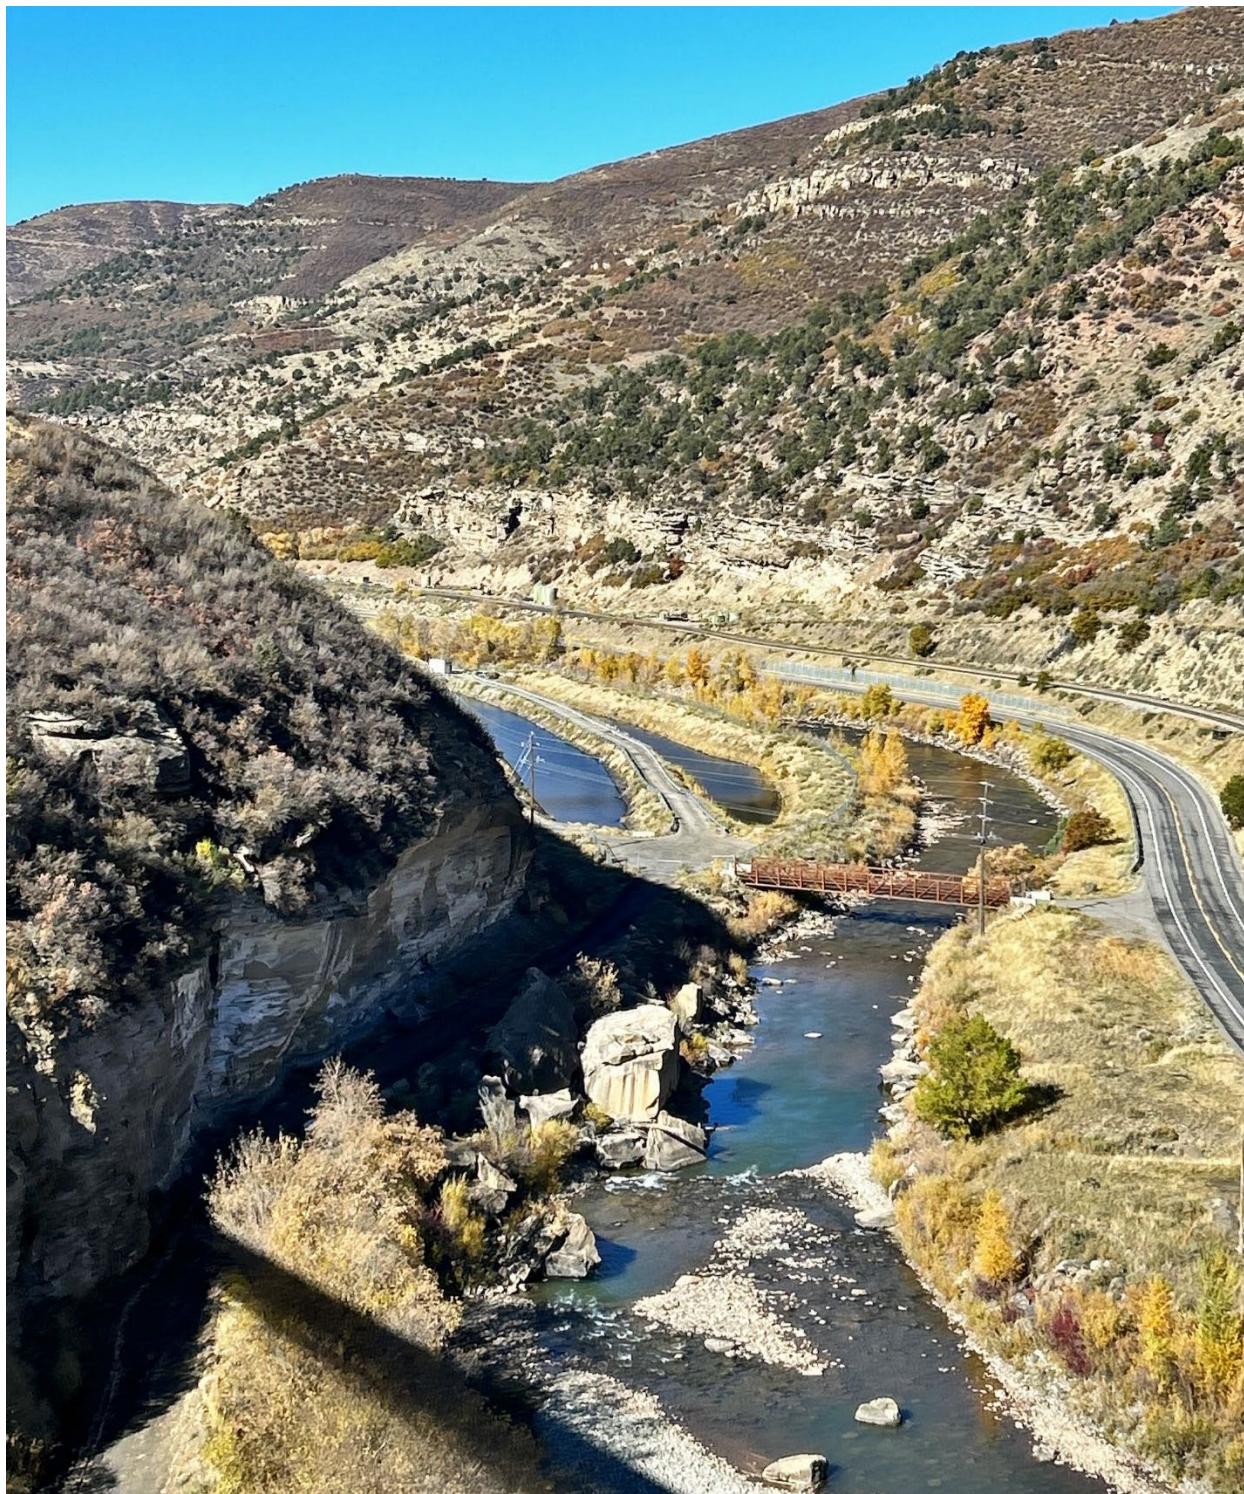
*Figure 7: MB5E pond, cleaned, from top of silo*

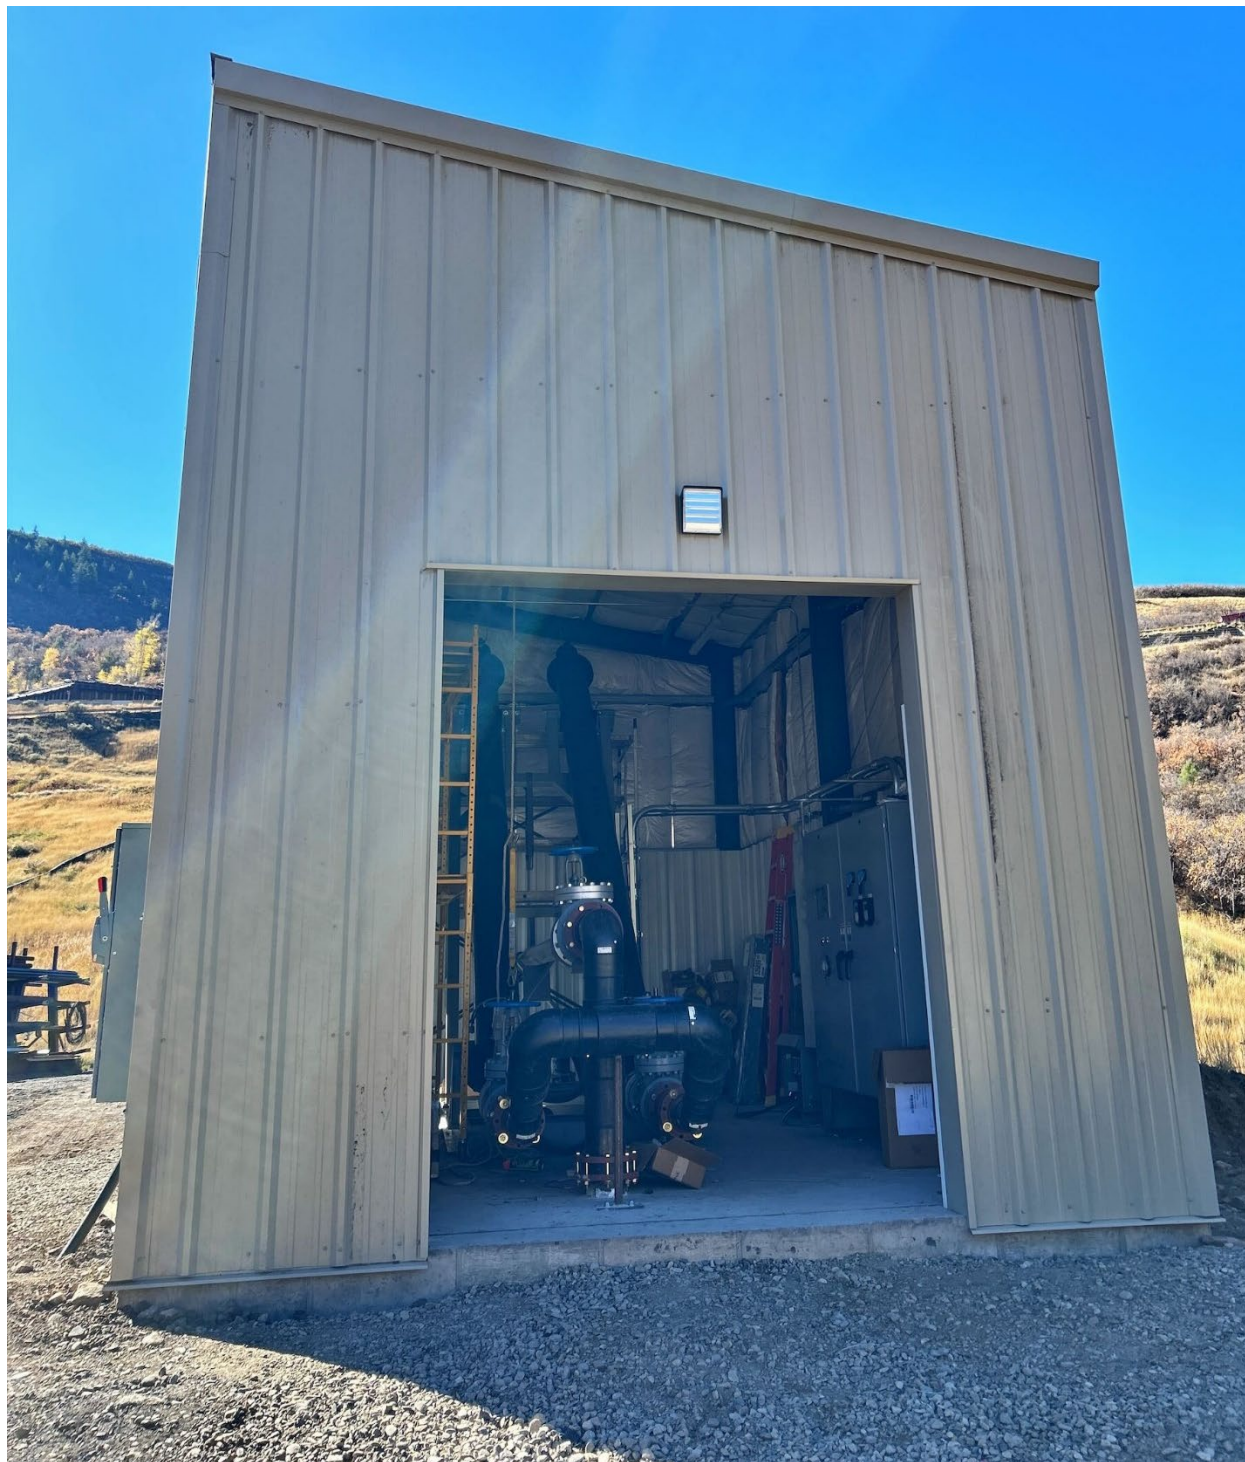
The booster pumphouse for the BCN well had been installed next to the FW-1 pond, but the connections had not yet been completed. MCC were still waiting on a well permit for the BCN well before setting a pump on the well and completing the pipeline project.

*Figure 8: BCN booster pumphouse*

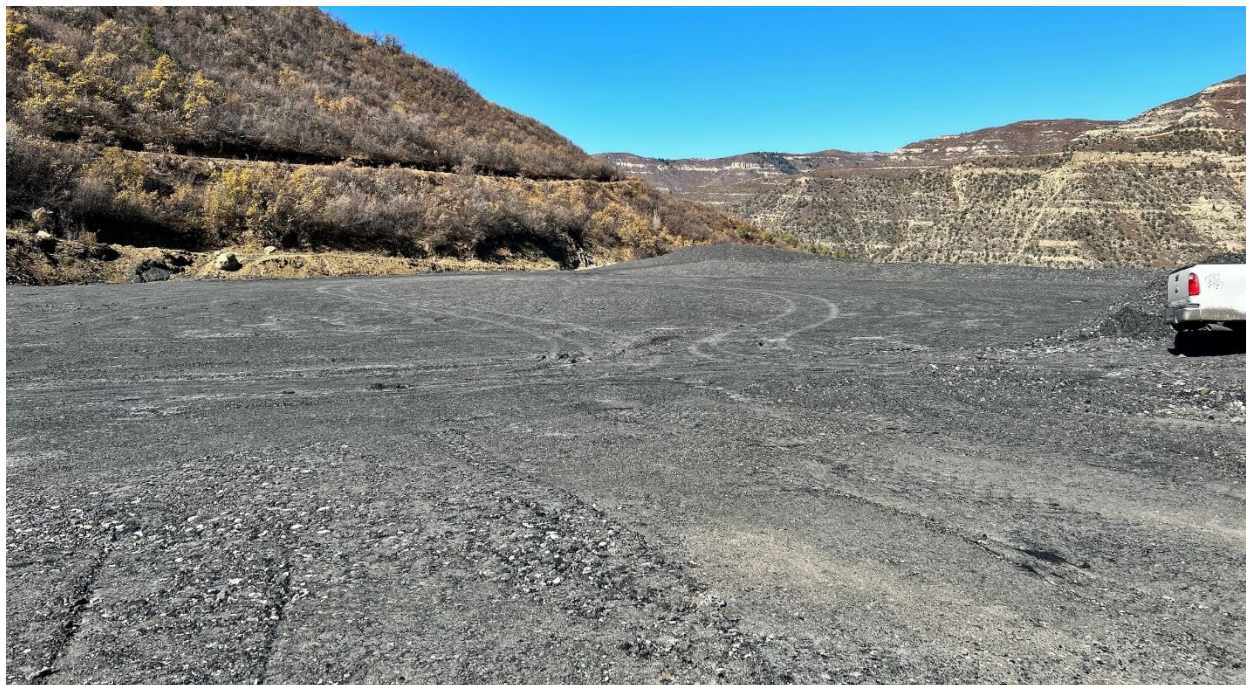
Processing waste stored on the RPE had been transported to the RPEE. The surface of the RPEE was smooth, compact and graded to drain to the northwest. Material cleaned from the sediment ponds was draining on the northeast of the RPEE, but all other material had been compacted. Topsoil had been stripped from the eastern

*Figure 9: RPEE surface*

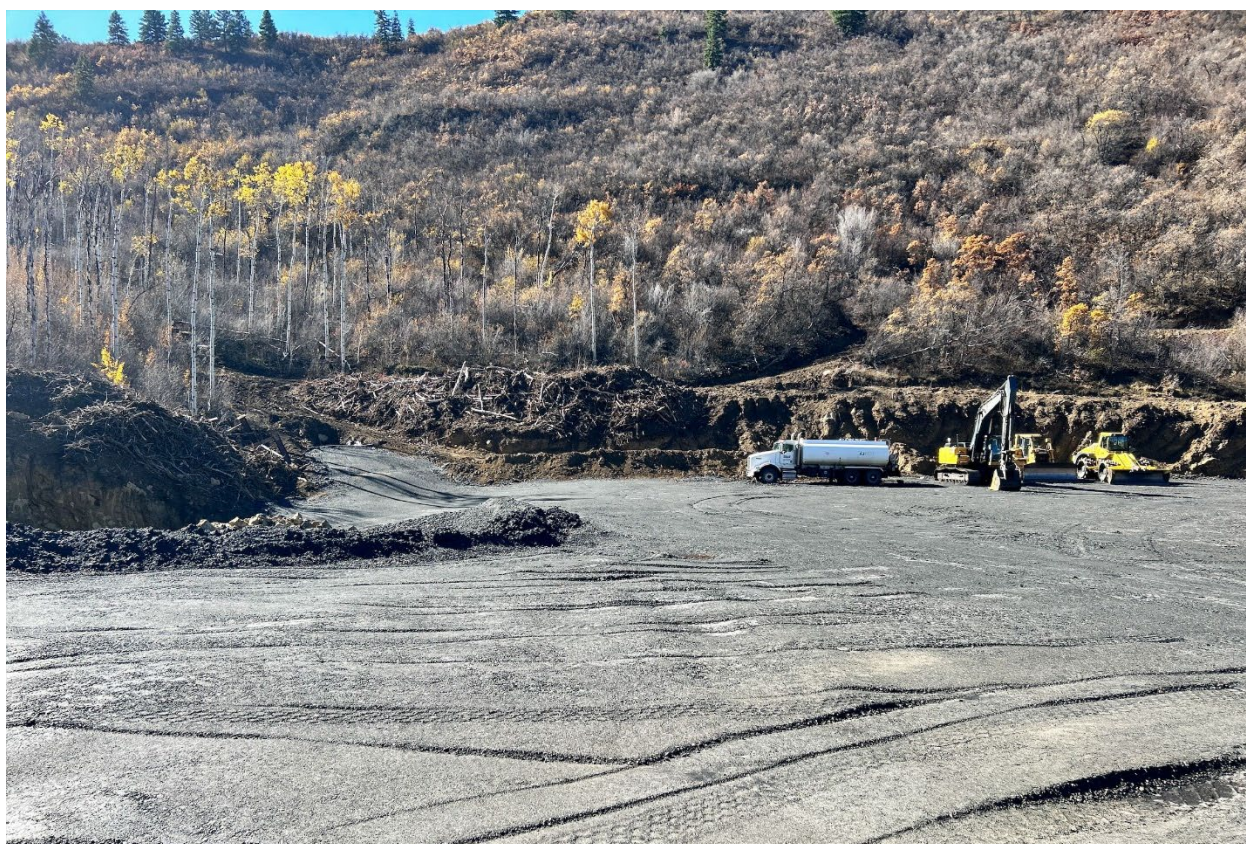
*Figure 10: Highest area of RPEE*

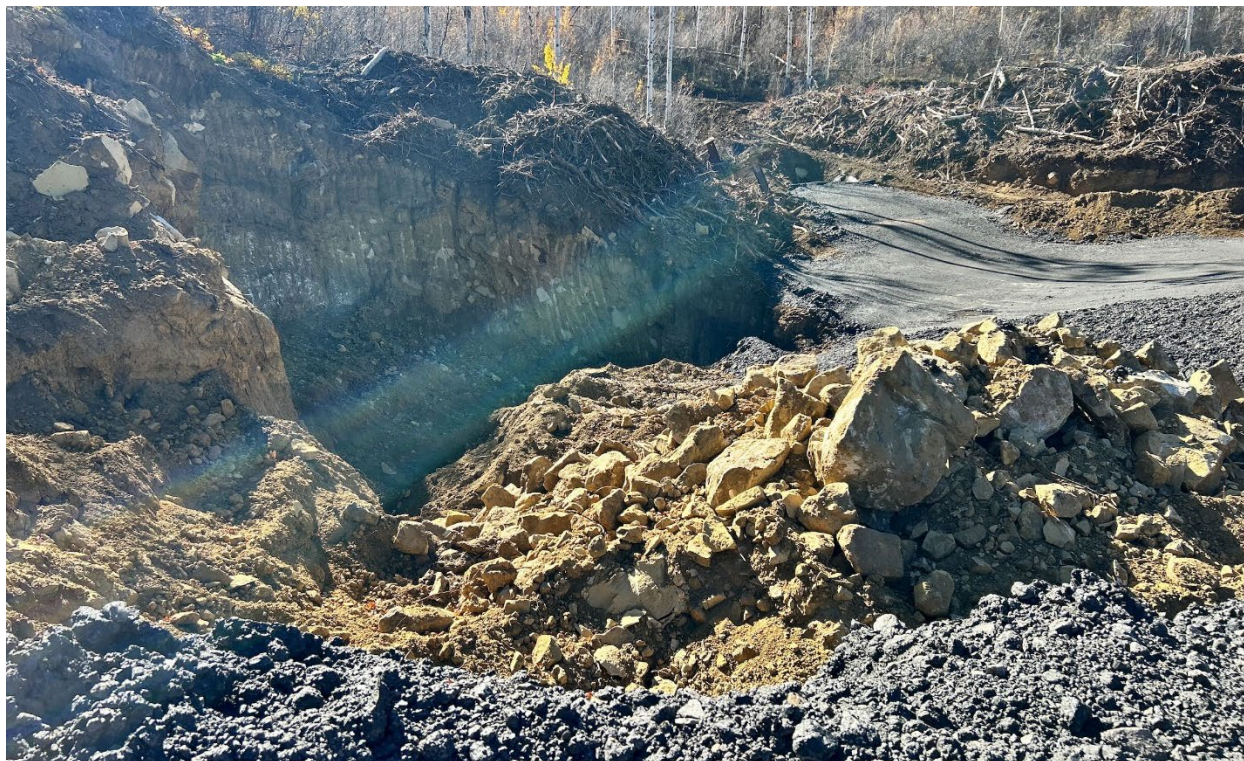
edge of the RPEE, and some large boulders had been excavated for use in the down drain.

*Figure 11: Topsoil stripped and large boulders excavated*

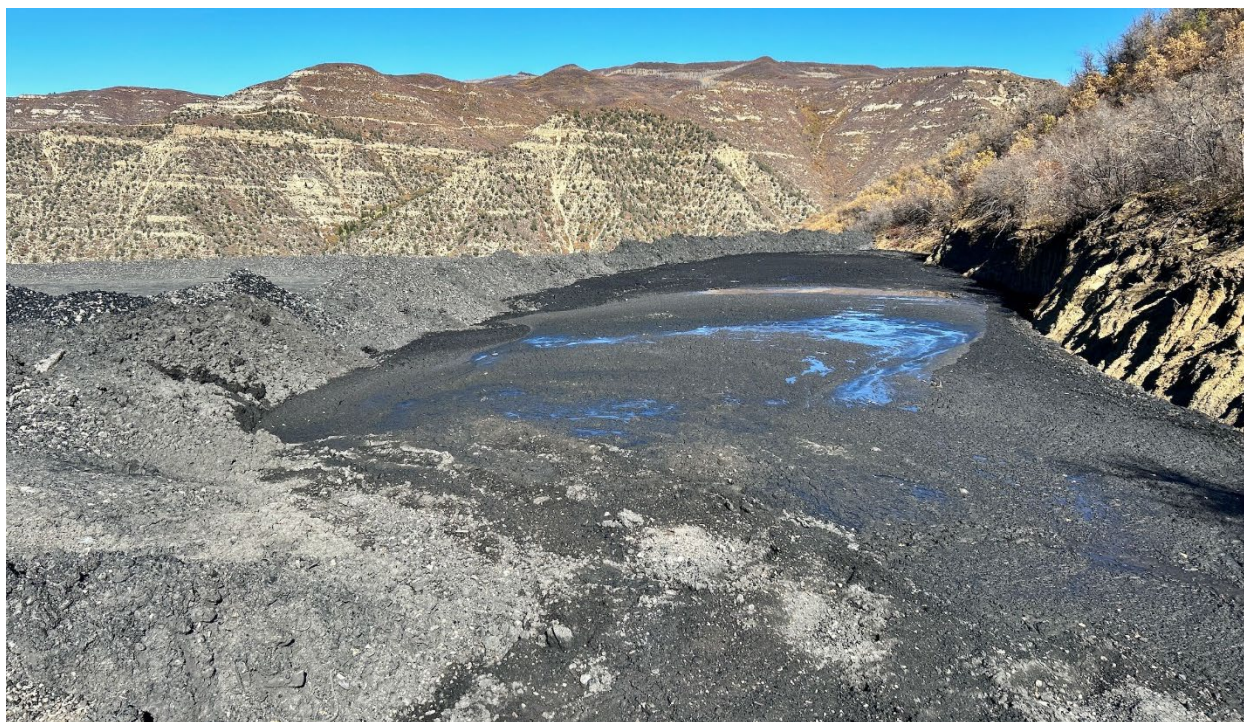
*Figure 12: Pond cleanings drying on northeast side of RPEE*

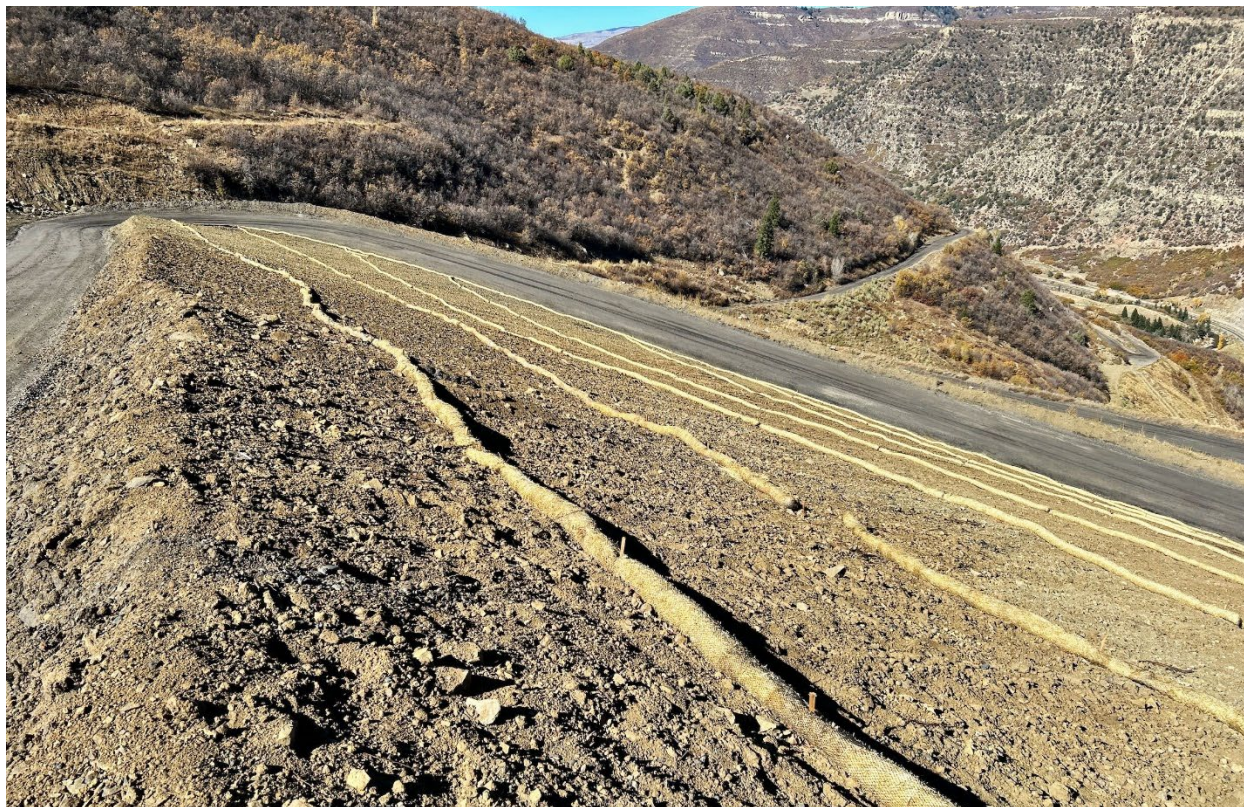
Out slopes on the RPEE had been graded and topsoiled. Straw wattles had been placed along the contour to reduce the effective slope length for surface water runoff. Some of the wattles had slipped and should be replaced.

*Figure 13: Topsoil and straw wattles on RPEE outslope*

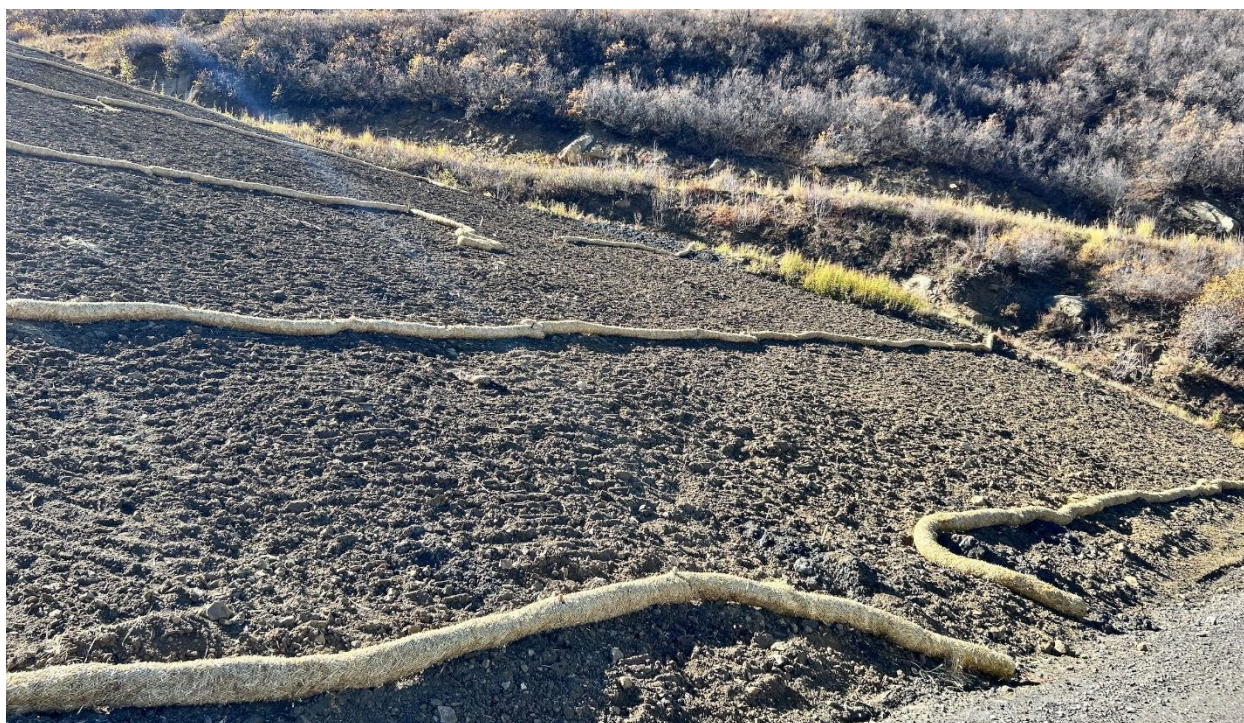
*Figure 14: Straw wattles need replacing*

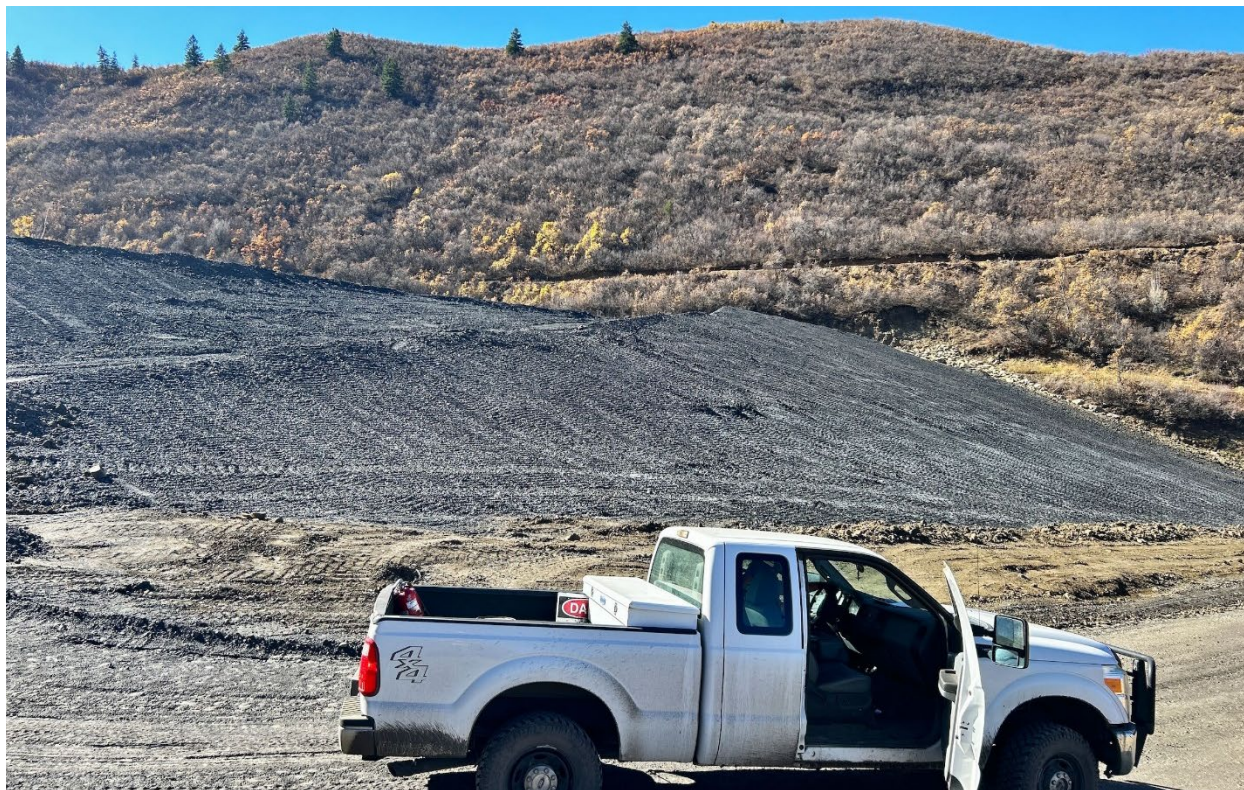
*Figure 15: Outcrops to be reclaimed*

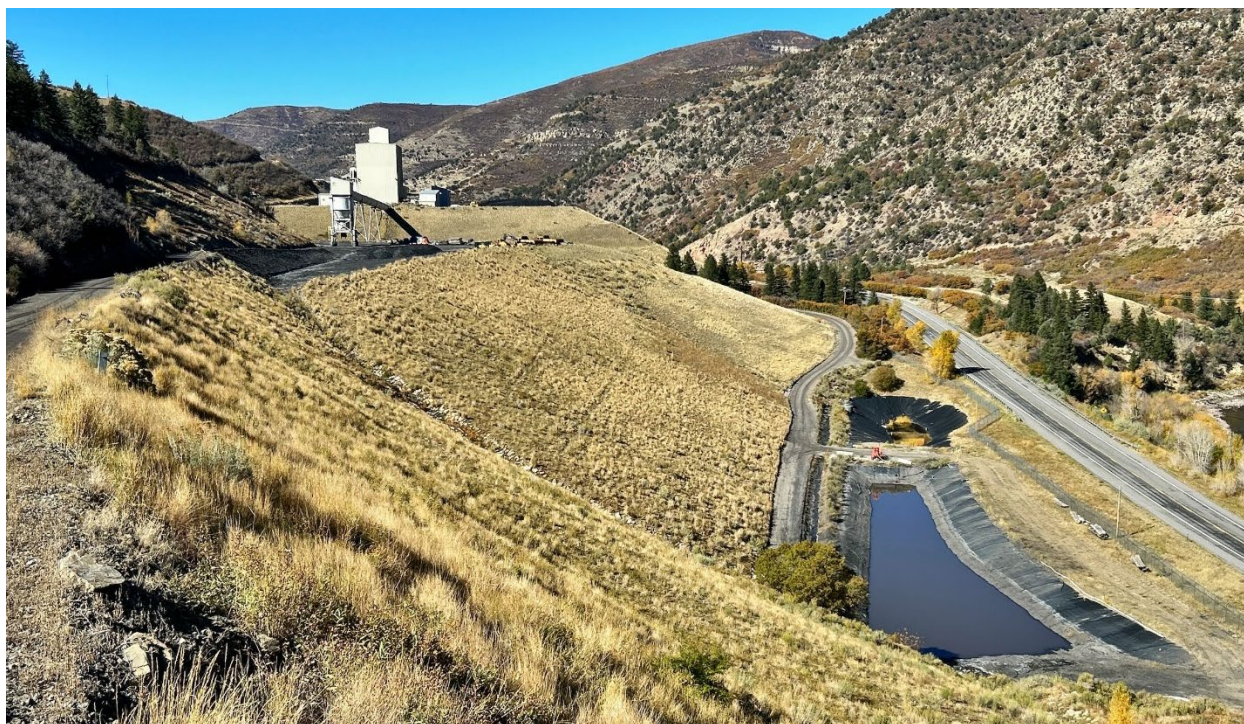
*Figure 16: RPE and RPE pond*
