MINERALS PROGRAM INSPECTION REPORT

MINE NAME: McKenna Limestone Quarry	MINE/PROSPECTING ID#: M-2000-039	MINERAL: Limestone (general) and shale	COUNTY: Huerfano
INSPECTION TYPE: Monitoring	WEATHER: Clear	INSP. DATE: October 24, 2024	INSP. TIME: 08:40
OPERATOR: Delhur Industries, Inc.	OPERATOR REPRESENTATIVE: Rick Hurworth	TYPE OF OPERATION: 110c - Construction Limited Impact	
REASON FOR INSPECTION: Normal I&E Program	BOND CALCULATION TYPE: Partial Bond	BOND AMOUNT: \$17,100.00	
DATE OF COMPLAINT: NA	POST INSP. CONTACTS: None	JOINT INSP. AGENCY: None	
INSPECTOR(S): Amber M. Gibson	INSPECTOR'S SIGNATURE:

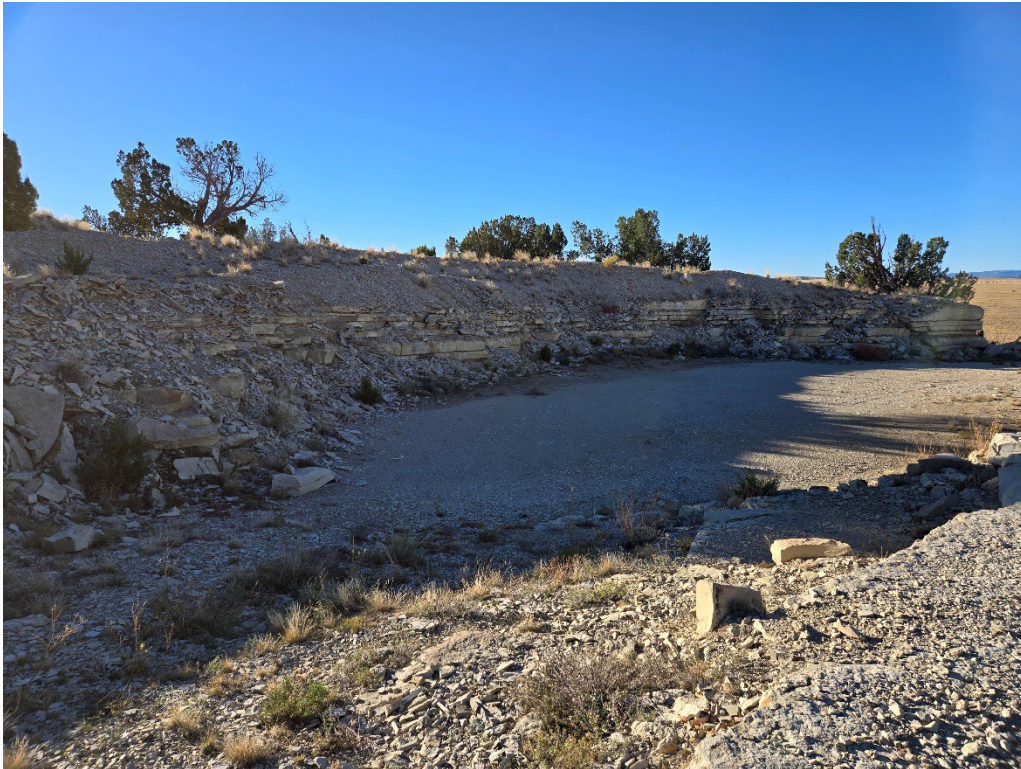
The disturbed area consists of a pit highwall located in the southern portion of the site that is 6-12 feet high and is approximately 350 feet long (see Figure 1 at the end of this report; Photo 1). In the central part of the area there are two stockpiles of dimensional stone in a matrix of fine-grained material (Photos 2 and 3). To the north there is a large stockpile of dimensional stone similar to the other piles (Photo 4). The Operator confirmed that the limestone was mined in support of remediation efforts at the Summitville Mine Superfund Site.

Photo 1: Looking southeast at the highwall located within the southern portion of the permit area.

CORRECTIVE ACTIONS: The Operator shall, conduct final backfilling and grading, seed with the approved seed mixture, and suitably restrict grazing during the seeding's initial establishment at the site. The Operator shall submit documentation that final reclamation has been completed by the corrective action date.

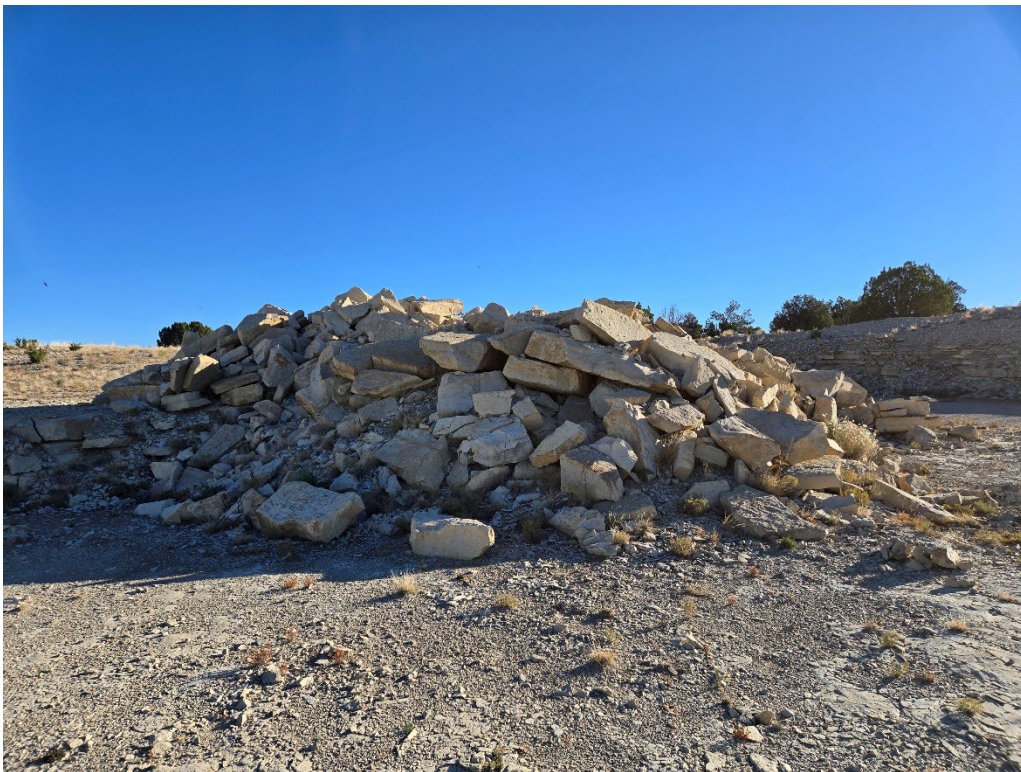
Photo 2: Looking southeast at the small material stockpile (southern-most brown polygon on Figure 1 below). The east side of the highwall is seen in the background.

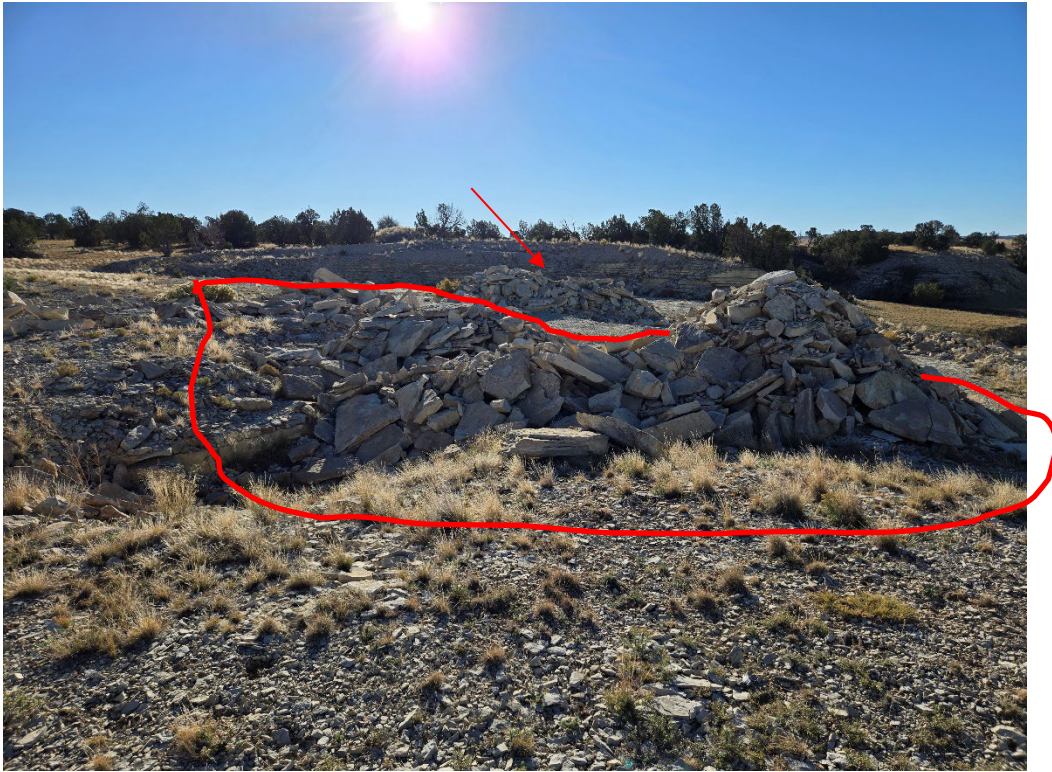
Photo 3: Looking south towards the highwall. The product stockpile circled is indicated by the middle brown polygon on Figure 1. The red arrow indicates the stockpile represented by the southern brown polygon on Figure 1.

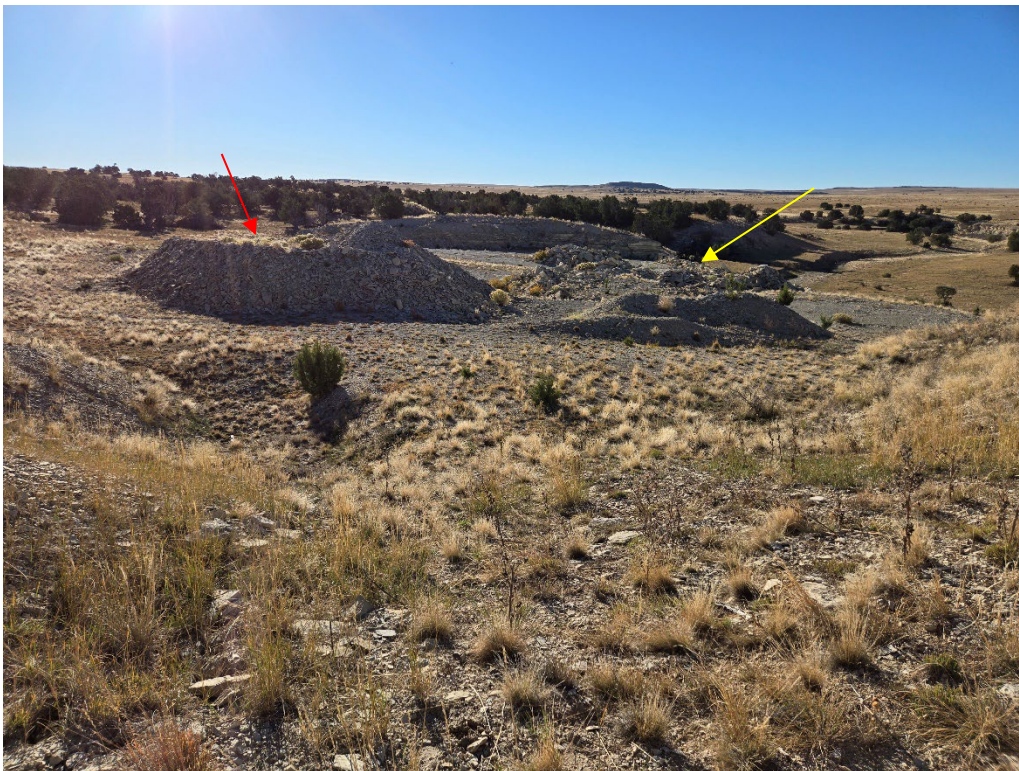
No standing water was observed onsite during the inspection. The storm water berms shown on the Operator's mining map (see Figure 1) were observed around the pit disturbance, ensuring stormwater runs to the southwest corner of the pit and separate from the arroyo adjacent to the site (Photo 4).

Photo 4: Looking south across the disturbed area from atop the topsoil pile. The red arrow points to the large stockpile indicated by the northern brown polygon on Figure 1. The yellow arrow points to the location of the stormwater berm along the west side of the pit. The arroyo is seen to the right of the stormwater berm in this image.

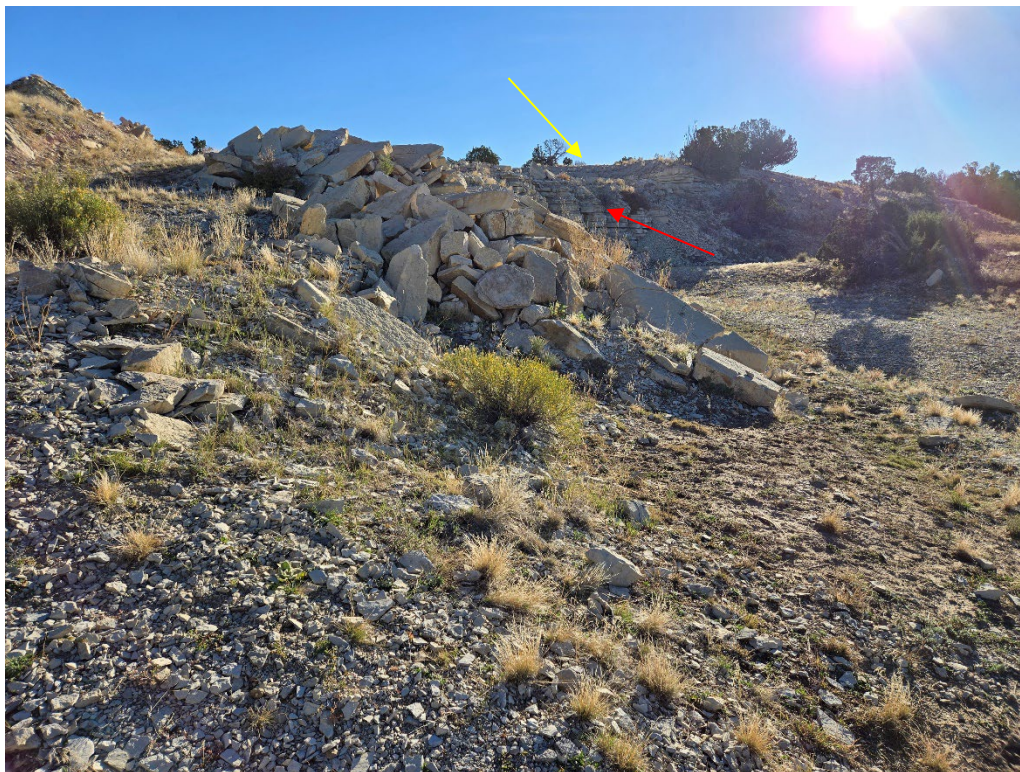
Photo 5: Looking east from the entrance to the pit. The red arrow points the west side of the stormwater berm/western portion of the pit. The yellow arrow points to the highwall along the south side of the pit.

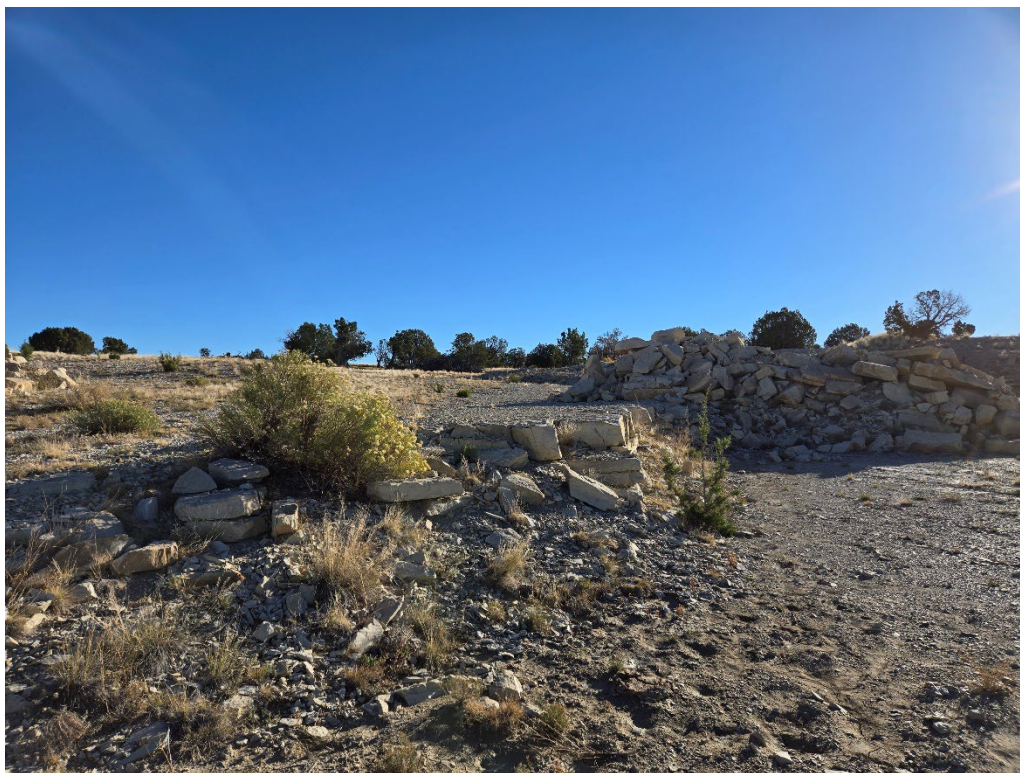
Photo 6: Looking east across the pit.

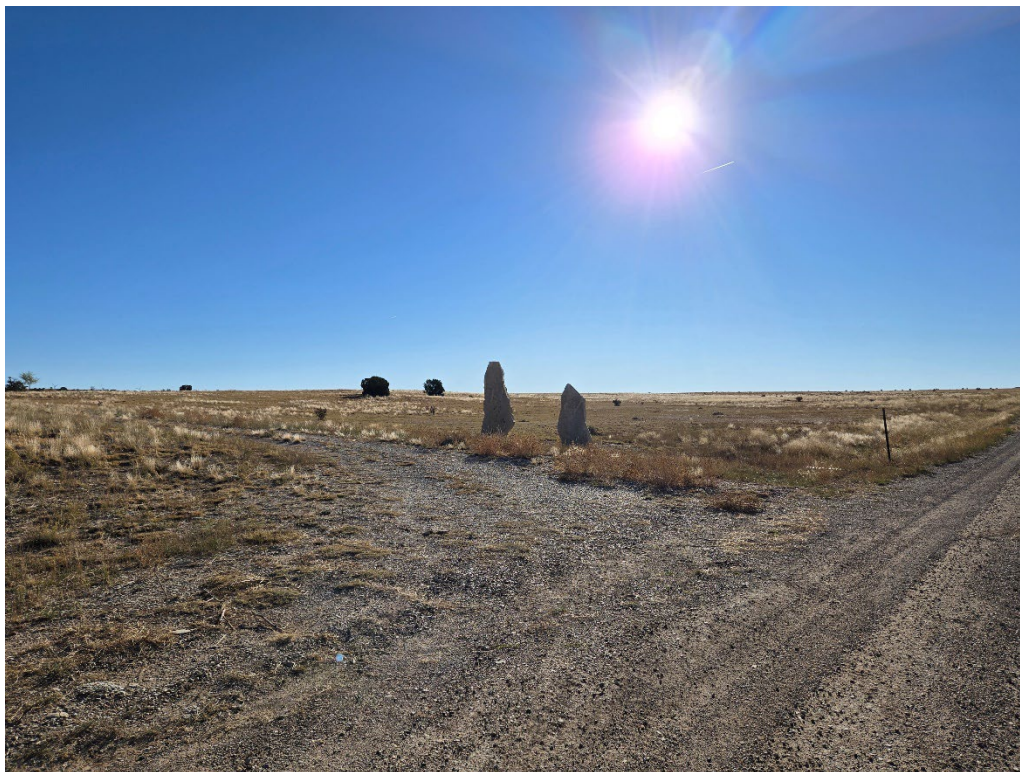
The haul/access road is in a 30-foot easement and is approximately 0.3 miles long from CR 211 that is allowed to remain in place after mining is complete (Photo 7).

The mine sign that had been posted following the Division's 2019 inspection is missing and needs to be replaced. **This has been cited as a problem above.** The Operator shall replace the mine sign with a sign that complies with the requirements of Rule 3.1.12(1) by the corrective action date.

Photo 7: Looking east at the access/haul road leading to the pit. The mine sign had been posted on one of the stones, but the Operator believes that it has been stolen. The road leading off to the right in this image is County Road 211.

CORRECTIVE ACTIONS: The Operator shall, at the entrance of the mine site, post a sign which shall be clearly visible from the access road with the following: the name of the Operator, a statement that a reclamation permit for the operation has been issued by the Colorado Mined Land Reclamation Board; and the permit number. The Operator shall submit photo documentation that a proper sign has been posted by the corrective action date.

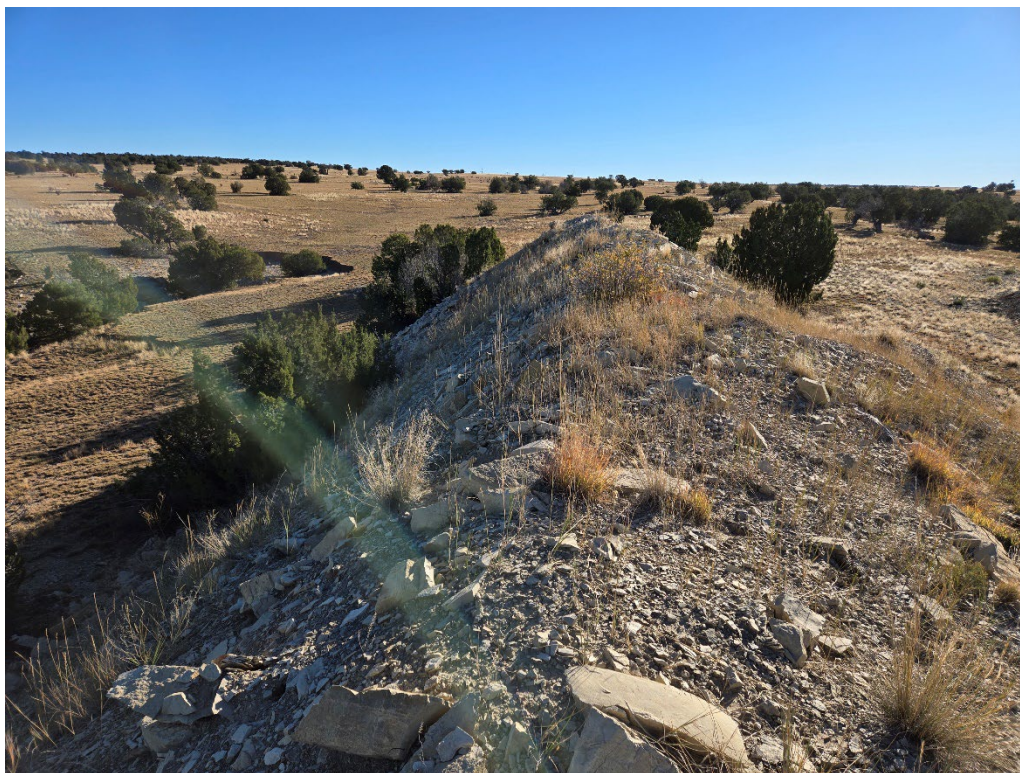
Topsoil is stockpiled along the northern boundary of the disturbance area (Figure 1; Photos 8 and 9). The topsoil piles both have volunteer native grasses growing on them and appear to be stable at this time. To the west of the western portion of the stockpile, woody vegetation that had been stripped prior to disturbance has also been stockpiled (Photo 10). During the inspection, the Operator stated that they will mulch and bury that material. The Division reminded the Operator that per Rule 3.1.9(2), woody debris must be appropriately incorporated into the existing topsoil/growth material. The Division also stated that the burial of woody debris is allowed if it is mulched and evenly distributed so as not to create slope stability and/or compaction issues upon reclamation.

Photo 8: Looking east across the eastern portion of the topsoil stockpile.

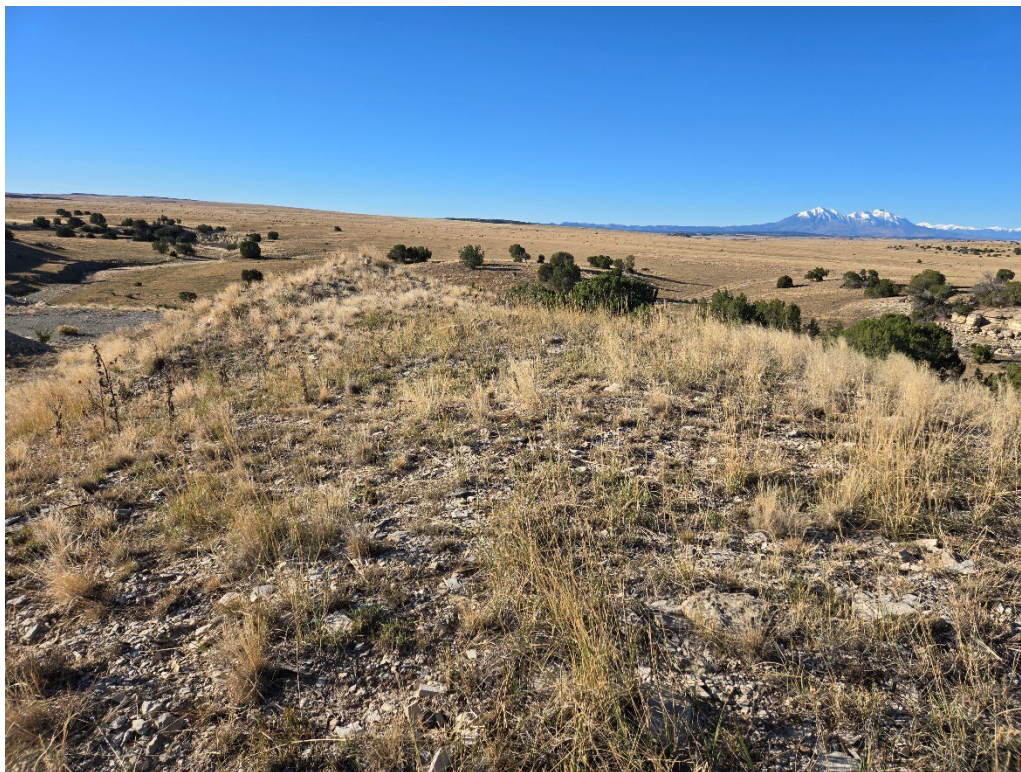
Photo 9: Looking south along the western portion of the topsoil stockpile.

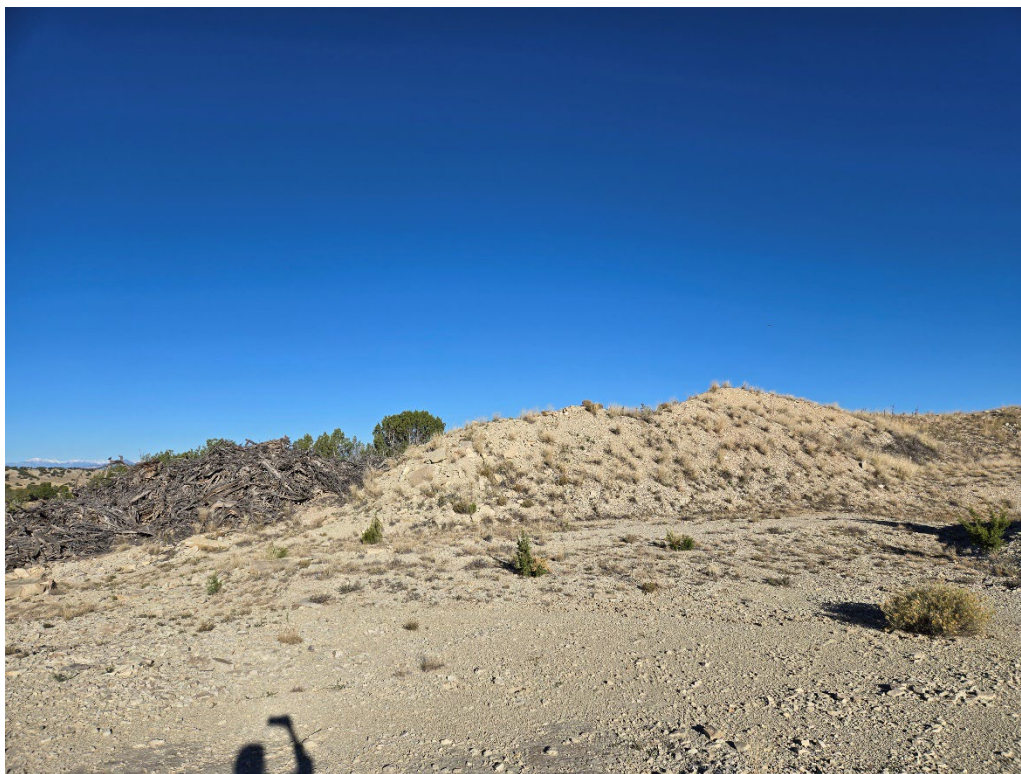
Photo 10: Looking northwest at the western portion of the topsoil stockpile, and at the stockpiled woody vegetation piled on the west side of the topsoil pile.

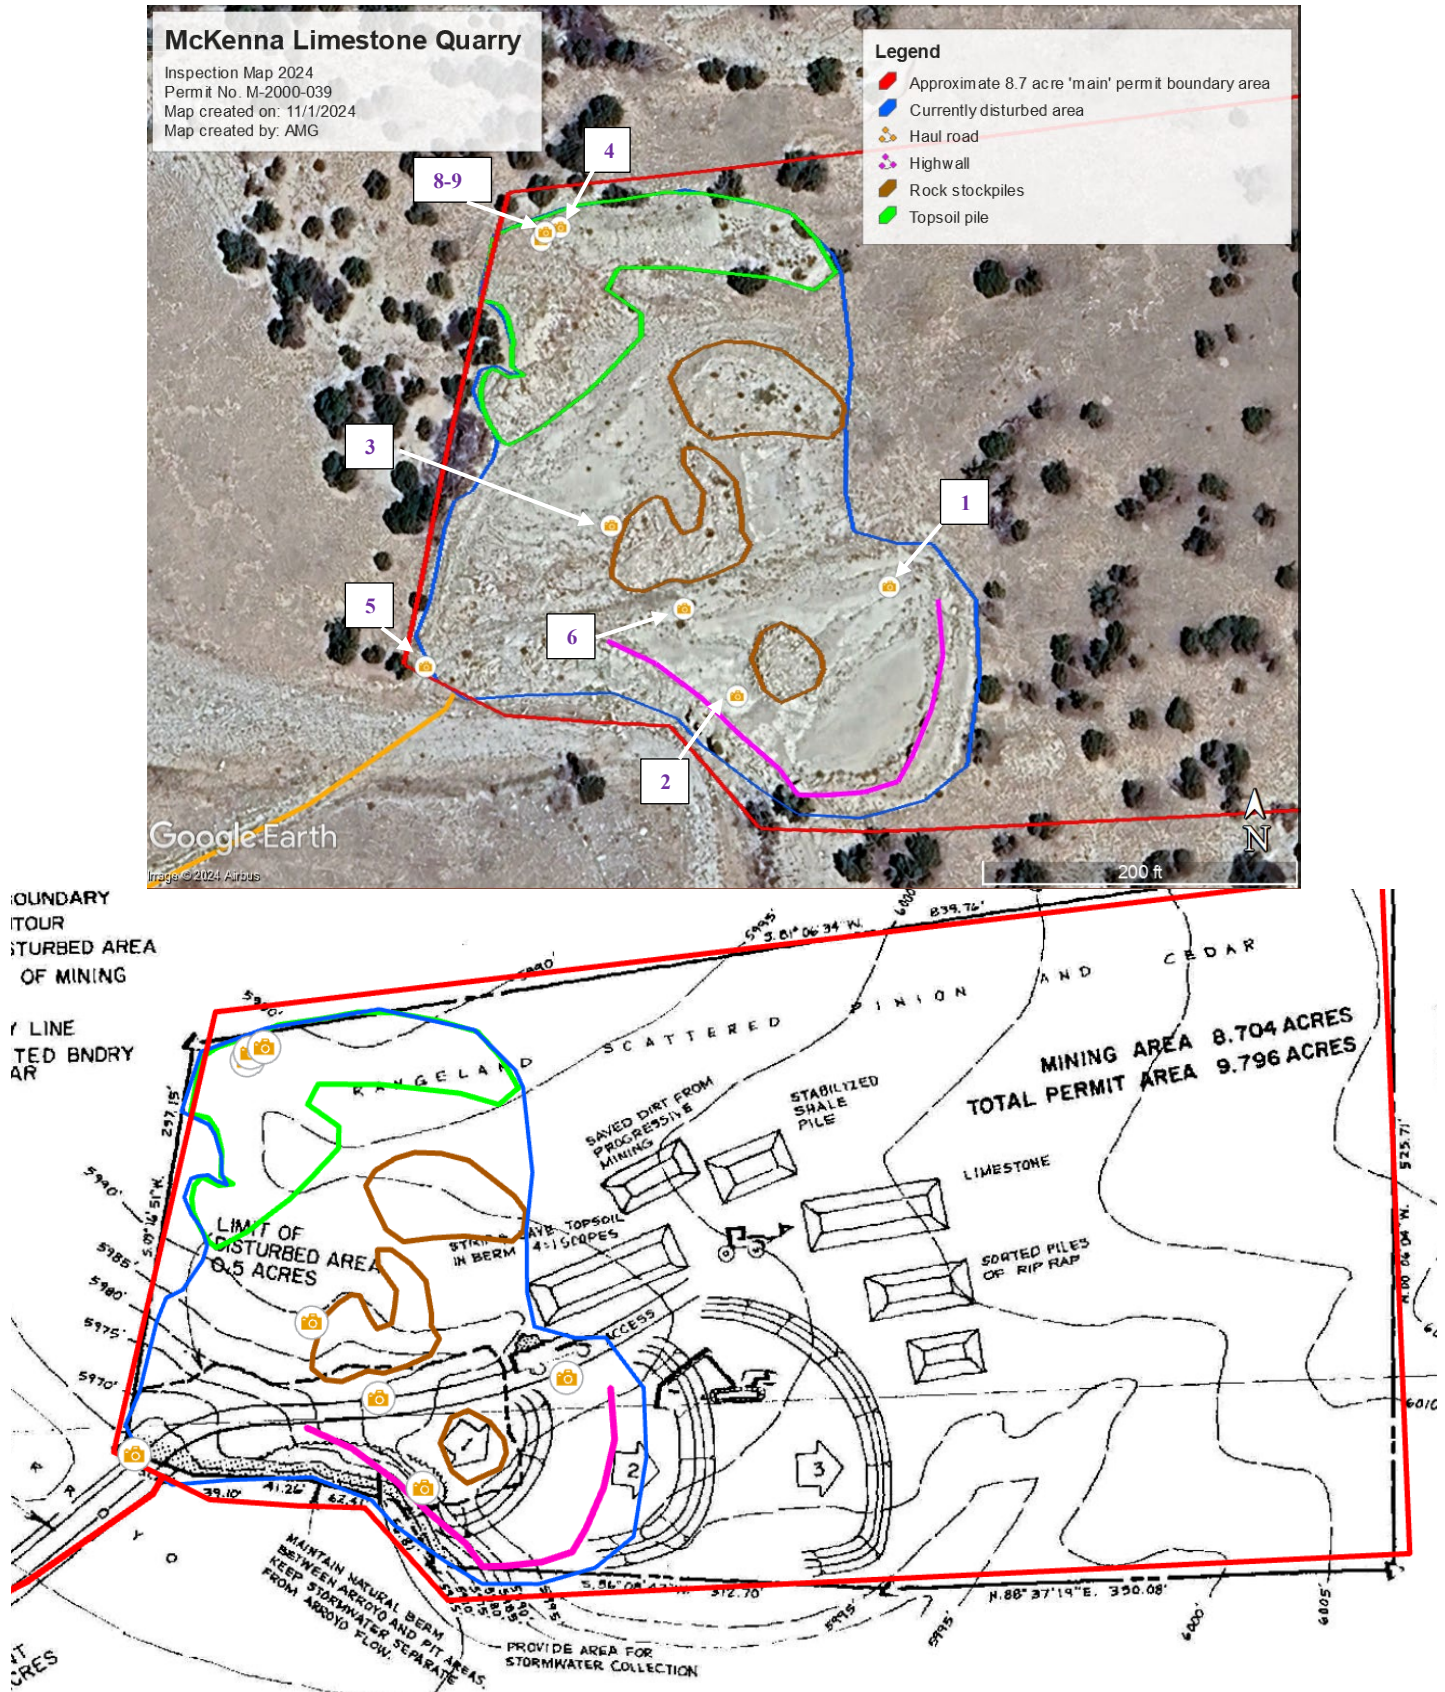
Figure 1: Inspection maps created to display the approximate permit boundary (red), the approximate disturbance boundary (blue), the topsoil pile locations (green), the product stockpile locations (brown), and the highwall location (pink) over ariel imagery (top)

image) and overlain on the Operator's mining plan map (bottom image). The camera icons indicate locations where photos were captured during the inspection and correspond with the inspection photos within this report. Photo 7 is located outside of the view of the images in the figure, to the west where the haul road intersects with County Road 211.
