RE: Collett Property, Permit No. M-2024-012 and M-2022-051, Unresolved Problem(s) Noted in a Past Inspection Report

MINERALS PROGRAM INSPECTION REPORT
PHONE: (303) 866-3567

MINE NAME: Collett Property	MINE/PROSPECTING ID#: M-2024-012 M-2022-051	MINERAL: Borrow	COUNTY: Rio Blanco
INSPECTION TYPE: Monitoring	WEATHER: Clear	INSP. DATE: August 7, 2024	INSP. TIME: 13:35
OPERATOR: W.W. Clyde & Co. IHC Scott, Inc.	OPERATOR REPRESENTATIVE: Abby Capwell	TYPE OF OPERATION: 111 - Construction by Government Agency	
REASON FOR INSPECTION: Normal I&E Program	BOND CALCULATION TYPE: Partial Bond	BOND AMOUNT: \$79,822.00	
DATE OF COMPLAINT: NA	POST INSP. CONTACTS: None	JOINT INSP. AGENCY: None	
INSPECTOR(S): Amy Yeldell	INSPECTOR'S SIGNATURE:

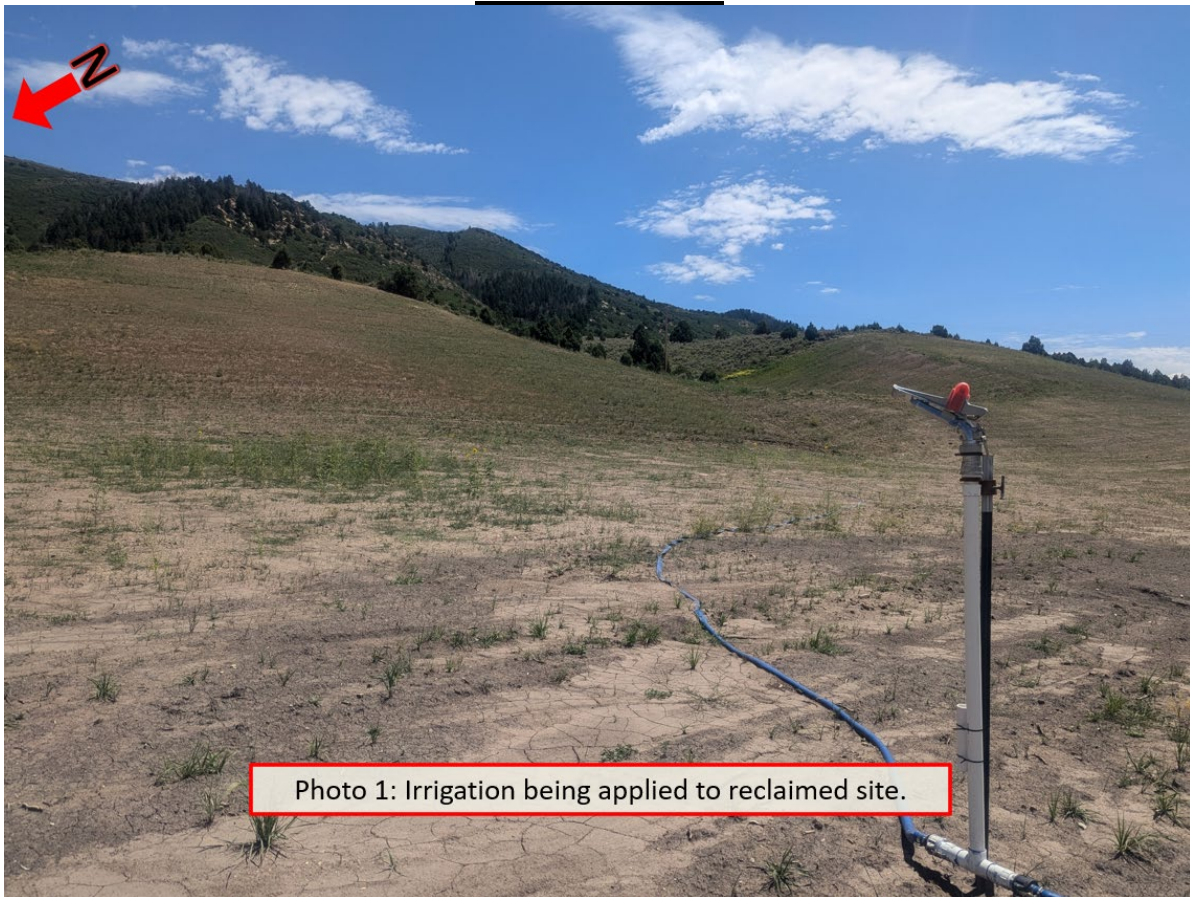
During the inspection irrigation infrastructure and evidence of applying water to the reclaimed areas was observed (Photo One). Per the approved reclamation plan this site is to be dry rangeland and no irrigation was to be applied. The Division acknowledges that this may be being done independent of the Operator by the landowner. The Operator needs to inform the landowner of the conditions of the permit and have him cease irrigation immediately. From a reclamation standpoint the Division cannot evaluate areas for reclamation success (dry rangeland) where they are being actively irrigated.

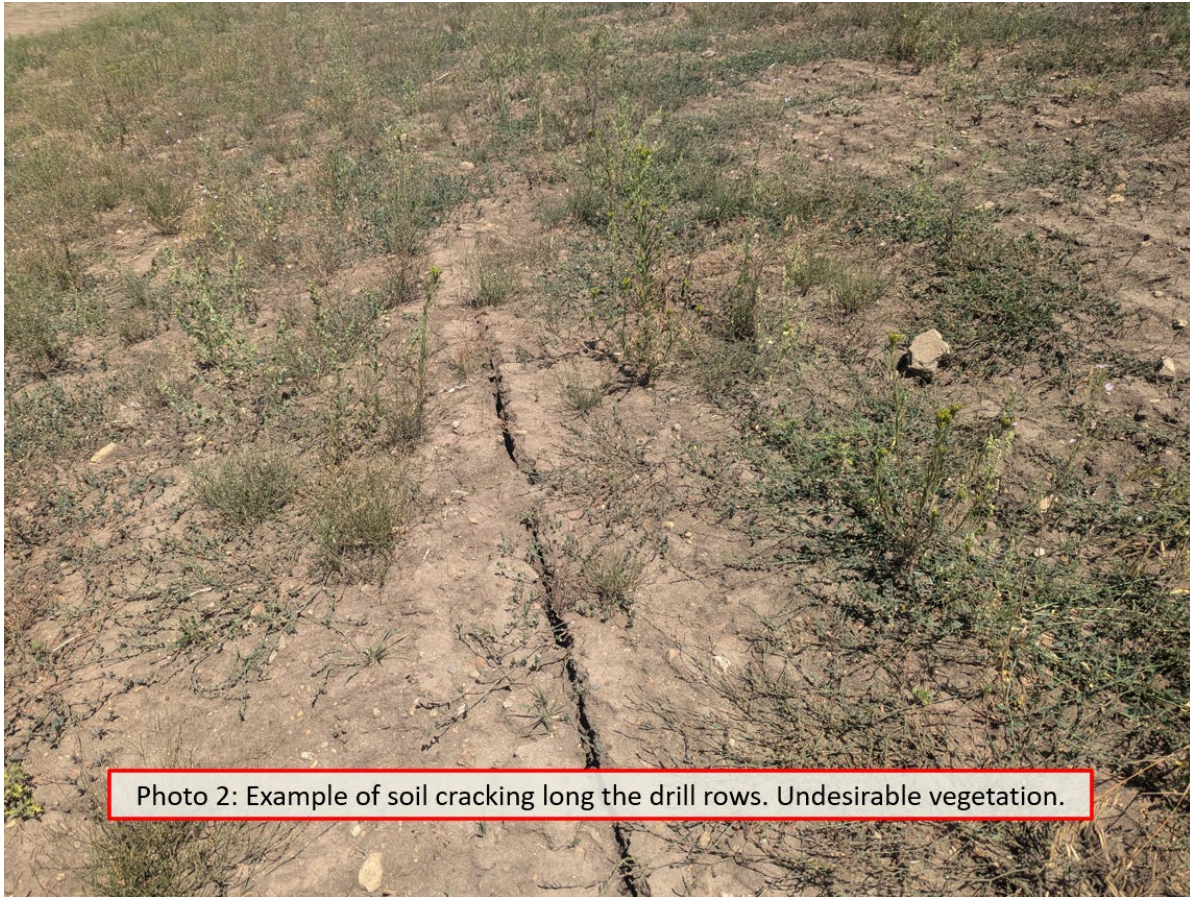
Furthermore, stress cracks were observed in the topsoil along the regraded highwalls. The cracks appear perpendicular to the slope along the drill seed furrows (Photo Two). This is likely due to the applications of water on the slope. There is a high potential for erosion and topsoil slippage if continued water is applied. There is also a depression between the two working areas that is now pond (Photo Three). A pond was not a part of the post mine land configuration. Water cannot be stored for more than 72 hours without having sufficient water rights for such water. The Division is unclear if the landowner or the operator has the appropriate water rights to use well water for irrigation or storing it on the surface.

Topsoil cracking was observed throughout the regarded areas (Photo Two). At this time, it has not escalated to the extent of subsidence, however it should be monitored.

Photo 2: Example of soil cracking long the drill rows. Undesirable vegetation.

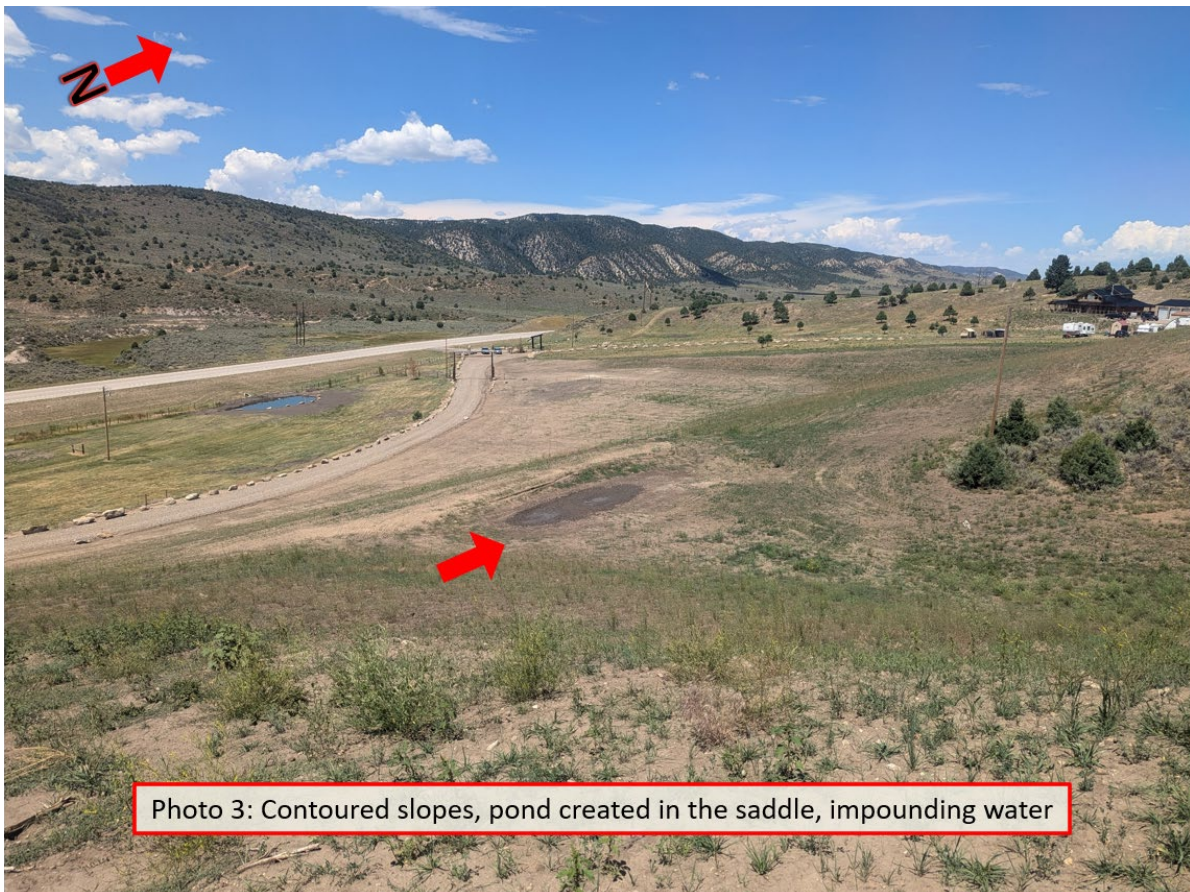
Photo 3: Contoured slopes, pond created in the saddle, impounding water

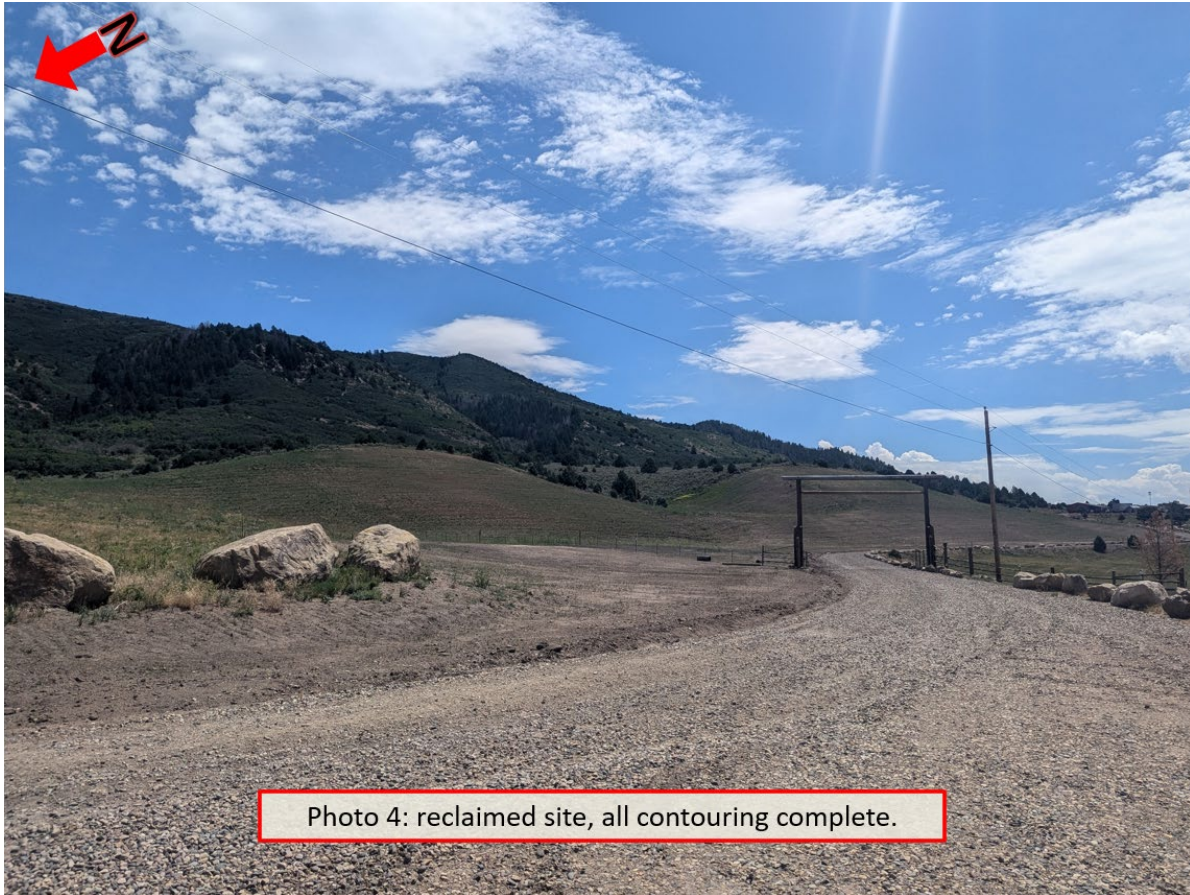
All slopes have been contoured and reseeded. The access road along the west side of the property remains in place as per the approved permit. Only 20% or all vegetation present on site is desirable. Most vegetation is noxious weeds. Overall vegetation cover is less than 50%. A subsequent seeding will likely be necessary based on the lack of germination. (Photos Four – Six)

The landowner has erected a wire fence and archway within the permit boundary (Photo Four and Six). Pursuant to Rule 1.1(52) these are permanent man-made features which are not included on the final reclamation plan maps. The Reclamation plan map will need to be updated to reflect current site conditions. No buildings or other mining related features are located on site.

Photo 4: reclaimed site, all contouring complete.

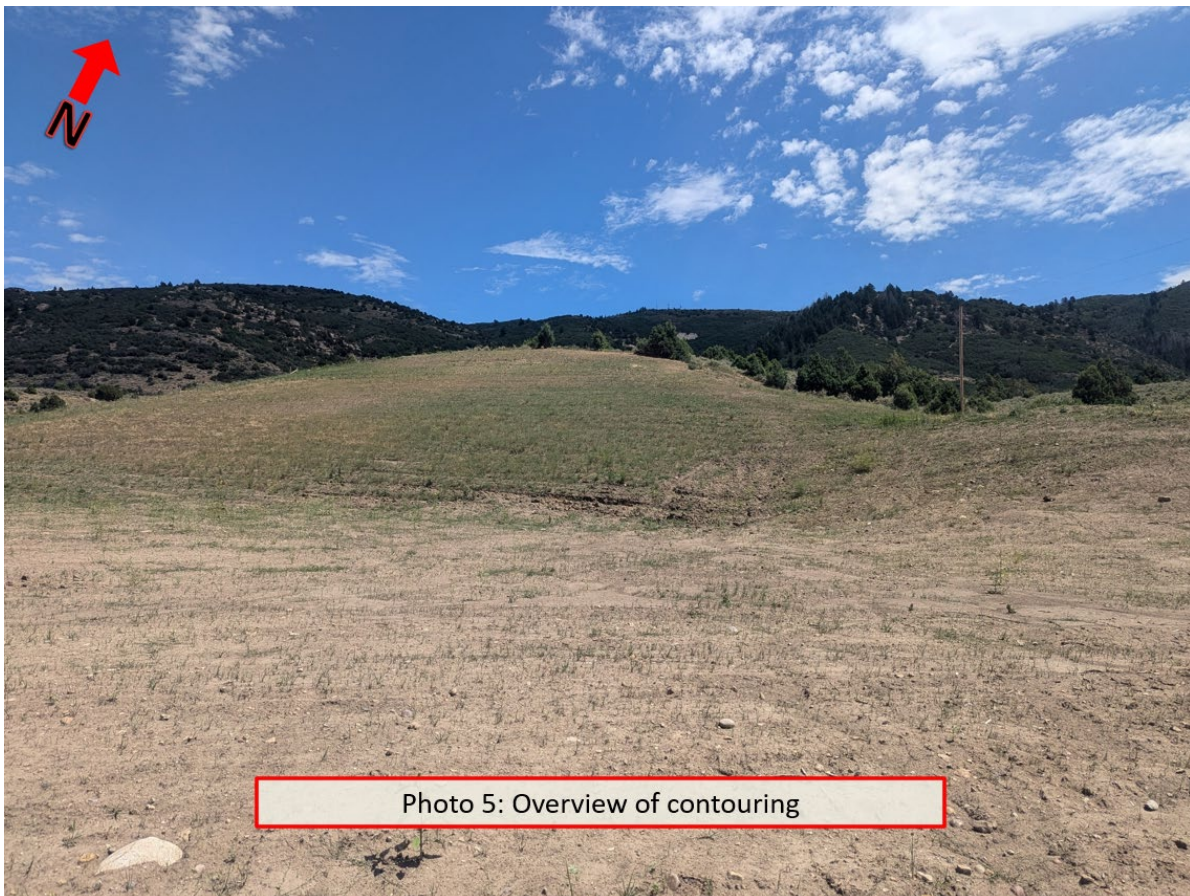
Photo 5: Overview of contouring

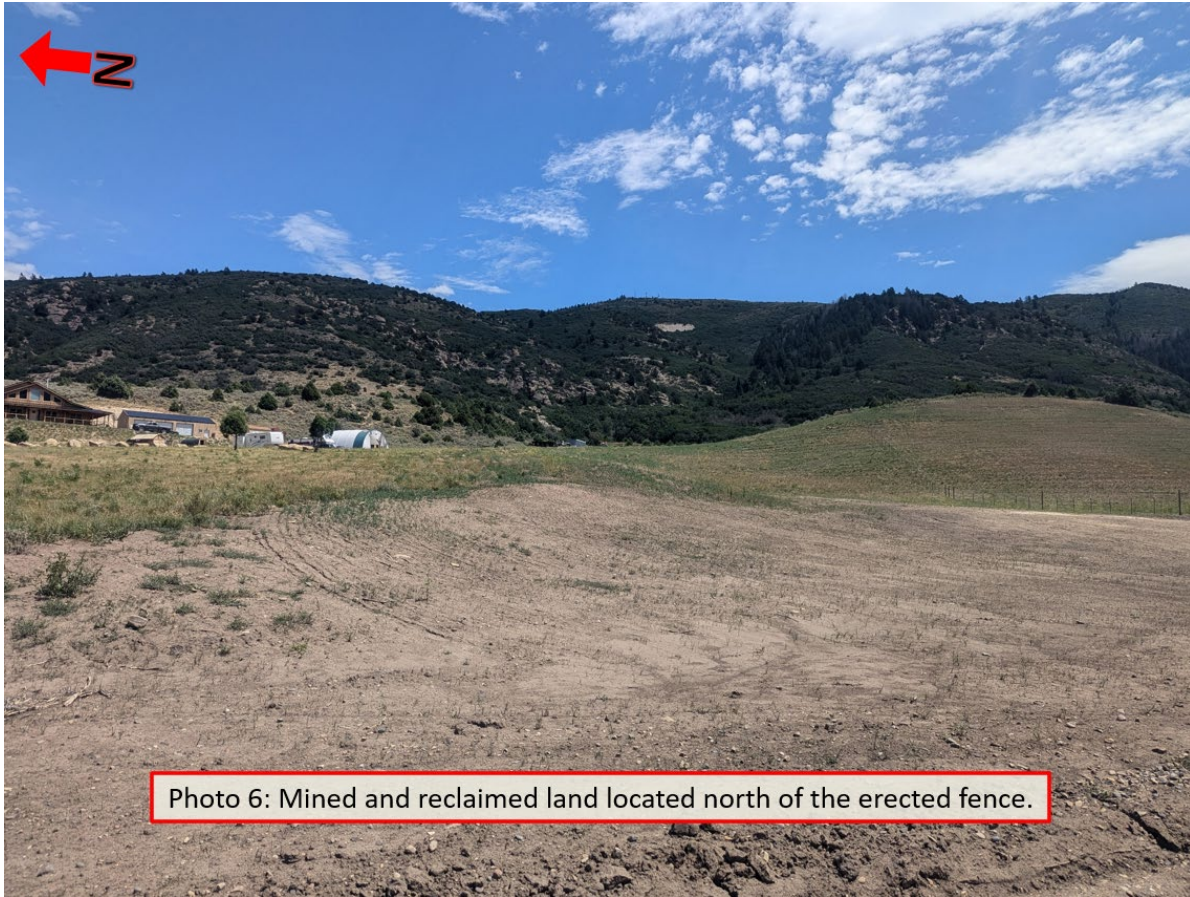
Photo 6: Mined and reclaimed land located north of the erected fence.

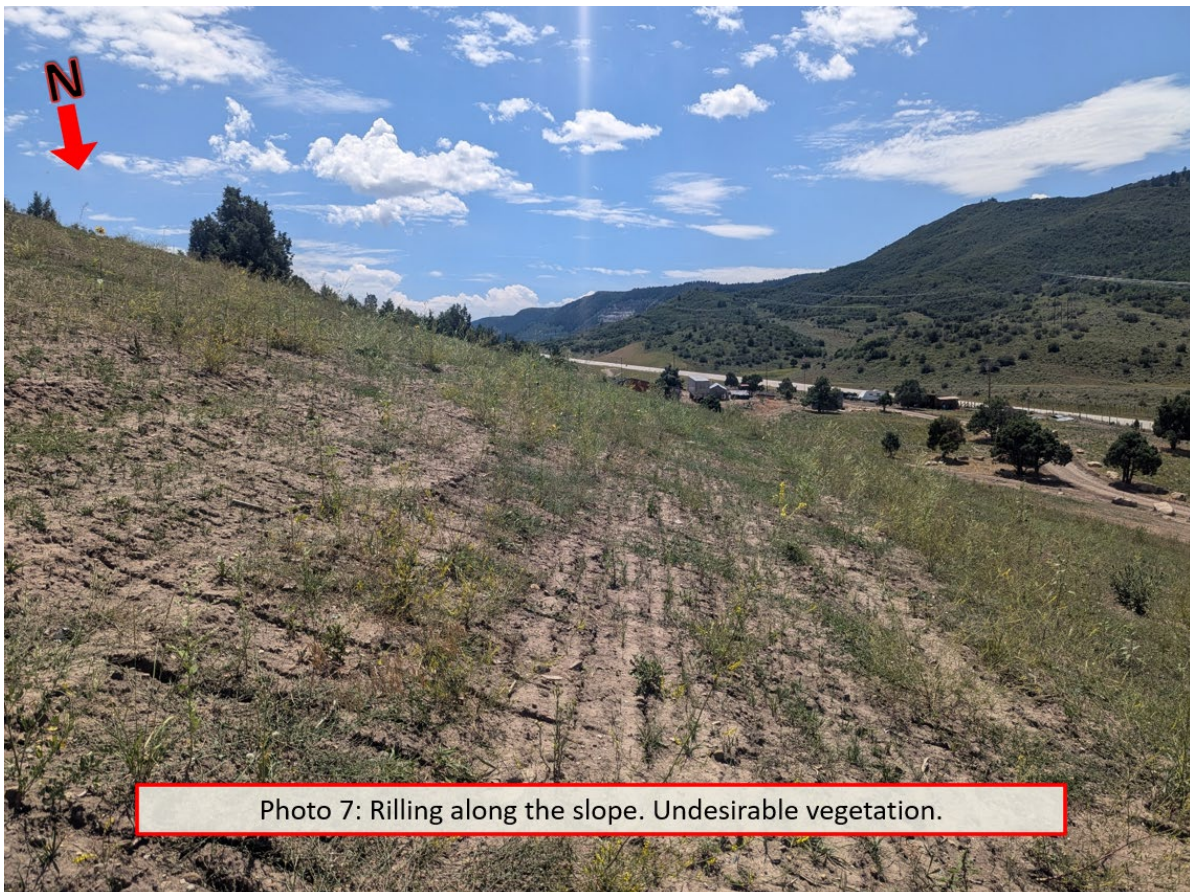
Erosion and rilling were observed on the contoured slopes (Photo Seven and Eight). Topsoil deposition is occurring at the toe of the slope from erosion. This is cited as a problem. At a minimum, slopes will need to be disced to removed rilling prior to revegetation. Per Rule 3.1.5(3) all grading shall be done in a manner to control erosion and siltation of the affected lands, to protect areas outside of the affected lands from slides and other damages.

Photo 7: Rilling along the slope. Undesirable vegetation.

CORRECTIVE ACTIONS: The operator shall provide photo documentation to the Division verifying that repairs have been made, and that the site has have been reconstructed and stabilized to prevent erosion damage by the corrective action date.

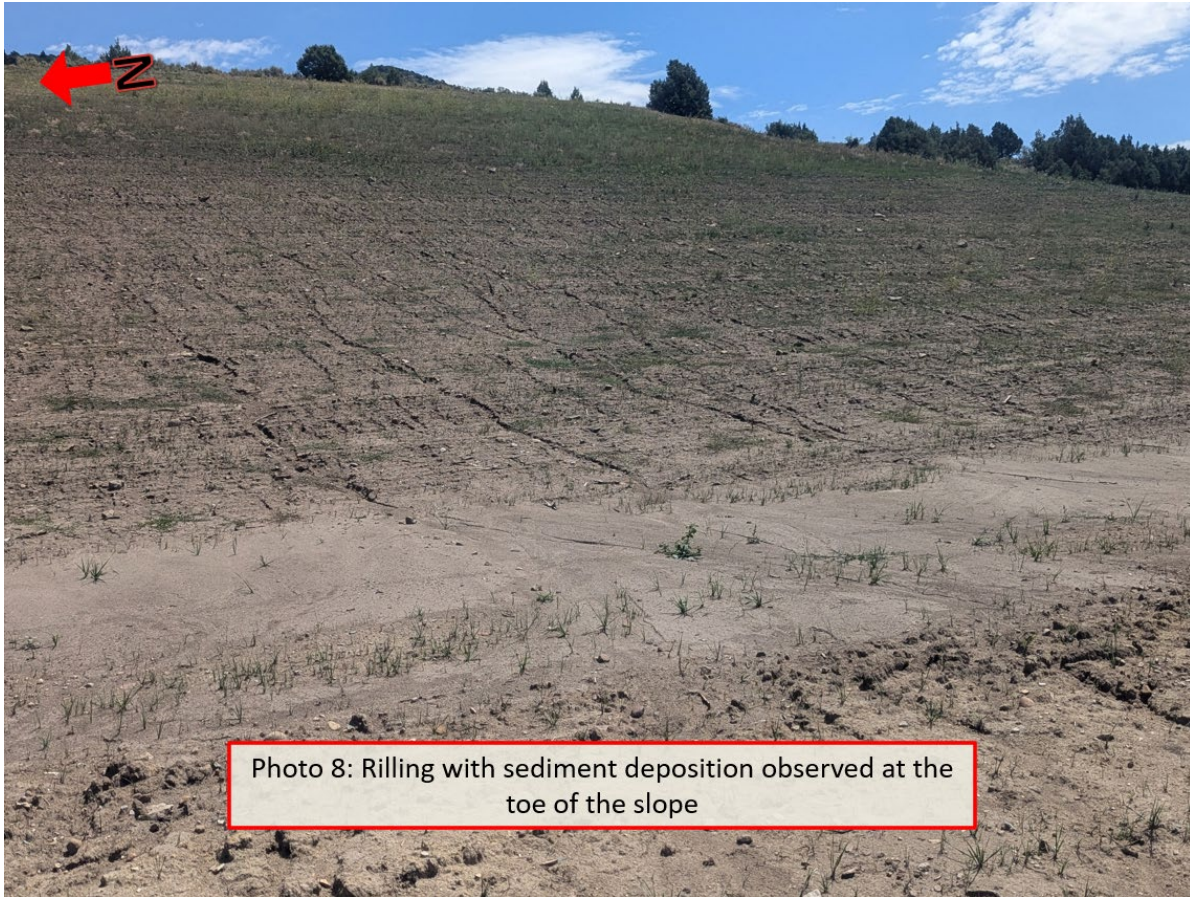
Photo 8: Rilling with sediment deposition observed at the toe of the slope

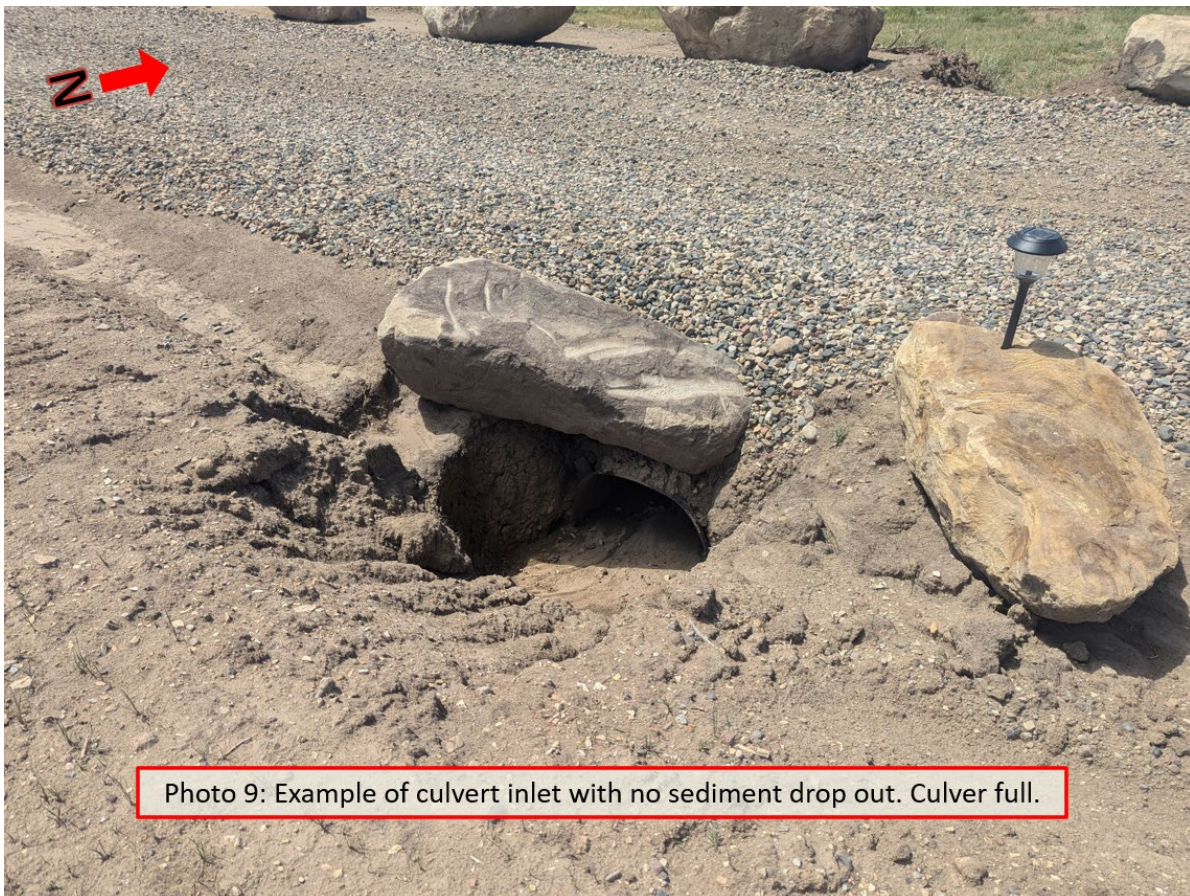
Multiple culverts direct water from the regraded highwalls under the road and to the west of the permit boundary. These culverts are not properly constructed (Photos Nine and Ten). No inlet structure was constructed. Sediment laden water will not be impounded to settle out before exiting the permit boundary. The outlets of the culverts have no armoring. This is cited as an inspection problem. BMPs must be properly installed in order to effectively convey water and protect the affected lands from erosion and sedimentation.

Photo 9: Example of culvert inlet with no sediment drop out. Culver full.
