**MINERALS PROGRAM INSPECTION REPORT**  
**PHONE: (303) 866-3567**

<b>MINE NAME:</b> Falk Pit #1	<b>MINE/PROSPECTING ID#:</b> M-2010-043	<b>MINERAL:</b> Clay (general), grave	<b>COUNTY:</b> Phillips
<b>INSPECTION TYPE:</b> Preoperation Inspection	<b>WEATHER:</b> Clear	<b>INSP. DATE:</b> October 22, 2024	<b>INSP. TIME:</b> 11:15
<b>OPERATOR:</b> Chamberlain Concrete	<b>OPERATOR REPRESENTATIVE:</b> Mr. Mason Chamberlain	<b>TYPE OF OPERATION:</b> 110c - Construction Limited Impact	
<b>REASON FOR INSPECTION:</b> Pre-operation Inspection	<b>BOND CALCULATION TYPE:</b> None	<b>BOND AMOUNT:</b> \$45,807.00	
<b>DATE OF COMPLAINT:</b> NA	<b>POST INSP. CONTACTS:</b> None	<b>JOINT INSP. AGENCY:</b> None	
<b>INSPECTOR(S):</b> Jocelyn Carter Ursula Armstrong	<b>INSPECTOR'S SIGNATURE:</b>

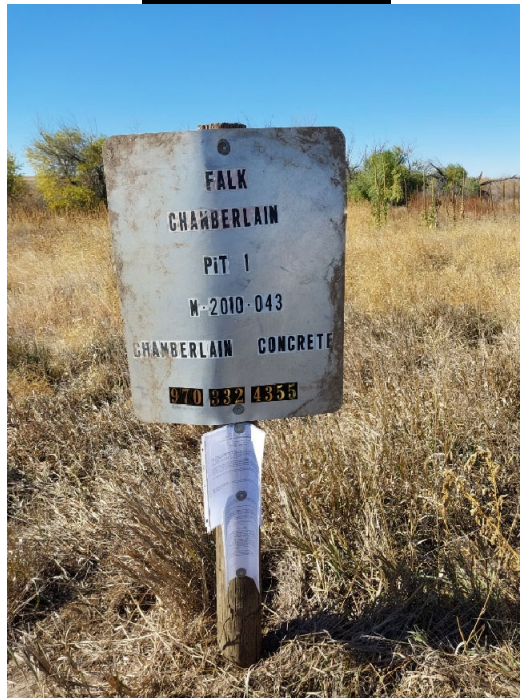
There was a mine sign in accordance with Rule 3.1.12(1), located at the entrance of the permit area, see Photo #1. Metal pickets with white tops, some with pink tape tied to the tops, were located at each of the permit boundary markers, in accordance with Rule 3.1.12.(2); see Photos #3-6. Rule 1.6.2(b) requires an additional notice be posted providing information about the conversion application and where anyone can obtain/review a copy of the conversion application at the County Clerk's or Recorder's office; this sign was also present; see photo #2.

Photo #1: Mine sign at the entrance of the site, per Rule 3.1.12(1).

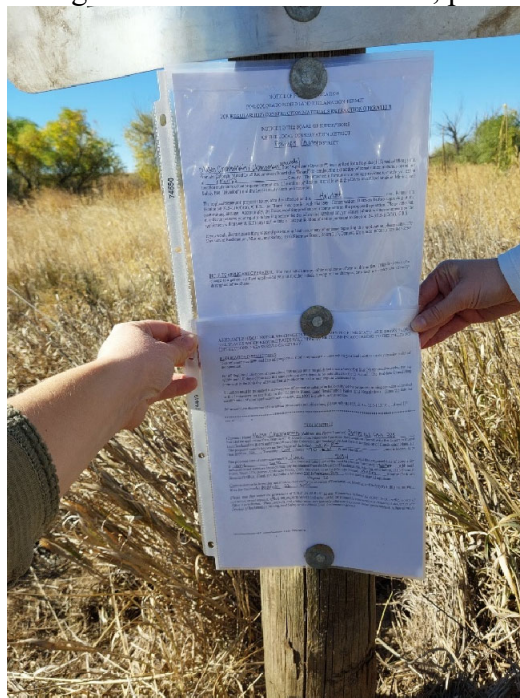
Photo #2: Notice of conversion application filed with the County Clerk's office, per Rule 1.6.2(b).

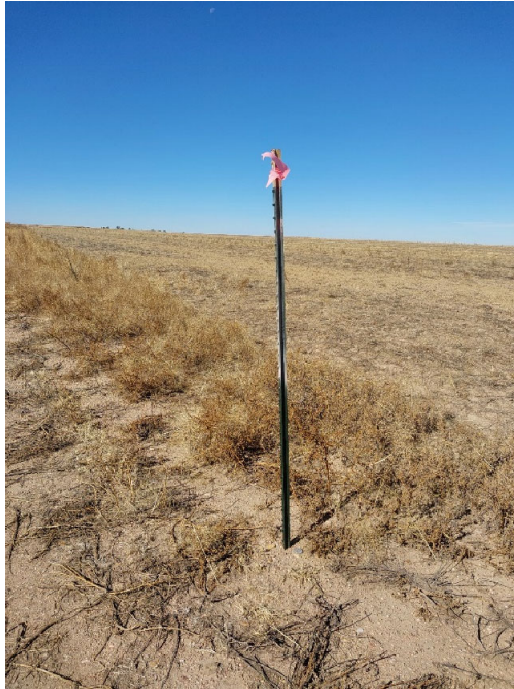
Photo #3: Permit boundary marker located in the northeast corner of the permit area; looking towards the northwest. Marker PB2 on the map below.

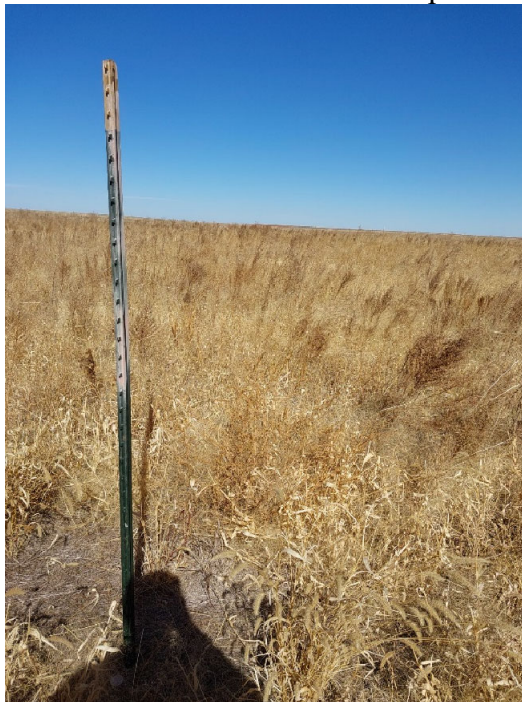
Photo #4: Permit boundary marker located in the northwest portion of the permit area; looking to the north-northeast. Marker PB 1 on the map below.

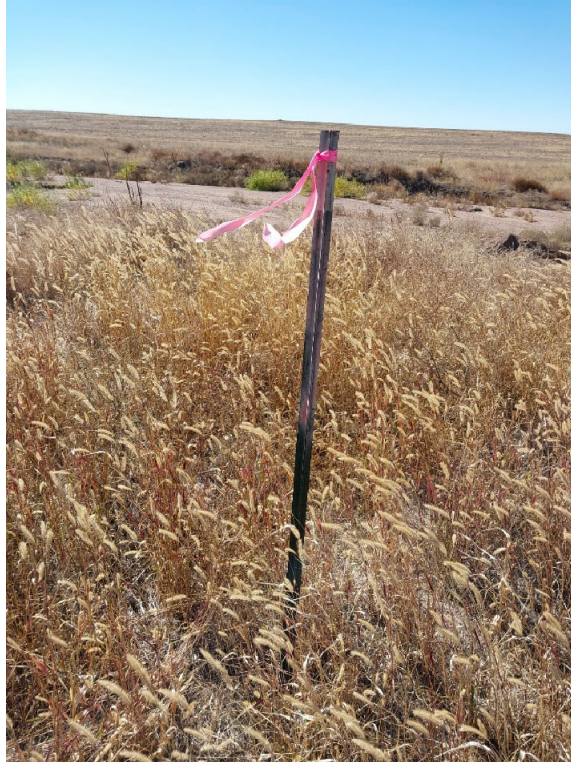
Photo #5: Permit boundary marker located on the northeast side of Patent Creek; looking south-southeast at the permitted area. Marker PB 10 on the map below.

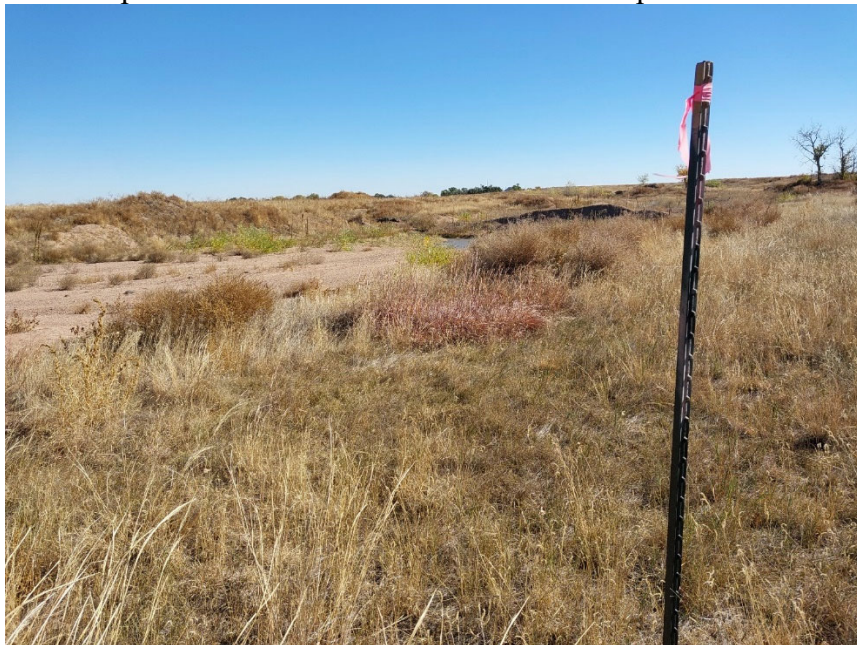
Photo #6: Permit boundary marker located on the southwest portion of the permit area and on the south side of Patent Creek; looking east-northeast at the permitted area. Marker PB 8 on the map below.

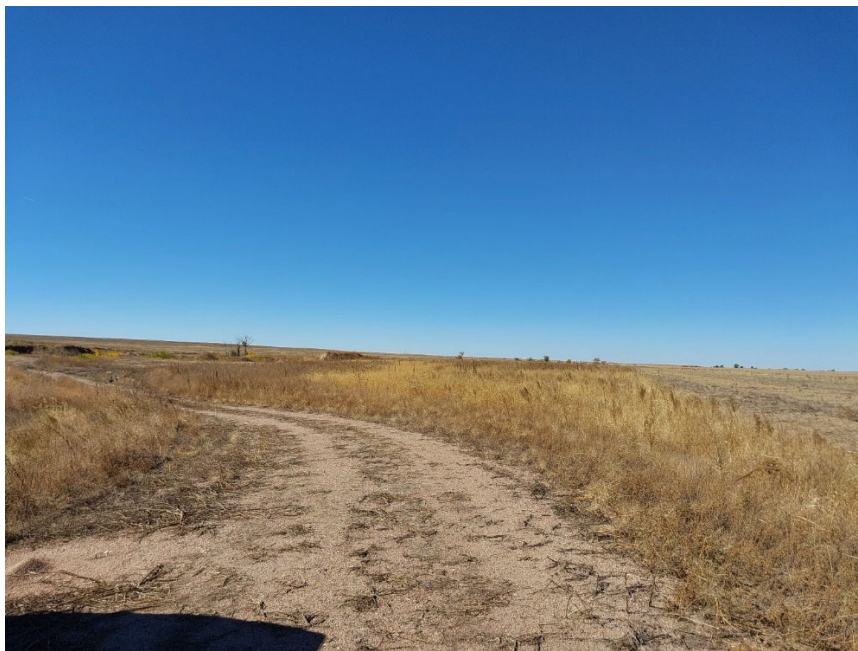
The road to be used for the operation appeared to be in good condition, see Photo #7.

Photo #7: View of the road from the mine entrance located at the northeast portion of the permitted area; looking west at the permitted area.

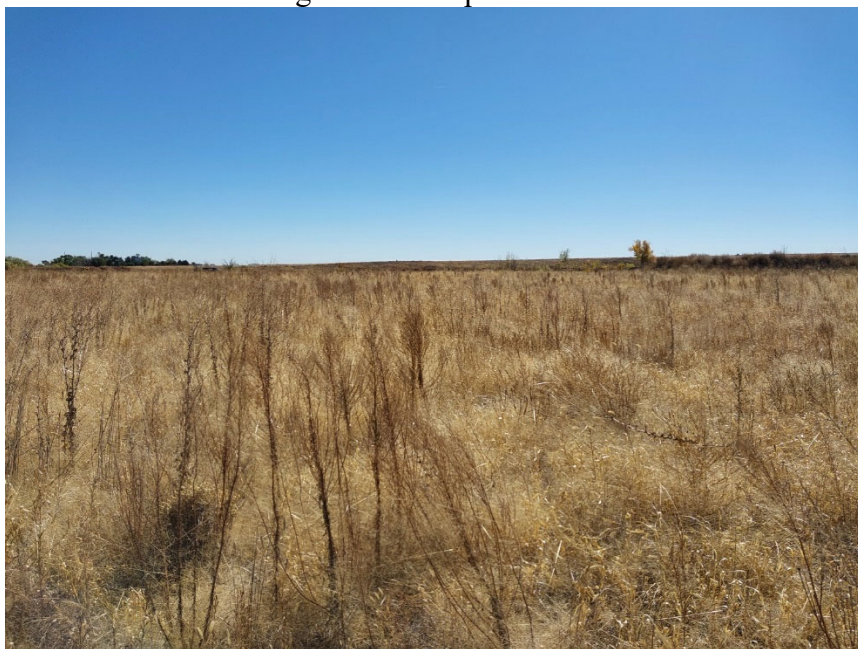
Photo #8: View of the permit area located north of Patent Creek from the northwest portion of the permitted area; looking southeast.

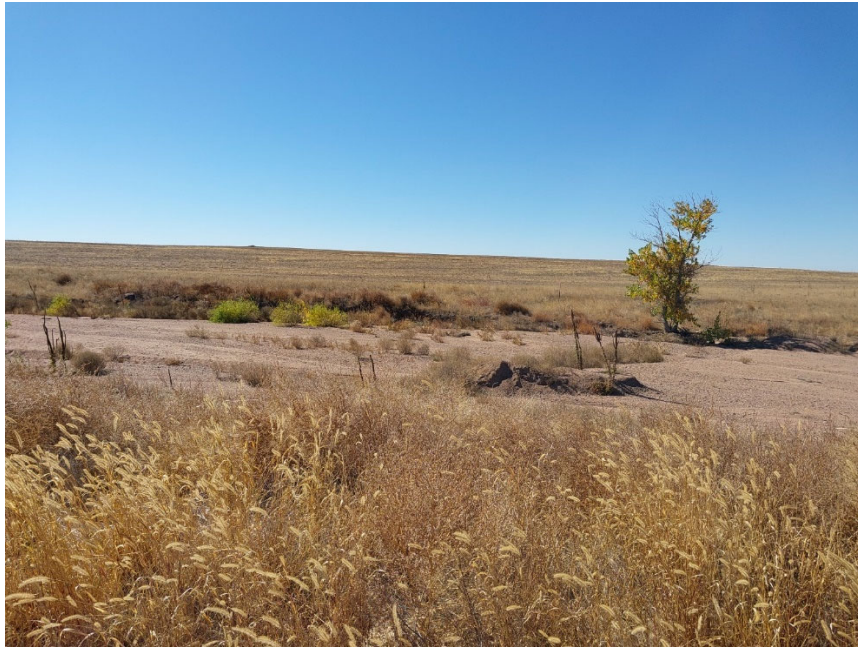
Photo #9: View of Patent Creek from the north side of the bank in the western portion of the permitted area; looking south-southeast.

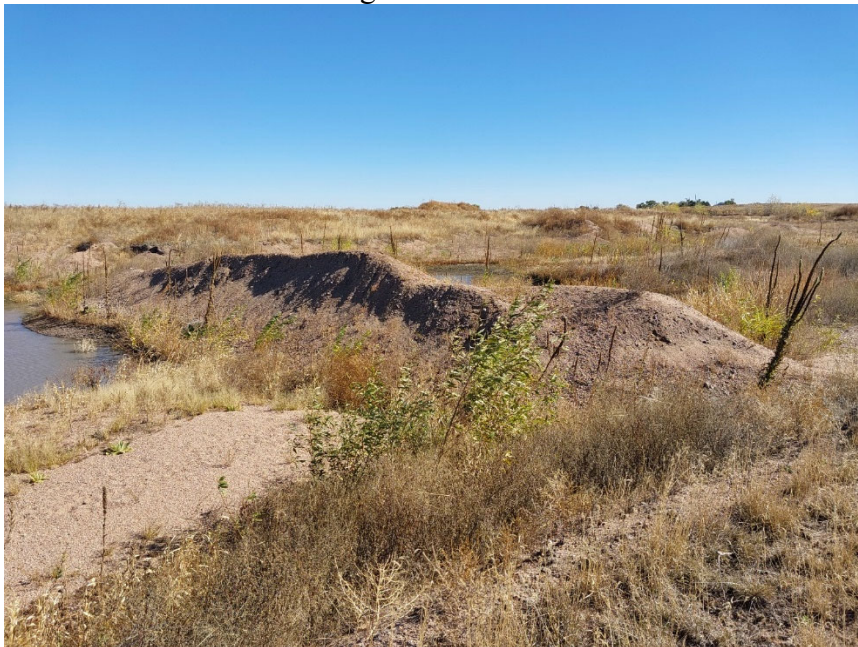
Photo #10: View of land disturbed by mining operation in Patent Creek from the south side of the creek; looking northwest.

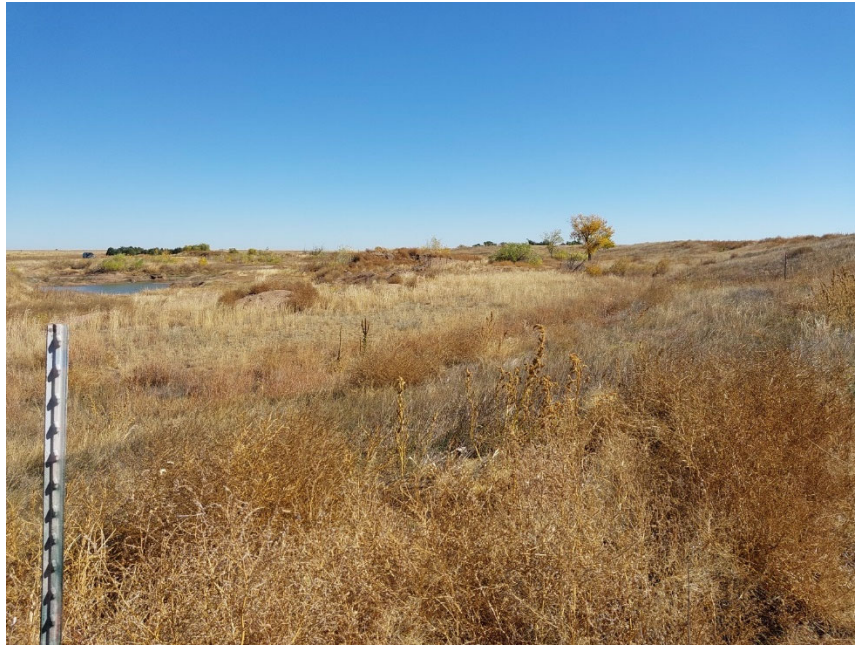
Photo #11: View of the permitted area from the southwest portion of the permitted area; looking northeast.  
Marker PB 6 on the map below.

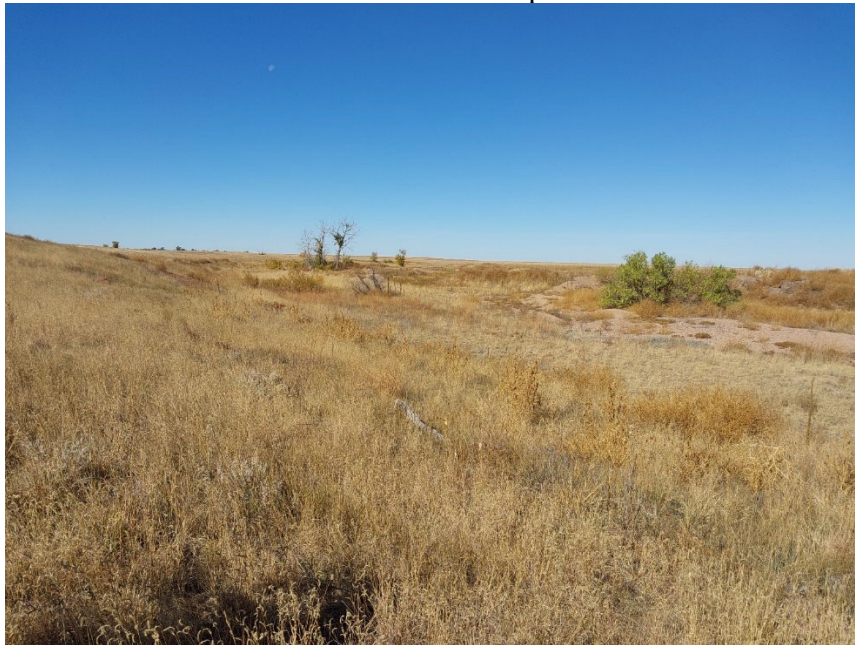
Photo #12: View of the permitted area from the south-central portion of the permitted area along the south bank of Patent Creek; looking northwest.

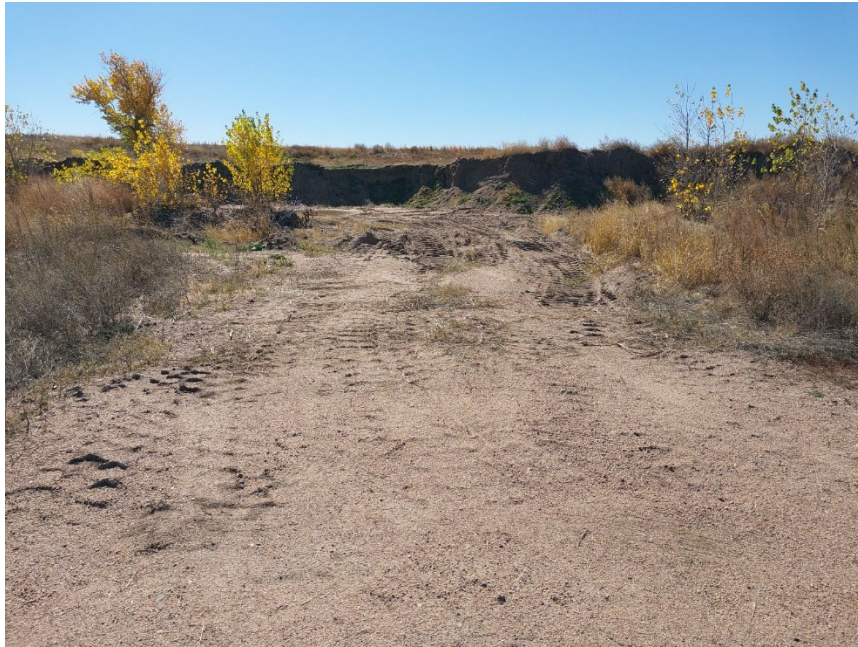
Photo #13: View of land disturbed by the mining operation located in the central portion of the permitted area; looking south.

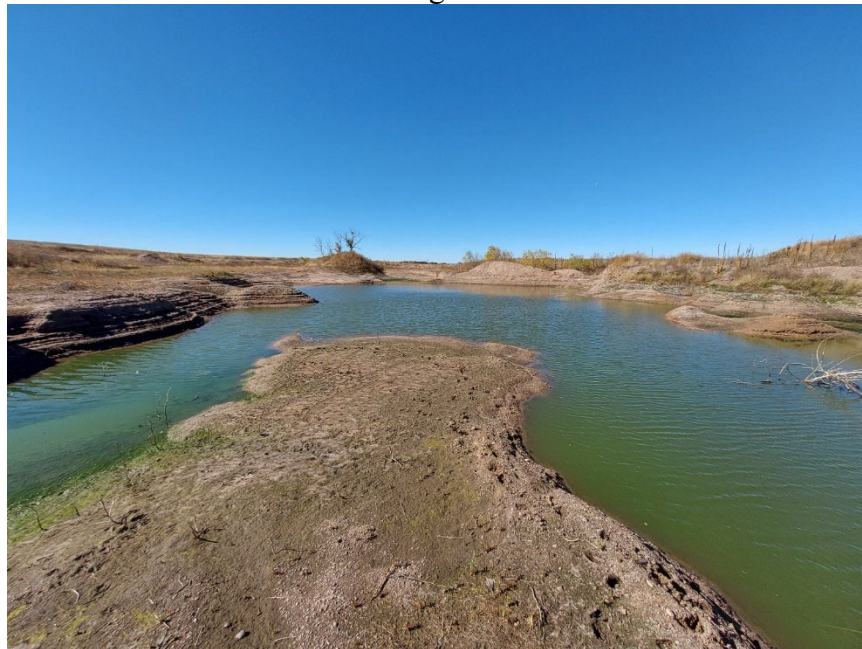
There was water in the lowest areas of the stream bed at the time of the inspection, see Photo #14. There was a small precipitation event in the area on October 19, 2024. There was no indication of the hydrologic balance being impacted by the operation.

Photo #14: View of the water held in the lowest portions of Paten Creek; looking west.

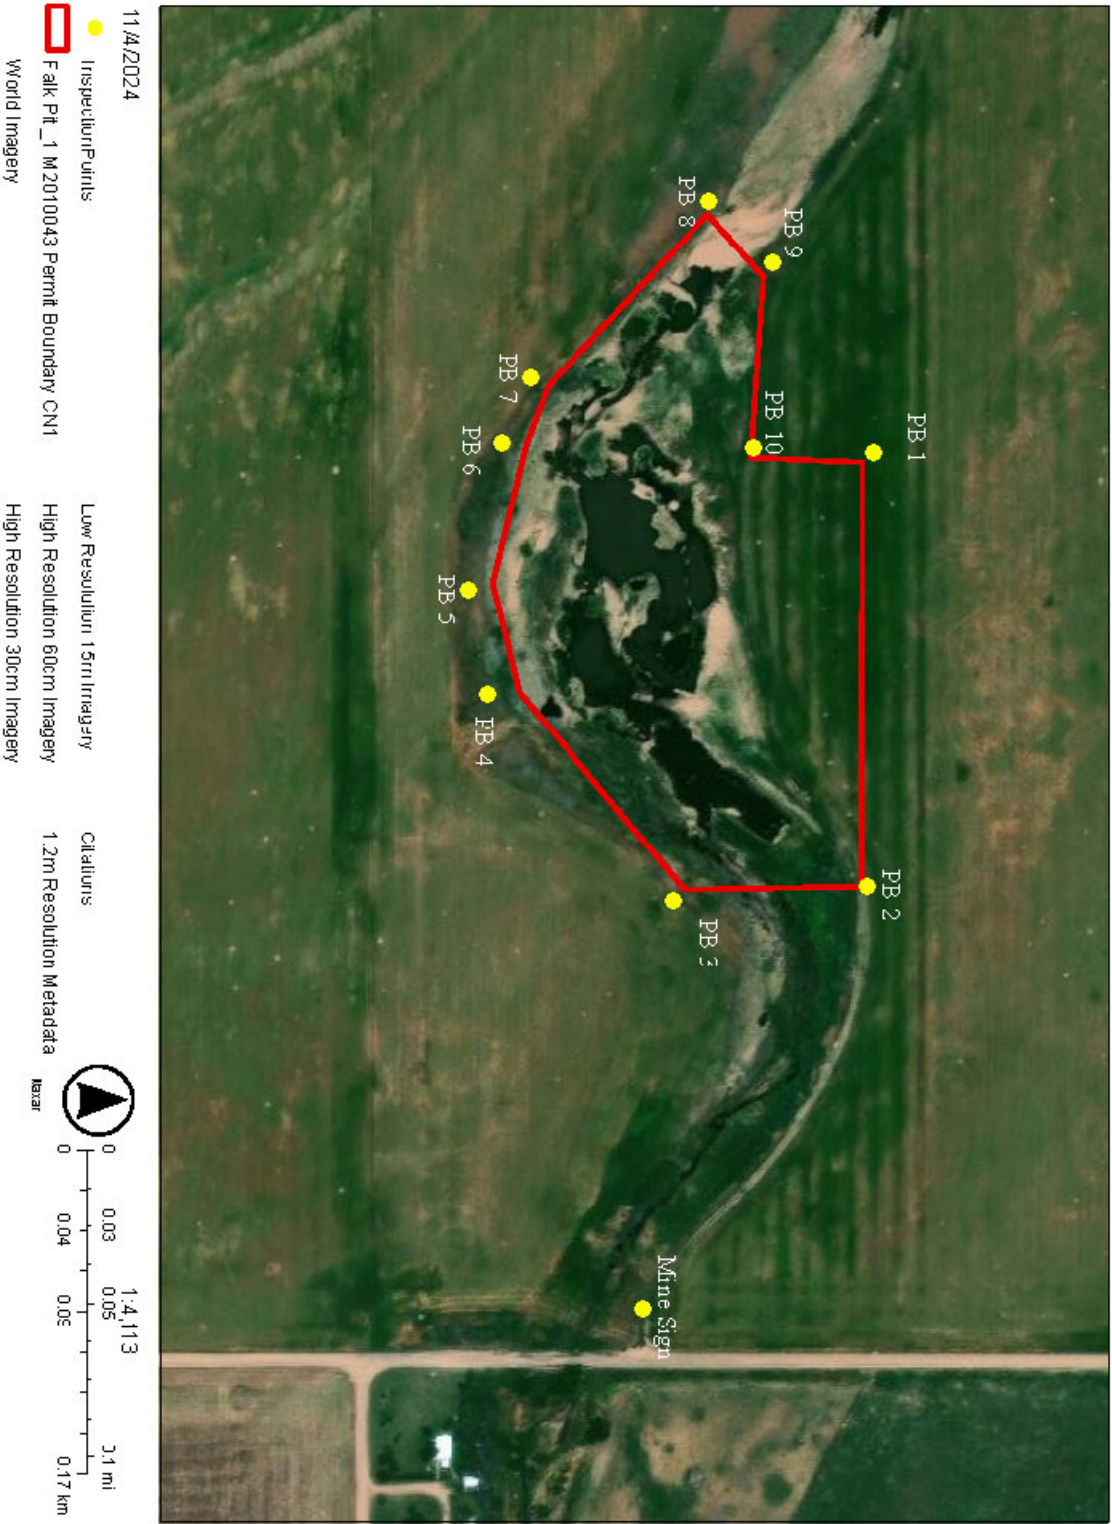
Map showing permit boundary locations found during inspection.
