P2016008, Bonanza Land, Inspection Report

MINERALS PROGRAM INSPECTION REPORT
PHONE: (303) 866-3567

MINE NAME: Bonanza Land	MINE/PROSPECTING ID#: P-2016-008	MINERAL: Gold and silver	COUNTY: Gilpin
INSPECTION TYPE: Mineral Prospect Inspection	WEATHER: Clear	INSP. DATE: October 31, 2024	INSP. TIME: 09:00
OPERATOR: Bonanza Land, LLC	OPERATOR REPRESENTATIVE: Carl Schembri	TYPE OF OPERATION: MP - Mineral Prospecting	
REASON FOR INSPECTION: Normal I&E Program	BOND CALCULATION TYPE: None	BOND AMOUNT: \$2,750.00	
DATE OF COMPLAINT: NA	POST INSP. CONTACTS: None	JOINT INSP. AGENCY: None	
INSPECTOR(S): Leigh Simmons	INSPECTOR'S SIGNATURE:

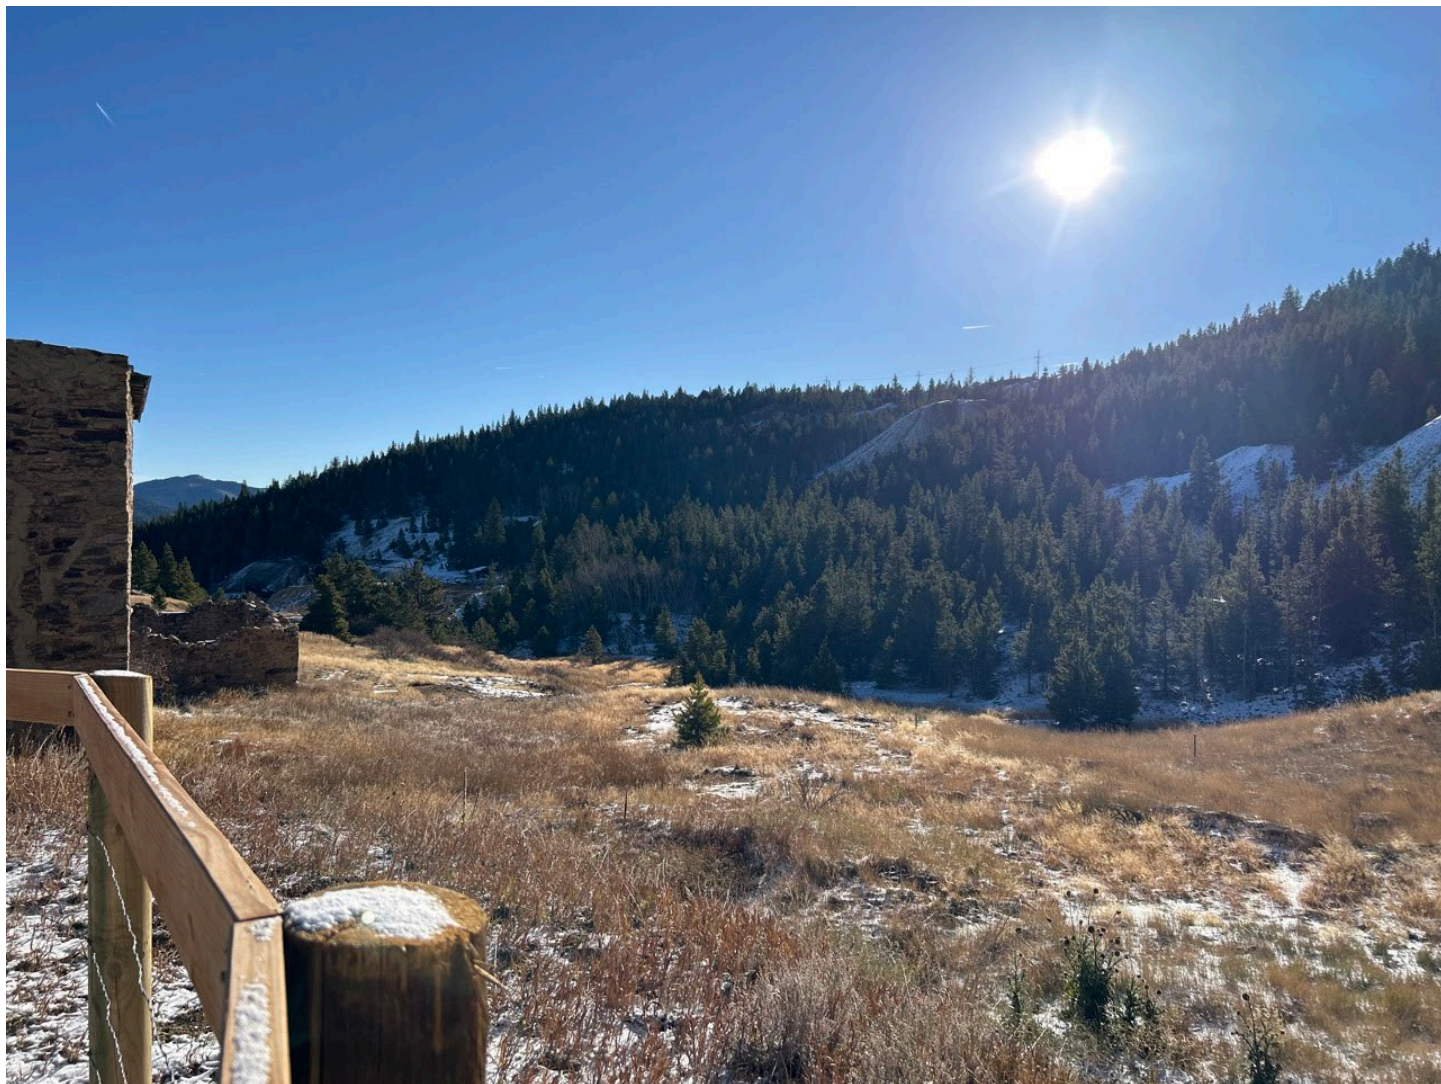
The weather was cold and clear, with a little snow on the ground in shady spots. The area where Bonanza Land conducted prospecting was extensively affected by historic mining, with un-reclaimed waste piles (see Figures 2-4) and buildings (see Figures 5-6) all around. According to annual reports Bonanza Land excavated six short trenches and drilled 17 holes in September 2016. The trenches were backfilled and the holes were abandoned immediately. A total of 0.7 acres were disturbed and reclaimed. Drill hole abandonment reports were submitted to the Division in November 2017.

Figure 2: Overview of site to SE (403)

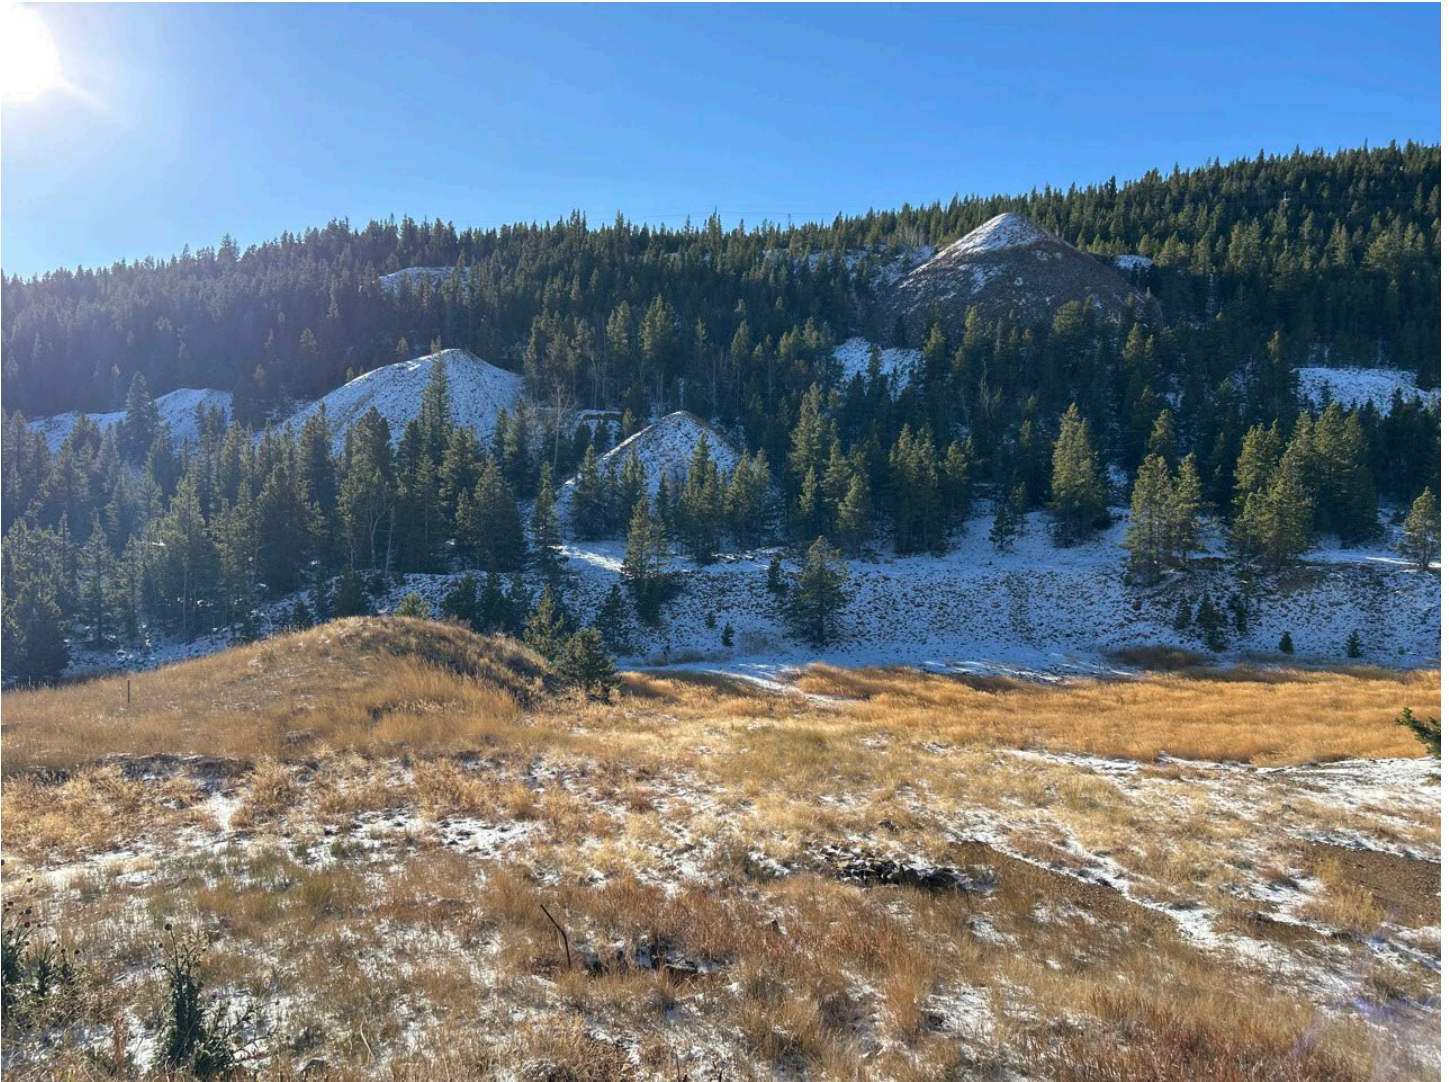
Figure 3: Overview of site to S (403)

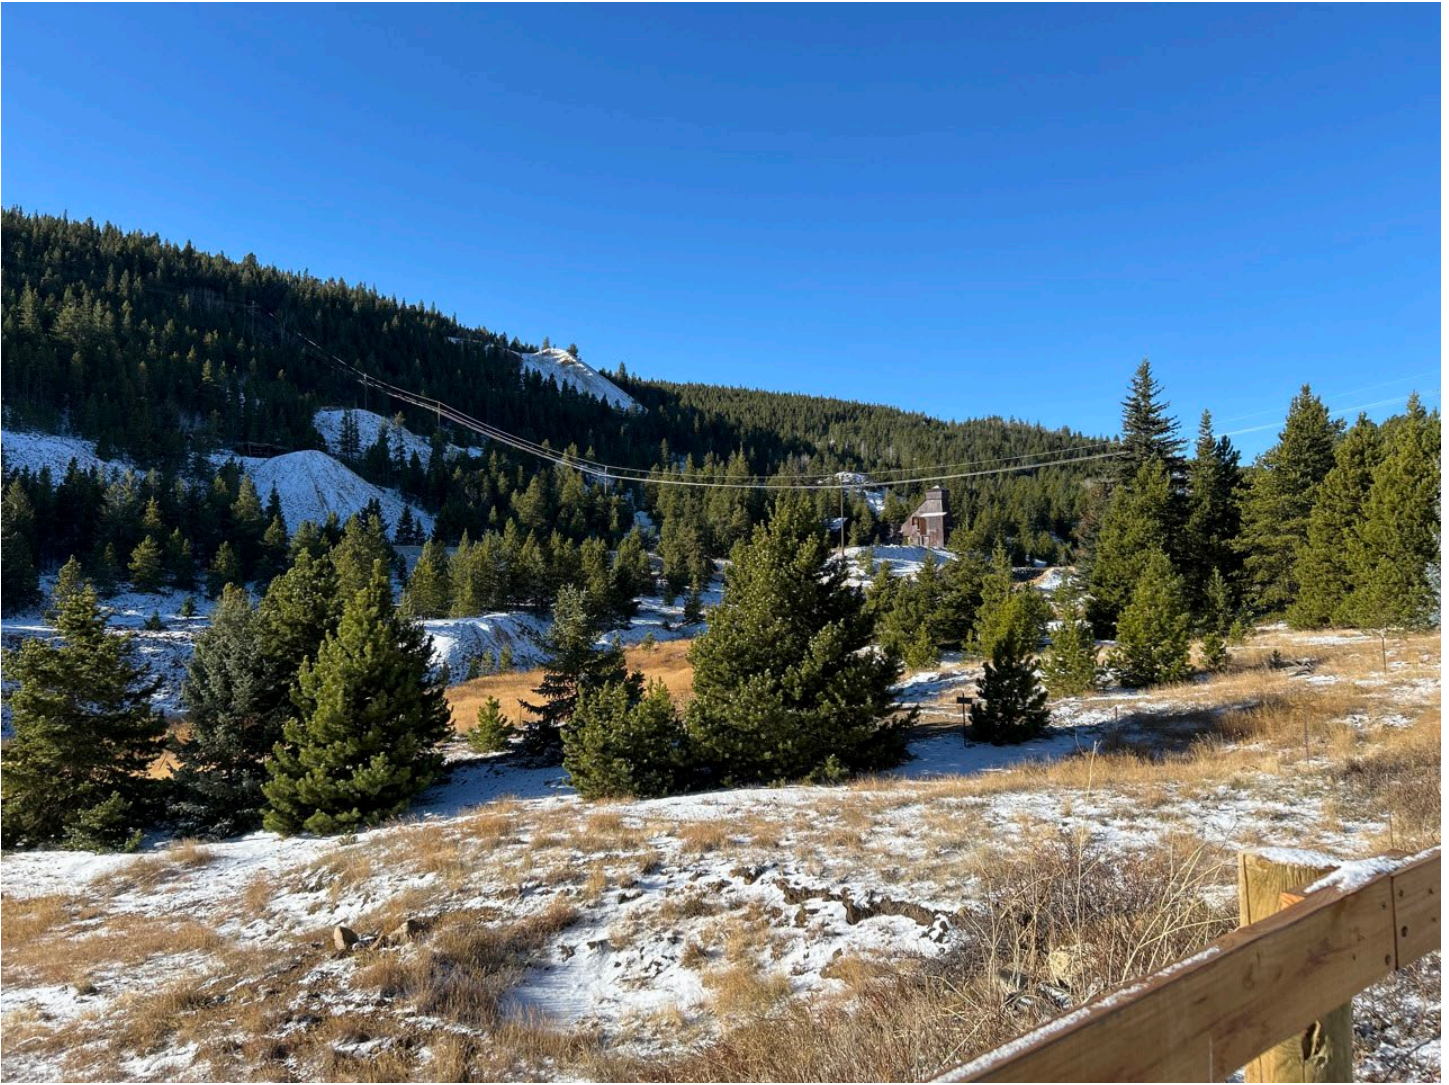
Figure 4: Overview of site to SW (403)

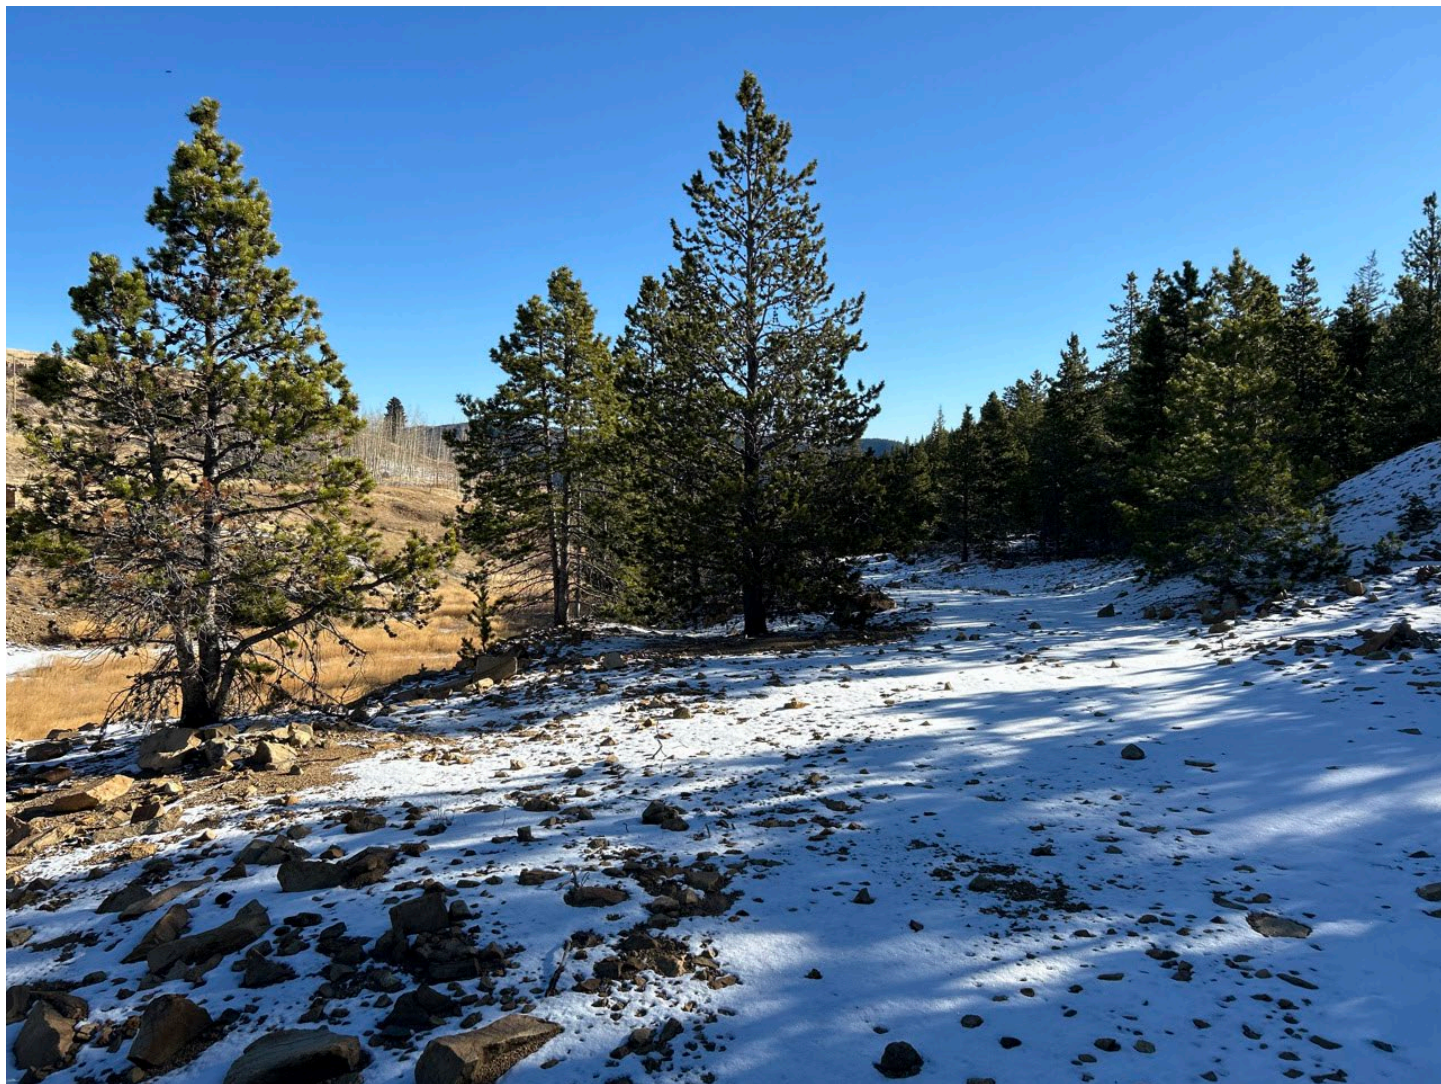
On the ground there was no evidence of any of the exploration holes, or of any trenches. The vegetation on the land within the disturbance boundary was indistinguishable from the surrounding land.

Figure 5: Reclaimed land (404)

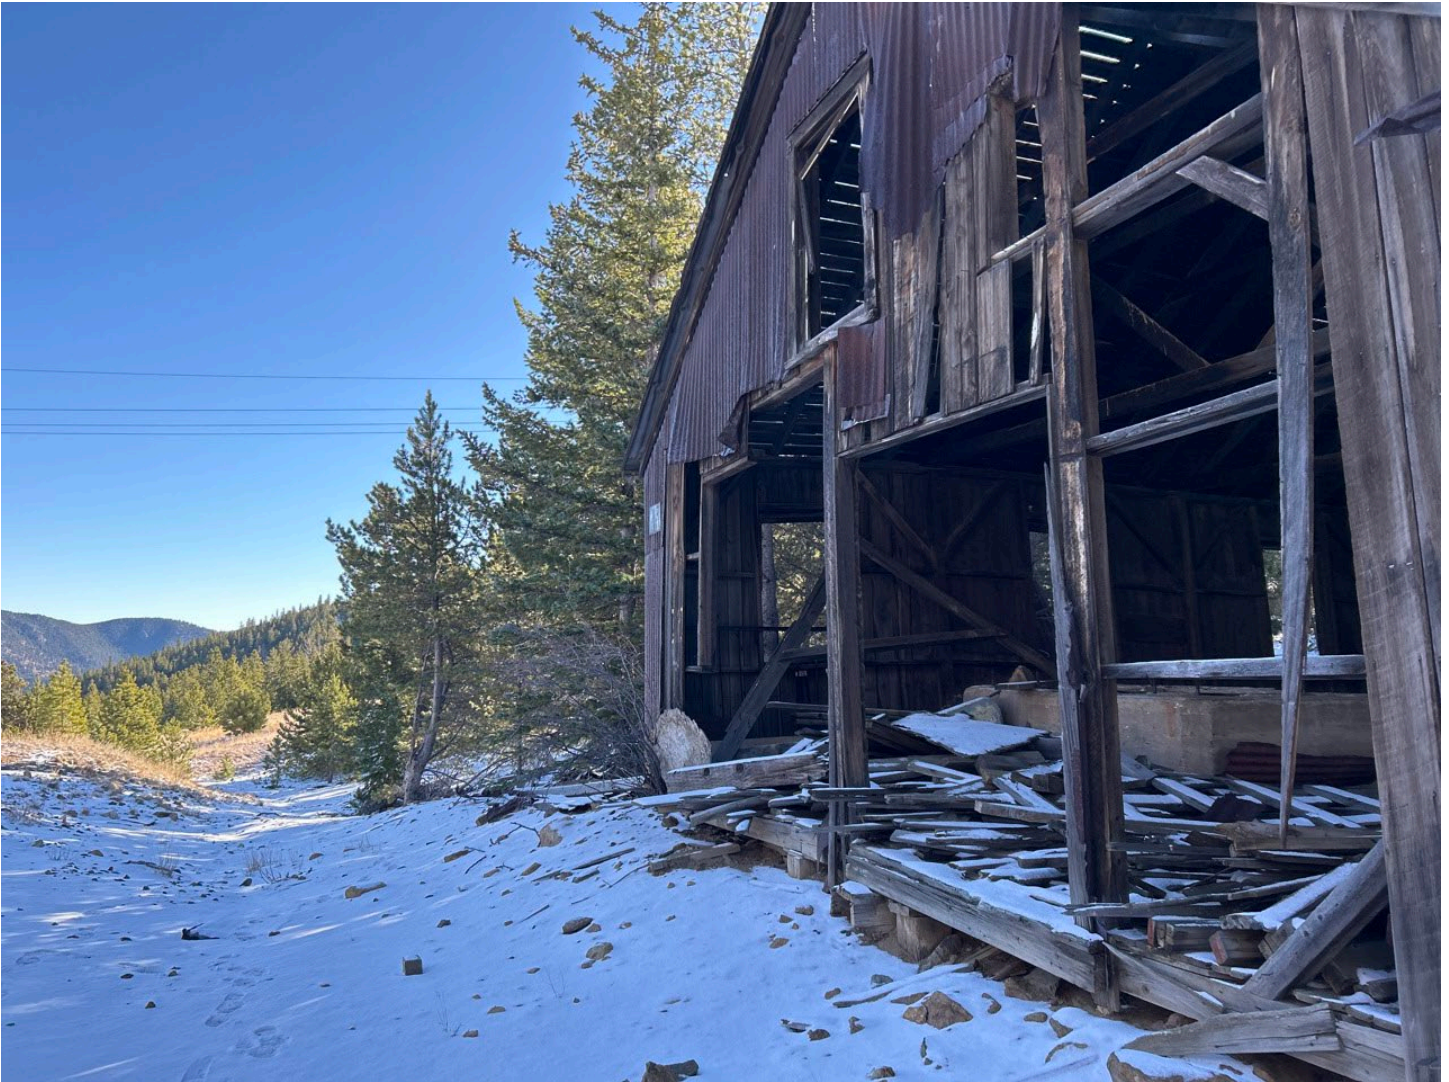
Figure 6: Pre-law mining disturbance (405)

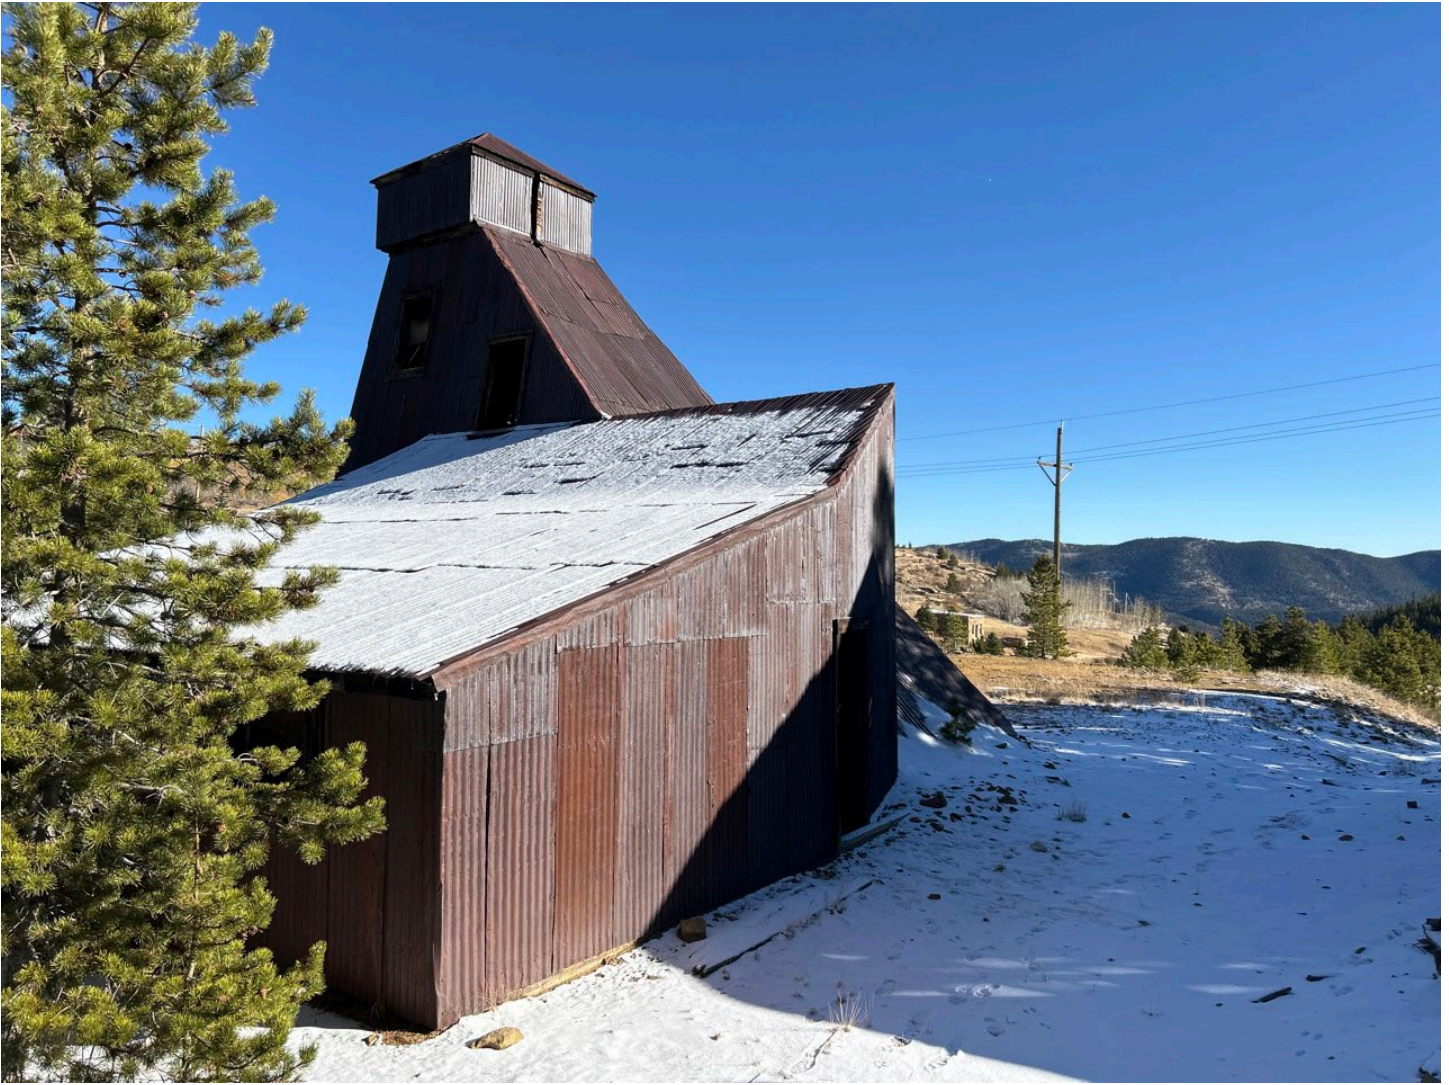
Figure 7: More pre-law mining disturbance (405)
