## MINERALS PROGRAM INSPECTION REPORT

<b>MINE NAME:</b> King Pit	<b>MINE/PROSPECTING ID#:</b> M-1987-012	<b>MINERAL:</b> Sand and gravel	<b>COUNTY:</b> Alamosa
<b>INSPECTION TYPE:</b> Monitoring	<b>WEATHER:</b> Clear	<b>INSP. DATE:</b> September 5, 2024	<b>INSP. TIME:</b> 11:20am
<b>OPERATOR:</b> Southwest Ready-Mix, Inc.	<b>OPERATOR REPRESENTATIVE:</b> Paul Bottini	<b>TYPE OF OPERATION:</b> 112c - Construction Regular Operation

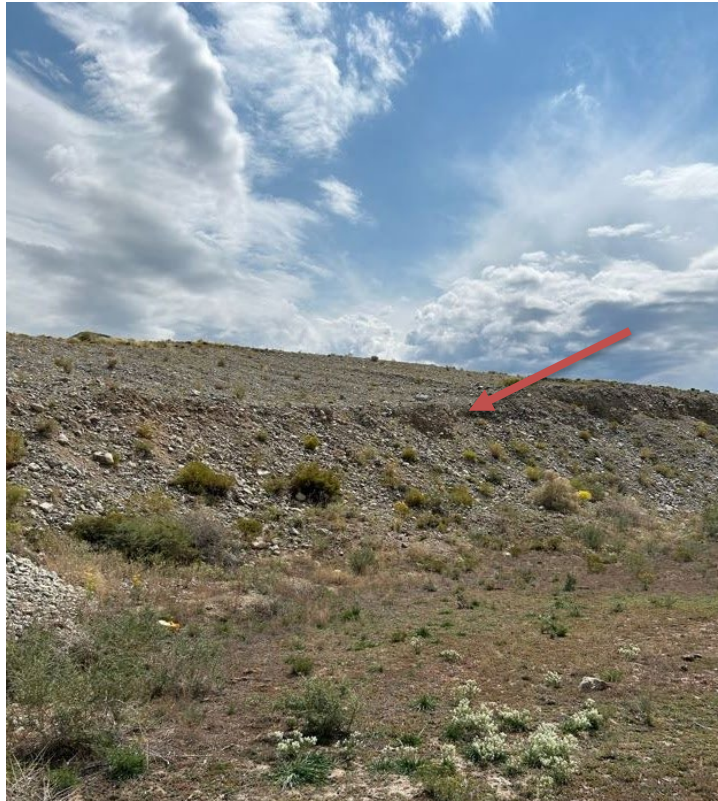
Photo 5: South Pit Area Highwall with toe of highwall closer to 1:1 slope.

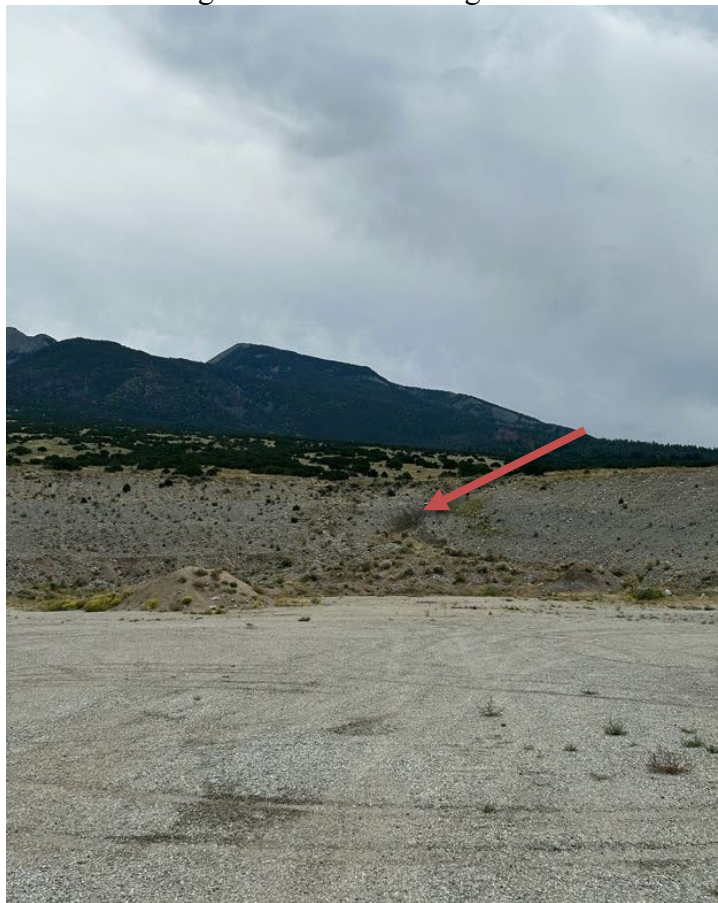
**PROBLEM:** Erosion gullies and ruts were observed in the South Pit Area. This is a problem at this time for failure to protect the affected land from erosion pursuant to C.R.S. 34-32.5-116(4)(j).

gullies have formed perpendicular to the pit slope (see Photos 6-7) due to upland drainage from the east. The DRMS noted that these gullies will need repair and stabilization in accordance with Rule 3.1.6(3). The highwall slopes ranged from 3:1 to 4:1 (horizontal to vertical ratio). However, along the north side of the South Pit highwall, the toe of the highwall was closer to a 1:1 slope (see Photo 5). The Operator claims that the BLM will not allow them to do any earthwork at the site without charging them royalties and therefore they have not been able to repair the erosion. The Operator must work with the BLM to come to a resolution and repair and stabilize the erosion observed at the site.

Photo 6: South Pit Area Highwall with erosion gully in the center, facing east.

**CORRECTIVE ACTIONS:** The operator shall provide photo documentation to the Division verifying erosion gullies and ruts have been repaired, and that the site has have been reconstructed and stabilized to prevent erosion damage by the corrective action date.

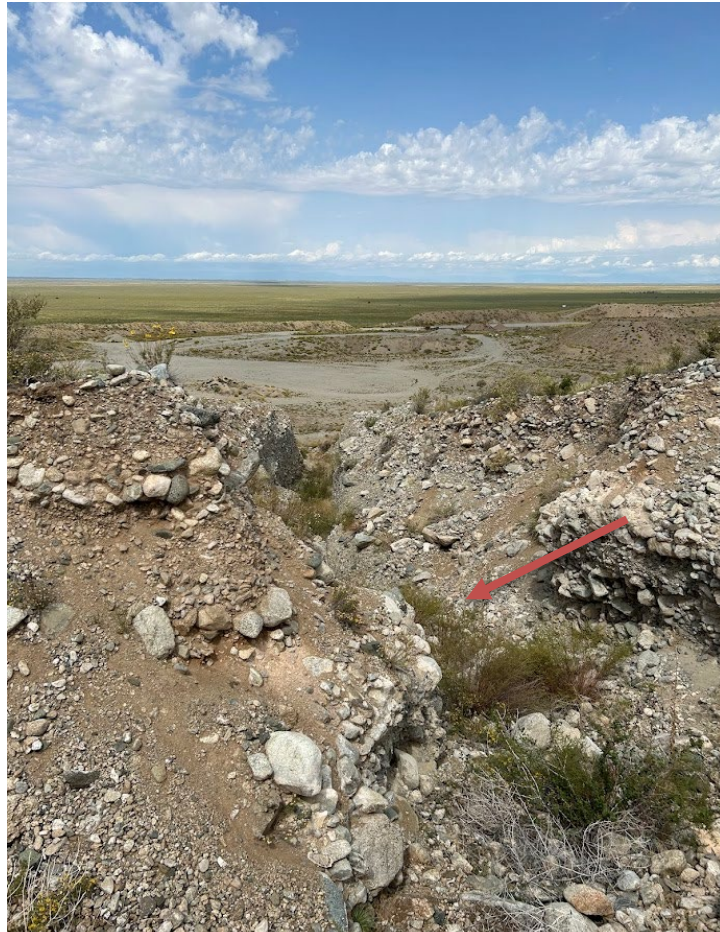
Photo 7: South Pit Area Highwall with erosion gully, facing west.

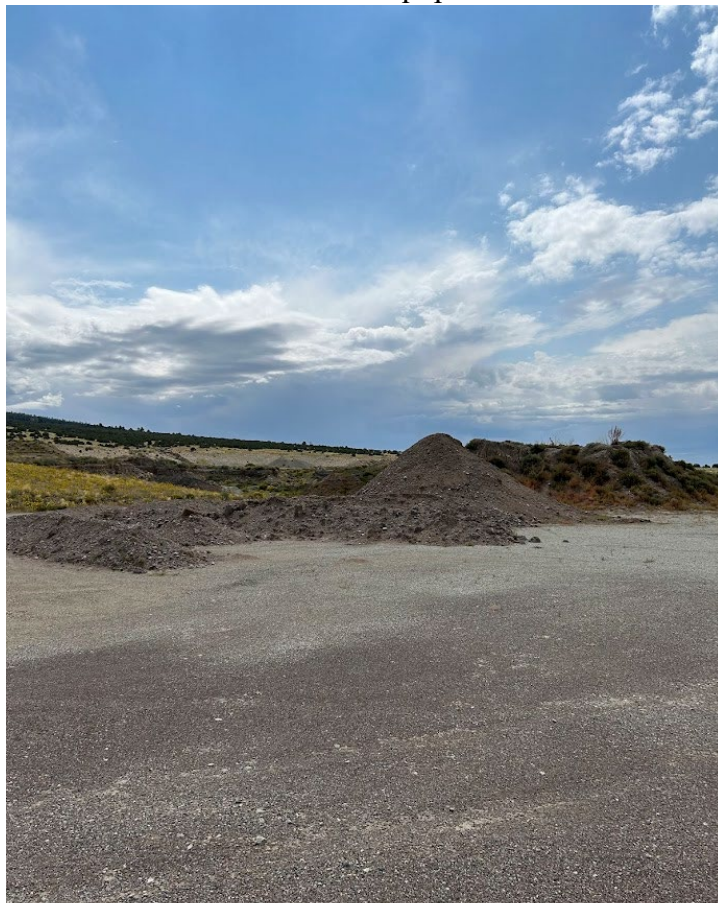
Photo 10: Reclamation material stockpiles, including topsoil and mulch.

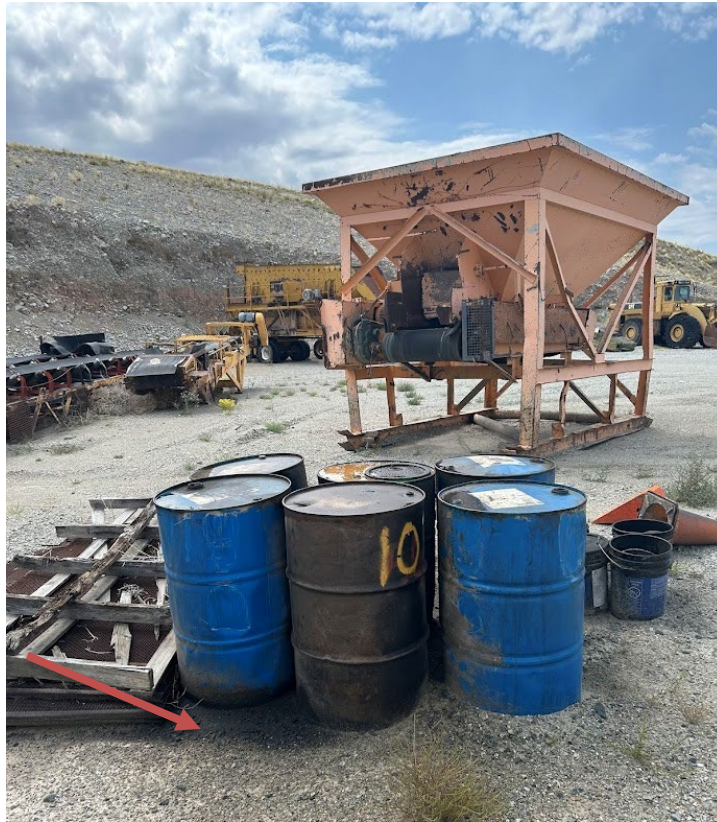
**PROBLEM:** A fuel spill has occurred at the site which may have impacted soils, surface water or groundwater.

The North Pit Area also contained an area for equipment, discarded materials, drums, and fuel tanks (see Photos 11-14). Within this area, the DRMS observed three empty drums that displayed evidence of leaked fuel oil (see Photos 11-13). This has been cited as a problem. The DRMS has requested that the Operator document how the spill(s) were cleaned up, including maps, volumes, photo documentation, as well as evidence in the form of a receipt that the contaminated soil was disposed of by an approved method.

Photo 11: Oil drum (#1) with evidence of leaking within the North Area Pit.

**CORRECTIVE ACTIONS:** The operator shall immediately remediate the spill and submit a final report to the Division containing at least the following information:

- 1.) A description of how the spill was cleaned up containing at a minimum - the appropriate maps, volumes removed, and photo documentation.
- 2.) Evidence in the form of a receipt that the contaminated soil was disposed of by an approved method (such as sent to an approved landfill, land farming, recycling center, etc.).

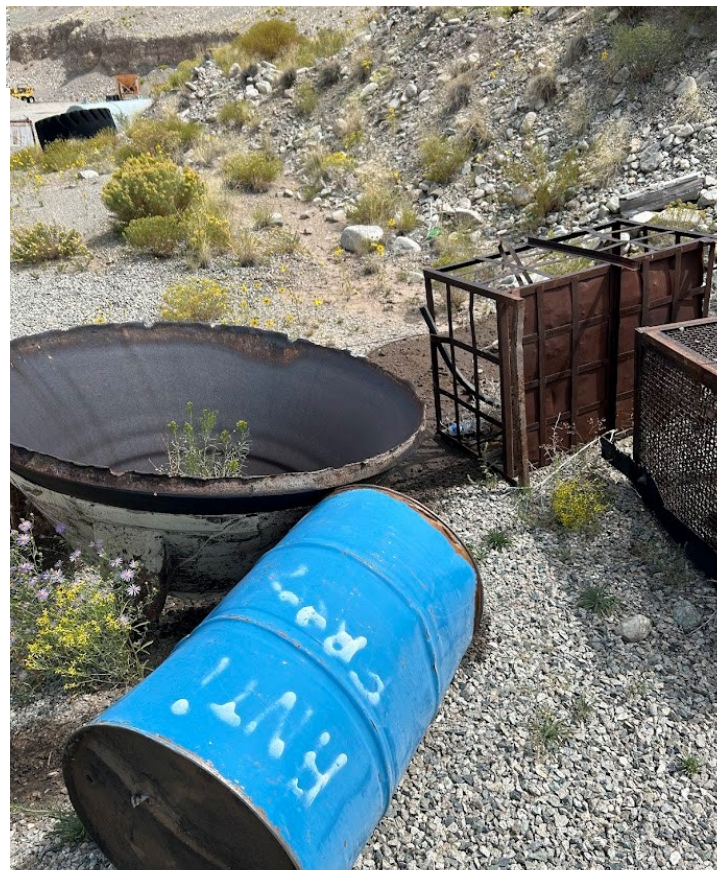
Photo 12: Oil drum (#2) with evidence of leaking within the North Area Pit.

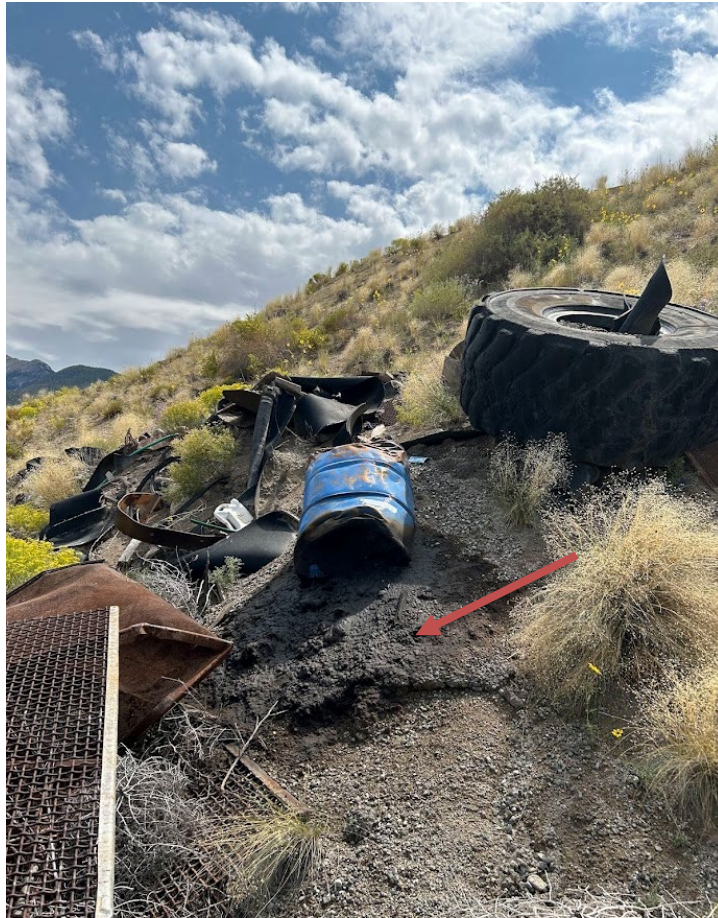
Photo 13: Oil drum (#3) with evidence of leaking within the North Area Pit.

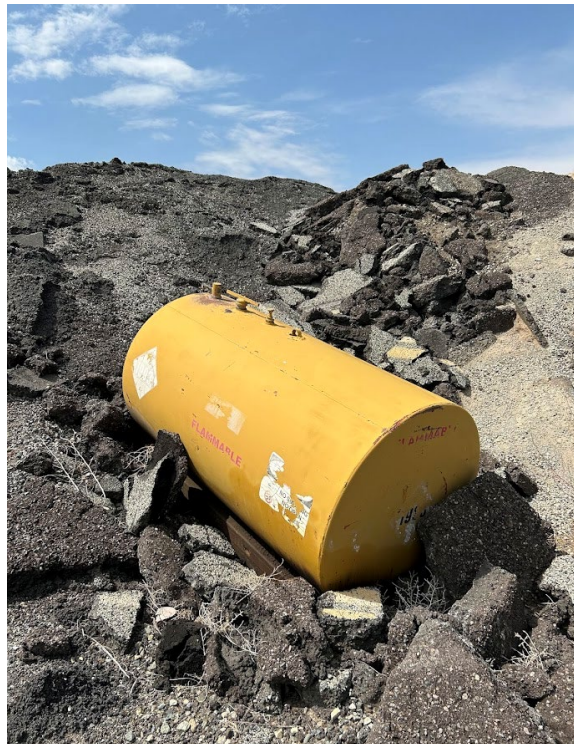
Photo 14: Empty fuel tank within the North Area Pit.

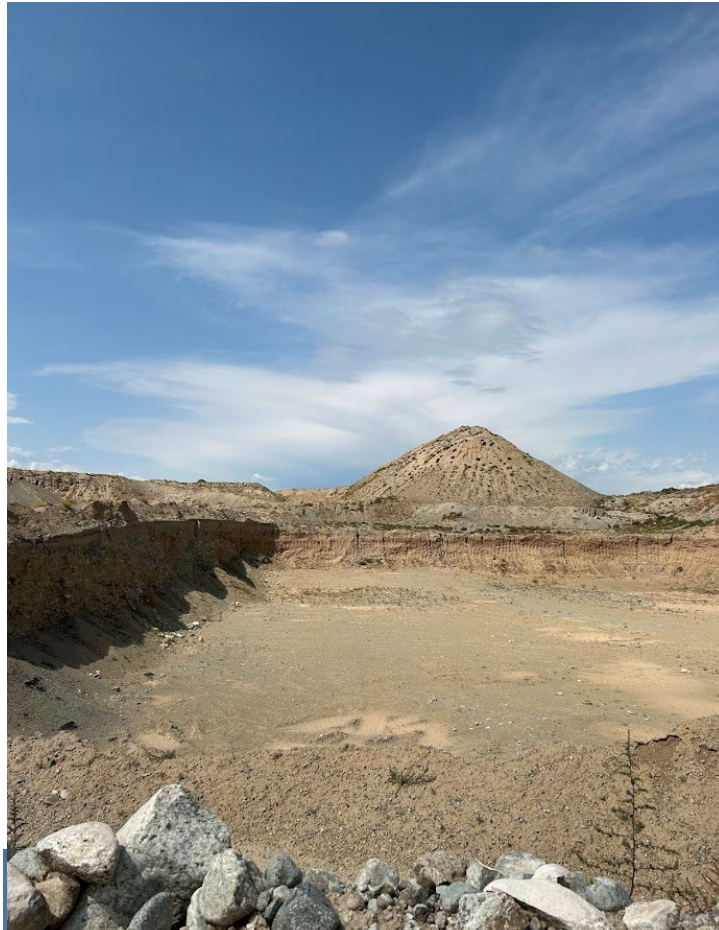
**PROBLEM:** The highwalls in the North Pit Area exceed the maximum highwall length of 300 feet in the approved mining plan. The current mine plan needs to be updated and clarified pursuant to C.R.S. 34-32.5-112 (1)(c)(VI). The operator must provide sufficient information to describe or identify how the operator intends to conduct the operation.

The North Pit Area was active at the time of the inspection. The pit contains a highwall with a length of over 2000 feet that is oriented from south to north and curls at the northern end to the west. The pit floor is approximately 40 feet deep, and the portion where the pit curls in the north (see Photo 15) is approximately twenty-five (25) feet deep. The Operator intends to continue to mine the highwall to the east. The approved mining plan stated the maximum vertical highwall will not exceed forty (40) feet in depth, and a maximum highwall length of three hundred (300) feet. In accordance with C.R.S. 34-32.5-112 (1)(c)(VI), the Operator needs to submit a Technical Revision (TR) to update the mining plan based on the current site activities.

Photo 15: The northern portion of the North Area Pit Highwall

**CORRECTIVE ACTIONS:** The operator shall submit a Technical Revision, with the required \$216 revision fee, to update and clarify the current approved mine plan to reflect existing and proposed activities by the corrective action date.

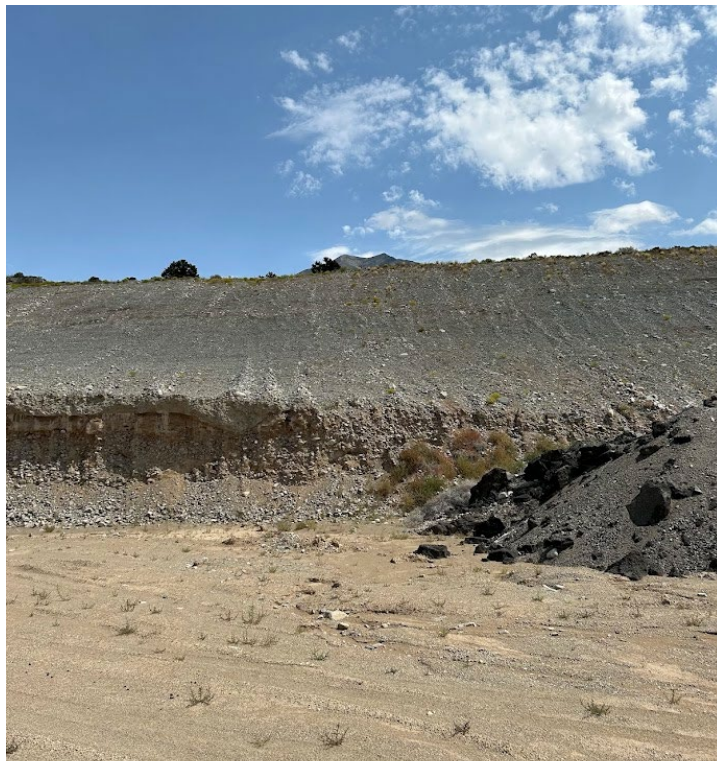
Photo 16: North Area Pit Highwall, facing east.
