Bachus Pit, M1995034- September 2024 Inspection Report and Cost Estimate

MINERALS PROGRAM INSPECTION REPORT
PHONE: (303) 866-3567

MINE NAME: Bachus Pit	MINE/PROSPECTING ID#: M-1995-034	MINERAL: Borrow material	COUNTY: Alamosa
INSPECTION TYPE: Monitoring	WEATHER: Clear	INSP. DATE: September 6, 2024	INSP. TIME: 08:00
OPERATOR: Absmeier Landscaping & Construction, LLC	OPERATOR REPRESENTATIVE: Adrian Absmeier	TYPE OF OPERATION: 112c - Construction Regular Operation

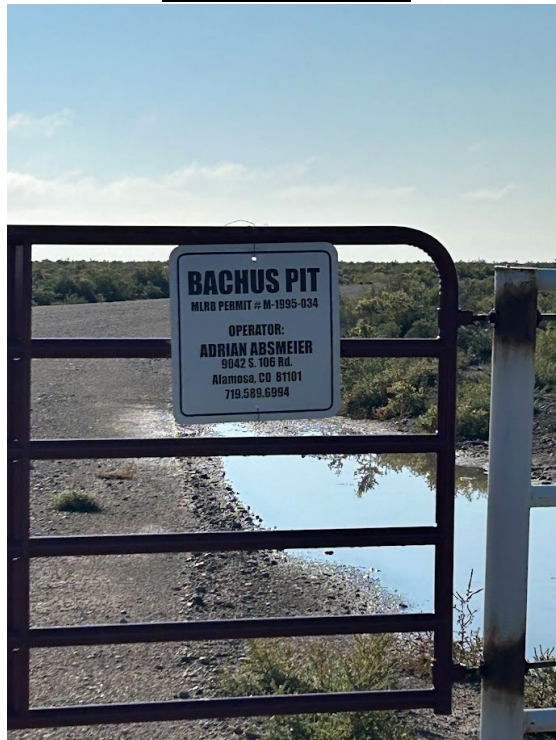
A mine identification sign was located at the entrance to the site in compliance with Rule 3.1.12 (see Photo 1). The site is accessed from the west using a gate. The permit boundary is enclosed with a fence.

Photo 1: Mine Signage at gate.

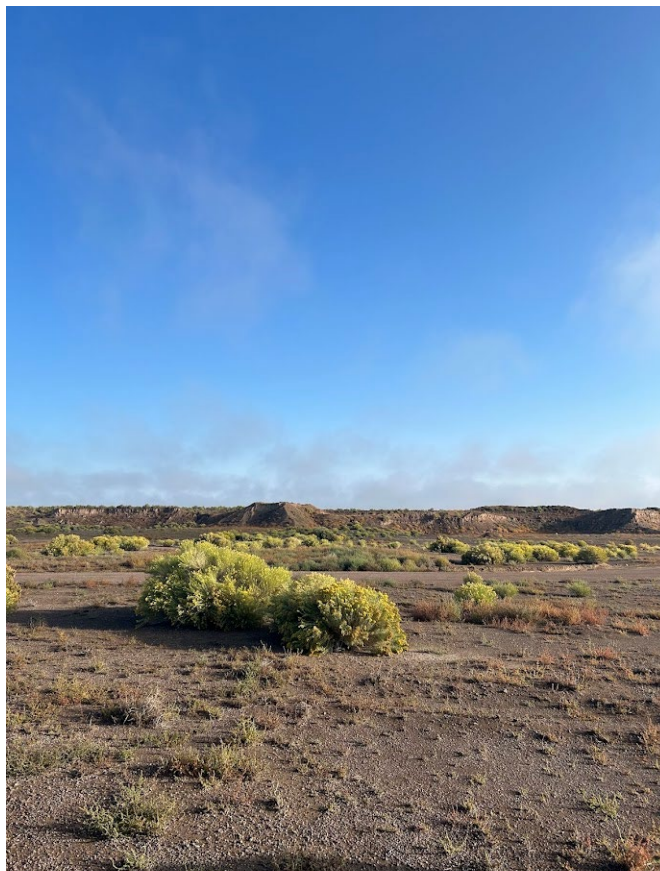
At the time of the inspection, no mining activity was observed. The site consists of a large pit approximately 28-acres in size and approximately 18 feet in depth. Vegetation has established in patches throughout the site consisting of Rabbit brush and small pockets of noxious weeds (see Photo 2). The pit maintains a highwall with slopes of 3:1 or less, with the exception of a vertical highwall in the northwest corner of the pit (see Photo 5). The Operator has allowed Adams State College geology students to visit the highwall to observe geological features. According to the Operator, however, the college has not visited the site for several years.

Photo 2: Pit floor with rabbit brush vegetation.

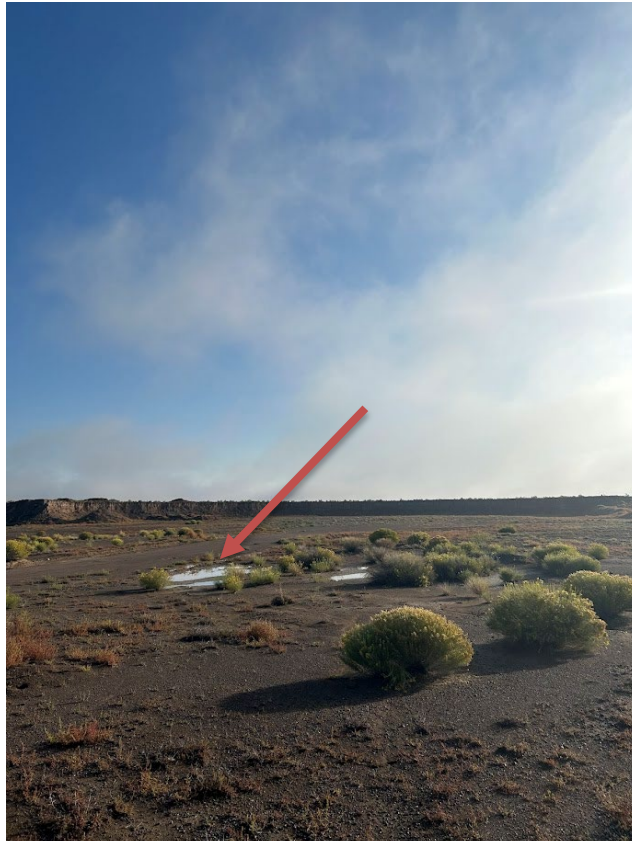
A wheel loader was located adjacent to the west highwall (see Photo 4). Minor ponding was observed in the pit. However, there had been heavy precipitation in the area the previous day (see Photos 1,3, 4, and6). Minor rilling erosion of the pit slope was observed in the southwest corner of the pit (see Photo 9). The DRMS noted that if increased erosion of the south pit slopes occurs, then stabilization measures will be necessary to remain in compliance with Rule 3.1.6(3) of the Construction Materials Rules and Regulations governing erosion of affected land. A stockpile of mulch was observed in the southwest area of the pit which, according to the Operator, had been recently placed by a mulch company. The DRMS noted that the Operator can't bury mulch in accordance with Rule 3.1.5(9) governing the burying of non-inert material. The Operator noted that no active reclamation had been completed and that the pit has naturally revegetated itself, as evidenced by the significant amount of Rabbit brush on the pit floor. During the inspection, it was observed that the northern area of the highwall was encroaching upon the northern boundary marker (see Photo 6).

Photo 3: Pit floor with vegetation and minor ponding.

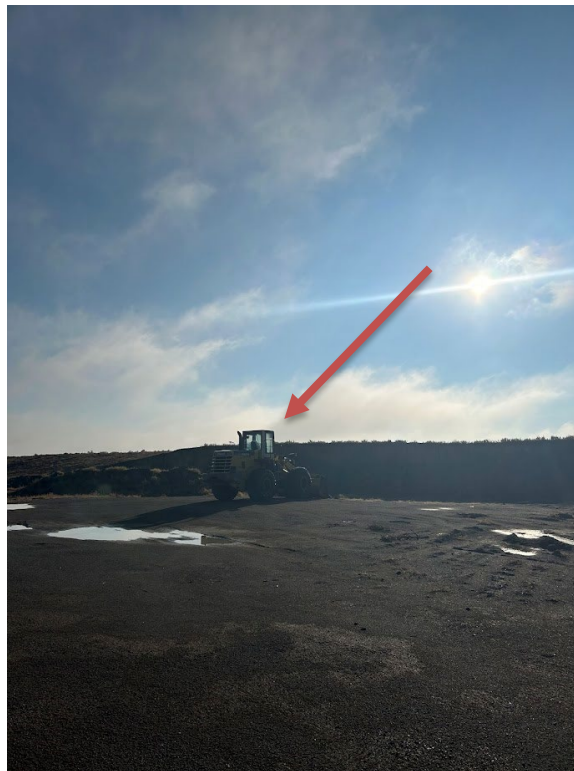
Photo 4: Wheel loader adjacent to the east highwall.

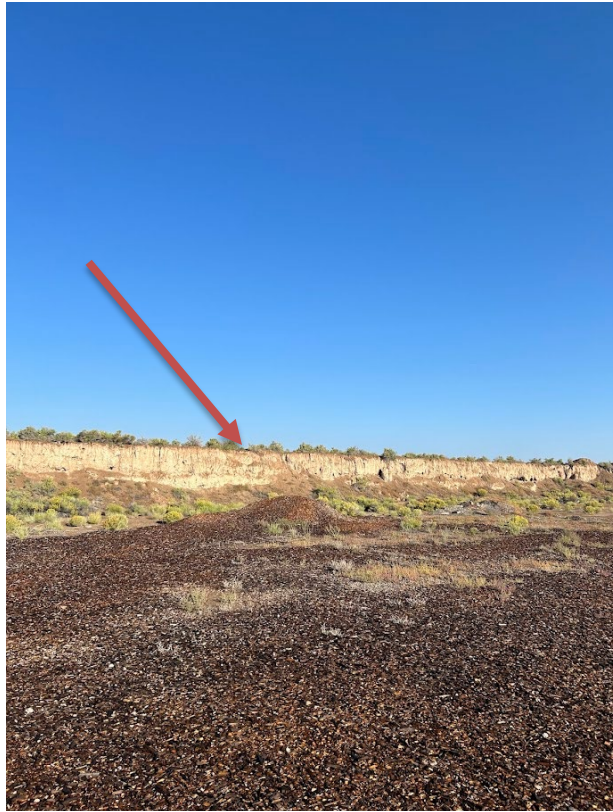
Photo 5: View of Vertical Highwall along eastern portion of pit, mulch pile on pit floor

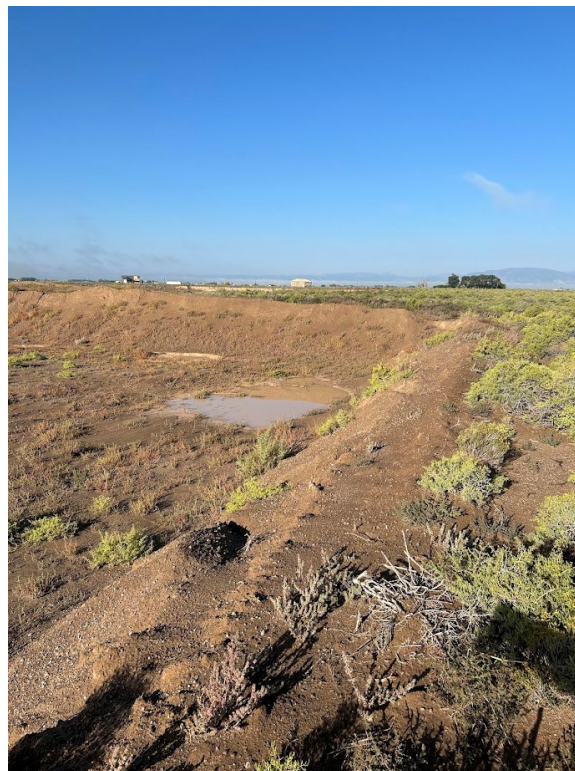
Photo 6: Highwall along north site of pit, minor ponding.

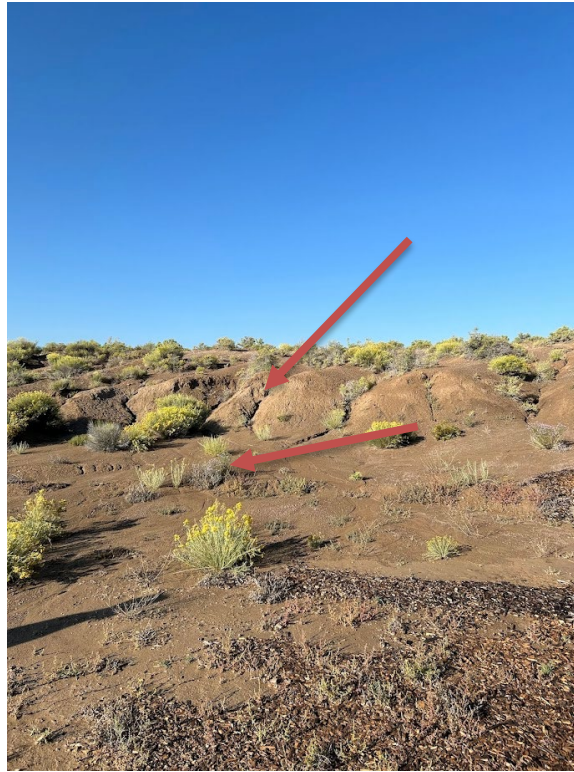
PROBLEM: There are state-listed noxious weeds present on site. This is a problem for failure to employ weed control methods for state listed noxious weed species within the permitted area, and to reduce the spread of weeds to nearby areas as required by Section 3.1.10 (6) of the rule.

A noxious weed infestation has occurred at the site. Noxious weed species observed were Halogeton, Russian knapweed, Russian thistle, and a Russian olive tree (see Photos 7-8). Halogeton was primarily concentrated in the northeast portion of the site. One (1) Russian olive tree was observed along the entry road leading to the northwest corner of the pit (see Photo 9). According to the Operator, Russian olive trees are removed annually. This has been cited as a problem. In accordance with Rule 3.1.10(6) of the Construction Materials Rules and Regulations governing weed control, the DRMS will require the Operator to develop a weed control plan to be employed to control the current infestation and prevent the spread of weeds to the surrounding area.

Photo 7: Minor rilling erosion of the pit along the southwest corner, Russian knapweed, and rabbit brush vegetation.

CORRECTIVE ACTIONS: The Operator shall develop a Weed Control Plan and submit this plan as well as a timeline for its implementation as a Technical Revision to the permit. The Technical Revision will be submitted to the Division by the corrective action due date noted below.

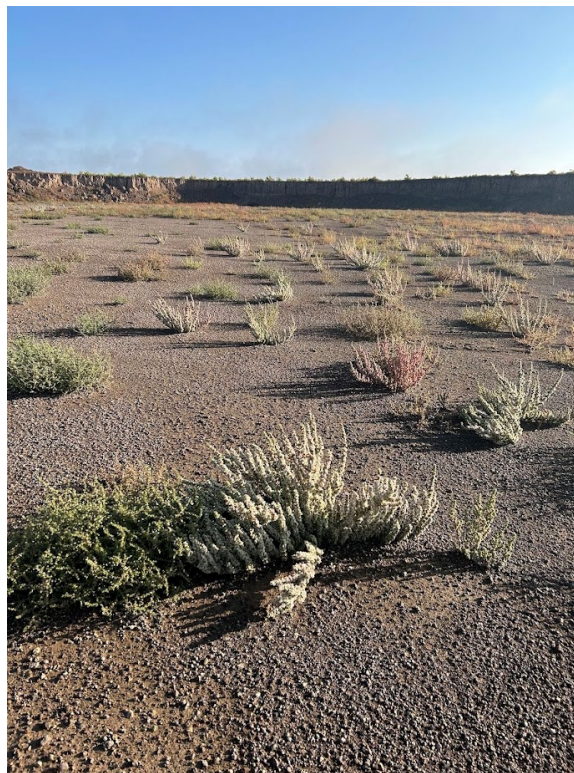
Photo 8: Halogeton weed infestation along the pit floor.

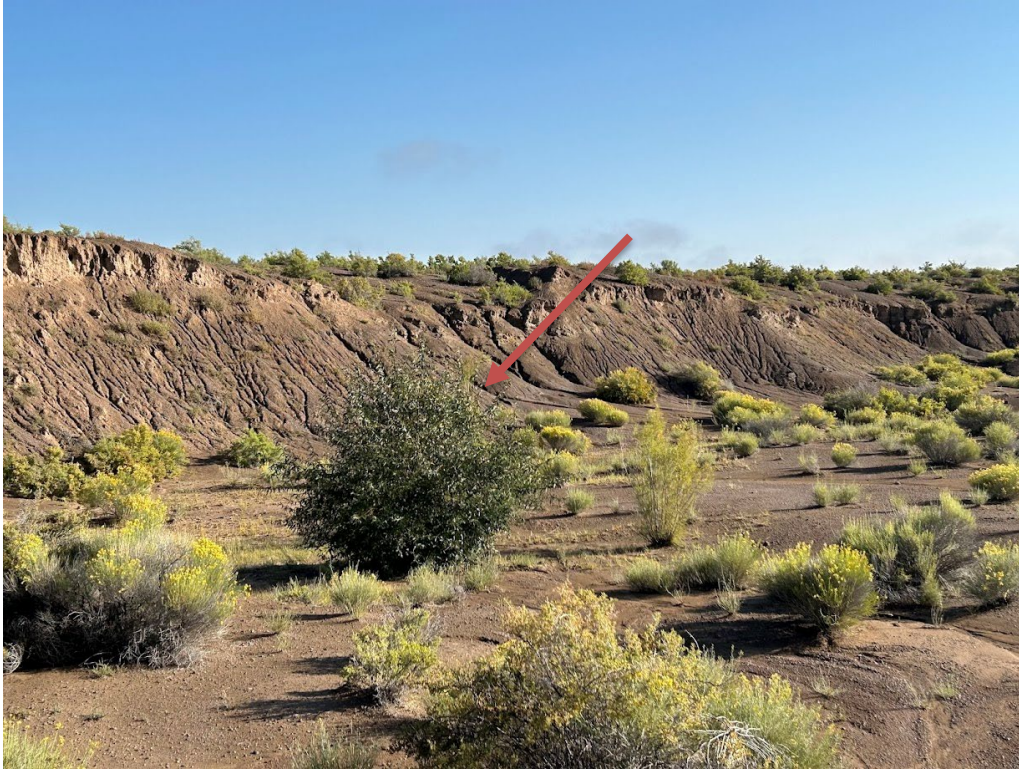
Photo 9: One Russian olive tree in the northwest area of the pit floor.
