November 5, 2024
Project#01349-0001

Subject: Summary of Instrumentation Monitoring
3rd Quarter 2024
Bowie Coal Waste Disposal Area No. 2
Paonia, Colorado

SUBJECT: Summary Report, 3rd Quarter 2024, Inclinator and Active Vibrating Wire Piezometer Data July – September 2024, Bowie Mine #2 Coal Waste Disposal Area (CWDA) #2

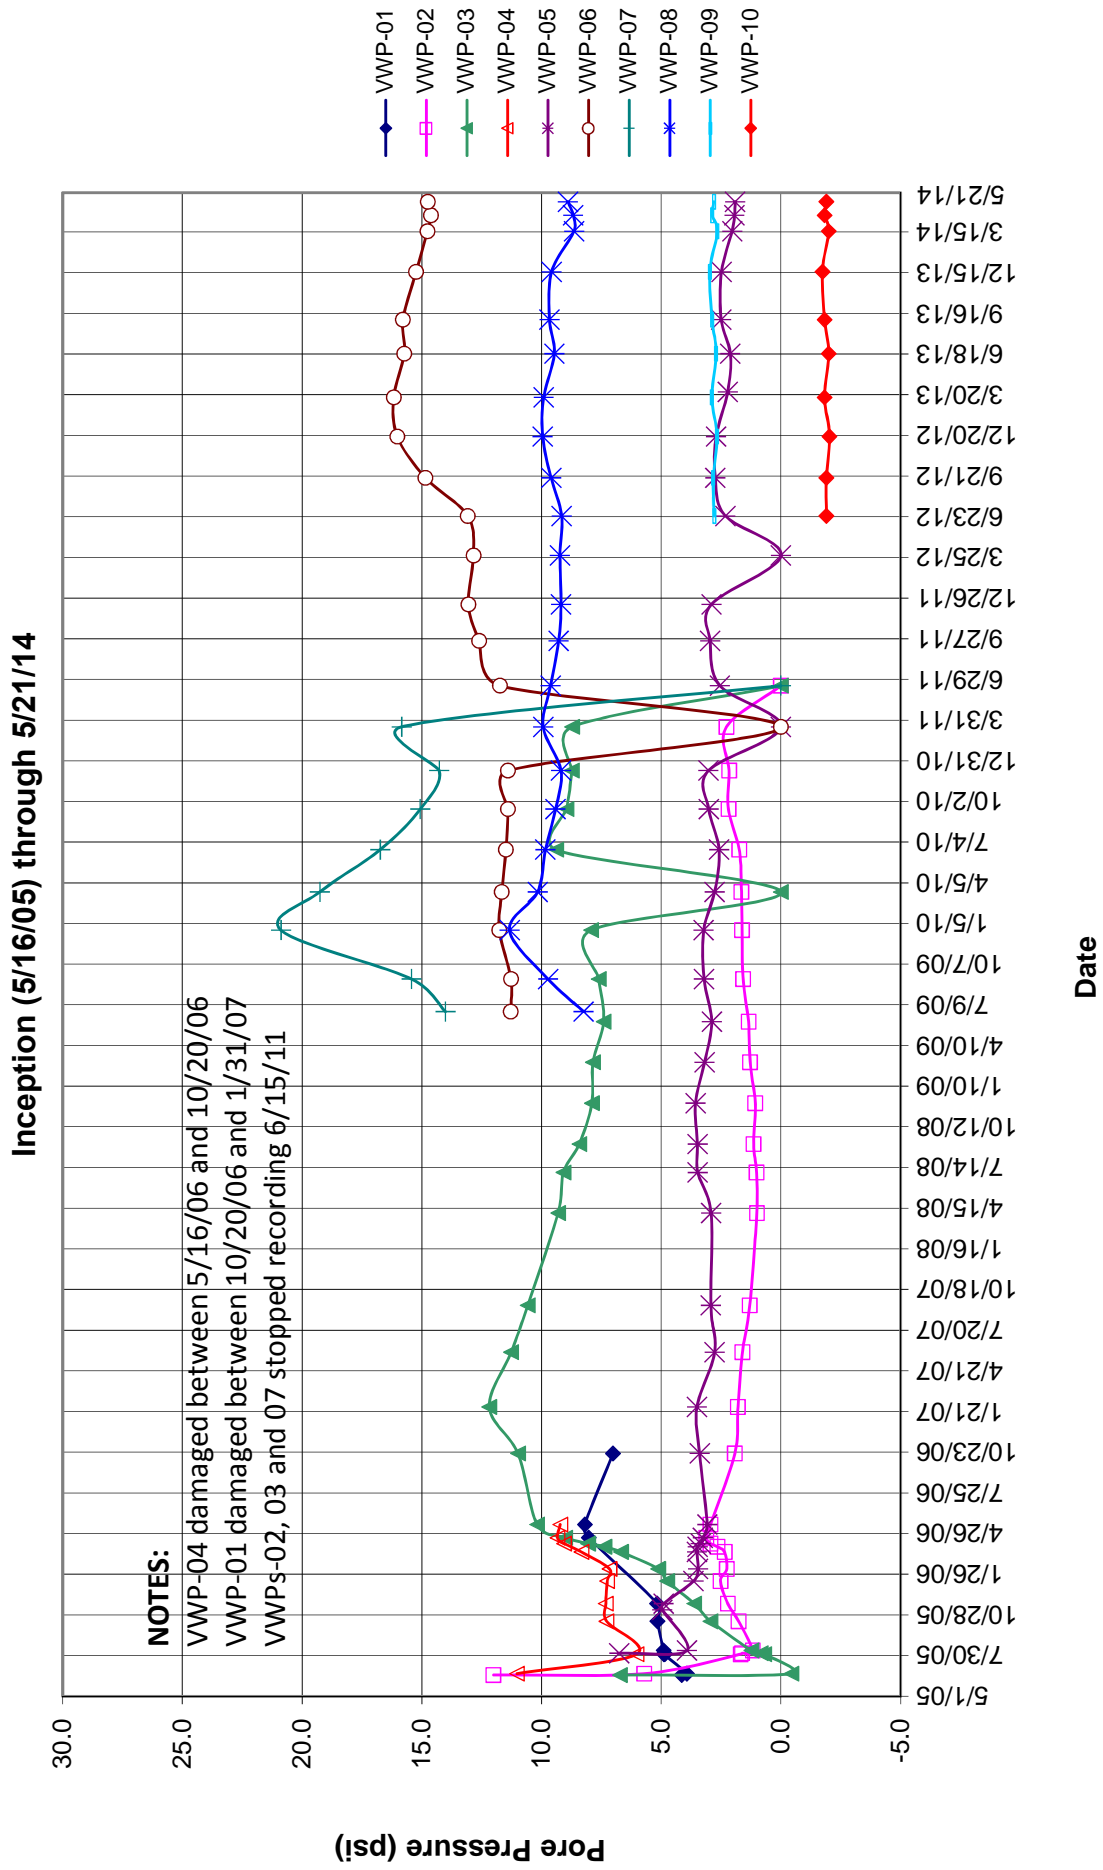
Figure 1 - Bowie Mine #2 - CWDA #2
Active and Damaged Vibrating Wire Piezometer Data

As seen on Table 1 and Figure 2, the VWP readings and trends are consistent with recent and historic readings. When compared to a year ago (Q3 2023), pore pressure readings in all the VWP's changed by small amounts (-0.7 to 0.5 psi). When compared with last quarter (Q2 2024), pore pressures also changed by relatively small amounts (-0.2 to 0.2 psi) for all five VWP's. Although four of the five VWP's remain steady or have general declining trends in pore pressure over the life of the VWP's, one of the piezometers (VWP-05) has exhibited pronounced seasonal cyclical behavior for its lifespan, except from mid-2021 to mid-2022 where there was a steady decline in pore pressures. This piezometer generally (but not always) shows low pore pressures for Q1 and Q2 and higher pressures for Q3 and Q4, with a net loss of -5.1 psi over the lifetime of that VWP. The other four VWP's have experienced net changes of -1.4 to 0.3 psi since installation, meaning current readings are very similar to initial readings. For VWP-09 and VWP-10, pressures have been consistent throughout the lifetime of the piezometers; however, for VWP-06 and VWP-08, they experienced wild fluctuations in pore water pressure in the first half of their lifetimes but have settled to pressures similar to the installation pressures in the past several years.

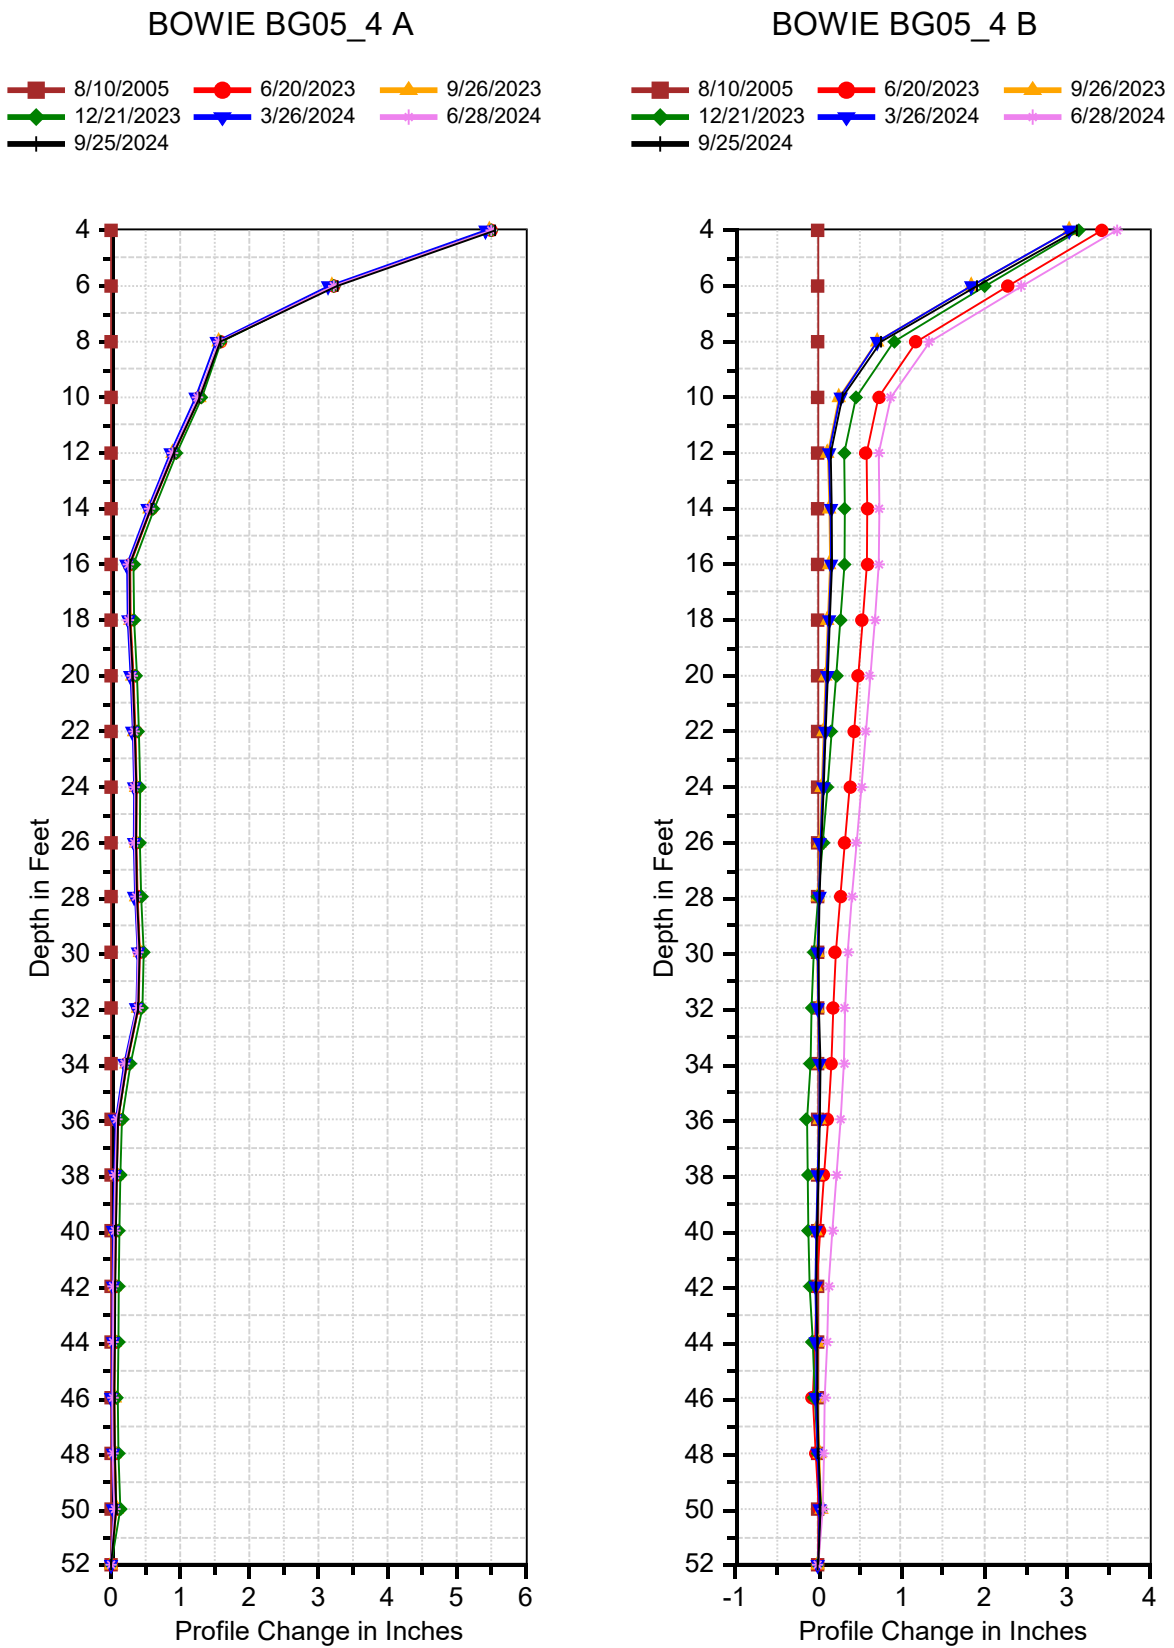
Figure 3 - Inclinomometer Displacement Curves

As described in previous reports, historic downslope displacements indicated on the plots for the approximate upper 14-16 feet of the inclinometers since installation in 2005 are due to placement of cover soil on the face of the waste pile during revegetation/regrading operations in late 2006 and early 2007. This man-caused displacement is documented in a report by Buckhorn Geotech dated December 22, 2008, to Bowie Resources called *Revised Stability Evaluations for Coal Mine Waste Disposal Area No. 2, Bowie No. 2 Mine*.

Based on the current inclinometer readings, BG05_7 shows near perfect alignment (essentially identical readings for 19 years) with the initial reading in 2005 for the downslope direction (Axis A). Inclinometers BG05_4 and BG05_5, however, show a bulge of less than 1/2-inch in the inclinometer pipes (below the surface regrading). Based on our records, this bulge developed slowly from 2005 to 2010, but no movement has been recorded since then. This suggests there had been some gob pile settlement early in the lifetime of the inclinometers, but no recent or additional movement has occurred. Some "noise" which is understood to be relatively common in orthogonal direction (Axis B) readings, was observed over the past few years for all three inclinometers. This can be due to various mechanical or installation causes that are unrelated to slope movement. For example, grout voids, poor grout coverage, or soil settlement around the instrument can all contribute to vibrations and pipe movement that impacts inclinometer

readings. No software bias adjustments were applied to filter this noise. All readings were consistent with previous readings and the “displacement” error was within equipment tolerances and not deemed to be due to slope movement.
