### MINERALS PROGRAM INSPECTION REPORT

<b>MINE NAME:</b> Indio Red Quarry Number 1 & 2	<b>MINE/PROSPECTING ID#:</b> M-1999-062	<b>MINERAL:</b> Sandstone (silica, st quartzite)	<b>COUNTY:</b> Larimer
<b>INSPECTION TYPE:</b> Monitoring	<b>WEATHER:</b> Cloudy	<b>INSP. DATE:</b> October 24, 2024	<b>INSP. TIME:</b> 10:30
<b>OPERATOR:</b> Hector Rodriguez	<b>OPERATOR REPRESENTATIVE:</b> Raul Vasquez	<b>TYPE OF OPERATION:</b> 110c - Construction Limited Impact

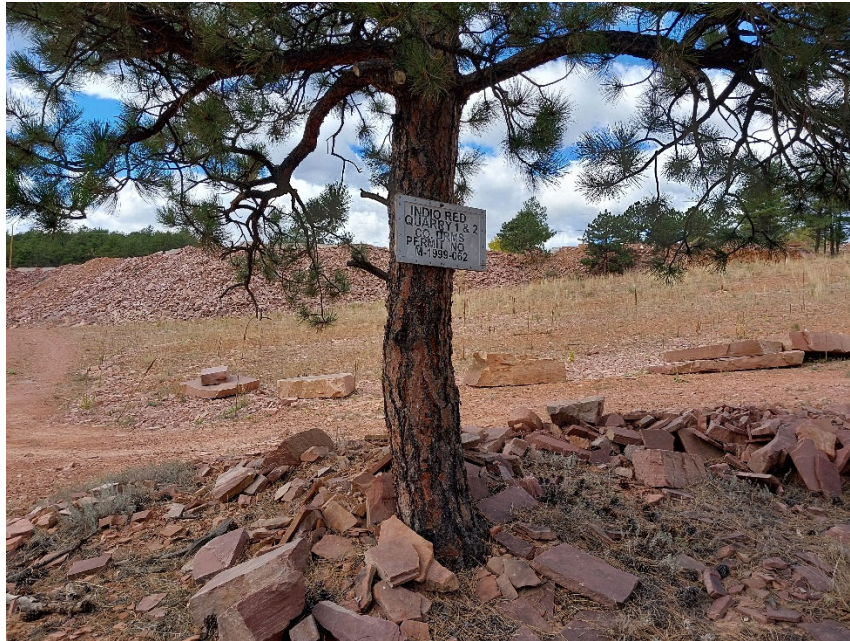
According to Rule 3.1.12(1), the mine sign is required to be posted at the entrance of the permitted area. The mine sign for this permit was not posted at the entrance of the permit, the map provided in this report shows where the mine sign was observed during the inspection. The mine sign is not located at the entrance and does not appear to be within the permitted site based on where the boundary markers were located.

Photo #1: Mine sign, the location of where the sign is posted is shown in the map below. The mine sign needs to be posted at the entrance of the permitted area.

**CORRECTIVE ACTIONS:** The operator shall, at the entrance of the mine site, post a sign which shall be clearly visible from the access road with the following: the name of the operator, a statement that a reclamation permit for the operation has been issued by the Colorado Mined Land Reclamation Board; and the permit number. The operator shall submit photo documentation that a proper sign has been posted by the corrective action date.

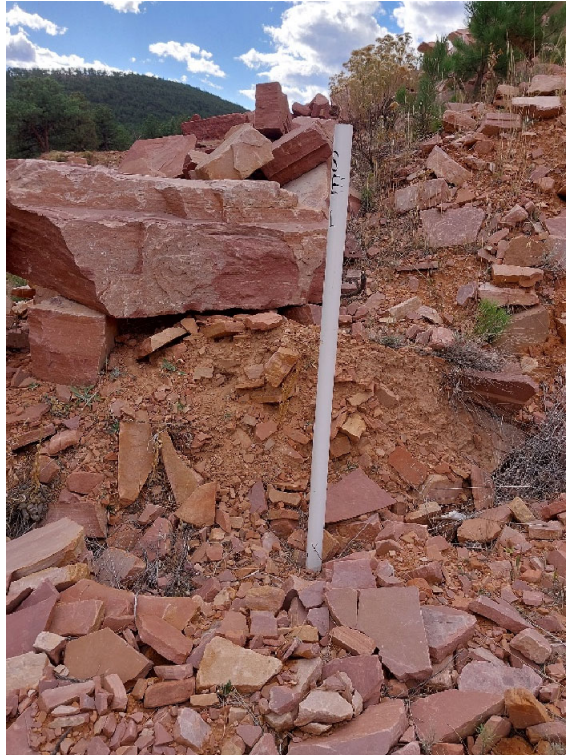
Photo #2: Southeast boundary marker of Quarry 1 parcel; looking to the southwest.

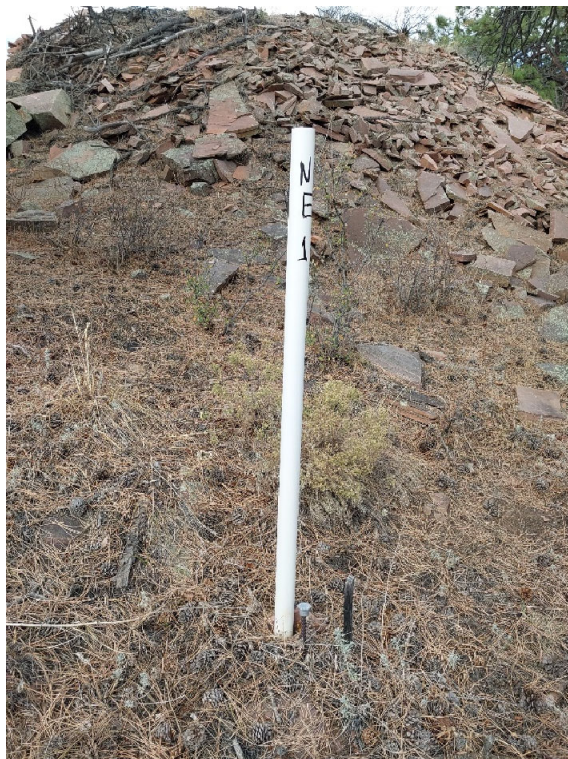
Photo #3: Northeast boundary marker of Quarry 1 parcel.

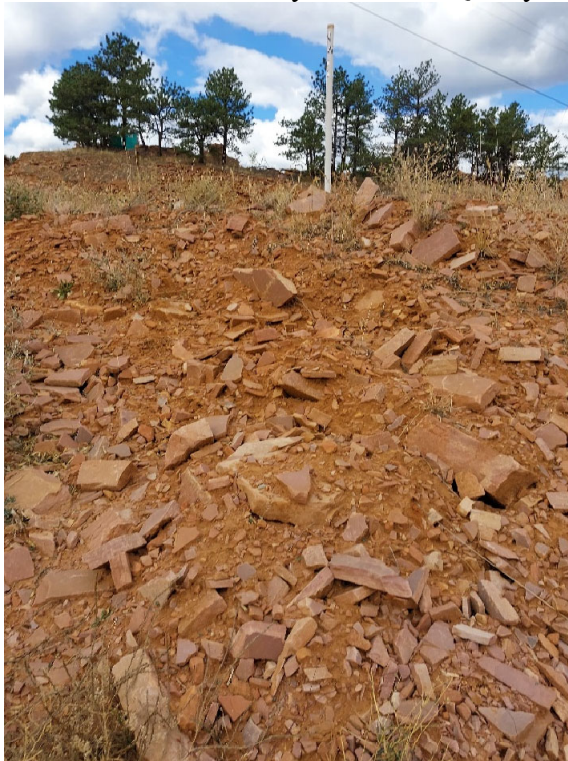
Photo #4: Northwest boundary marker of Quarry 1 parcel; looking northwest.

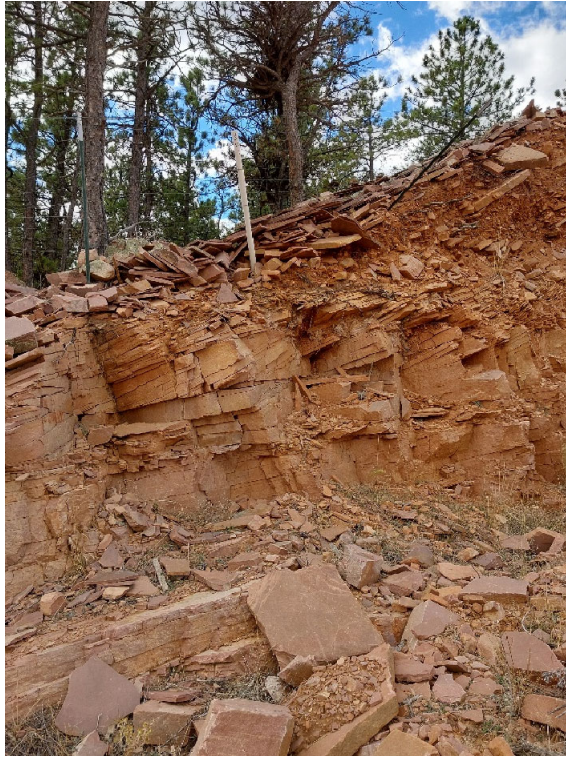
Photo #5: Southwest boundary marker of Quarry 1 parcel; looking south-southwest.

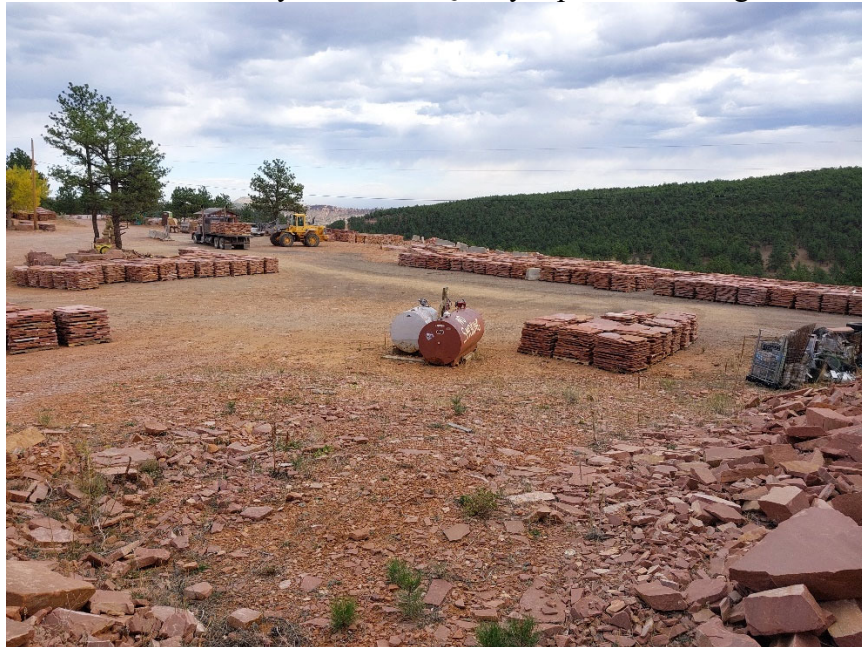
Photo #6: West side of Quarry 1 parcel looking northeast from the southwest boundary marker. The two diesel tank vessels can be seen at the center of the photo. I the background a wheel loader and the flatbed truck can be seen in the left of the photo.

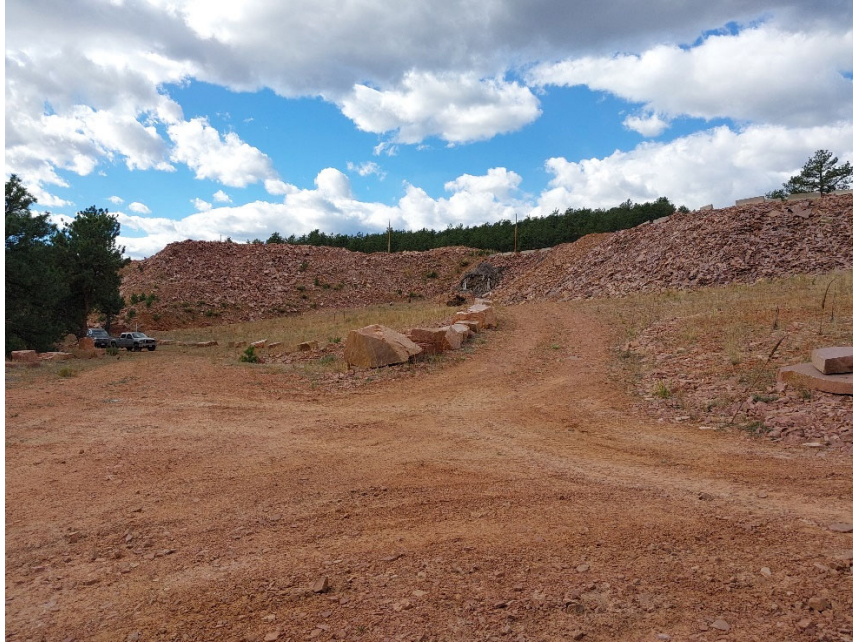
Photo #7: East side of Quarry 1 parcel looking to the southwest from the about center of the eastern boundary. The stockpiled material seen in the background on the left side of the photo is on the T Bone Stone (M-2004-030) permitted area.

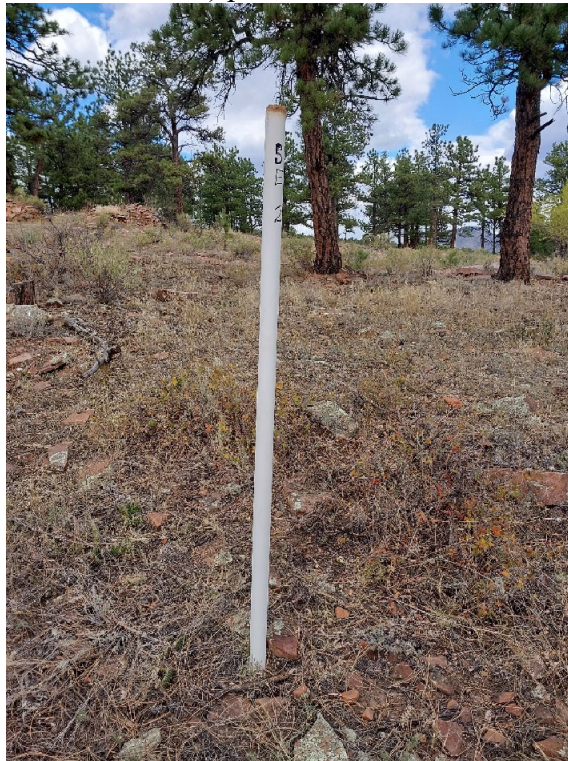
Photo #8: Southeast boundary marker of Quarry 2 parcel; looking northwest.

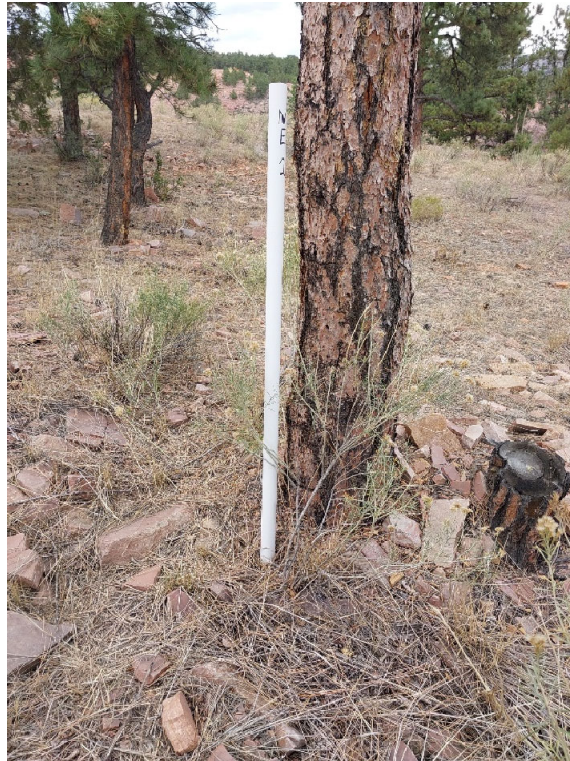
Photo #9: Northeast boundary marker of Quarry 2 parcel; looking northwest.

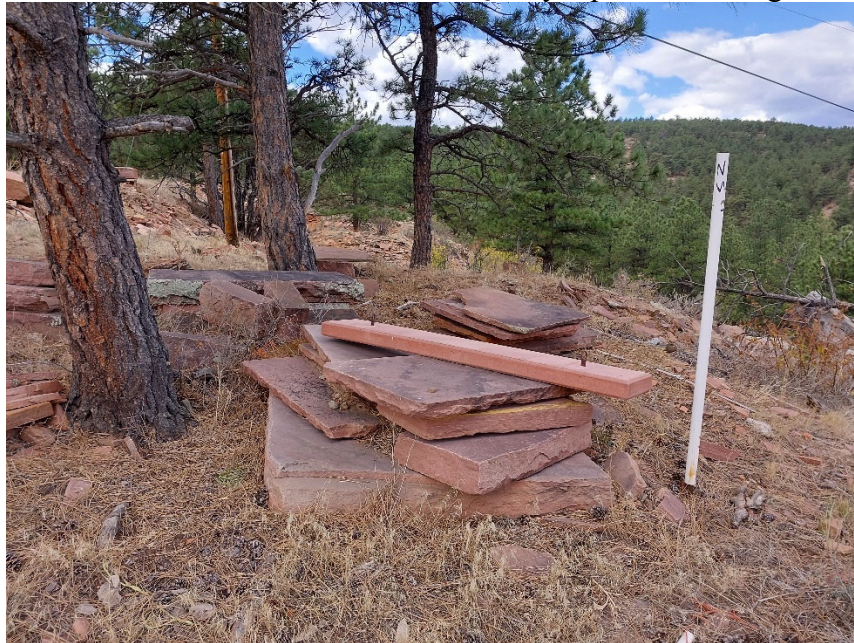
Photo #10: Northwest boundary marker of Quarry 2 parcel; looking northwest. The stones in this area are from pre-law mining activity and are not considered to be disturbances associated with this permit.

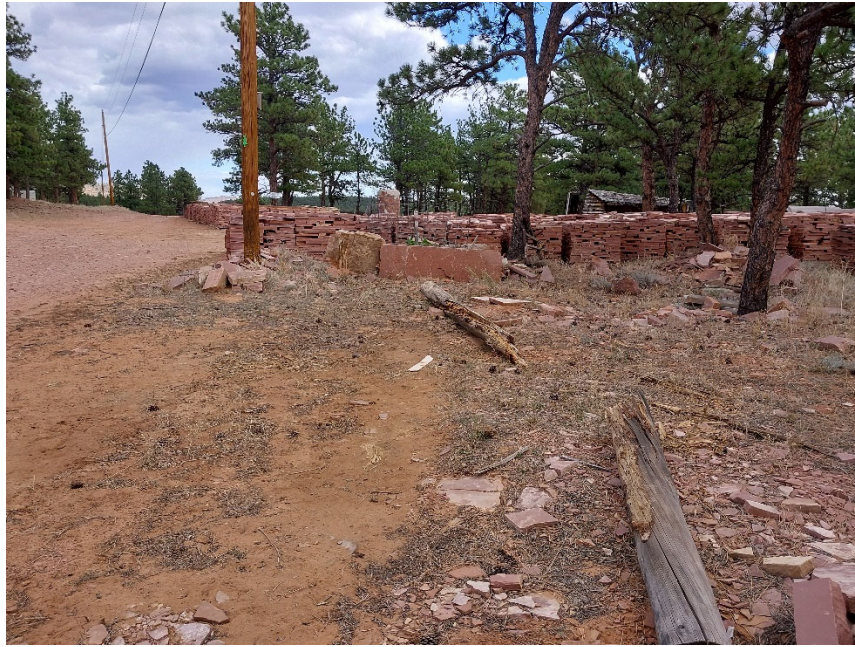
Photo #11: Southwest side of Quarry 2 parcel from the southwest parcel corner; looking north-northeast.

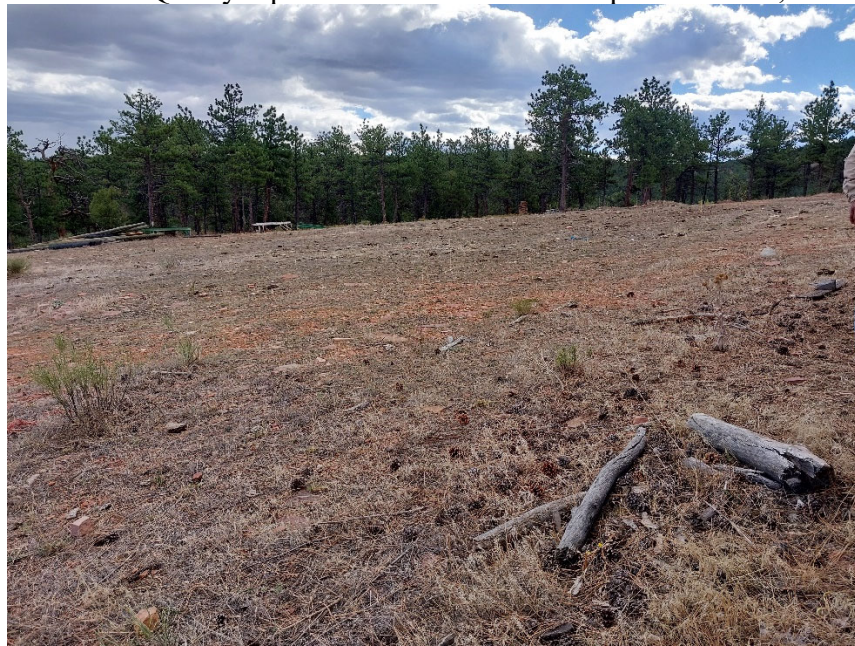
Photo #12: Northwest side of Quarry 2 parcel from the northwest boundary marker; looking east-southeast.

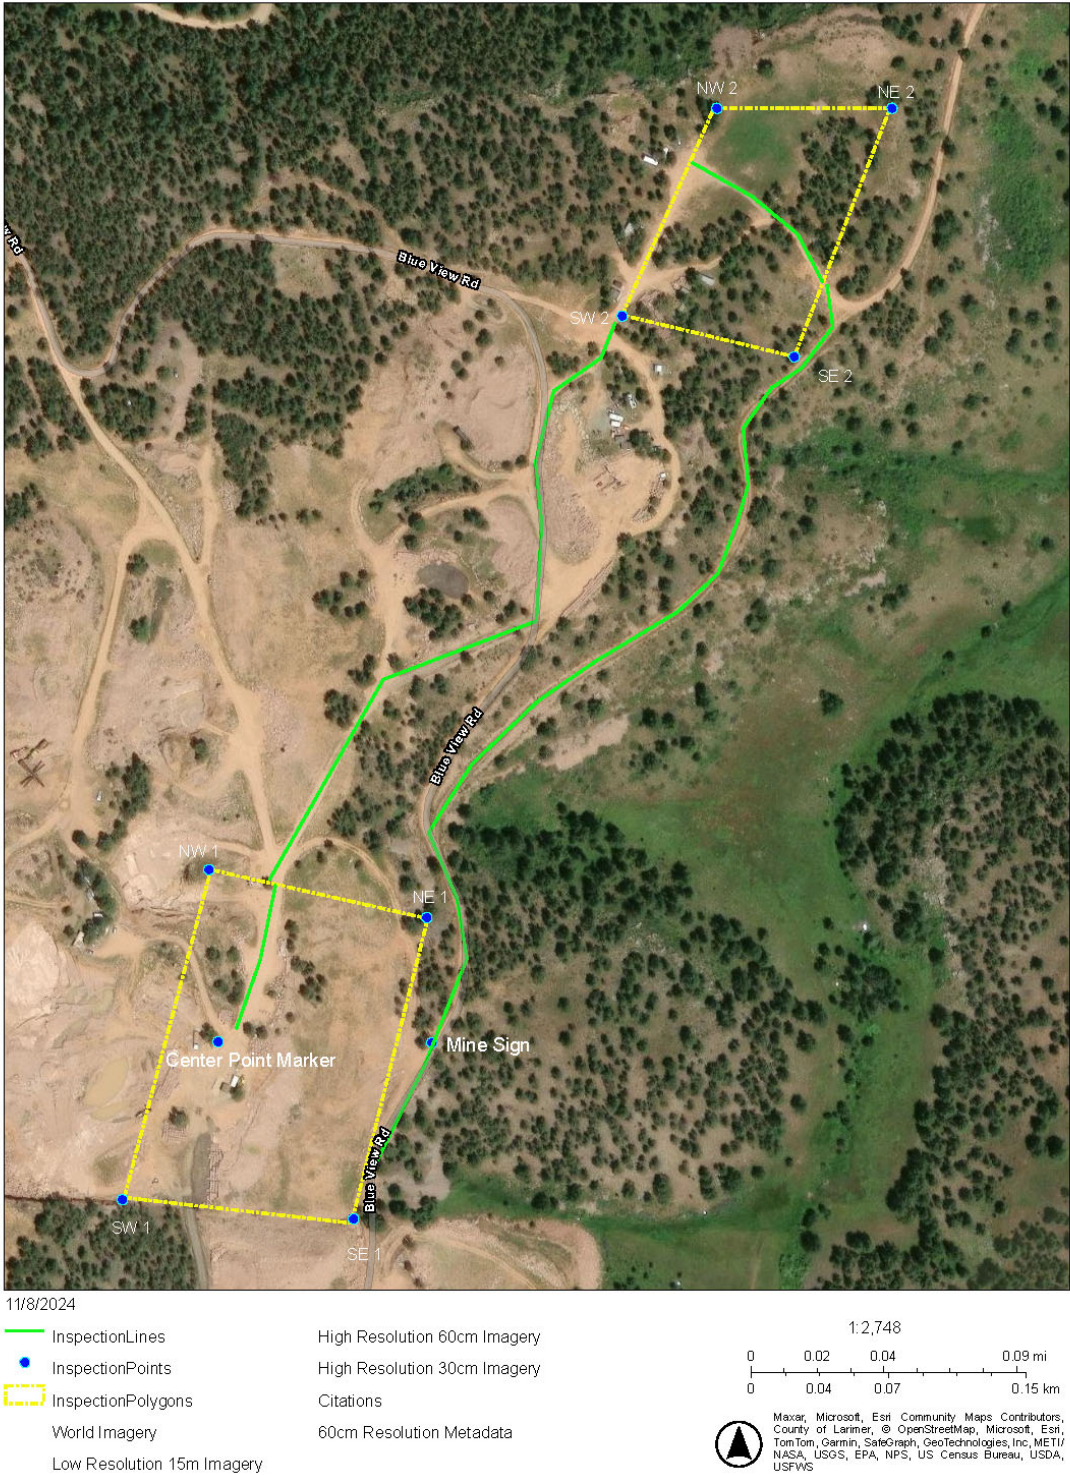
Indio Red Quarry Number 1&2 M1999062 2024 Inspection

Permit boundary markers were in place marked by white PVC tubes. It is unclear if these points correlate with the maps on file for this permit. In addressing the general mining plan corrective action, the Operator is asked to provide the location of the permit boundaries markers on the updated maps. The locations and the labels of the PVC markers observed during the inspection are provided on the map below.

There are additional roads that were observed within the two parcels of the permitted area and two roads that connect the two parcels. The location of the roads is provided in the map below. The condition of all roads was good, there did not appear to be any environmental issues associated with the roads. Mr. Vasquez stated that the roads are regularly maintained by him, as the landowner.

Map created from data points collected during the inspection. Each inspection point is labeled. The inspection polygons outline the approximate parcel boundaries of Quarry 1 and Quarry 2 the permitted area. The boundary marker points ending in '1' are associated with Quarry 1 and those ending in '2' are associated with Quarry 2. The inspection lines depict the additional roads observed during the inspection.

**CORRECTIVE ACTIONS:** The operator shall submit one Technical Revision, with the required \$216 revision fee, to update and clarify the current approved mine plan and map to reflect existing and proposed activities by the corrective action date. The Technical Revision will need to clarify how the land is being used and also update the reclamation plan and map addressing the additional roads observed on site.
