Butcher Pit M1995060- September 2024 Inspection Report

MINERALS PROGRAM INSPECTION REPORT

MINE NAME: Butcher Pit	MINE/PROSPECTING ID#: M-1995-060	MINERAL: Sand	COUNTY: Alamosa
INSPECTION TYPE: Monitoring	WEATHER: Raining	INSP. DATE: September 5, 2024	INSP. TIME: 14:30
OPERATOR: Southway Construction Company, Inc.	OPERATOR REPRESENTATIVE: Paul Bottini	TYPE OF OPERATION: 112c - Construction Regular Operation	
REASON FOR INSPECTION: Normal I&E Program	BOND CALCULATION TYPE: Complete	BOND AMOUNT: \$61,370	
DATE OF COMPLAINT: NA	POST INSP. CONTACTS: None	JOINT INSP. AGENCY: None	
INSPECTOR(S): Chris Girardi Jared Ebert	INSPECTOR'S SIGNATURE:

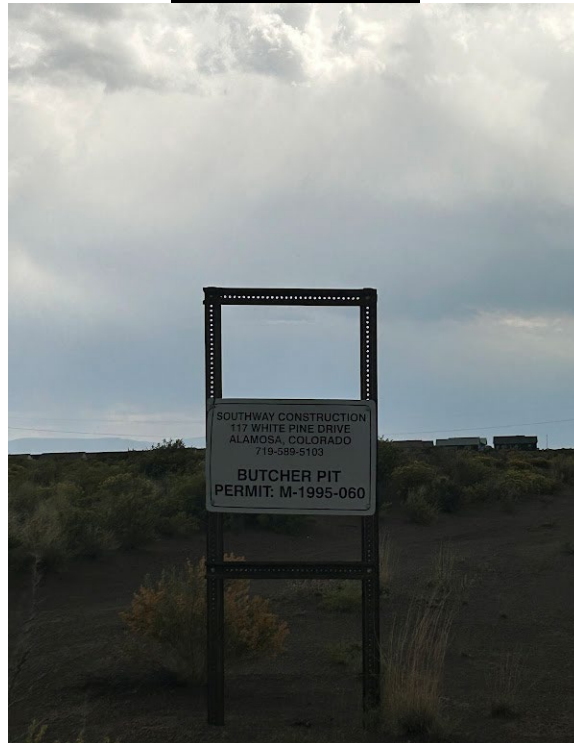
A mine identification sign was located adjacent to the south of Road 7 South in compliance with Rule 3.1.12 (see Photo 1). The site is accessed from the north using a small ditch leading to the permit area.

Photo 1: Mine entrance sign.

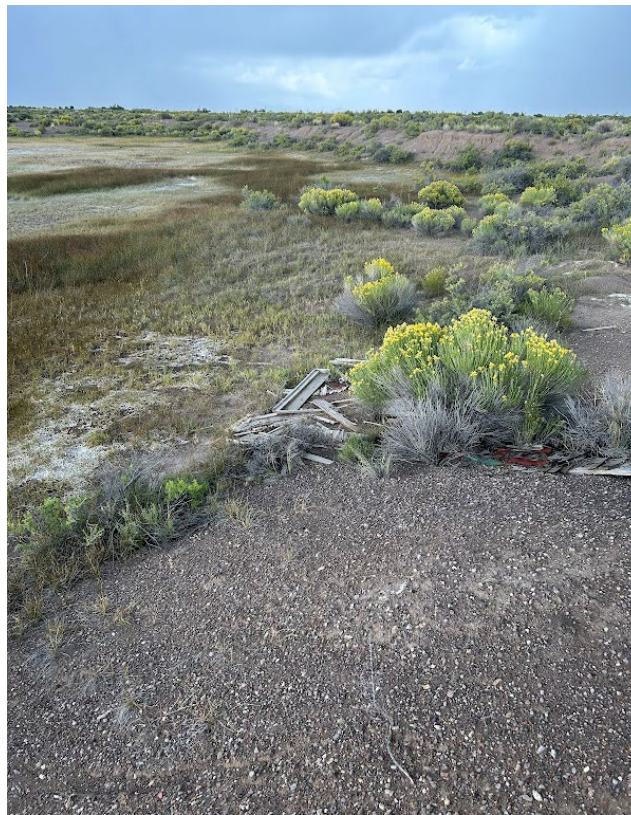
The north portion of the permit area contains a small 1-acre pit approximately four (4) feet deep with gentle slopes and well-established vegetation. Based on Google Earth imagery, the pit in the southern portion of the permit area is approximately six (6) feet deep and also contains gentles slopes with well-established vegetation.

Photo 2: North pit floor facing west, Rabbit brush vegetation and wetland vegetation.

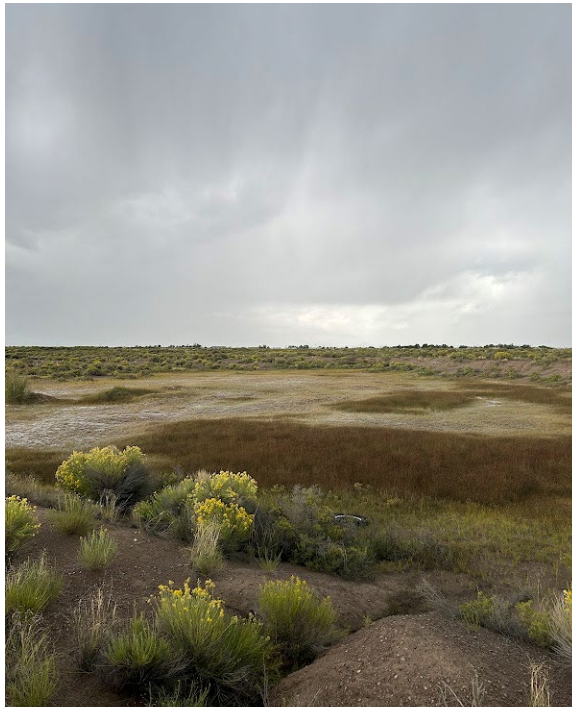
Photo 3: Pit floor with wetland vegetation, Rabbit brush and Fourwing saltbrush along edge of the pit.

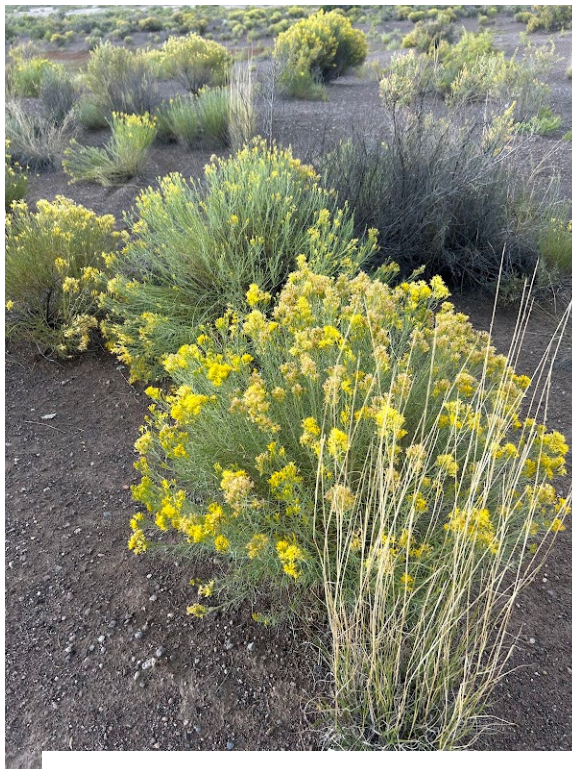
Photo 4: Rabbit brush vegetation.

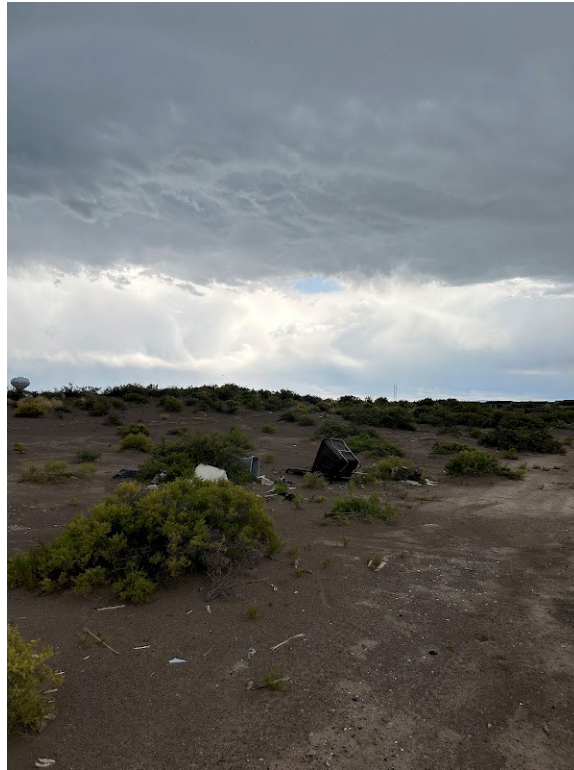
The site consists of two shallow pits with rough, predominantly flat land that slopes to the south. Vegetation has established across the site consisting of Rabbit brush, Fourwing saltbrush, and wetland vegetation (see Photos 2-4). No noxious weeds were observed. Trash and other debris were scattered along the eastern portion of the site. According to the Operator, the site is commonly used as a dump area in Alamosa. The operation is a sand mine for fill materials for construction sites in Alamosa. No equipment was onsite. The DRMS inspected the northeast portion of the permit area and did not examine the rest of the permit area due to inclement weather. Based on historical Google Earth imagery, it is evident that less than 15 acres has been disturbed. In accordance with the approved reclamation plan, the Operator is required to reclaim the site in 10-acre phases. If the Operator intends to disturb more of the permit area, then a Technical Revision (TR) will be required to update the mining and reclamation plan in accordance with C.R.S. 34-32.5-112 (1)(c)(VI).

Photo 5: Trash scattered along the eastern edge of the permit area.

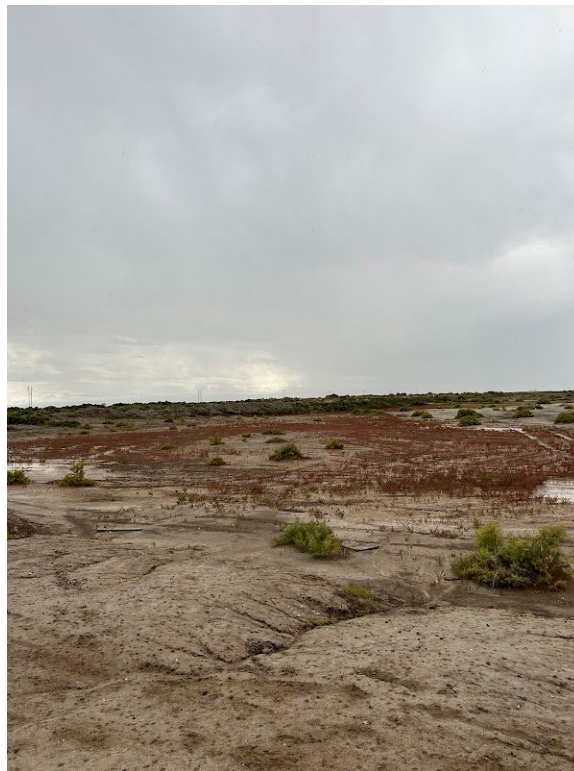
Photo 6: South area of the permit, facing west.
