**MINERALS PROGRAM INSPECTION REPORT**  
**PHONE: (303) 866-3567**

<b>MINE NAME:</b> Pikeview Quarry	<b>MINE/PROSPECTING ID#:</b> M-1977-211	<b>MINERAL:</b> Limestone (general), granite gneiss and do	<b>COUNTY:</b> El Paso
<b>INSPECTION TYPE:</b> Surety-Related Inspection	<b>WEATHER:</b> Clear	<b>INSP. DATE:</b> October 23, 2024	<b>INSP. TIME:</b> 10:00
<b>OPERATOR:</b> Riverbend Industries Inc.	<b>OPERATOR REPRESENTATIVE:</b> Jerry Schnabel	<b>TYPE OF OPERATION:</b> 112c - Construction Regular Operation	
<b>REASON FOR INSPECTION:</b> Surety Related	<b>BOND CALCULATION TYPE:</b> Complete Bond	<b>BOND AMOUNT:</b> \$6,805,607.00	
<b>DATE OF COMPLAINT:</b> NA	<b>POST INSP. CONTACTS:</b> None	<b>JOINT INSP. AGENCY:</b> None	
<b>INSPECTOR(S):</b> Hunter Ridley	<b>INSPECTOR'S SIGNATURE:</b>

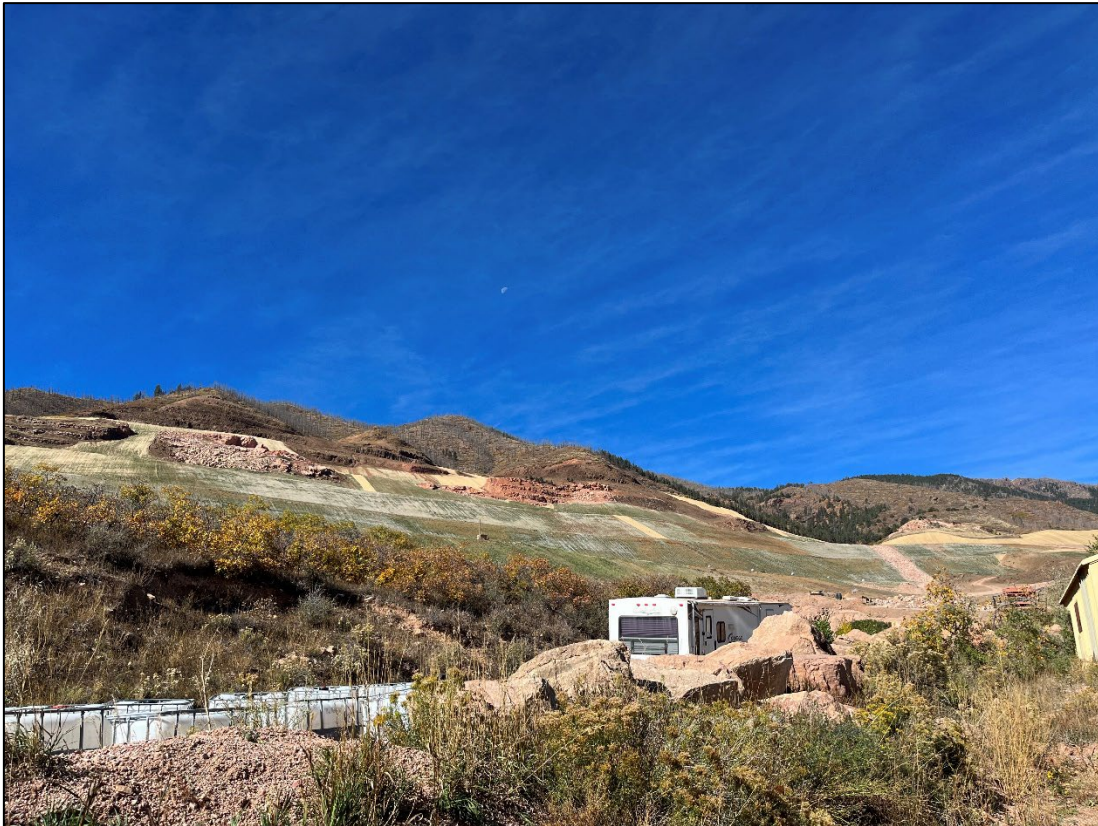
**Photo 1: View of the revegetating slope from the office building.**

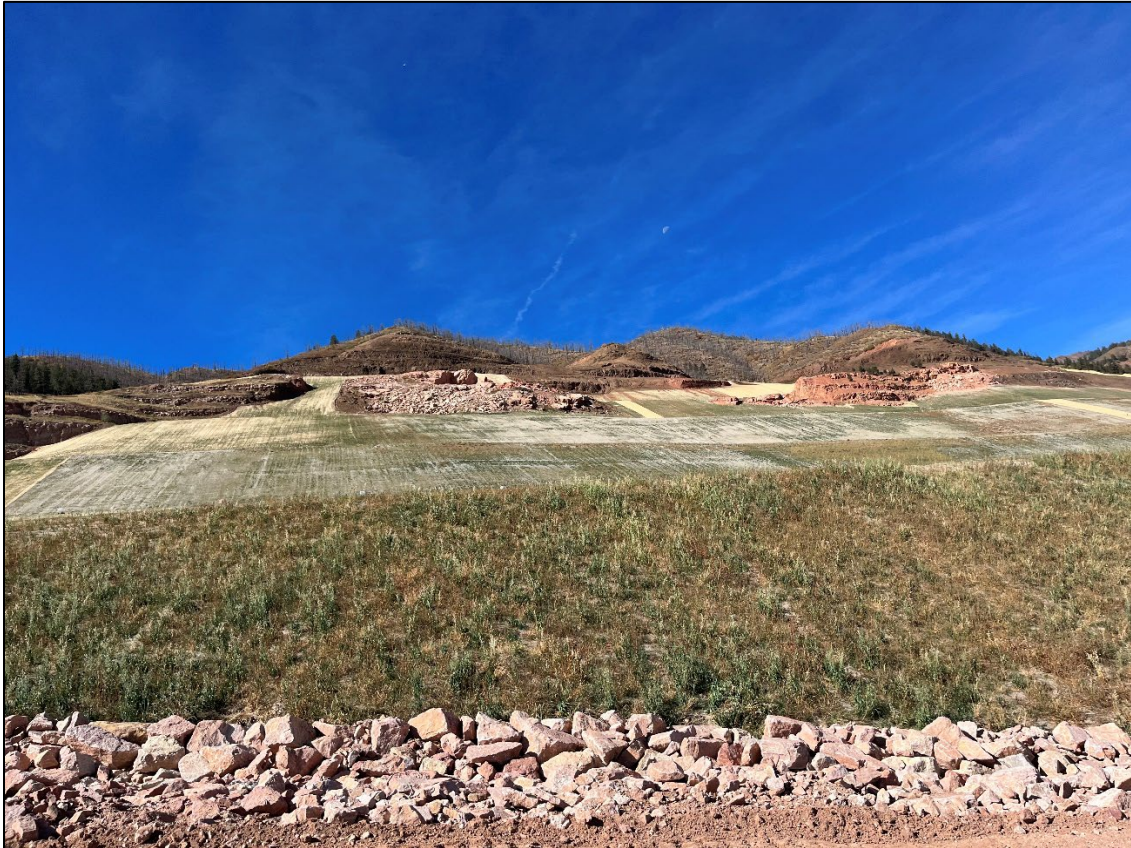
**Photo 2: View west looking up at the revegetating buttress.**

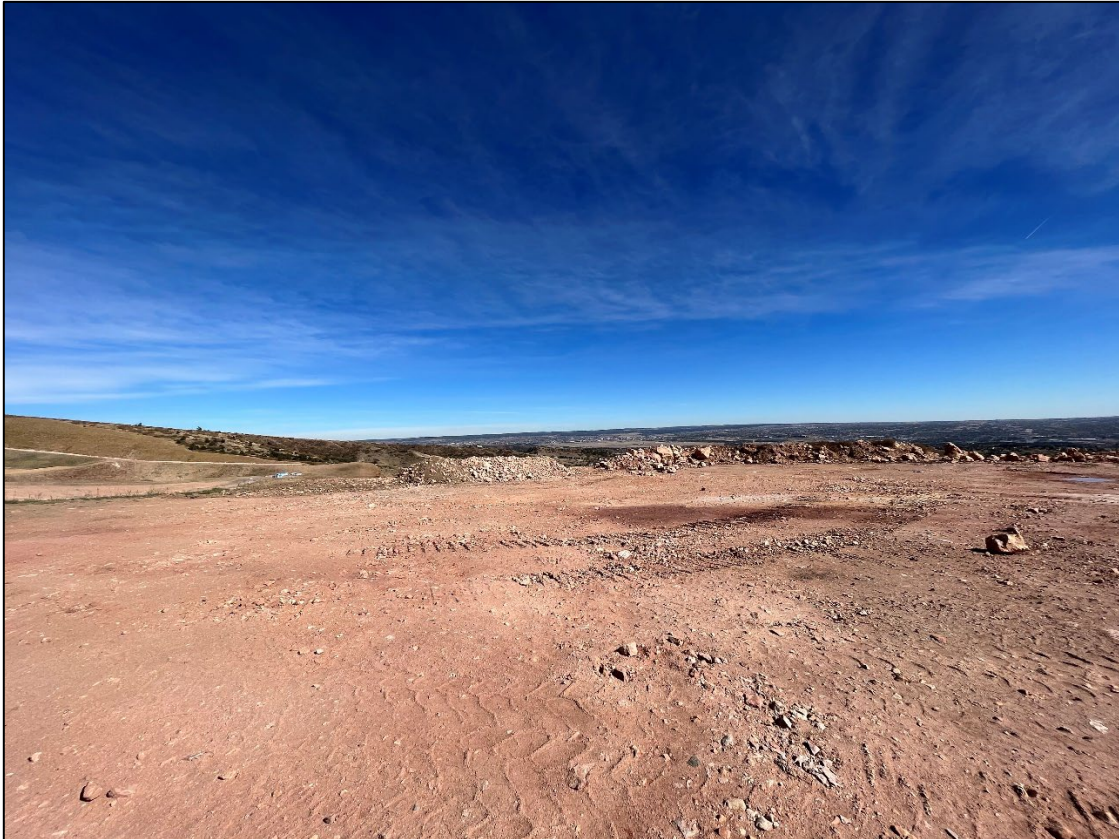
Recent vegetation growth was observed across the entire buttress portion of the site (Photos 3 and 4). Irrigation tanks still remain on the lower buttress bench (Photos 6 and 10). No additional irrigation tanks are planned to be added anywhere onsite. Some areas of the site, particularly those which were revegetated using the matting method are showing signs of growth, with a small set of diverse species coming through. Some annual weeds were noted among the native growth but were not in excess. Other areas, such as the first buttress bench level, are struggling more with stability in supporting shrubs and grasses. The Division does not yet have a clear indication of how well tree transplants are doing across the site. As part of the Amendment 4 (AM-4) revision, Pikeview has committed to a 70% survival rate for trees on site. Data for these conclusions will be collected by Pikeview via the point-transect method. No areas of major grass or shrub die-off was noted at the time of inspection.

**Photo 4: View east of the south borrow area bench to be topsoiled and seeded.**

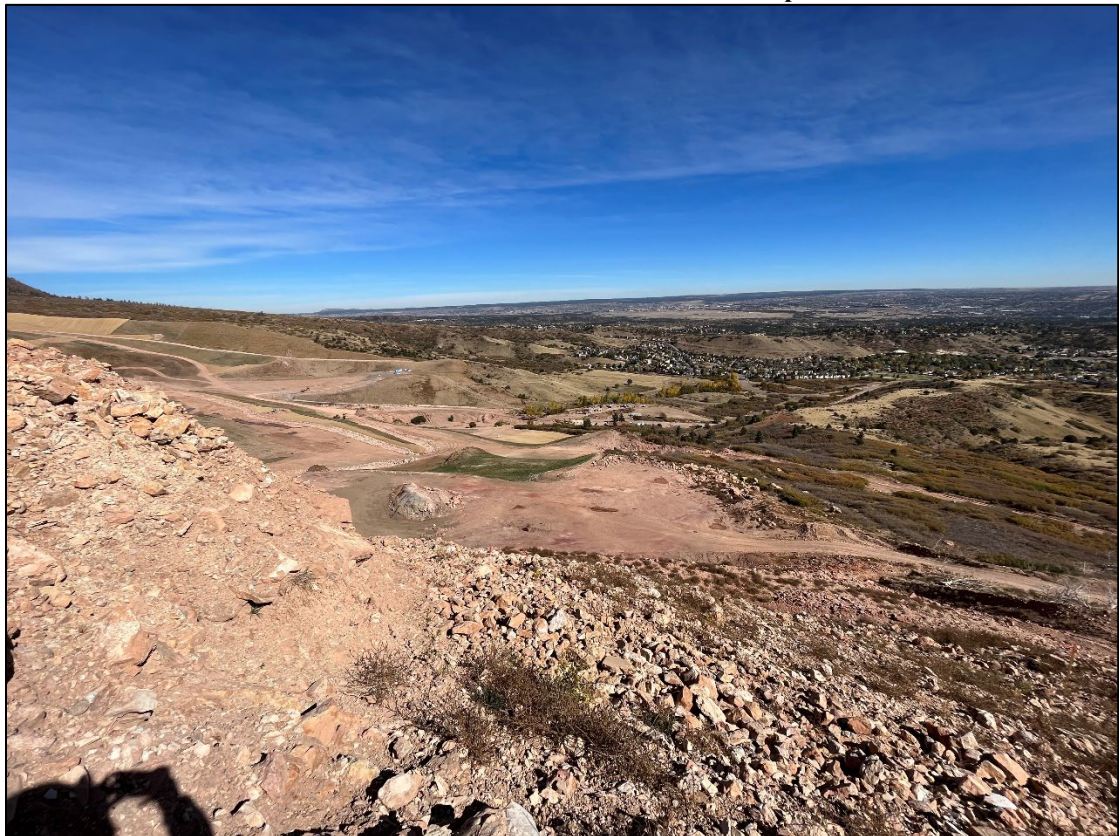
**Photo 5: View east of the south borrow / quarry area bench to remain after rip rap removal and topsoiling and seeding.**

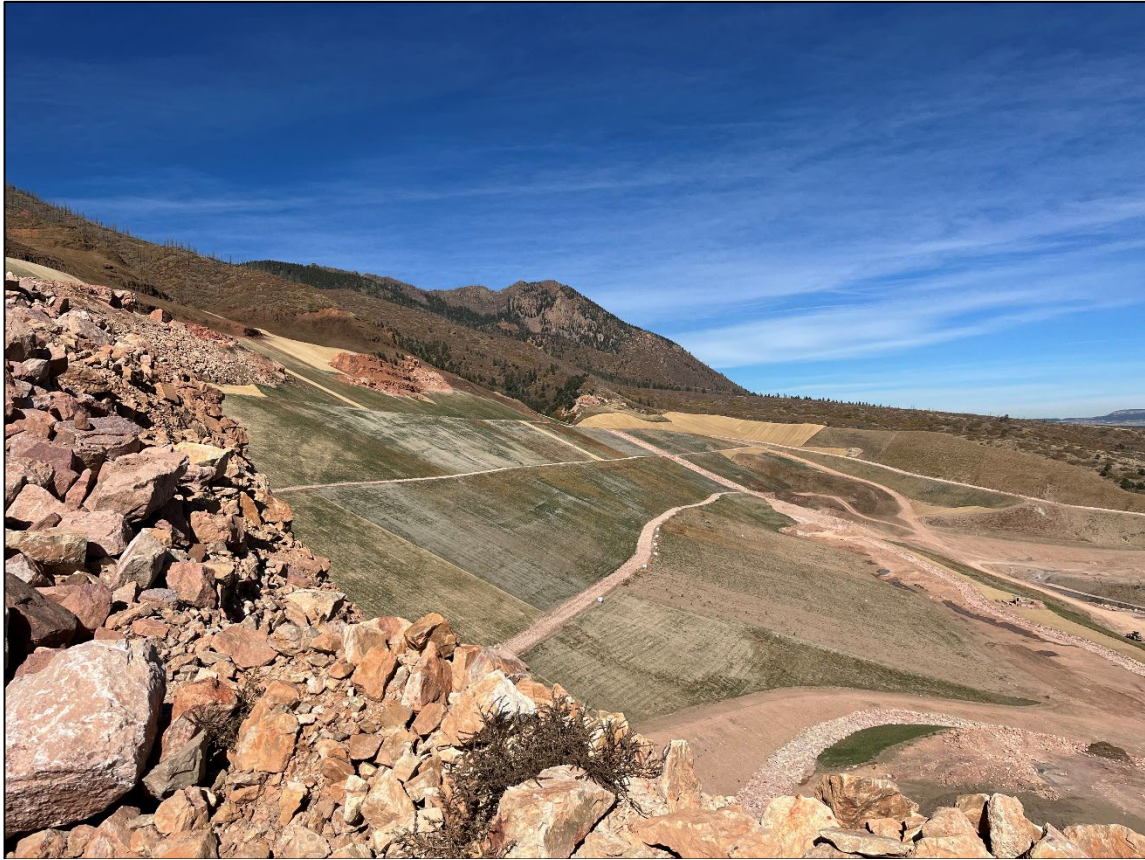
A small amount of ponding was visible at the Leica prism level bench (Photo 6). Site representatives stated that they would be regrading this area to promote proper drainage in the next few days.

**Photo 6: Overlook north of the revegetating buttress.**

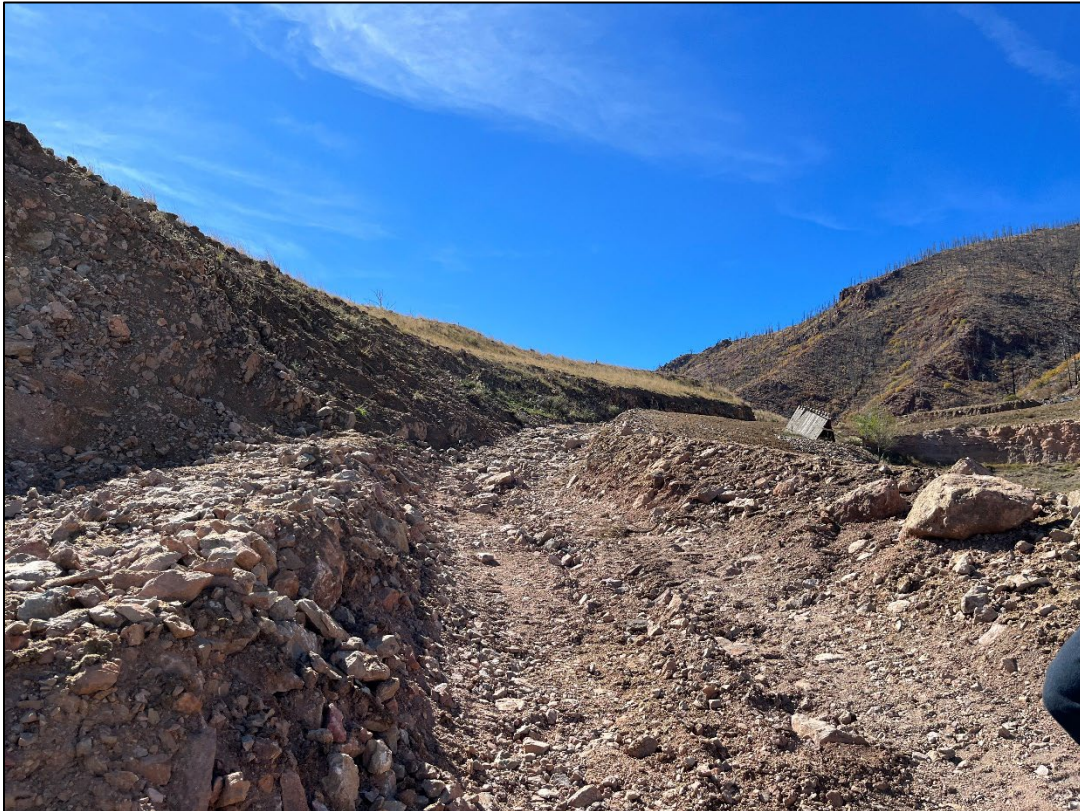
Pikeview continues to work with the City and a Forest Service hydrologist to address previous concerns about the Upper South Channel (Photos 7 and 8). At the time of inspection, Pikeview staff were excavating a trench into the Upper South Channel to determine how deep a layer of unconsolidated material was atop 'bedrock'. It was determined that ~2-3 feet down into unconsolidated material lies a hard, consolidated clay layer. Pikeview and the Forest Service are still discussing final plans for this channel. The tentative plan is to extend the western rock wall currently in place along the ditch (Photo 8) towards the newly cut trench on the south side of the channel (Photo 8). This is done with the intention of cutting off hydrology between the Upper South Channel and the drainage area to the south, which will prevent stormwater from flowing outside of its planned channel.

**Photo 7: View west, looking up at the bedrock channel of the Upper South Channel. USFS land is visible to the west.**

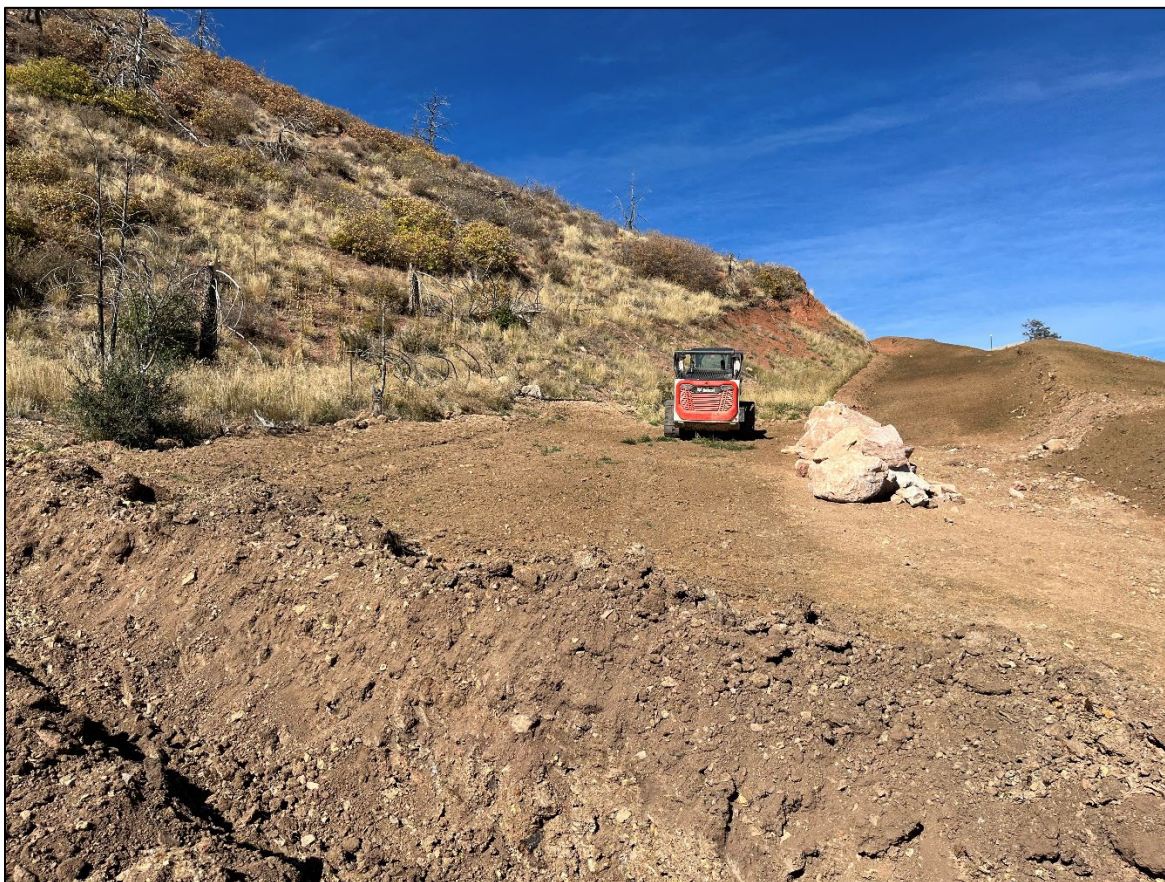
**Photo 8: View north of the Upper South Channel on USFS land.**

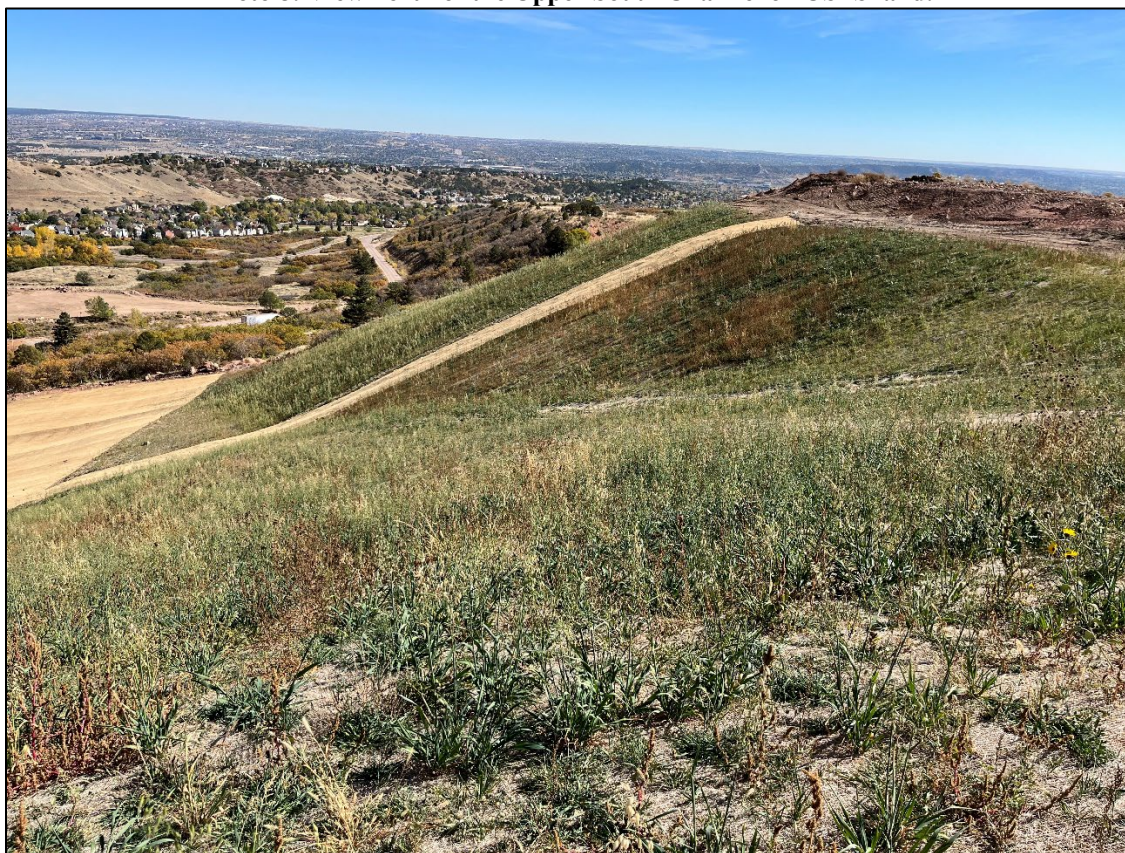
**Photo 9: View east of the topsoiled area south of the Leica level. Vegetation growth here is more full and diverse than other**

areas. Some weeds are present.

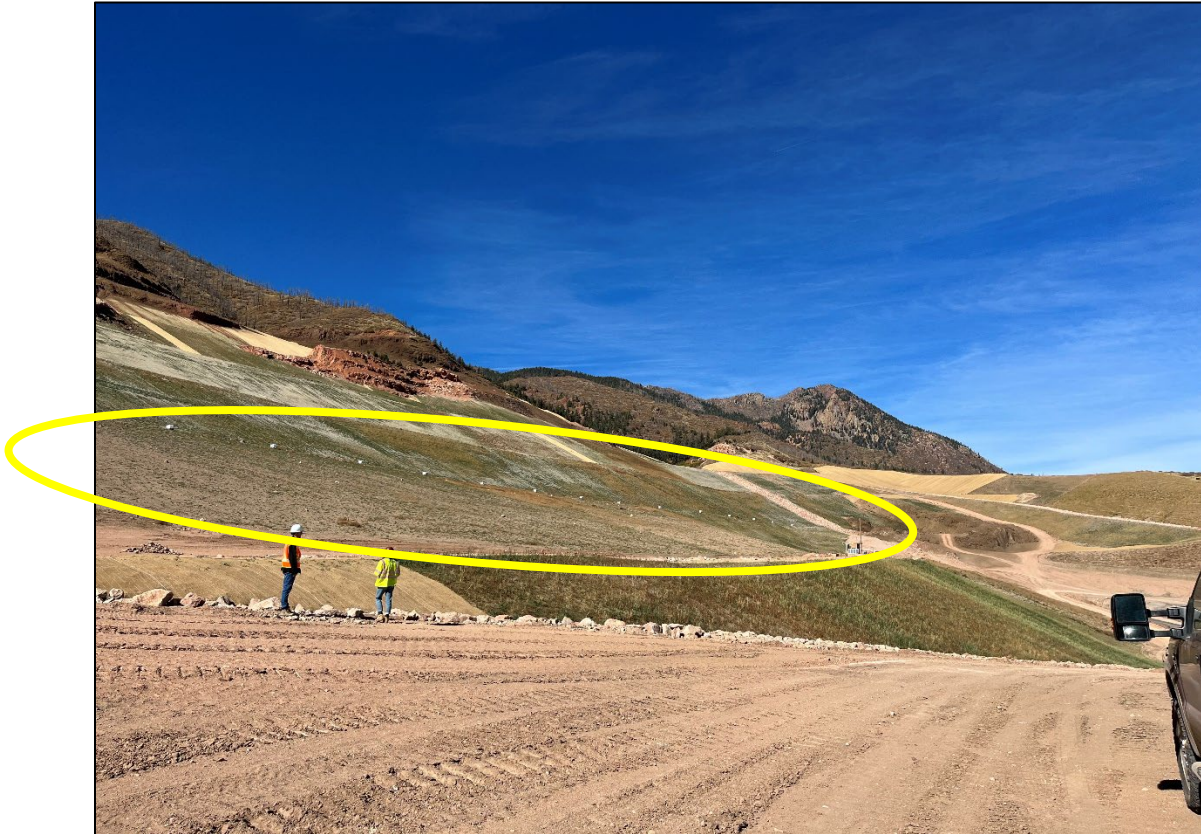
**Photo 10: View northwest of the first bench of the buttress, vegetation growth is weakest in this area.**
