Partial Inspection 2024 November

6 November 2024

Permit Number: C1981010
Mine Name: Trapper Mine
Operator: Trapper Mining, Inc.
Operator Address:

Inspection Start Date: 6 Nov. 2024 Inspection Start Time: 9:30 a.m. Inspection End Date: 6 Nov. 2024 Inspection End Time: 14:00 p.m.	Inspection Type: Coal Partial Inspection Inspection Reason: Normal I&E Program Weather: Cloudy
Joint Inspection Agency:	Joint Inspection Contacts:
Post Inspection Agency:	Post Inspection Contacts:
None	
Inspector(s):	Inspector's Signature: Signature Date:
Robin A. Reilley, M.S. GISP	
	Bobin Beilles 7 November 2024

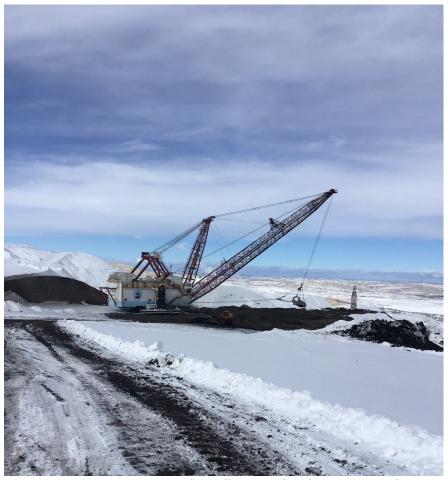
L Pit: The Baby Doe idle the middle of the pit and Molly Brown was working at south end of the pit casting spoil. Coal and overburden were being loaded and hauled.

Photo 1: L Pit activities, the Molly Brown drag line casting spoil.

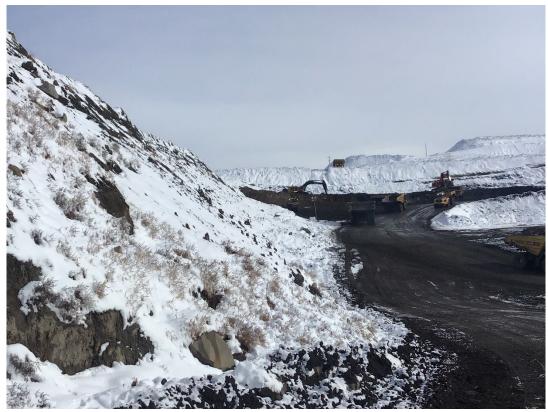
N Pit: overburden being removed at east end backfilling was occurring at mid pit. Coal extraction was idle at the time of inspection. The Highwall miner in J Pit will be moved to N Pit in approximately one month.

Photo 2: Looking east at N Pit activities, moving overburden.

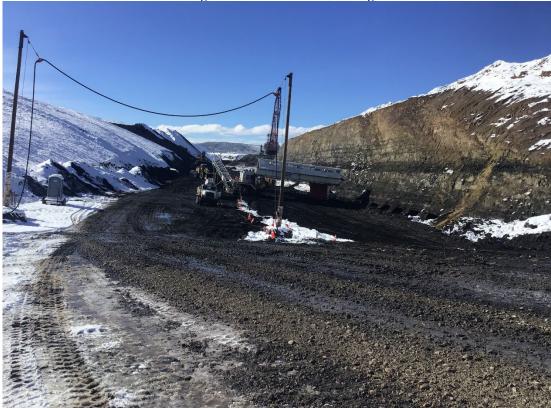
J Pit West: Coal was being hauled from J Pit and higwall mining was occurring on the North wall.

Photo 3: Looking west in J Pit at highwall mining operation of the north wall.
