**PERMIT INFORMATION**

<b>Permit Number:</b> C-1981-019 <b>Mine Name:</b> Colowyo Coal Mine <b>Operator:</b> Colowyo Coal Company L.P. <b>Operator Address:</b> Mr Tony Tennyson 5731 State Highway 13 Meeker, CO 81641	<b>County:</b> Moffat, Rio Blanco <b>Operation Type:</b> Surface <b>Permit Status:</b> Active <b>Ownership:</b> Private
	<b>Operator Representative Present:</b>  Tony Tennyson
<b>Operator Representative Signature: (Field Issuance Only)</b>

**INSPECTION INFORMATION**

<b>Inspection Start Date:</b> October 30, 2024 <b>Inspection Start Time:</b> 08:00 <b>Inspection End Date:</b> October 30, 2024 <b>Inspection End Time:</b> 13:00		<b>Inspection Type:</b> Coal Partial Inspection <b>Inspection Reason:</b> Surety Release Requested <b>Weather:</b> Cloudy	
<b>Joint Inspection Agency:</b>  OSM		<b>Joint Inspection Contacts:</b>  Jim Stark	
<b>Post Inspection Agency:</b>  OSM		<b>Post Inspection Contacts:</b>  Jim Stark	
<b>Inspector(s):</b>  Hunter Ridley	<b>Inspector's Signature:</b>  <i>Hunter Ridley</i>		<b>Signature Date:</b>  November 12, 2024

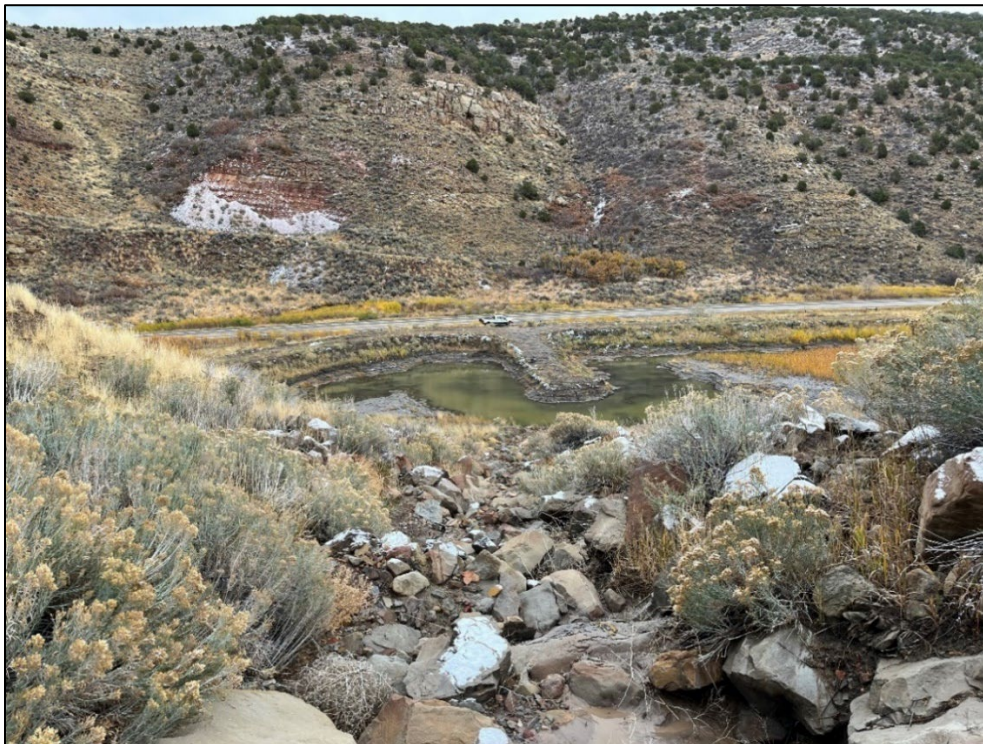
Streeter Pond was inspected visually and is shown below in Photos 2, 14-19. Streeter Pond was approved to remain as a permanent structure in August 2024 under MR259. The primary spillway, riser, and trash rack were measured against the as-built design and found to be constructed accordingly (Photos 17 and 19). The SEDCAD demonstrations for the 10-year 24-hour and 25-year 24-hour storm events were approved under TR145 and ensure the capacity of the impoundment is in compliance with Rule 4.05.9(13)(e) and also prevents the contribution of suspended solids to streamflow or runoff outside the permit area in excess of pre-mining levels, as required in Phase II bond release criteria (Rule 3.03.2(3)(b)). The emergency spillway, at the southern end of the pond, was inspected and found to be free of obstructions (Photo 16). The primary discharge point was found to be flowing and was also free of obstructions (Photo 18). Although water discharges from this point, the Colorado Department of Public Health and Environment, Water Quality Control Division, released Colowyo of monitoring the discharge from the Streeter Pond in 2017. Streeter Pond was found to be in compliance with the permanent impoundment requirements and water quality standards specified under Rule 4.05.9(13)(a-f).

*Photo 2: Point 2, view east. Streeter Pond is visible below.*

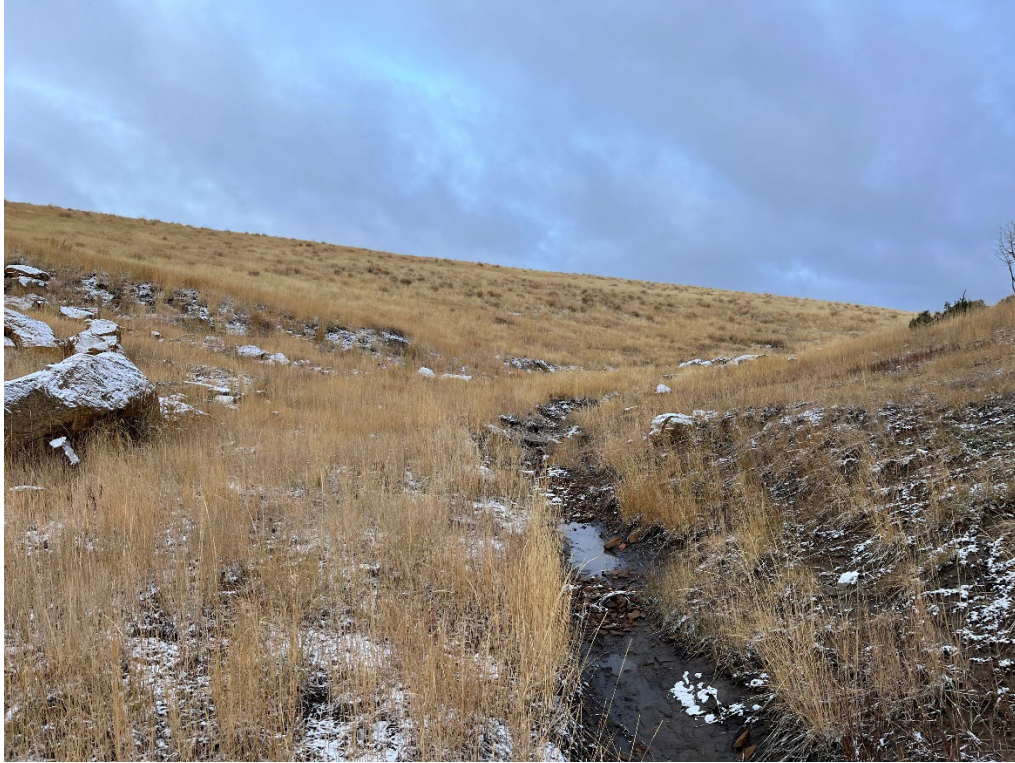
*Photo 8: Point 7, view west. Boulders to the south show channel edge.*

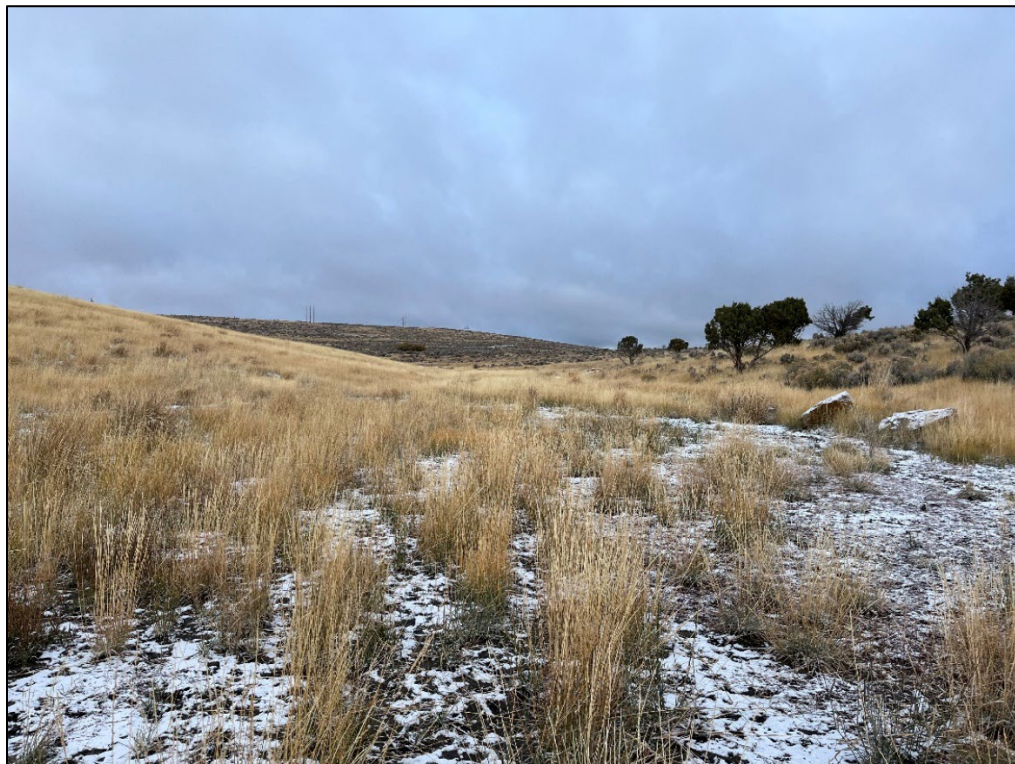
Streeter Ditch was walked in its entirety, from Streeter Pond to Lower Section 3 Pond, beginning from an access road in the mid-section of the ditch. Data was collected at various points along the ditch where accessible. In total, nine points of data (represented below in Table 1) were collected. Measurements were taken at each point to determine elevation, channel width, channel depth, and channel material to be checked against the SEDCAD design and as-built profiles for the ditch. In depth analysis of these data points will be provided as part of the Division’s Proposed Decisions and Findings of Compliance Document for SL-23. During visual inspection of the ditch, no erosional issues were noted, and no areas were identified that would suggest stormwater would flow outside of the approved channel area. Rip rap was in place and stable along the channel areas approved for such design (Stations 0+00 to 45+00). From Stations 45+00 to 68+41, the channel shifts into a vegetated channel. Around Station 40+00, the channel widens and has taken on a braided effect with smaller meandering channels which have established within the larger channel itself (Figure 2). These meandering channels, however, are not very deep or wide, have been at a stable size for many years, and are well within the width of the constructed ditch channel (Photos 9 and 10). The same pattern of steady state meander repeats from approximately Station 62+00 to 67+00.

*Photo 9: View of the meandering channel area, taken at ~Station 40+00, the riprap channel edge is visible on the right.*

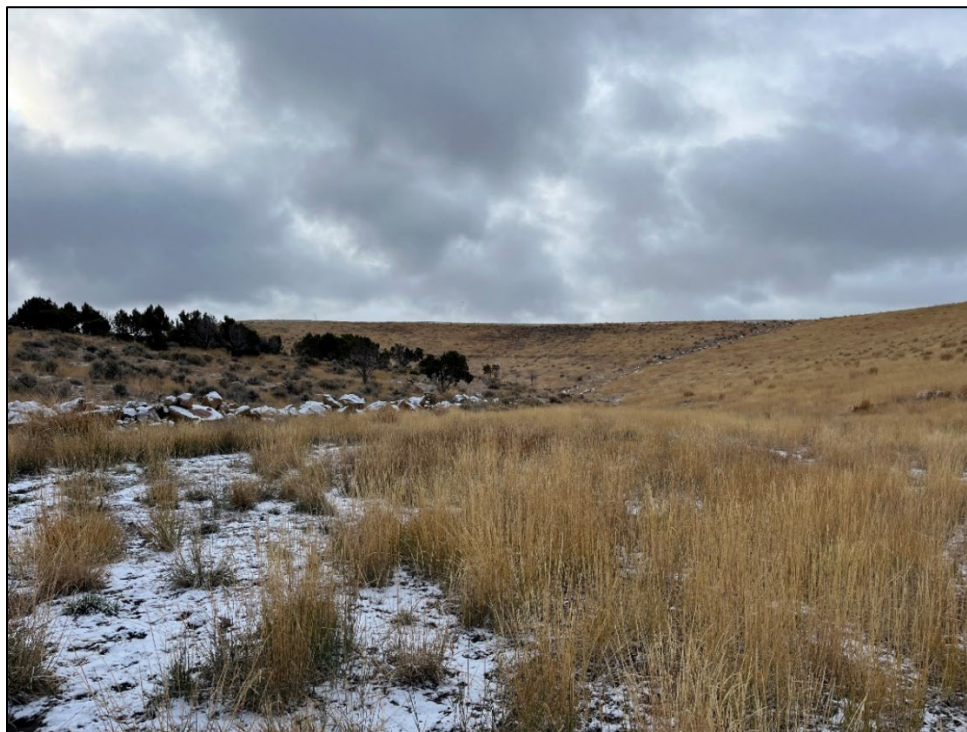
*Photo 10: View of the meandering channel area, taken at ~Station 40+00, the riprap channel edge is visible on the left.*

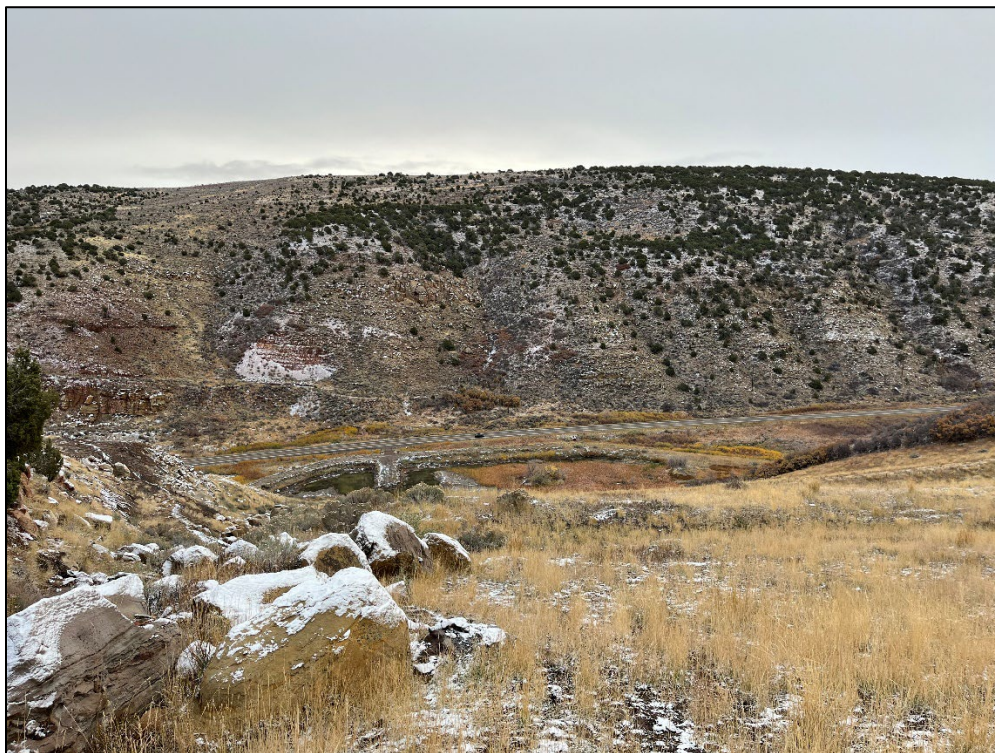
*Photo 14: View east towards Streeter Pond.*

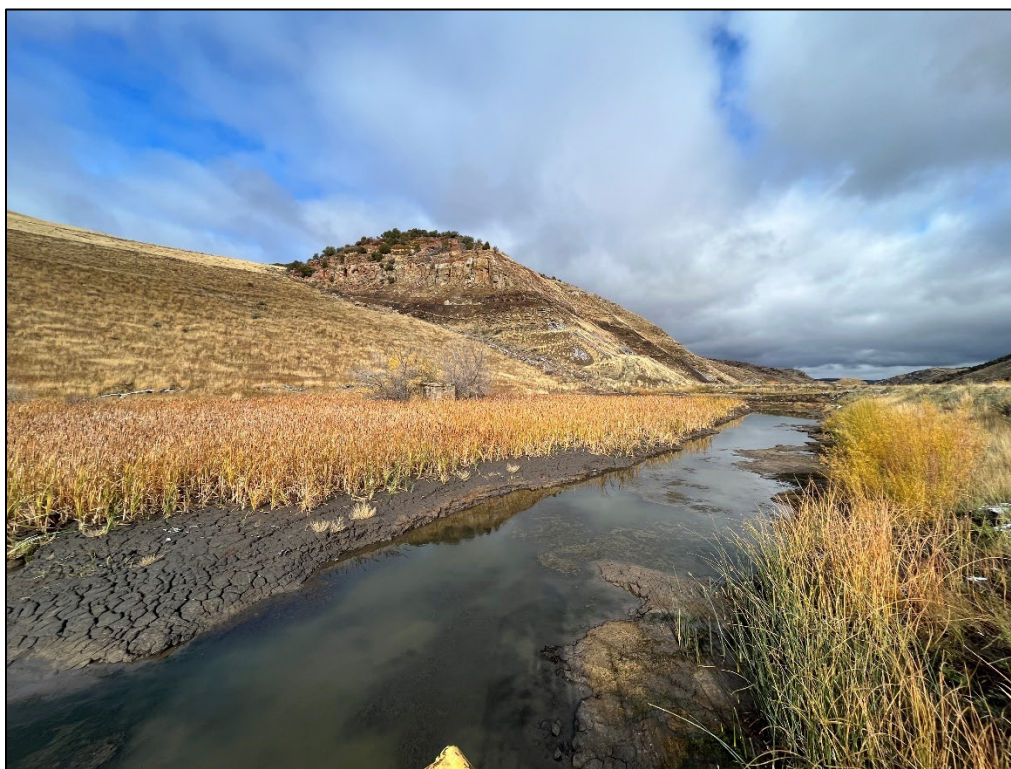
Streeter Pond was holding water but was low at the time of inspection. Water is currently being pumped from Streeter Pond to support work being conducted by the State of Colorado Inactive Mines Program to mitigate the historical Axial Basin underground coal fire. Pond embankments were stable and vegetated (Photos 15, 16, and 19) No issues were observed.

*Photo 15: View north of Streeter Pond.*

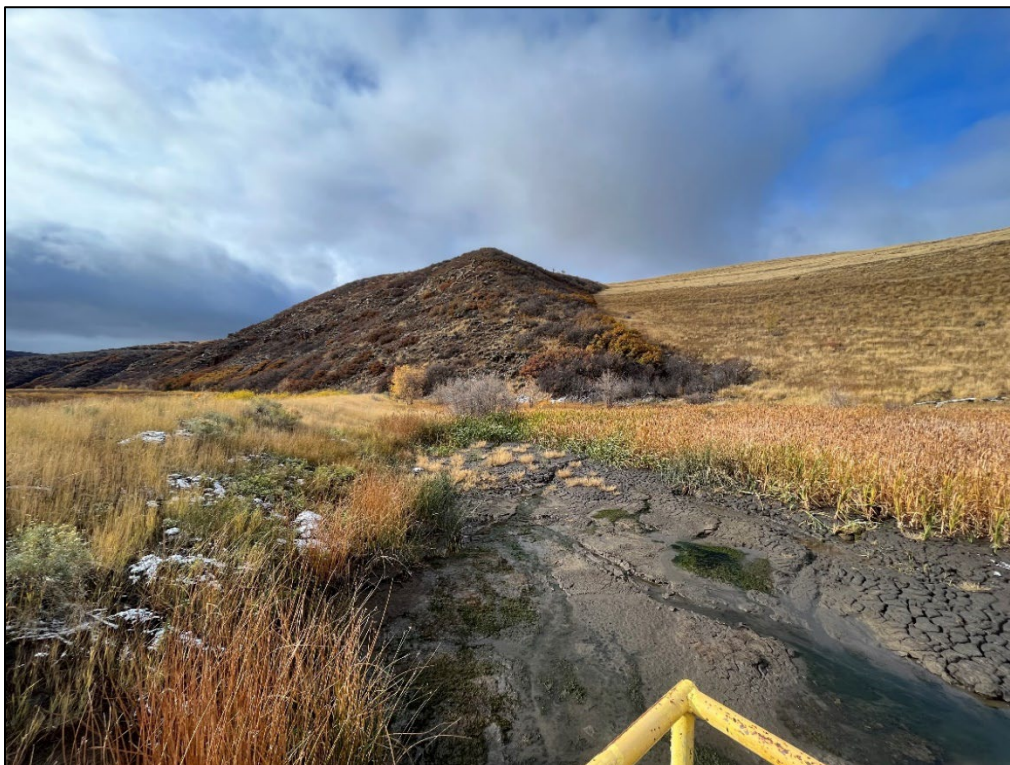
*Photo 16: View southwest of Streeter Pond and emergency spillway.*

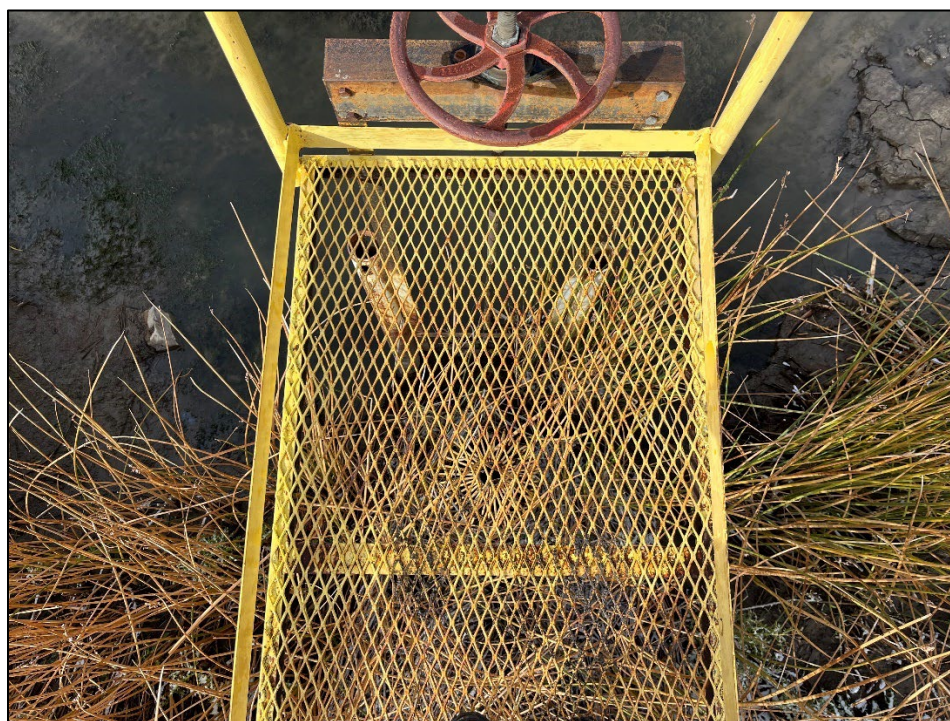
*Photo 17: 3 ft x 12 in diameter riser.*

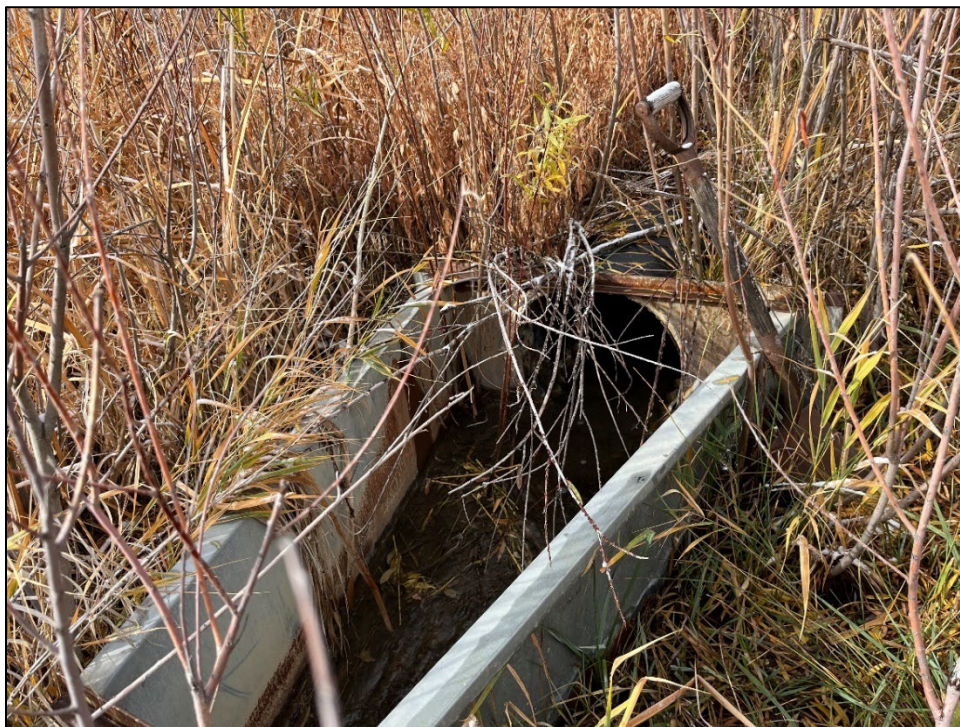
*Photo 18: Flume and flowing water at the discharge point for Streeter Pond.*

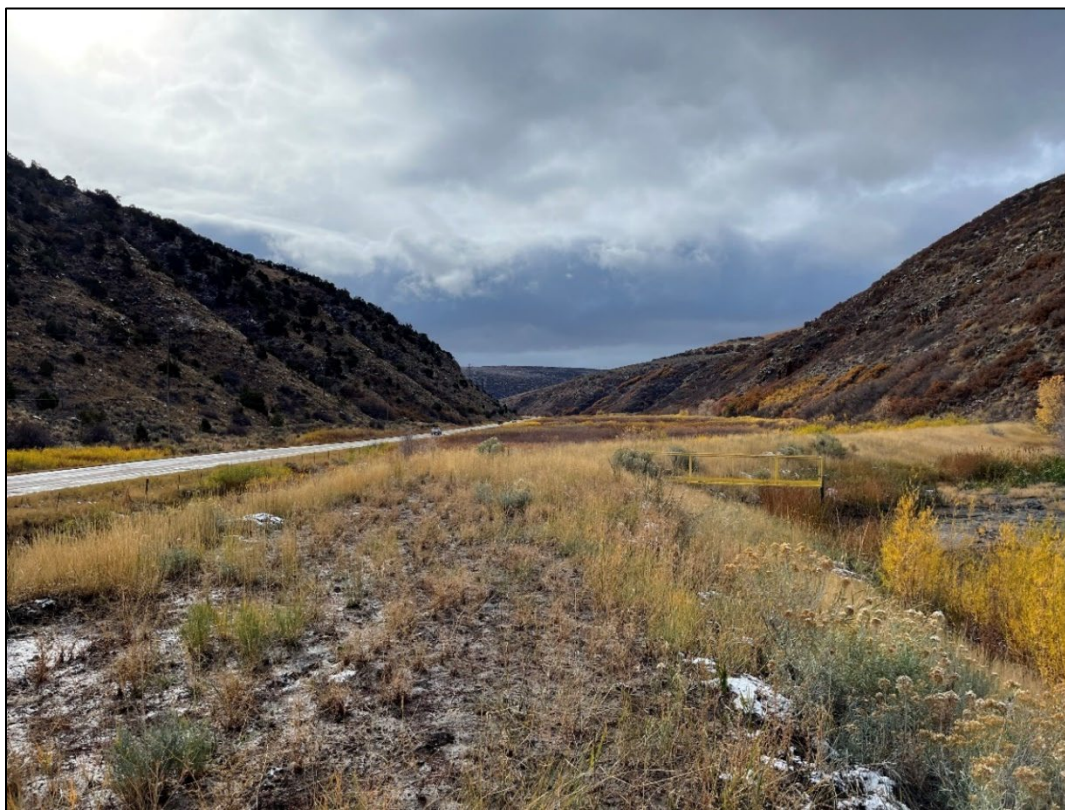
*Photo 19: View south of Streeter Pond primary spillway.*

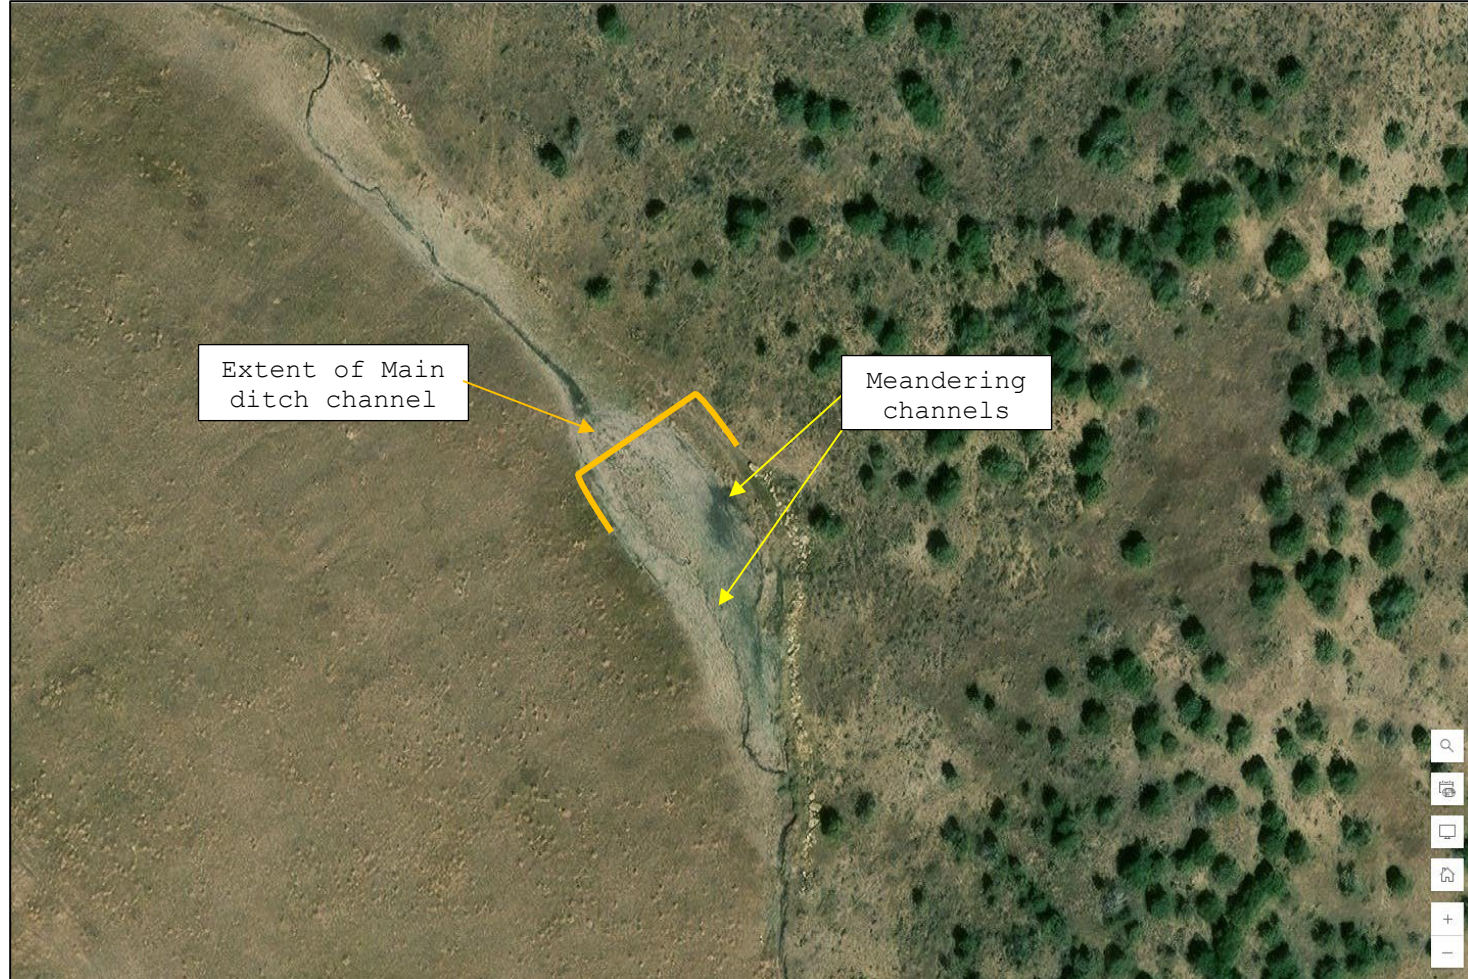
*Figure 2: Aerial imagery view of Station 40+00, where two smaller channels have meandered within the larger ditch channel.*
