Re: Henderson Mine M-1977342 Inspection Report

MINERALS PROGRAM INSPECTION REPORT
PHONE: (303) 866-3567

MINE NAME: Henderson Mine	MINE/PROSPECTING ID#: M-1977-342	MINERAL: Molybdenum	COUNTY: Clear Creek, Grand
INSPECTION TYPE: Monitoring	WEATHER: Clear	INSP. DATE: September 25, 2024	INSP. TIME: 09:00
OPERATOR: Climax Molybdenum Company	OPERATOR REPRESENTATIVE: Miguel Hamarat	TYPE OF OPERATION: 112d-3 - Designated Mining Operation	
REASON FOR INSPECTION: Normal I&E Program	BOND CALCULATION TYPE: None	BOND AMOUNT: \$143,264,468.00	
DATE OF COMPLAINT: NA	POST INSP. CONTACTS: None	JOINT INSP. AGENCY: None	
INSPECTOR(S): Nikie Gagnon Robert Zuber, P.E. Amber Gibson	INSPECTOR'S SIGNATURE:

The inspection was focused on the Tailings Storage Facility (TSF), including the deposition of tailings, the condition of the 1-Dam and 3-Dam Tailings Impoundments, and the seepwater collection system. Prior to the inspection, the Division reviewed the Annual Report for the Henderson Mine and Mill, sent March 8, 2024. Attachment D of the annual report is the Tailings Storage Facility Evaluation by the Engineer of Record, AECOM. In the evaluation, Ms. Yenne provides the following key observations:

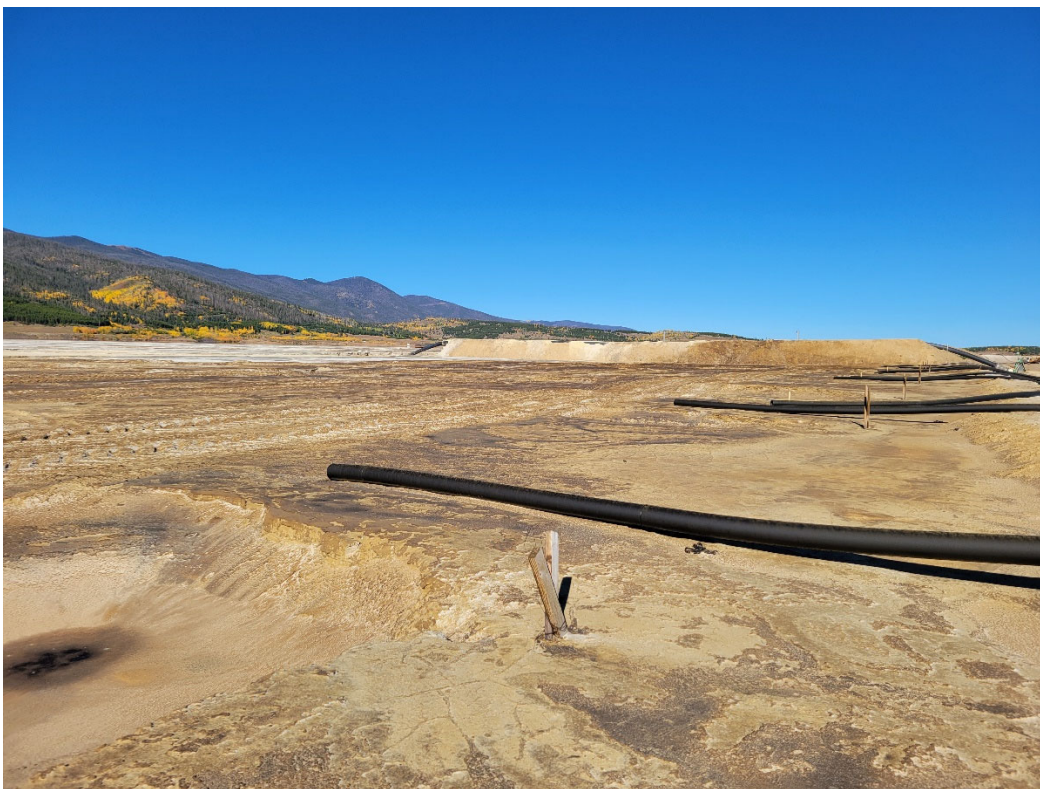
Photo 1: Looking northwest across the 3-Dam deposition area within the tailings impoundment.

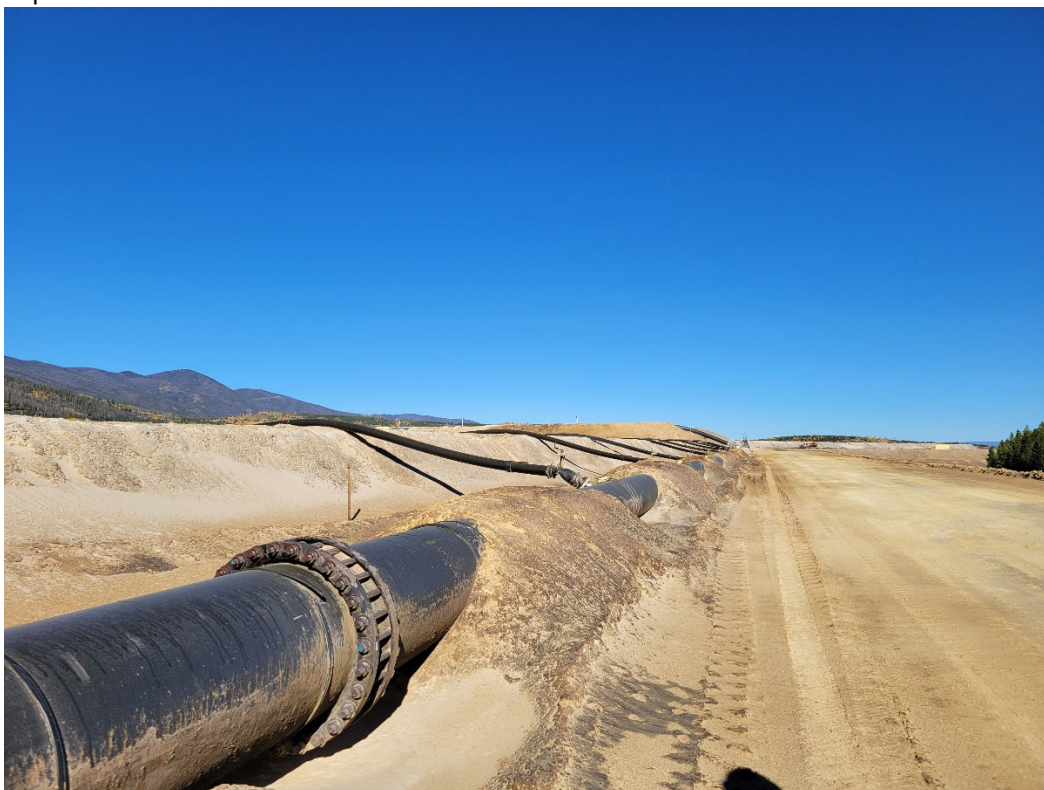
Photo 2: Looking north down the 30" tailings delivery pipeline on the east side of 3-Dam. The 6" spigot lines deliver the slurry over the raised dam to the deposition area.

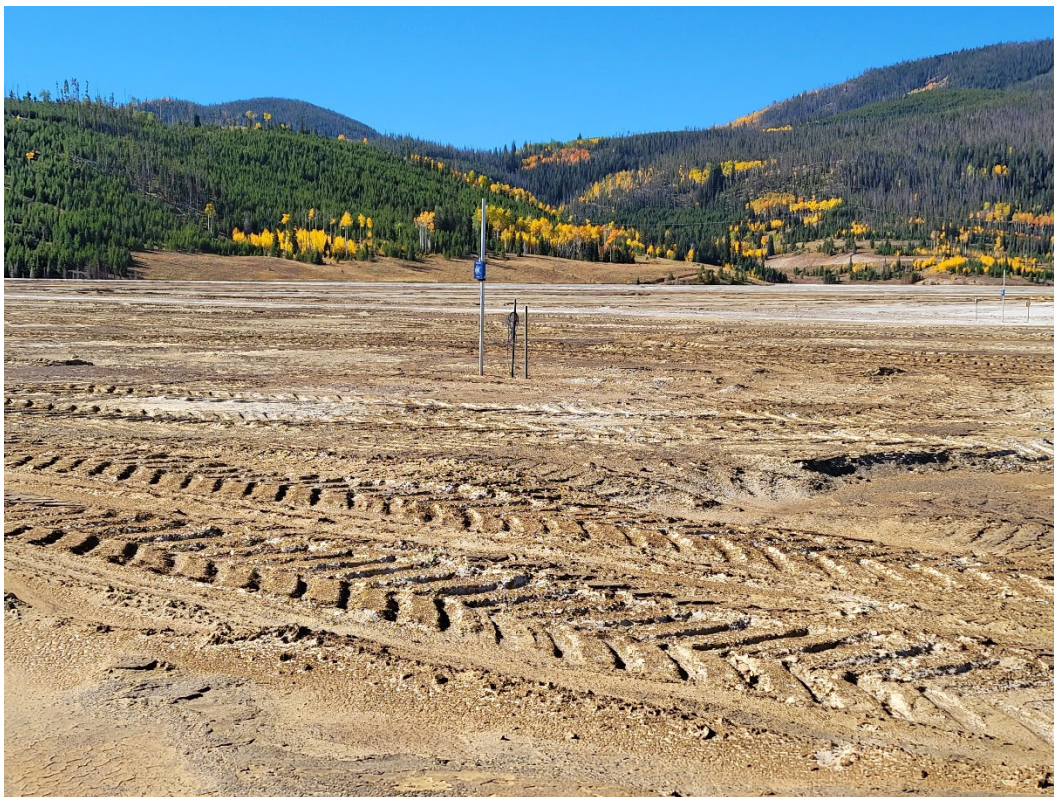
Photo 3: Looking southwest at monitoring instrumentation within the 3-Dam Cell. Equipment tracks are from the application of Cohex dust suppressant on top of the tailings.

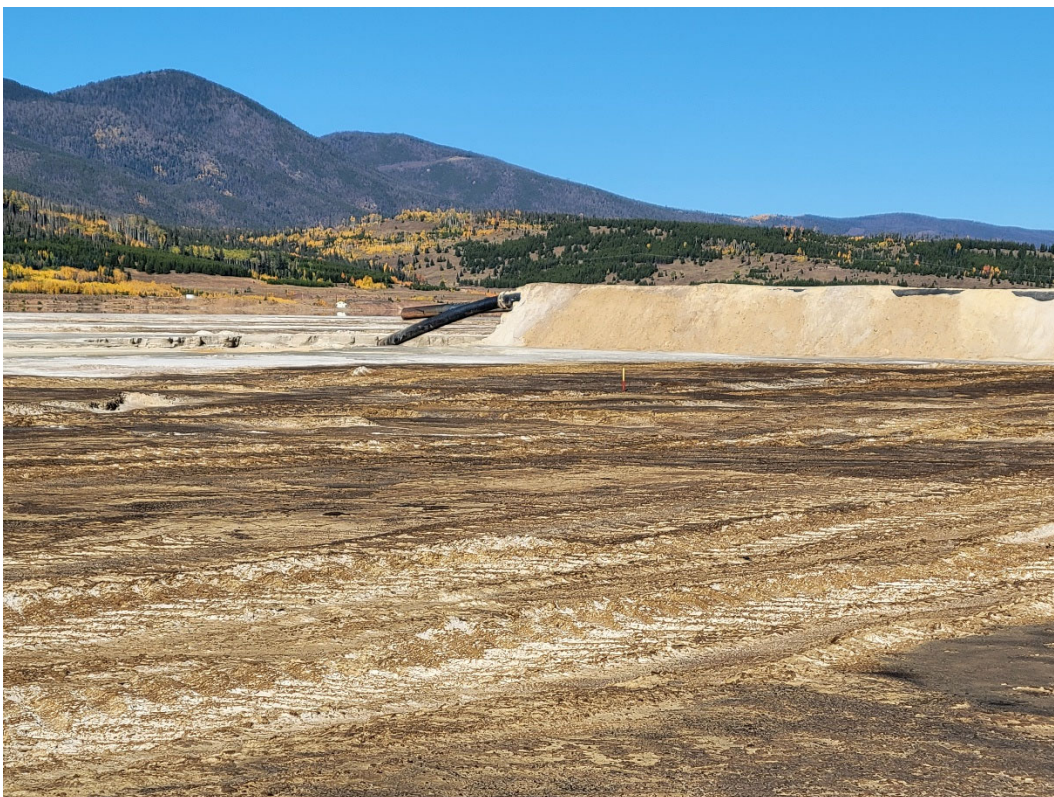
Photo 4: Looking northwest at 24" lead-off tailings delivery pipeline in the 3-Dam area. The lead-off pipes are used predominantly in the winter months.

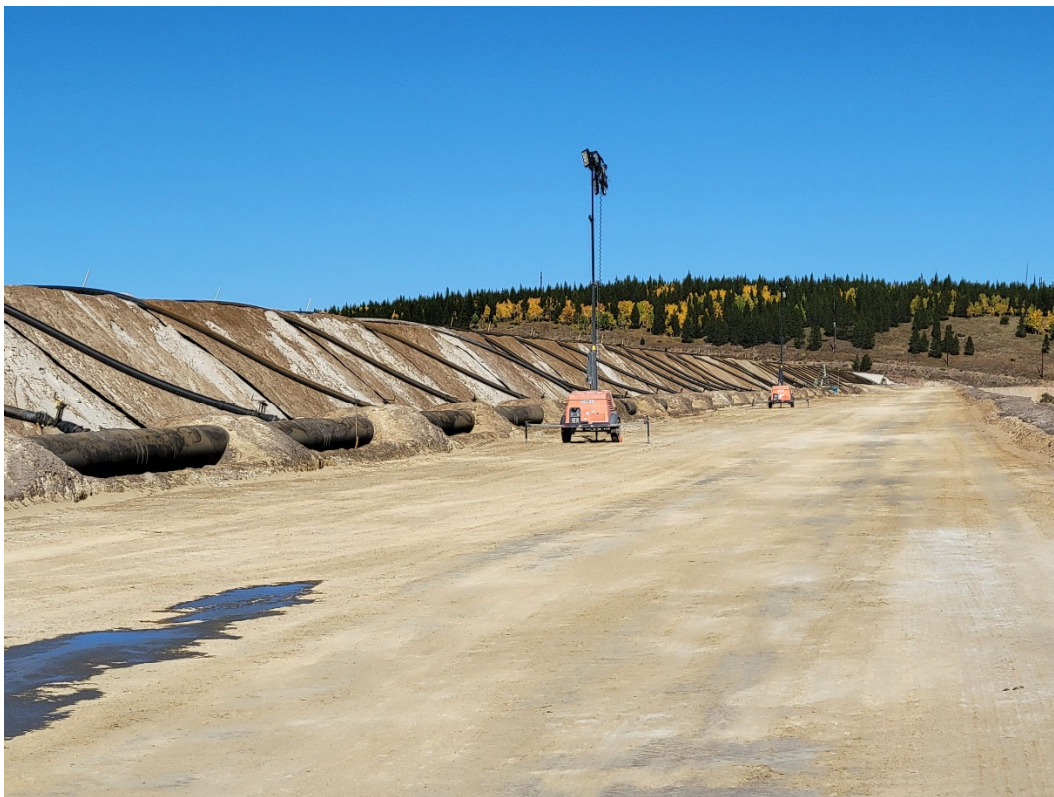
Photo 5: Looking north at the 30" tailings pipeline and 6" spigot lines on 1-Dam.

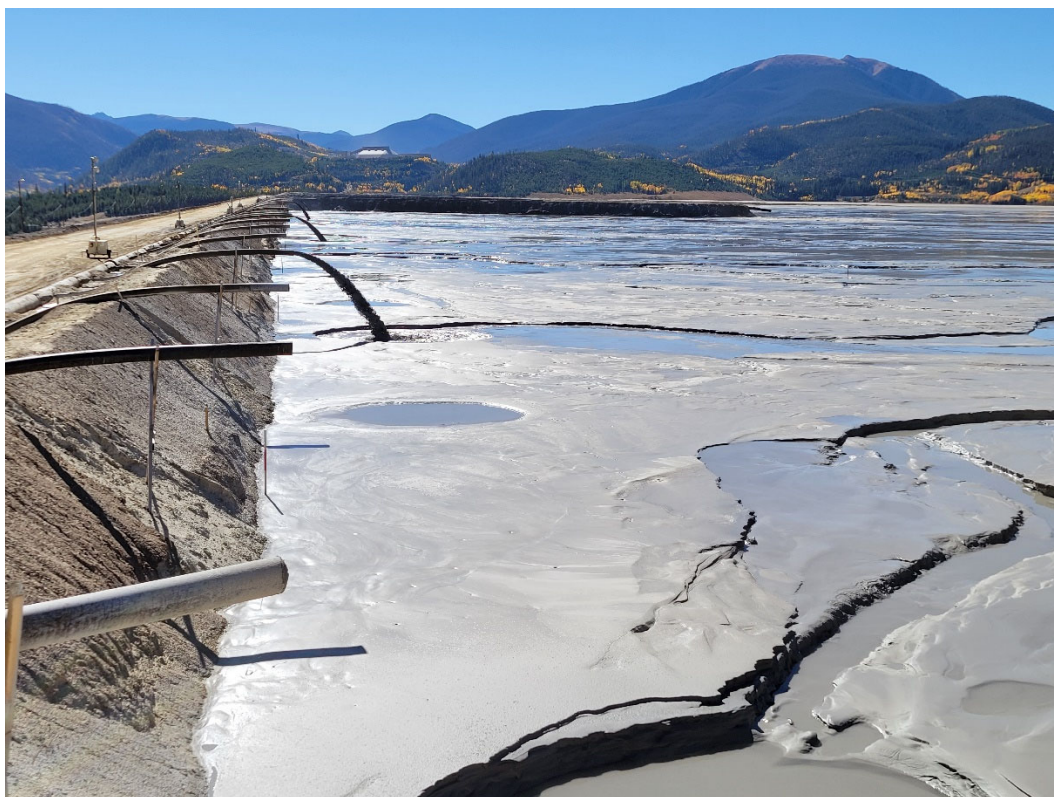
Photo 6: Looking south at tailings deposition within Cell 6 of 1-Dam. Deposition is almost complete here.

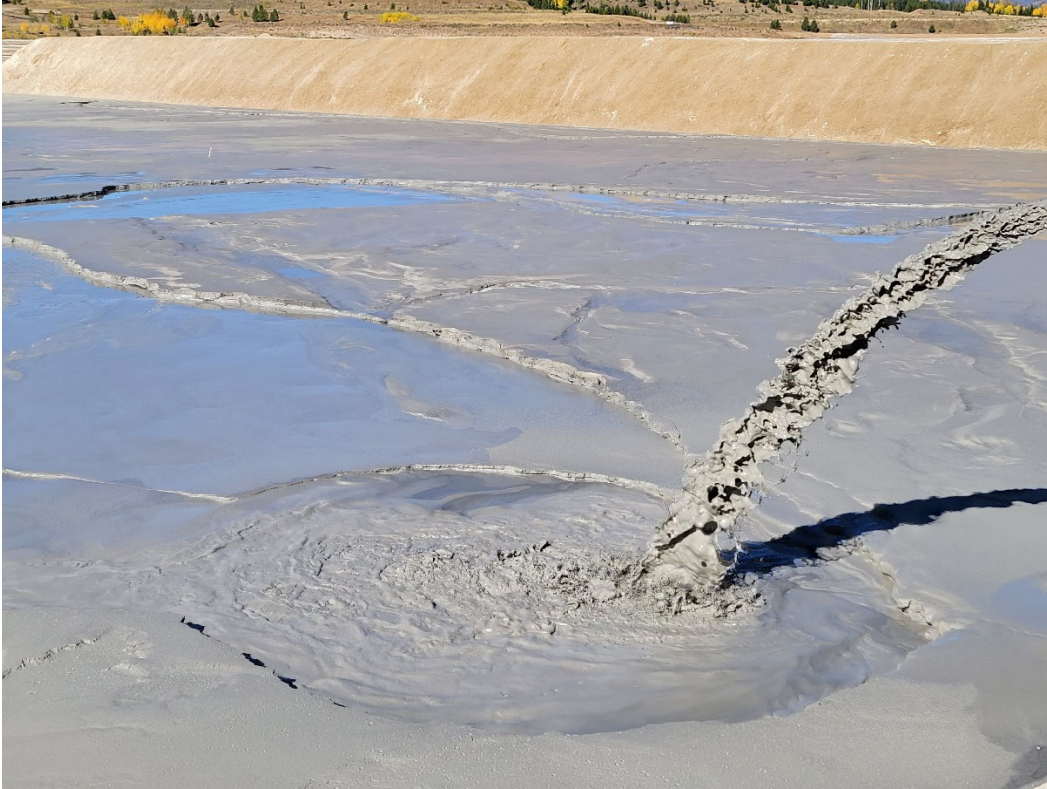
The beaches were observed for key performance indicators, as described by Ms. Yenne. The plunge pools were the desired diameter, approximately 6-8 feet. The projection of the slurry exiting spigots was the desired size, approximately 3 – 5 feet. The channels of water and sediment leaving the spigot area were found to be

Photo 7: Closeup of plunge pool created by deposition within Cell 6 of 1-Dam.

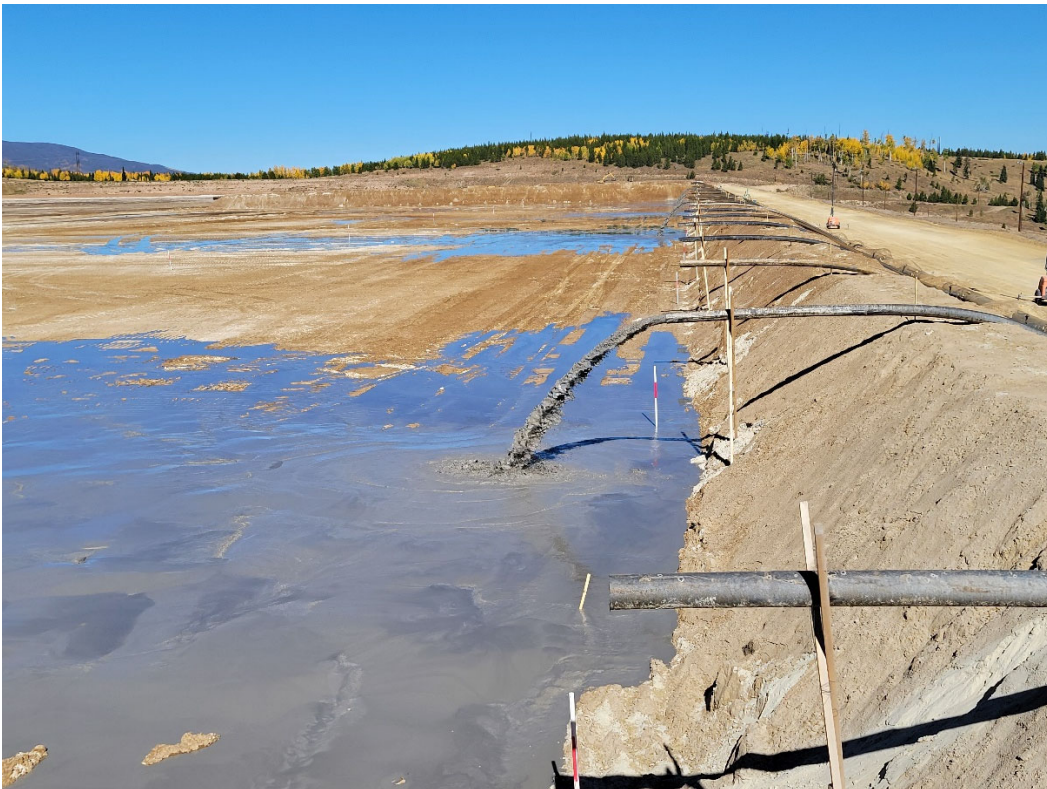
Photo 8: North end of 1-Dam. Looking north at tailings deposition starting within Cell 7.

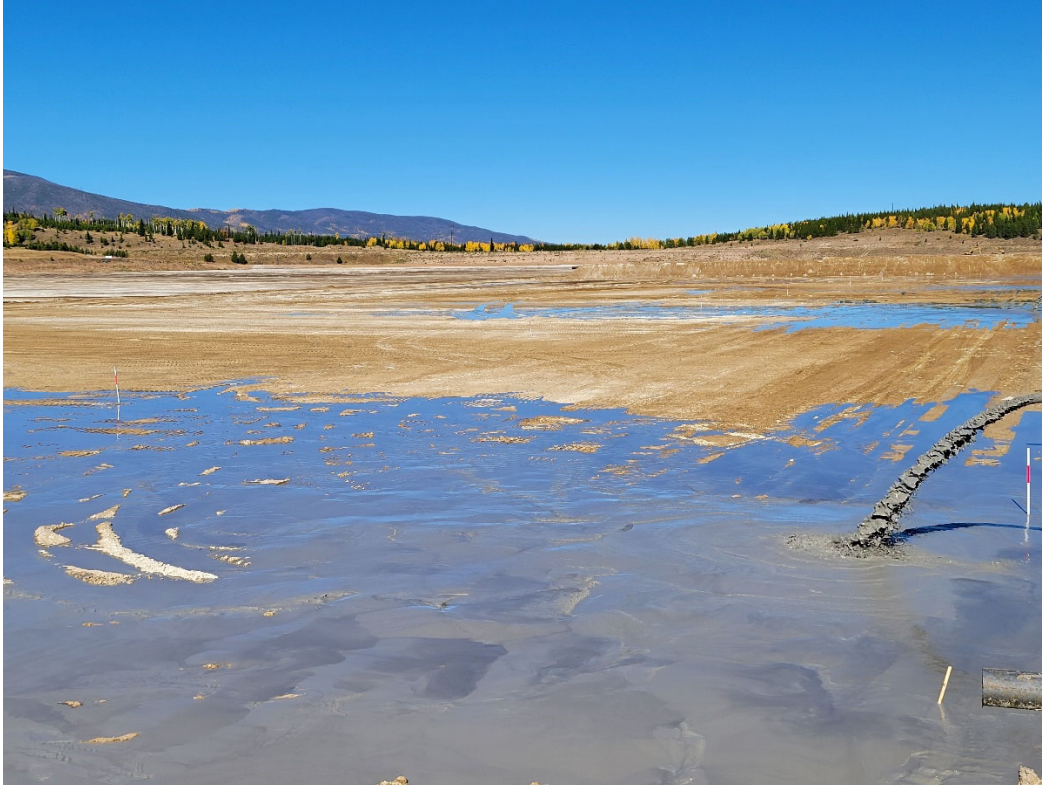
Photo 9: Looking northwest across Cell 7 on 1-Dam.

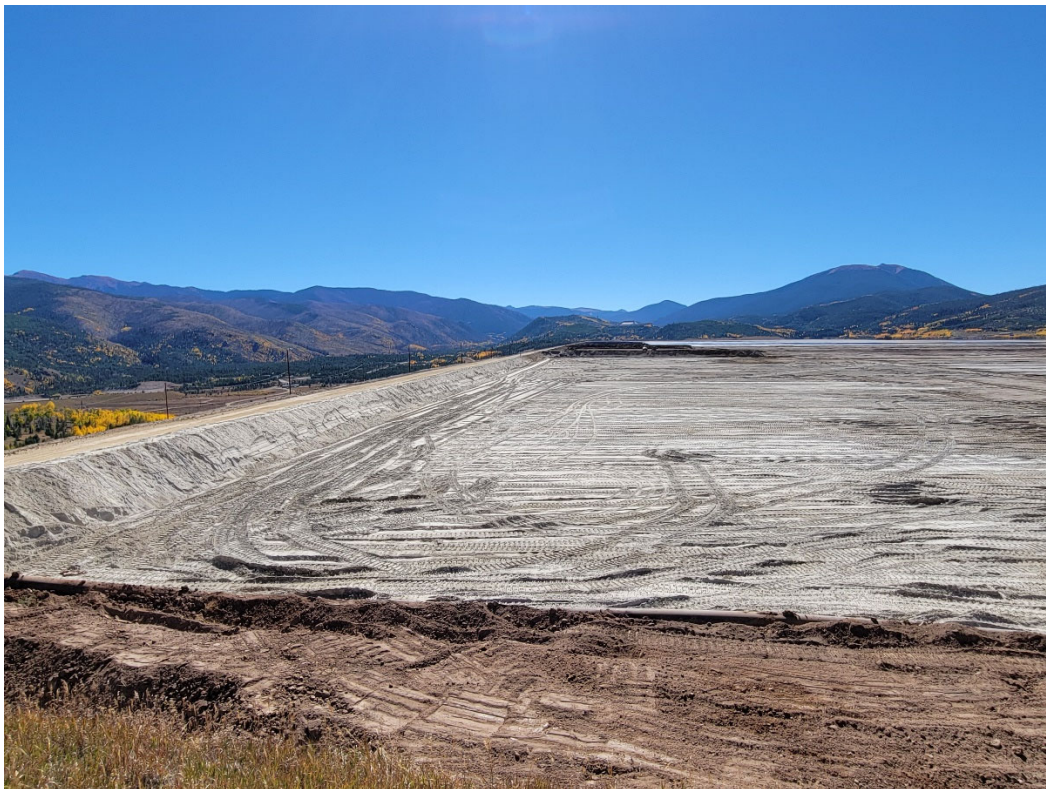
Henderson raised the 1-Dam berm six feet to provide deposition infrastructure (walking platform, spigot rest, etc.) for the next few years. A berm raise is completed ahead of deposition throughout the summer. On average, Henderson raised one cell every two weeks, but this was not a continuous project. The northern-most cell (Cell 9) had been raised prior to the inspection. Mr. Hickman stated the actual tailing raises in 2024 are approximately two feet. Henderson was constructing a leadoff at the northwest end of 1-Dam during the inspection.

Photo 10: Looking south across Cell 9 in 1-Dam. Deposition berm was recently raised here. Henderson was constructing a leadoff at the northwest end of 1-Dam during the inspection (recent disturbance in the foreground).

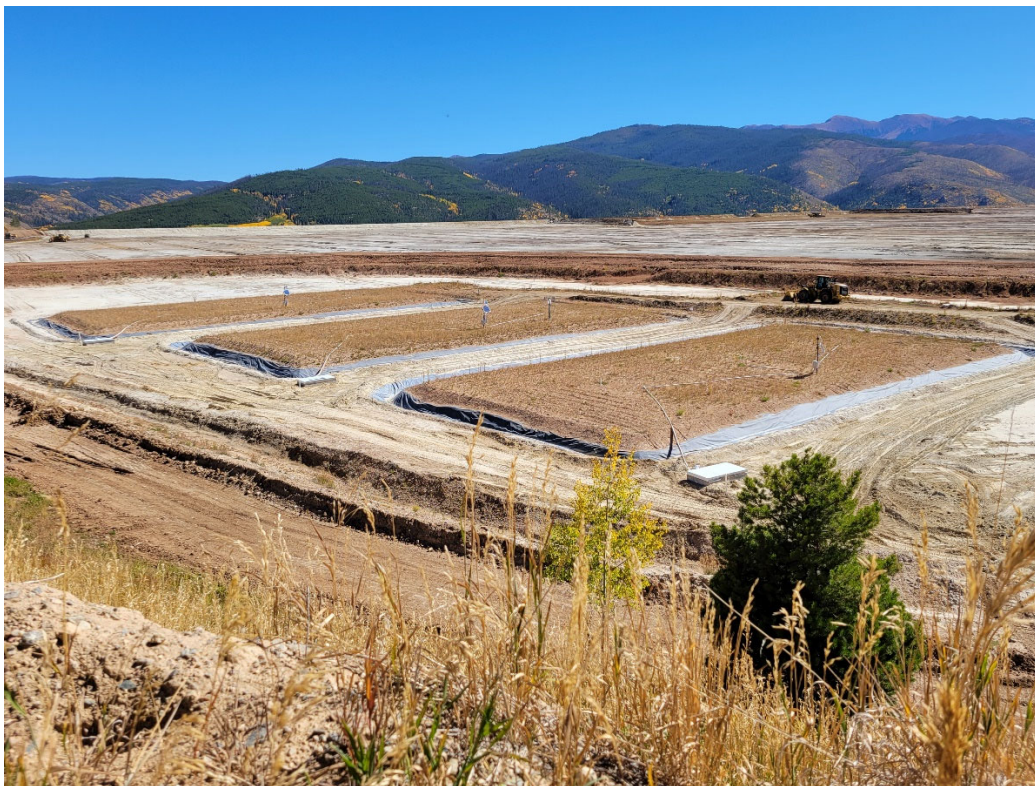
The Division observed vegetation test plots near the north end of the impounded water of the TSF. From afar, the vegetation growth did not appear to be good. Mr. Hamarat indicated that the plots are only in their second year of observation.

Photo 11: Looking southeast at revegetation test plots on the northwest end of 1-Dam.

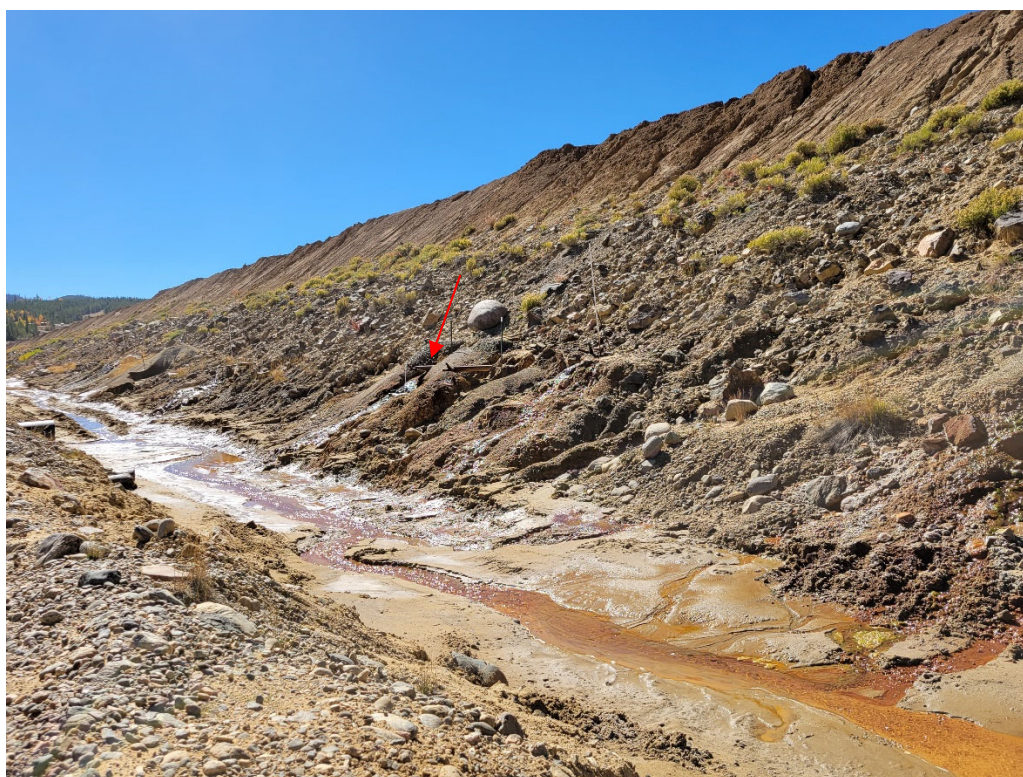
Water in the return pipe for the seepage system was flowing into the TSF during the inspection. Per Henderson representatives, there are 112 horizontal drains, and almost all (105) are at 1 Dam. They all appear to have P traps to prevent air from entering the pipes. Many of the horizontal drains were flowing during the inspection; flow rates varied. Ms. Yenne pointed out the ability to see the phreatic surface by observing the soil near these drains. She also noted that a small number of seeps, in between the horizontal drains, are not problematic. Per Ms. Yenne, horizontal drains are cleaned twice per year.

Photo 12: Looking southwest down the starter dam at the base of 1-Dam. Seep water is collected in channel and drains through culverts to the Ute Park collection area. Water observed discharging from horizontal drain noted by arrow.

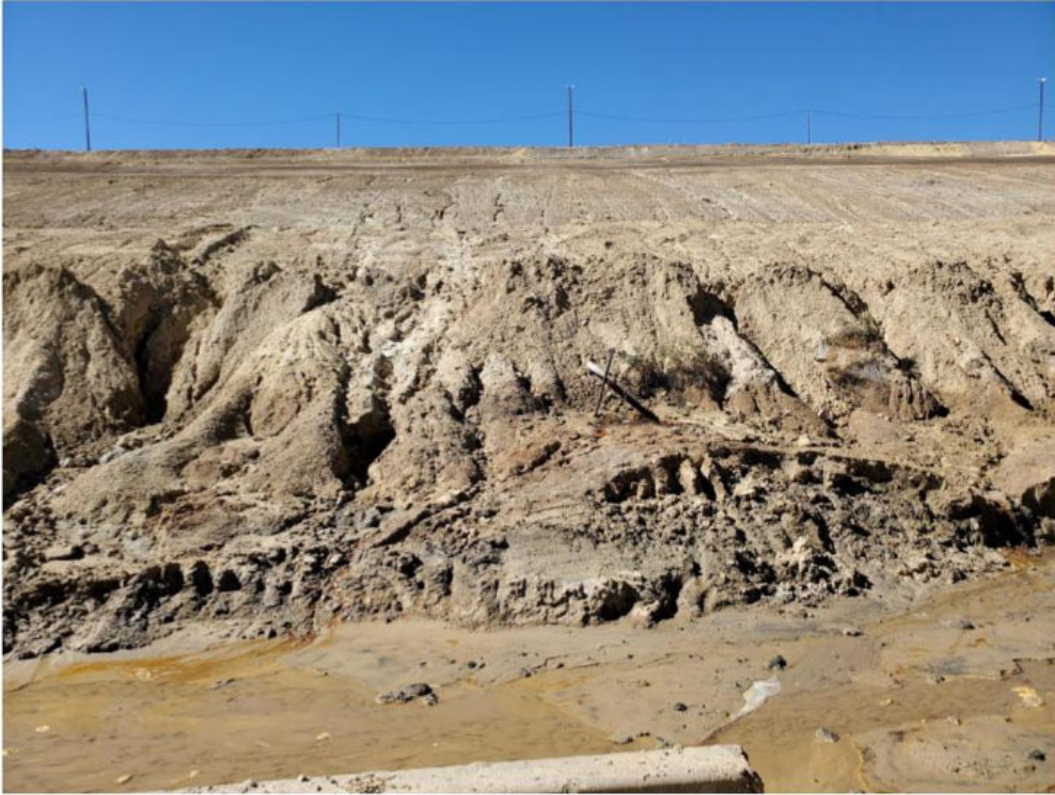
The following aspects of the dams were observed during the inspection: dam crests, downstream faces, toes, abutments, starter dams, and buttress. No settlement, cracking, or signs of movement were observed. No ponds were observed on the crest road. Some rills were observed on the faces of the dams. They did not appear to be more than maintenance issues but should be addressed in the fall of 2024. In particular, erosion on the buttress needs to be addressed soon. Some seepage was observed near the toe of 1-Dam but did not appear to be problematic as the horizontal drains were operating nearby. Also, this seepage has been noted during past inspections by Division inspectors. Mr. Hamarat indicated that they typically conduct erosion control repair work across both dams in the fall.

Photo 13: Looking at erosion rills along the eastern slope of 1-Dam. Attached map indicates location.

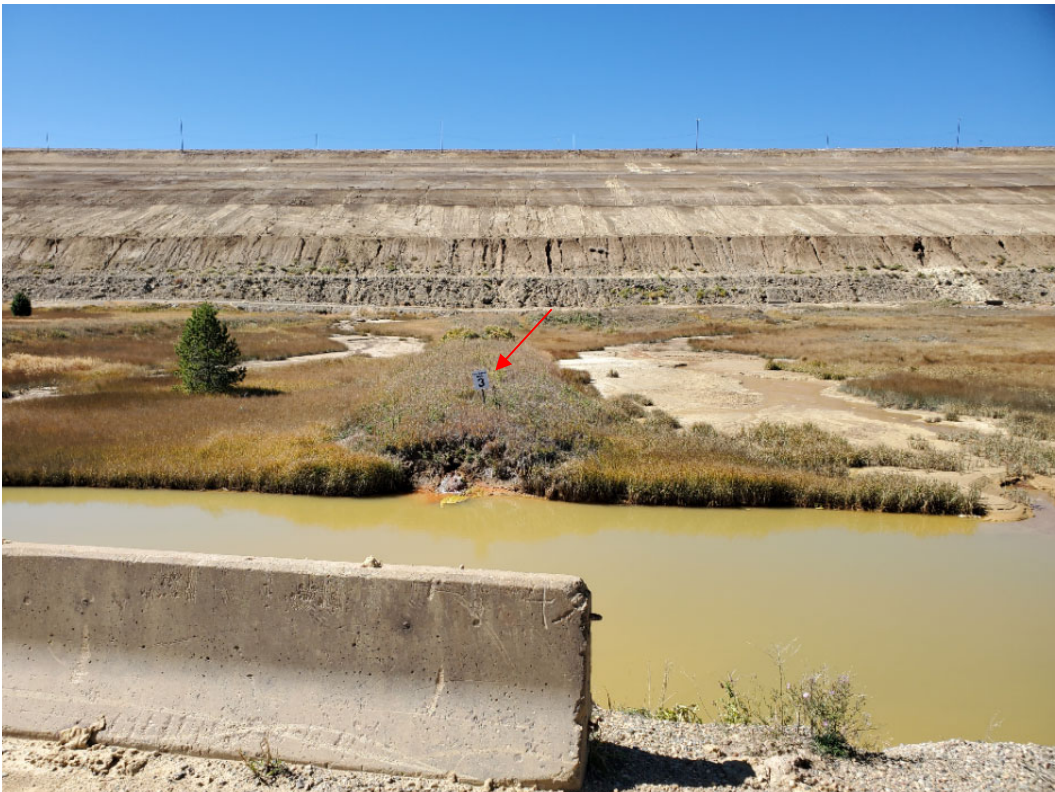
Some of the foundation drains were flowing (e.g., #3) and some were not (e.g., #2). Mr. Hamarat indicated that these drains are not cleaned because they are fragile and nearing the end of their life. A French drain system has been constructed at the south end of 1 Dam where it abuts the natural ground. This structure appeared to be functioning.

Photo 14: Looking at 1-Dam from the Ute Park collection area. Seepage channel in the foreground. Erosion rills observed along the base of the dam. Berm indicated by red arrow is the location of the foundation drain #3 as indicated by sign.

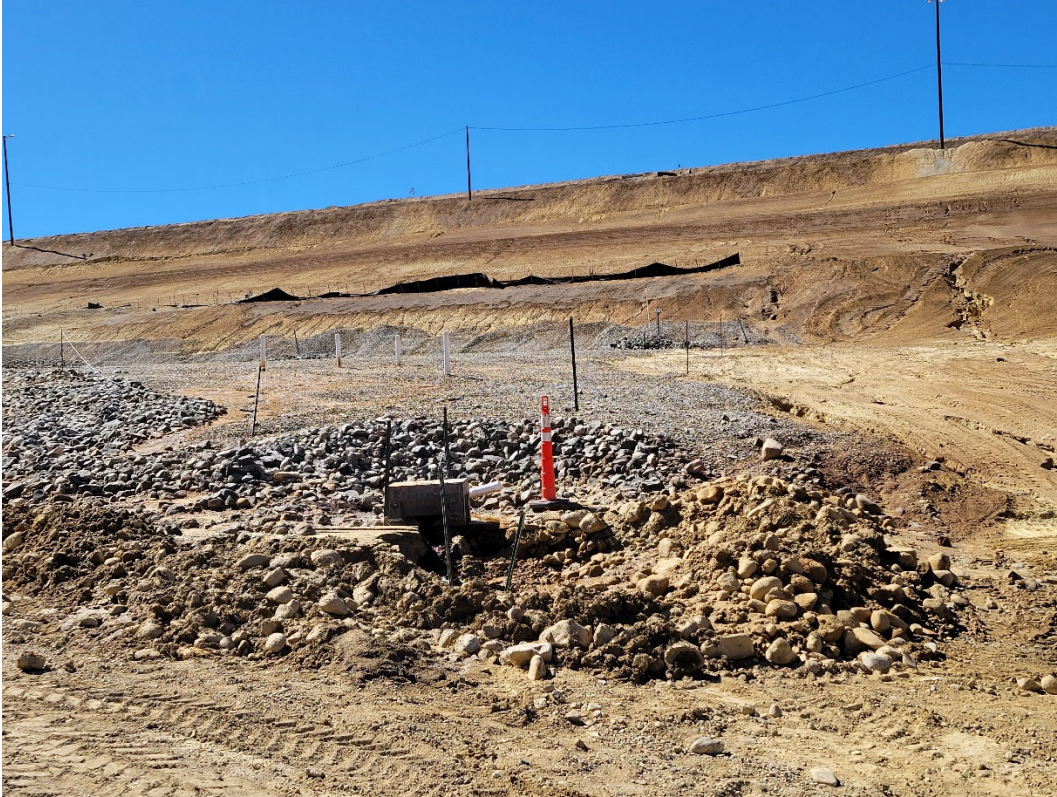
Photo 15: South end of 1-Dam. French drain system recently installed here to minimize erosion where the base of 1-Dam abuts the natural ground.

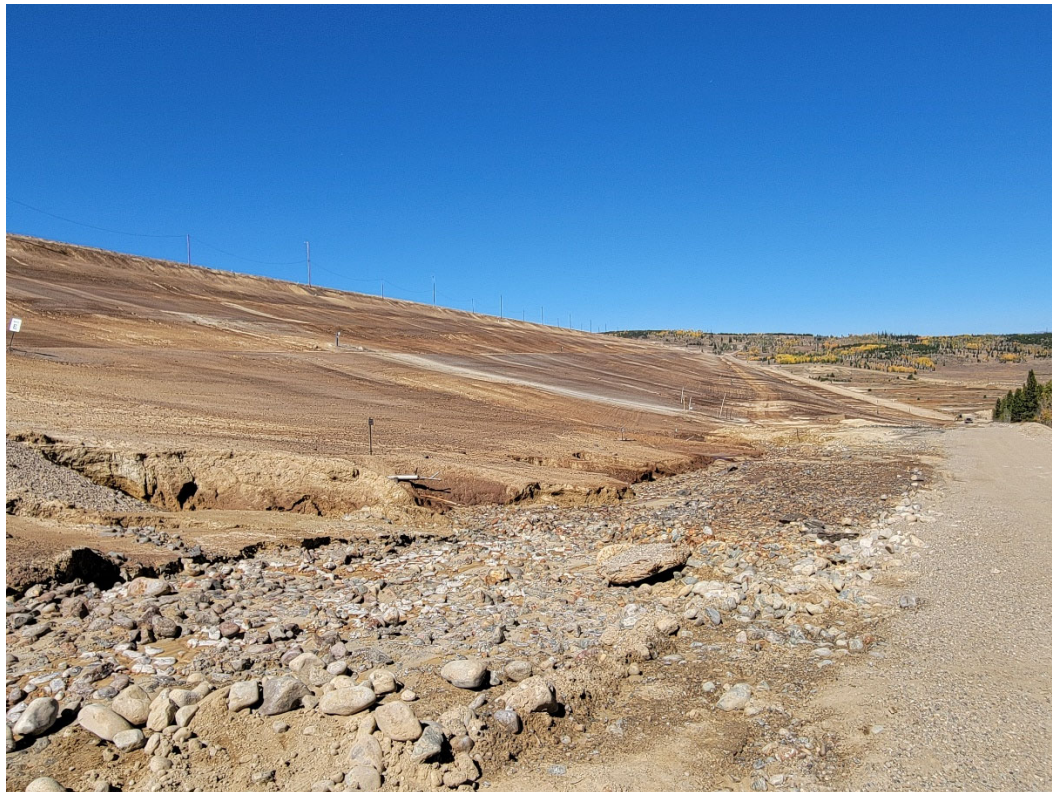
Photo 16: Looking north from the south end of 1-Dam, erosion rills on the dam recently repaired in this area. Erosion at base is being addressed by the installation of the adjacent French drain.

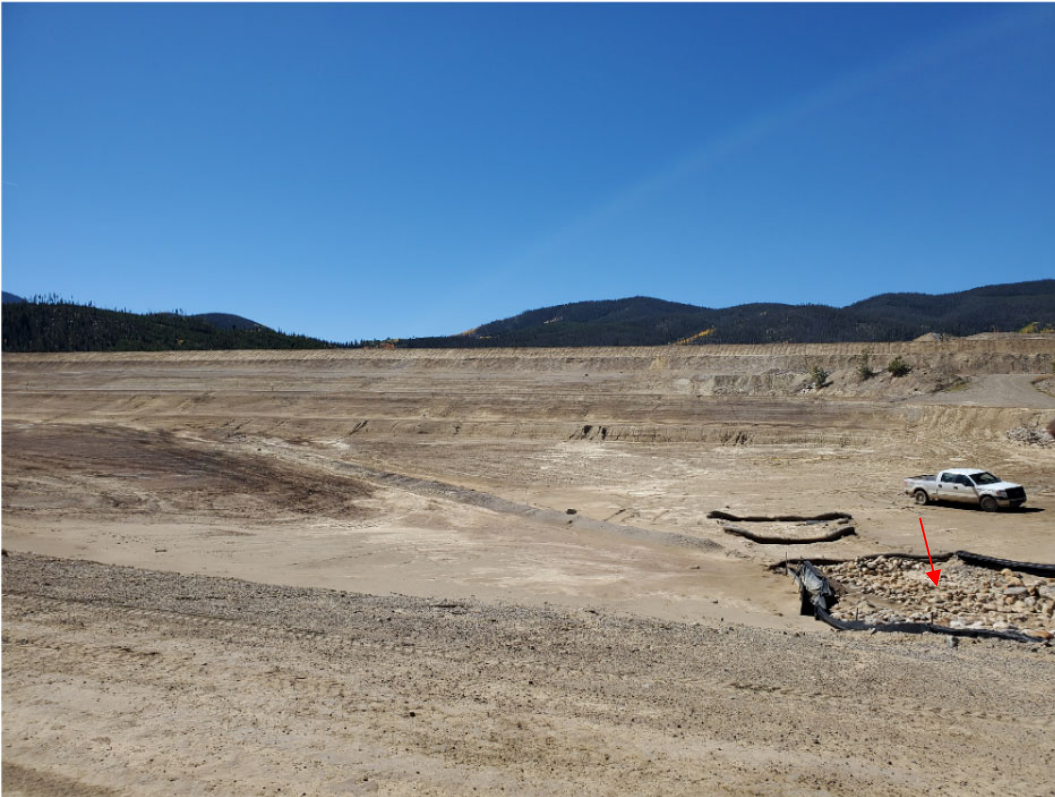
Photo 17: Looking at the east side of 3-Dam. Seepage collection area noted by arrow.

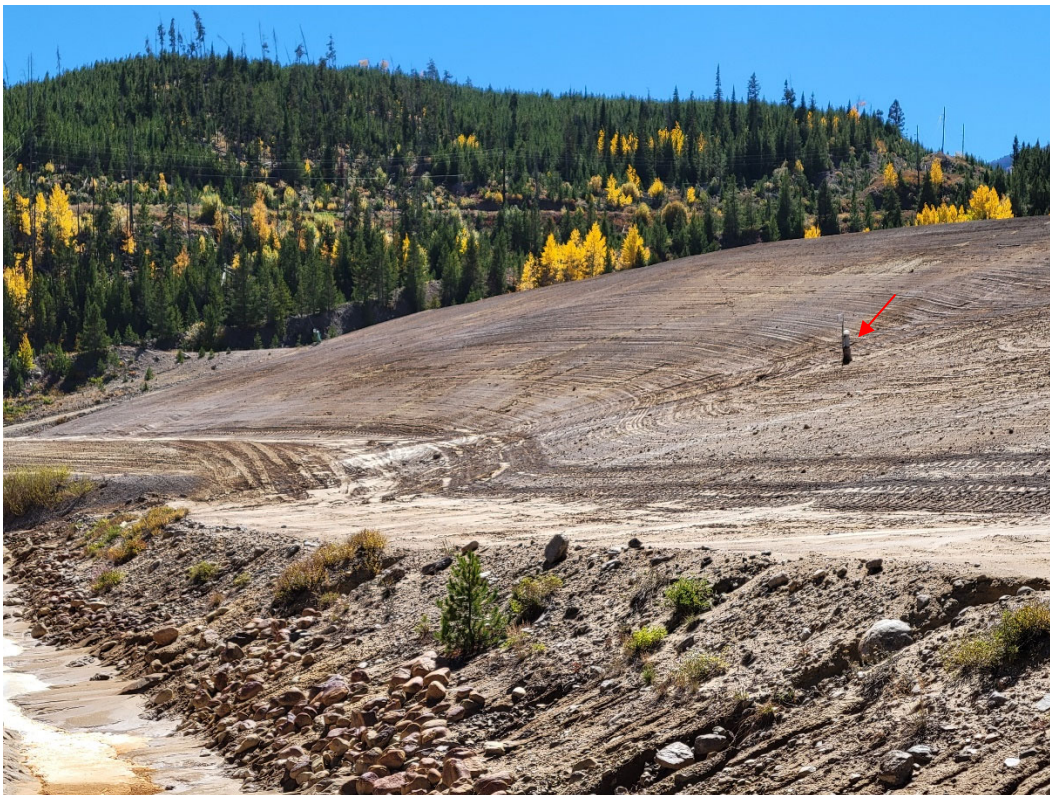
A buttress has been built below the 3-Dam. Henderson and AECOM representatives discussed that this includes a step-back, north toe, and south toe components. These structures were built to provide an extra layer of protection for the TSF.

Photo 18: Looking at area where north buttress is installed below 3-Dam. Monitoring instrumentation noted by red arrow.

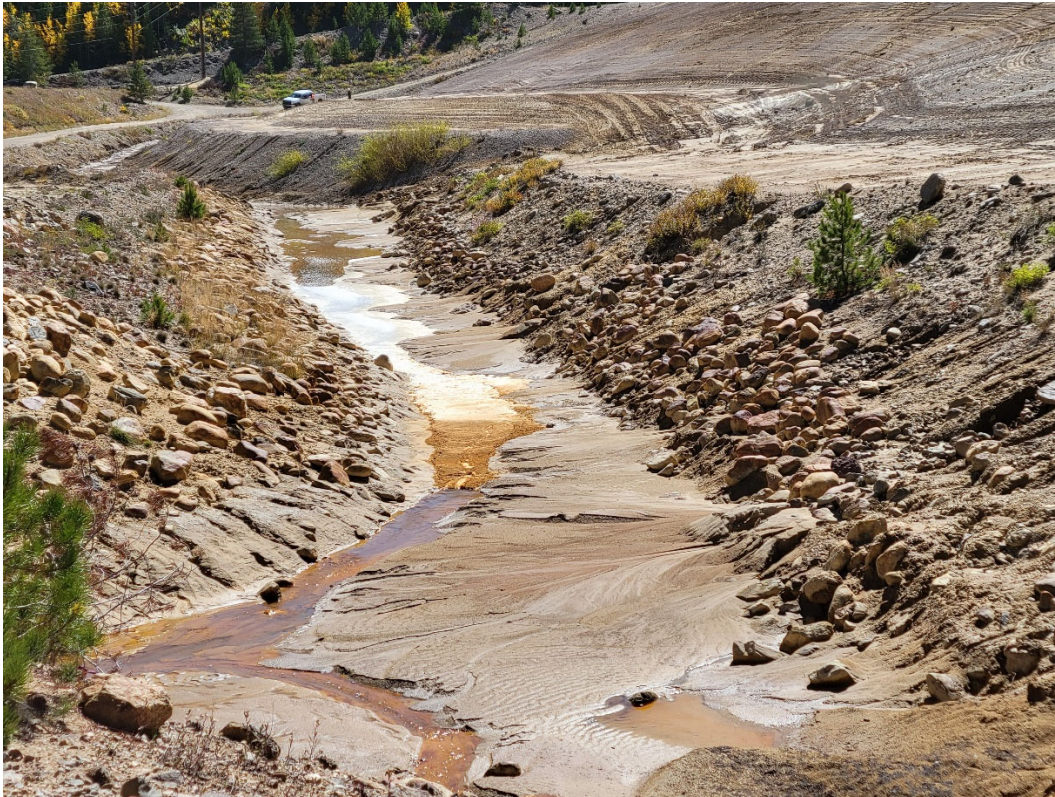
Photo 19: Seepage collection canal below 3-Dam.

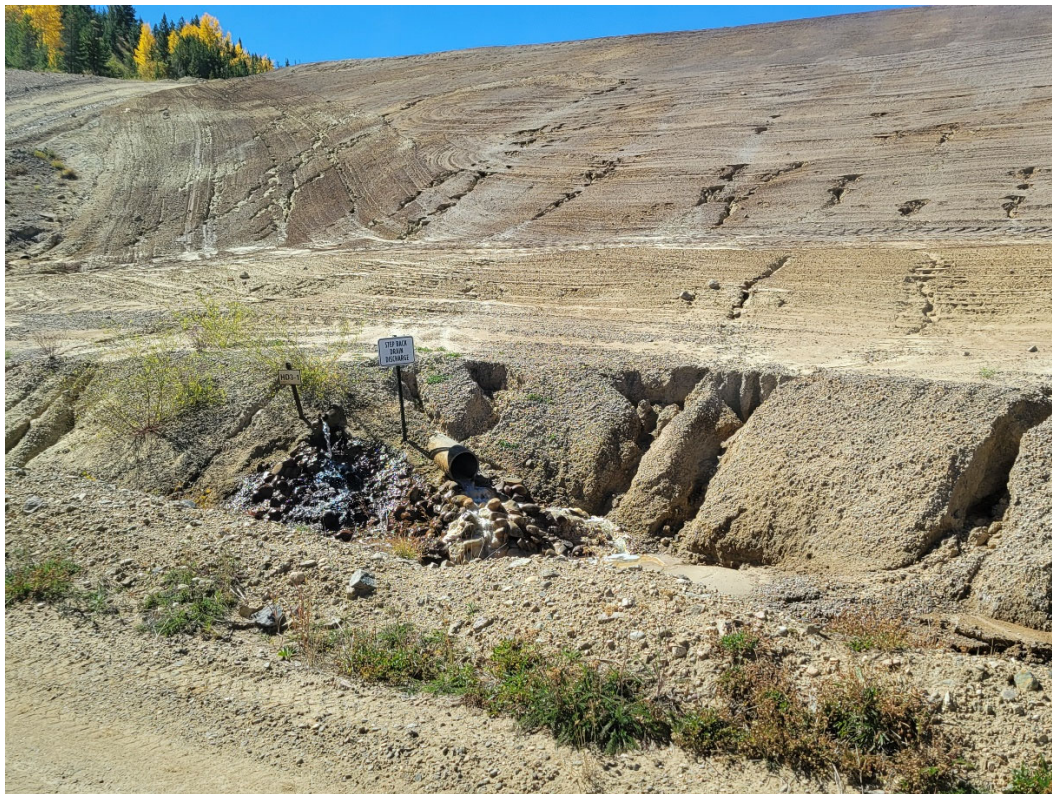
Photo 20: Step back drain discharge below 3-Dam.

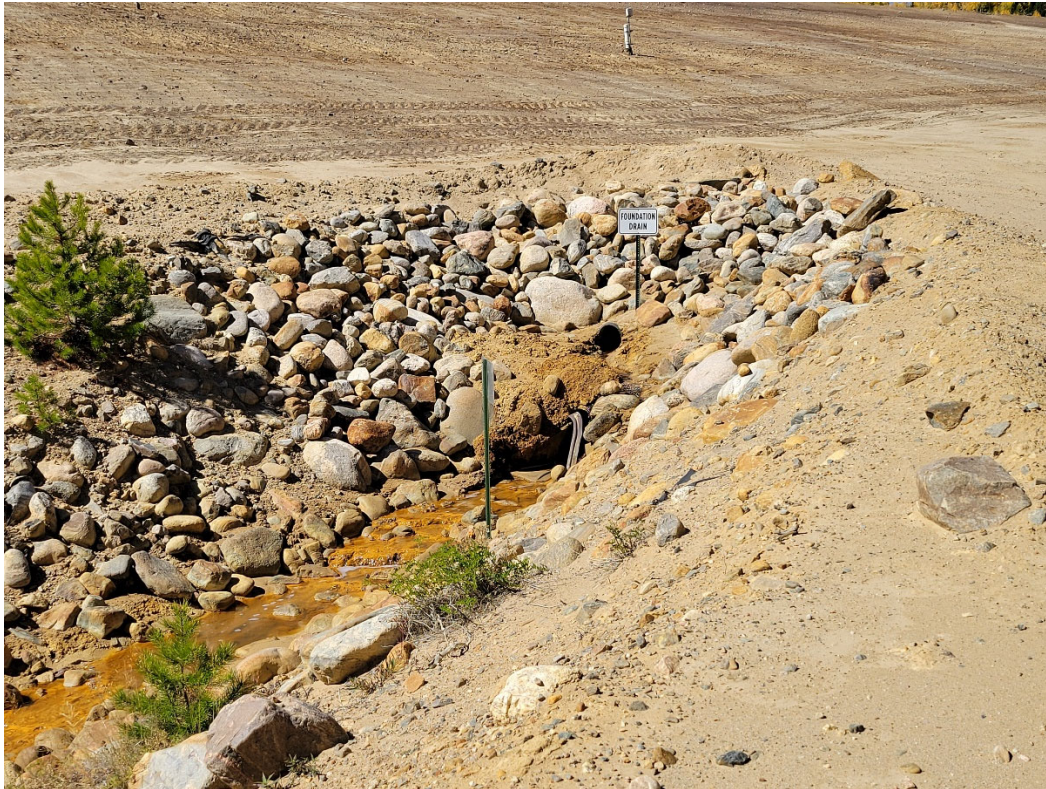
Photo 21: Foundation drain below 3-Dam

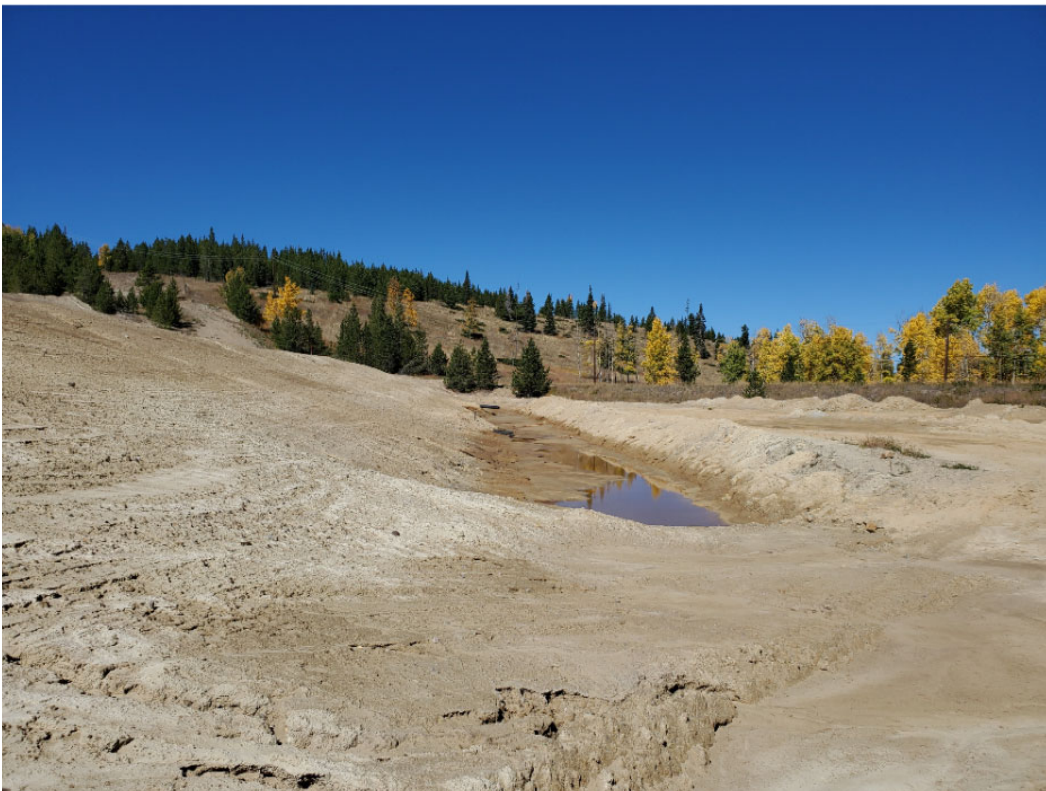
Photo 22: Seepage collection canal on the constructed south buttress below 3-Dam.

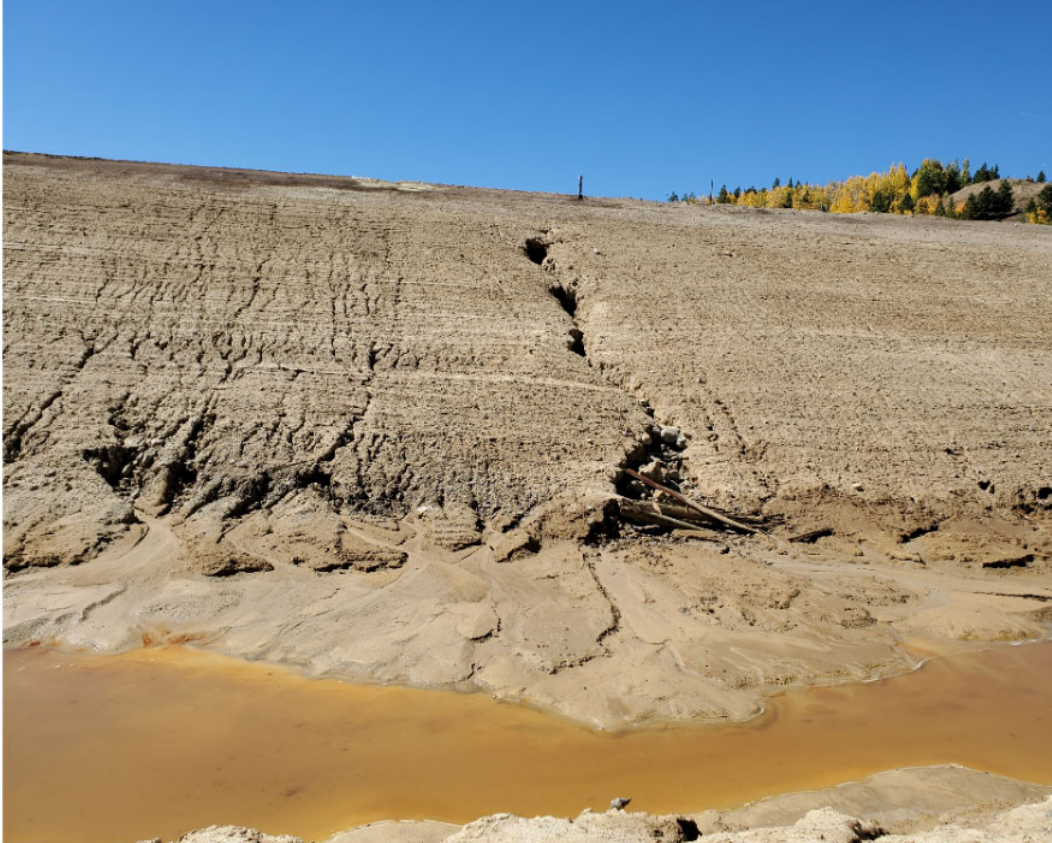
Photo 23: Erosion rill observed on south toe of 3-Dam buttress. Operator indicated the rill will be promptly repaired on the engineered structure.

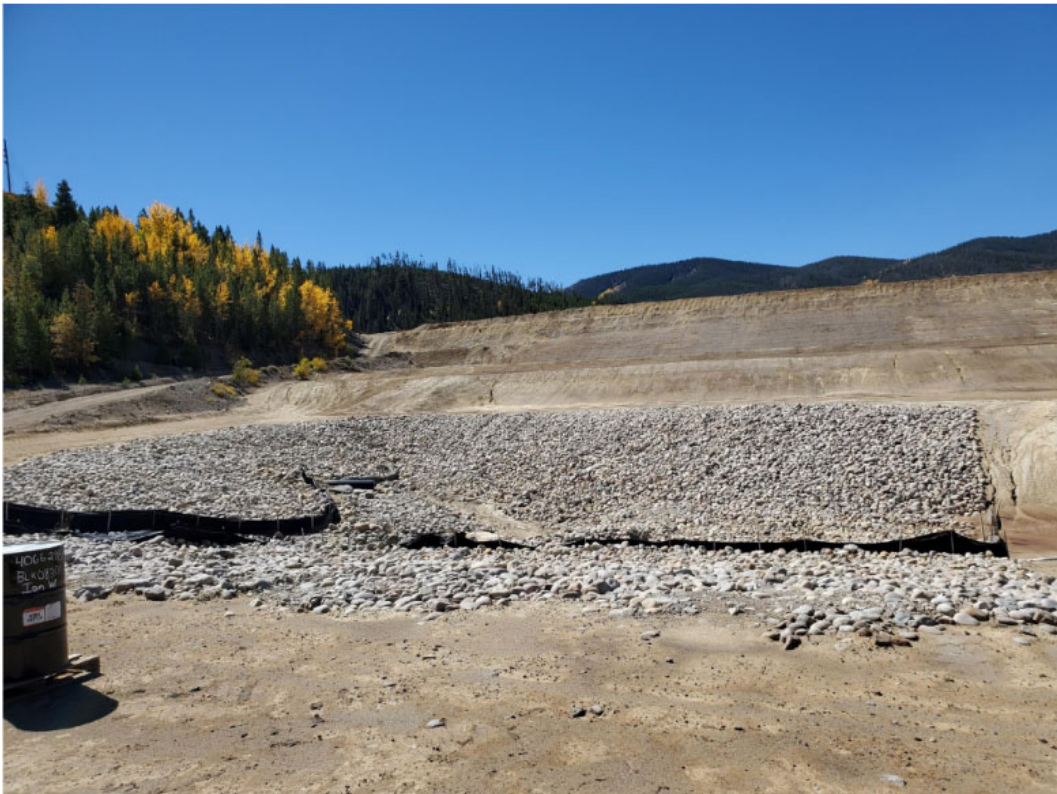
Photo 24: Seepage collection/erosion control area below 3-Dam (north side). Attached map indicates location.
