MINERALS PROGRAM INSPECTION REPORT
PHONE: (303) 866-3567

MINE NAME: Bokelman-Walters	MINE/PROSPECTING ID#: M-2006-080	MINERAL: Sand and gravel	COUNTY: Larimer
INSPECTION TYPE: Monitoring	WEATHER: Clear	INSP. DATE: September 24, 2024	INSP. TIME: 12:30
OPERATOR: Loveland Ready-Mix Concrete, Inc.	OPERATOR REPRESENTATIVE: Stephanie Fancher-English	TYPE OF OPERATION: 112c - Construction Regular Operation	
REASON FOR INSPECTION: Normal I&E Program	BOND CALCULATION TYPE: Complete Bond	BOND AMOUNT: \$644,075.00	
DATE OF COMPLAINT: NA	POST INSP. CONTACTS: None	JOINT INSP. AGENCY: None	
INSPECTOR(S): Joel Renfro	INSPECTOR'S SIGNATURE:

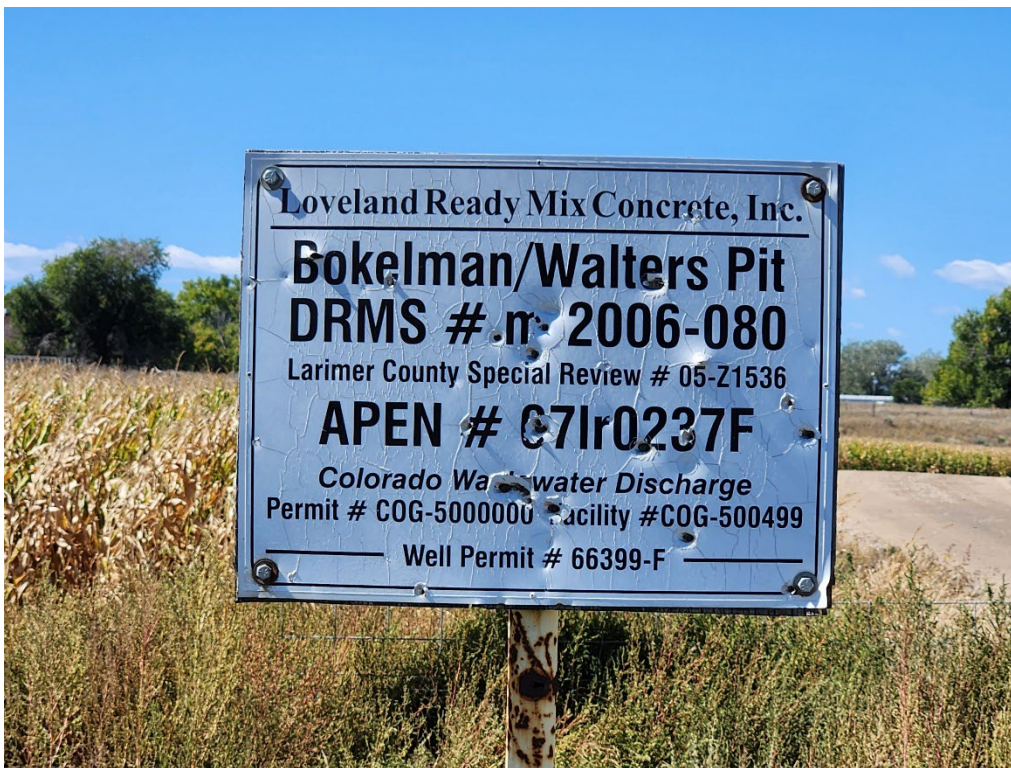
At the time of inspection, the mine entrance sign appeared to not be in compliance with Rule 3.1.12. This was discussed at the end of the inspection and the operator has since replaced the mine entrance sign. An image of the new sign is attached to this report. Since this was resolved prior to the report being sent, it is not cited as a problem.

Photo 1. Mine entrance sign, looking east. Sign has been replaced since the inspection.

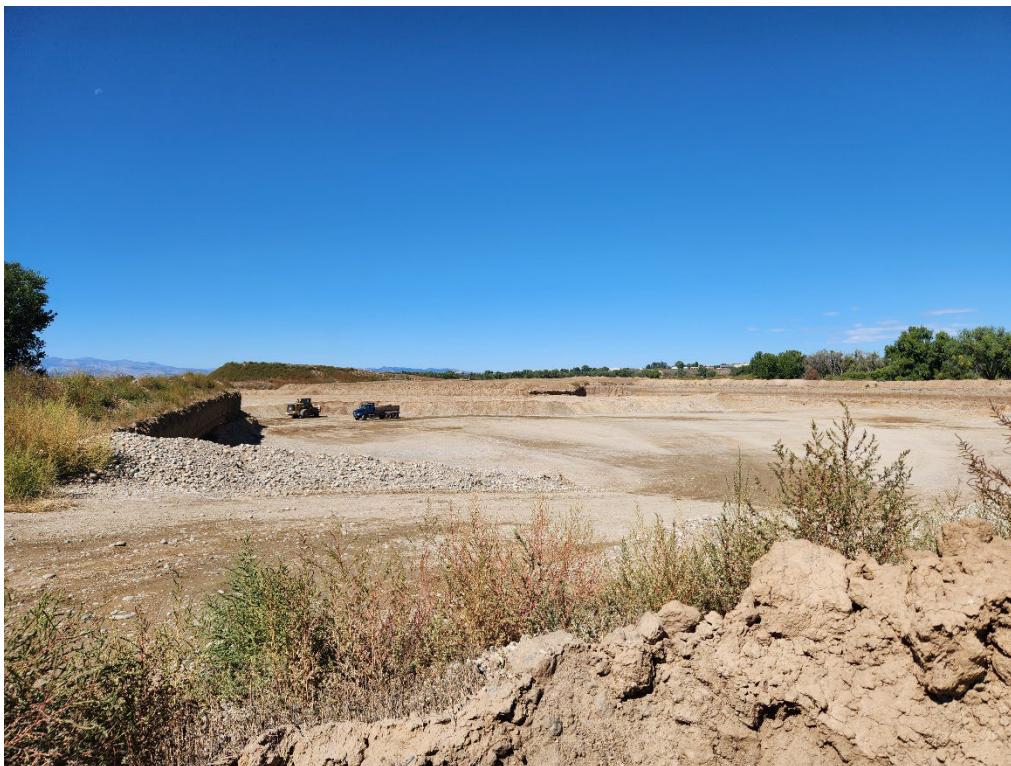
Photo 2. The most recent pit disturbance in Cell 3, looking west.

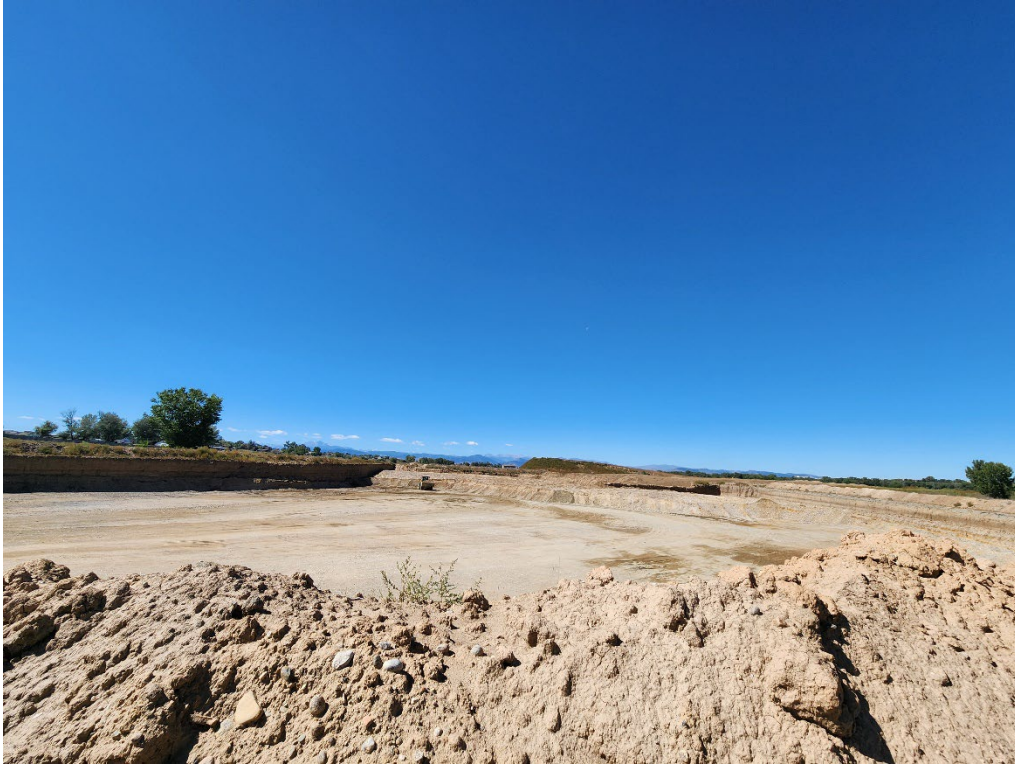
Photo 3. Cell 3, surface is stripped away, looking southwest.

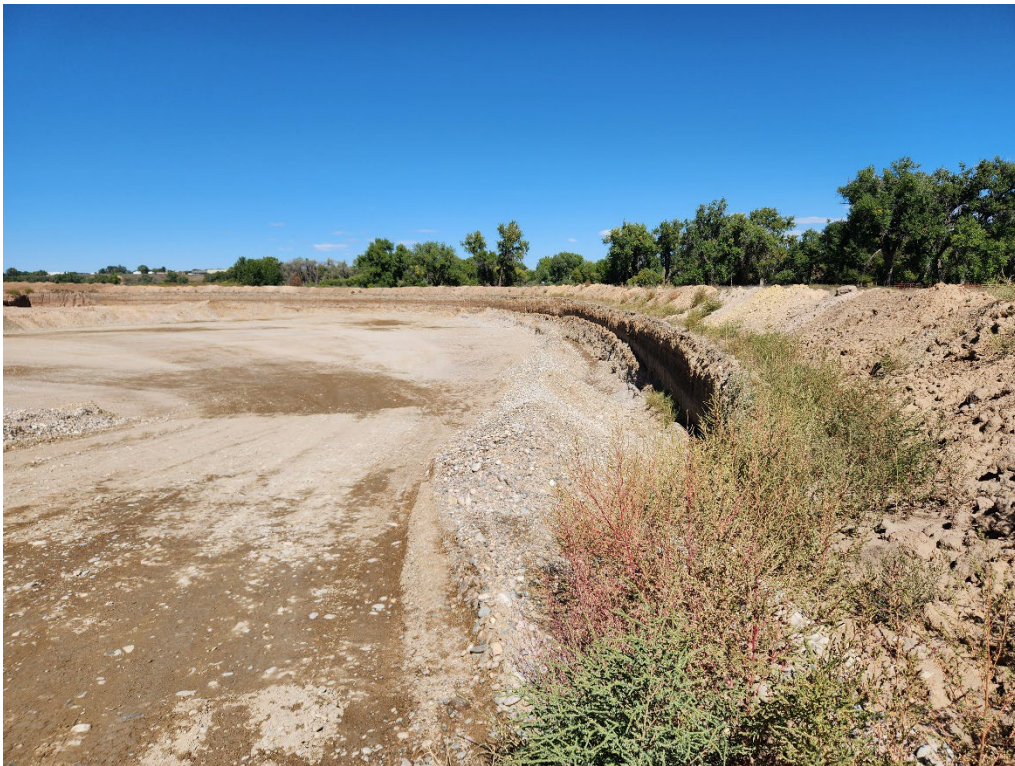
Photo 4. Cell 3 high wall, looking north.

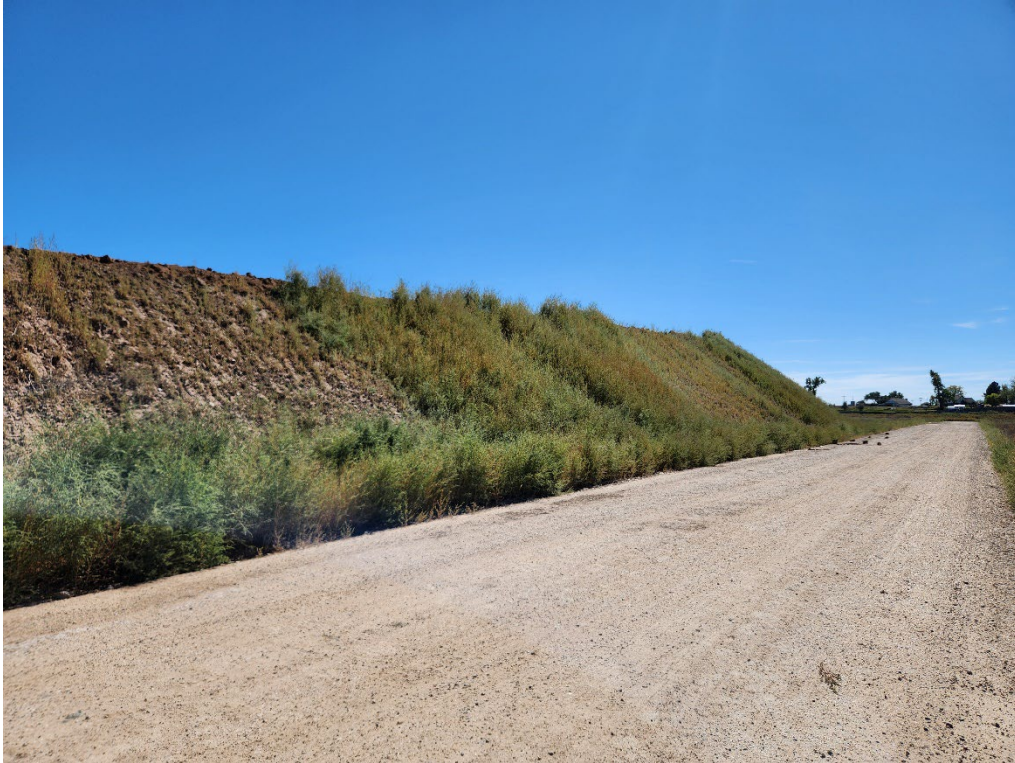
Photo 5. Overburden stockpiles, looking south.

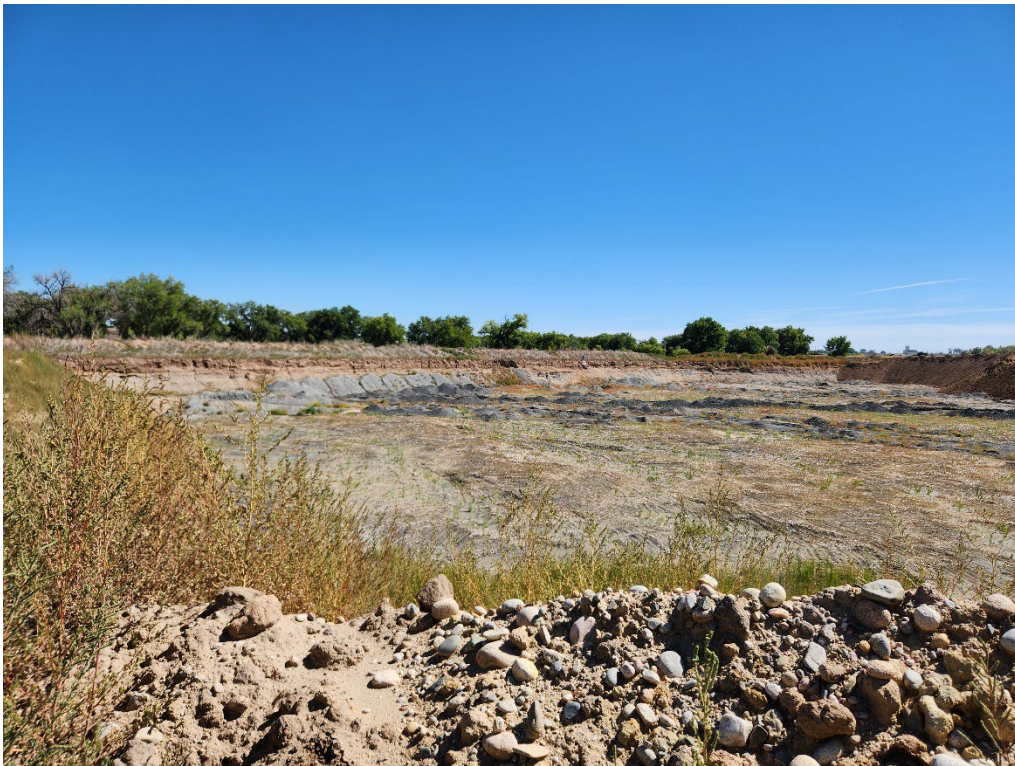
Photo 6. Cell 4 disturbance, looking east.

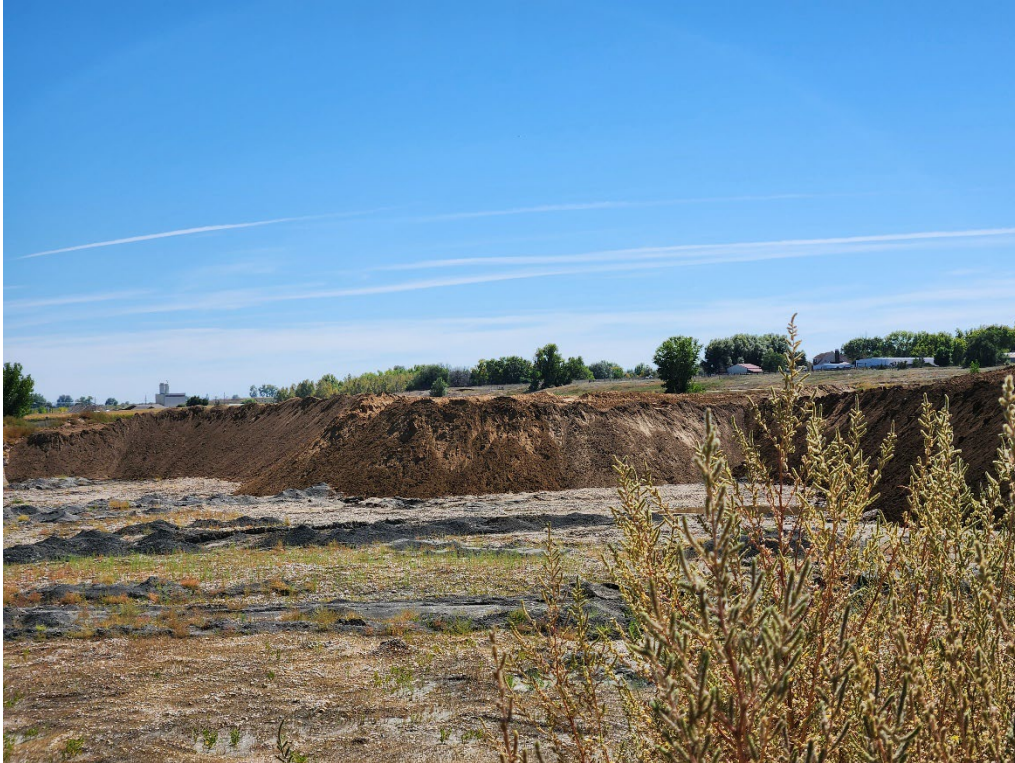
Photo 7. Cell 4 high wall, looking east.

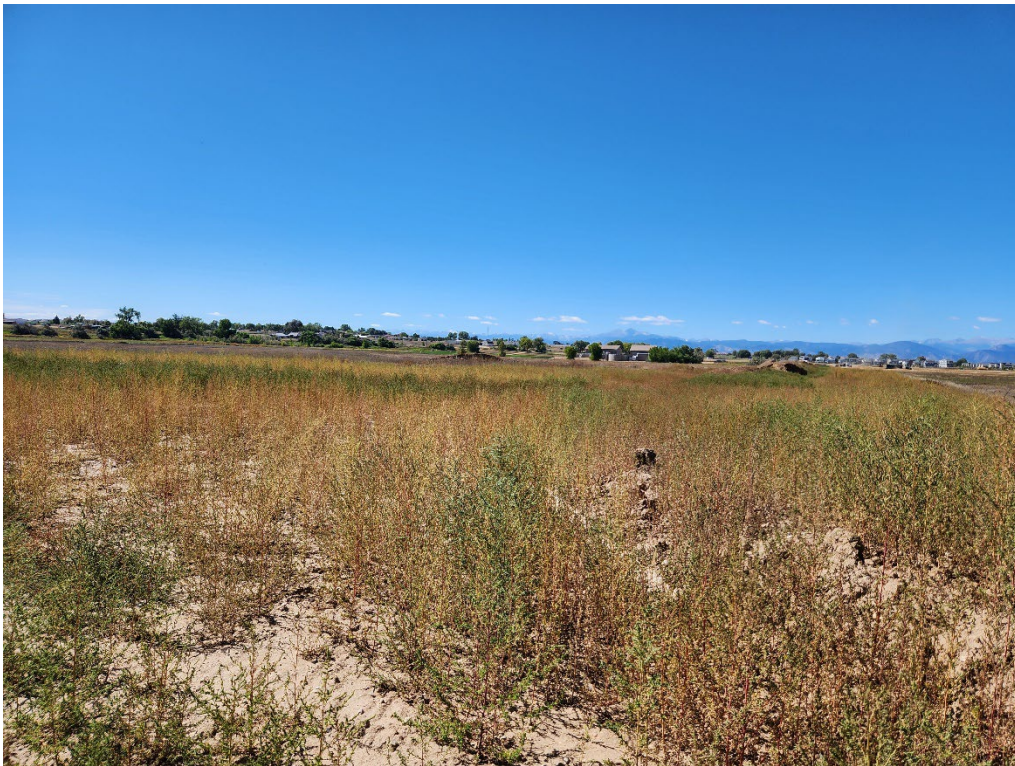
Photo 8. Cell 1 reclamation, looking west.

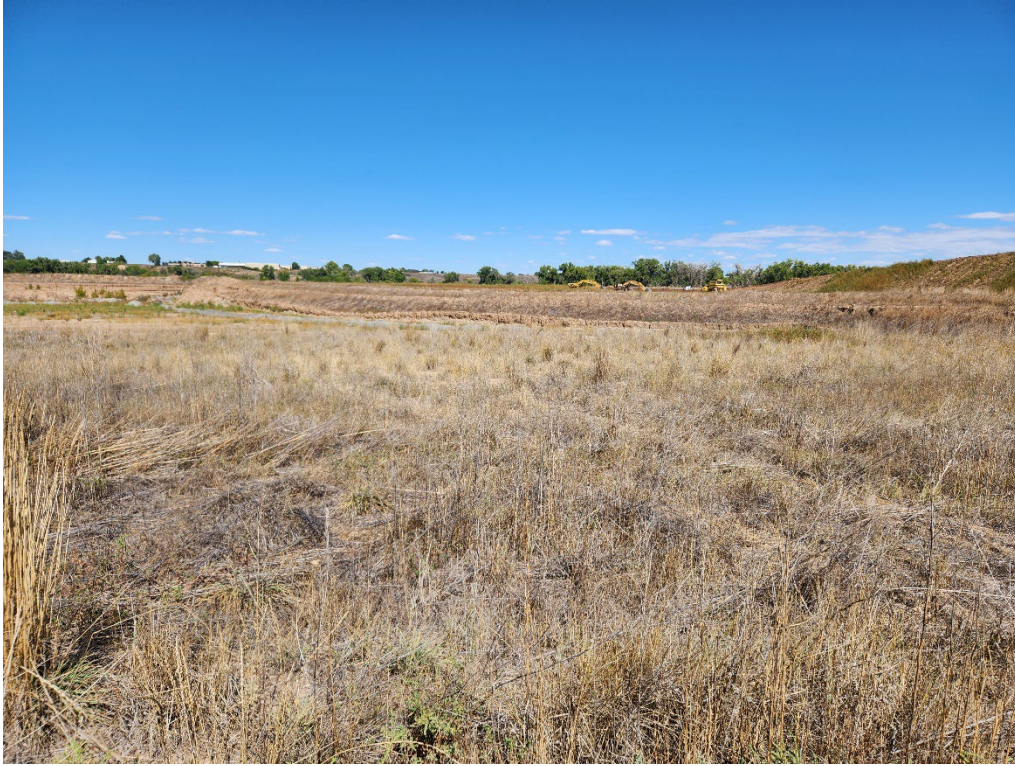
Reclamation around Cell 2 was observed. Most of Cell 2 has been graded and re-seeded, with some of the pit floor still needing grass seed and some of the high walls needing to be graded and seeded as well. Reclamation in the south of the pit looks successful with a dense and diverse make-up of native grasses. Some of the newer reclamation east of Pit 2 is showing typical signs of new reclamation being dominant with nuisance annual plants such as Kochia. All around though, no noxious weeds were observed at the time of inspection and it appears that the operator is following their reclamation and weed management plan.

Photo 9. Cell 2 reclamation, looking north.

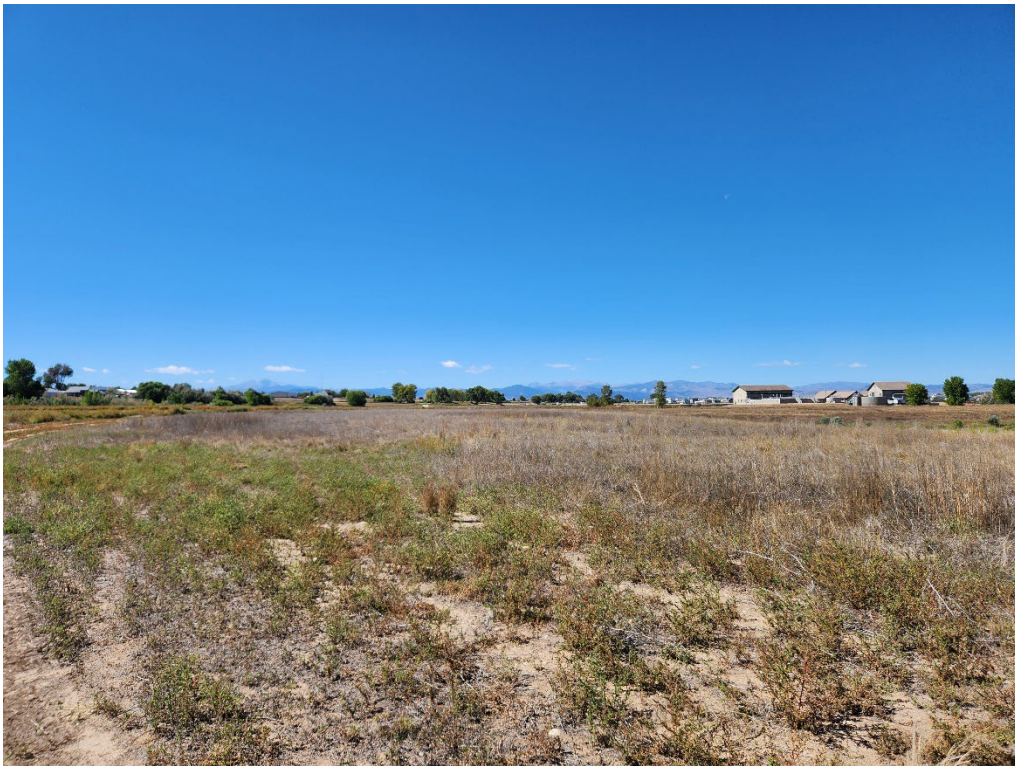
Photo 10. Cell 2 reclamation, looking west.

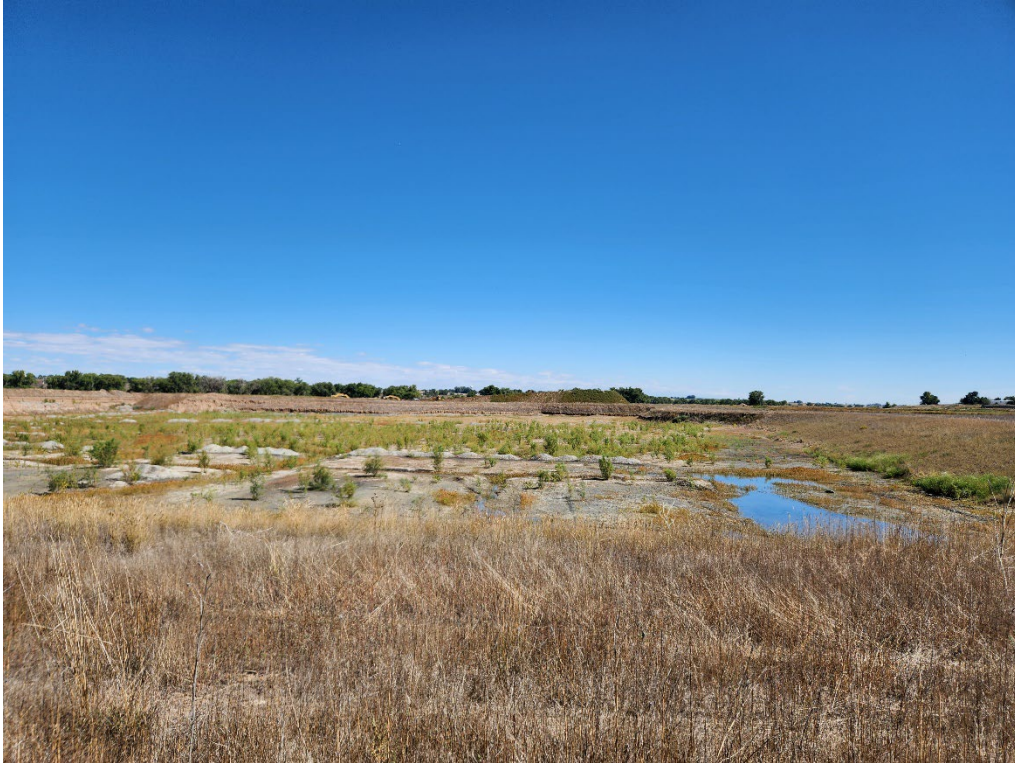
Photo 11. Cell 2, looking north.

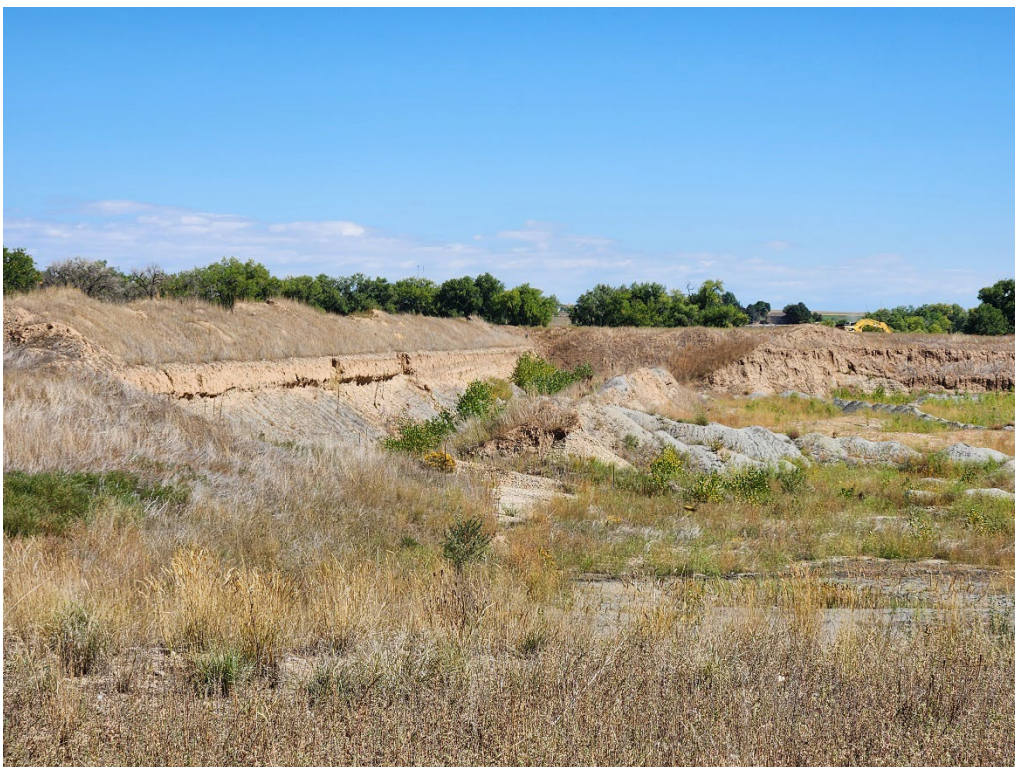
Photo 12. Mining disturbance in the north east.
