MINERALS PROGRAM INSPECTION REPORT
PHONE: (303) 866-3567

MINE NAME: Cross Gold Mine	MINE/PROSPECTING ID#: M-1977-410	MINERAL: Gold, copper, silver, zinc and lead	COUNTY: Boulder
INSPECTION TYPE: Monitoring	WEATHER: Clear	INSP. DATE: November 15, 2024	INSP. TIME: 09:00
OPERATOR: Grand Island Resources LLC	OPERATOR REPRESENTATIVE: Richard Mittasch	TYPE OF OPERATION: 110(2) - Hard Rock Limited Impact	
REASON FOR INSPECTION: Priority	BOND CALCULATION TYPE: None	BOND AMOUNT: \$546,751.00	
DATE OF COMPLAINT: NA	POST INSP. CONTACTS: None	JOINT INSP. AGENCY: None	
INSPECTOR(S): Patrick Lennberg	INSPECTOR'S SIGNATURE:

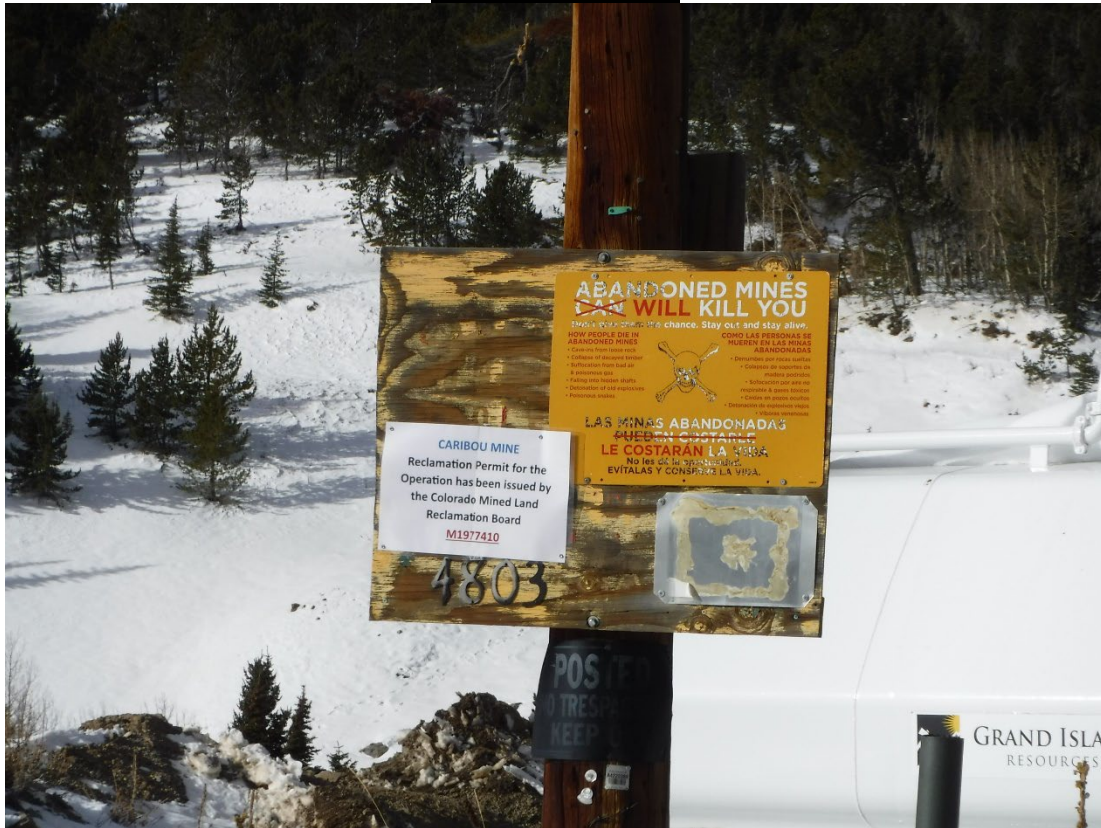
Photo 1: Mine sign at the primary mine entrance

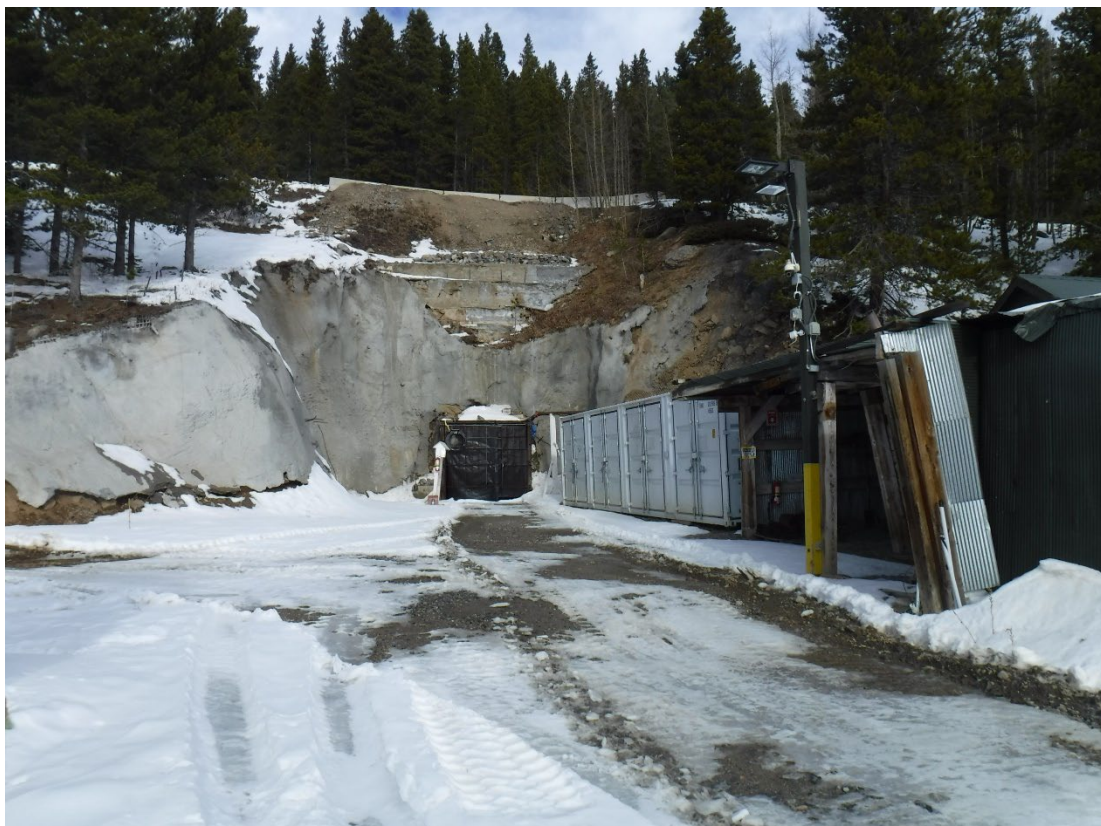
Photo 2: The Idaho Tunnel at the Caribou Mine

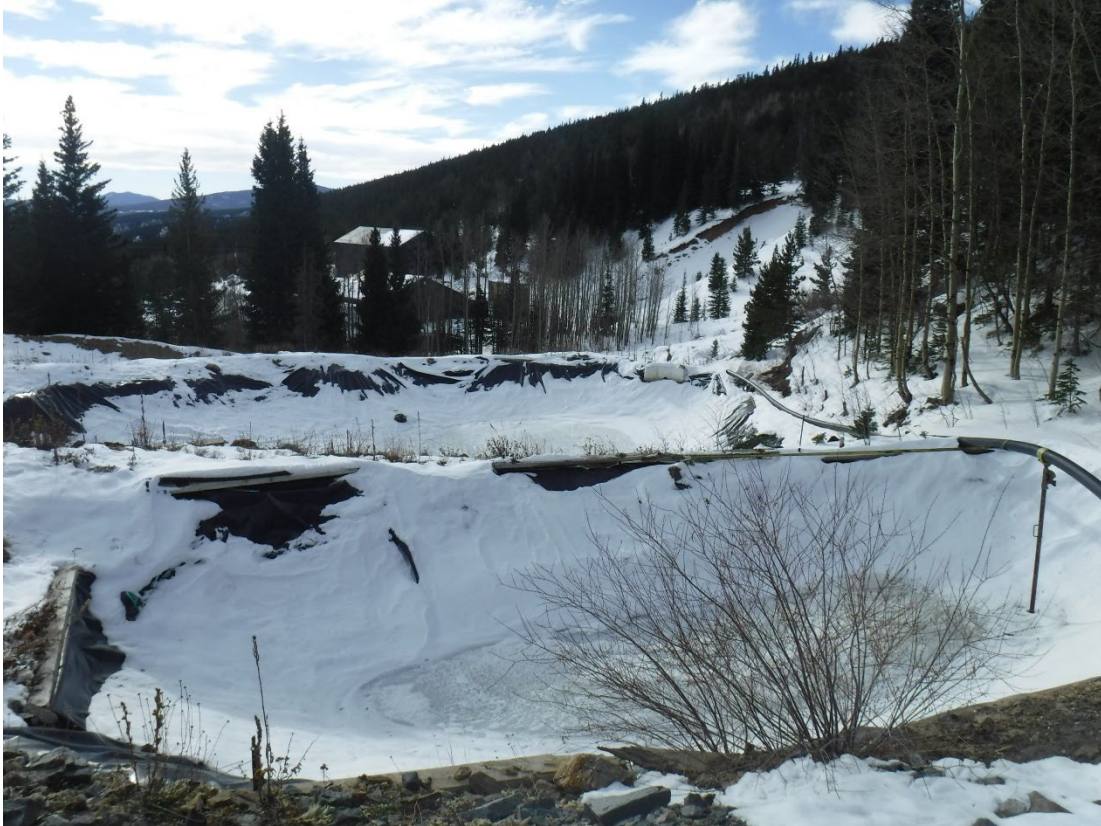
Currently, the Operator is diverting the Idaho Tunnel effluent into a pipeline that bypasses the series 3 Ponds and discharges to Pond 1. The water can be directed from Pond 1 to Joliet Raise for storage prior to being treated and released. The 3 series Ponds, 3a, 3b and 3c, were observed during this inspection. The ponds are retaining snow and melt water and have not been cleaned out. The Division has stated the 3 series Ponds could be abandoned through a Technical Revision that provided the details on the proper disposal of the sediment, as determined through chemical analysis, and the remaining geomembrane. Once the revision was approved the Operator could proceed.

Photo 3: Ponds 3b and 3c

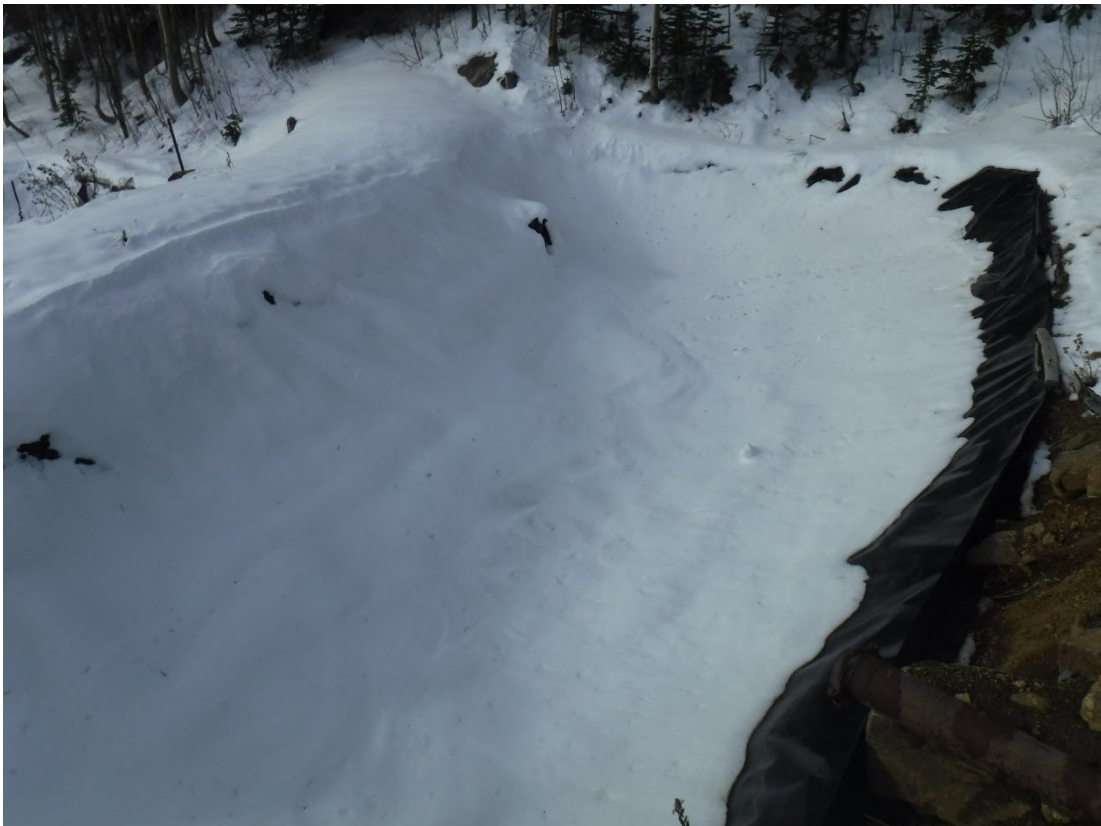
Photo 4: Pond 3a

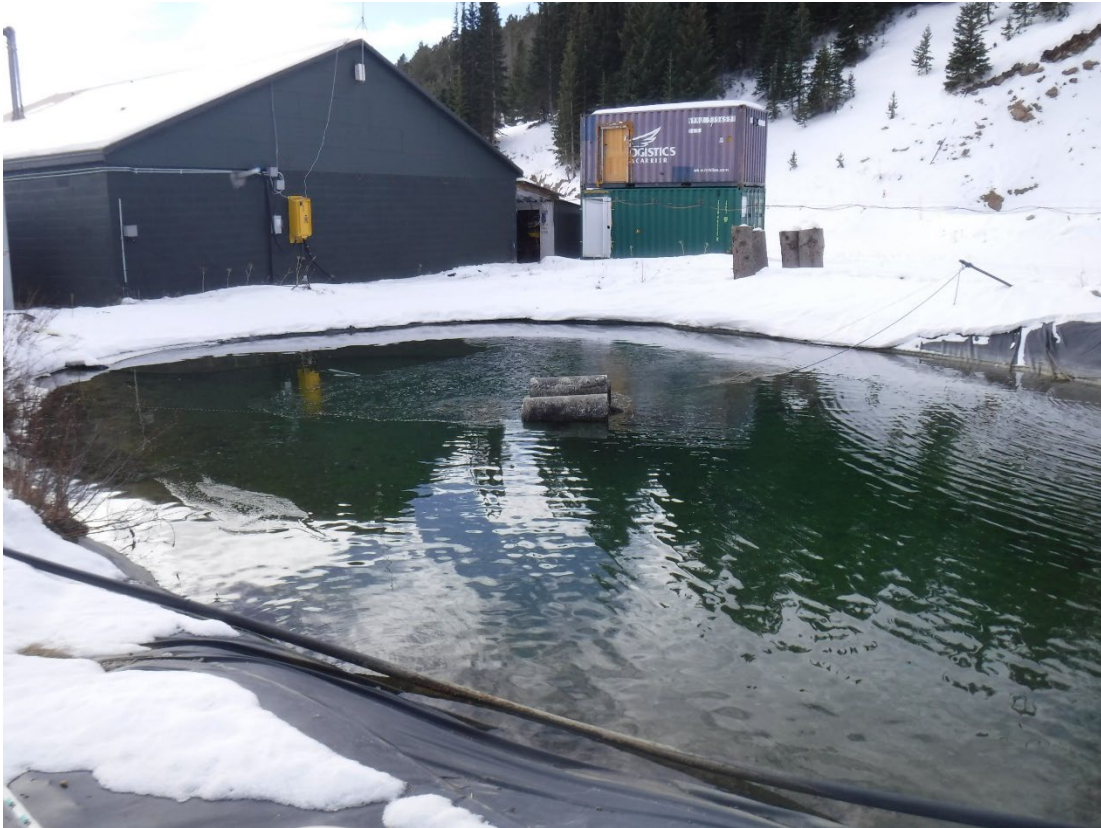
Photo 5: Pond 1

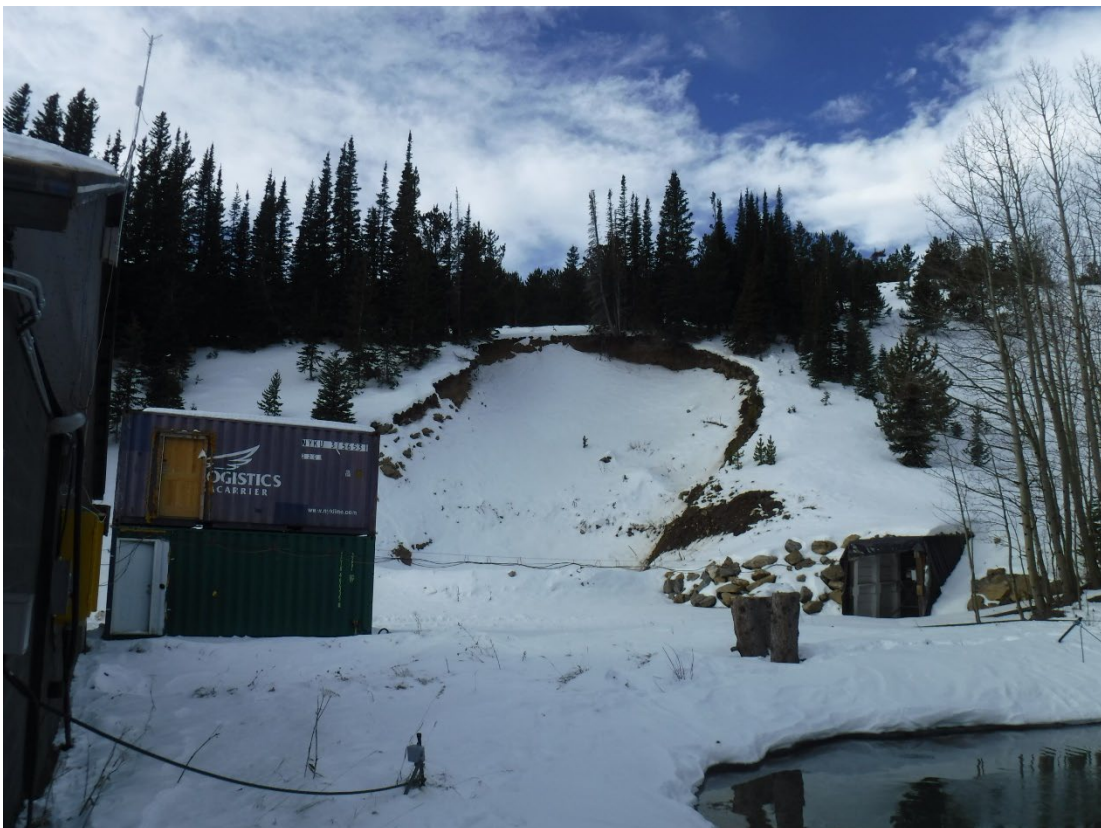
Photo 6: Looking at the area where the snow shed and water treatment plant are to be located

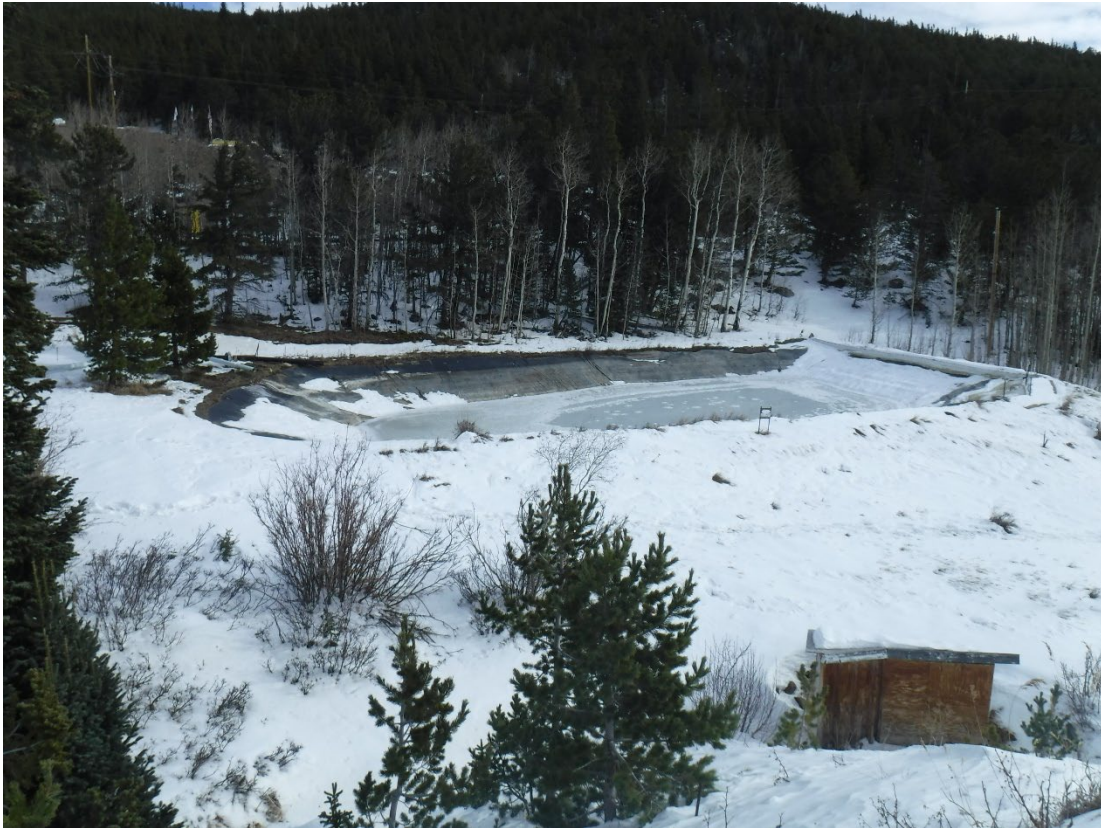
Photo 7: Pond 2

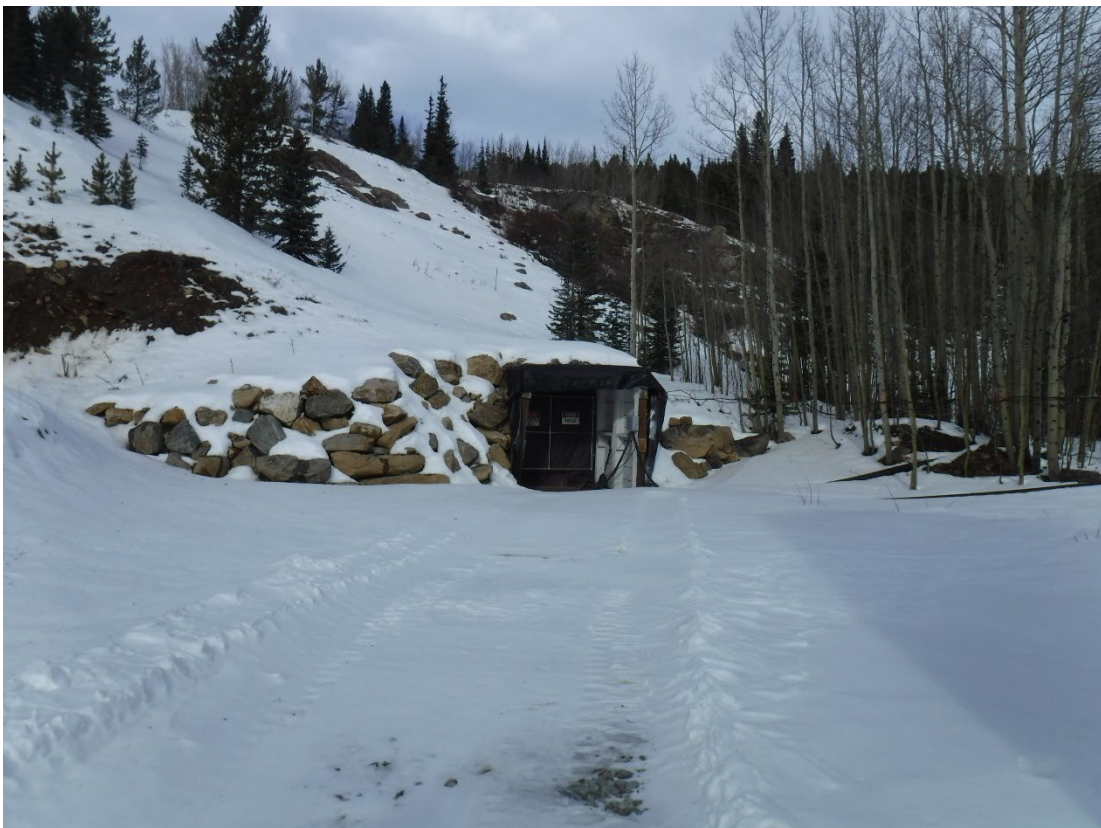
Photo 8: Cross Tunnel at the Cross Mine

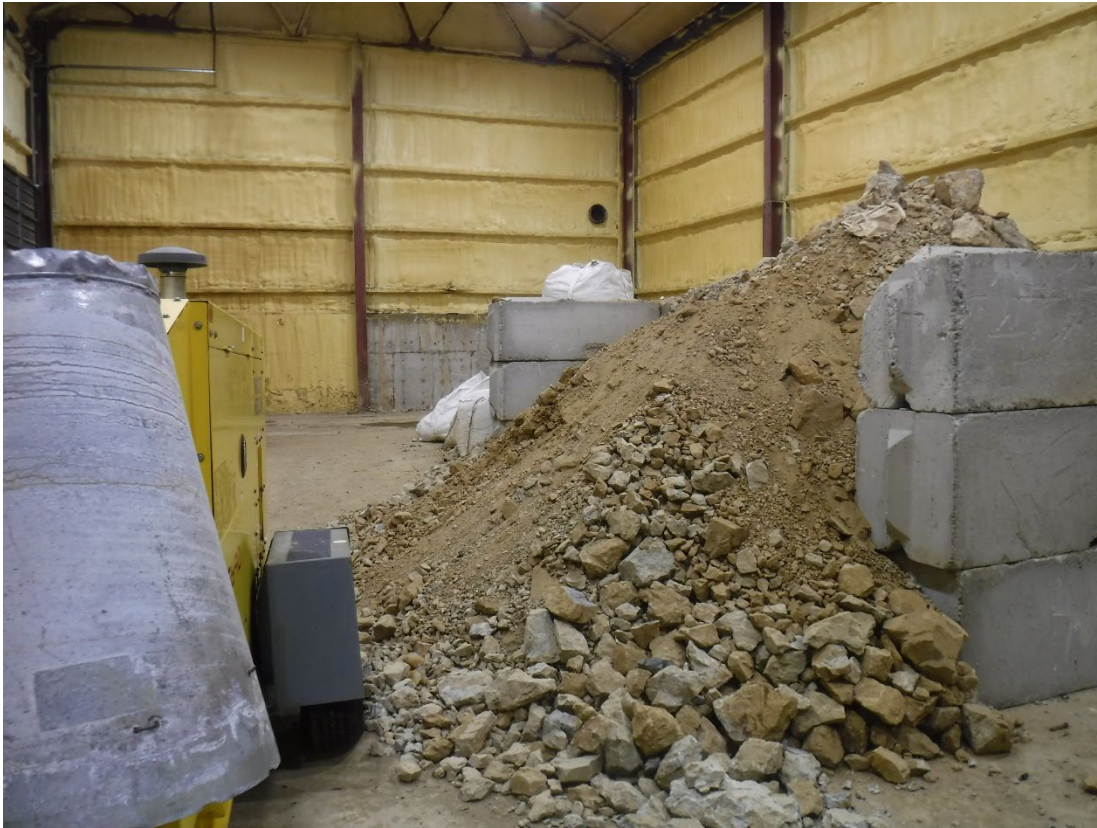
Mr. Mittasch stated that they were going to ship stockpiled ore to the Sooner Lucky Strike Mill (M1982-020) for processing. They want to generate tailings material (~50 tons) that then can be used by laboratories to evaluate possible mixing ratios to create a paste backfill that may be used in future operations at the site. The Division stated that the Sooner Lucky Strike Mill may not be able to take and process the material as permitting for that site does not allow for Cross Gold material to be imported and processed. Please be aware that as a condition of the approved permit for the Sooner Lucky Strike Mill they must notify the Division prior to receiving ore. The notification will contain information on the source of the ore and the results of geochemical testing to demonstrate that said ore may be processed at the Mill. Mr. Mittasch stated that he was informing the Division, during this inspection, of their intent of shipping material to the Lucky Strike Mill. The Division will require written notification, including the quantity of material, prior to ore material leaving the site along with a demonstration that the Operator of the Sooner Lucky Strike Mill has provided the appropriate notification to the Division.

Photo 9: Ore material in the warehouse

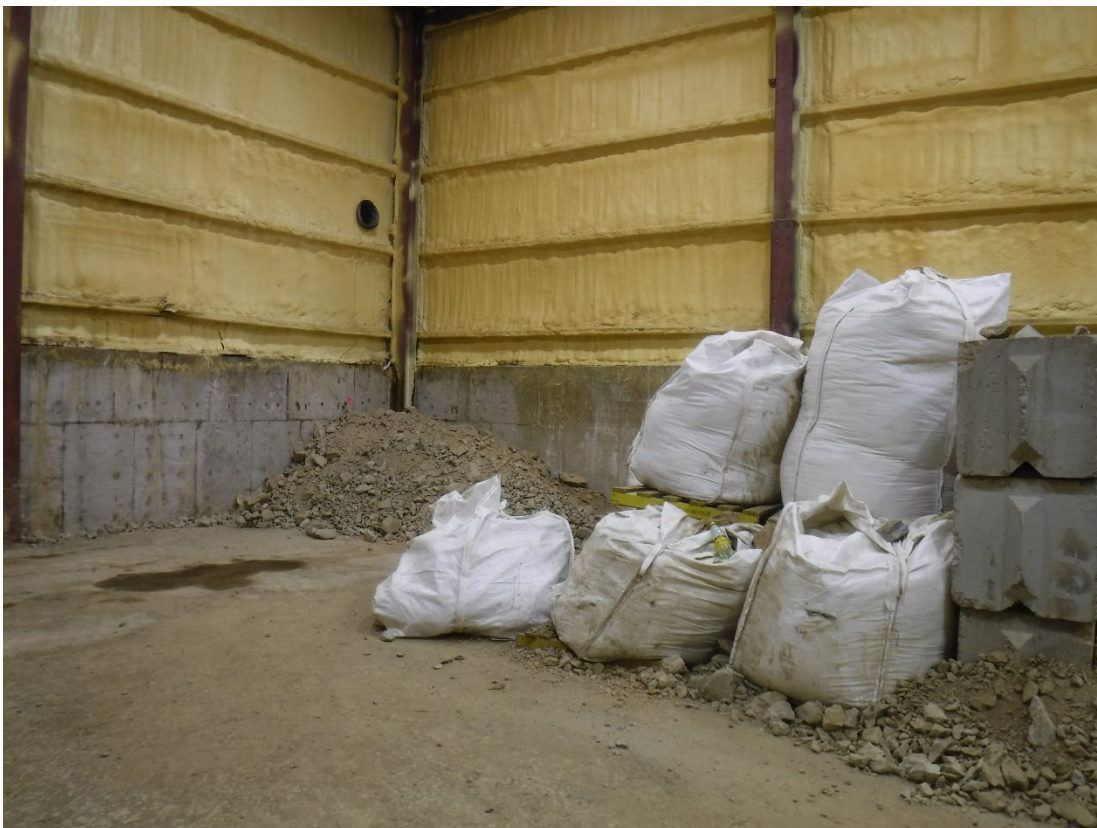
Photo 10: Ore material in the warehouse

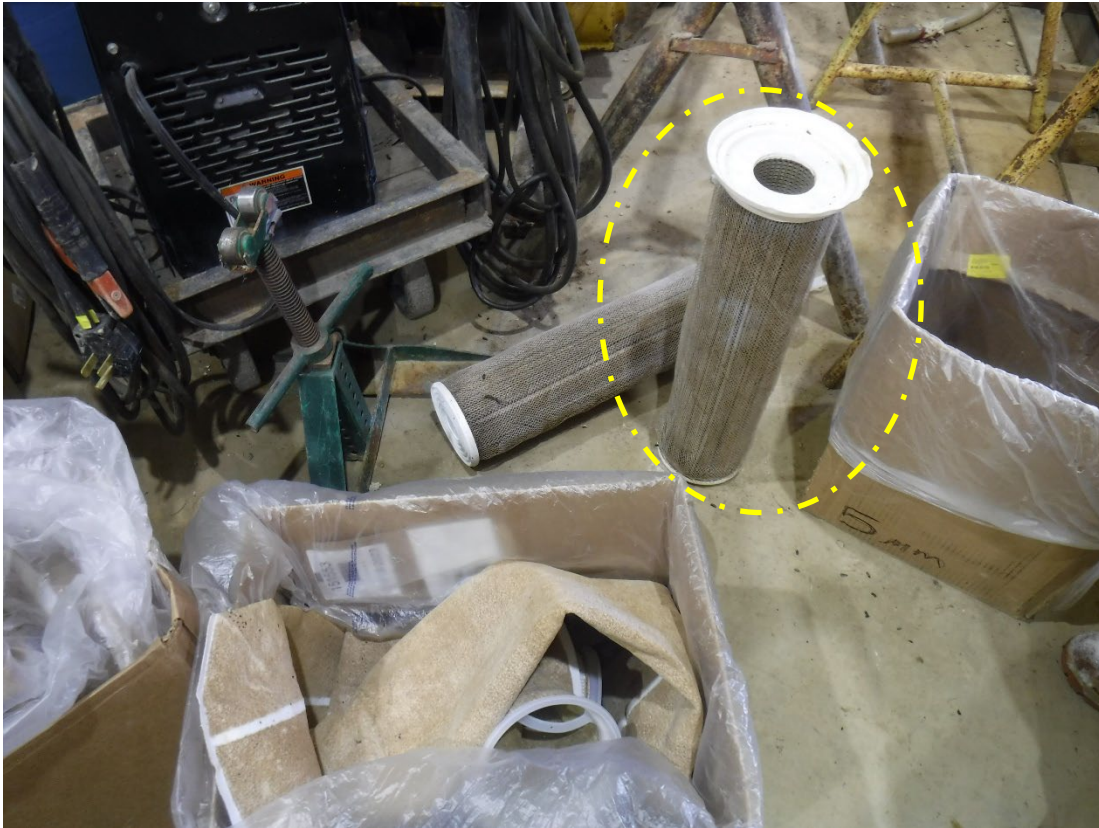
The site was not active during the inspection. The only activities reported to be taking place are related to normal operational activities associated with the water treatment plant and general site maintenance. The Operator did state that they have recently changed the style of filters used in the water treatment plant. The new filters have a larger capacity to hold sediment and still function correctly. The larger capacity results in less waste generated from water treatment.

Photo 11: Used water treatment filters, new style of filter circled

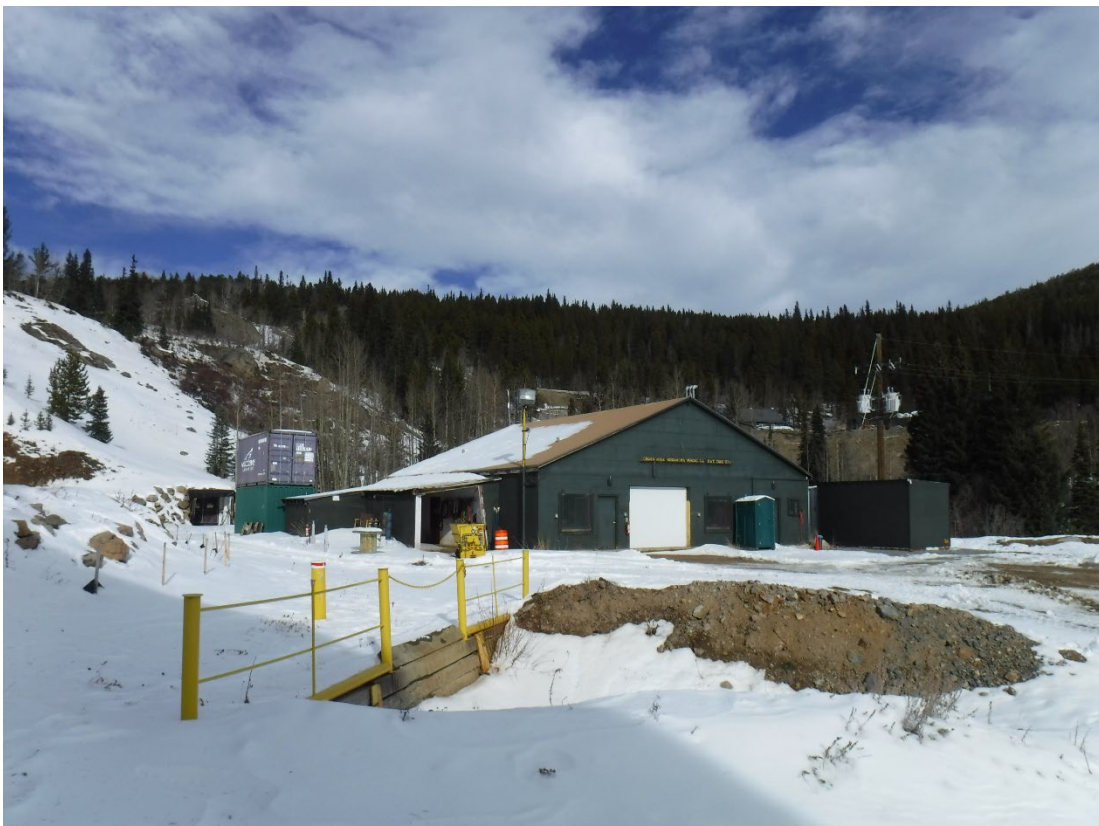
Photo 12: Looking north across the site.
