Bowie #1 inspection report

Permit Number: C-1981-038 Mine Name: Bowie No. 1 Mine Operator: Bowie Resources, LLC Operator Address: Mr Basil R Bear P.O. Box 1488 Paonia, CO 81428	County: Delta Operation Type: Underground Permit Status: Active Ownership: Private
	Operator Representative Present: None
Operator Representative Signature: (Field Issuance Only)

Inspection Start Date: November 13, 2024 Inspection Start Time: 12:45 Inspection End Date: November 13, 2024 Inspection End Time: 16:15		Inspection Type: Coal Complete Inspection Inspection Reason: Normal I&E Program Weather: Clear	
Joint Inspection Agency: None		Joint Inspection Contacts:	
Post Inspection Agency: None		Post Inspection Contacts:	
Inspector(s): Robert Zuber, P.E.	Inspector's Signature:

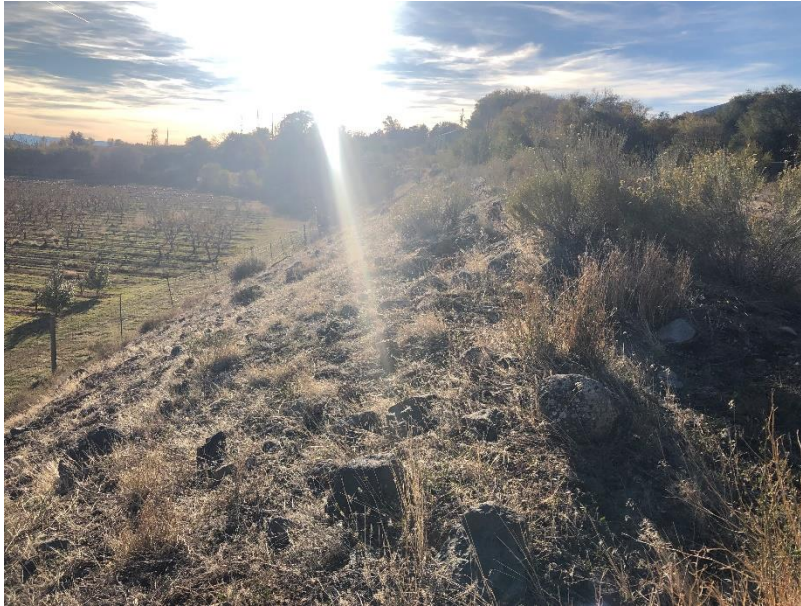
No erosion was seen at the loadout, including the steep slope between the loadout and the orchard below. The trestle across the river appears stable.

Slope below the loadout

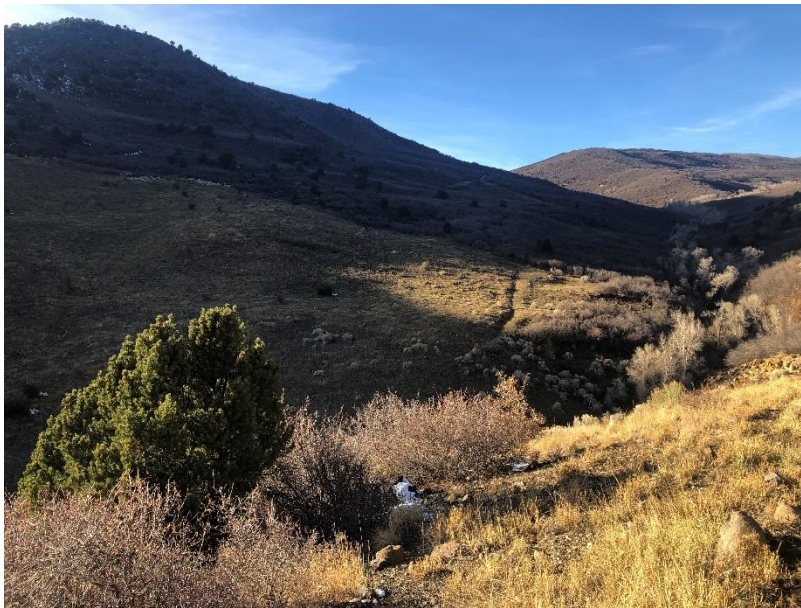
No erosion was seen at the West Mine, including the reclaimed road. The vegetation cover was good.

Reclaimed road at the West Mine

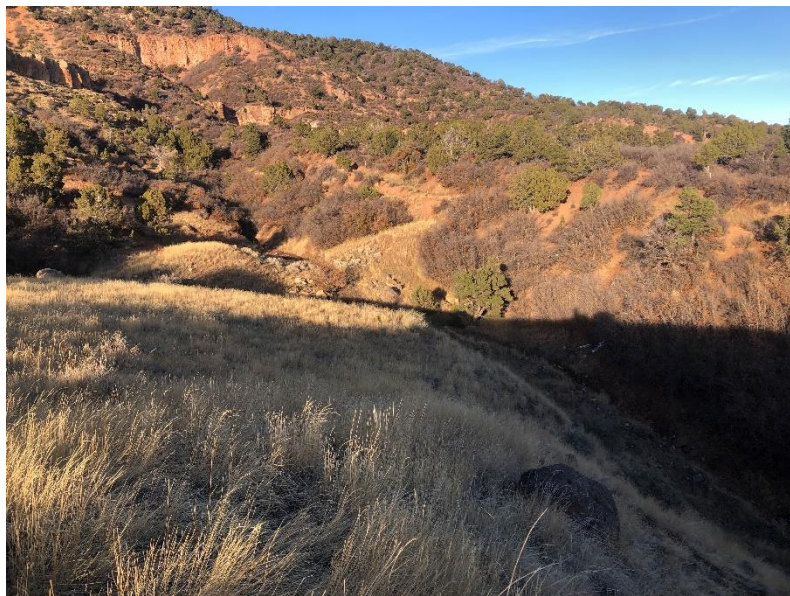
No problems were identified with the reclamation in the area of Ponds 1, 2, 3, and 4 (East Mine).

East Mine, looking toward reclaimed Pond 1

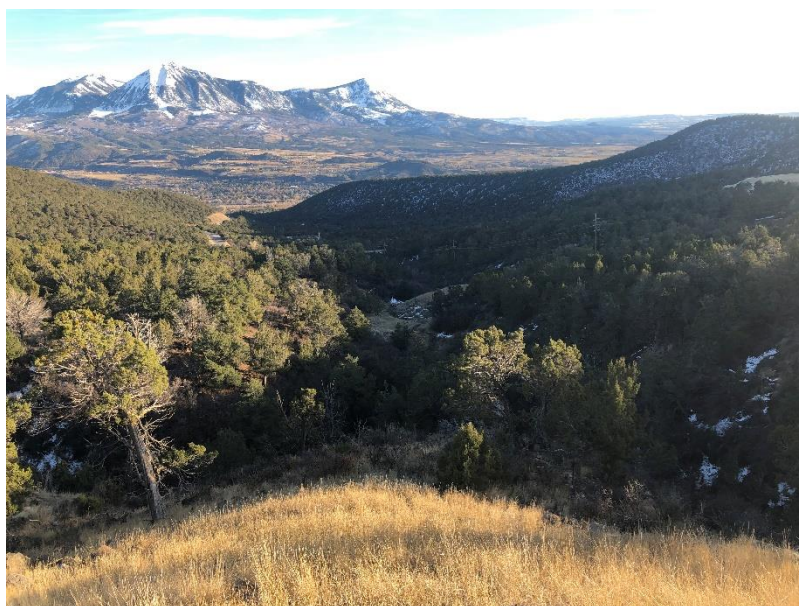
East Mine, looking toward reclaimed Ponds 3 and 4
