Bowie #2 inspection report

PERMIT INFORMATION

Permit Number: C-1996-083 Mine Name: Bowie No. 2 Mine Operator: Bowie Resources, LLC Operator Address: Mr. Basil Bear P.O. Box 1488 Paonia, CO 81428	County: Delta Operation Type: Underground Permit Status: Active Ownership: Private
	Operator Representative Present: Ken Pitt
Operator Representative Signature: (Field Issuance Only)

Inspection Start Date: November 13, 2024 Inspection Start Time: 13:00 Inspection End Date: November 13, 2024 Inspection End Time: 15:00		Inspection Type: Coal Complete Inspection Inspection Reason: Normal I&E Program Weather: Clear	
Joint Inspection Agency: None		Joint Inspection Contacts:	
Post Inspection Agency: None		Post Inspection Contacts:	
Inspector(s): Robert Zuber, P.E.	Inspector's Signature:

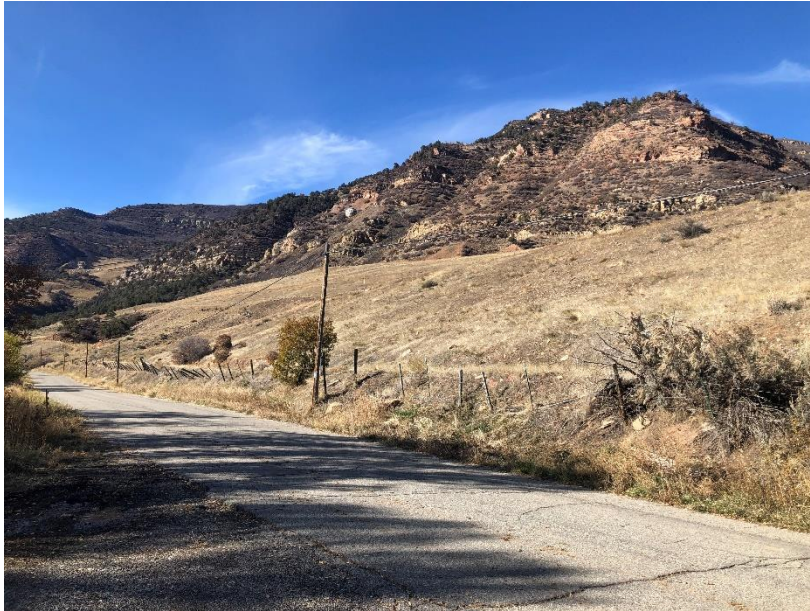
Gob Piles 1, 2, 3, and 4 appeared stable, and no significant erosion was observed. The overburden pile that is southeast of Gob Pile #2 has been reduced to a small amount of material, as most of it has been spread on this pile. A berm below the remaining pile appears to be functioning to prevent the material from being transported by runoff.

Gob Piles 1 and 4

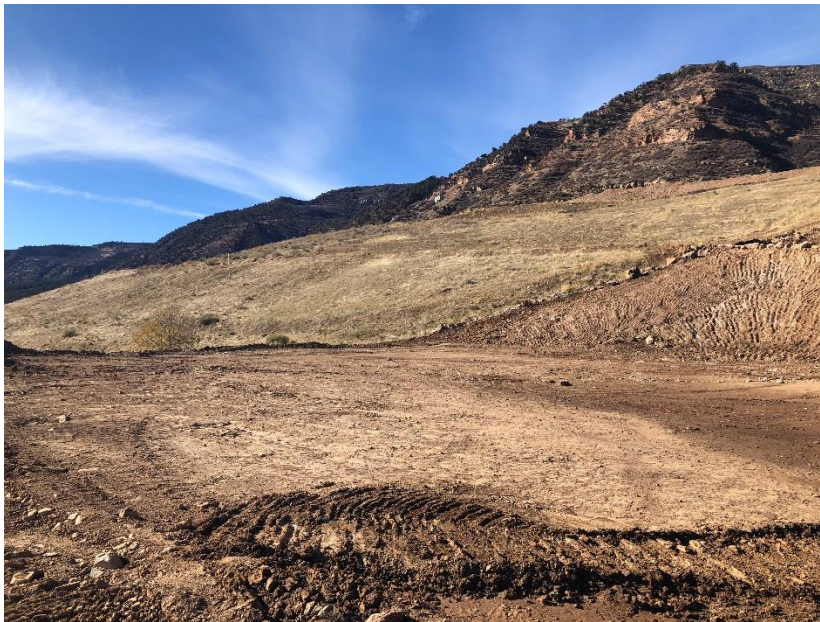
Gob Pile #2 – slope below upper (flat) area

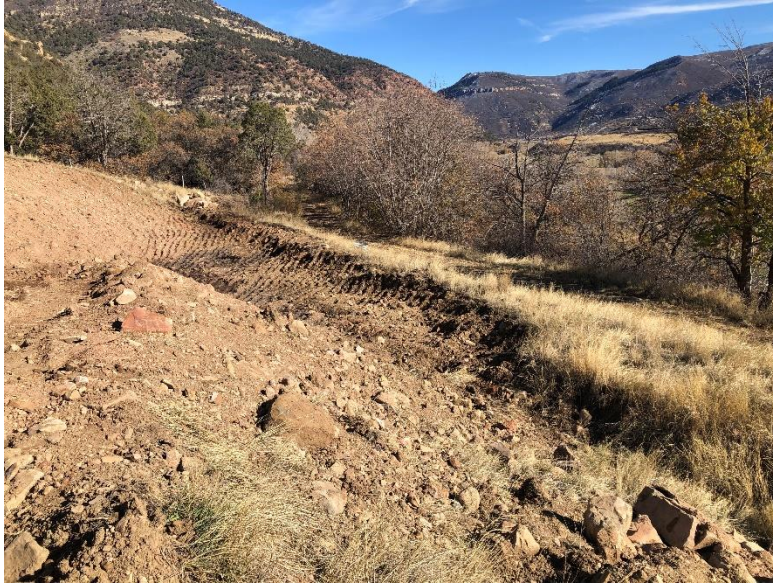
Berm protecting material in soil pile beside Gob Pile #2

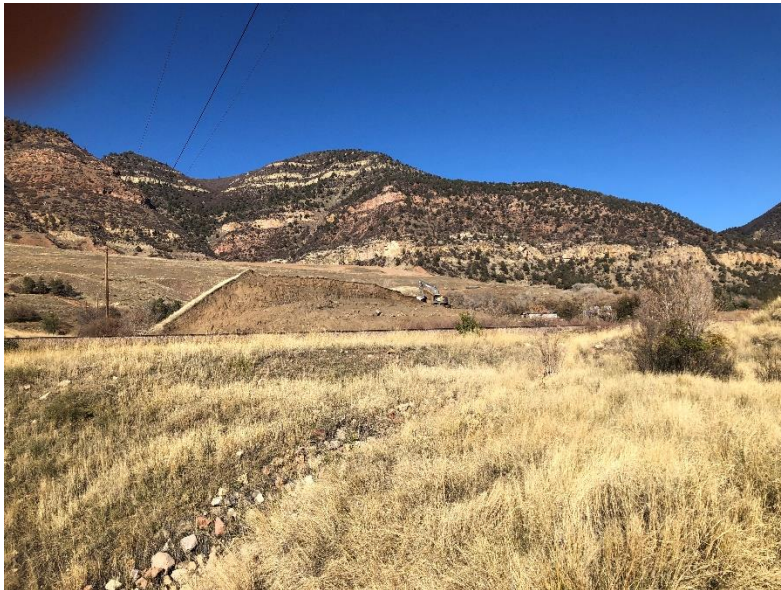
Equipment removing material from soil pile beside Gob Pile #3

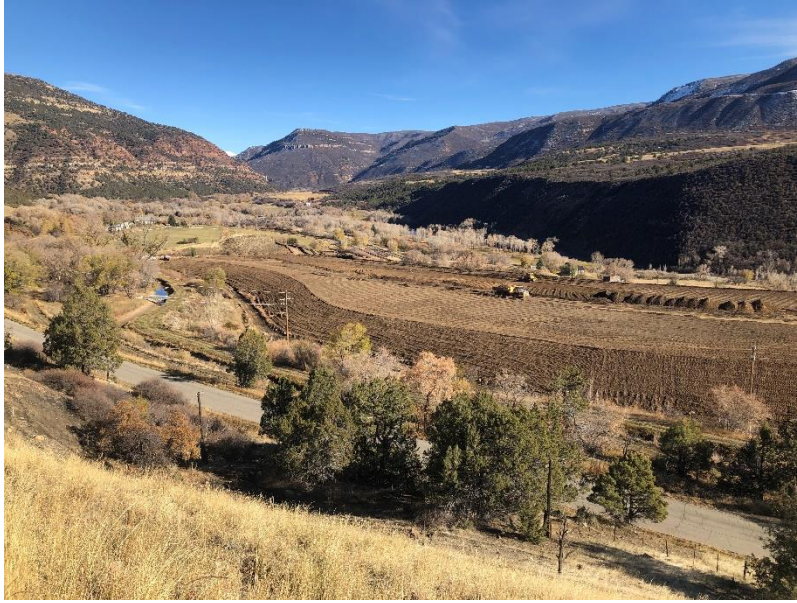
The primary activity onsite was hauling of topsoil to Gob Pile #3 by a contractor, Tribble and Sons.

Equipment hauling topsoil to Gob Pile #3 (east side)

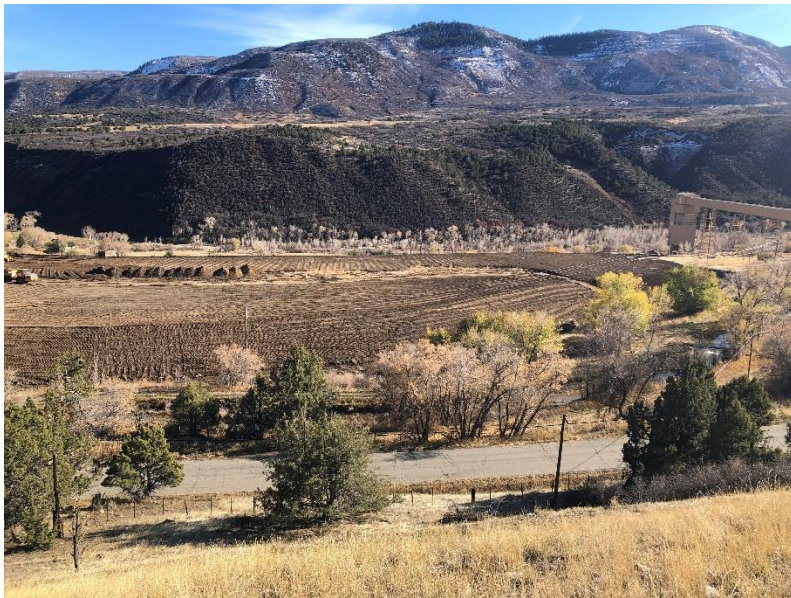
Equipment hauling topsoil to Gob Pile #3 (west side)

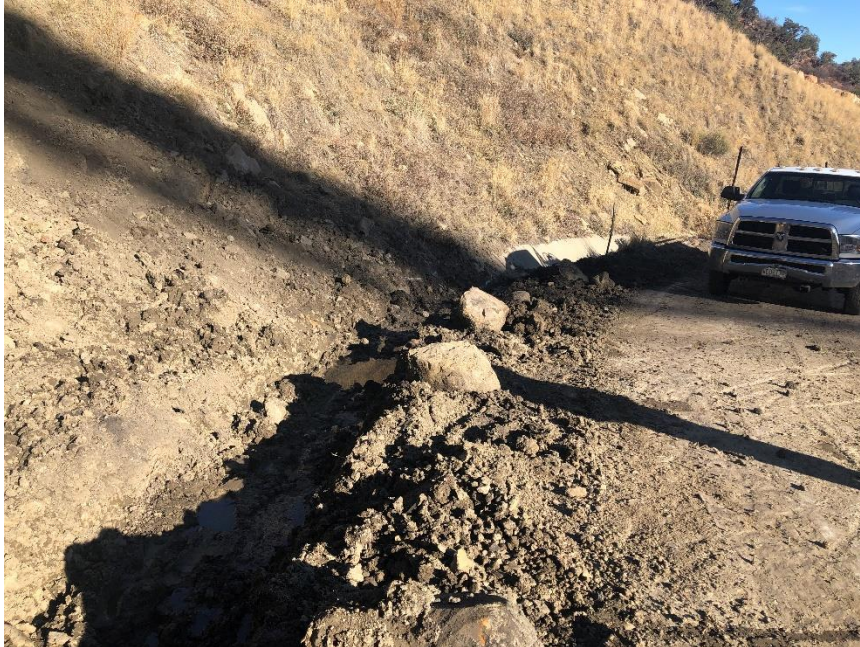
At the slide above Curve Number 10, Ken Pitt has worked to lower large boulders off the slope to prevent them from falling down the hill, and to keep the drainage ditch open below the slide. At the time of the inspection, this ditch appeared to be functioning.

Curve 10 – ditch that has been cleared

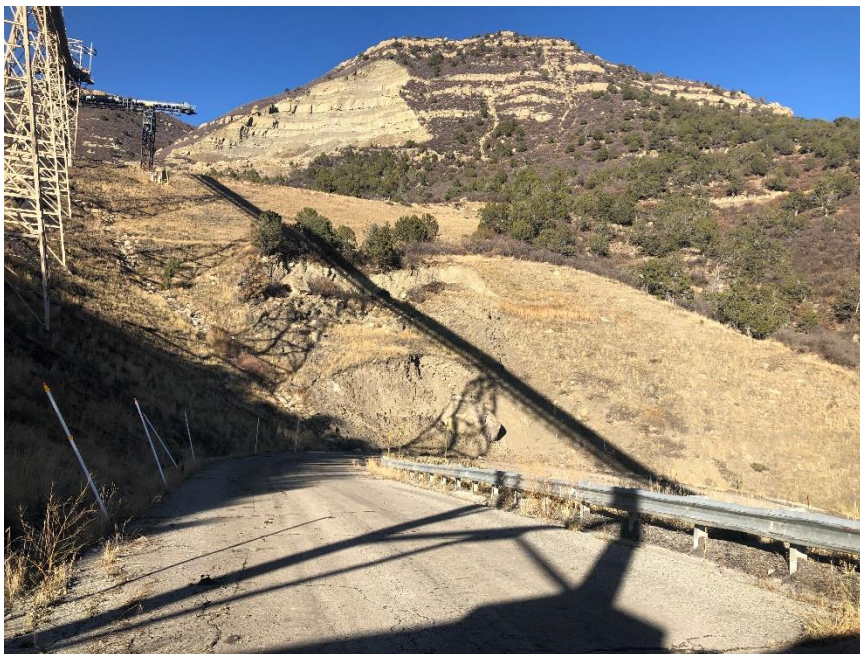
Curve 10 – slide area (note large rock below shadow of conveyor)

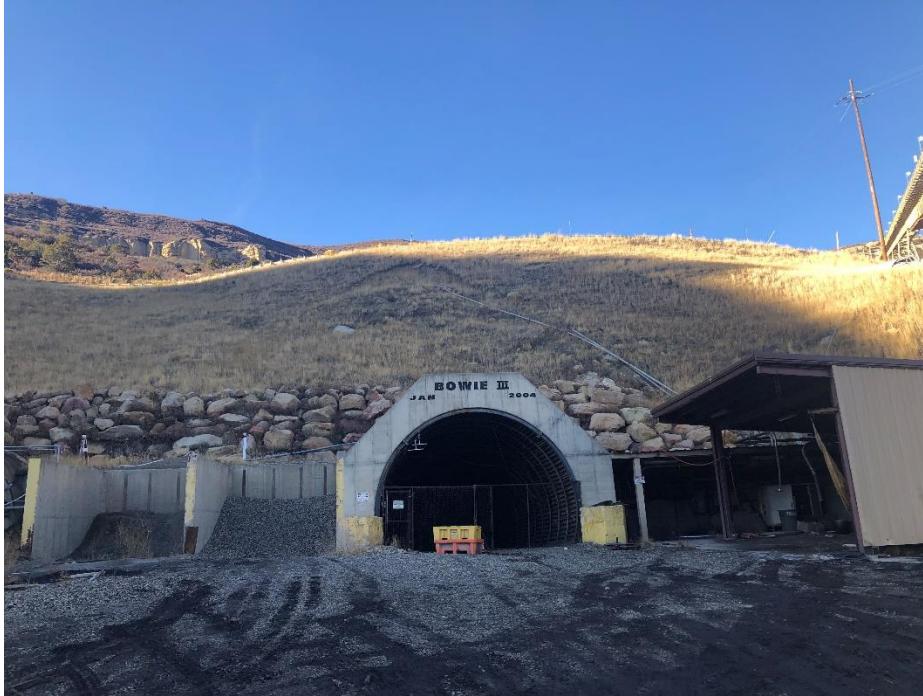
No problems were seen on the slopes above and below the benches. The slides above the B Portal Bench and Curve 11 (noted in the past) look stable.

Slump at B Portal Bench, north side

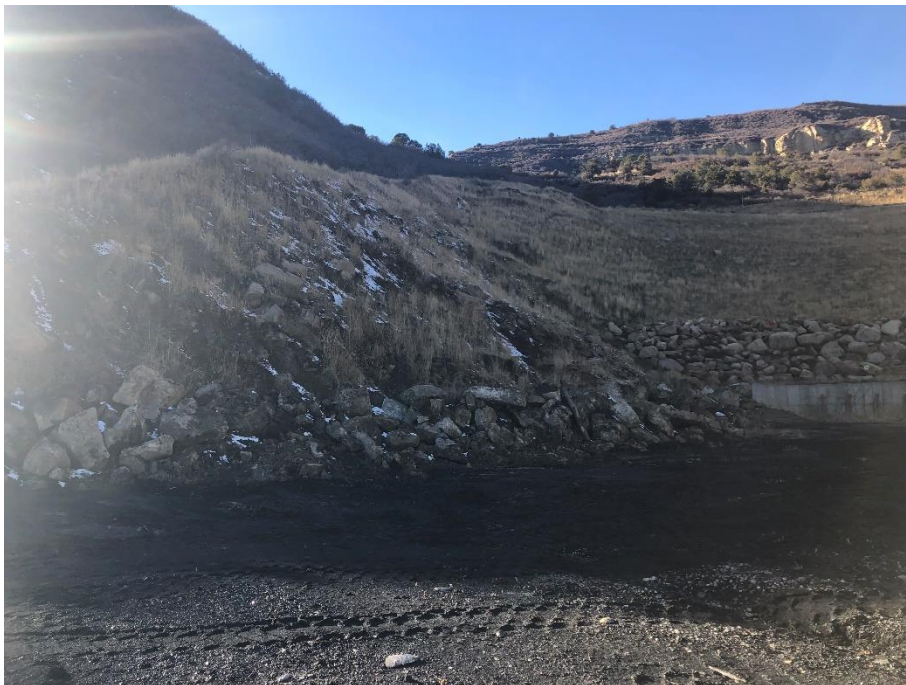
Slump at B Portal Bench, west side
