C1980007, West Elk Mine, November Inspection Report

PERMIT INFORMATION

Permit Number: C-1980-007 Mine Name: West Elk Mine Operator: Mountain Coal Company, LLC Operator Address: Jessica Wilczek 5174 Highway 133 Somerset, CO 81434	County: Delta, Gunnison Operation Type: Underground Permit Status: Active Ownership: Private
	Operator Representative Present: Josh Thompson
Operator Representative Signature: (Field Issuance Only)

INSPECTION INFORMATION

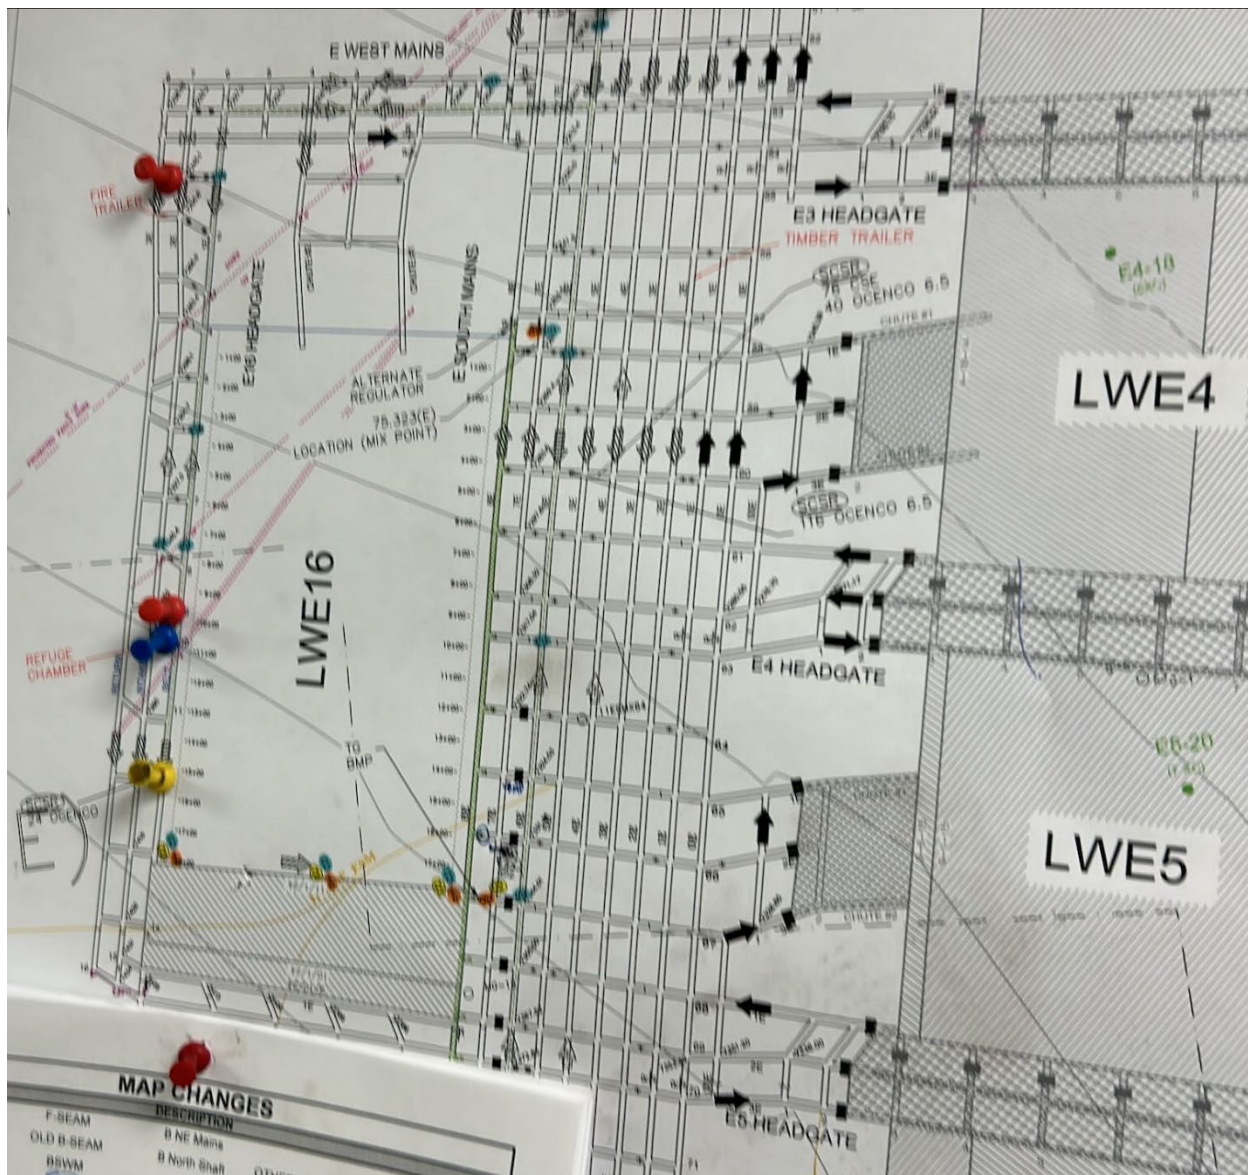
Longwall mining of the LWE16 panel was in progress, at around cross-cut 13 on the head gate.

Figure 1: Mine map showing longwall progress in LWE16

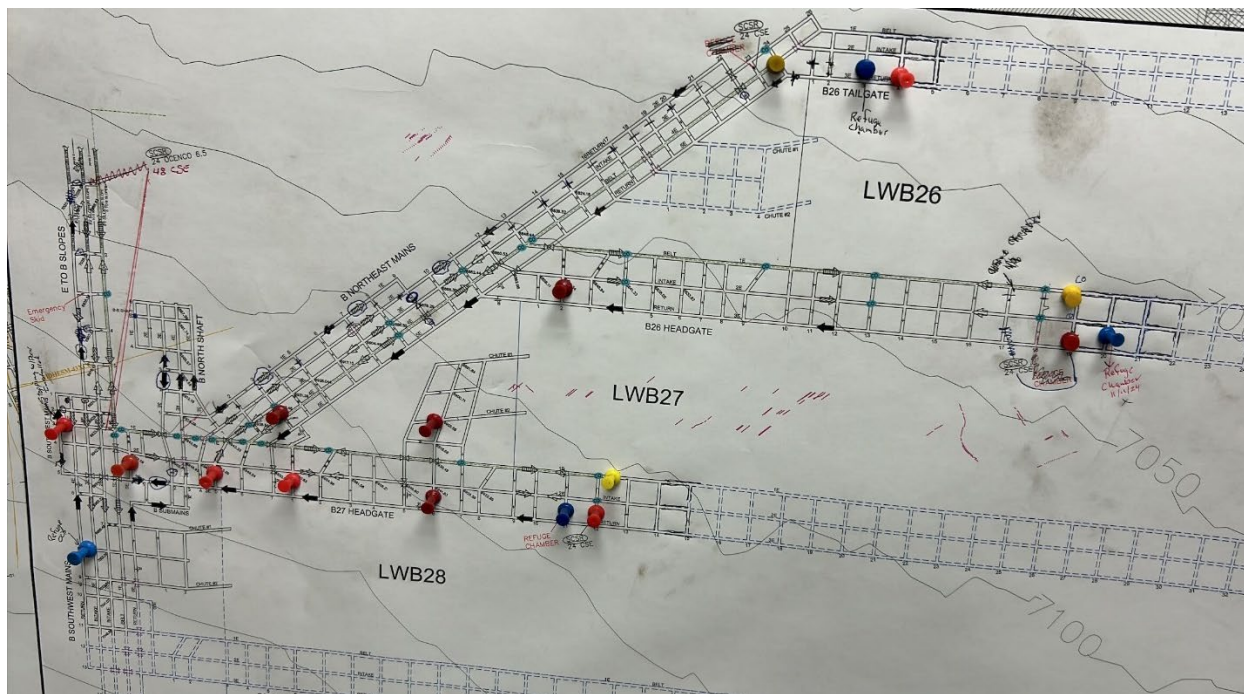
Three development crews were working: in the B26 tail gate at around cross-cut 5, in the B26 head gate at around cross-cut 22, and in the B27 head gate at around cross-cut 15.

Figure 2: Mine map showing development progress in B-seam

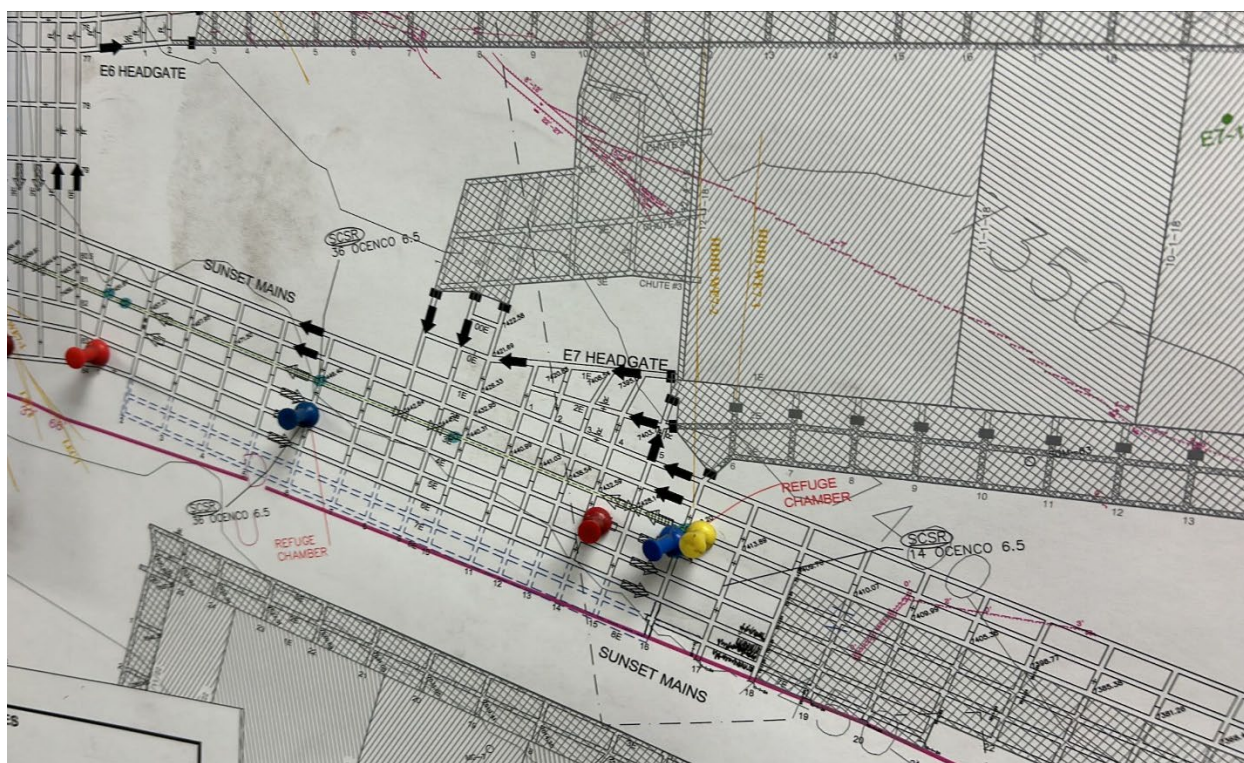
Contractors with Phoenix Mining continued to work on pillaring of the Sunset Mains, the job was expected to be completed by March 2025.

Figure 3: Mine map showing pillaring progress in Sunset Mains

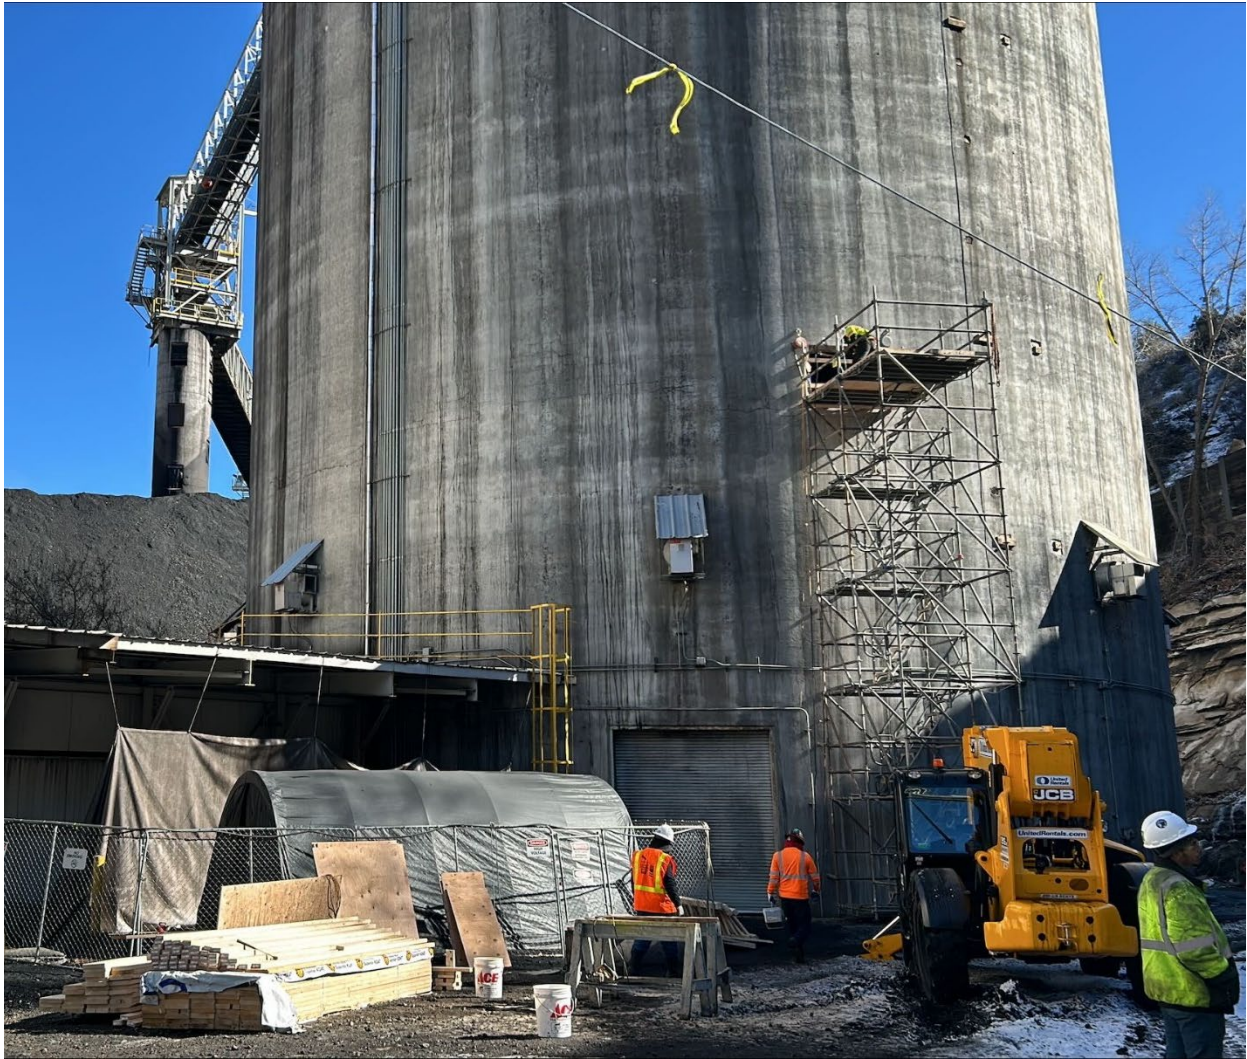
Work was in progress on silo 2. The contractors had constructed a scaffold outside the silo and cut a hole for access above the level of the hoppers and were working to construct platforms from timber and plywood inside the silo.

Figure 4: Scaffold tower and access to silo 2

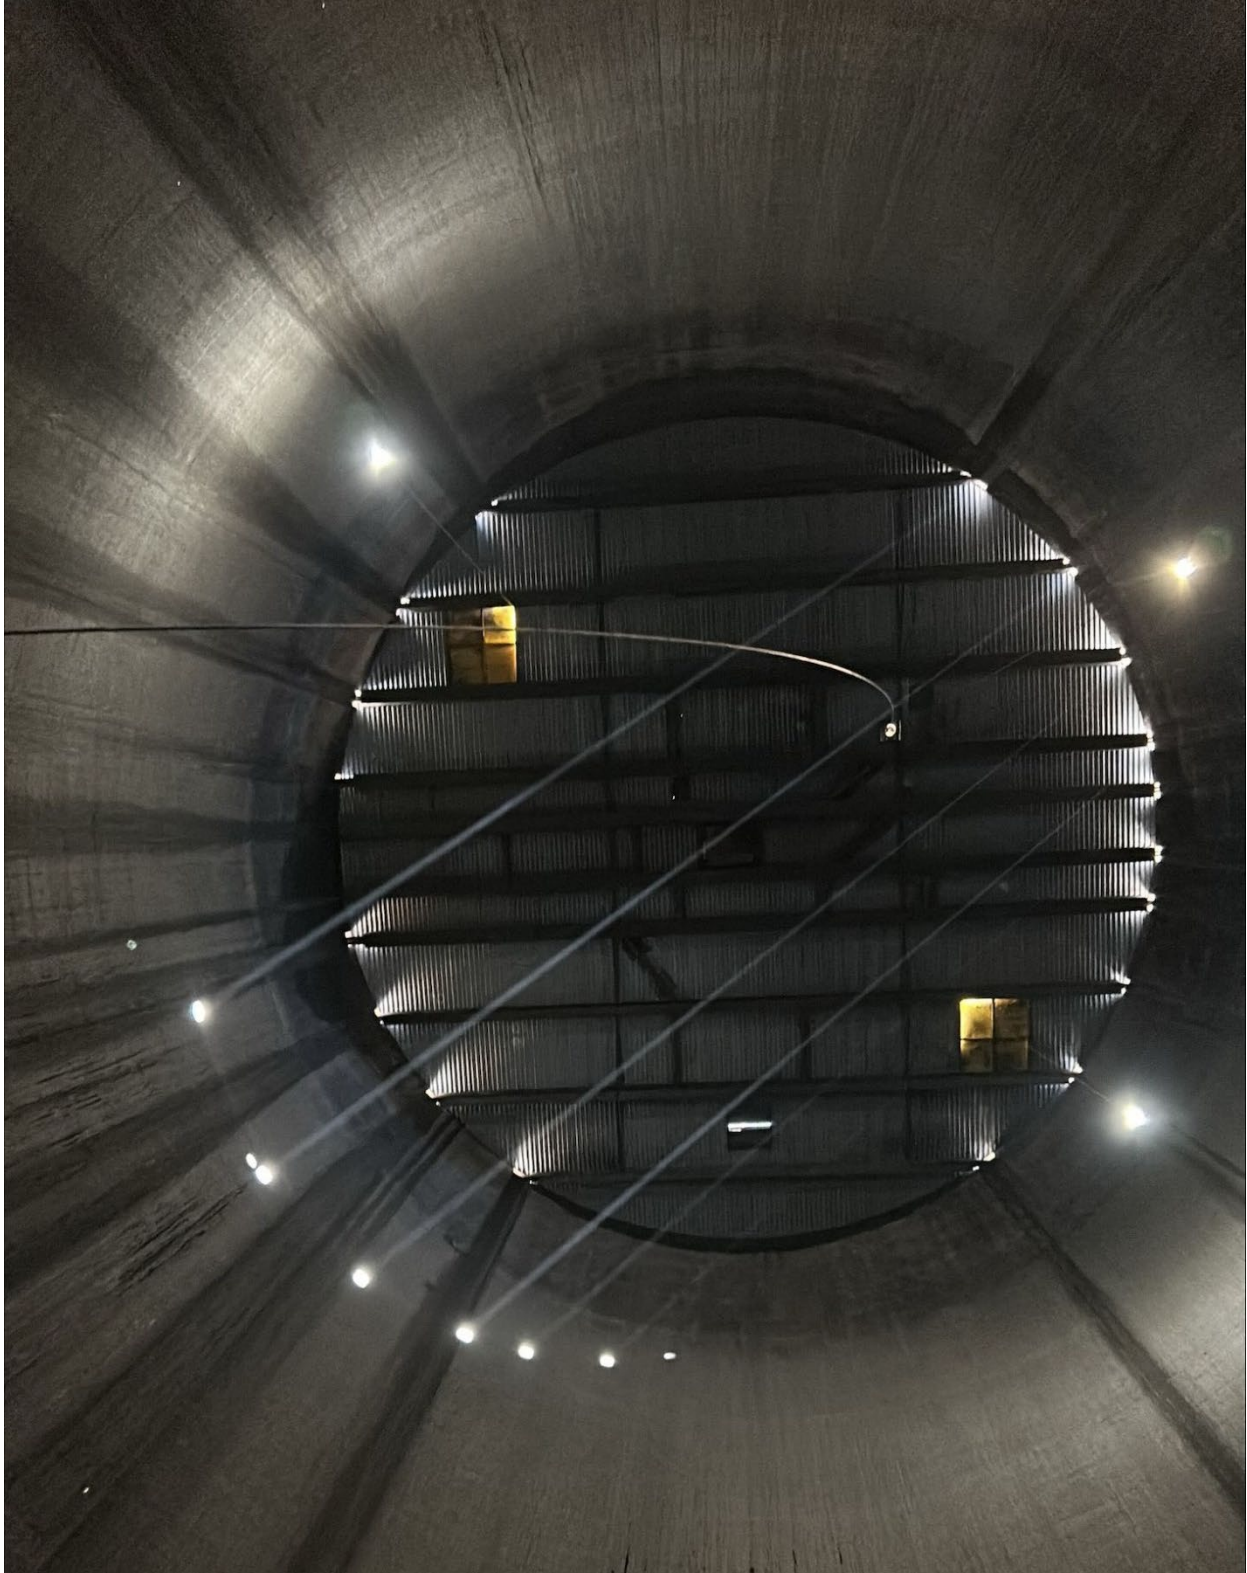
Figure 5: Inside of silo 2, looking up

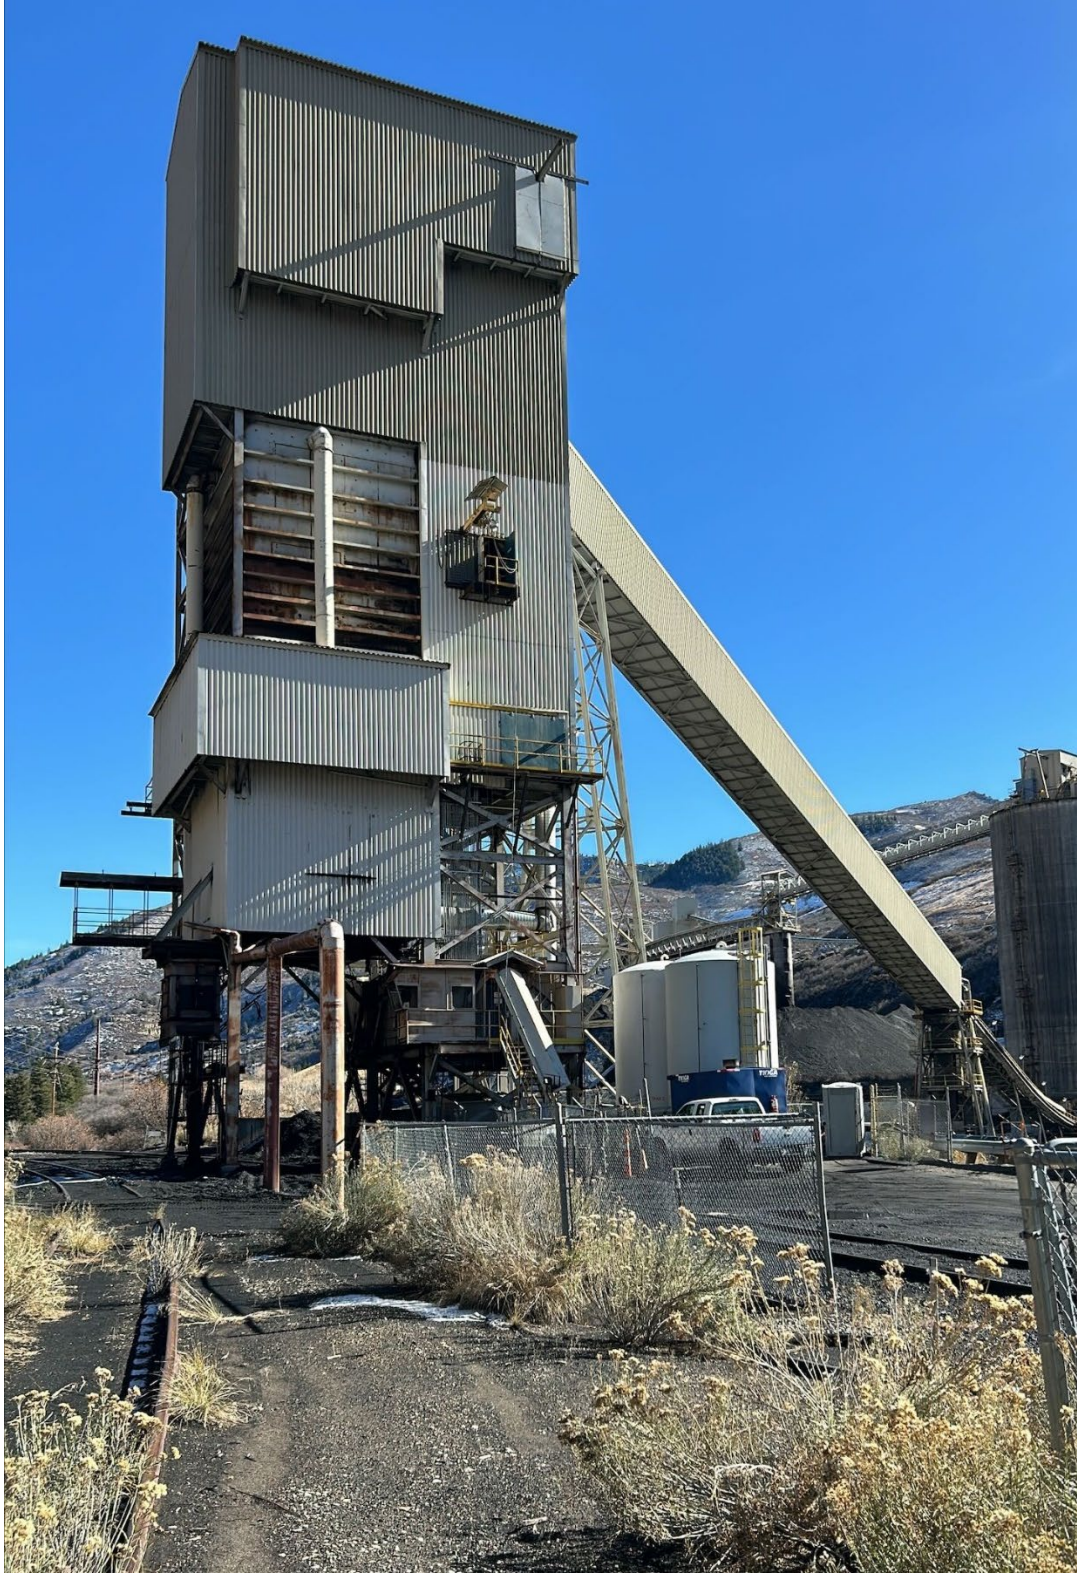
MCC had solicited bids to begin work on the stormwater project at the train loadout but had not yet awarded the contract.

Figure 6: Train loadout

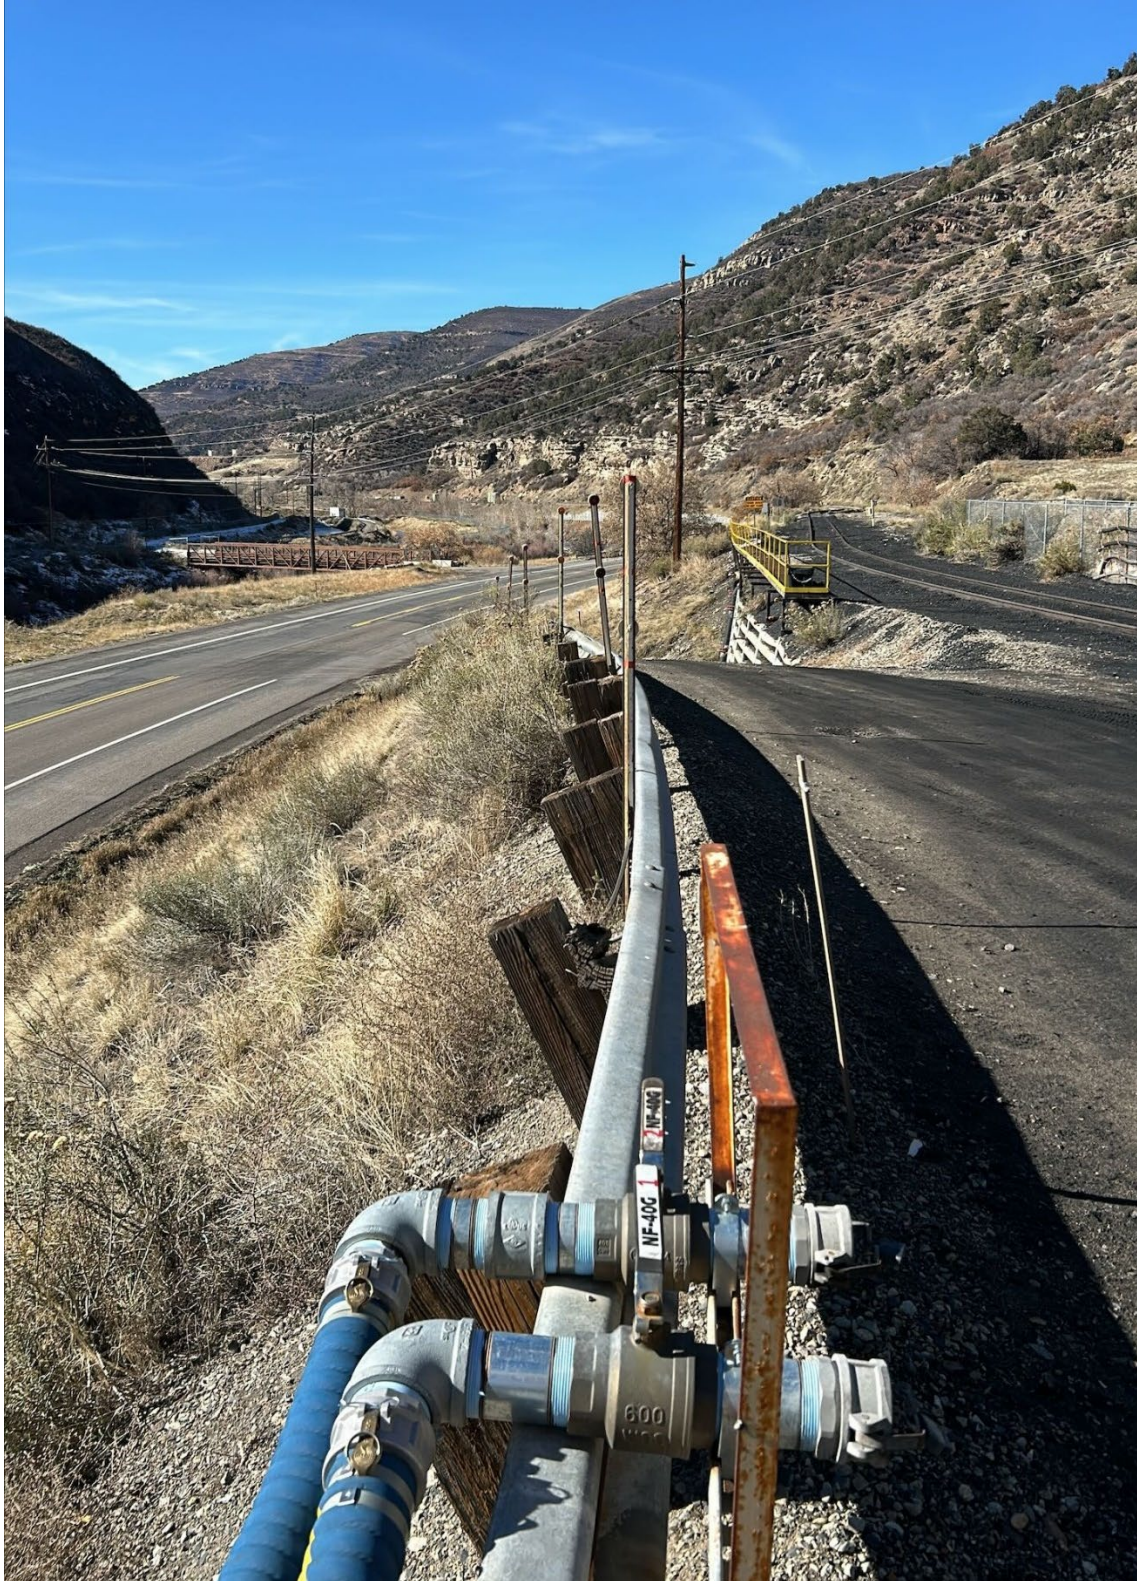
Figure 7: Train loadout access road

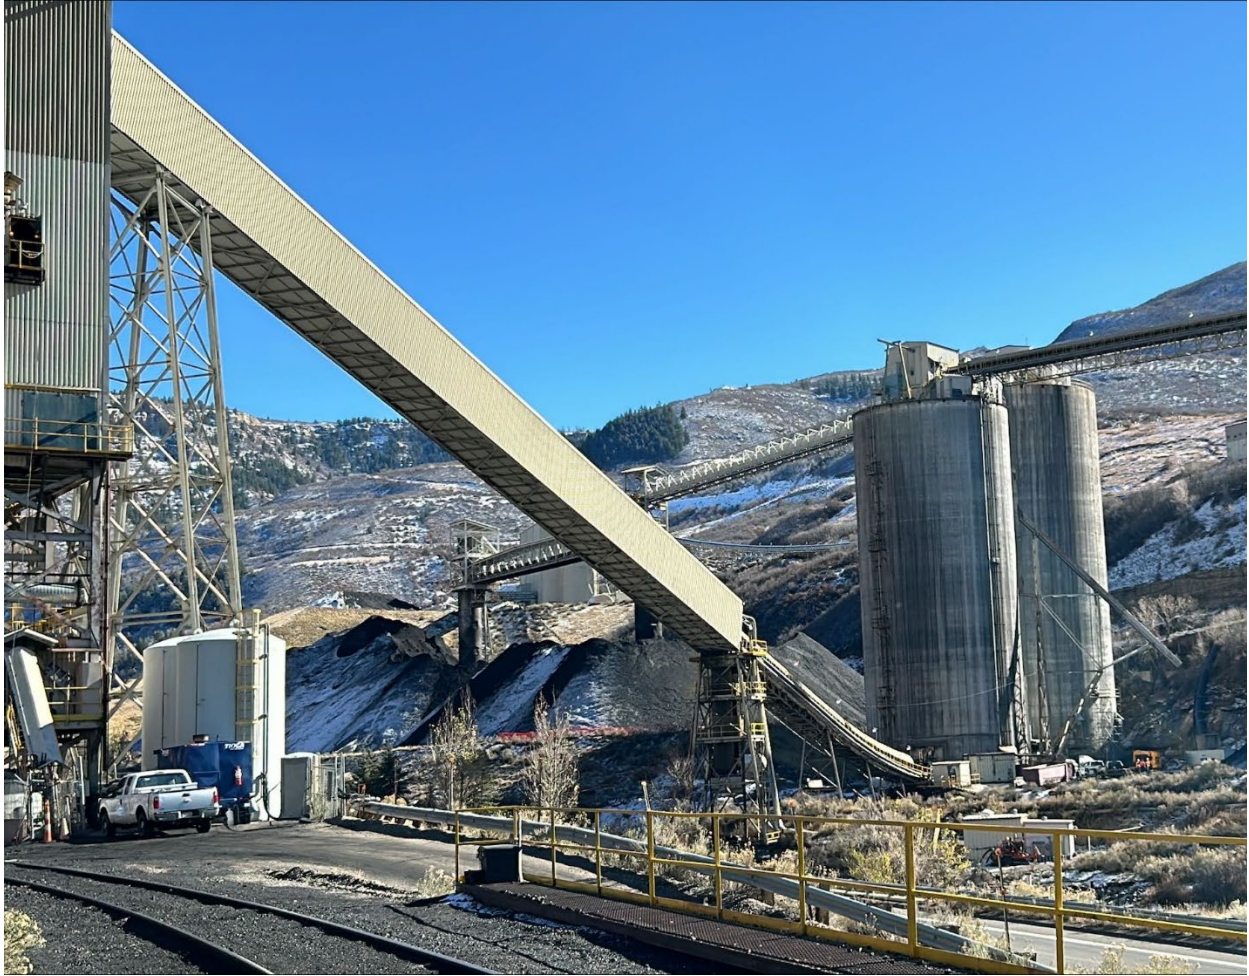
Figure 8: Silos and conveyor from train loadout

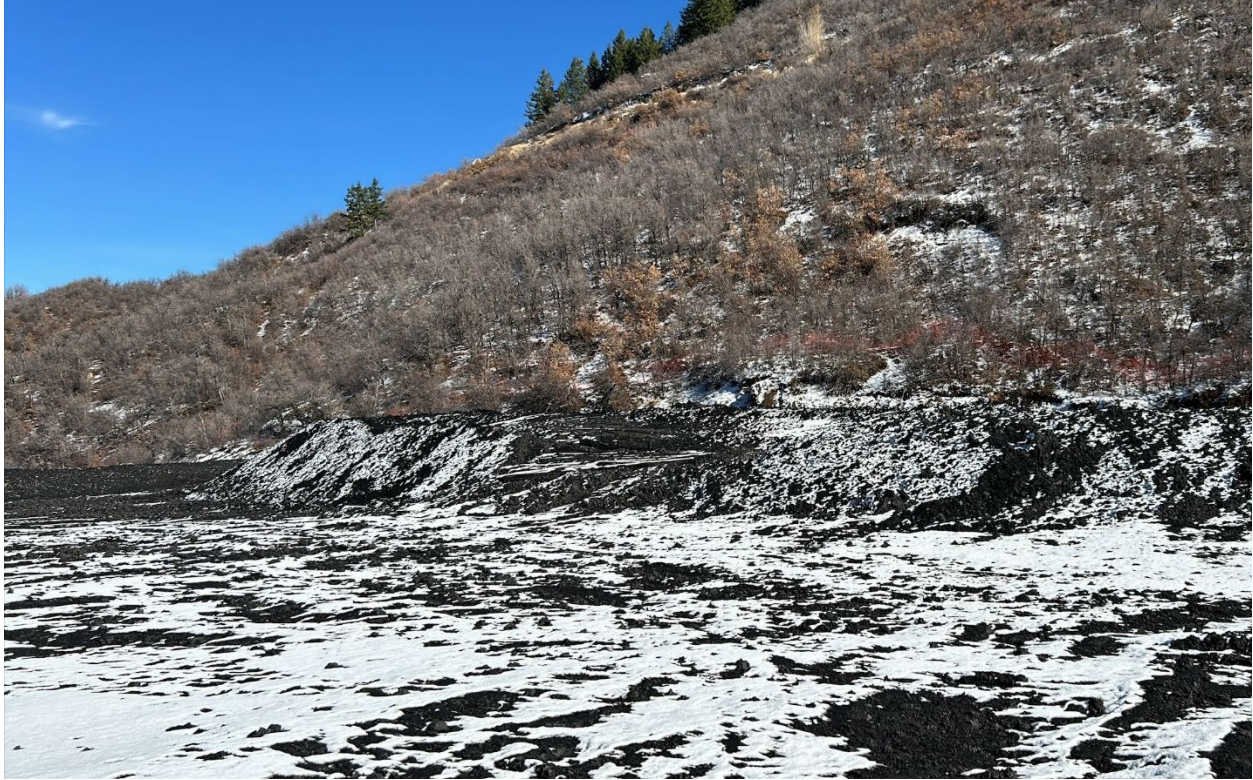
There was no significant processing waste stored on the RPE. The surface of the RPEE was smooth, compact and graded to drain to the northwest. Material cleaned from the sediment ponds was draining on the northeast of the RPEE, and some new material had been mixed in. A fence had been installed above the area to protect wildlife from straying into it.

Figure 9: Pond cleanings drying on RPEE, temporary orange fence in background
